# Near-Ground Tornado Wind Fields

Prepared by J. R. McDonald

Texas Tech University

Prepared for  
U.S. Nuclear Regulatory  
Commission

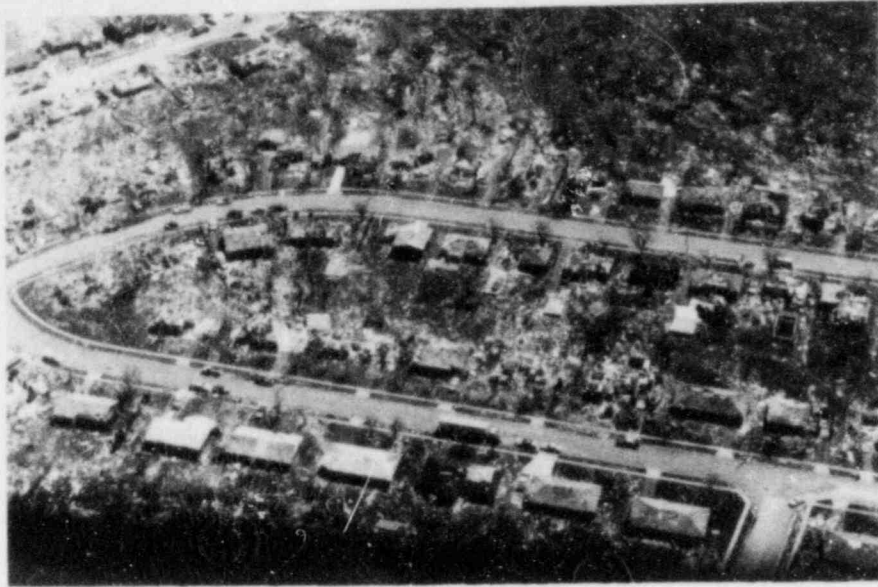
FIGURE 4. DAMAGE TO RESIDENCES IN XENIA, OHIO

Aerial photographs of residential damage such as the one shown in Figure 4 show swaths of debris on the ground that proponents of the suction vortex damage theory would say suggest the presence of suction vortices. Two alternate explanations are offered for the presence of the swaths:

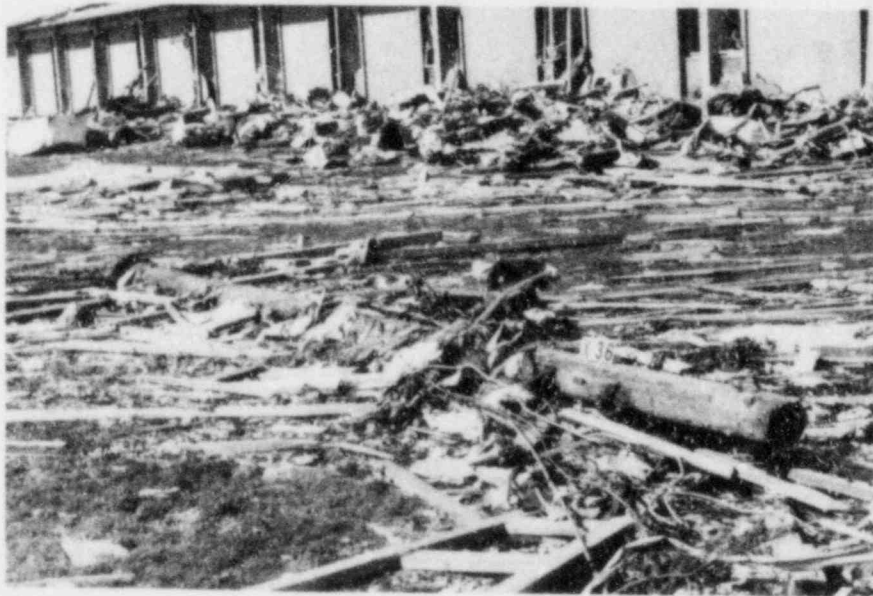
FIGURE 5. DEBRIS HAS COLLECTED AGAINST ARROW WOOD SCHOOL (when a structure interferes with flow of debris, it gives appearance of a swath)

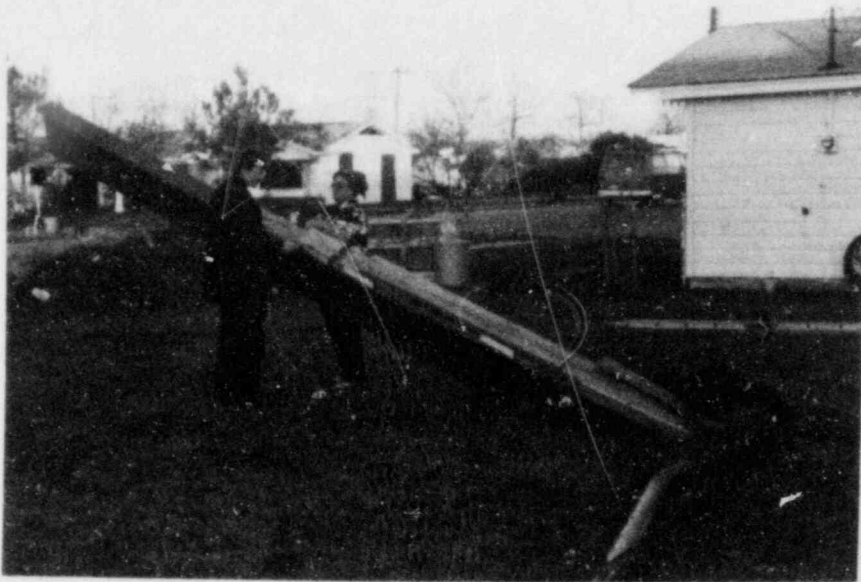
FIGURE 8. STEEL WIDE FLANGE BEAM TRANSPORTED  
BY BOSSIER CITY, LOUISIANA TORNADO

point. There has not, to our knowledge, been a documented case of a utility pole or large diameter pipe being picked up and transported as have the wide flange beams. Further studies on both the flight characteristics and impact effects need to be conducted for the wide flange missiles.

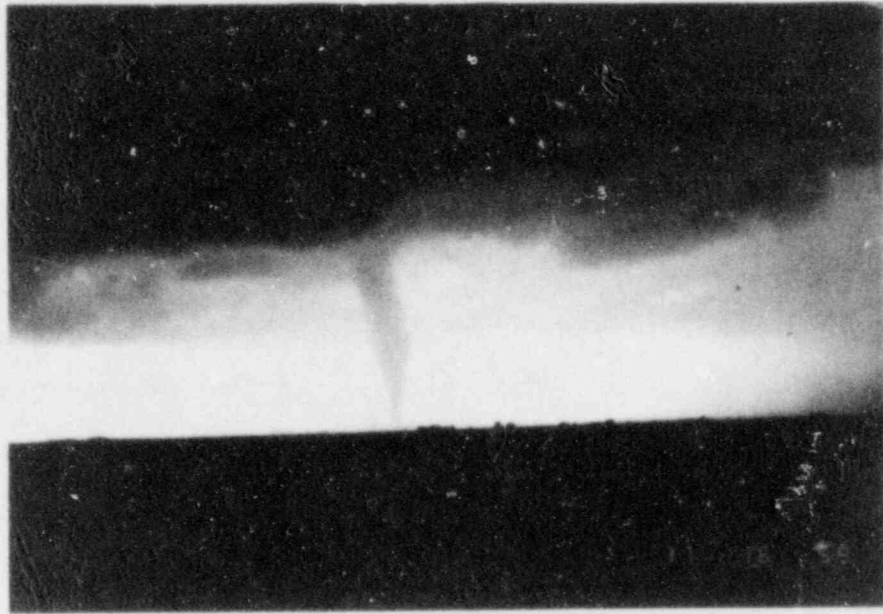
FIGURE 1. VIEW LOOKING WEST OF THE TORNADO WHICH STRUCK THE ALTUS AIR FORCE BASE (photograph courtesy of Dr. Howard Bluestein, OU-NSSL Severe Storm Intercept Project).

On the afternoon of May 11, 1982, several tornadoes touched down in southwestern Oklahoma. One of the tornadoes struck the east side of the city of Altus and traveled three miles in a northeasterly direction through the Altus Air Force Base, causing extensive damage (Figure 1). A second tornado touched down northeast of the Air Base just west of the Friendship community and traveled in a northerly direction at least twelve miles (Figure 2).

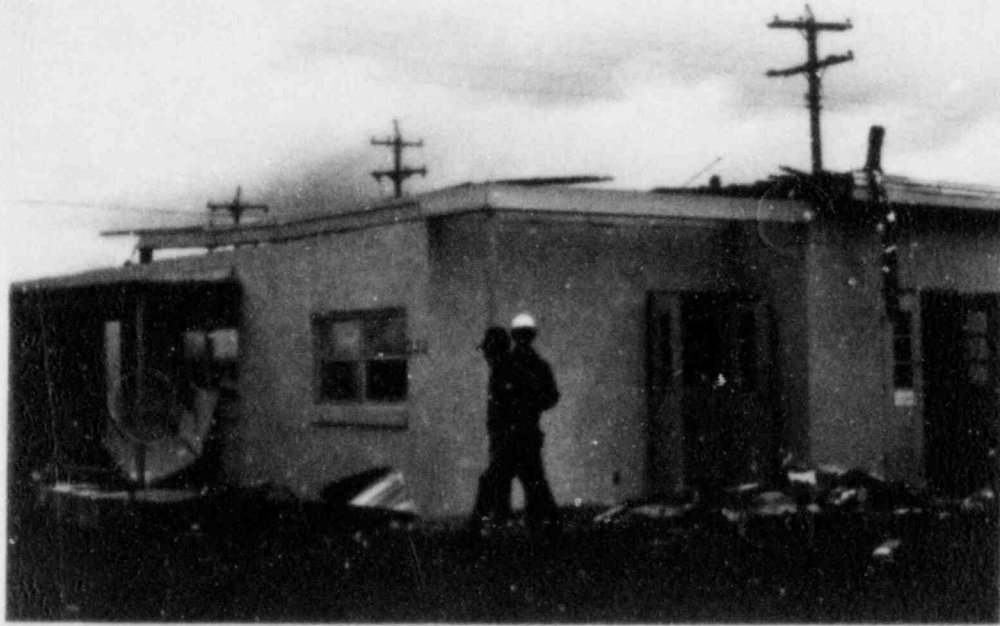
FIGURE 6. VIEW OF SOUTHEAST CORNER OF VETERINARY CLINIC (the cracks in the mortar joint below the bond beam occurred as the roof lifted).

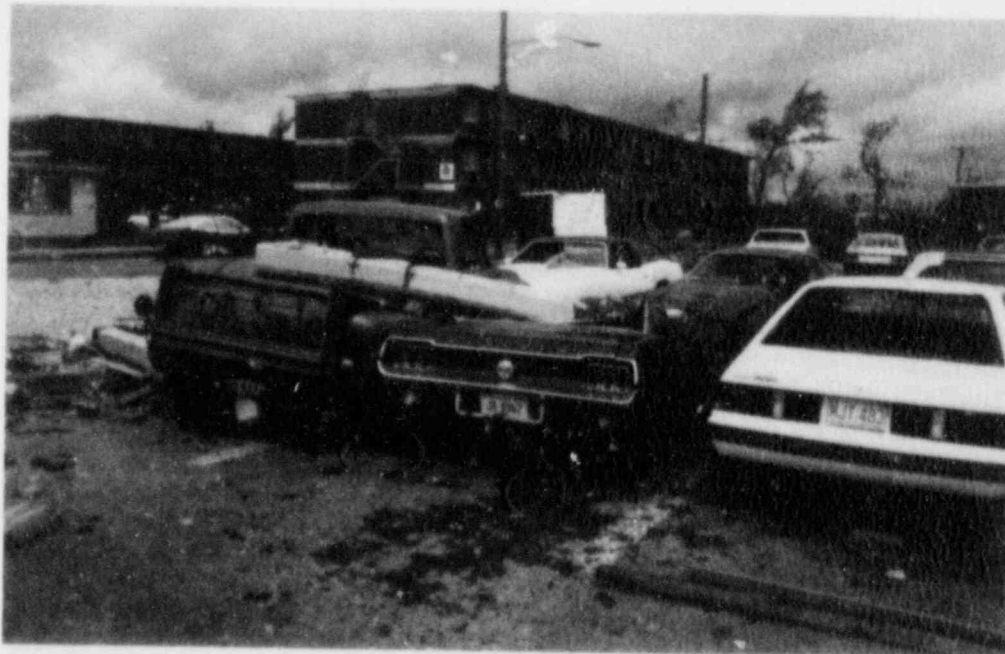
FIGURE 9. CONCRETE MASONRY BOND BEAM MISSILE (missile traveled from the base lawyer's office northeastward approximately 200 feet before striking the vehicles).

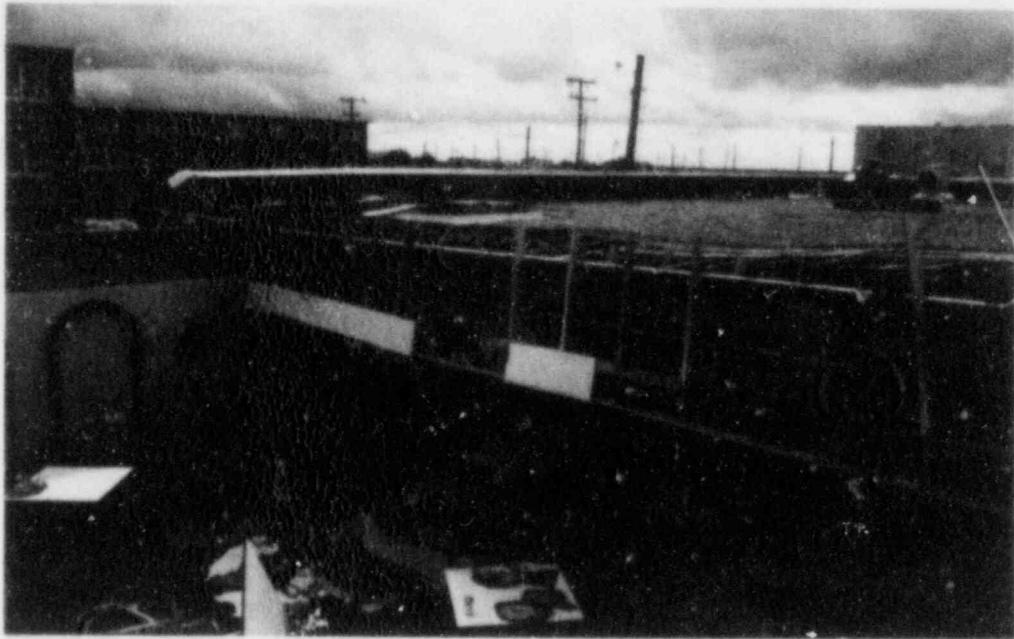
FIGURE 11. DAMAGE TO THE DINING HALL CAFETERIA ROOF.

A closer view of the damage to the cafeteria roof is shown in Figure 11. The roof consisted of 2x10 wooden joists spaced at 12 inches on center. The joists were secured with 10d nails which were toenailed to a wooden plate at the top of the wall. As the tornado passed, part of

the roof, including the roof joists, was removed and one precast concrete bond beam was lifted up and slightly displaced.

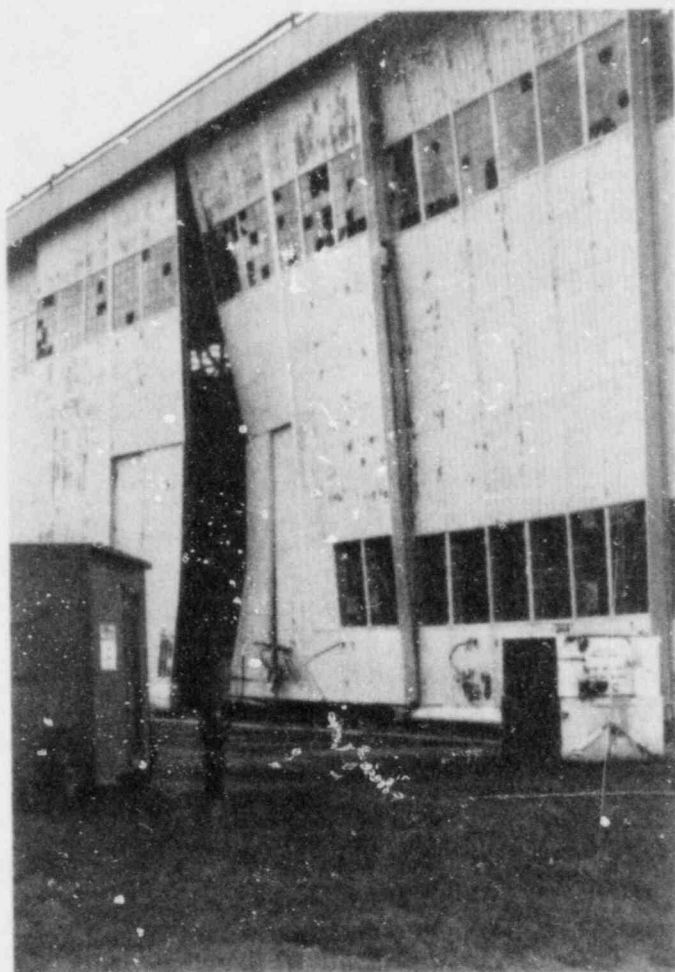
FIGURE 15. DOORS OF AIRCRAFT HANGAR (force of wind bent doors inward).

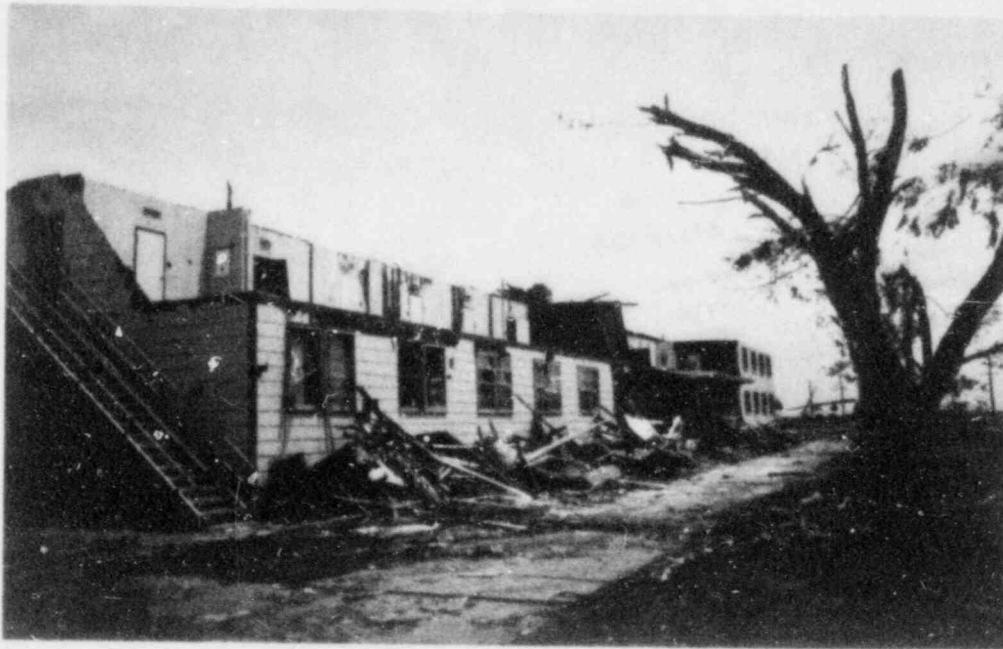
FIGURE 18. SEVERE-LOOKING DAMAGE TO WOODEN BARRACKS (most barracks lost their roofs and parts of second-story walls).

A series of five two-story wooden barracks were heavily damaged by the tornado. Sections of the roofs were removed and second story walls collapsed (Figure 18). Not all the roofs failed in the same manner. Some of the roof failures were attributed to anchorage of the roof to the

wide. Roof joists that were toenailed to plates on top of the walls pulled loose. In other cases, the wood joists split horizontally along their entire length. When the roof joists were removed the top of the walls were left unsupported and in many cases the walls collapsed. The damage intensity was estimated to be F2 or F3 based on damage to the wooden roof system.
