NUREG/CR-5785
ORNL/TM-11950

Experimental Results of Tests to Investigate Flaw Behavior of Mechanically Loaded Stainless Steel Clad Plates

Oak Ridge National Laboratory

Prepared for
U.S. Nuclear Regulatory Commission

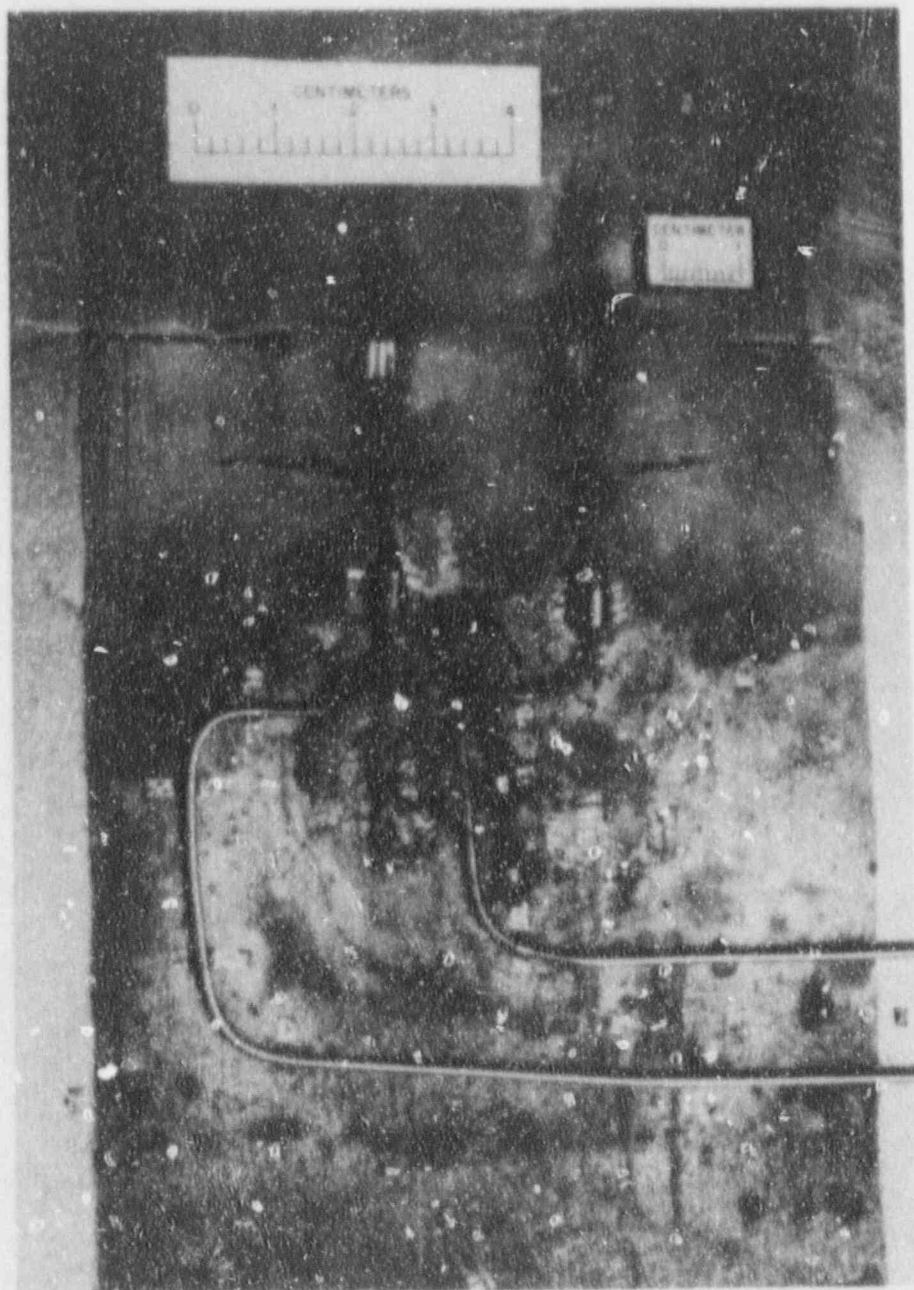
Fig. 4.2. Surface crack in the heat-affected zone of the electron beam weld of clad plate CP-15 after the second pop-in (top center), extending as dimples into the cladding on either side. The crater on the left of the crack was formed during electron beam welding and not during testing.

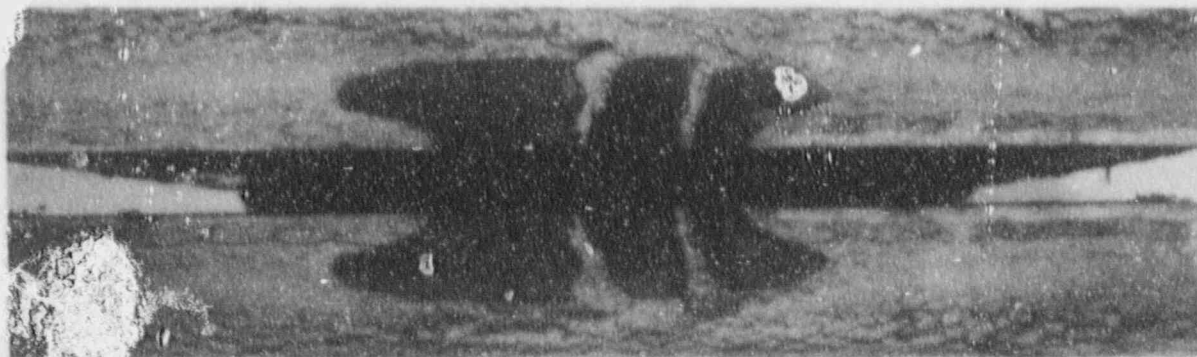
Fig. 4.9. Fracture surfaces of the broken halves of clad plate CP-17.

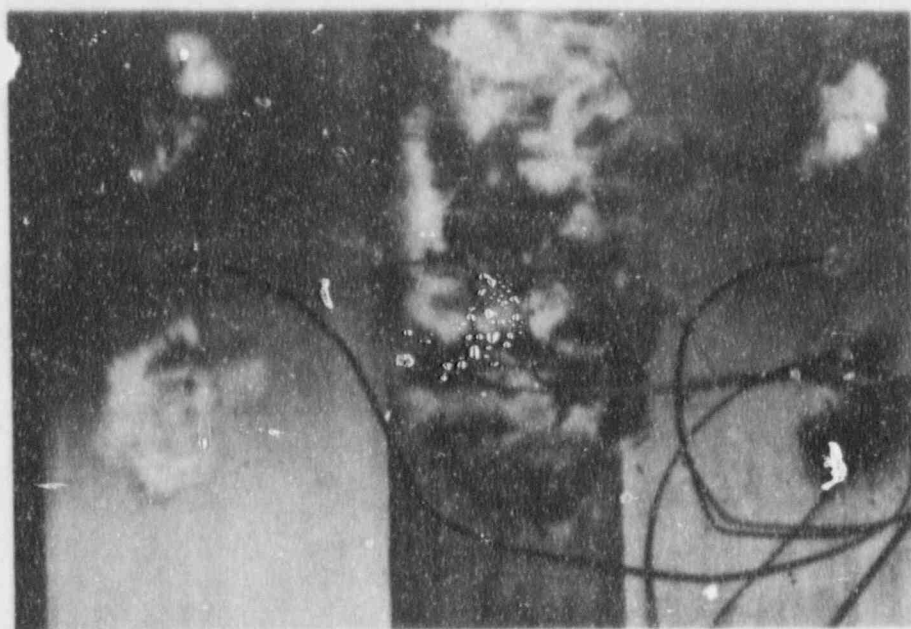
Fig. 4.11. Fairly wide but shallow crater formed on the surface of clad plate CP-19 as the flaw tunneled below.

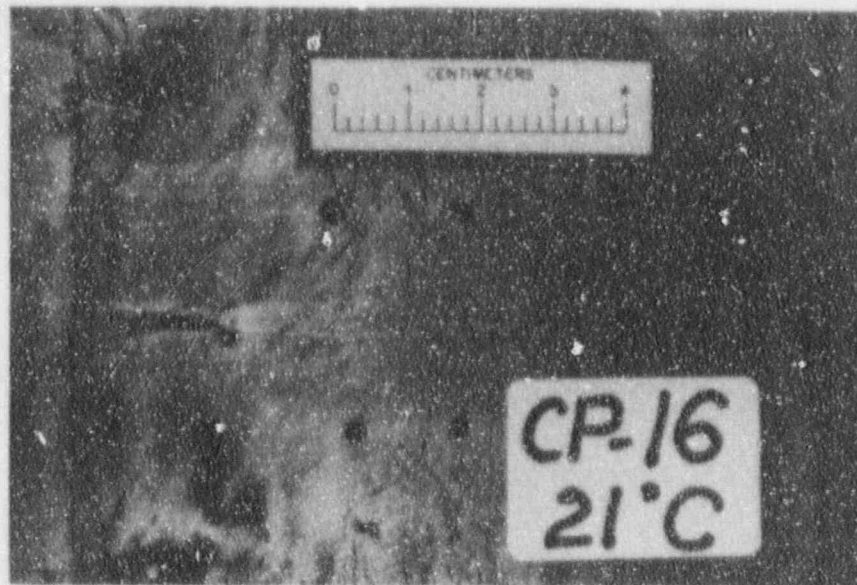
Fig. 4.18. The flaw in the electron beam weld heat-affected zone after the first event during the test of clad plate CP-16. No evidence of propagation along the surface can be seen. Note the dimpling that extends from the crack ends to the cladding.

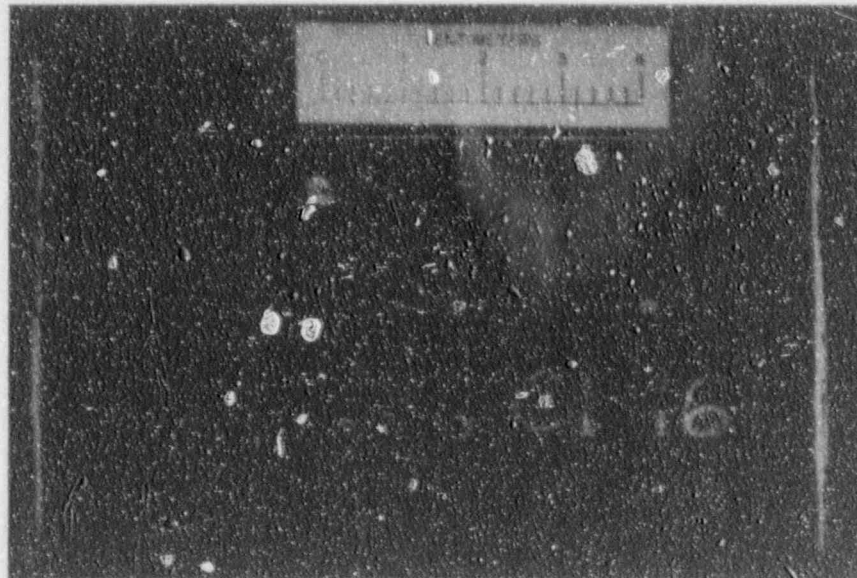
Fig. 4.19. Dye penetrant indication of flaw in clad plate CP-16 after first event. This is the same area as shown in Fig 4.18, but no surface crack other than that in the electron beam weld heat-affected zone could be detected. The two parallel lines normal to the flaw were added to mark the start of the cladding.

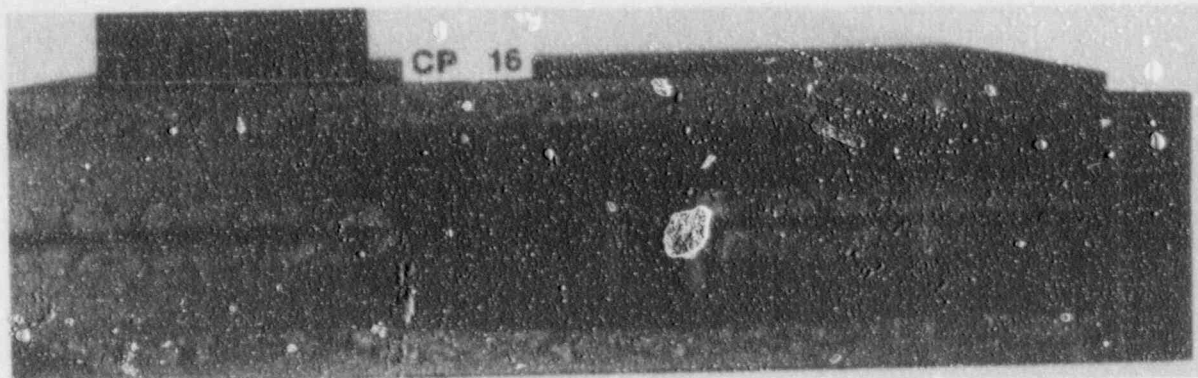
Fig. 4.21. The fracture surface of clad plate CP-16. During the second event the flaw propagated along the central portion of the plate thickness, with intact ligaments approximately 10 and 16-mm-thick along the top and bottom surfaces of the plate, respectively.

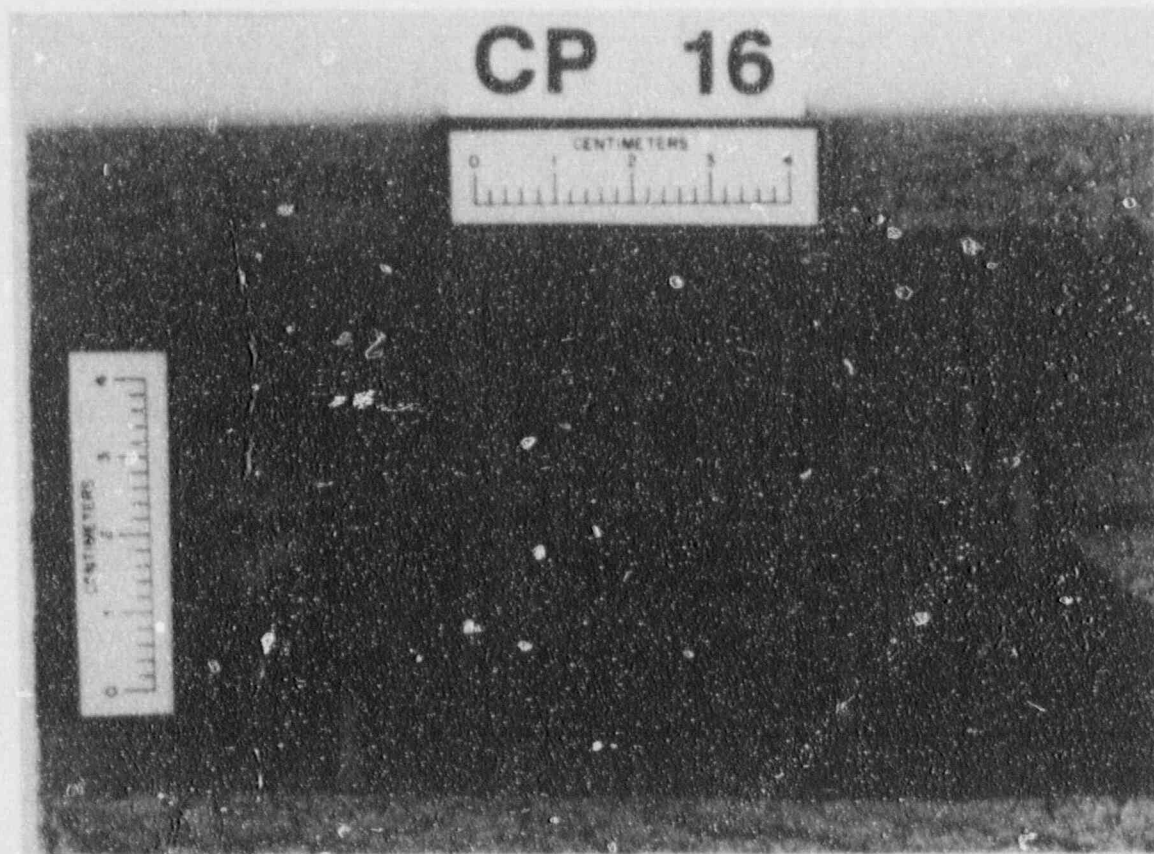
Fig. 4.22. Closeup of the electron beam weld flaw and its arrested shape in clad plate CP-16 at the end of the first event.

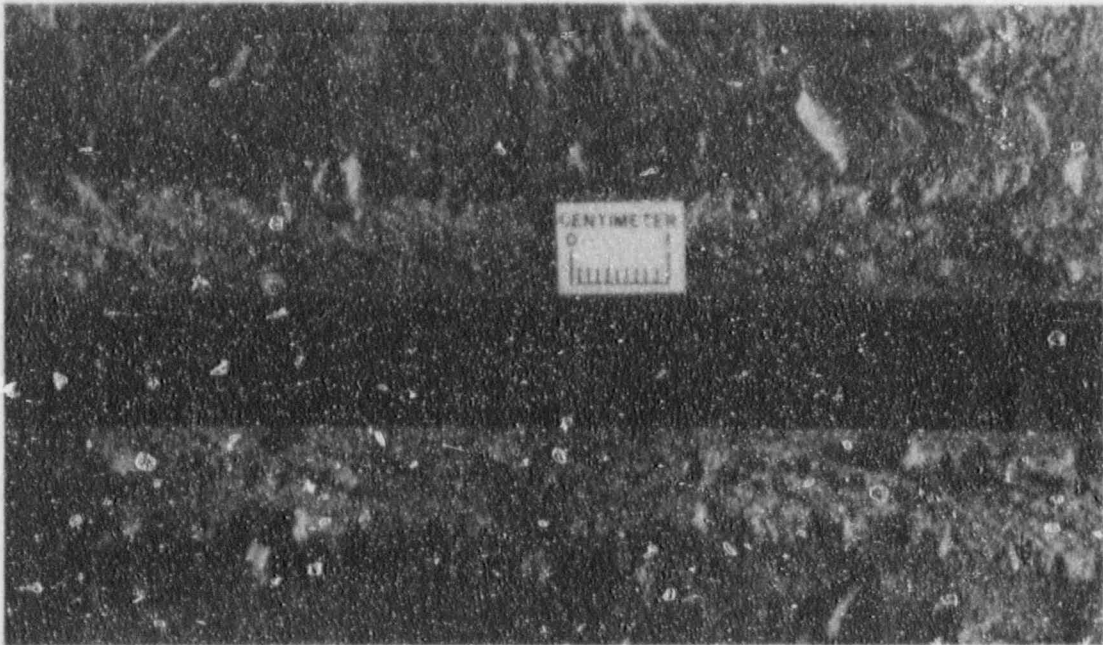
Fig. 5.2. Pop-in, postarrest loads, and corresponding crack lengths for the four plates tested at room temperature.

In each case, the flaw initiated and arrested after propagating beneath the cladding a distance that increased with increasing target strain. The pop-in, postarrest loads and corresponding crack lengths for the four plates tested at room temperature are shown schematically in Fig. 5.2. It may be noted that as the potential energy stored in the plate increased, the length of the arrested flaw also increased as shown schematically by the shaded flaw shape in Fig. 5.2. The actual flaw shapes can be discerned from the photographs of the fracture surfaces shown in Fig. 5.3. Drawings of all the crack shapes are given in Appendix C, and may be used as a guide in discerning the crack shape on the photographs.

The postarrest loads shown in Fig. 5.2 and Table 5.1 are controlled by the compliance of the specimen, and are not necessarily the loads at the moment of arrest of the flaw. The crack initiates, propagates and arrests in a time interval that is smaller than that required for the specimen (because of its inertia) to deflect. The crack velocity, measured in one of the plate tests, is approximately 500 m/s. The flaw can, therefore, propagate the full half-width of the plate, a distance of 0.2 m, in 400 μs . In all cases the flaw propagates less than 0.2 m. The first natural period of vibration of the plate [4], approximated as a simply supported beam is approximately 1000 μs . Thus, only after arrest does the new and smaller stiffness of the flawed plate have an effect. Because the tests were performed under machine ram stroke control, the load drops to a value controlled by the new stiffness of the specimen. The actual load at arrest of the flaw can be higher than the final load shown.
