NONDESTRUCTIVE BORE EXAMINATION
AND
CONDITION ASSESSMENT OF
GEC ALSTROM HP ROTOR
ENRICO FERMI NUCLEAR STATION, UNIT 2
DETROIT EDISON COMPANY

June 27, 1994

WESDYNE INTERNATIONAL INC.
Murry Corporate Park
1002 Corporate Drive
Export, PA 15632

SIEMENS POWER CORPORATION
Fossil Division
1040 South 70th Street
Milwaukee, WI 53214

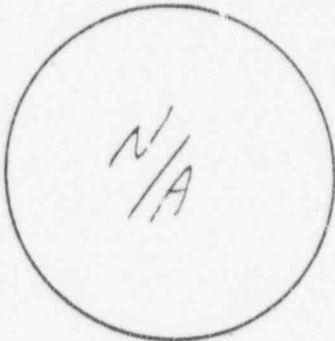
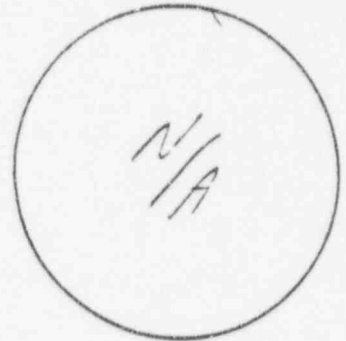
Ind. # 1 Deg. 1 to 360
 Axial Start FULL LENGTH
 Length N/A
 Description MEDIUM CORROSION

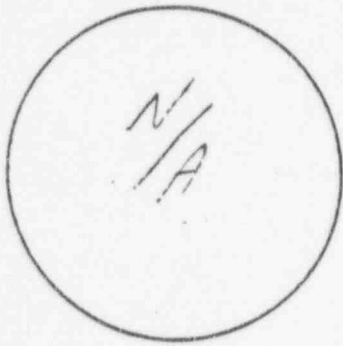
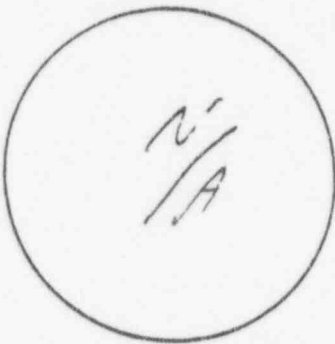
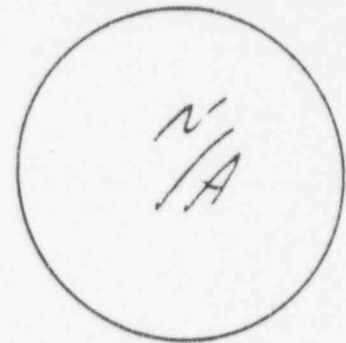
Ind. # _____ Deg. _____
 Axial Start _____
 Length _____
 Description _____

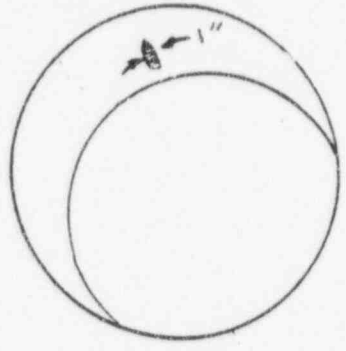
Ind. # 2 Deg. 345°
 Axial Start 183.5°
 Length 3" x 1"
 Description DIMPLE

- The visual examination showed five areas of dimpled regions.
- The magnetic particle examinations did not reveal any flaw like indications including the dimpled regions.
- The ultrasonic examination using [UDRPS] system resulted 13 centroids of indications. A linkup analysis of these indications yielded 3 potentially linked up flaws.

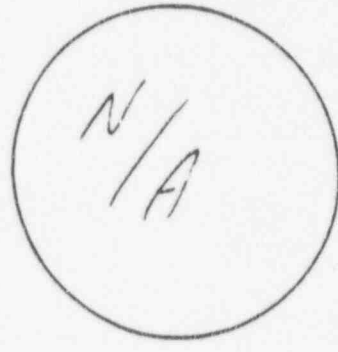
REMARKS: NO RELEVANT INDICATIONS FOUND
