Enrico Fermi 2 Materials and Fuels Evaluation Final Report

*Prepared for
Detroit Edison Company*

Enrico Fermi 2 Materials and Fuels Evaluation

Final Report

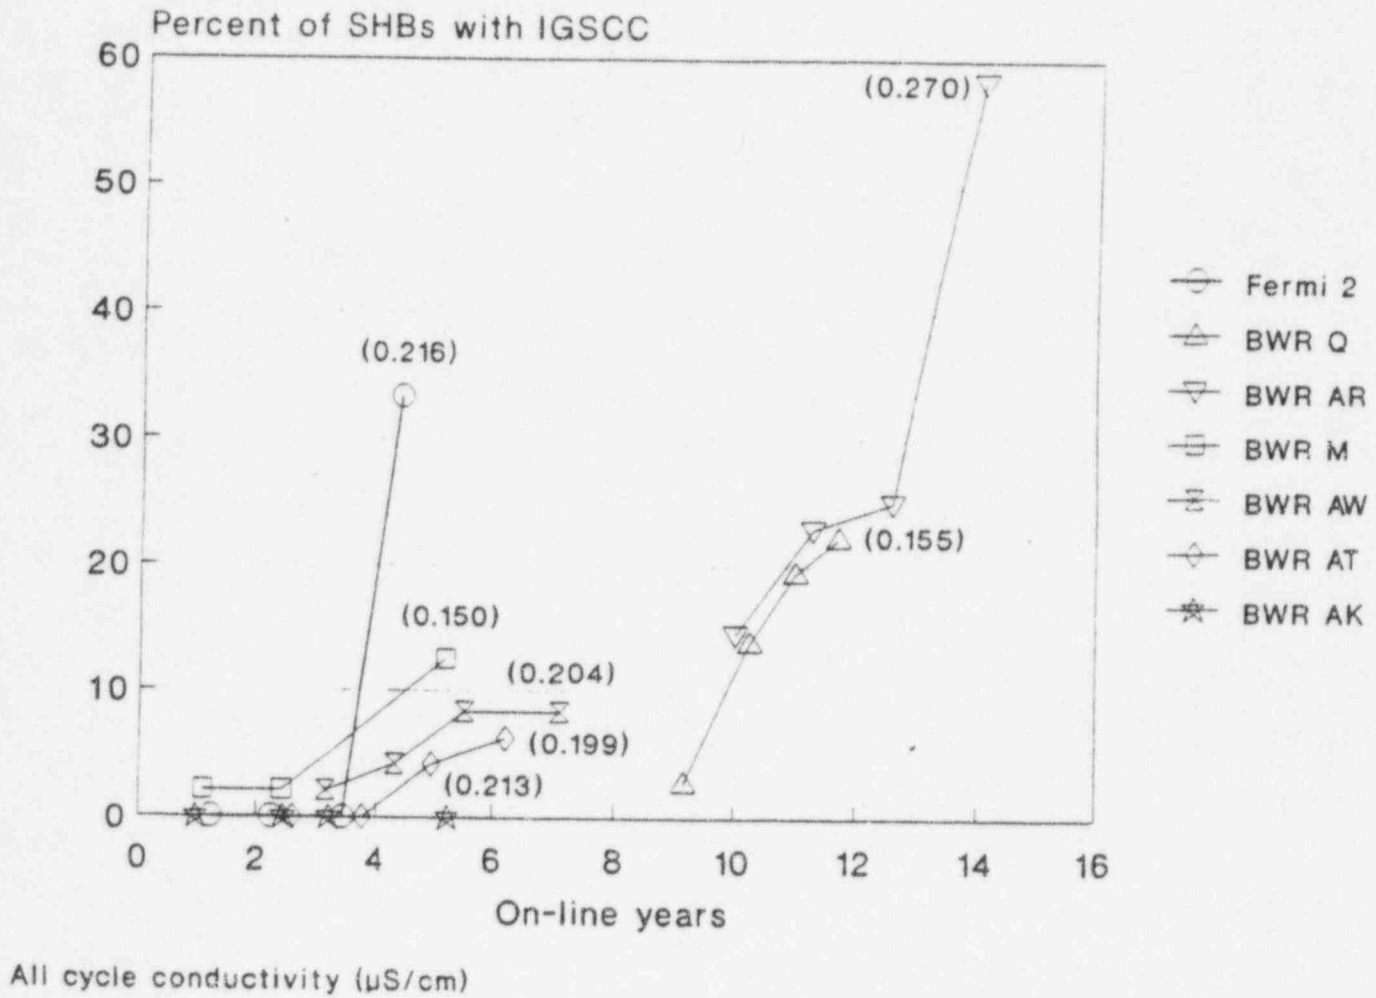
Figure 2.2-2. Shroud Head Bolt Failure Rate Trends for Fermi 2 and Other Comparable BWRs

Shroud head bolts (SHBs) were ultrasonically inspected by DECo. It was found that 16 of the 48 SHBs exhibited evidence of cracking. All of the rejected SHBs were replaced and one additional bolt was replaced because of bowing found during the removal and repositioning process. The new, non-crevice design SHBs were placed in a symmetrical pattern. A new seismic/stress analysis was performed and it was determined that only 20 bolts were required to maintain a positive margin.
