North Anna Unit 1  
Steam Generator Startup Approval Meeting  
Presentation Materials

April 1992

**Detailed Discussion of Inspection Results**

North Anna Unit 1  
Steam Generator Mid-Cycle Inspection Outage  
NRC Startup Approval Meeting

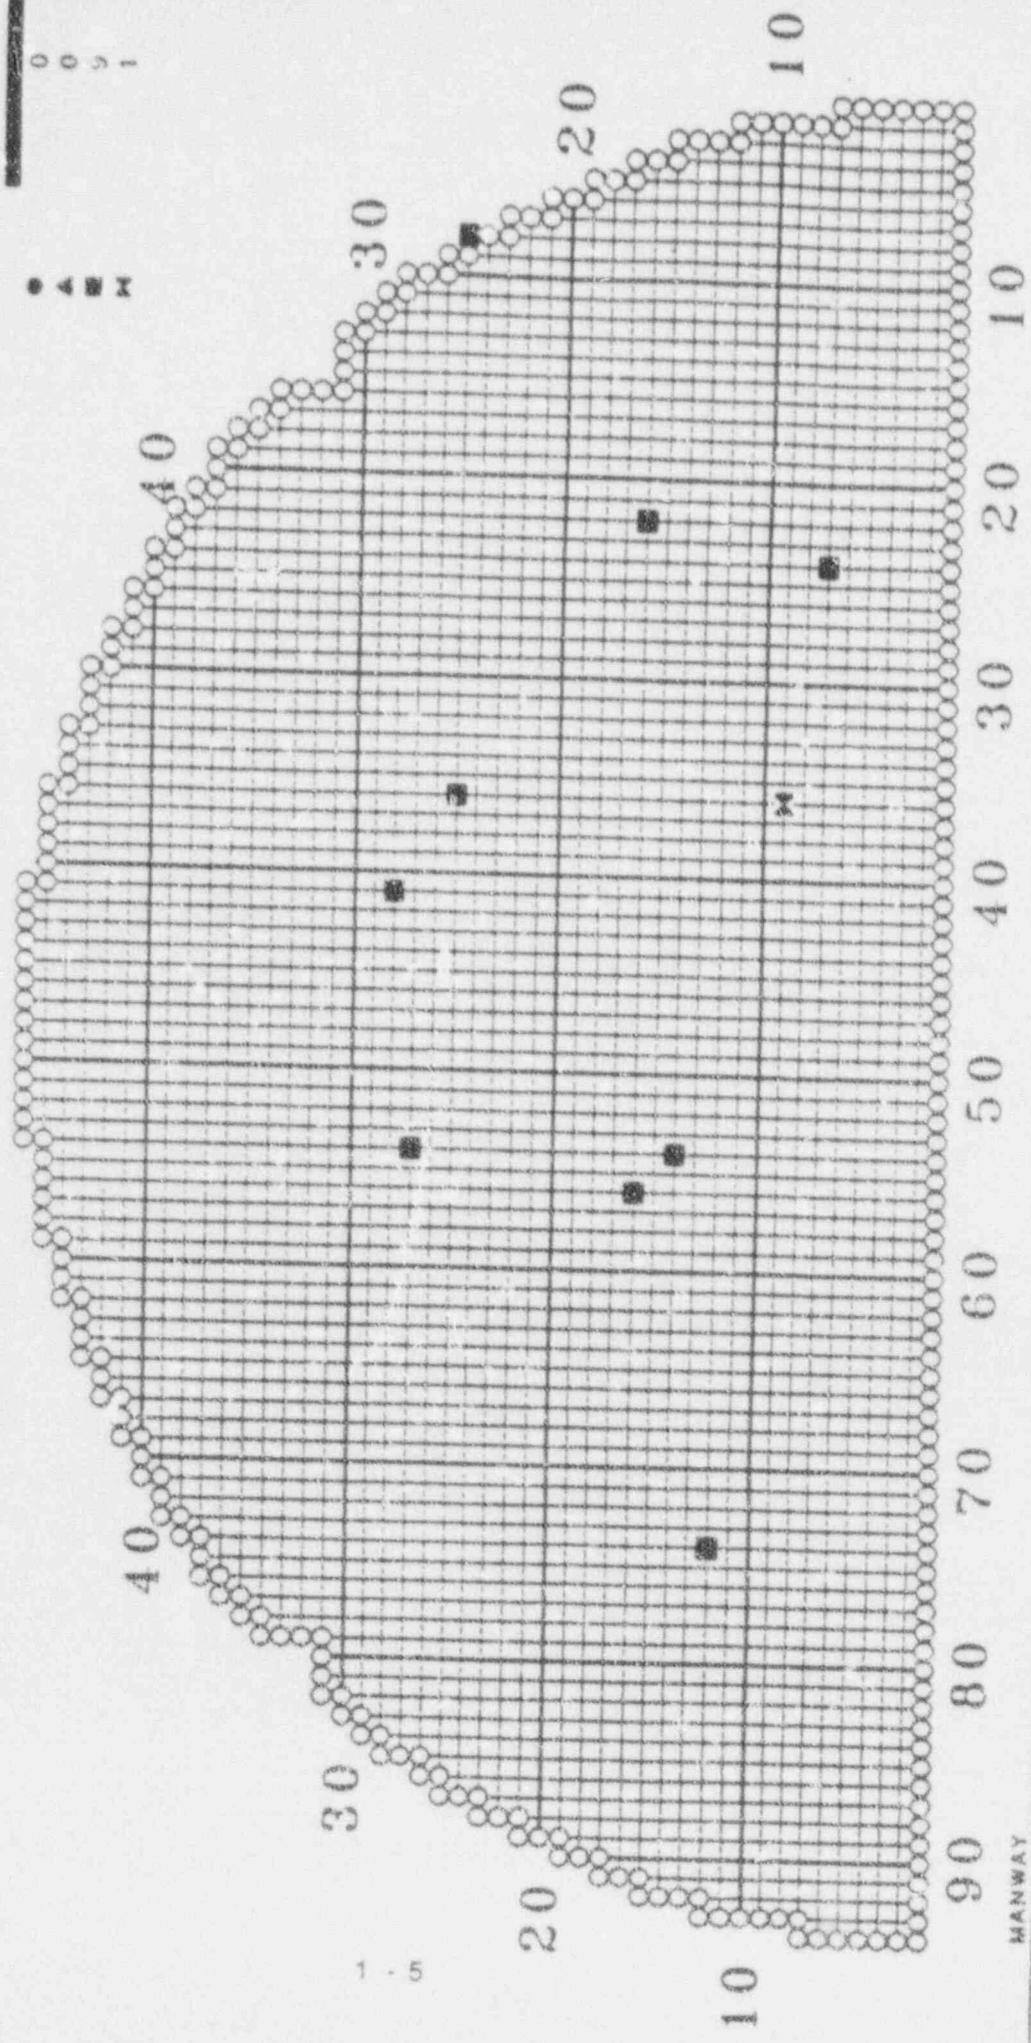
# NORTH ANNA UNIT 1 S/G B 2/27 PLUG LIST

# TUBES	STEAM GENERATOR		
	A	B	C
SINGLE AXIAL	3	0	2
MULTIPLE AXIAL	0	0	0
SINGLE CIRCUMFERENTIAL	10	9	7
MULTIPLE CIRCUMFERENTIAL	2	1	2

## WEXTEX INDICATIONS (RPC PROBES)

●	0
▲	0
■	9
■	1
