LICENSEE: Southern Nuclear Operating Company
FACILITY: Joseph M. Farley Nuclear Plant, Units 1 and 2
SUBJECT: SUMMARY OF NOVEMBER 20, 1991, MEETING WITH SOUTHERN NUCLEAR
OPERATING COMPANY

SNC and its contractor, Westinghouse Electric Corporation, met with the NRC staff and its contractors, Oak Ridge National Laboratory and Battelle-Pacific Northwest Laboratory, to discuss the continuing staff review of the requested APC amendments. The discussions were based on information contained in Revision 1 to WCAP-12871 (Proprietary), and Revision 1 to WCAP-12872 Non-proprietary,, "J.M. Farley Units 1 and 2 SG Tube Plugging Criteria for OUSCC at Tube Support Plates," submitted by licensee letter, dated November 13, 1991.

OBTAIN TUBE PLUGGING CRITERIA THAT RELATE NDE MEASUREMENT TO TUBE INTEGRITY (BURST, LEAKAGE) CRITERIA OF R.G. 1.121

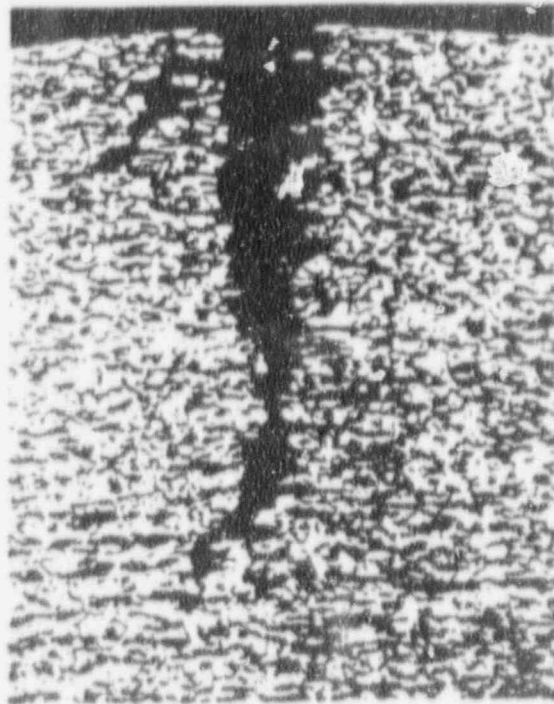
Top micrographs are from a transverse section through one half of the main burst crack. The morphology is that of IGSCC with significant IGA characteristics (width of IGA is 0.015 inch on one side of the crack). Bottom micrograph is from a transverse section through the only other crack found in the crevice region. Its morphology is more that of IGSCC. (Note: crack has been opened wide by tube deformation).

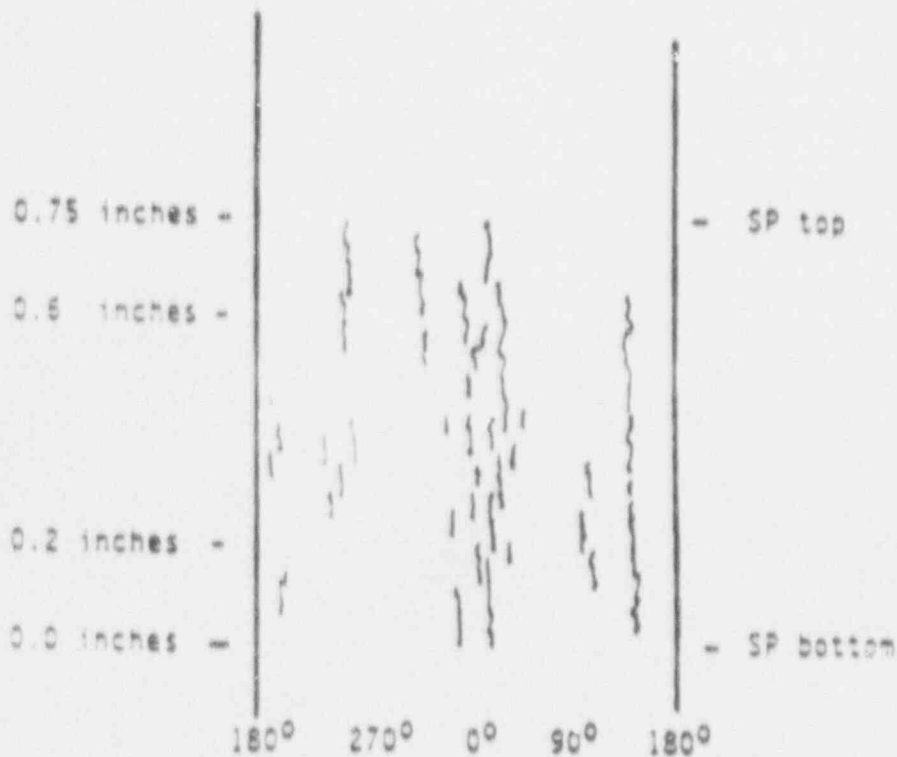
Sketch of Crack Distribution

Number of Microcracks = at least 6 (ligaments have mostly intergranular features)

Morphology = 10500

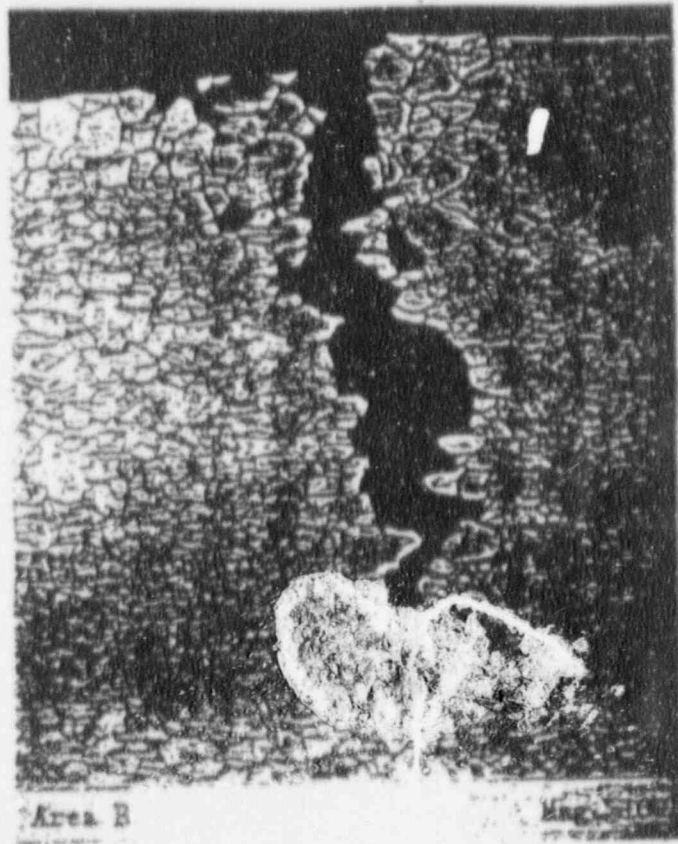
Figure 4-6. Metallographic details seen in Areas B and C (Figure 4-5).
