Subject: Crystal River Unit 3 Docket No. 50-302 Operating License No. DPR-72 IE Bulletin 84-03 Refueling Cavity Water Seal

IE BULLETIN 84-03 REFUELING CAVITY WATER SEAL FLORIDA FOWER CORPORATION'S RESPONSE

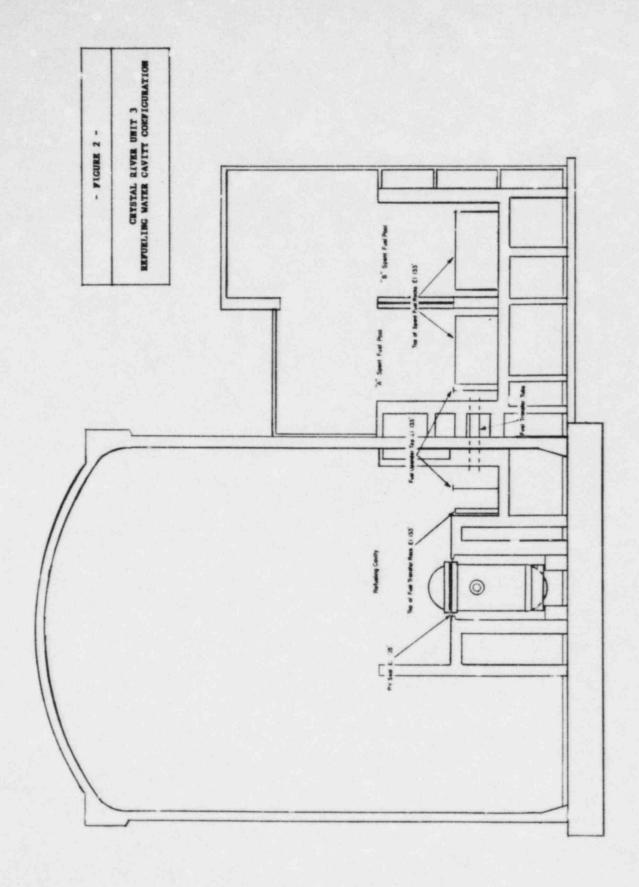
The refueling cavity water seal at Crystal River Unit 3 (CR-3) has been used for approximately seven years with no significant leakage. It is not similar to the seal used at the Haddam Neck Plant. The passive seal system at CR-3 consists of a stainless steel ring with two non-inflatable rubber seal rings. One rubber seal is positioned between the steel ring and the reactor vessel flange. The other rubber seal is positioned between the steel ring and the refueling canal floor. These rubber seal rings are compressed between the surfaces with stainless steel bolts. Figure 1, depicting the CR-3 seal design, is attached. Due to this configuration, any possible seal leakage would be insignificant compared to the makeup capability at CR-3. The steel seal ring width is greater than the opening it covers, therefore, gross seal failure due to lack of interference between the width of the seal annulus and the width of the opening as described in IE Bulletin 84-03 is not considered probable at CR-3.

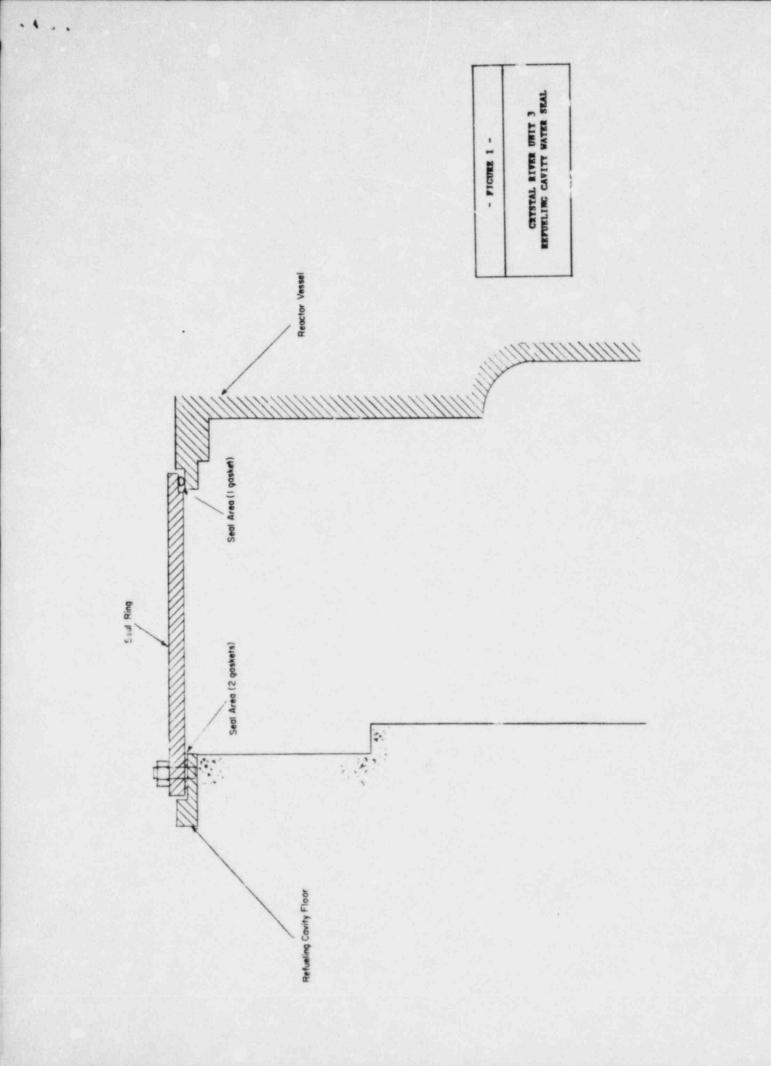
Assuming that the seal could fail and the water would be allowed to drain through the annular opening between the reactor vessel and the refueling canal floor, the resulting water level in the refueling canal would be at the 135 foot elevation (elevation of the refueling cavity water seal). Due to plant configuration, fuel stored in the reactor, the transfer tube area, and the spent fuel storage area would remain covered by the water during such an occurrence. The relative locations of these areas are shown in Figure 2.
