NUREG/CP-0058
Vol. 4

Proceedings of the U.S. Nuclear Regulatory Commission

Twelfth Water Reactor Safety Research Information Meeting

Volume 4
- Materials Engineering Research

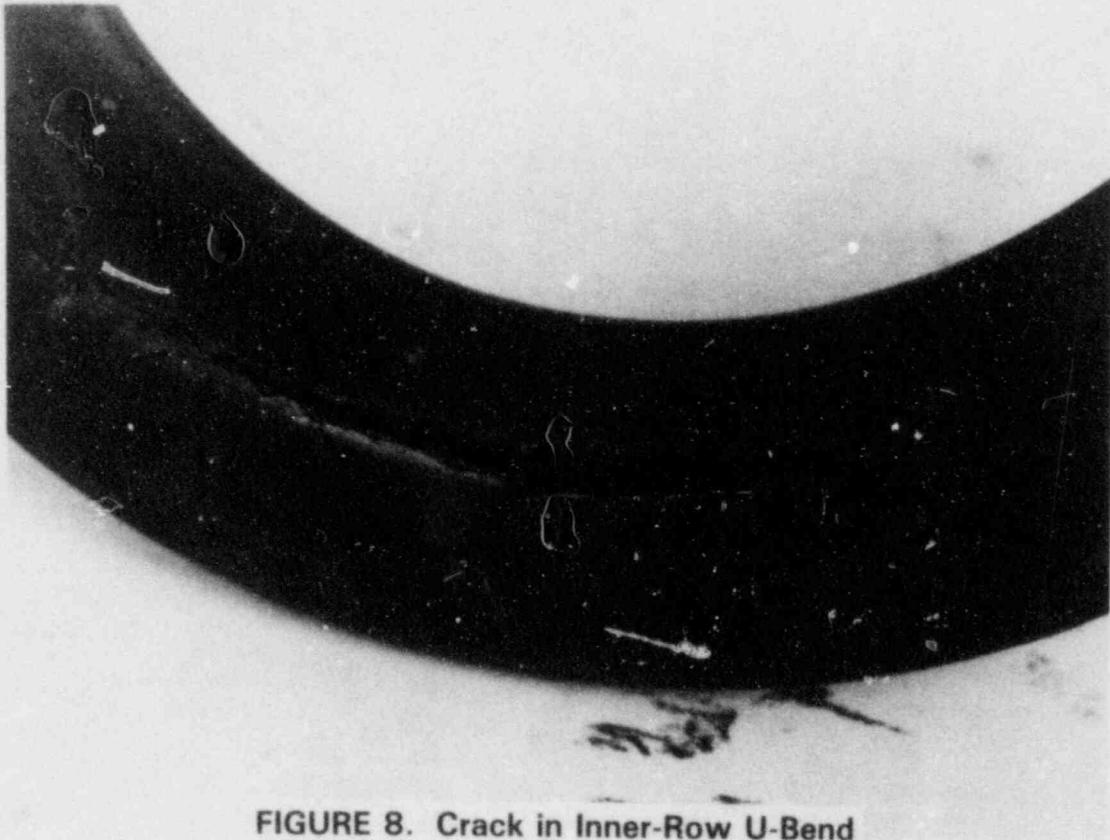
FIGURE 8. Crack in Inner-Row U-Bend

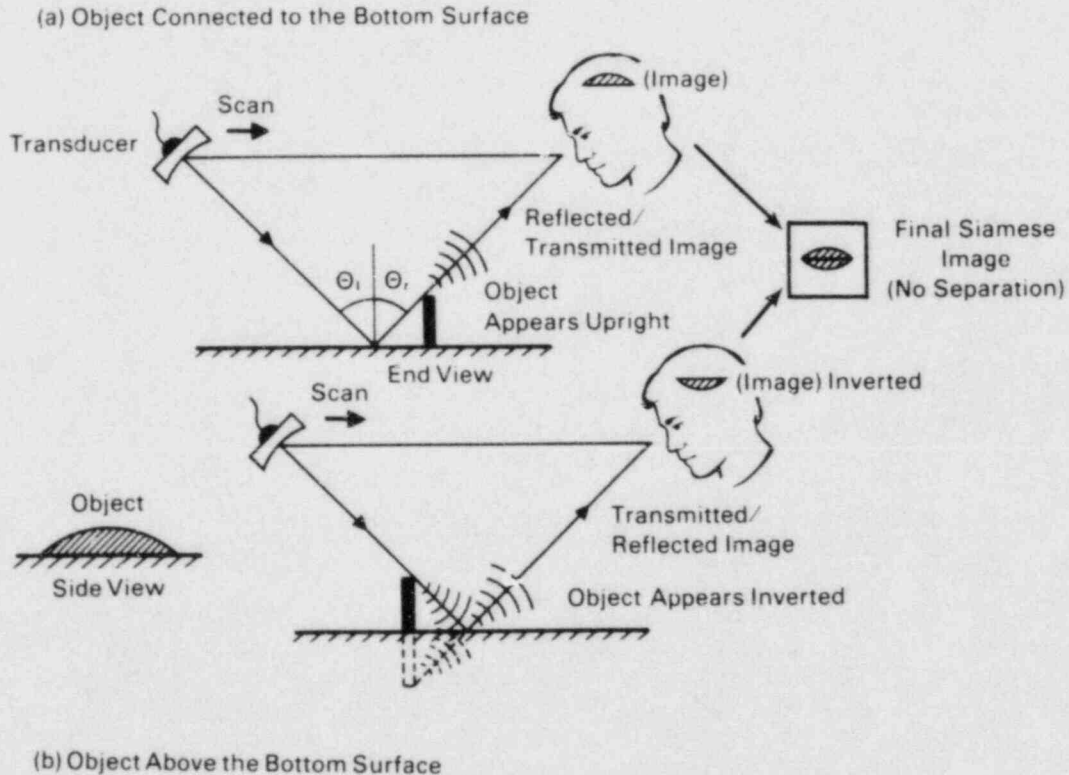
Figure 1. Siamese Image Concept SROS (Object on Lower Surface).
