Catawba Unit-1

Technical Support for Steam Generator

Interim Tube Plugging Criteria for

Indications at Tube Support Plates

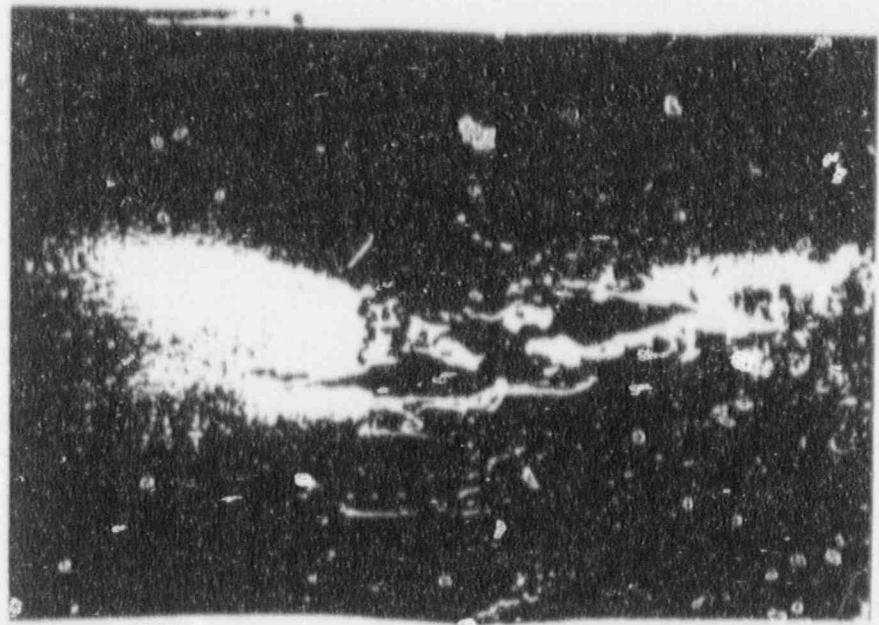
Figure 4-5. Photographs of the burst opening in tube 590-2 showing axial and circumferential cracking.

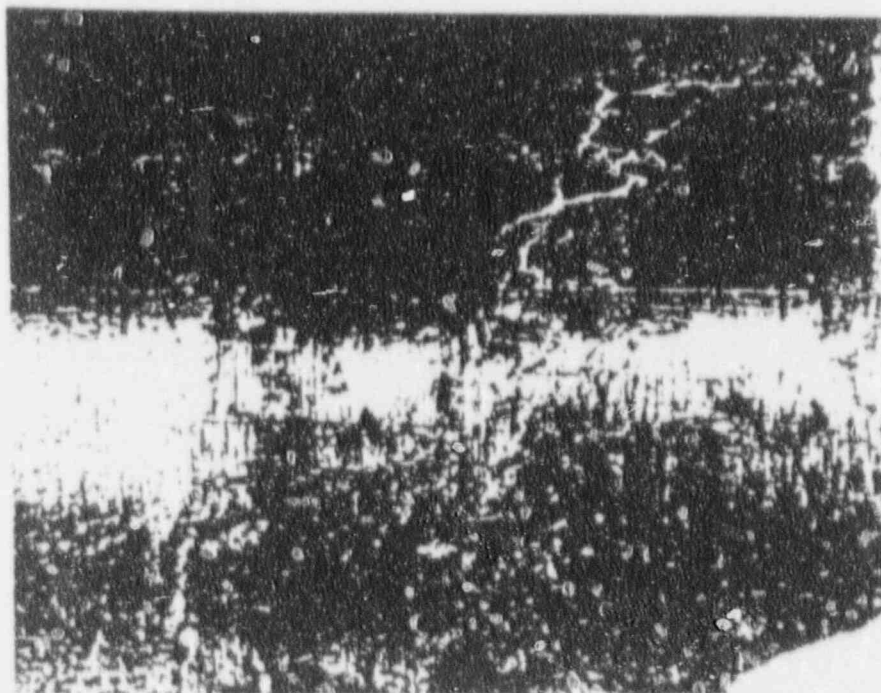
Figure 4-6. Photographs away from the burst opening in tube 590-2 showing axial and circumferential cracking.

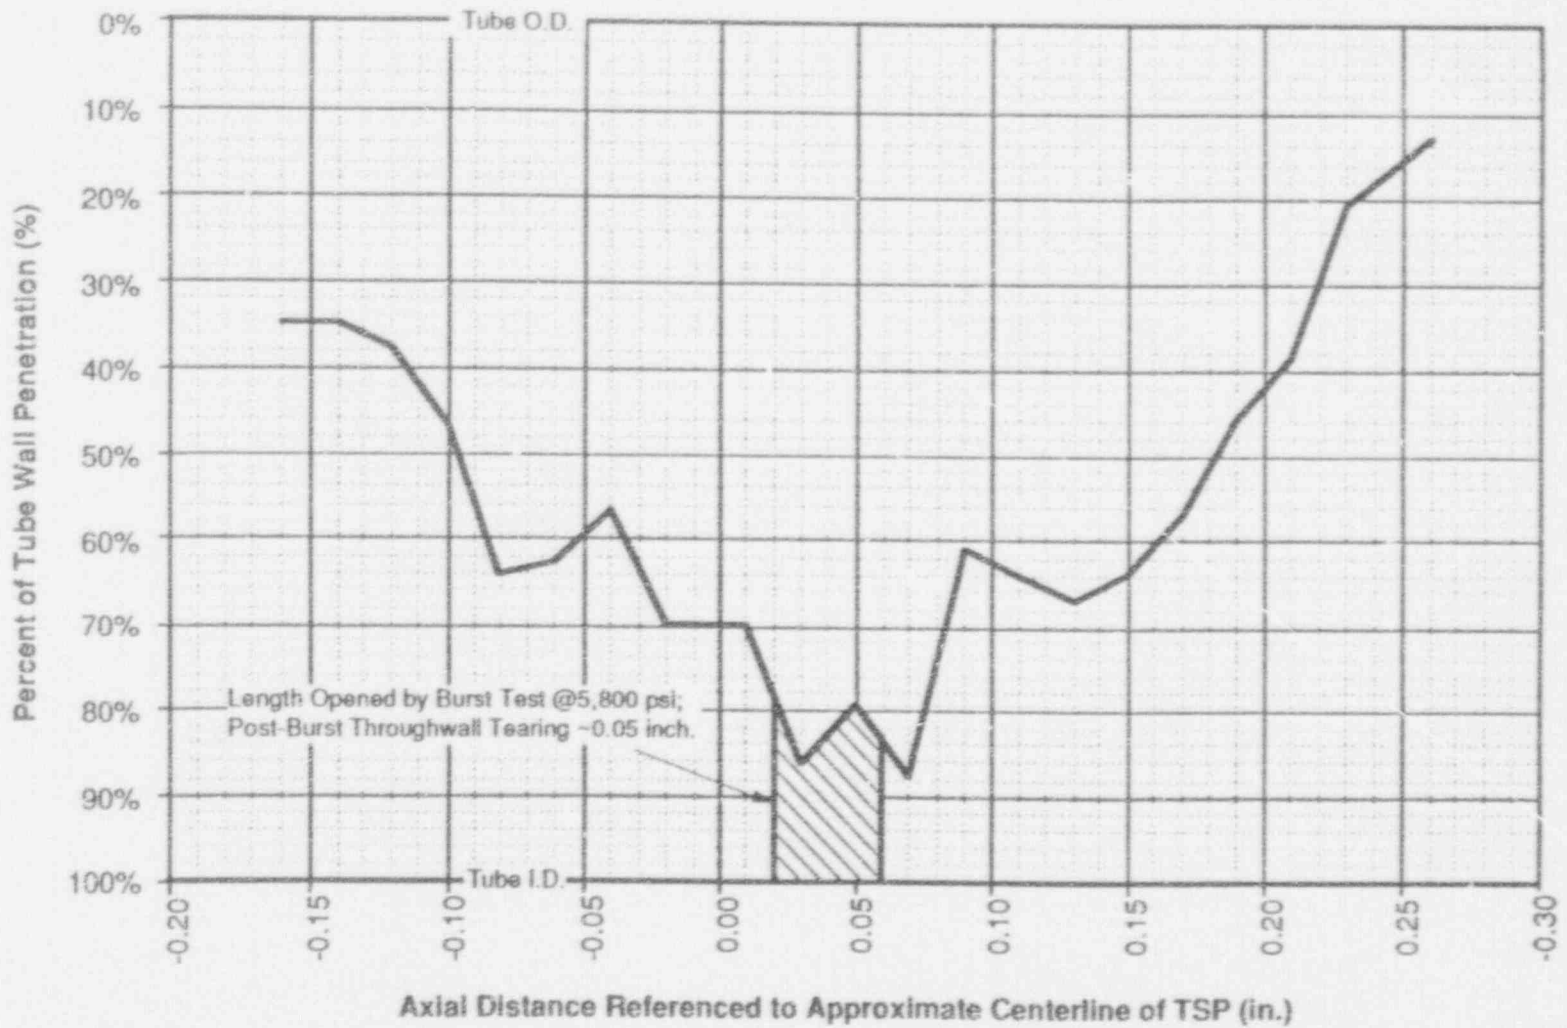
Figure 6-8. Catawba-1 Pulled Tube R7C47, TSP-3: Crack Depth Profile

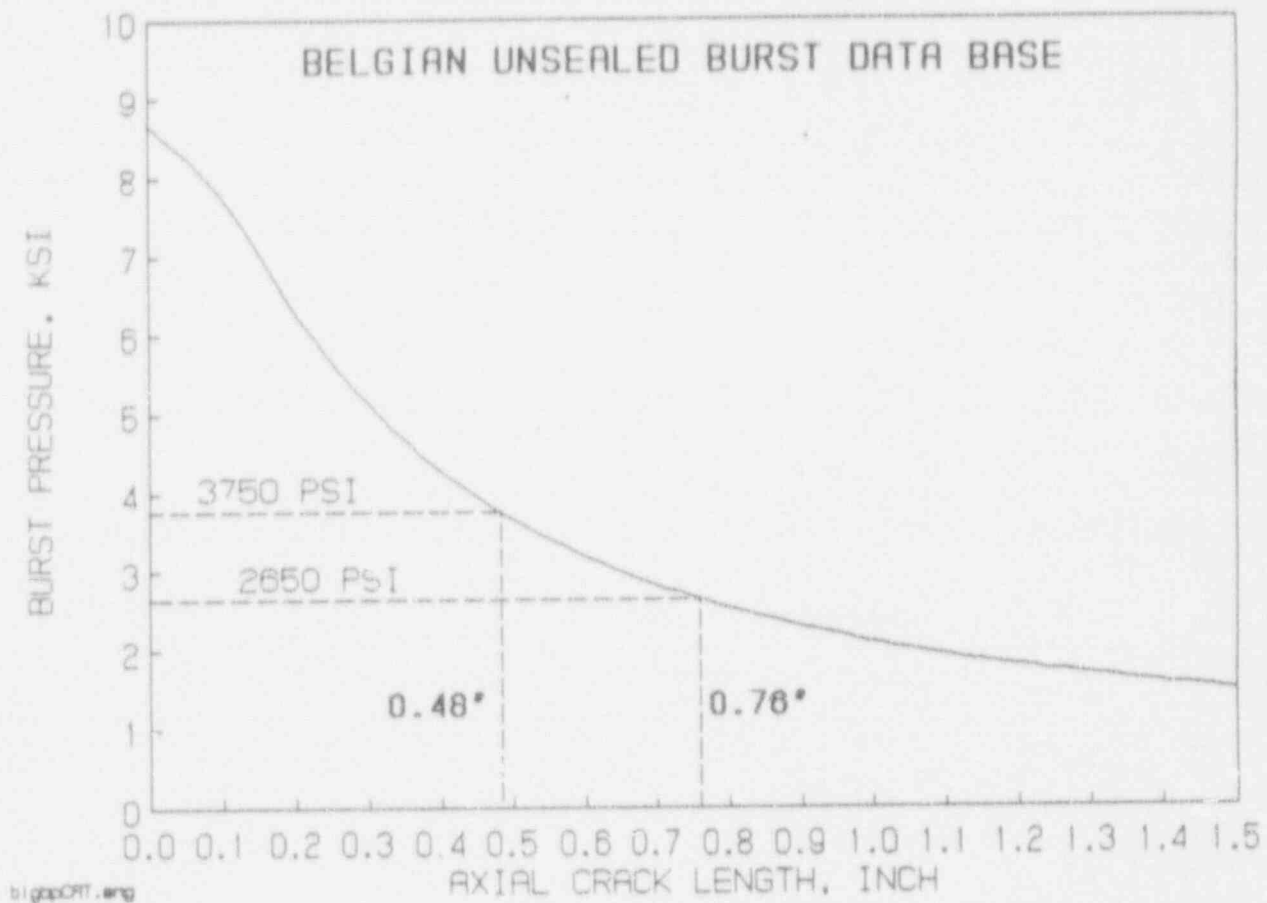
### BURST PRESSURE VERSUS CRACK LENGTH 3/4X0.043 INCH TUBING

Figure 10-6. Burst Pressure versus Crack Length for 3/4 inch Tubing
