Evaluation of Field-Tested Fugitive Dust Control Techniques for Uranium Mill Tailings Piles

Final Report

Prepared by M. R. Elmore, J. N. Hartley

Pacific Northwest Laboratory
Operated by
Battelle Memorial Institute

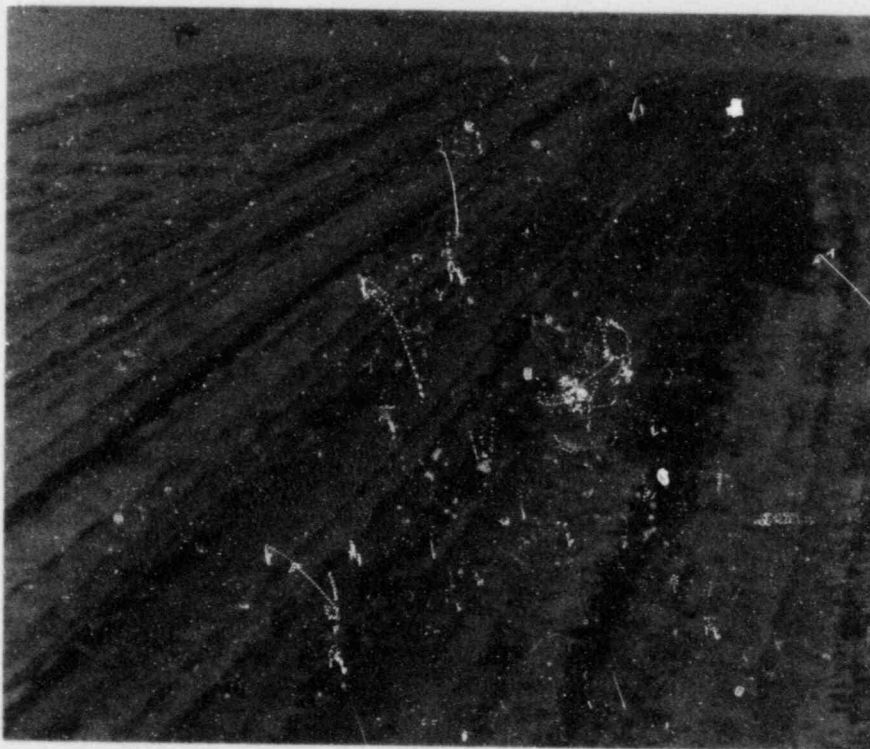
FIGURE 2. Deterioration of the Stabilized Tailings Surface Initially Treated with Retain After Nine Months of Weathering

Figure 1 shows the surface of the test plot soon after application of the Retain asphalt emulsion. Figure 2 shows the same test plot after nine months of weathering. The contrasting colors of the asphalt and tailings clearly illustrate the change in condition of the stabilizer with time. The deterioration of the surface crust is readily apparent. Many of the other stabilizers from both years' field tests behaved similarly. Appendix A contains photographs of both test plots of the two newer stabilizers, Retain and Soil Sement, and of the Wallpol 40-133 test plot from the 1983 field test. The first figure of each test plot was taken soon after application of the stabilizer. The second photograph shows the same area after nine months of exposure at the test site.

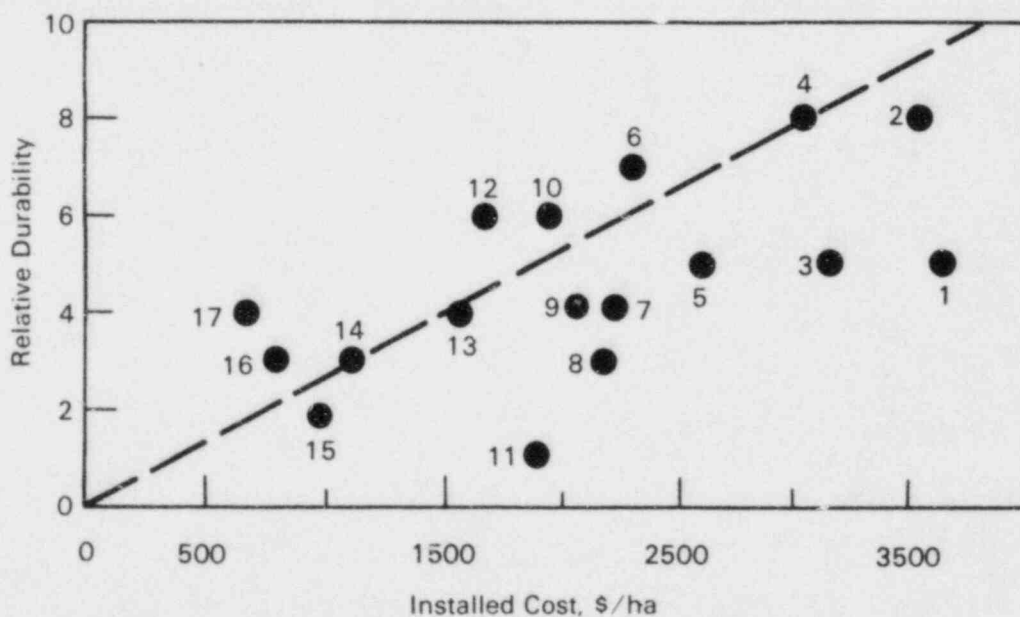
FIGURE 3. Cost Versus Relative Durability of Field-Tested Chemical Stabilizers. Numbers correspond to the numbered stabilizers in Table 2.

To assess the cost effectiveness of the stabilizers, the relative observed durabilities of the materials are plotted against the estimated large-scale application costs (Figure 3). The longer-lasting stabilizers tend to be the more expensive ones, with some exceptions. However, any stabilizers falling on a diagonal line drawn through the origin are for practical purposes equally cost effective. That is, a less expensive stabilizer can be applied more frequently to produce the same degree of erosion protection for essentially the same cost (compared to a more expensive stabilizer on the same diagonal line). For example, stabilizer 4 was given a durability rating of 8; its applied cost is \$3010/ha and its effective lifetime was observed to be equivalent to eight-tenths of a year. Stabilizer 13 was given a rating of 4 with an applied cost of \$1570/ha, and so could be applied twice as often for approximately the same

cost and degree of erosion protection. Those chemicals lying below the diagonal line would then be less cost effective than those lying above the diagonal. However, the final selection of a particular chemical stabilizer will depend on many site-specific requirements such as tailings pile construction and management, weather conditions, mill location, price and availability of stabilizers, and other such factors.

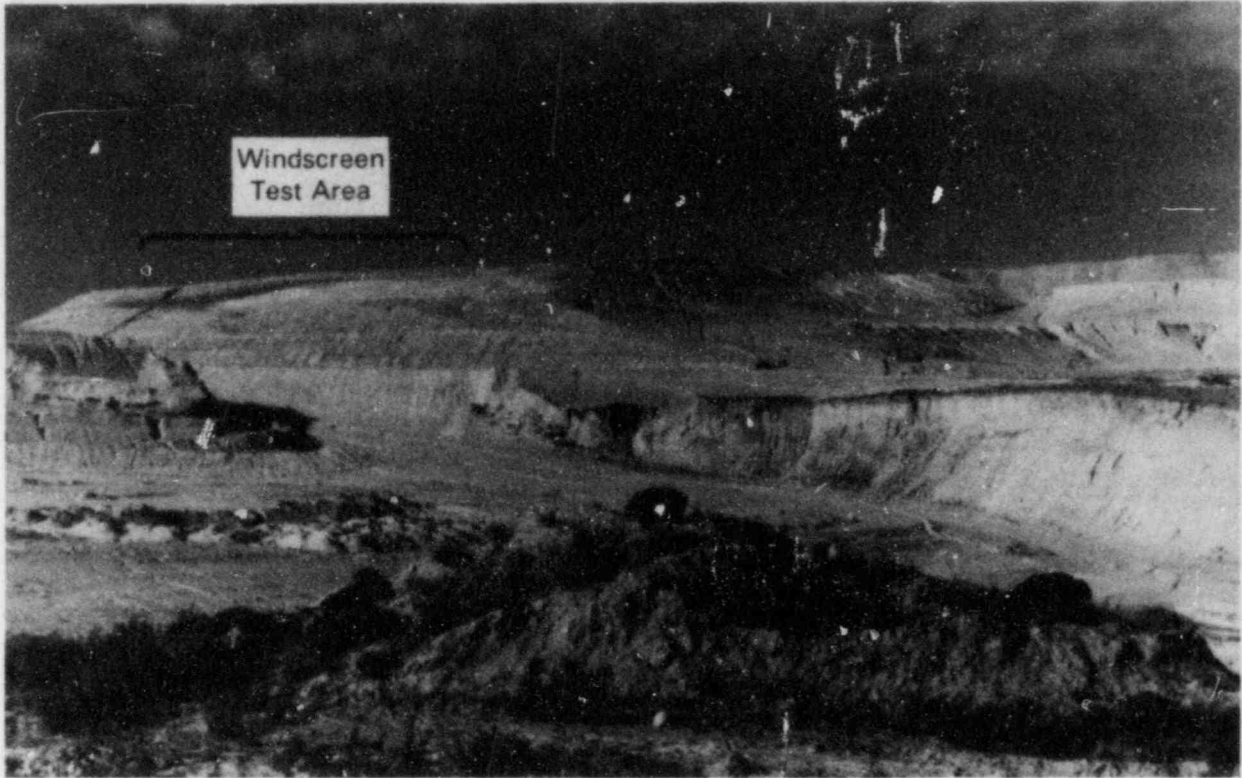
FIGURE 6. View of the High Bluff on Which the Windscreen Test Panels Were Erected at the Wyoming Test Site

The windscreen durability test area at the Wyoming test site was located on a high flat bluff (Figure 6) that is exposed to the most extreme wind conditions in the area. The installed windscreens are shown in Figures 7a and 7b. The selected materials were chosen to be representative of the various types of commercially available windscreens, including the more common vertical wood-slat snow fence, extruded plastic screens with different opening sizes, and woven synthetic materials with different sizes and shapes of openings. The windscreen test panels were placed on the high bluff and oriented perpendicular to strong prevailing southwest winds. Appendix B includes photographs of the eight tested windscreens both at the time of construction and after nine months of exposure.

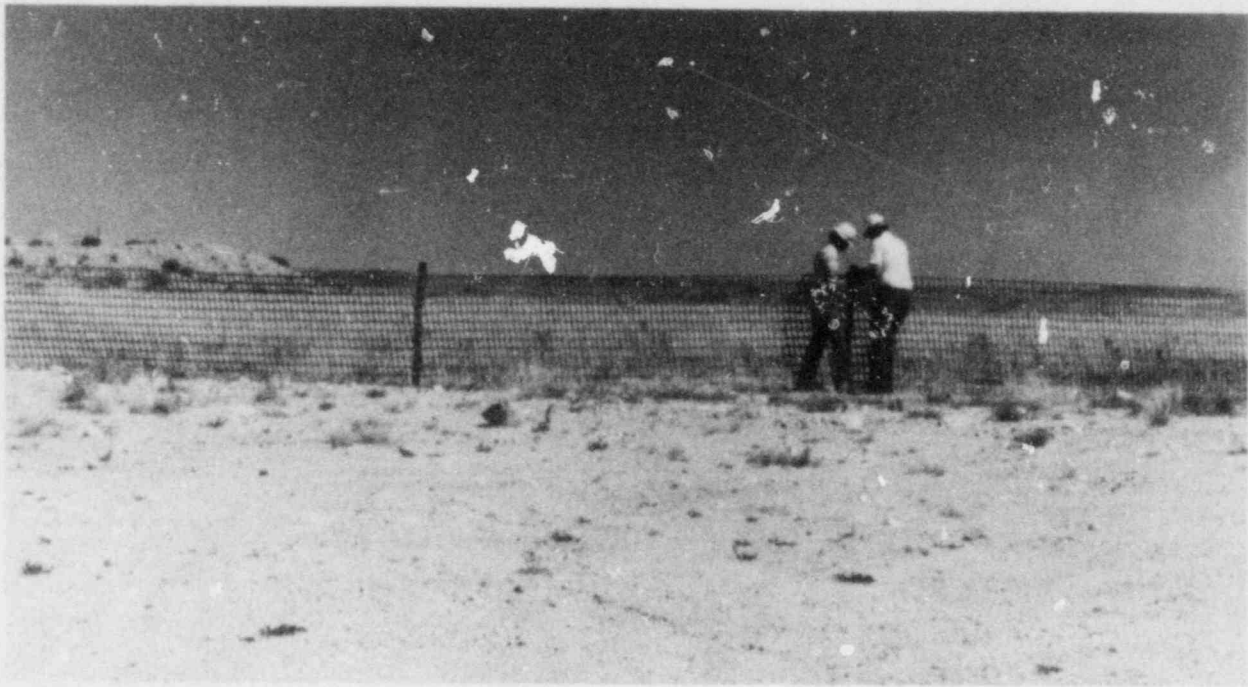
FIGURE 7. (a) Installation of the DuPont Canada L-300 Windscreen Test Panel at the Wyoming Test Site; (b) Several Windscreen Test Panels Erected at the Wyoming Test Site

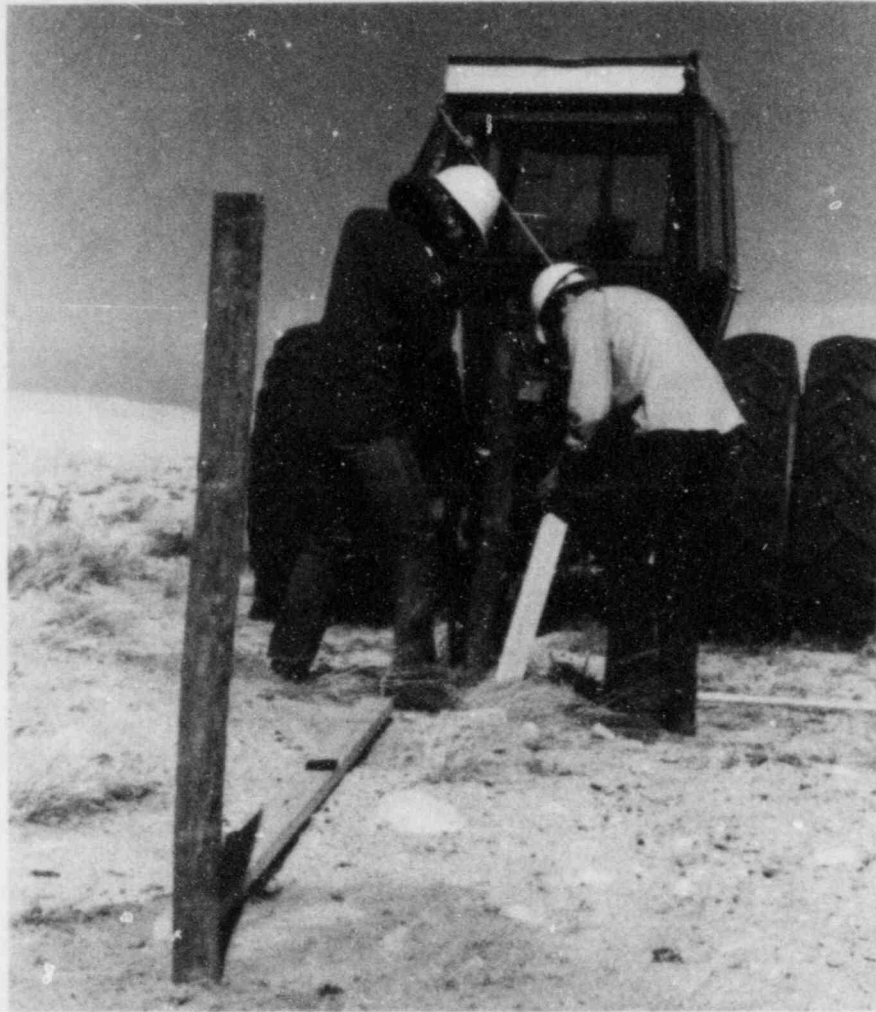
FIGURE 8. Wood Posts Tested as Supports for Selected Windscreen Test Panels

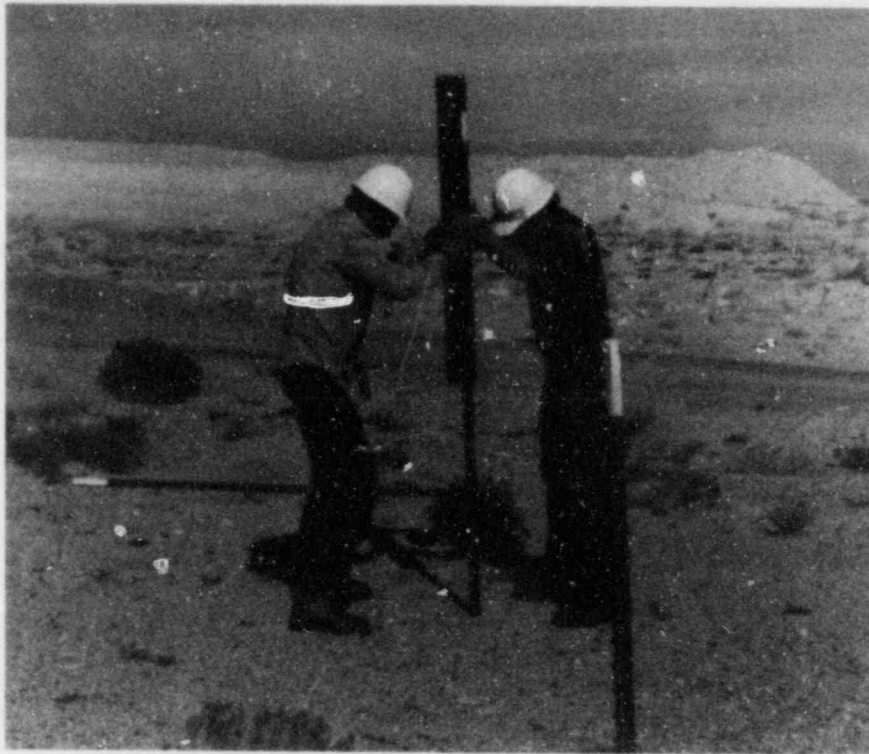
FIGURE 9. Steel Fence Posts Tested as Supports for Selected Windscreen Test Panels

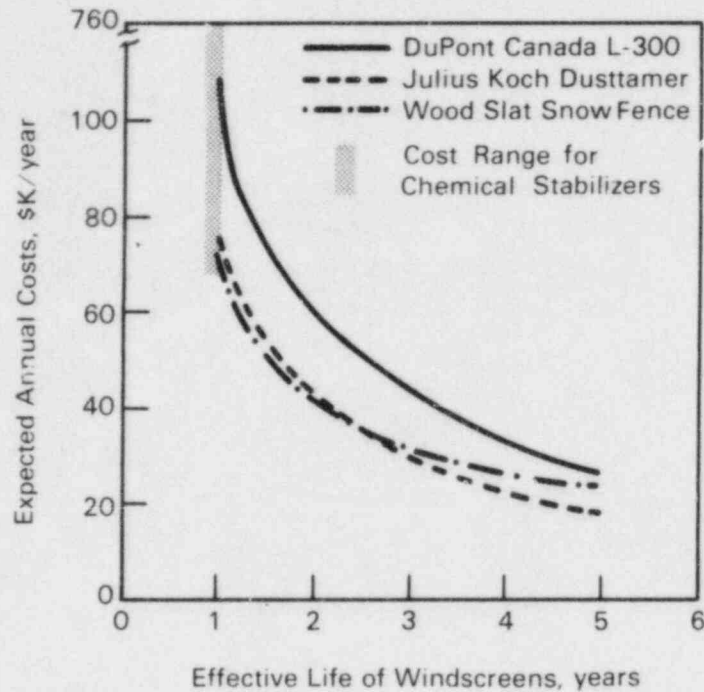
FIGURE 17. Total Cost per Year Versus the Expected Life of Windscreen Systems for the Hypothetical 40-ha Tailings Pile. The vertical bar at year one is the range of costs for tested chemical stabilizers.

annual cost for windcreens would still be lower than for the chemical stabilizers if their effective life were at least more than one year. Other factors can also make the choice of a windscreen system more attractive than chemical stabilization. For instance, some windscreen systems may be considered capital investments for many companies, which then may qualify for investment tax credits. Also, new tax laws may allow depreciation of the system costs over a period of a few years. Chemical dust suppressants do not afford the same tax incentives. The major drawback to windcreens is the complexity and increased costs of installation for a site where strong winds occur from more than one direction. For such a site, surface stabilization may be the only practical alternative.

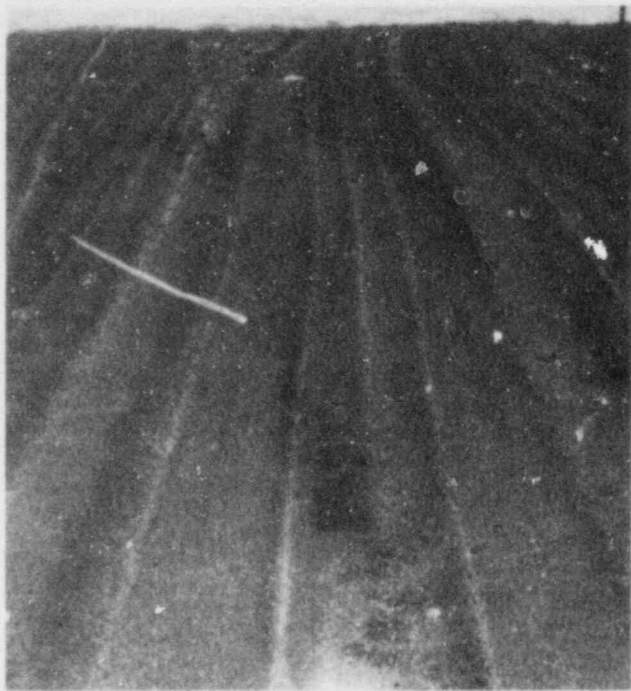
FIGURE A.1. Surface of Test Plot Treated with Retain: (a) soon after application; (b) after nine months of exposure.

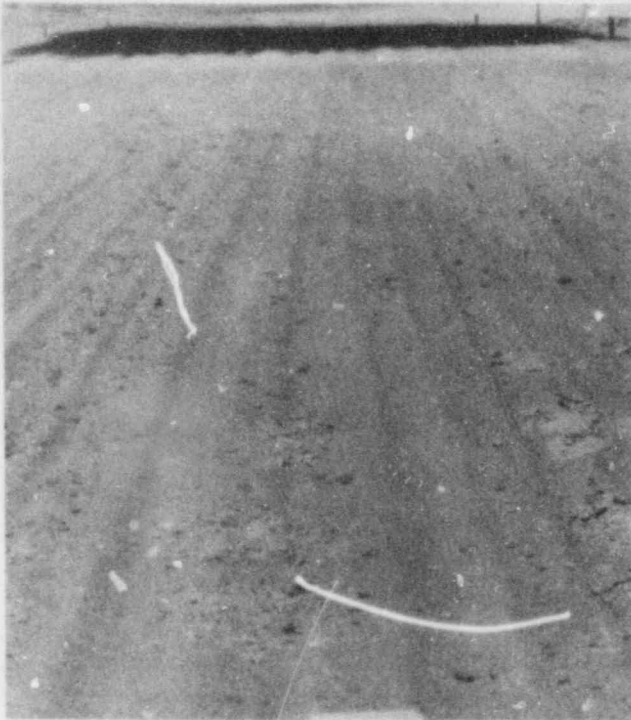
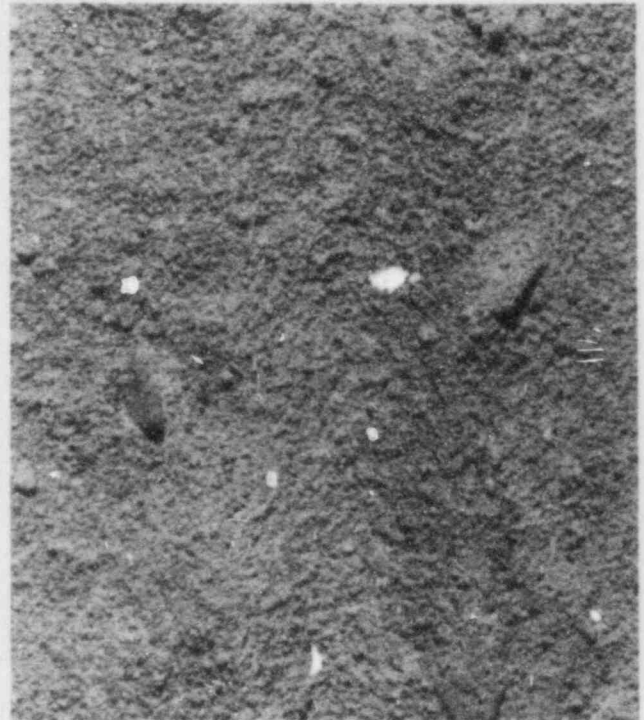
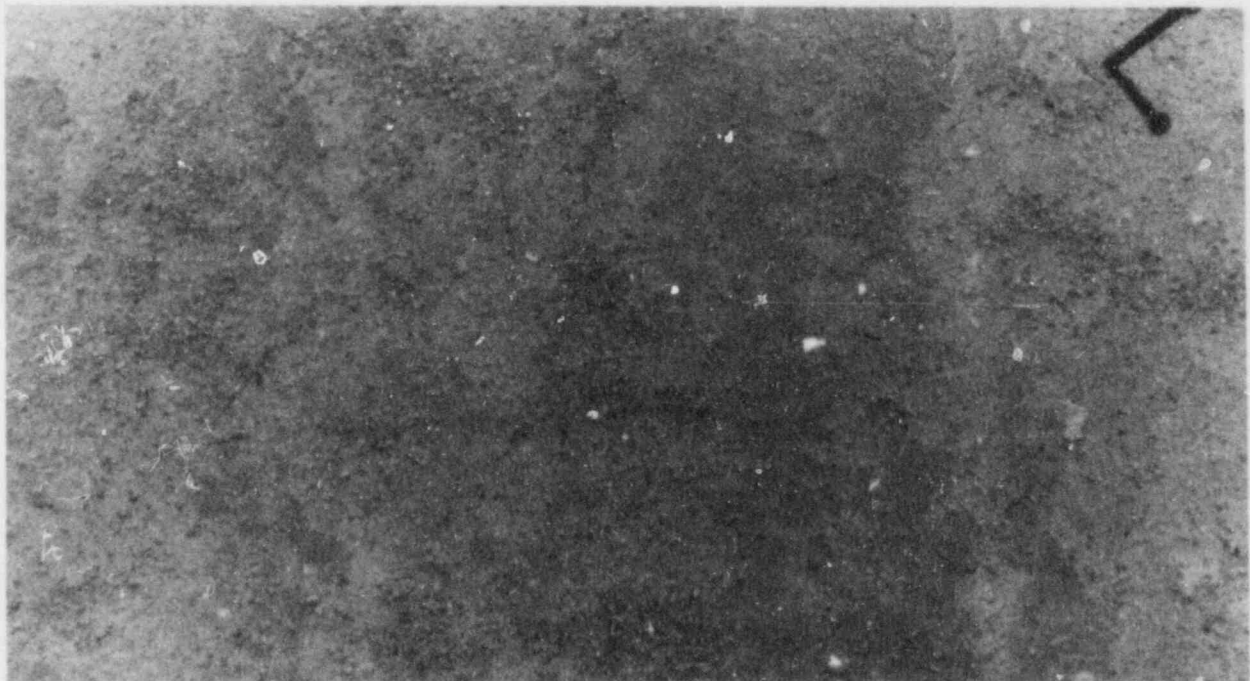
FIGURE A.2. Surface of Test Plot Treated with Soil Sement: (a) soon after application; (b) after nine months of exposure.

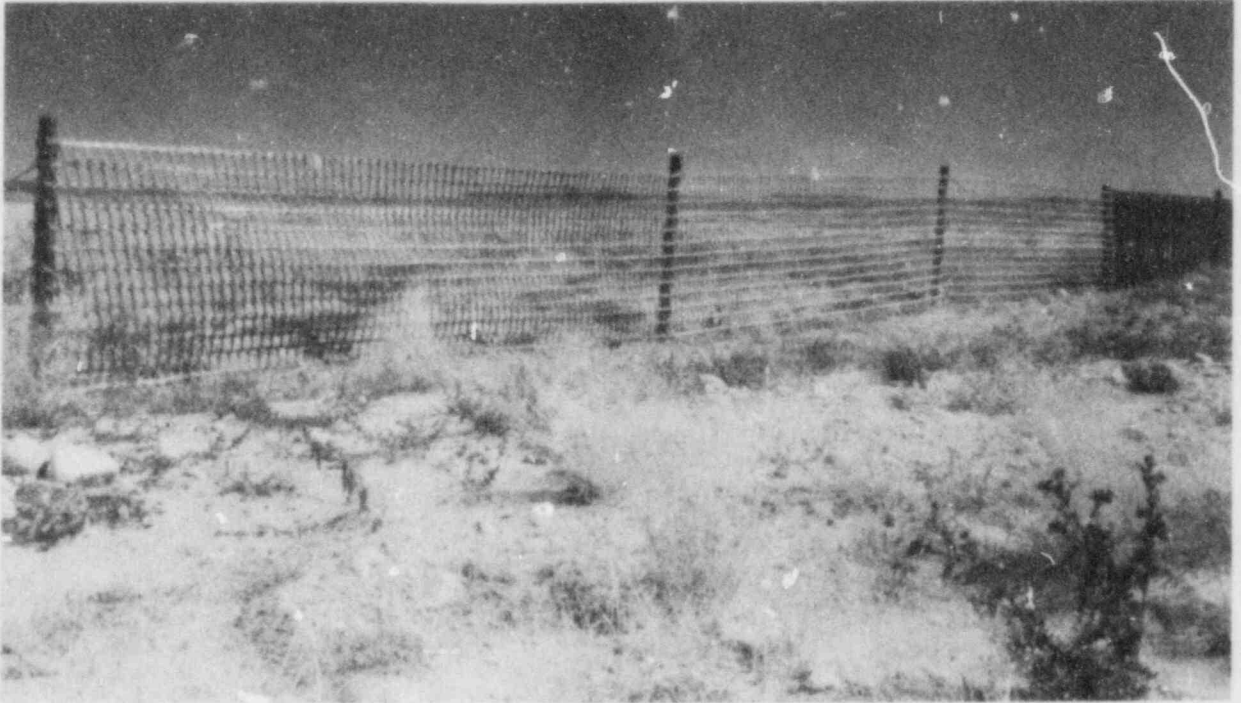
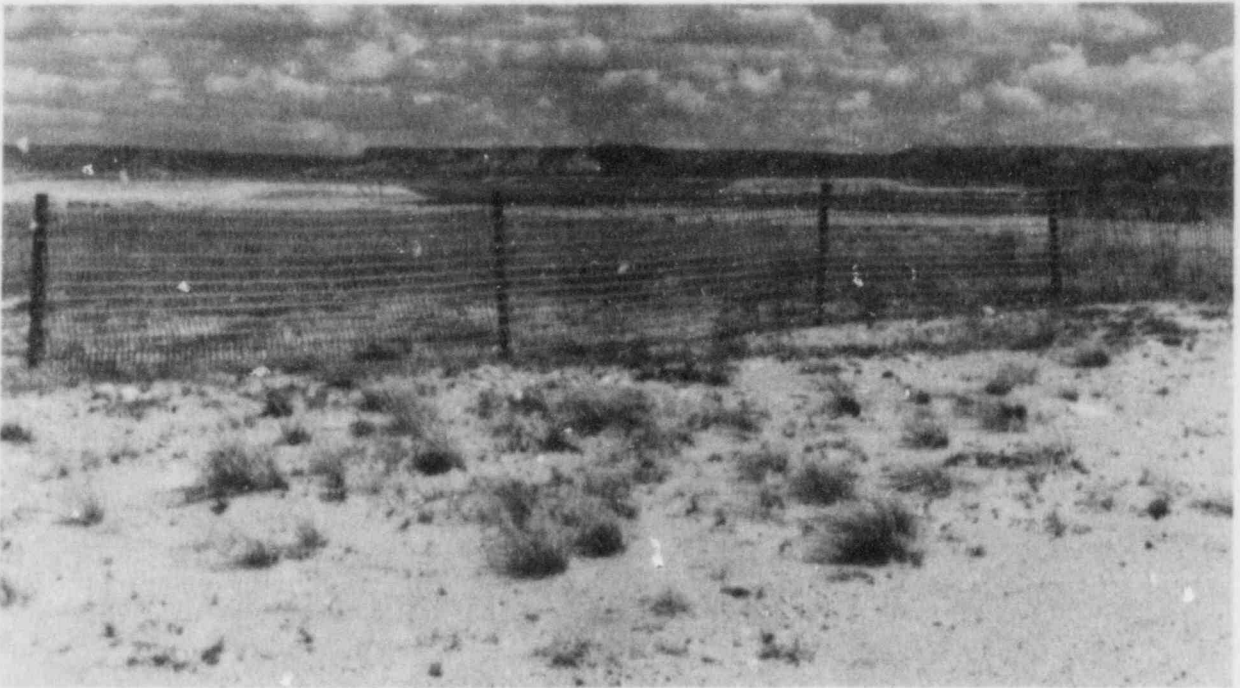
FIGURE B.3. DuPont Canada L-300 Windscreen/Snow Fence (a) as installed; (b) after nine months of weathering. This screen showed the best durability of the tested materials.

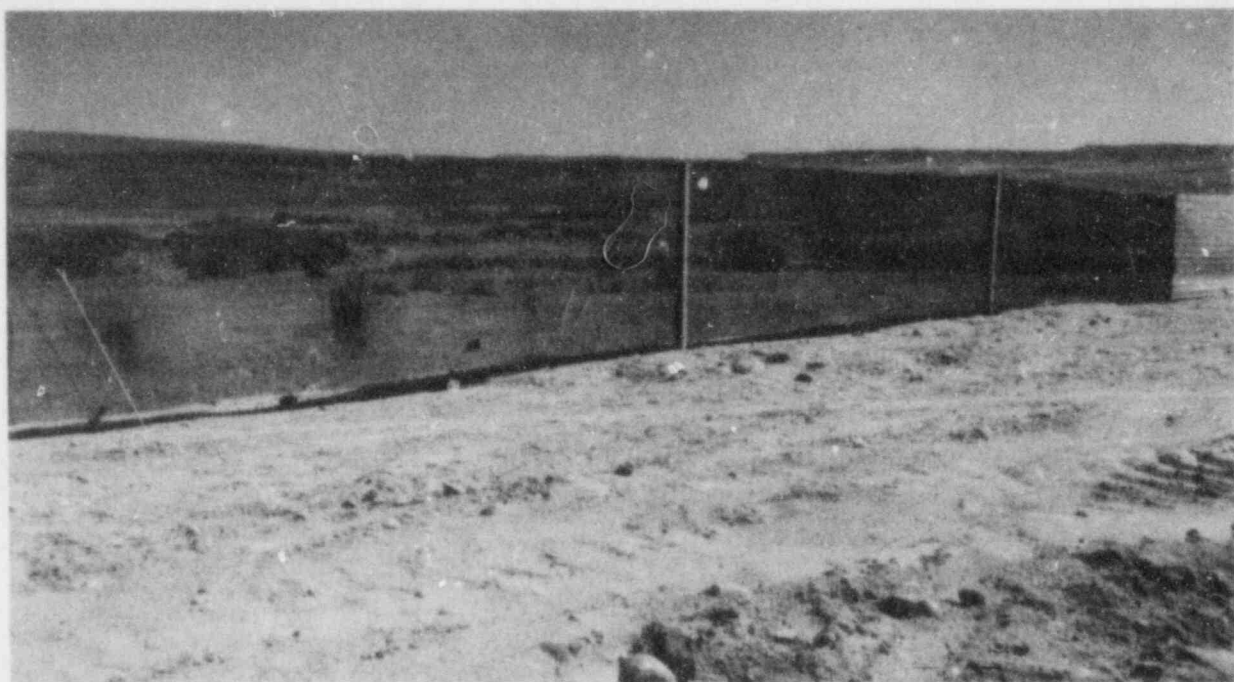
FIGURE B.4. DuPont Canada L-36 Windscreen (a) as installed; (b) after nine months of weathering. The material showed good durability, but with slightly more stretching than other DuPont screens.

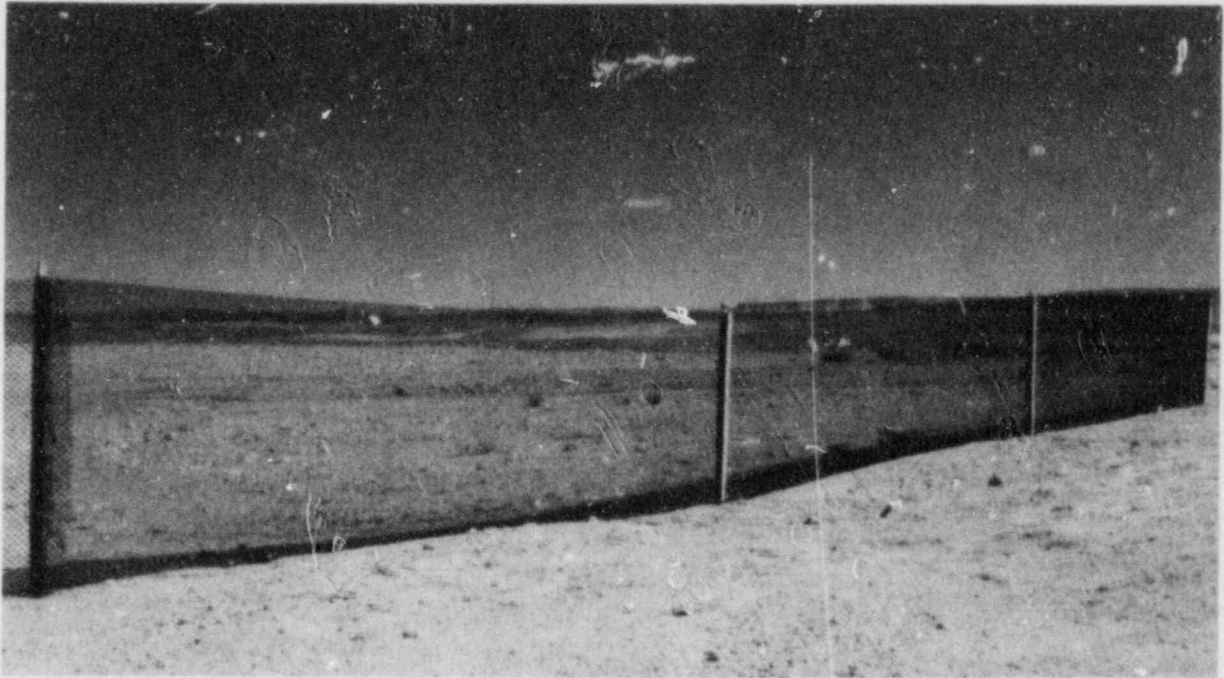
FIGURE B.5. DuPont Canada CE-121 Windscreen (a) as installed; (b) after nine months of weathering. This material had stretched a minor amount, but showed no other signs of degradation.

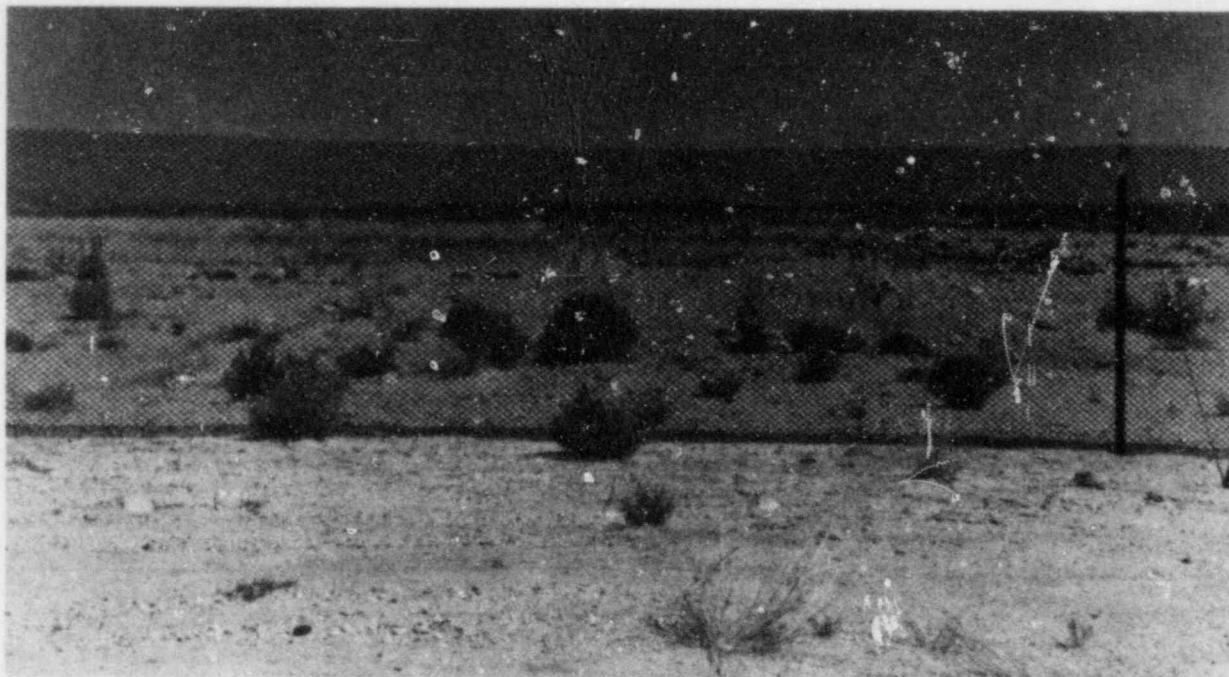
FIGURE B.6. DuPont Canada L-38 Windscreen (a) as installed; (b) after nine months of weathering. The material showed very little stretching or other degradation after the exposure period.

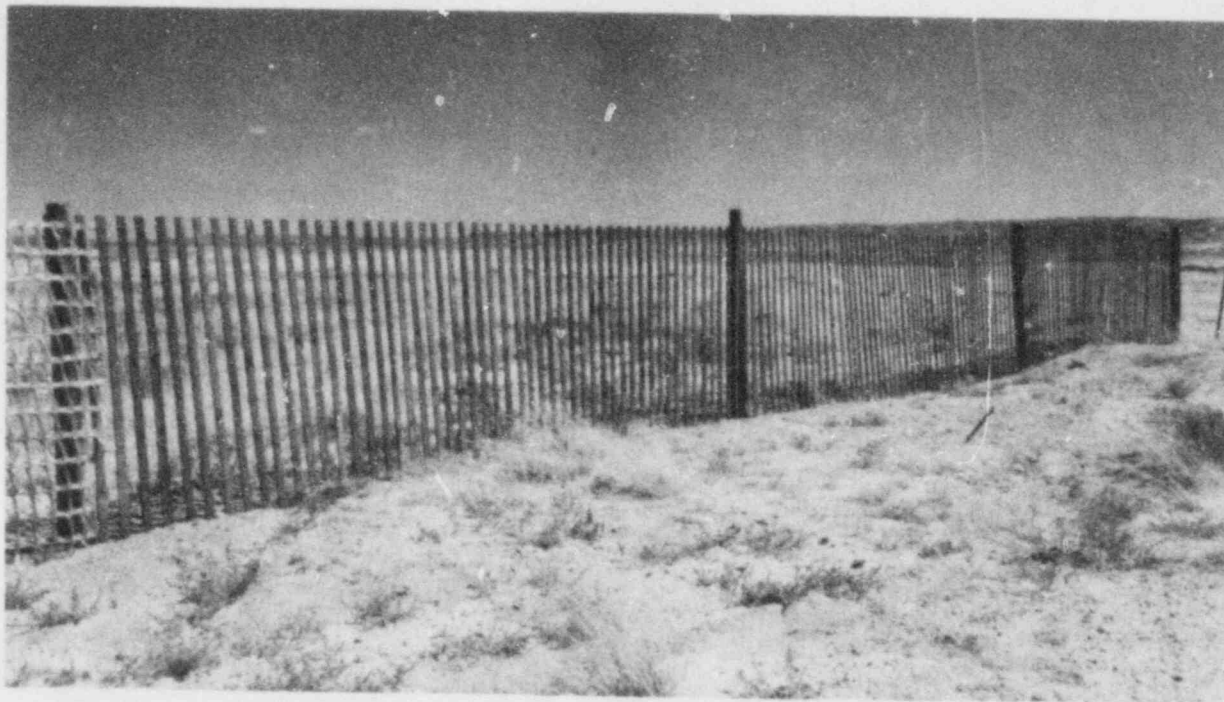
FIGURE B.8. Wood-Slat Snow Fence (a) as installed; (b) after nine months of weathering. Note both the broken wood slats and wires.

The deteriorated condition of the wood-slat fence, on the other hand, was less surprising. The wires and wood slats were broken in several places along the length of the test panel, as shown in Appendix B (Figure B.8b). The experience of many people with this product indicate that, although initially less expensive than most other similar products, the vertical wood-slat fence
