# Steam Generator Group Project

## Task 6 - Channel Head Decontamination

Prepared by R. P. Allen, R. L. Clark, W. D. Reece

**Pacific Northwest Laboratory**  
Operated by  
Battelle Memorial Institute

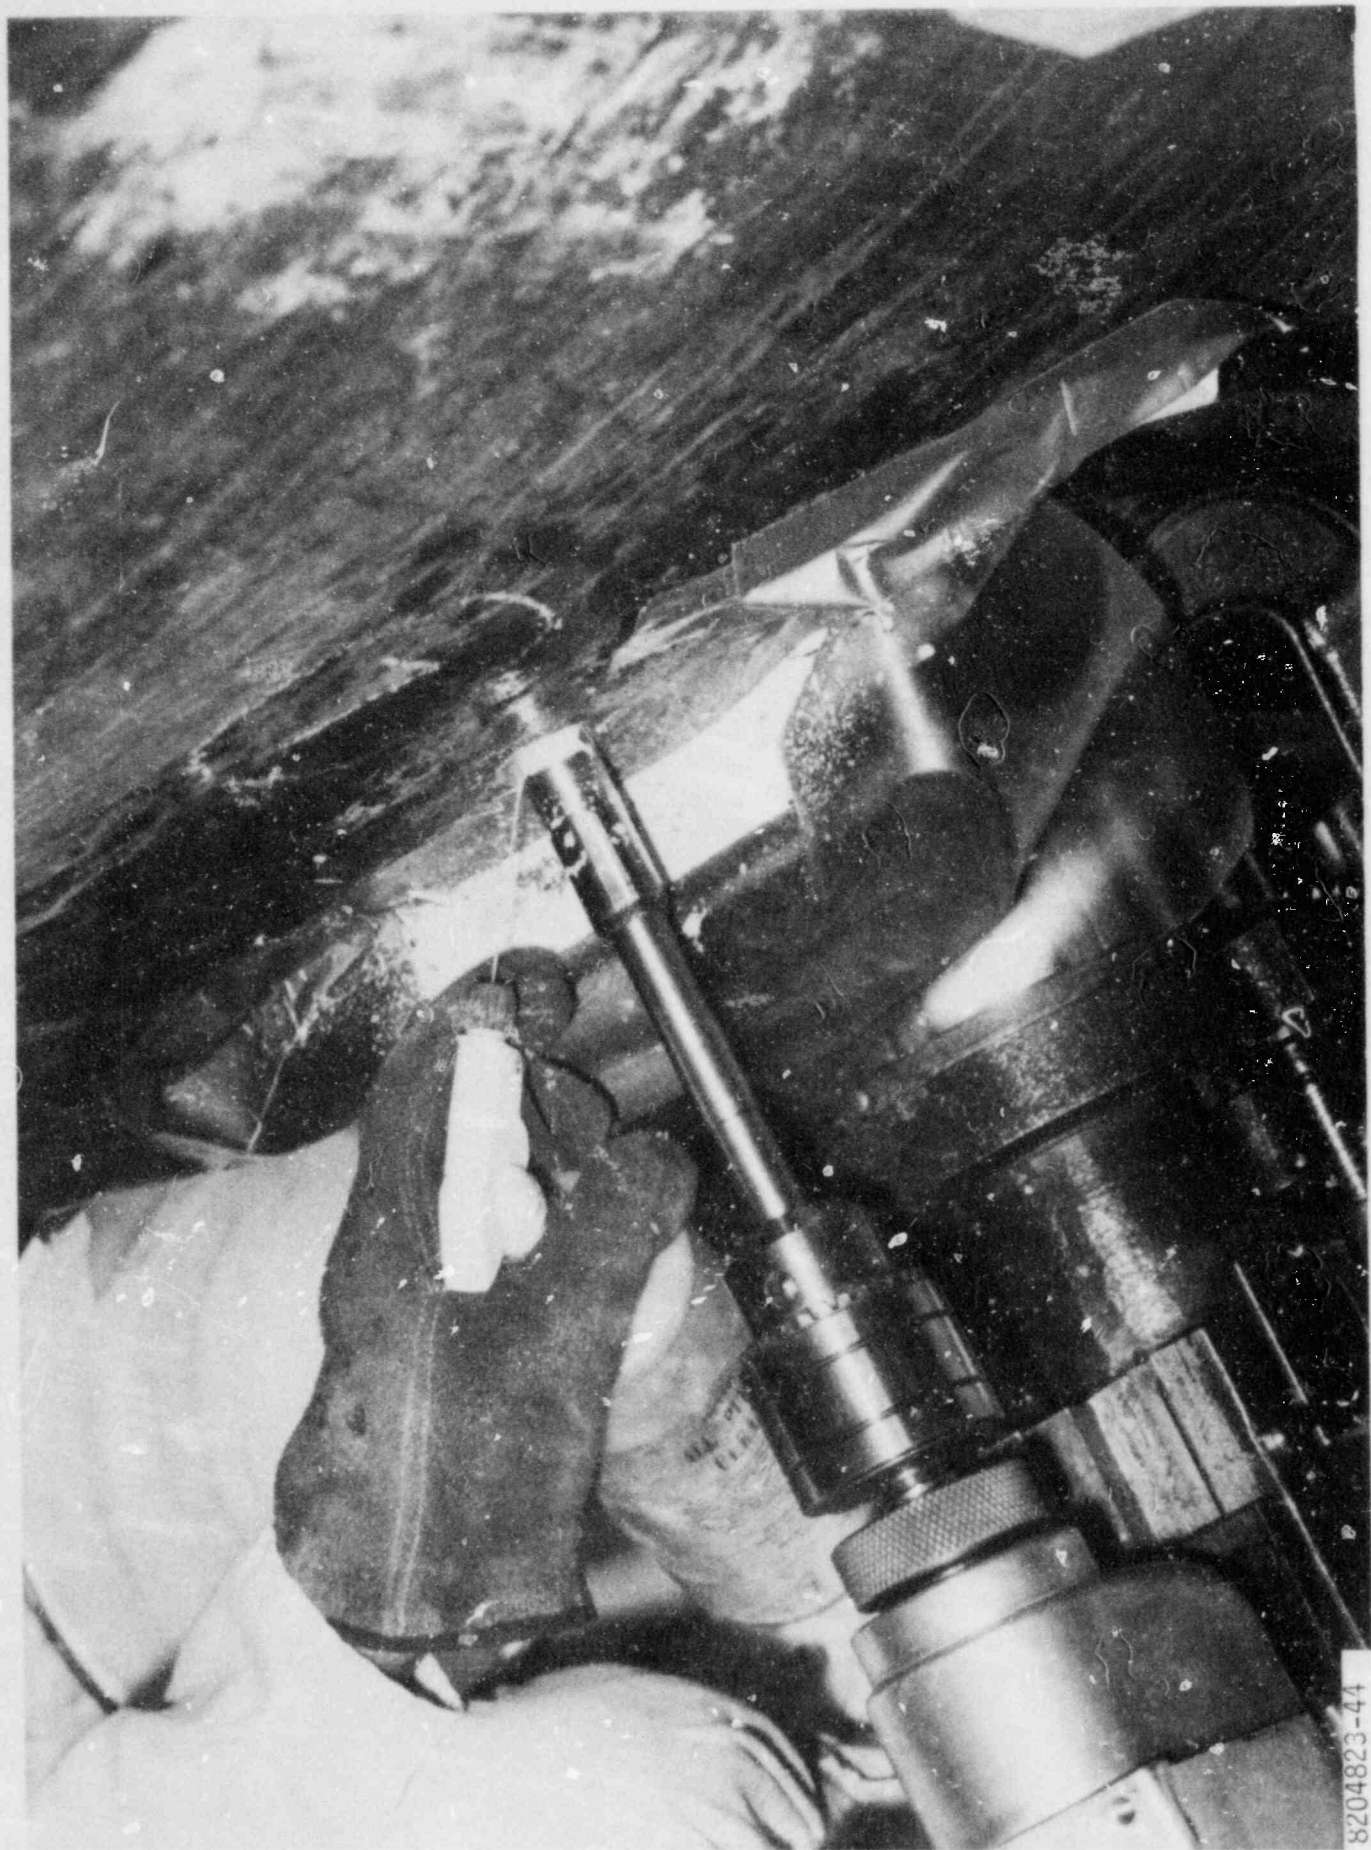
8204823-44

FIGURE 2-1. Core Drilling to Obtain Samples of the Interior Channel Head Surfaces

Samples of the hot leg and cold leg stainless steel surfaces were obtained prior to decontamination by core drilling through the outer carbon steel shell as illustrated in Figure 2-1. This was a very difficult operation because of the hardness of the weld overlay stainless steel. Similar samples were taken after the decontamination operations. A 25-cm section of the tubing (Row 1, Column 94, between support plates 6 and 7) was removed and used to prepare ring specimens for the corrosion and decontamination effectiveness studies. This was to assess effects of the decontamination processes on tube ID (primary side) and OD (secondary side) films.

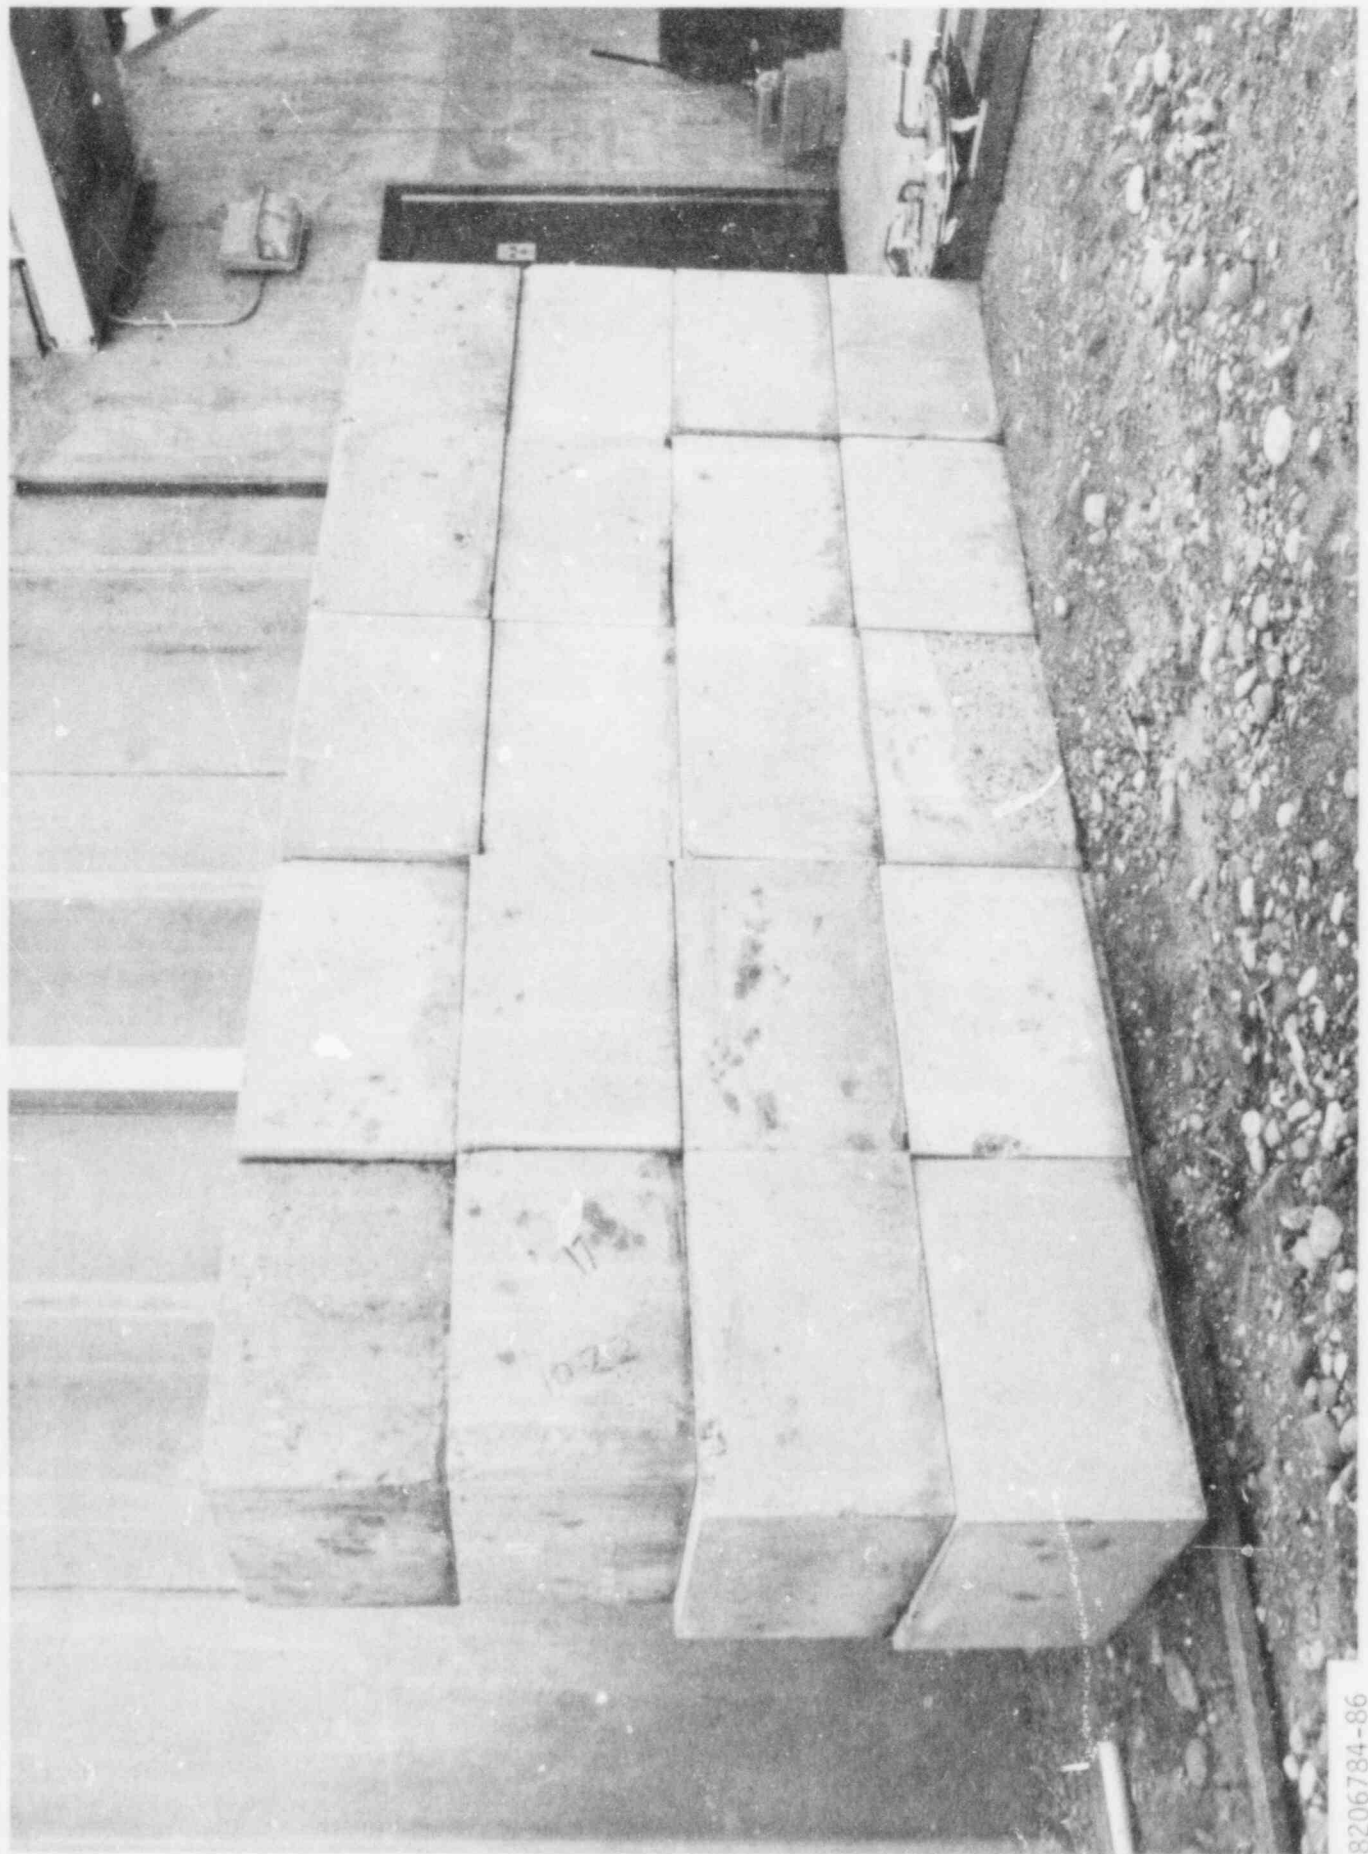
8206784-86

FIGURE 2-8. Concrete Block Shielding Wall Outside the Steam Generator Examination Facility

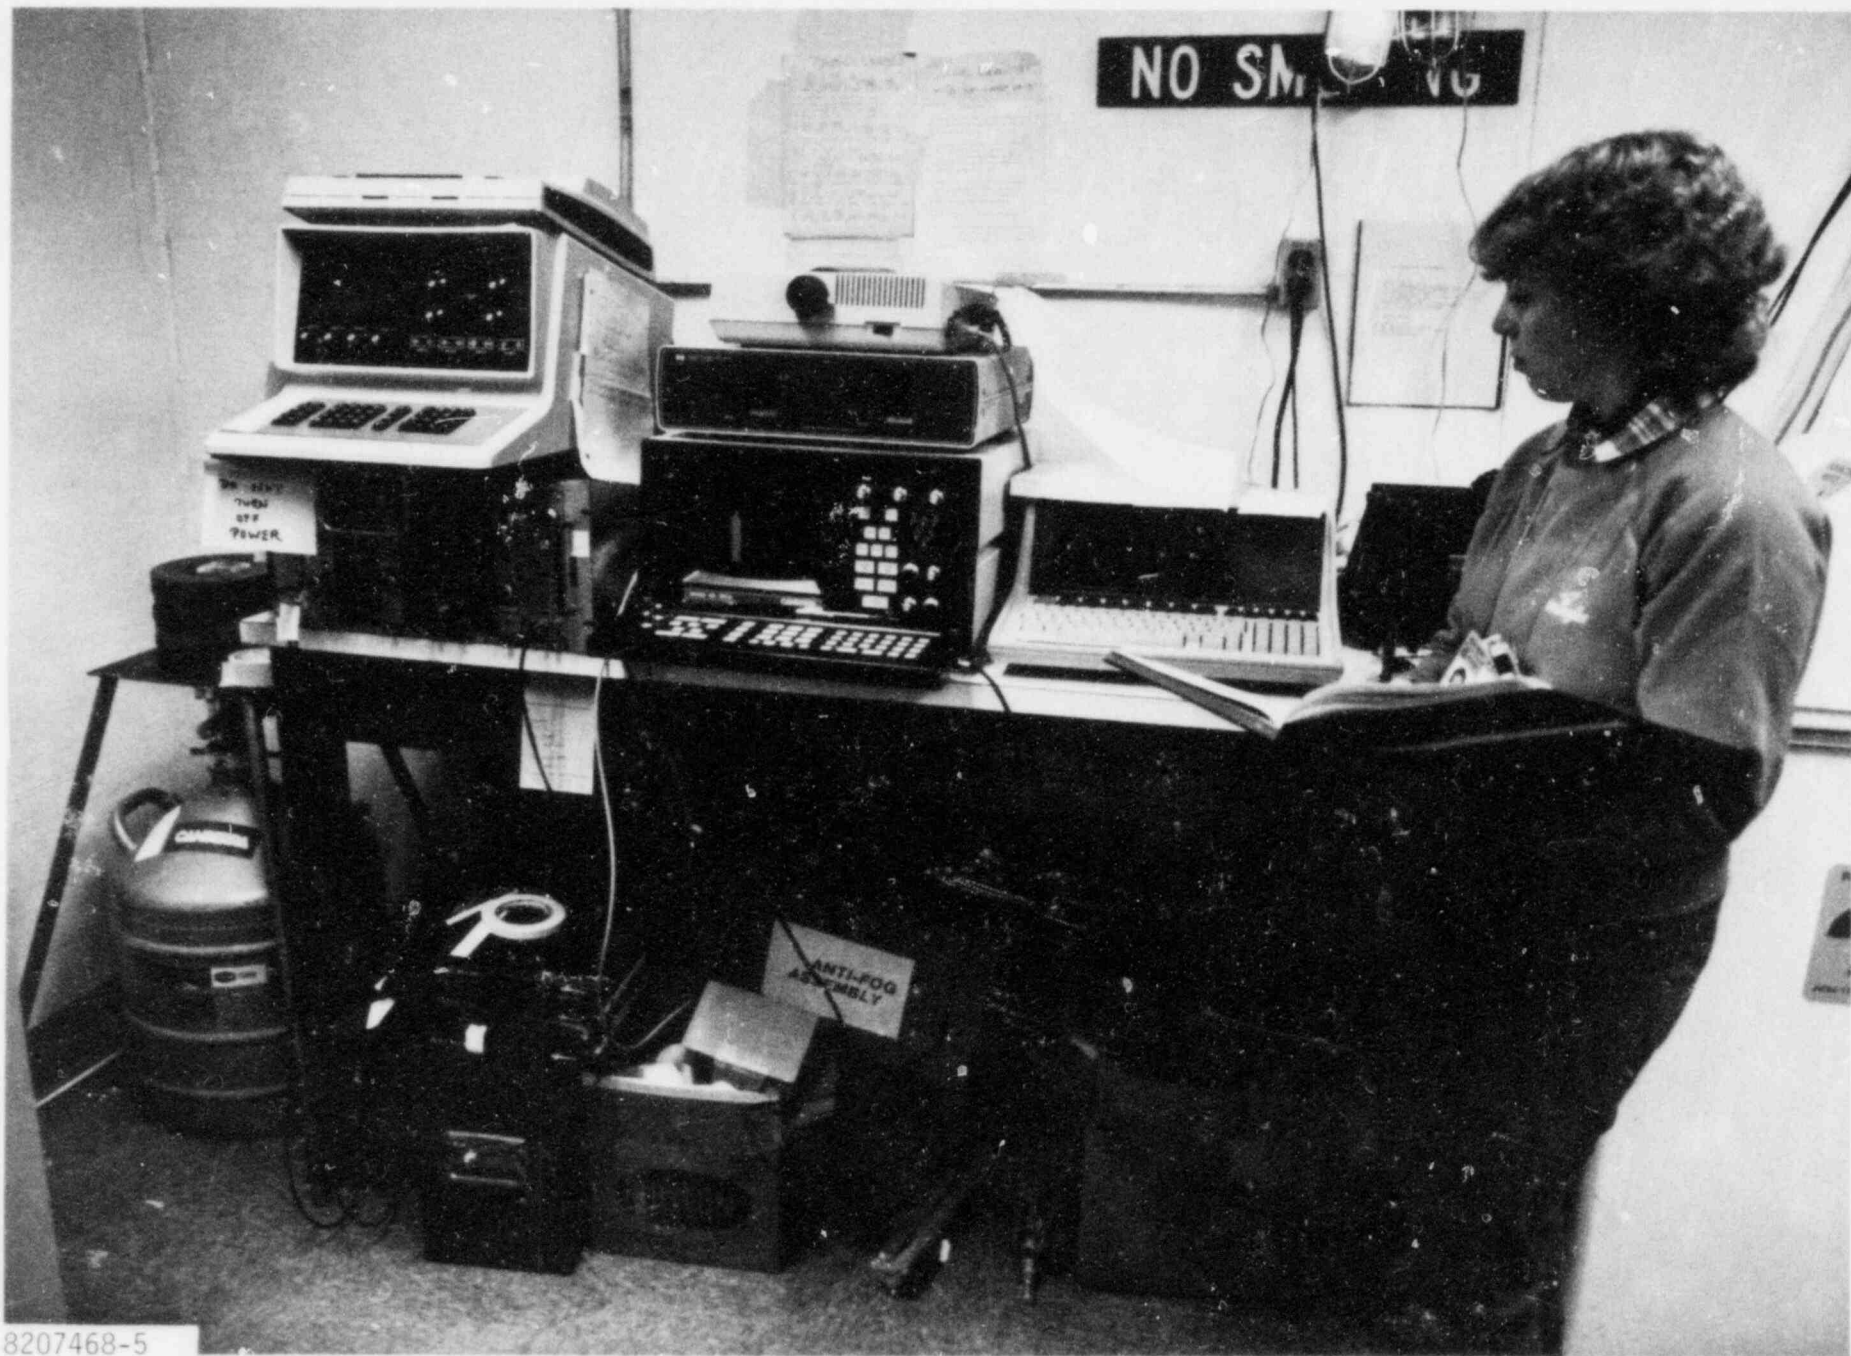
8207468-5

- Co-60 Activity - The concentrations of Co-60 in the decontamination solutions was measured throughout the decontamination operations using the Ge(Li) detector, analyzer and data acquisition system shown in Figure 2-17. A description of the evaluation procedures is included in Section 5.
- Corrosometer Data - Corrosion rate data ( $\mu\text{m}$  penetration) were obtained at approximate 2-h intervals for carbon steel, 304 stainless steel and 304L stainless steel for the cold leg decontamination, and for carbon steel, 304 stainless steel and Inconel 600 for the hot leg decontamination.

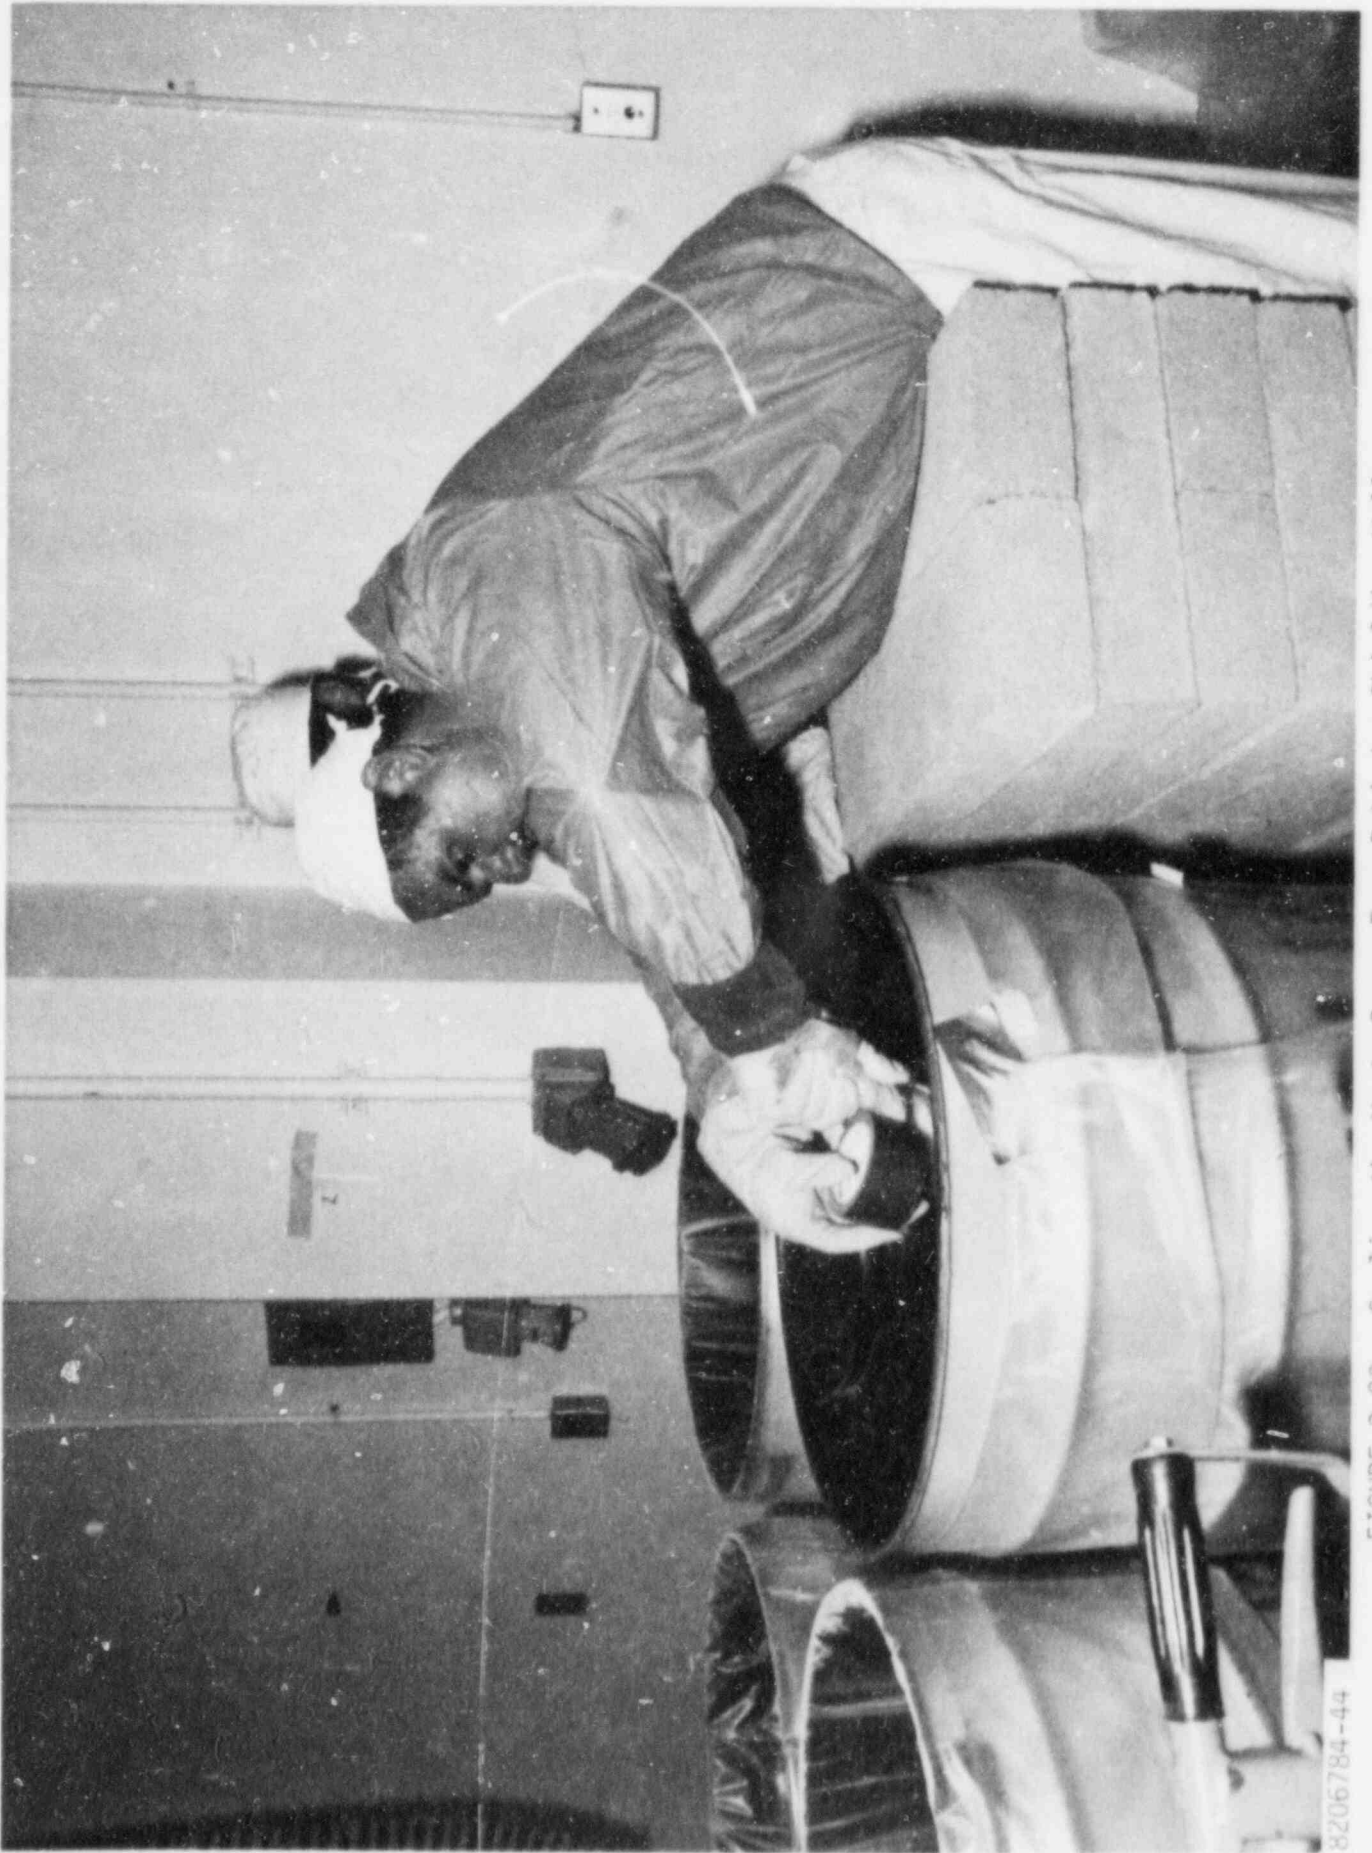
8206784-44

FIGURE 3-23. Sealing the Waste Drums From Behind a Shielding Wall

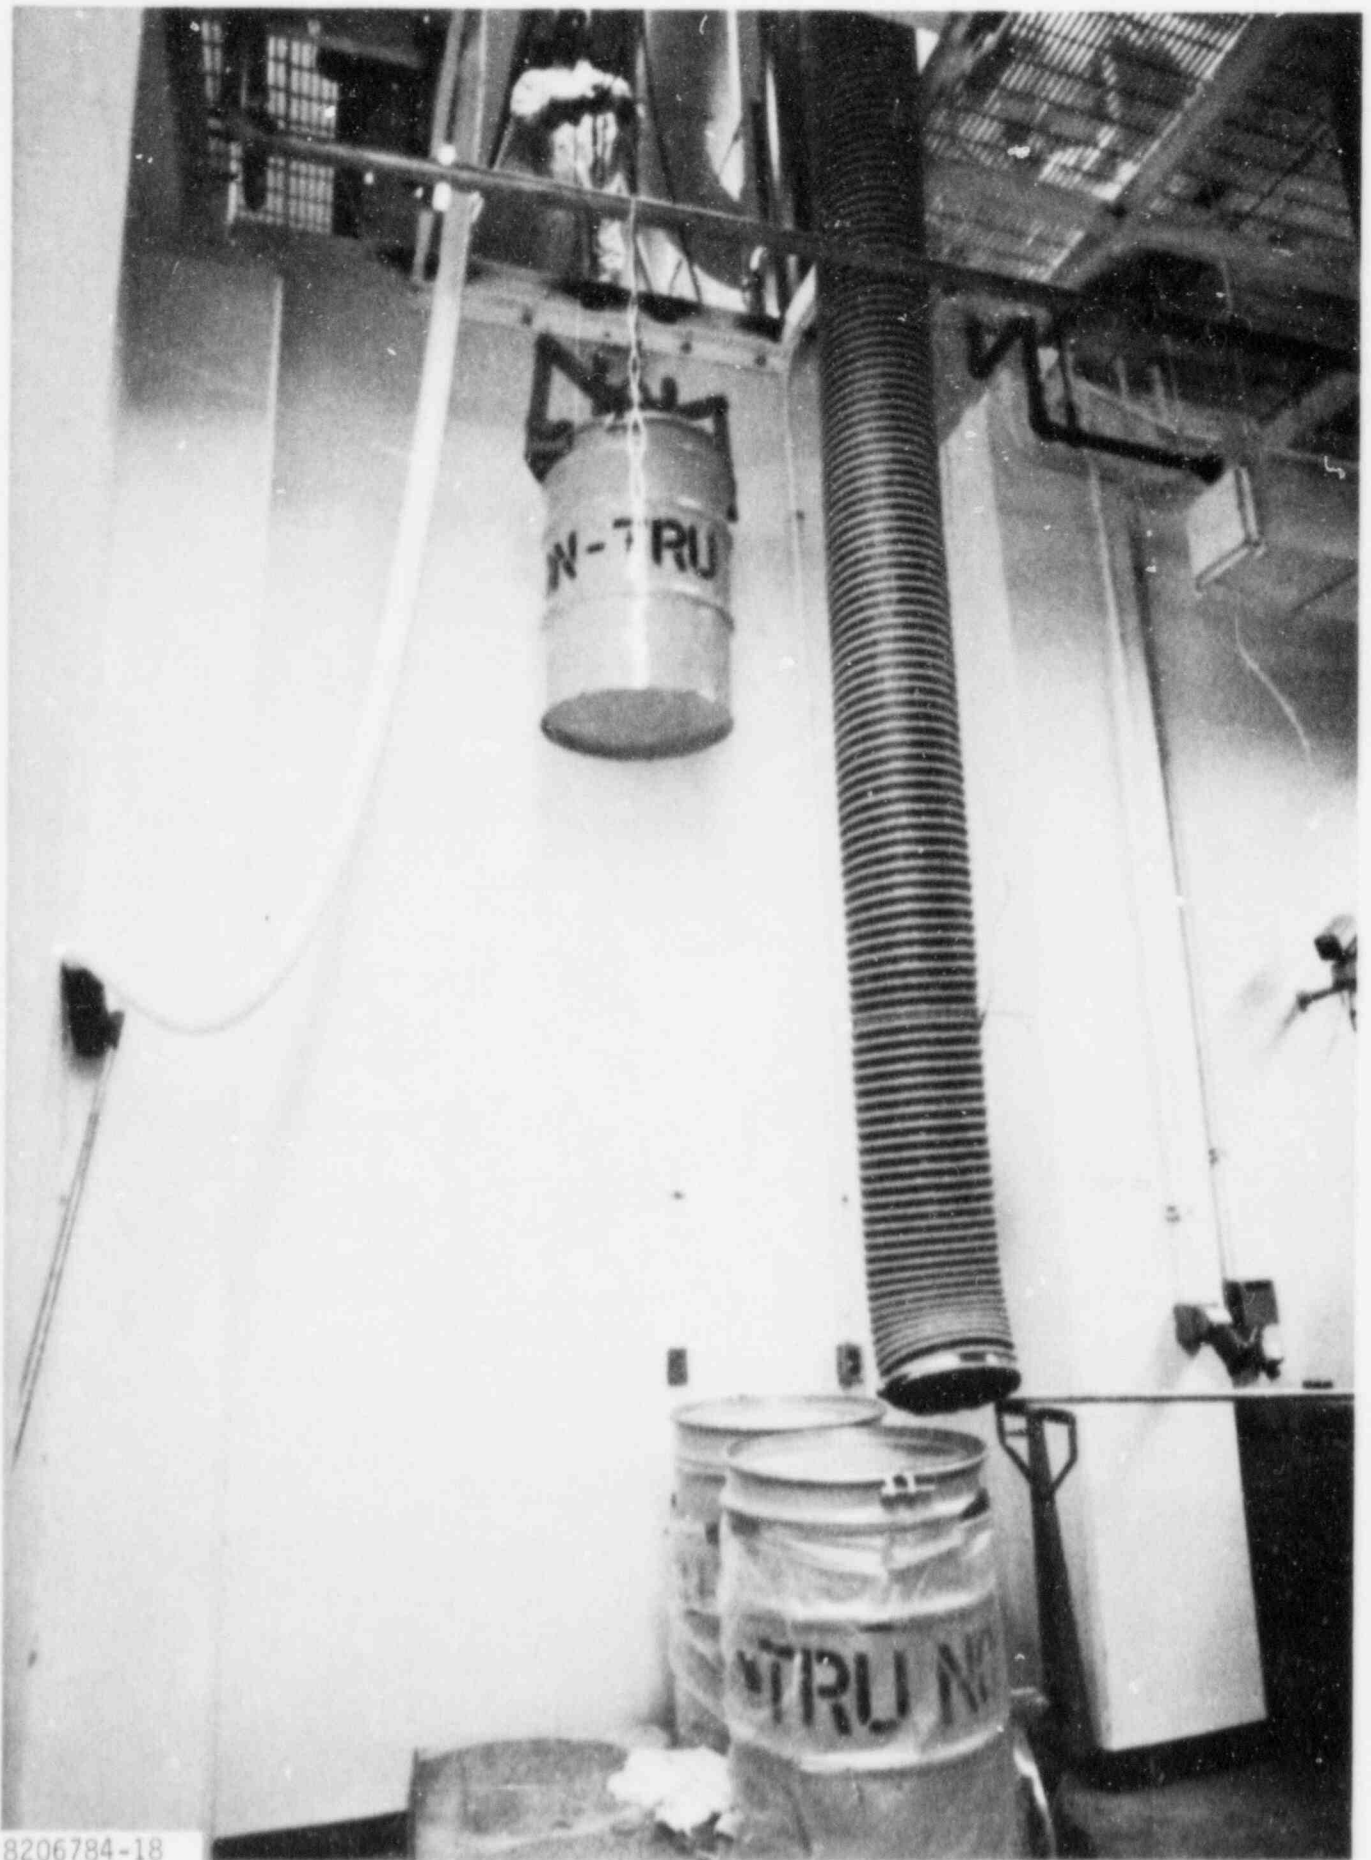
8206784-18

FIGURE 3-24. Remote Clamping and Hoisting System

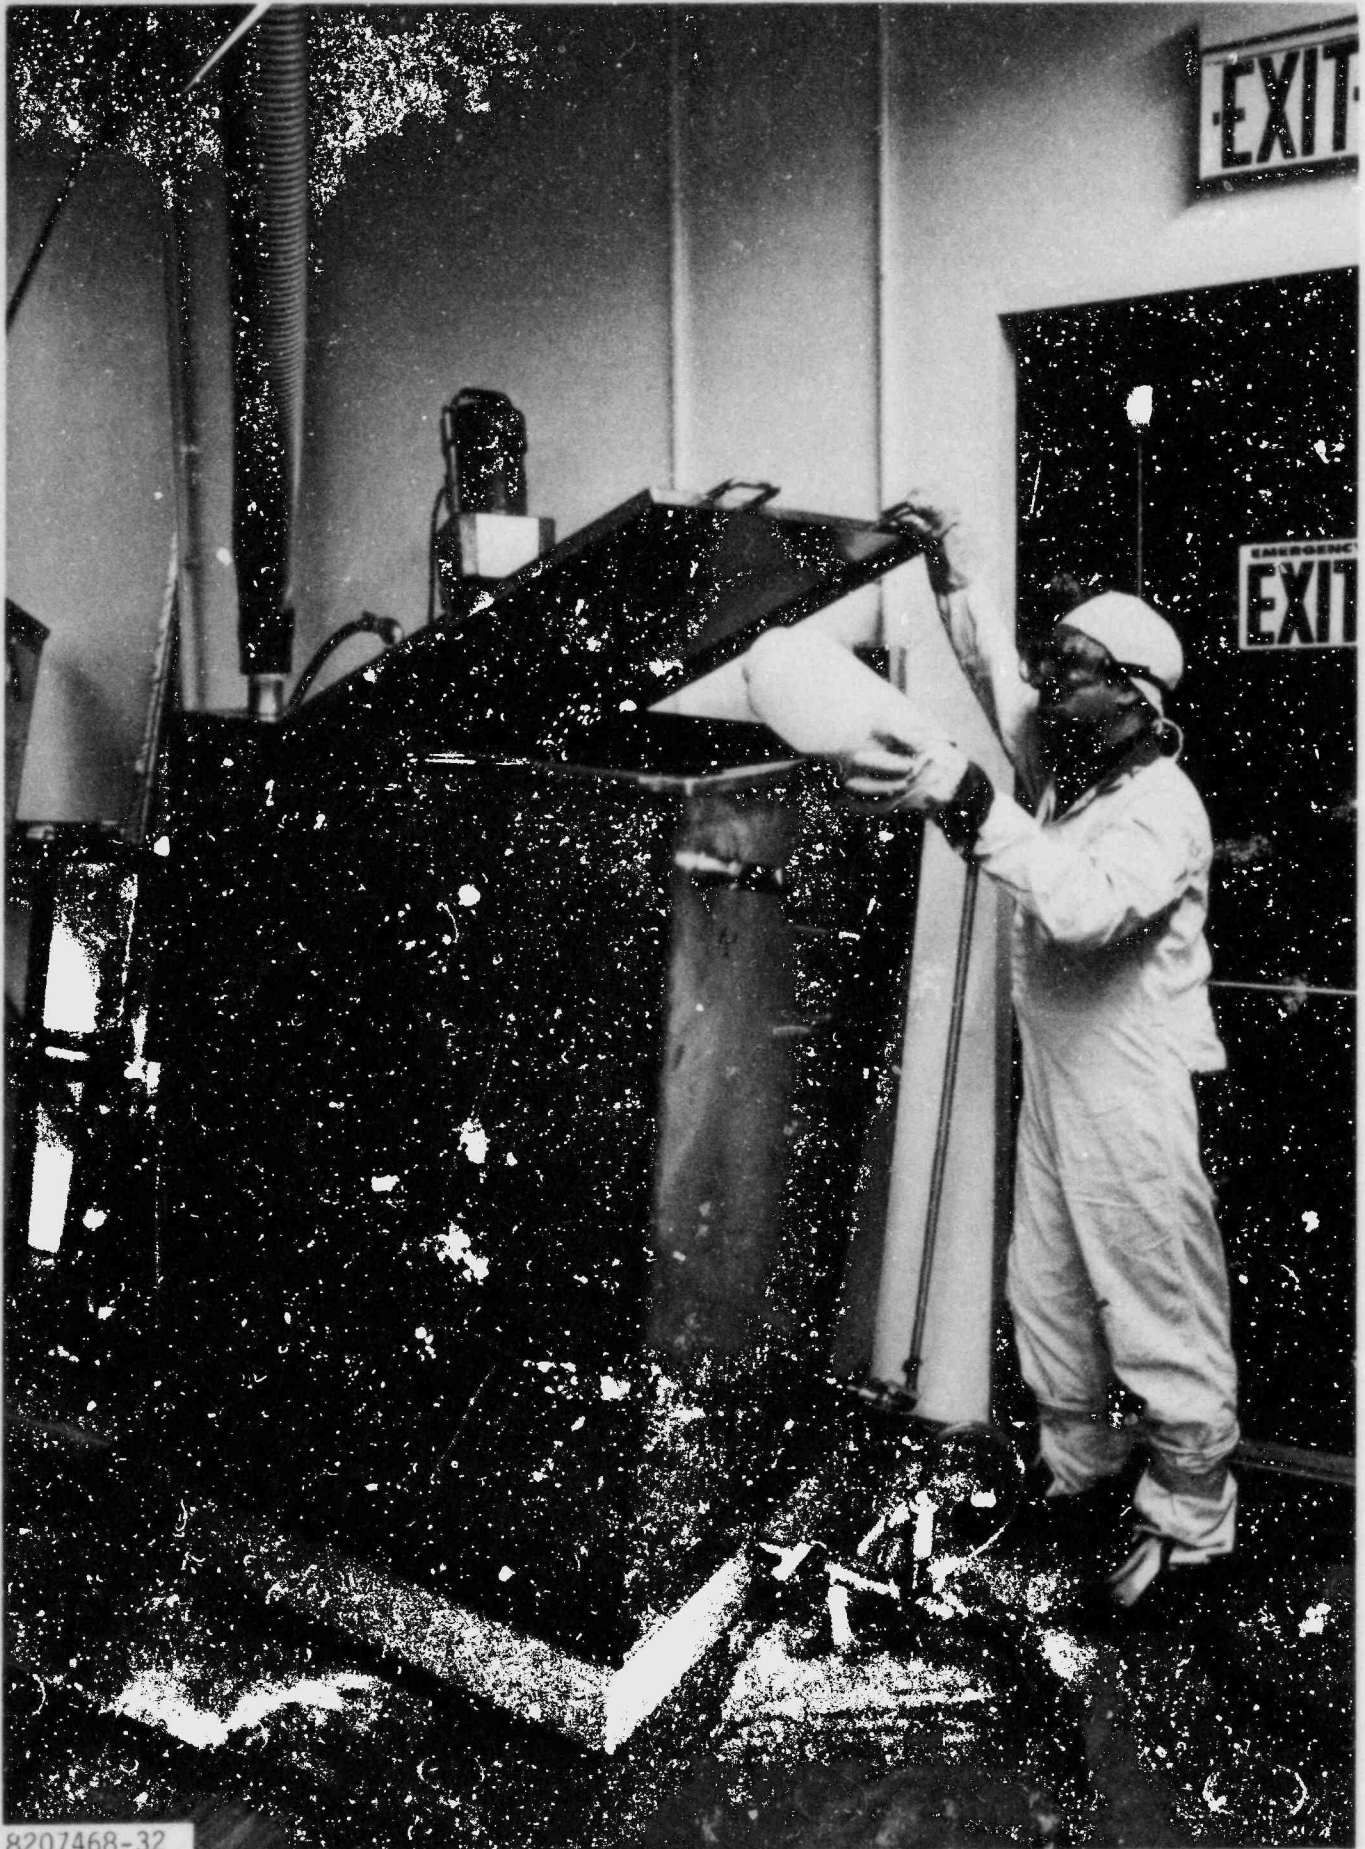
8207468-32

FIGURE 4-1. Chemical Addition/Mixing Tank for Hot Leg Decontamination

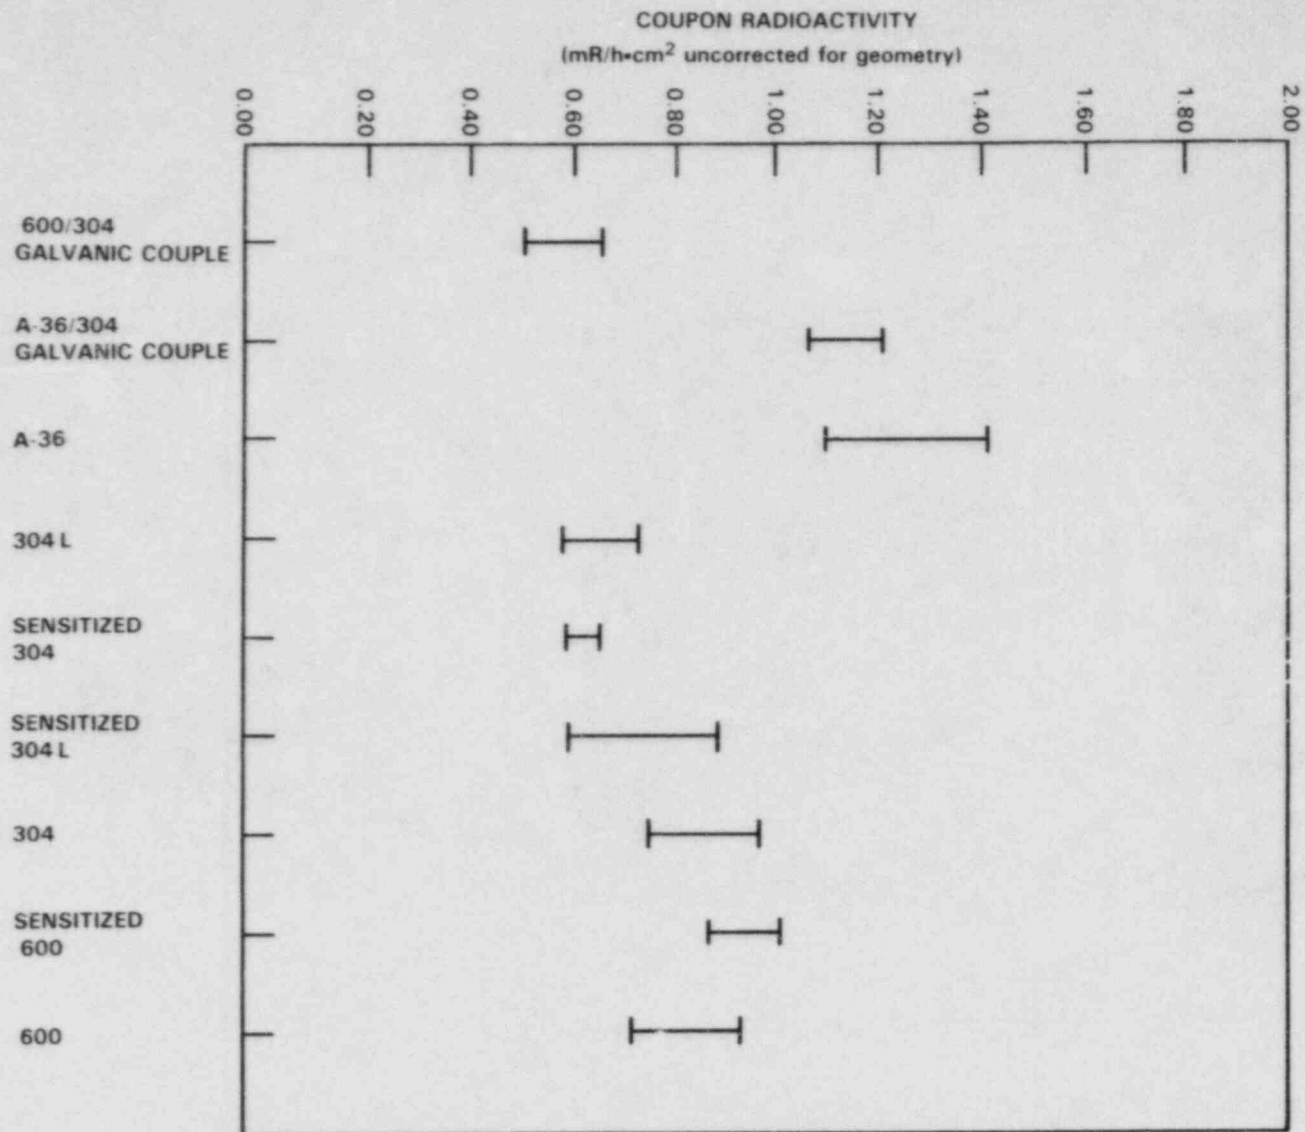
FIGURE 6-2. Deposited Radioactivity on Corrosion Coupons After the Cold Leg Decontamination

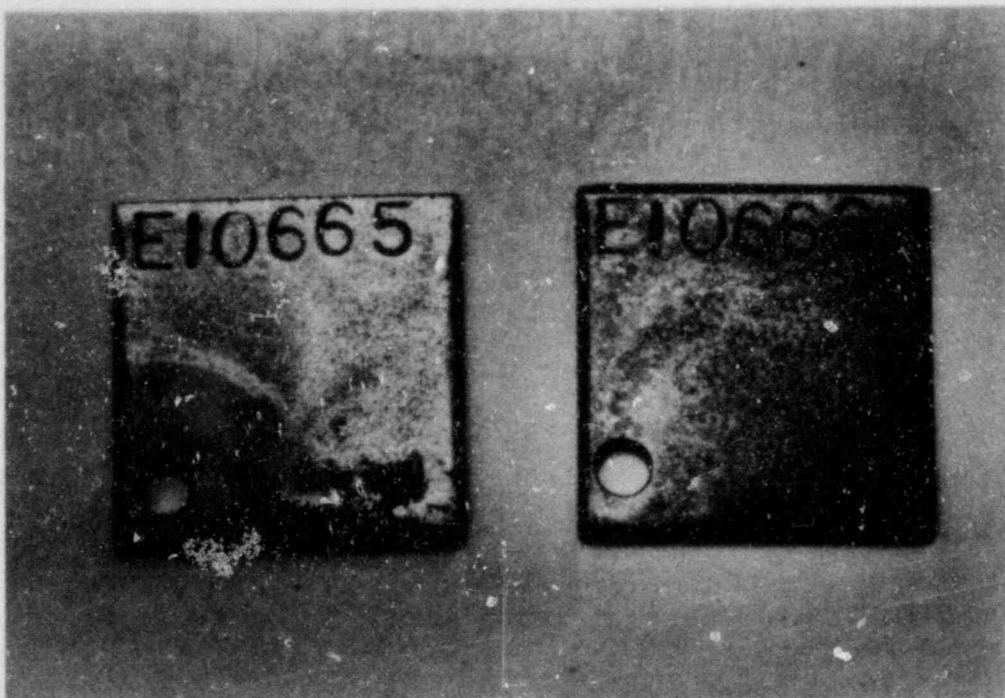
FIGURE 6-13. Prefilmed Corrosion Coupons After the Hot Leg Decontamination
