FACILITY: Vogtle, Units 1 and 2

SUBJECT: SUMMARY OF VISIT TO EXAMINE CLASTIC DIKES NEAR VOGTLE,
JUNE 21-22, 1984

Coastal Plain Clastic Dikes Field Trip Report

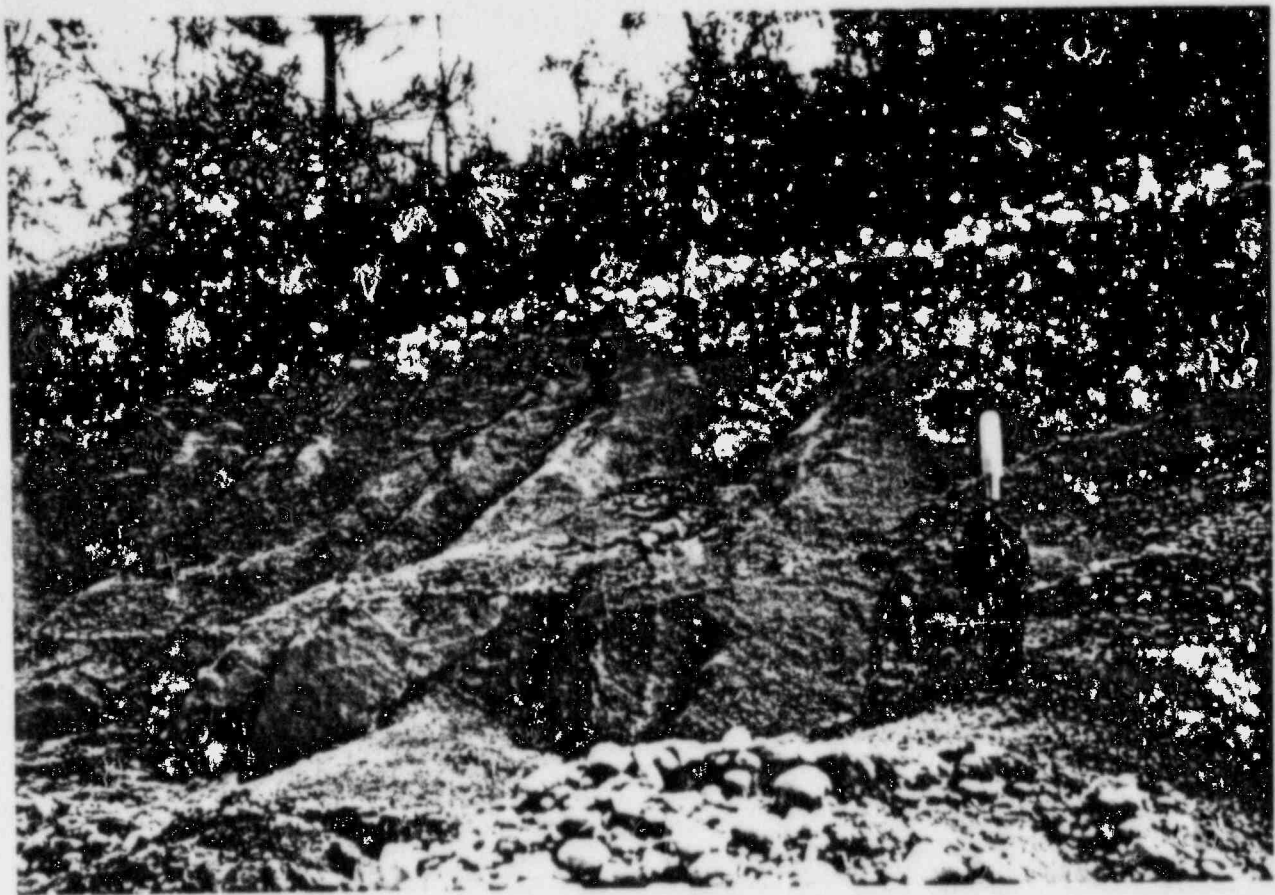
FIG. 2a

Yellow-buff dike-like projections about 1-2" thick from the bottom of the soil at the top of the outcrop were clearly visible. A weathered mottled zone at the top gradually changed to the narrow vertical to low dipping projections, some of which joined with others and ended abruptly and some, individual structures (Fig. 2a).

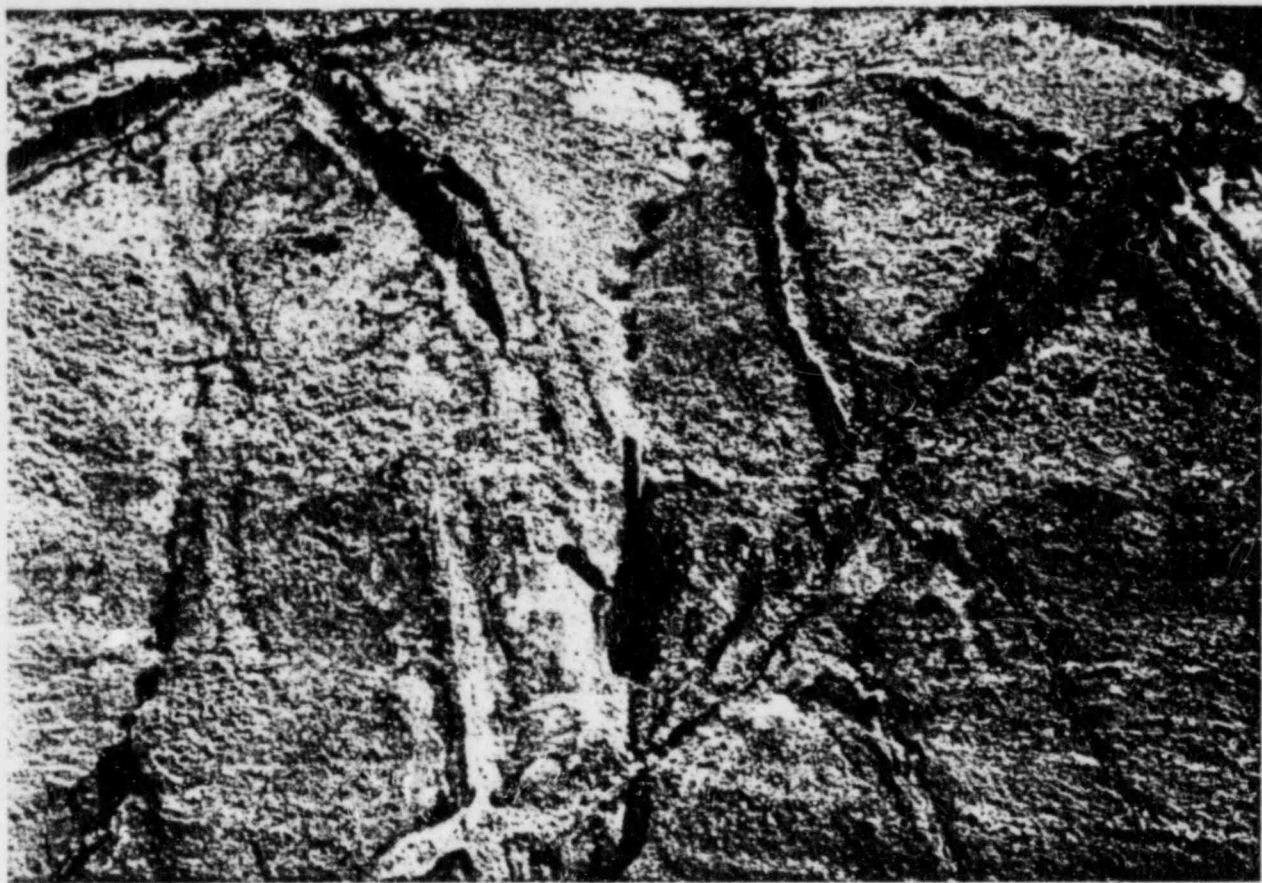
FIG. 3

Stop 1-2 - A short walk into the woods along an old railroad track brought us to a large, low level exposure, at ground level and a few feet above. The strata were yellow and red weathered clayey sands with some gravel stringers. Cutting across in several directions were 4" wide dike-like structures, the borders of which stood up above the host rock due to differential weathering. For the most part the dikes consisted of thin white clay (kaolin) seams about $\frac{1}{4}$ " thick bordered by yellow weathered sandy clay grading into a red to maroon rind or crust which stands out in relief on the weathered surface (Fig. 3).

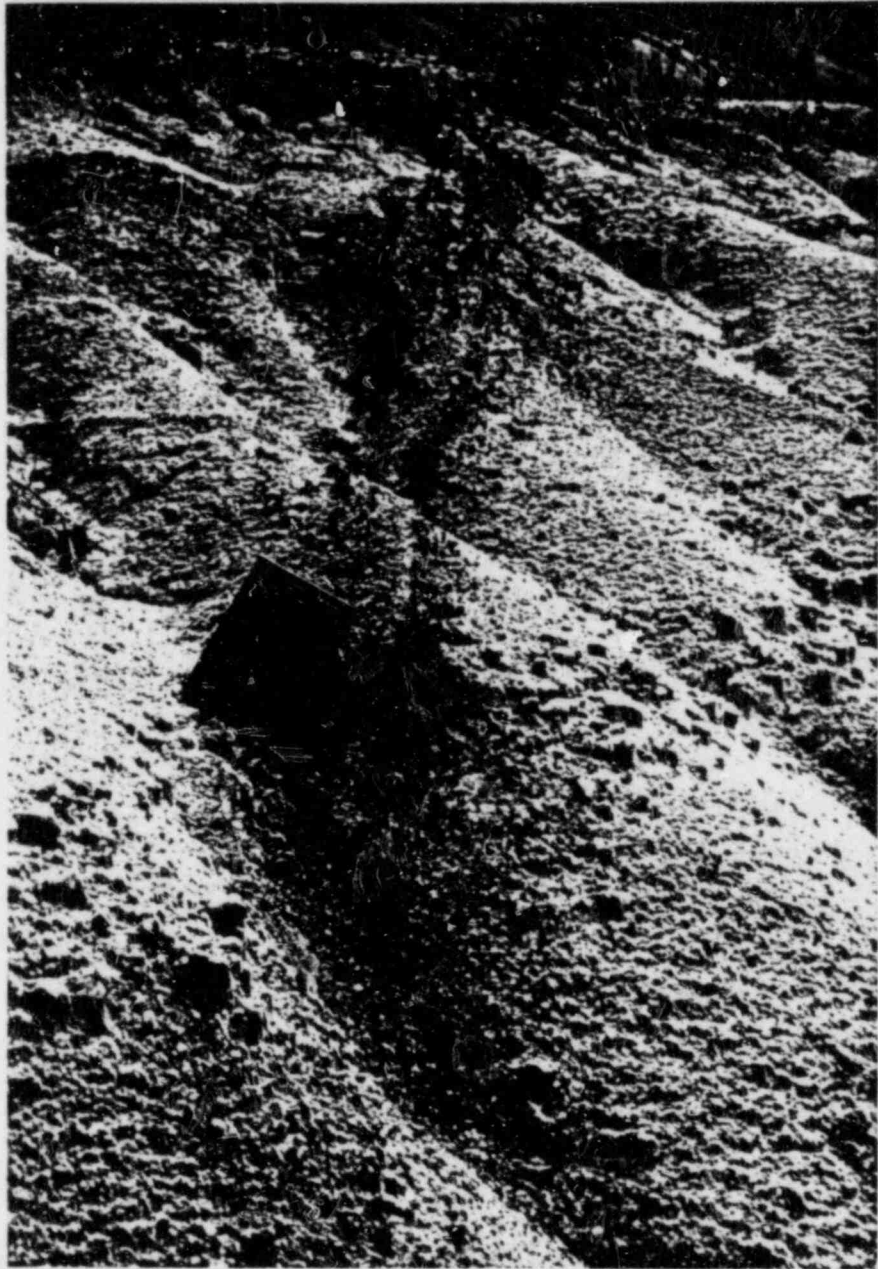
FIG. 4

That the clay material appeared to be intruded into the host rock was indicated by one dike with 2" thick clay that cut across a gravel bed. No gravel could be found in the dike, indicating the gravel did not continue across the dike (Fig. 4).

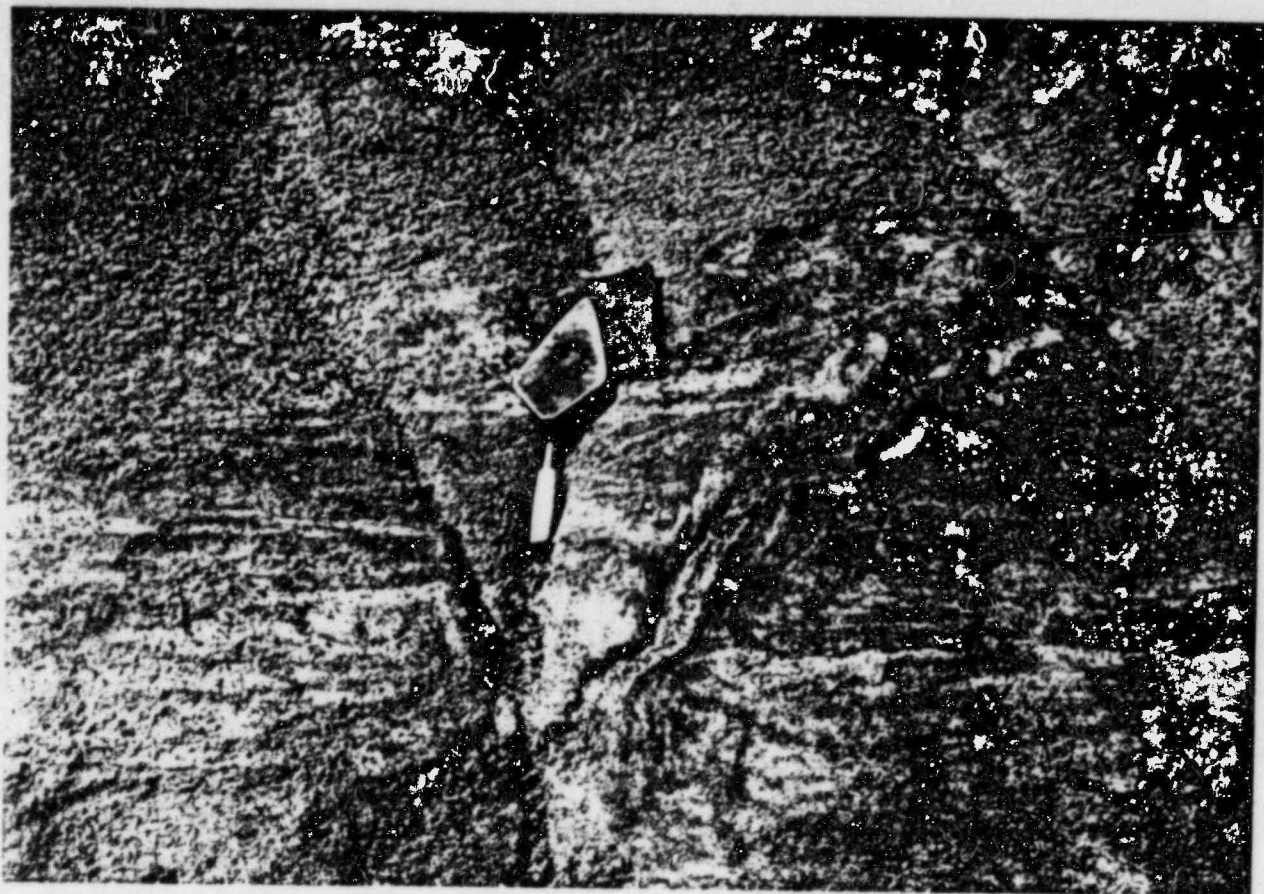
FIG. 5

One anomalous irregularly shaped dike of gray clay, about 3" wide, offset a series of yellow and red layers in a reverse or thrust displacement (Fig. 5) indicating some form of minor disturbance during opening of the fissure into which the injected material was emplaced.

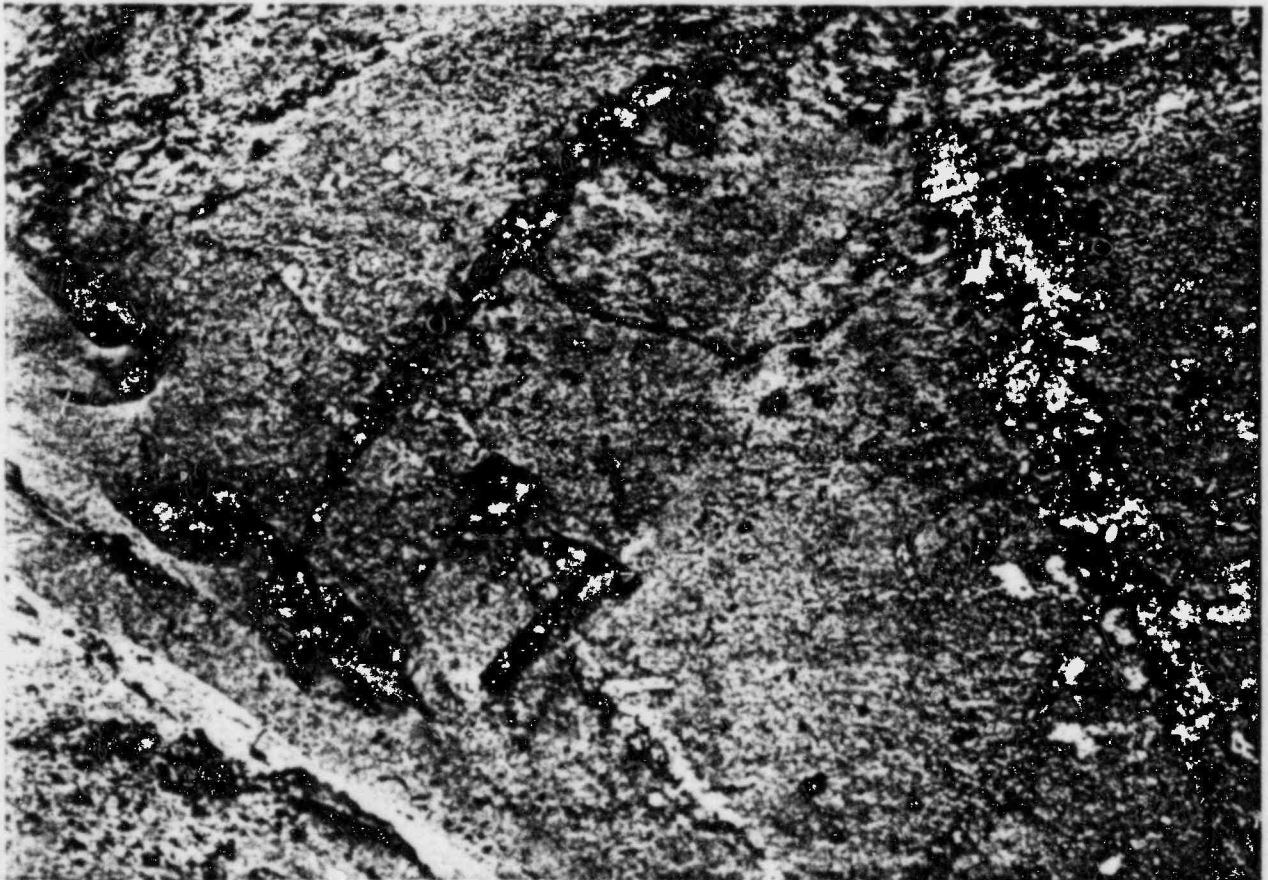
FIG. 8

The other group are similar to those seen at Stop 1-2, with red rinds standing up in relief from the surrounding sedimentary material. These crossed each other, in places following the yellow-buff dikes and in other places diverging from these or cutting across (Figs. 8 and 9). The red-crust dikes are mixtures of sand, silt and clay, with a larger proportion of clay in the dikes than in the host strata, according to the consultants.

An unusual feature of this exposure was the circular "blob"-like appearance of some of the red-crust material, suggesting that in the third dimension these are pipe-like structures (Fig. 6, near hammer handle; Figs. 7 and 8, near hammer head; Fig. 9, at lower left corner of photo).

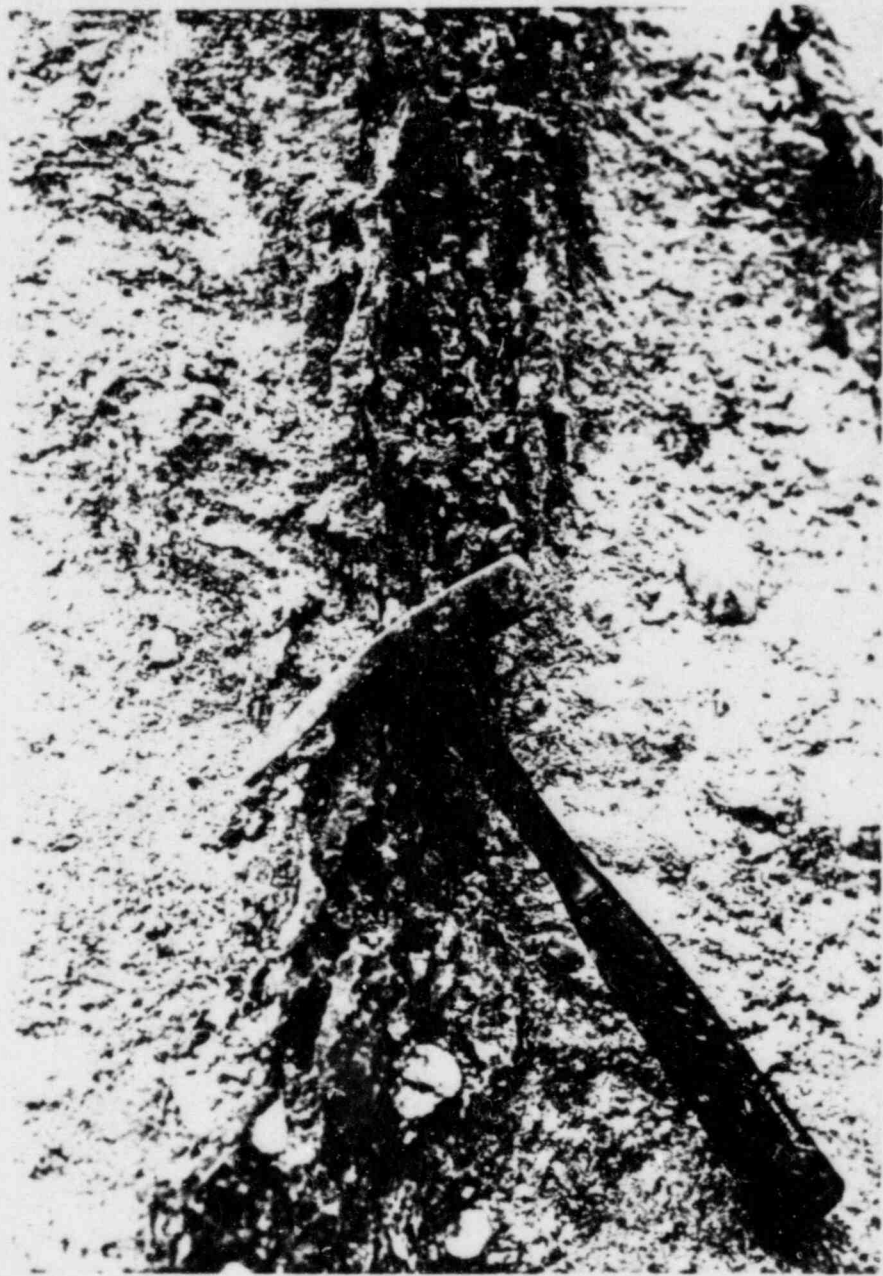
FIG. 10

An observation that may have some significance in determining the history of the dikes is that the north-south oriented, vertical, red-crust dikes exhibited crude planar or anastomosing shears within the dike boundaries. A nonsystematic sampling showed occasional pebbles within the dikes were sheared across parallel with these planar

features (Figs. 10 and 11). The east-west oriented red-crust dikes and the buff colored dikes did not show this structure within them.

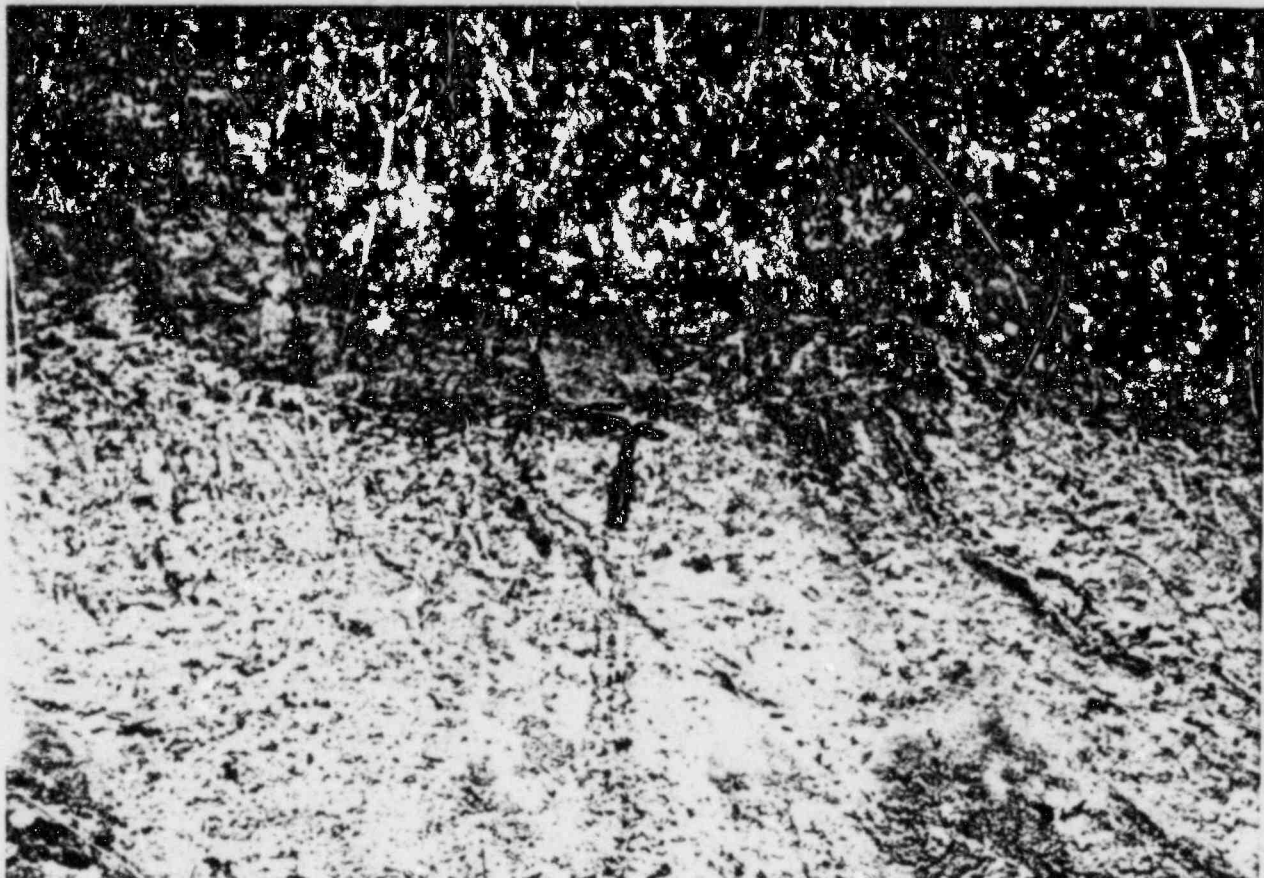
FIG. 12

Stop 1-5 - The outcrop here was a roadcut up to about 6-8 ft above road level. The outcrop was in a yellow sand member of the Barnwell Formation. The dikes were 1-2 in thick, consisting of yellowish clay with sand and silt and red rinds. They appear to end upwards at a weathered soil boundary, but close inspection indicated that they continue across the weathered zone but are faded, probably due to chemical weathering (Fig. 12, to right above hammer head).

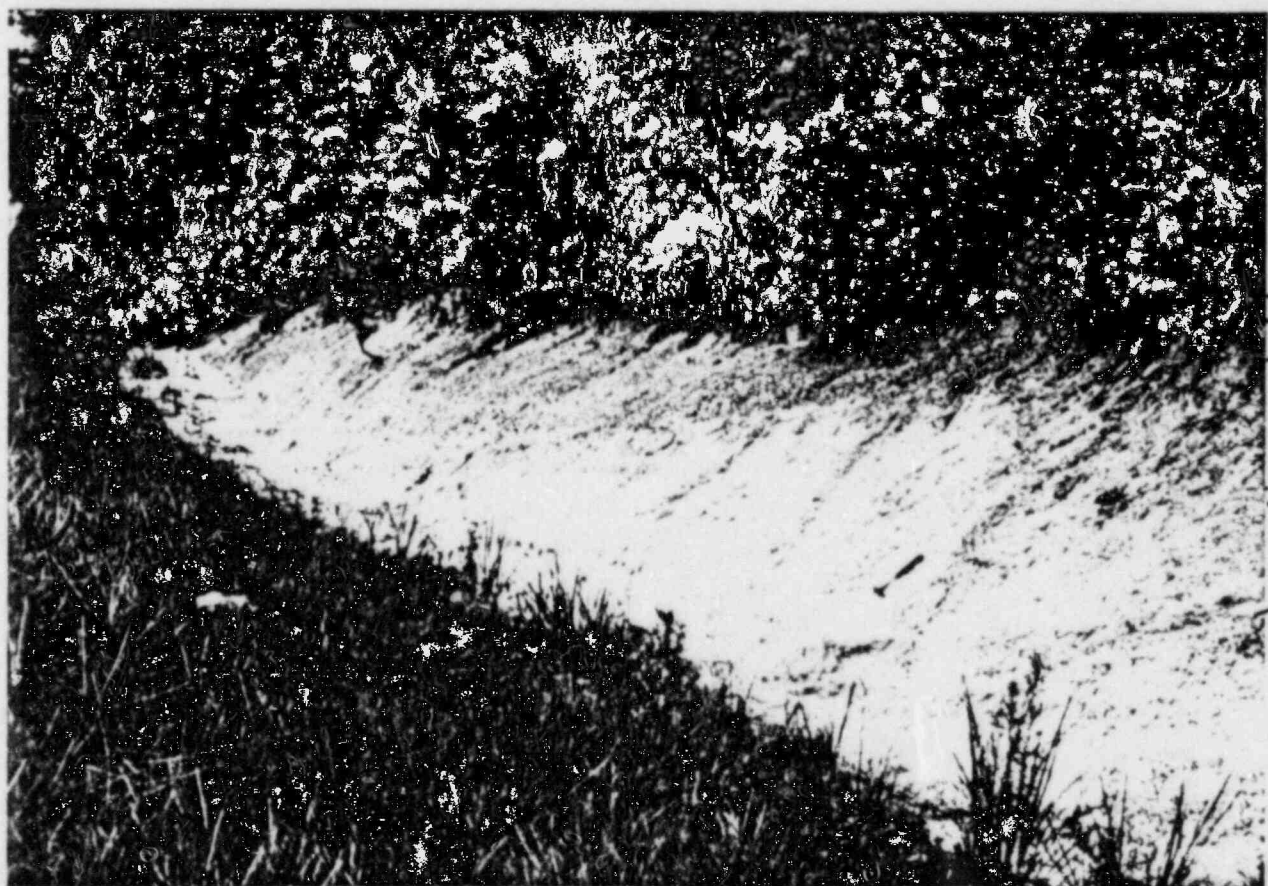
FIG. 13

Stop 1-5a- This stop had some instructive features that a systematic study of the dikes could no doubt use in understanding their origin. The outcrop is about 3m high and consisted of three distinctively weathered units (Fig. 13).

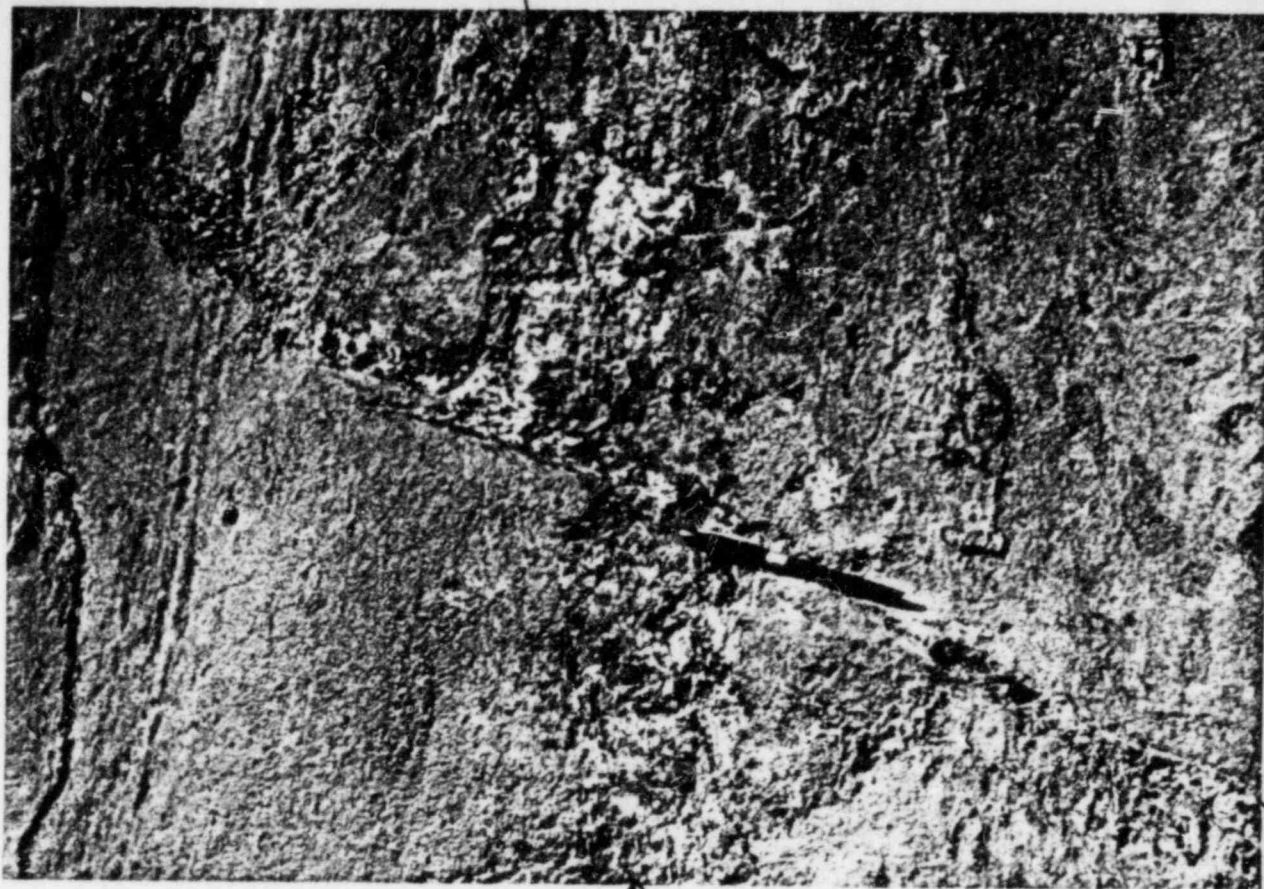
DIKE
FIG. 16

Stop 1-6 The exposure was a large clay pit opening of Barnwell red silt. The exposed wall was about 3m high and had a few yellow clay dikes about 2-3 in wide. Two of these dikes were cut by low angle faults which offset them (Fig. 16) in a reverse sense. The faults dip in opposite directions (Fig. 17) and bear a similar relationship as faults at the Barnwell Low Level waste repository which were evaluated by USGS geologists. Their opinion was that these faults probably represented a possible subsurface subsidence into a depression, causing the overlying material to appear to shift upward (John B. Robertson memo dated Nov. 12, 1979 in Allied General, 1980). The cause of the void that could result in such collapse may be a solution cavity in an underlying soluble carbonate unit, or removal of material by liquefaction. This could not be determined from the field observations.

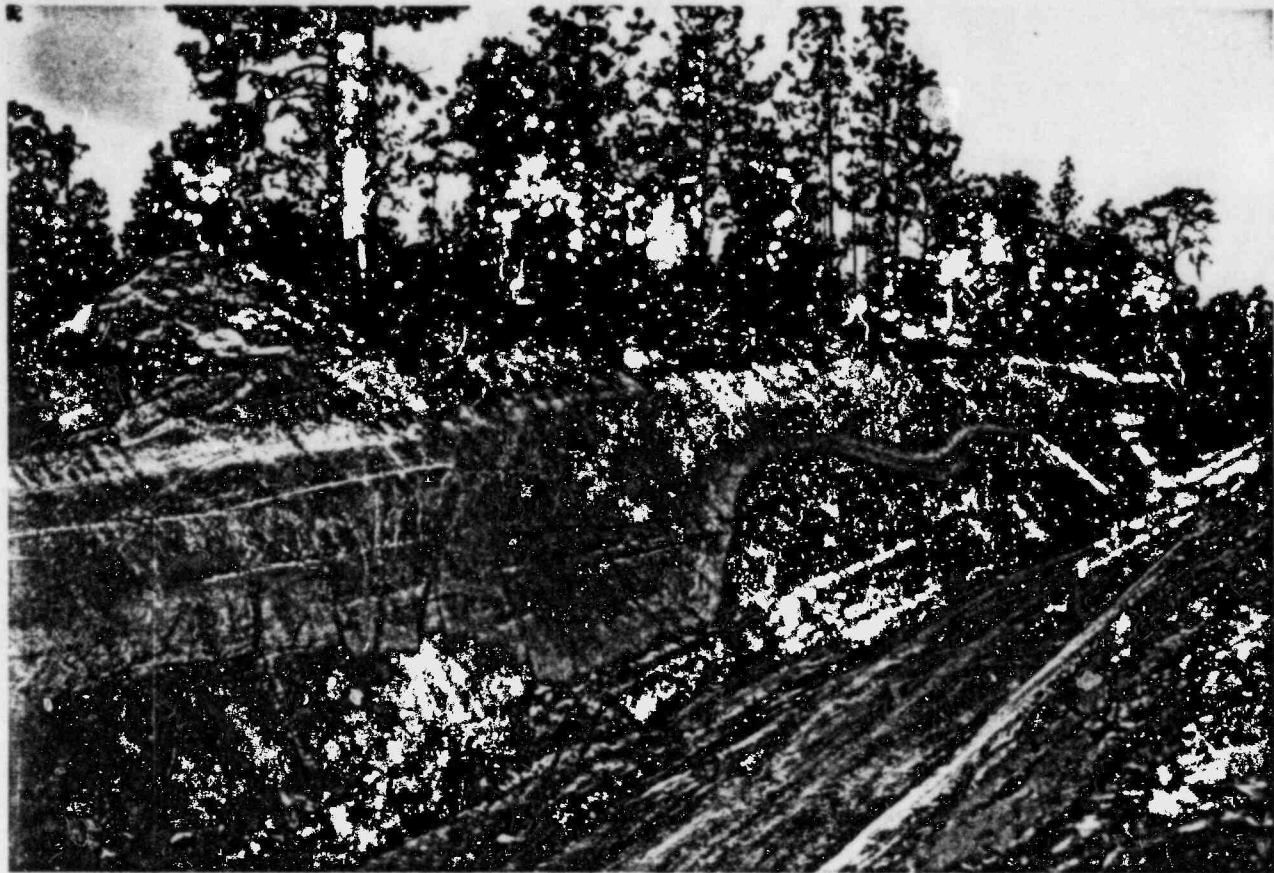
FIG. 18

Stop ~~1-6~~ - Because of time limitations, it was decided to visit the most extensive exposure available for the second day's trip. This was a waste disposal trench, about 300m long, 10-15m high and 25m wide, dug on the Vogtle site about 2 km ^{north}~~south~~ of the plant (Fig. 18).

The strata exposed in the trench were reported to be the Barnwell red beds. The overall structure was of a series of antiformal/synformal features (Fig. 18) that were noncylindrical in longitudinal shape, as

determined by their variation in crosssectional shape on either side of the trench. That these were not classic-type folds formed by compression was indicated by two observations: (1) the axes of the various fold-like structures, measured by extending in imaginary line from identical points on the "fold" hinges on each sidewall of the trench, were at high angles to each other, roughly N45E and N45W for two successive antiforms, and (2) numerous small normal faults and graben-like structures are associated with the synforms, indicating extension, rather than compression (Figs. 19-26). Note the similarity of Photo 21 to Photo 15 of Stop 1-5a, both showing a small graben in the trough of the synform bounded by vertical normal faults. These two exposures are 25 km apart, and the folds are oriented at about 90° from each other indicating that regional compression was not the cause of these folds.
