NEDO-30730
DRF B31-00106
Class I
September 1984

PILGRIM NUCLEAR POWER STATION
RECIRCULATION NOZZLE REPAIR PROGRAM
AND HYDROGEN WATER CHEMISTRY
MATERIALS QUALIFICATION

NUCLEAR ENERGY BUSINESS OPERATIONS • GENERAL ELECTRIC COMPANY
SAN JOSE, CALIFORNIA 95125

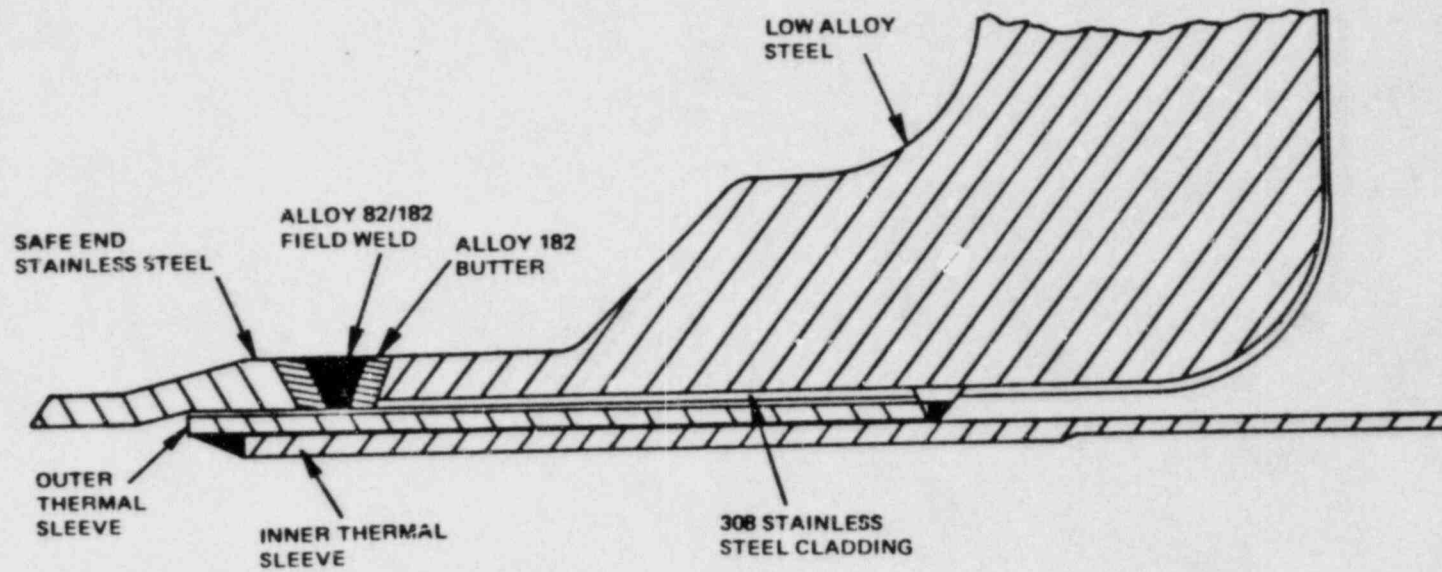
NOTE: 28-INCH RECIRCULATION OUTLETS HAVE NO THERMAL SLEEVES

Figure 3.0-1. Existing Pilgrim Recirc Inlet Nozzle - 12 inch

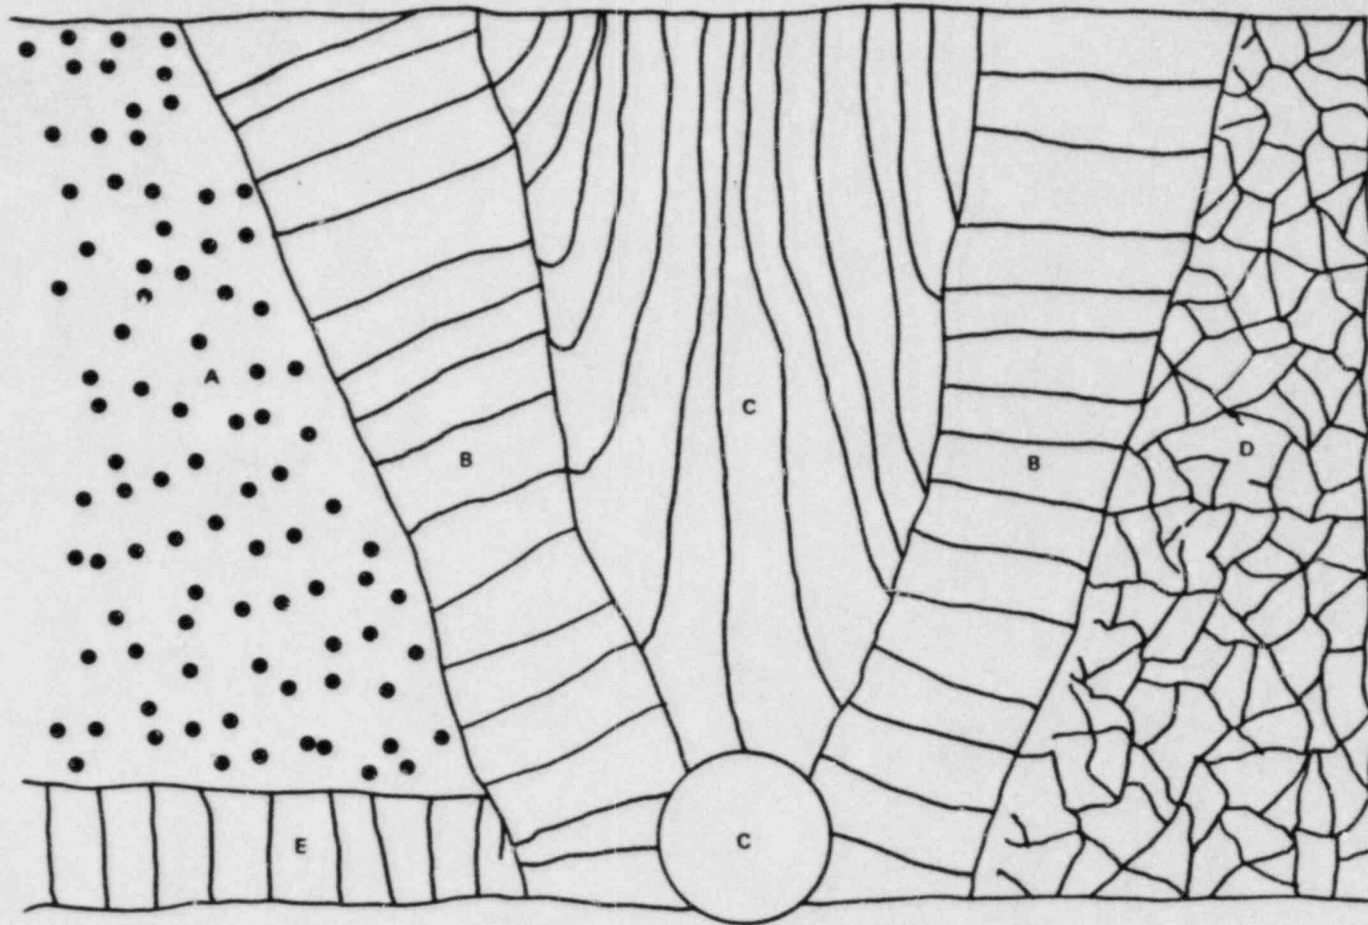
- A) LOW ALLOY STEEL NOZZLE
- B) ALLOY 182 WELD BUTTER
- C) ALLOY 182 OR ALLOY 82 WELD METAL
- D) STAINLESS STEEL 304 SAFE-END
- E) STAINLESS STEEL CLADDING

Figure 3.0-2. Complex Metallurgical Condition of Safe-End to Nozzle Attachment

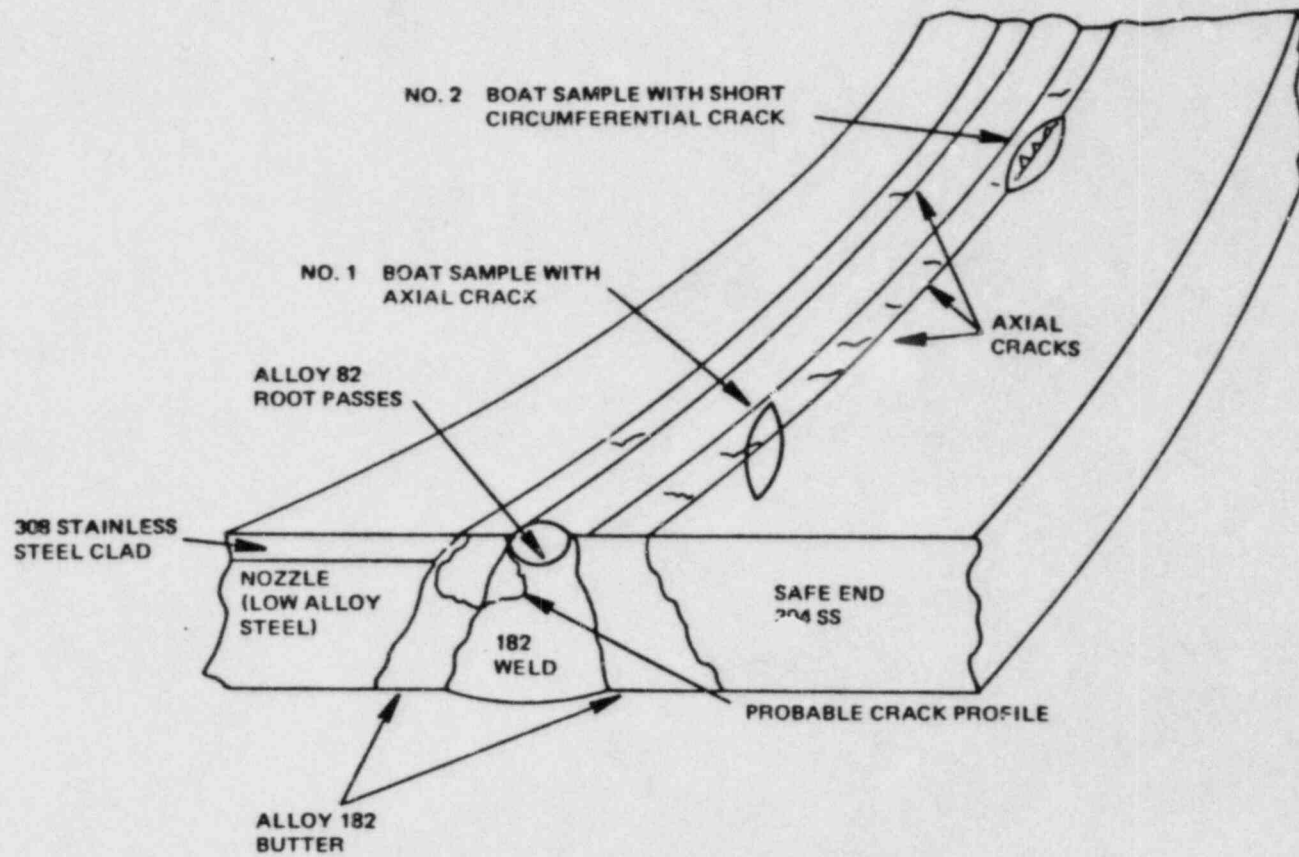
Figure 3.1-1. 28-Inch Recirculation Outlet Nozzle-to-Safe-End Weld N1-B

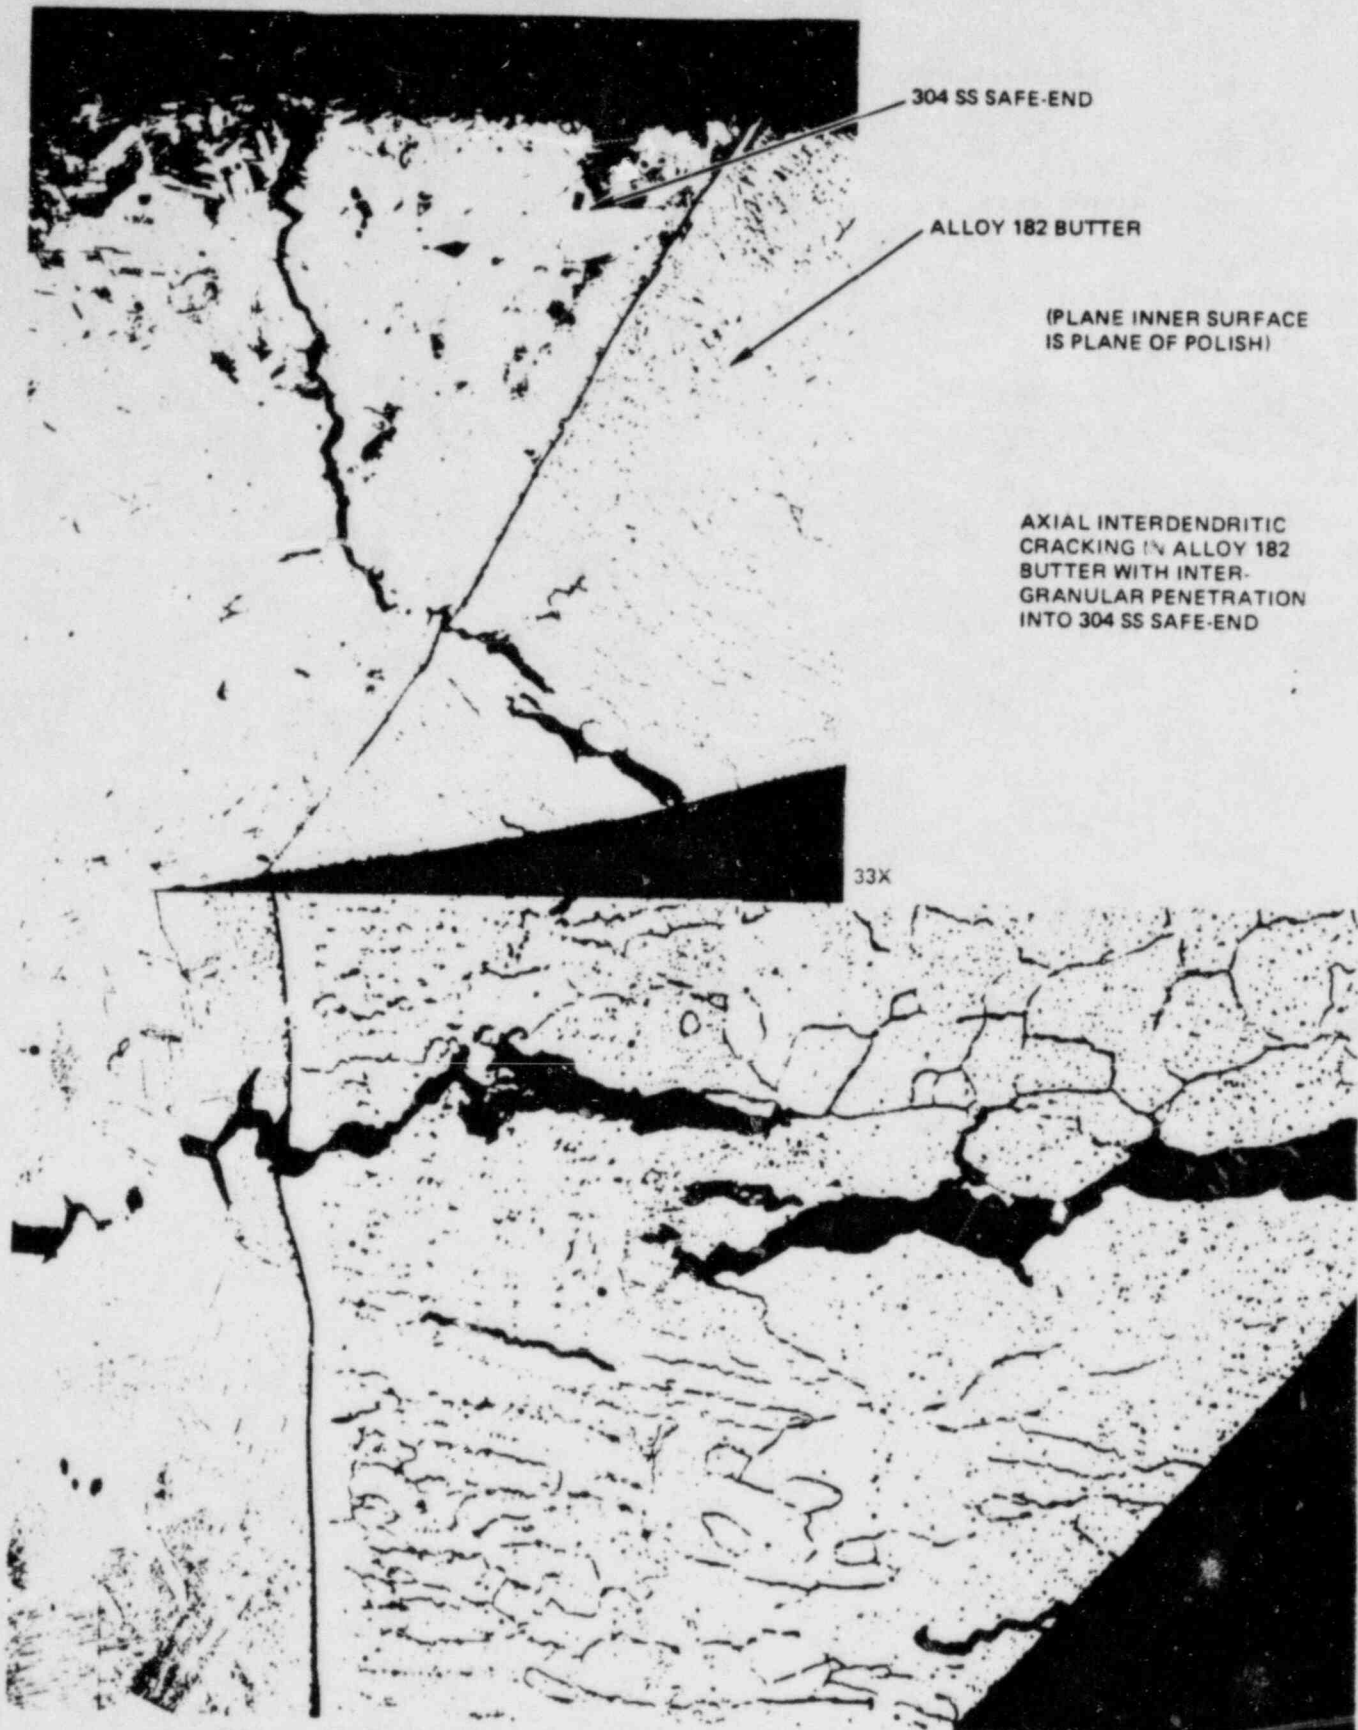
Figure 3.1-3. Intergranular Cracking in Alloy 182 Butter (Boat Sample 1)

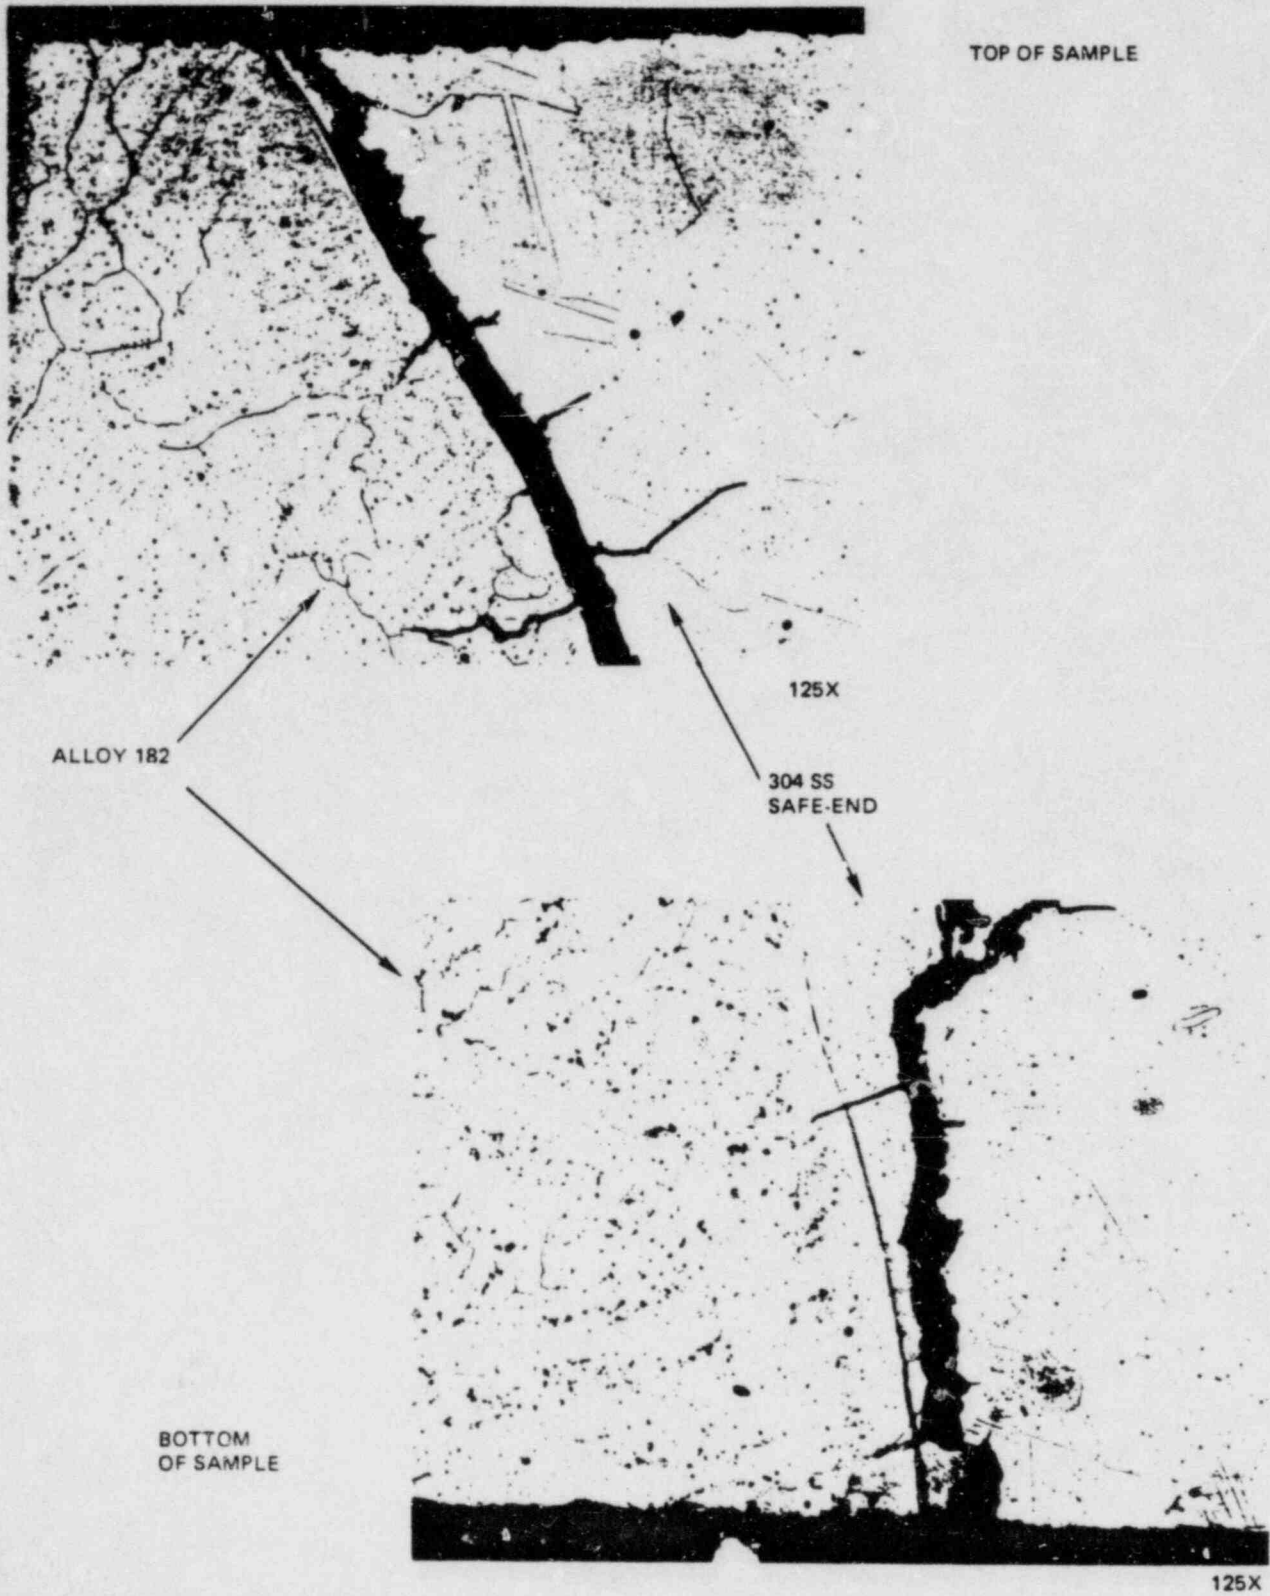
Figure 3.1-4. Cracking Near Weld Interface, Boat Sample No. 2, 125X Magnification

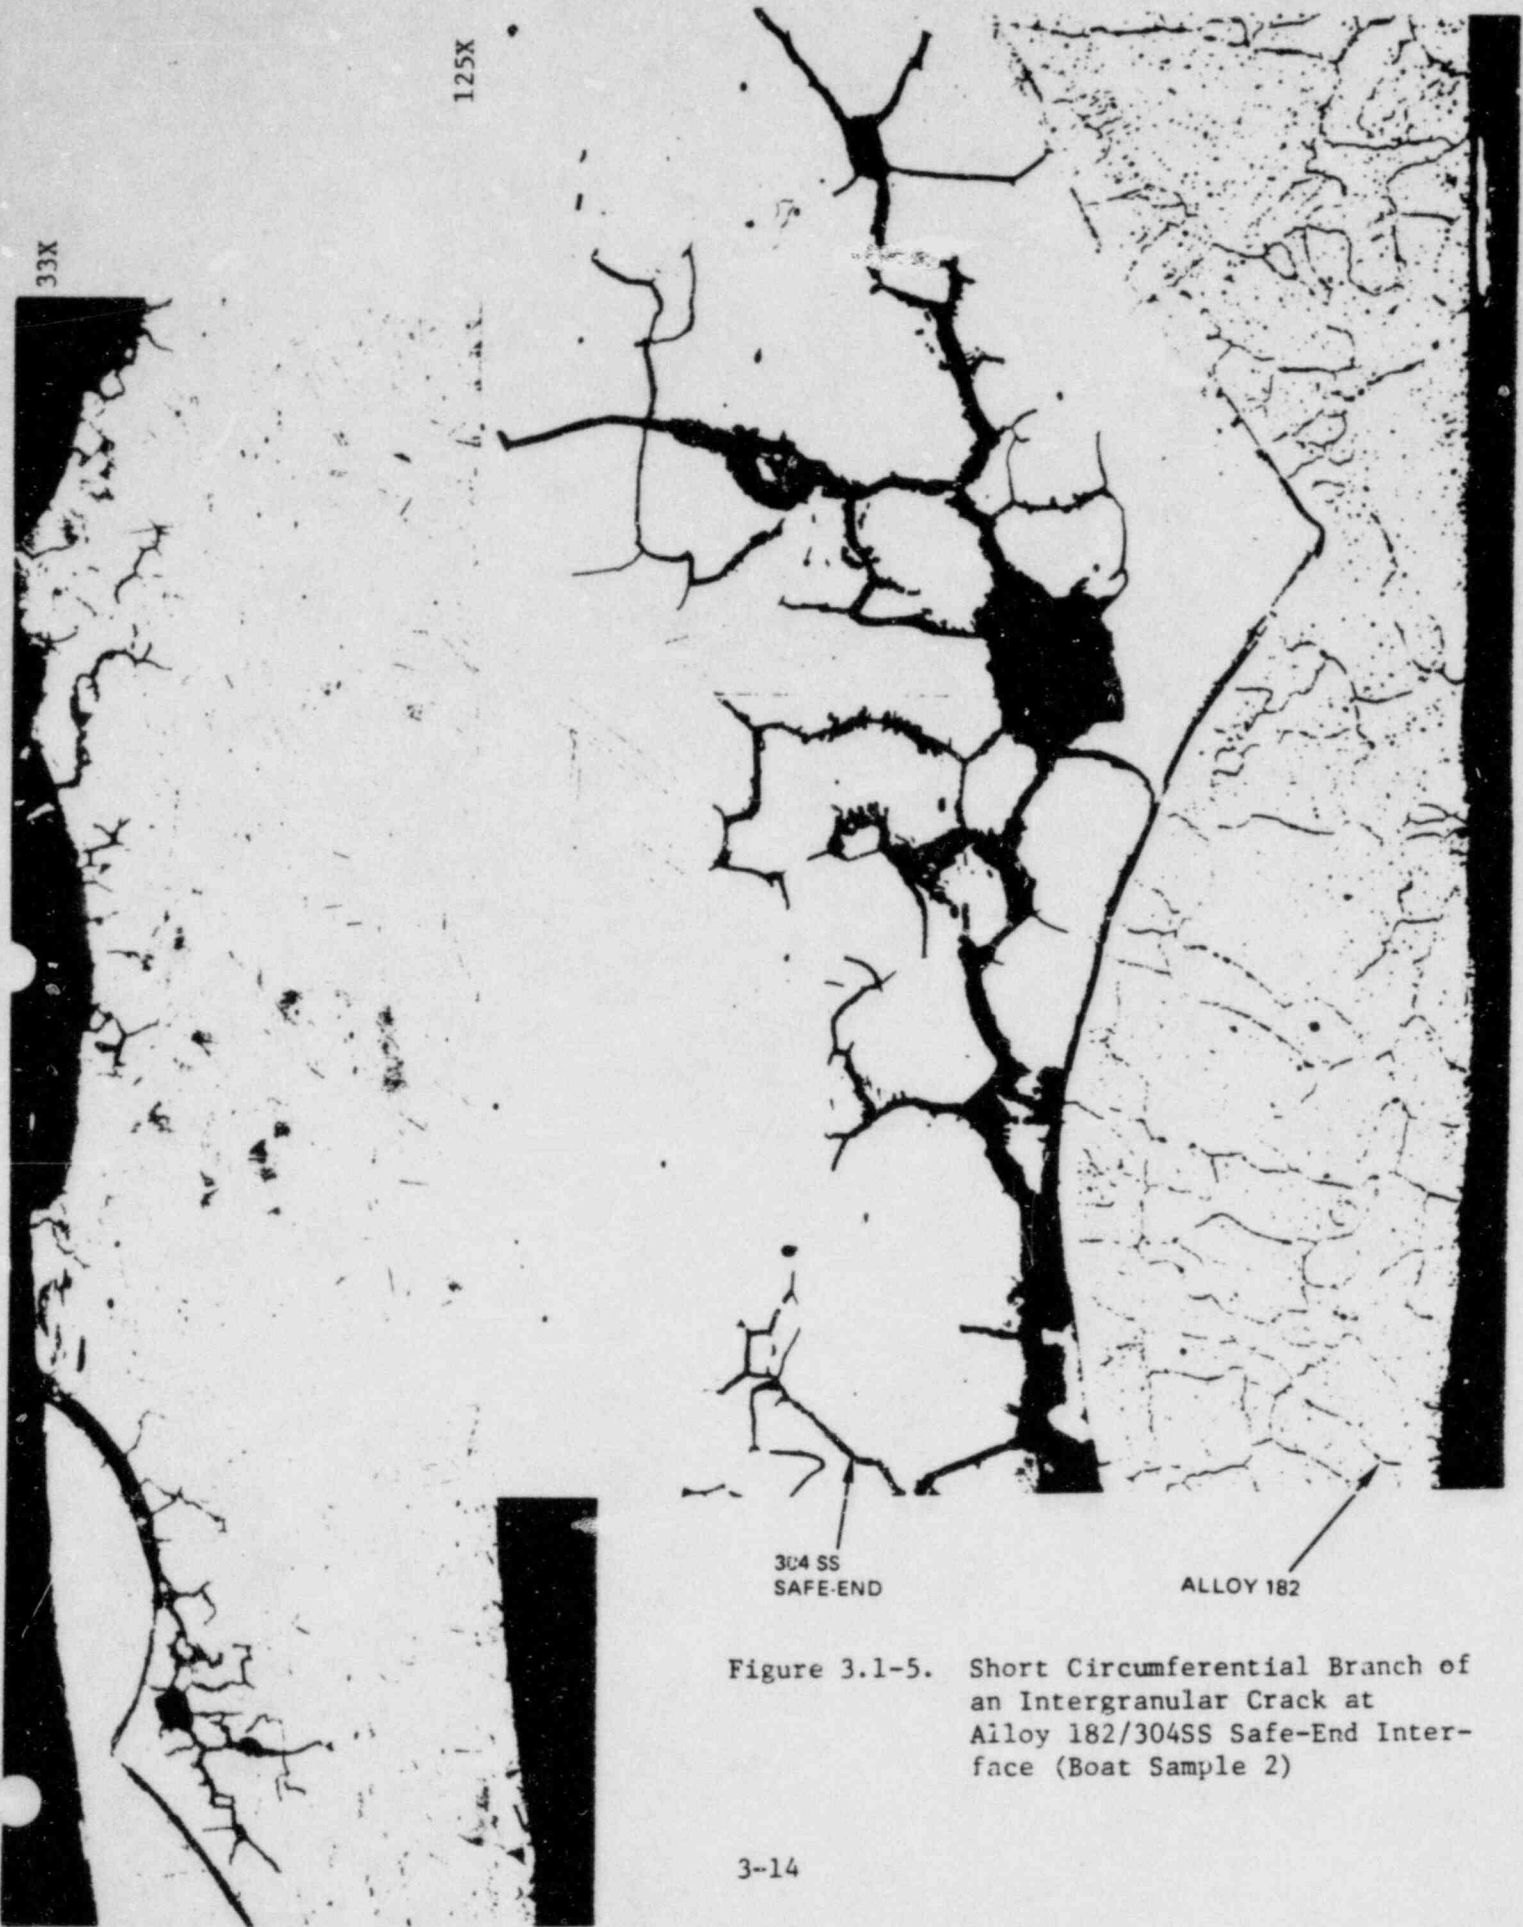
304 SS
SAFE-END

ALLOY 182

Figure 3.1-5. Short Circumferential Branch of an Intergranular Crack at Alloy 182/304SS Safe-End Interface (Boat Sample 2)

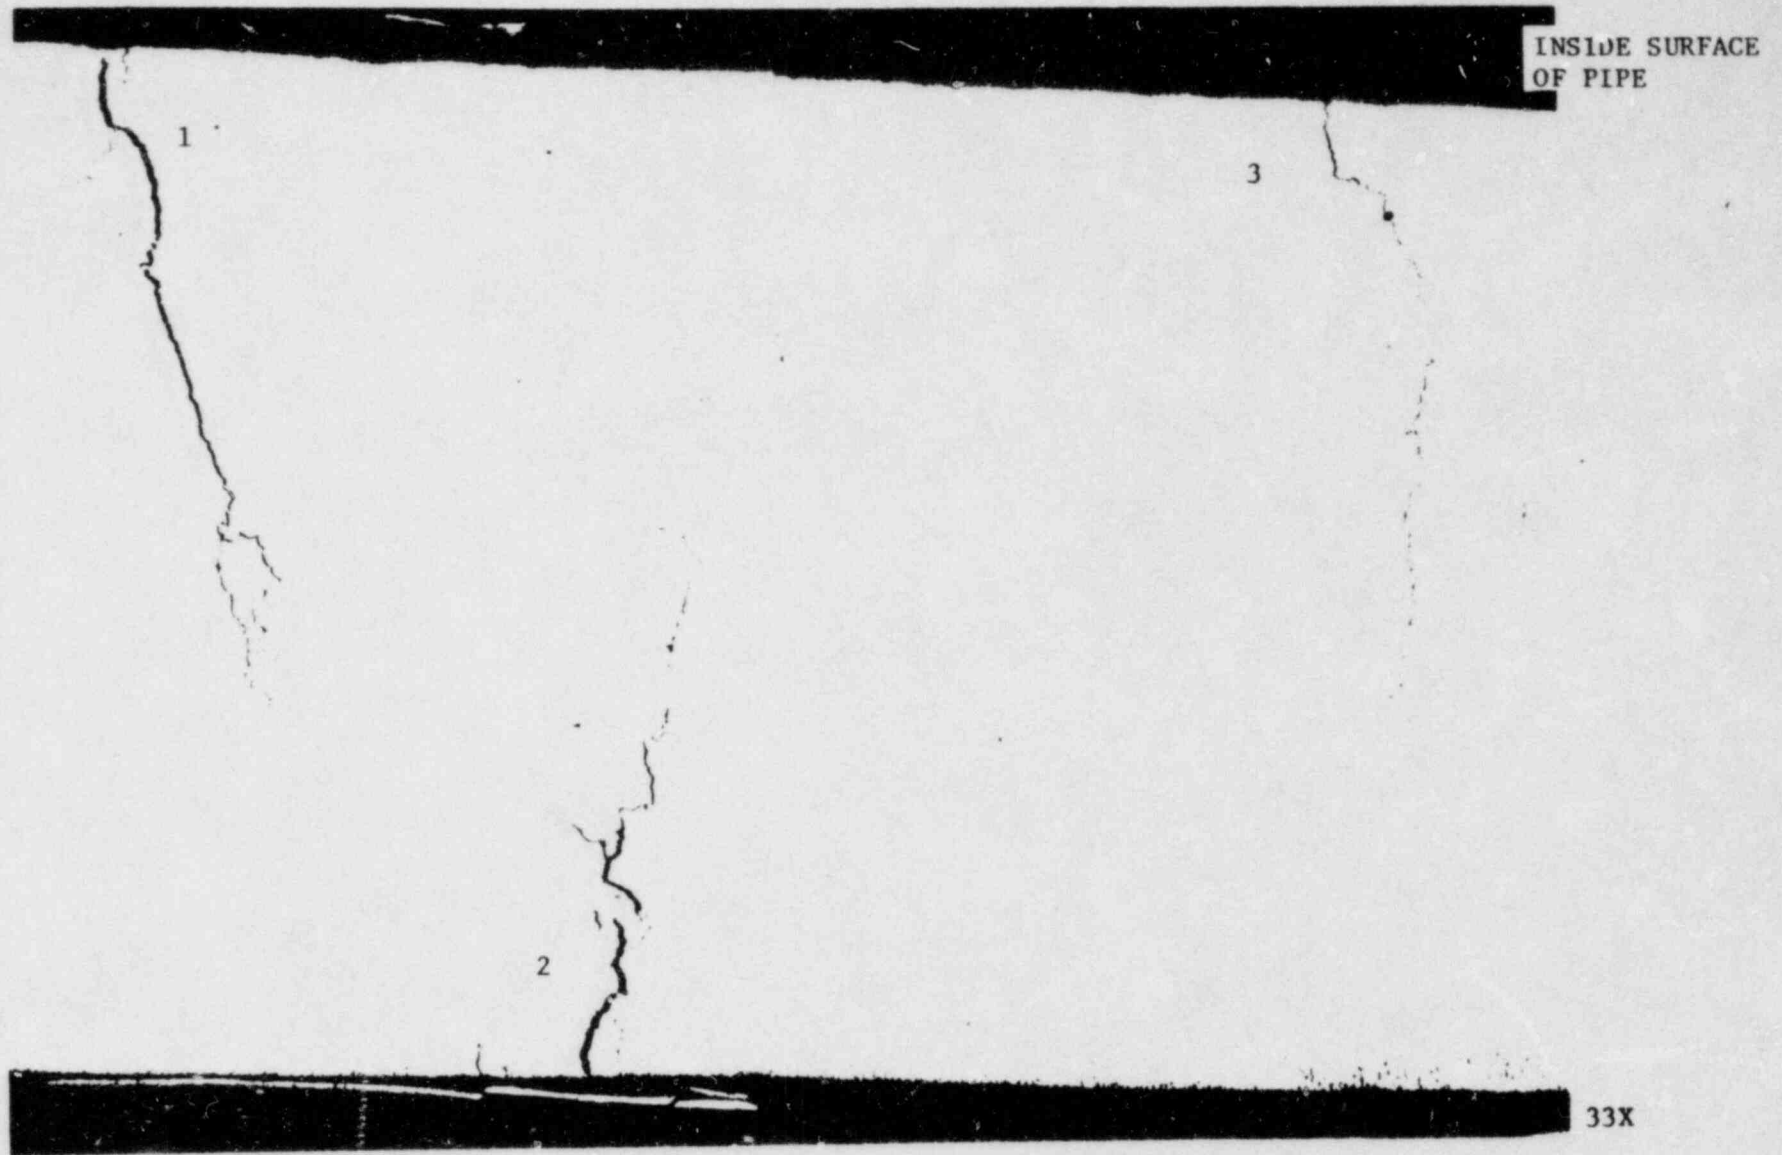
Figure 3.1-6. Axial Interdendritic Cracking in Alloy 182 Butter Adjacent to Weld Root on Safe-End Side (Boat Sample 3) (Crack in center of photo initiated in Alloy 182 butter on nozzle side of the weld).

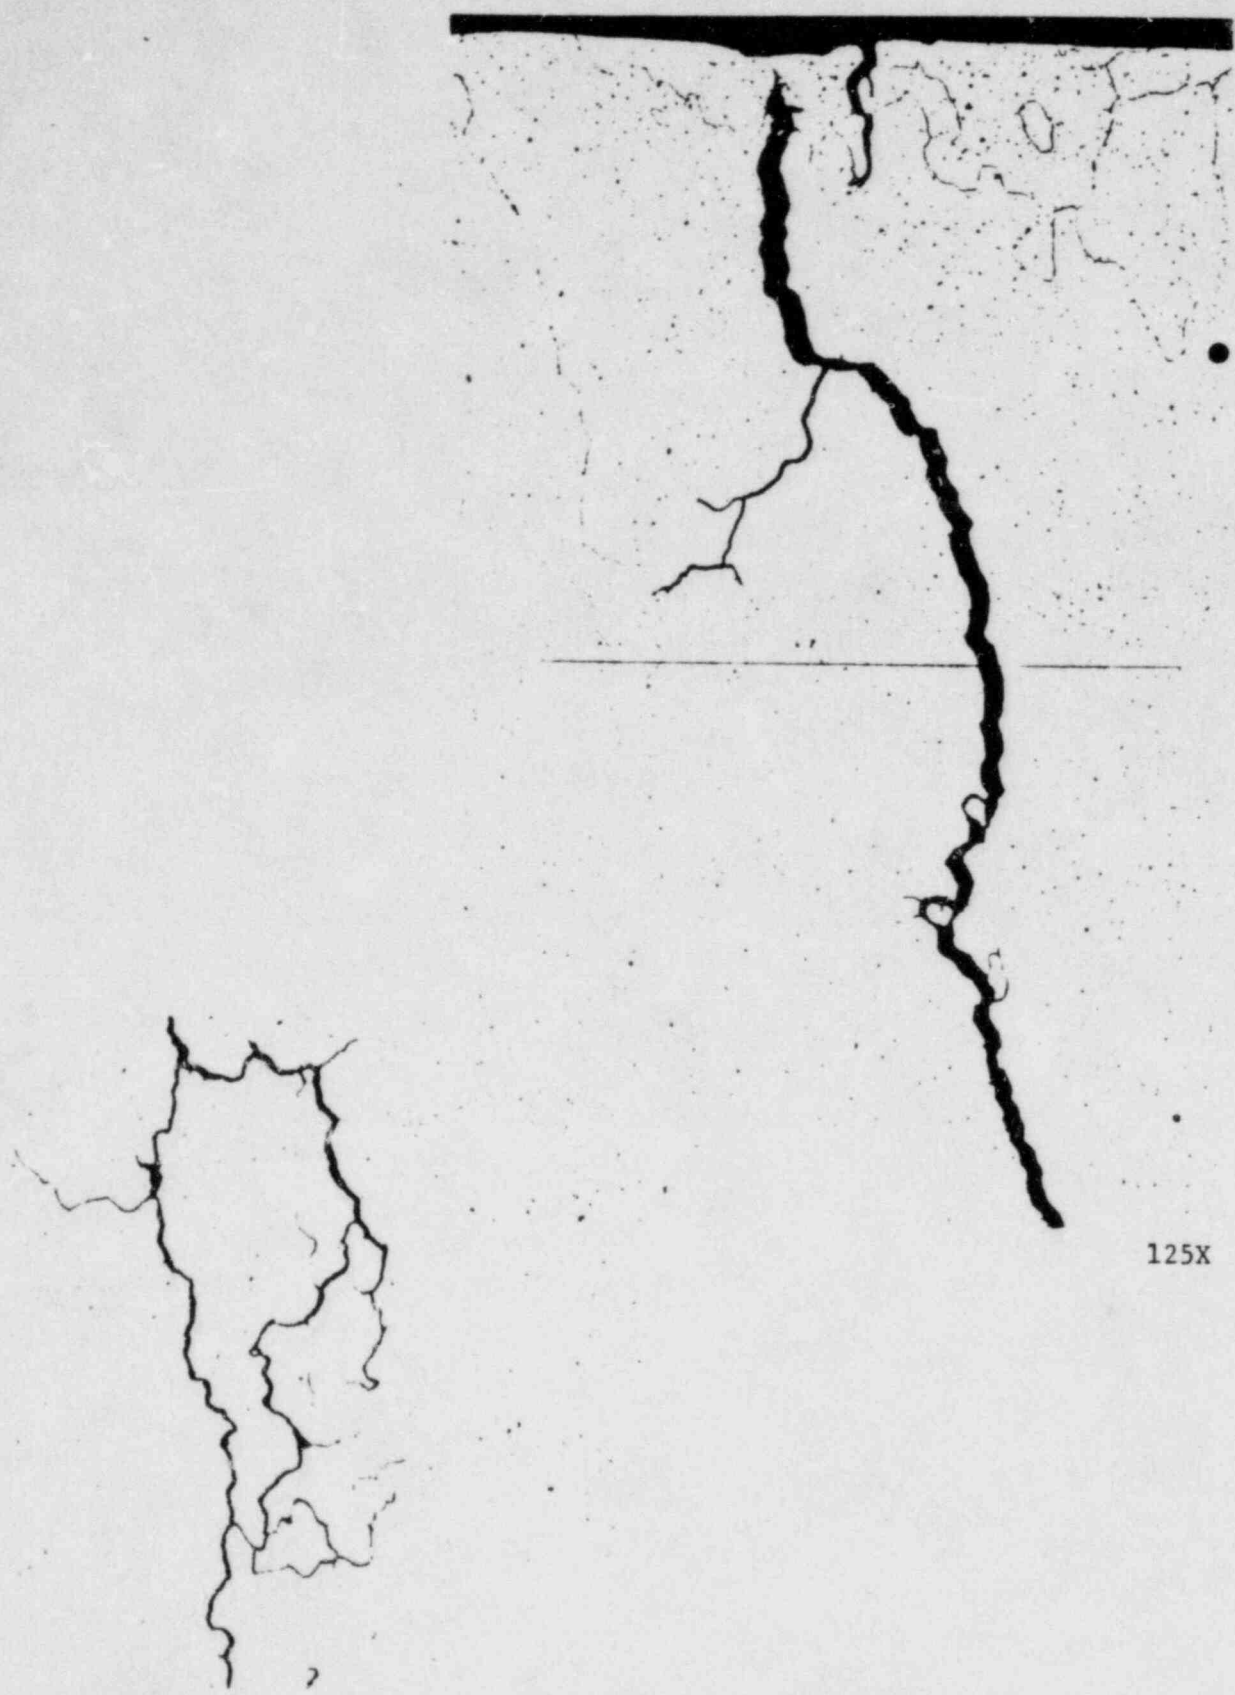
Figure 3.1-7. High Magnification View of Interdendritic Crack No. 1 of 33X Composite - Alloy 182 Butter (Boat Sample 3)

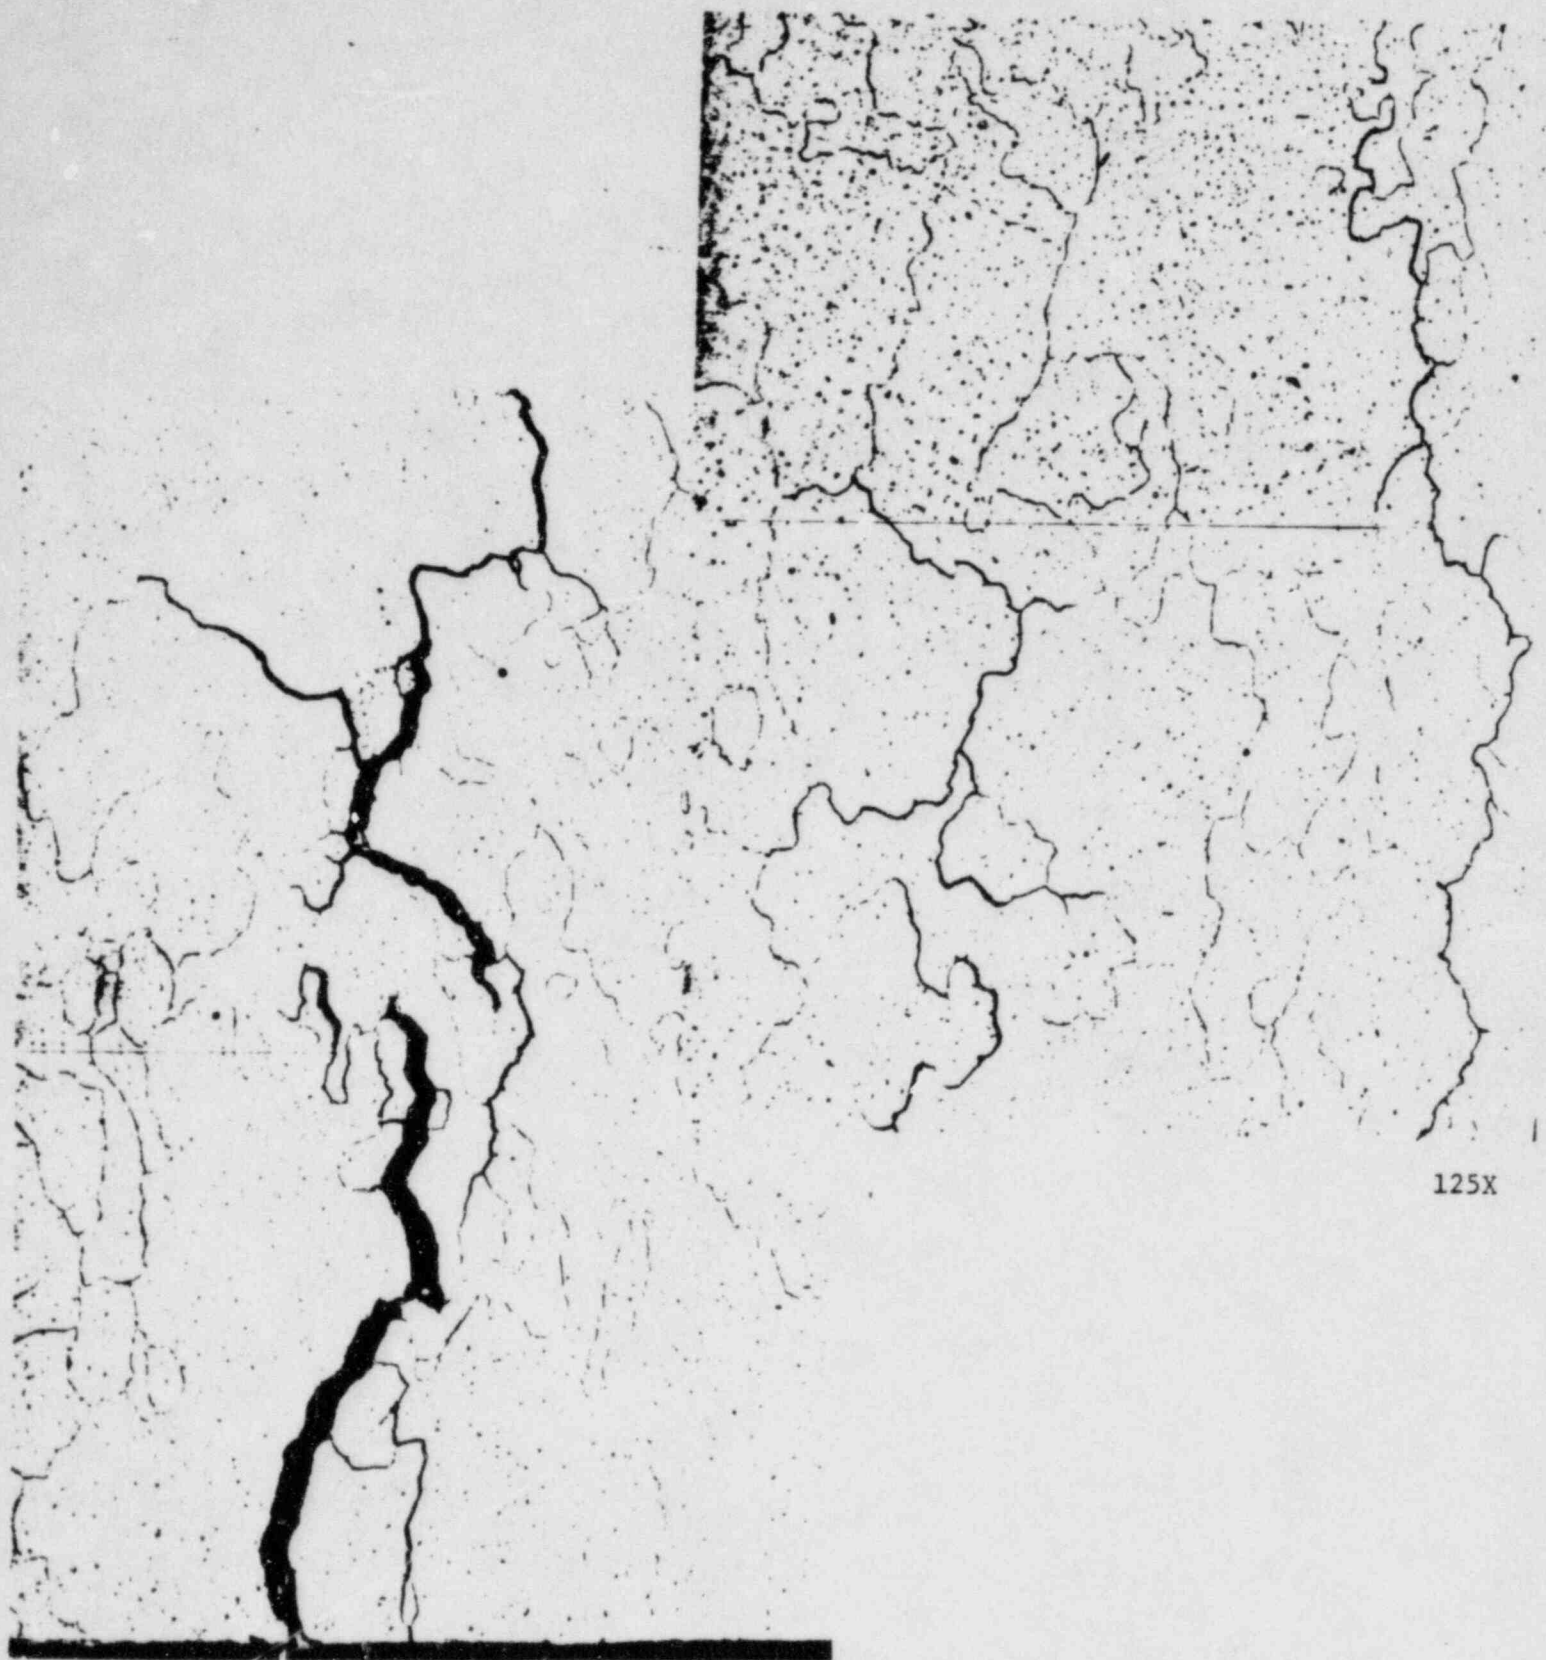
Figure 3.1-8. Interdentritic Cracking in Alloy 182 (Boat Sample 3, Crack No. 2)

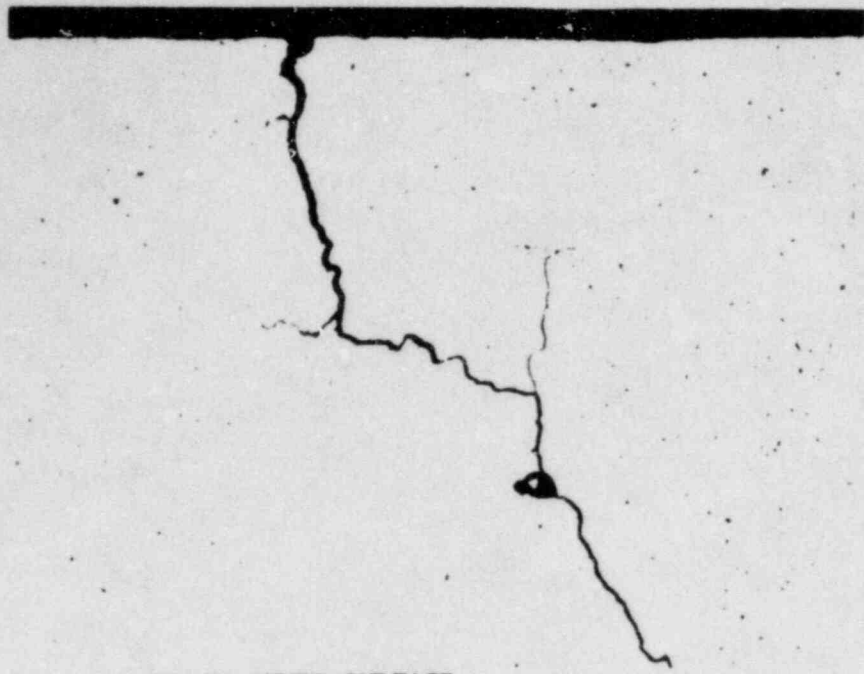
CRACK INNER SURFACE

CRACK TIP

Figure 3.1-9. High Magnification View of Interdendritic Crack No. 3 of 33X Composite - Alloy 182 Butter (Boat Sample 3)

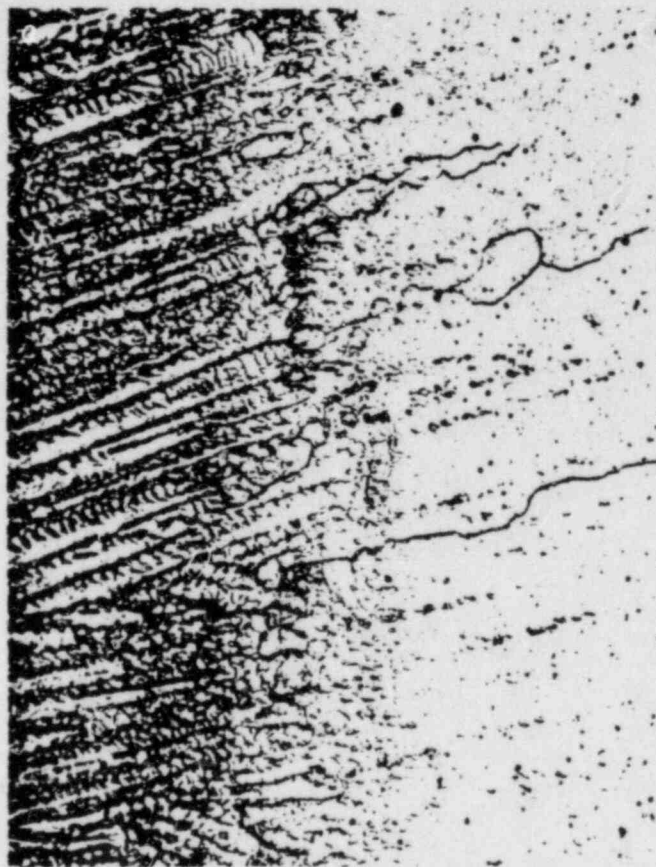
ALLOY 82
ROOT PASS

ALLOY 182
BUTTER

Figure 3.1-10. Crack Arrest in Alloy 82 Weld Root (Boat Sample 3)

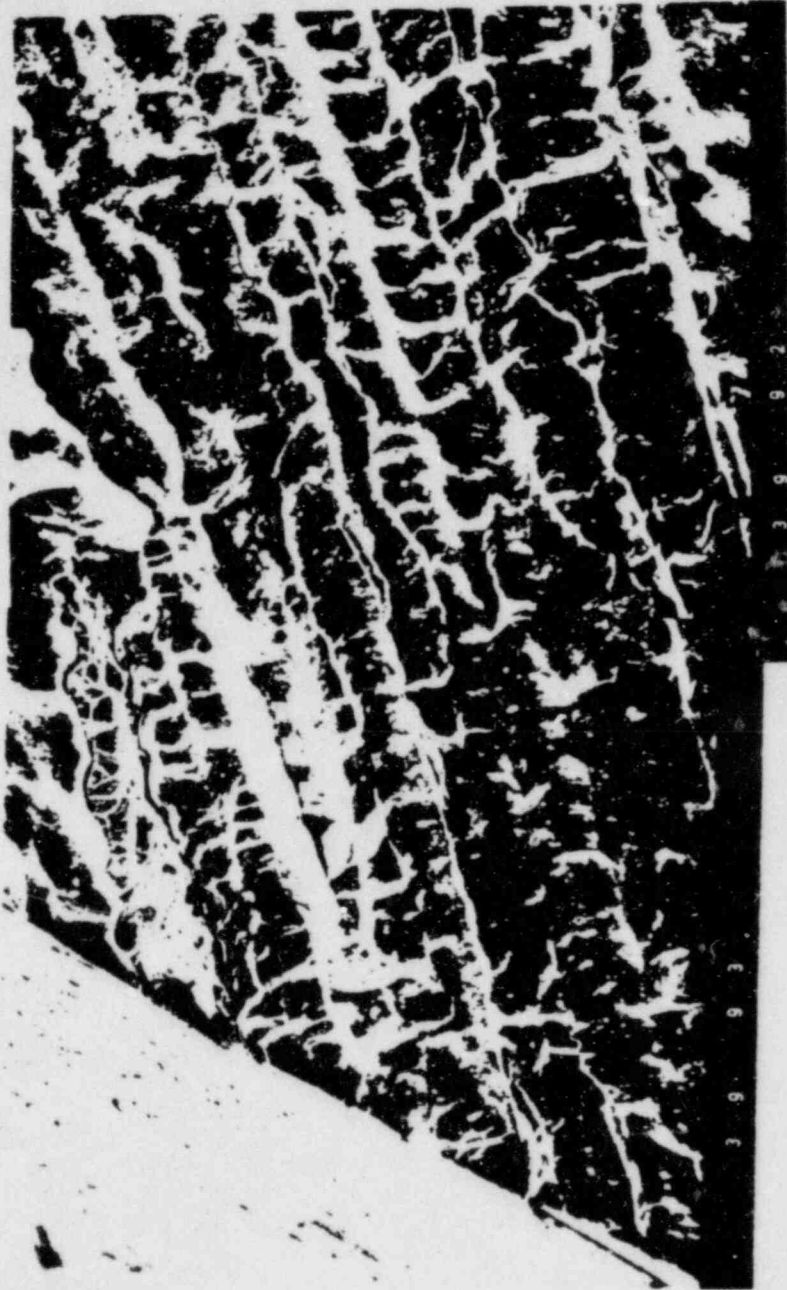
Figure 3.1-11. Scanning Electron Micrograph of Axial Crack in Boat Sample No. 3

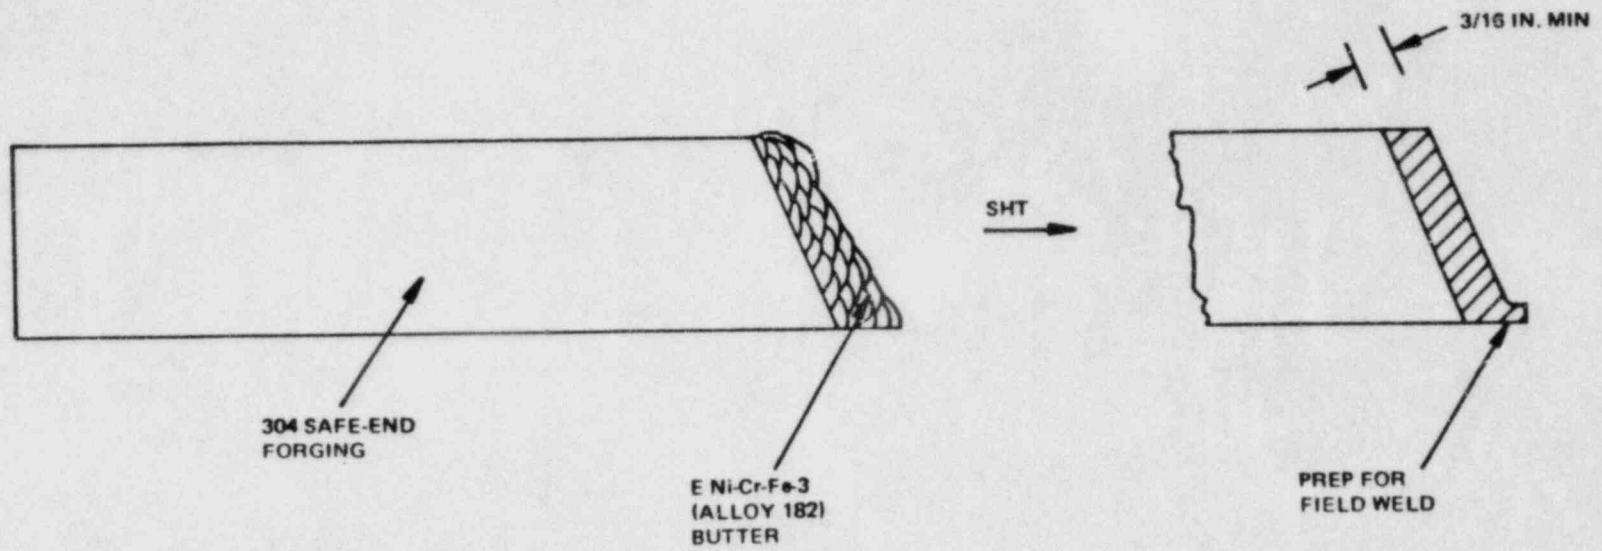
BUTTER, SOLUTION HEAT TREAT (SHT),
AT 1950°F, WATER QUENCH, FINAL MACHINE

Figure 3.3-5. Shop Fabrication of Replacement Safe-End

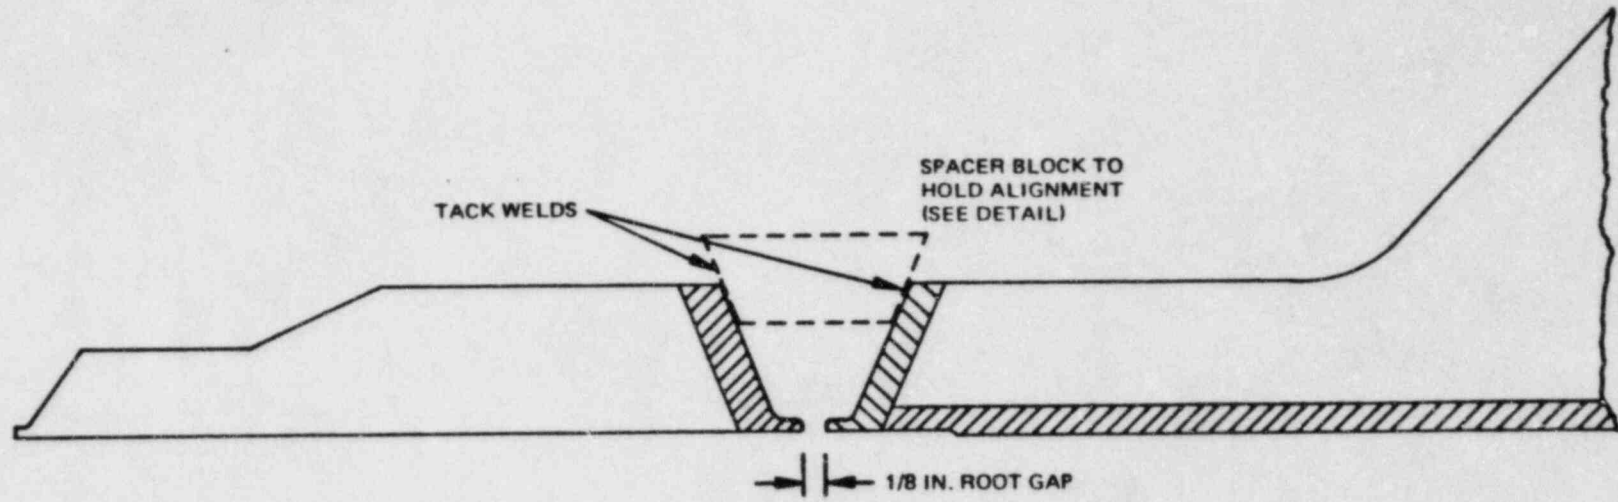
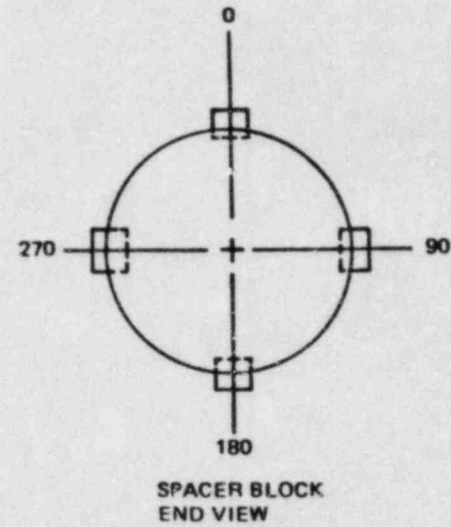
Figure 3.3-6. Field Weld Technique for Safe-End Installation
