NEDO-30730
DRF B31-00106
Class I
September 1984

PILGRIM NUCLEAR POWER STATION
RECIRCULATION NOZZLE REPAIR PROGRAM
AND HYDROGEN WATER CHEMISTRY
MATERIALS QUALIFICATION

NUCLEAR ENERGY BUSINESS OPERATIONS • GENERAL ELECTRIC COMPANY
SAN JOSE, CALIFORNIA 95125

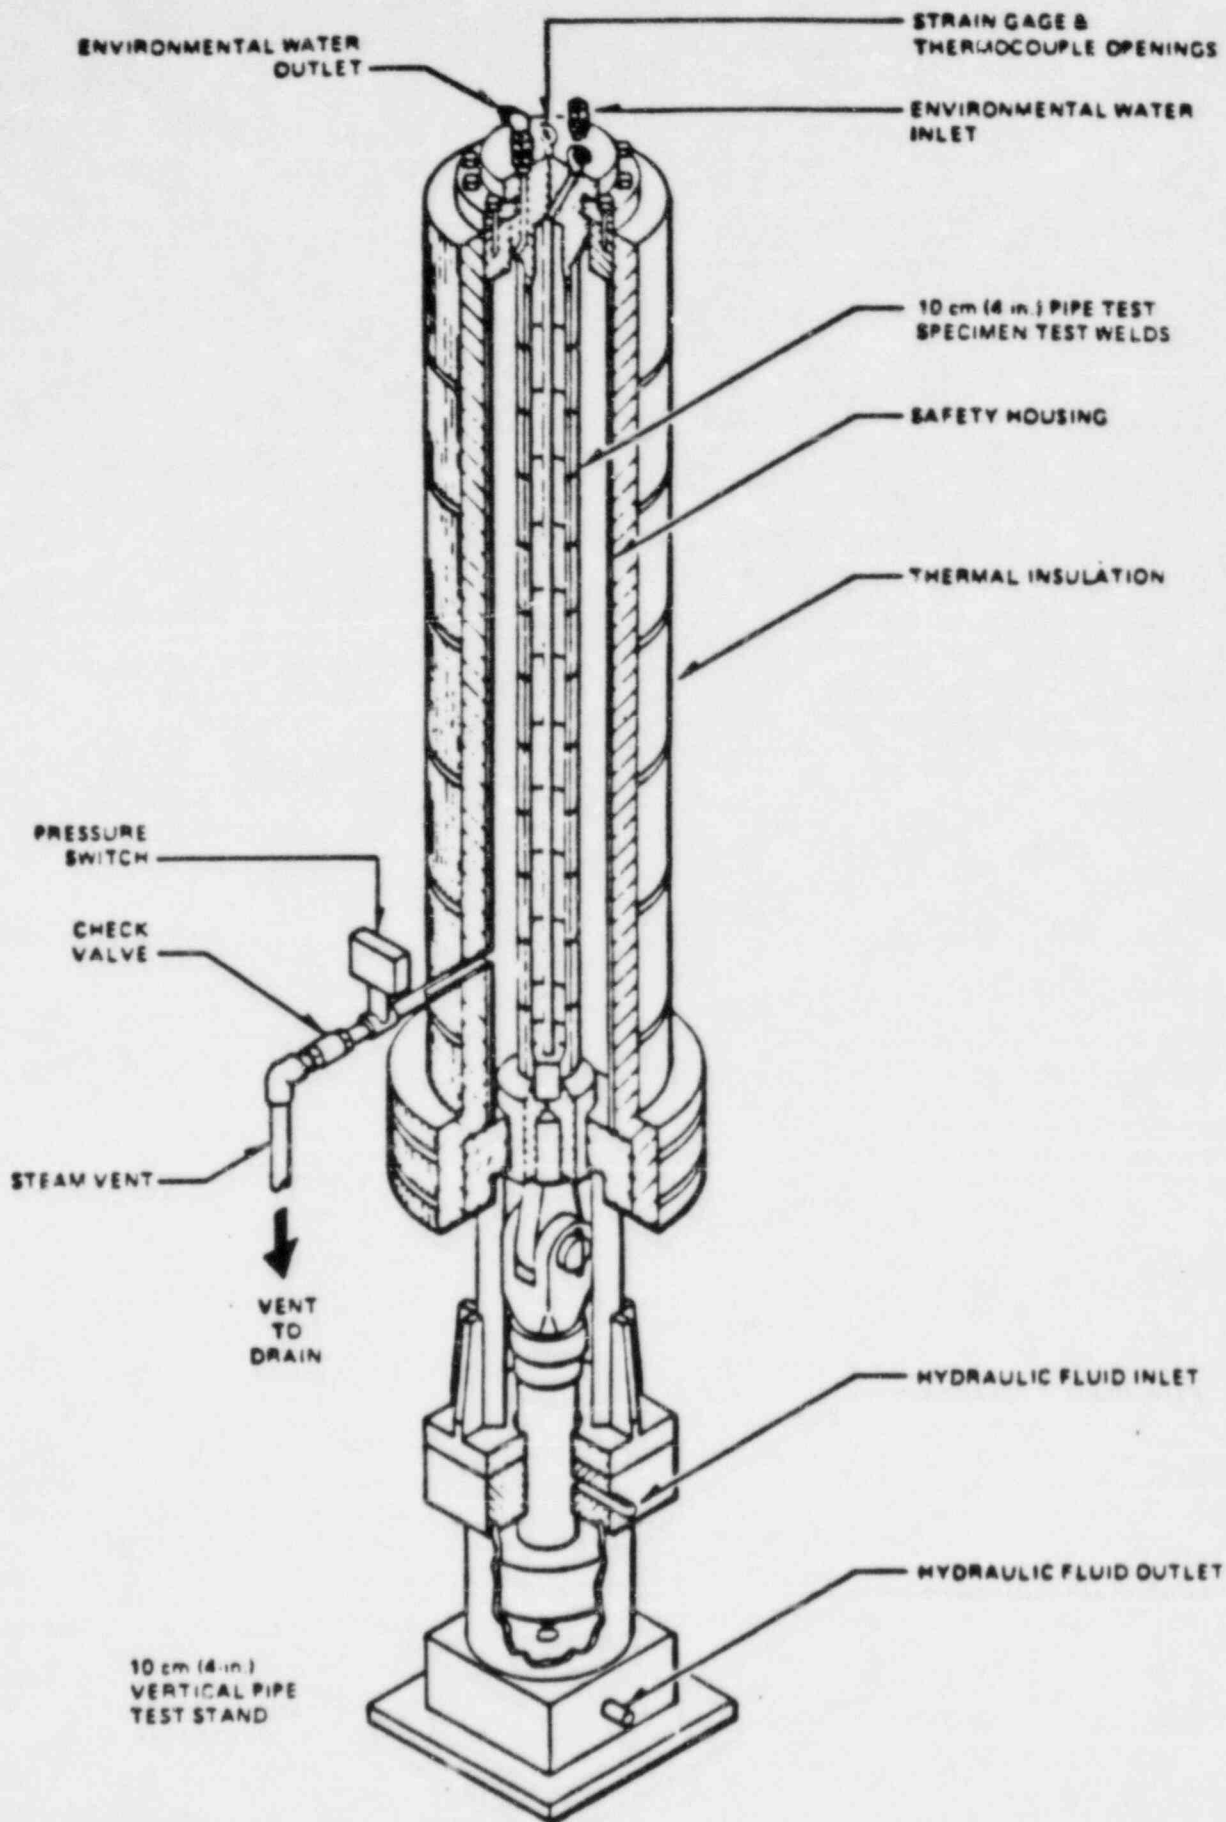
Figure 3.5-2. Pipe Test Specimen Loading Stand

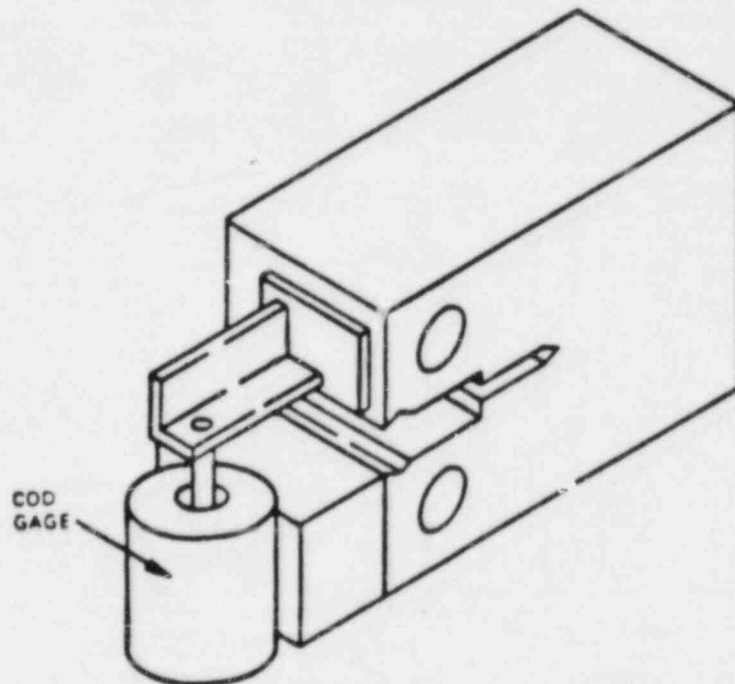
Figure 3.5-4. Typical WOL or Compact Tension Specimen for Crack Growth Rate Study

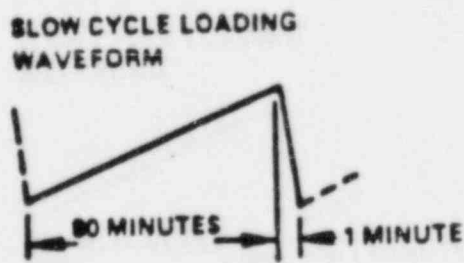
Figure 3.5-5b. Slow Cyclic Loading Waveform Detail

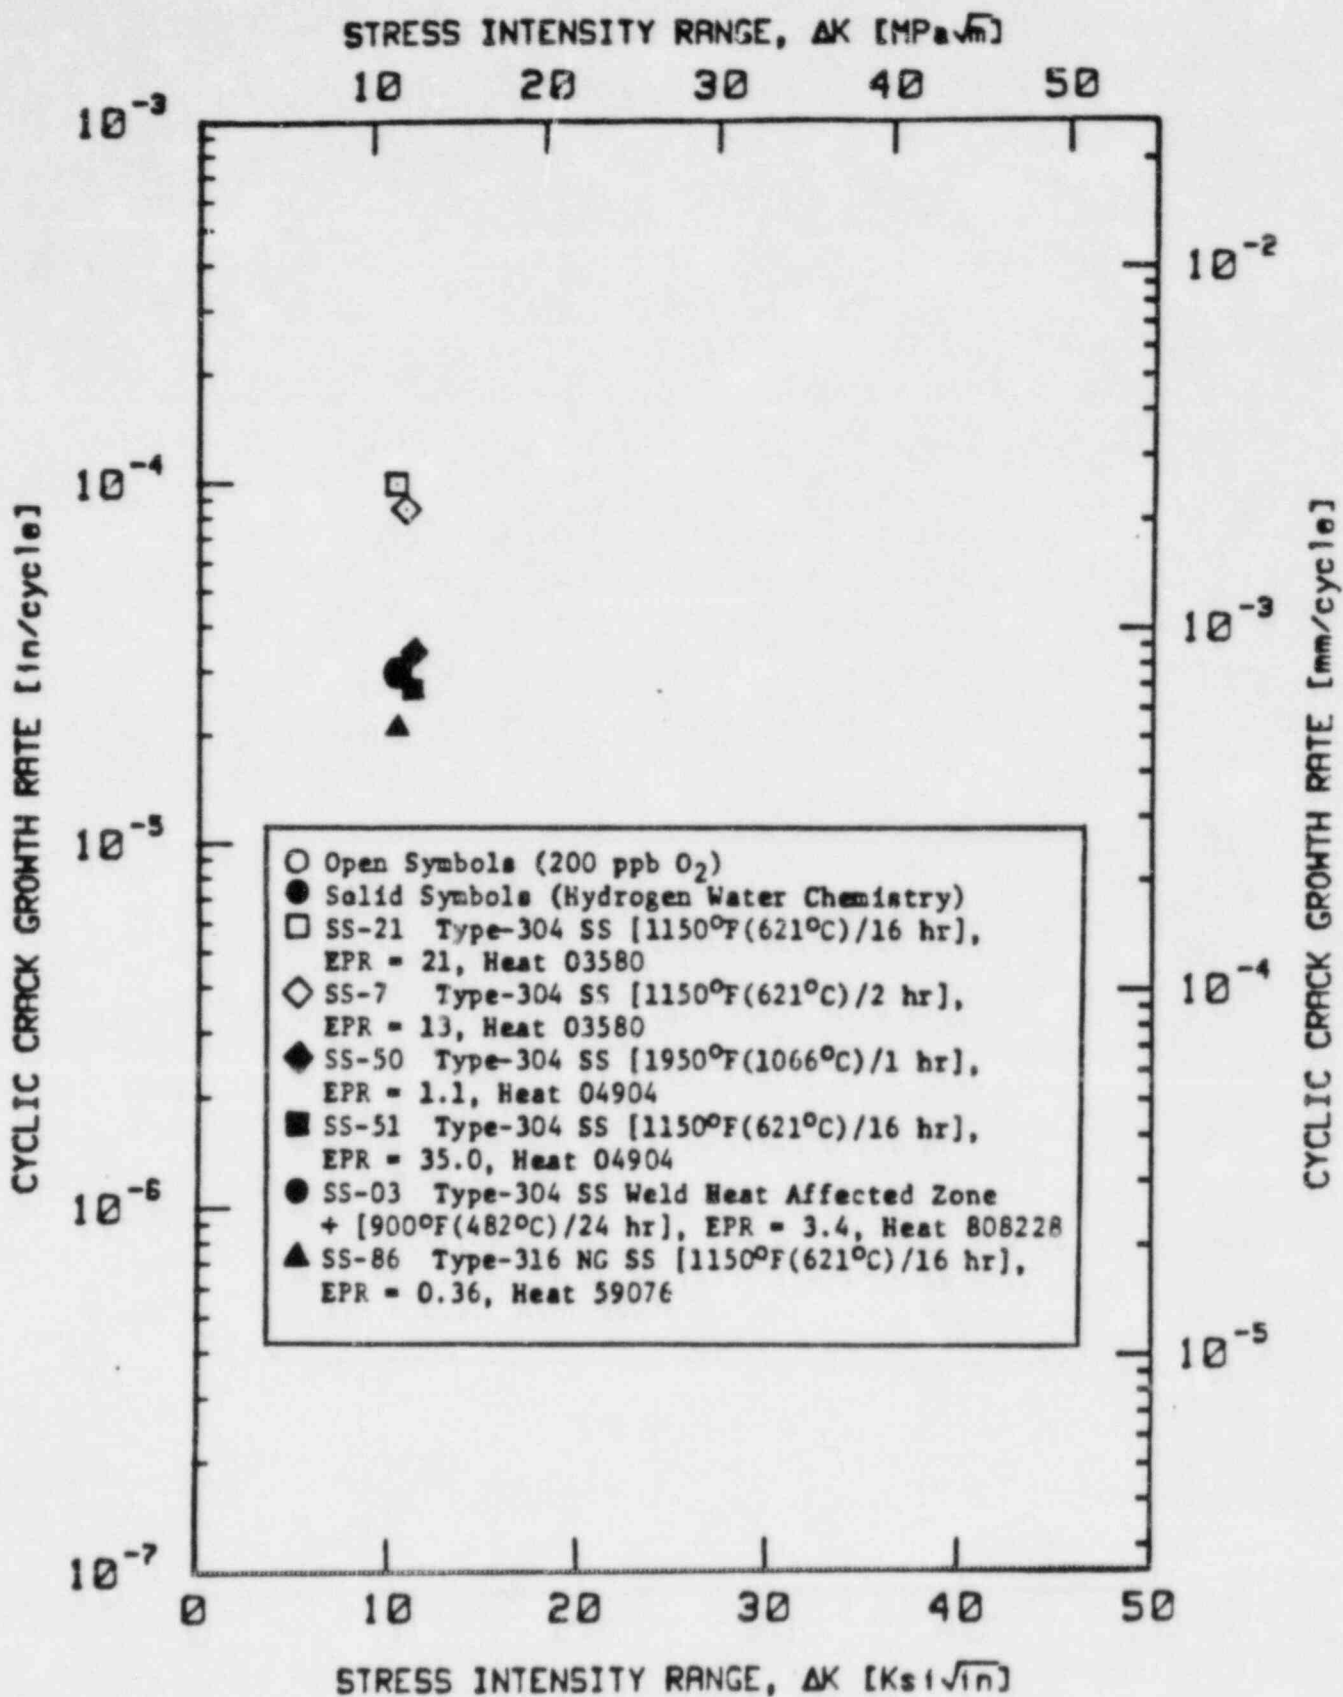
Figure 3.5-7. Comparison of Cyclic Crack Growth Data (0.74 cph, R=0.6) in H₂WC versus Nominal Environment for Furnace Sensitized Stainless Steel

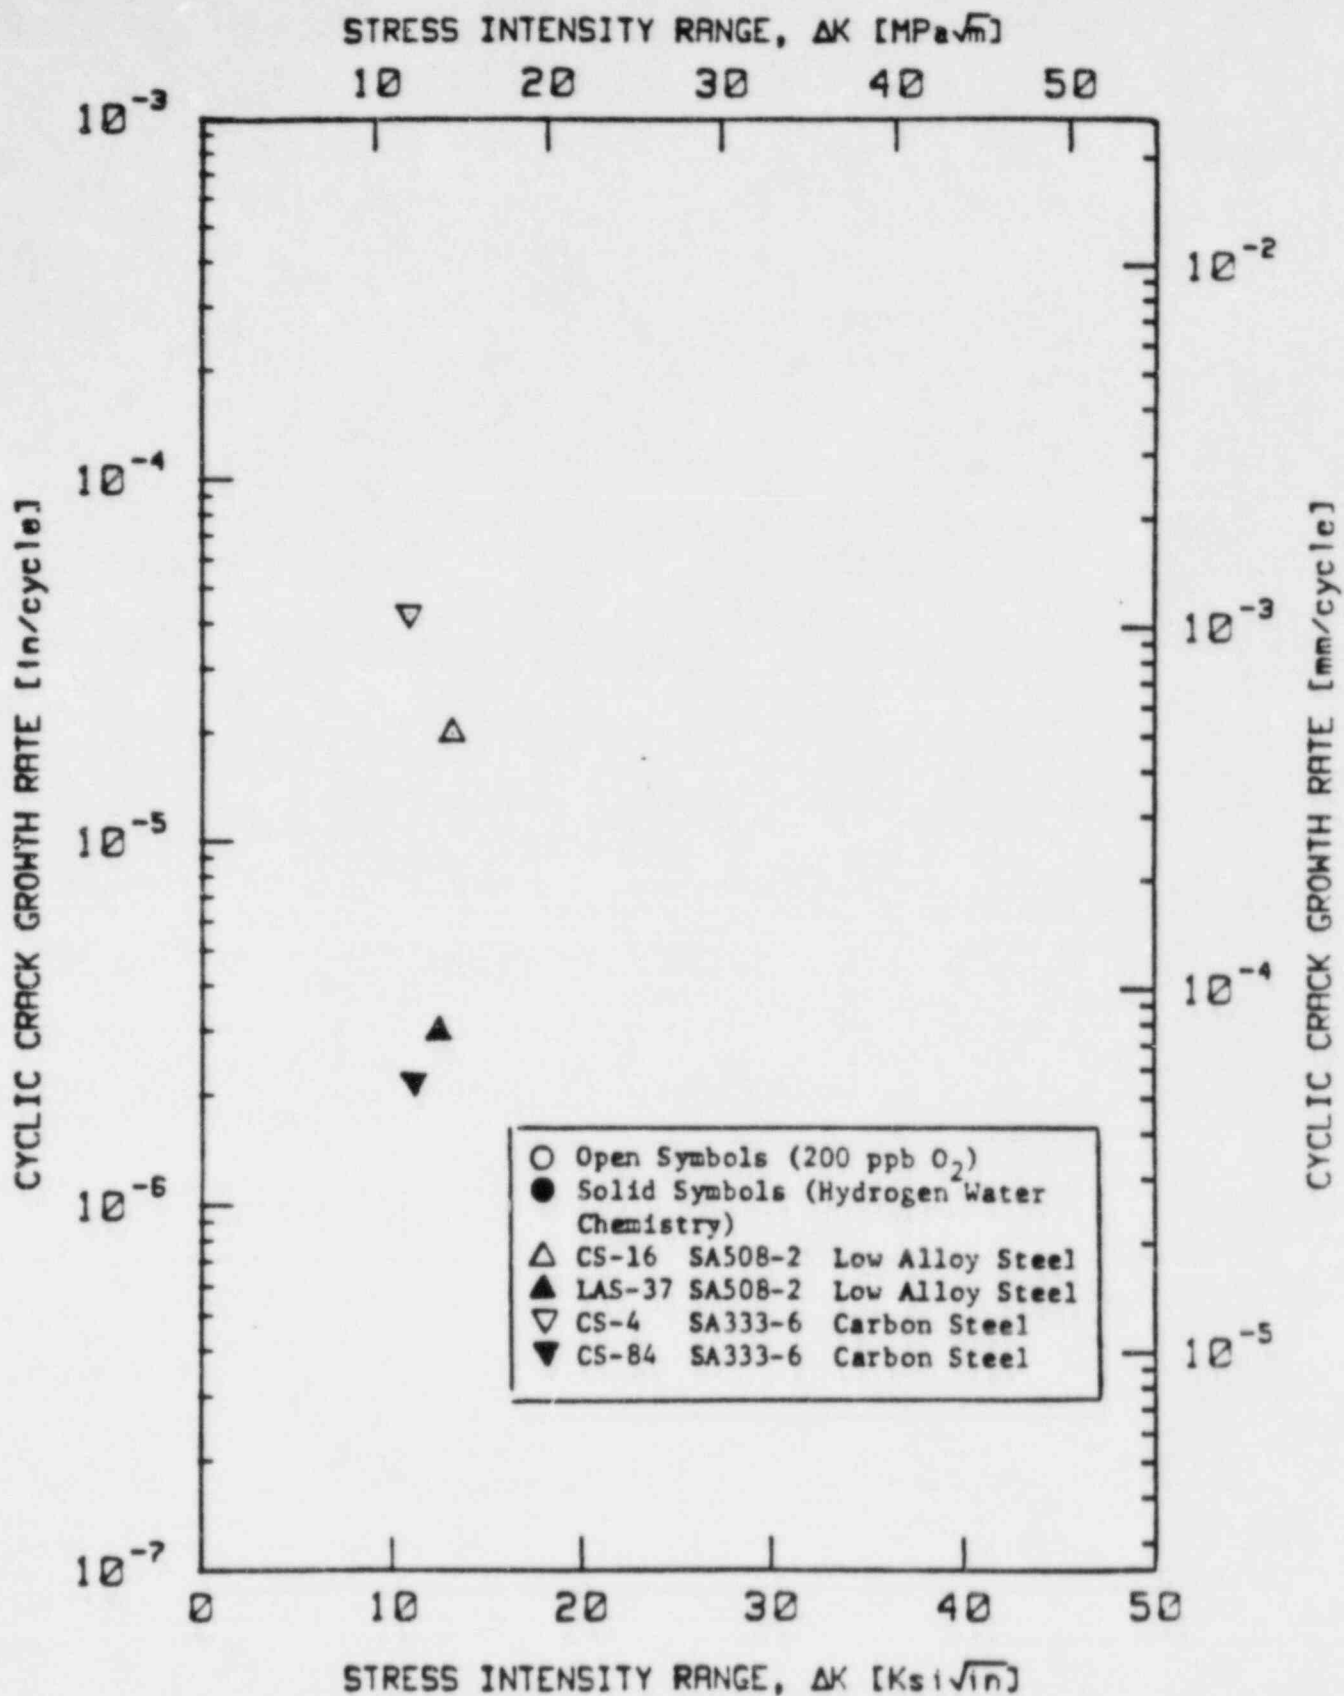
Figure 3.5-8. Comparison of Cyclic Crack Growth Data (0.74 cph, R=0.6) in H₂WC versus Nominal Environment for Carbon and Low Alloy Steel

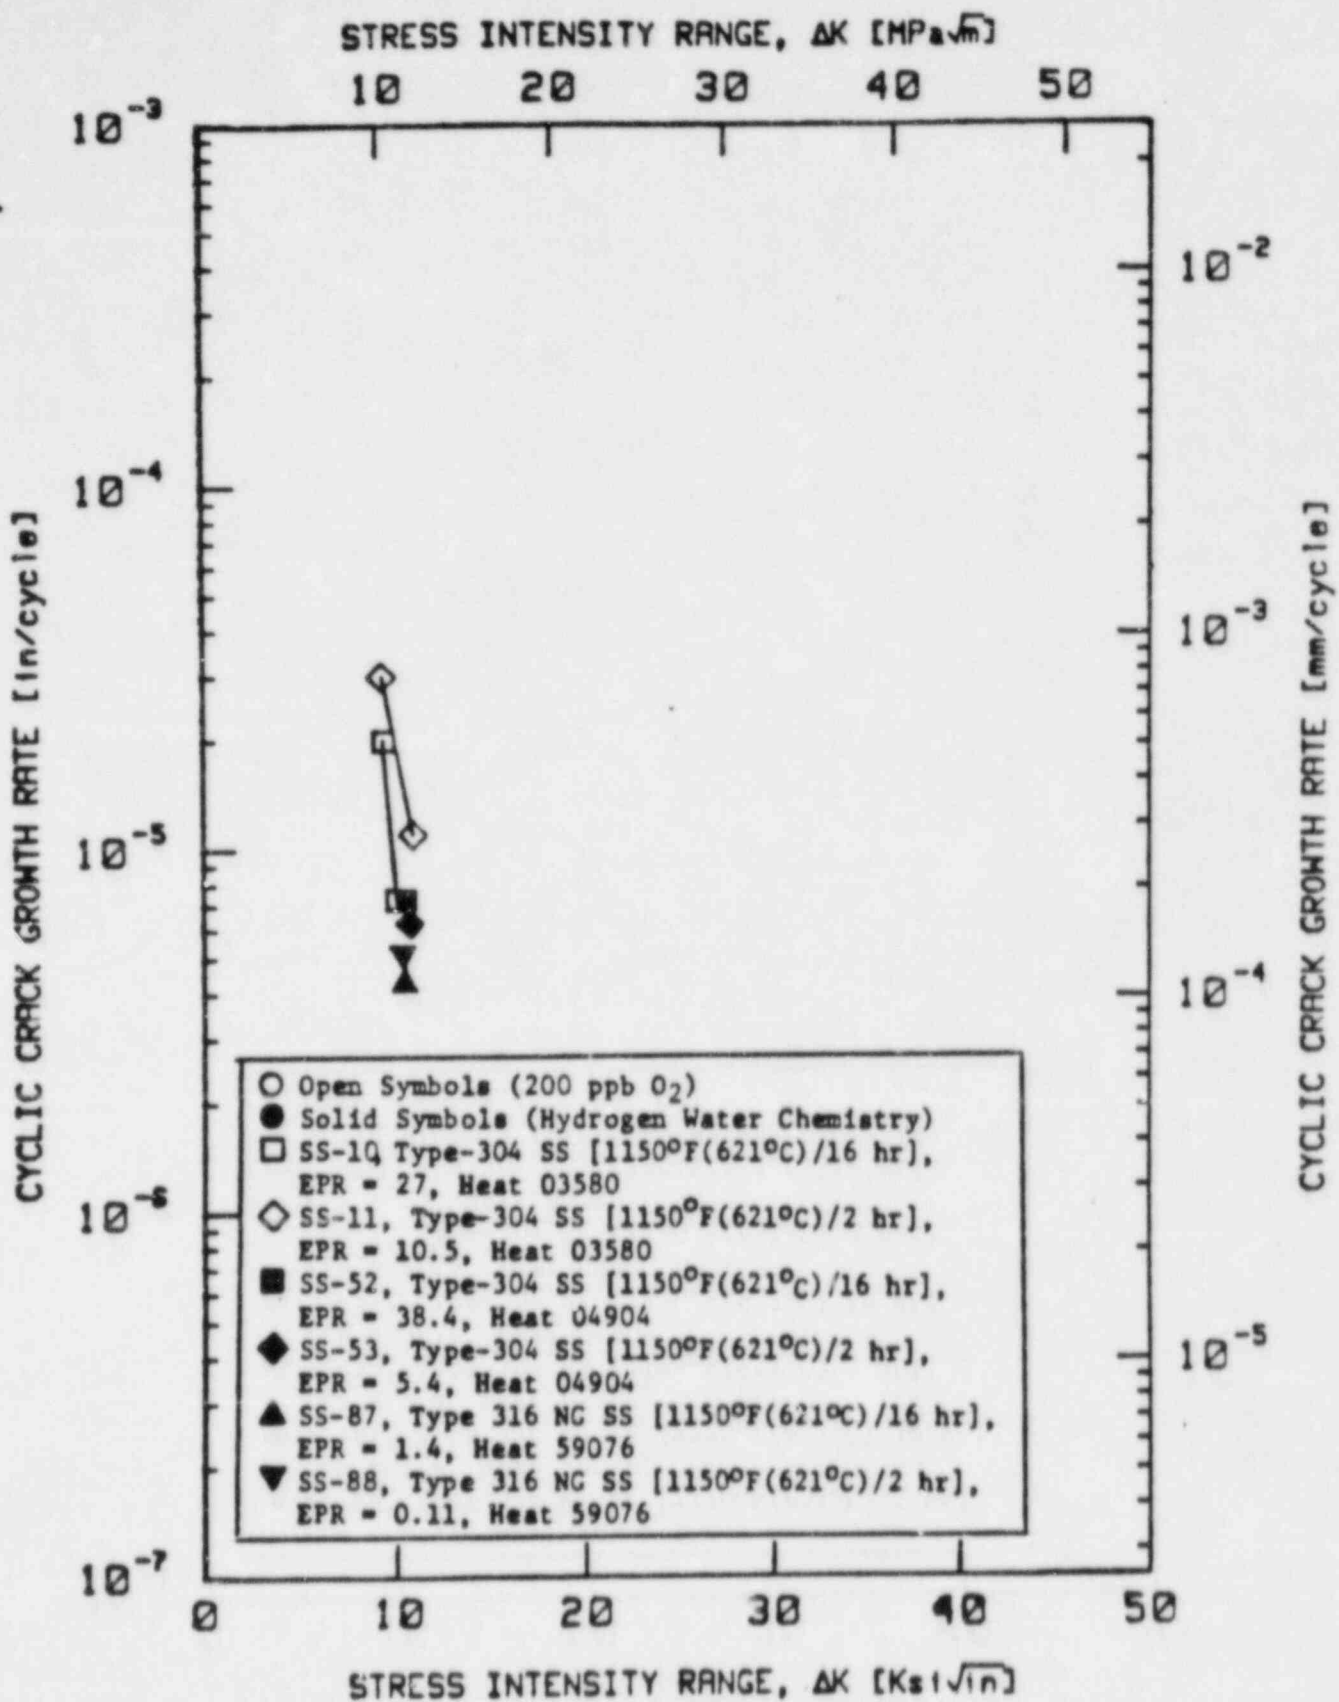
Figure 3.5-9. Comparison of Cyclic Crack Growth Data (7.5 cph, R=0.6) in H_2WC versus Nominal Environment for Furnace Sensitized Stainless Steel

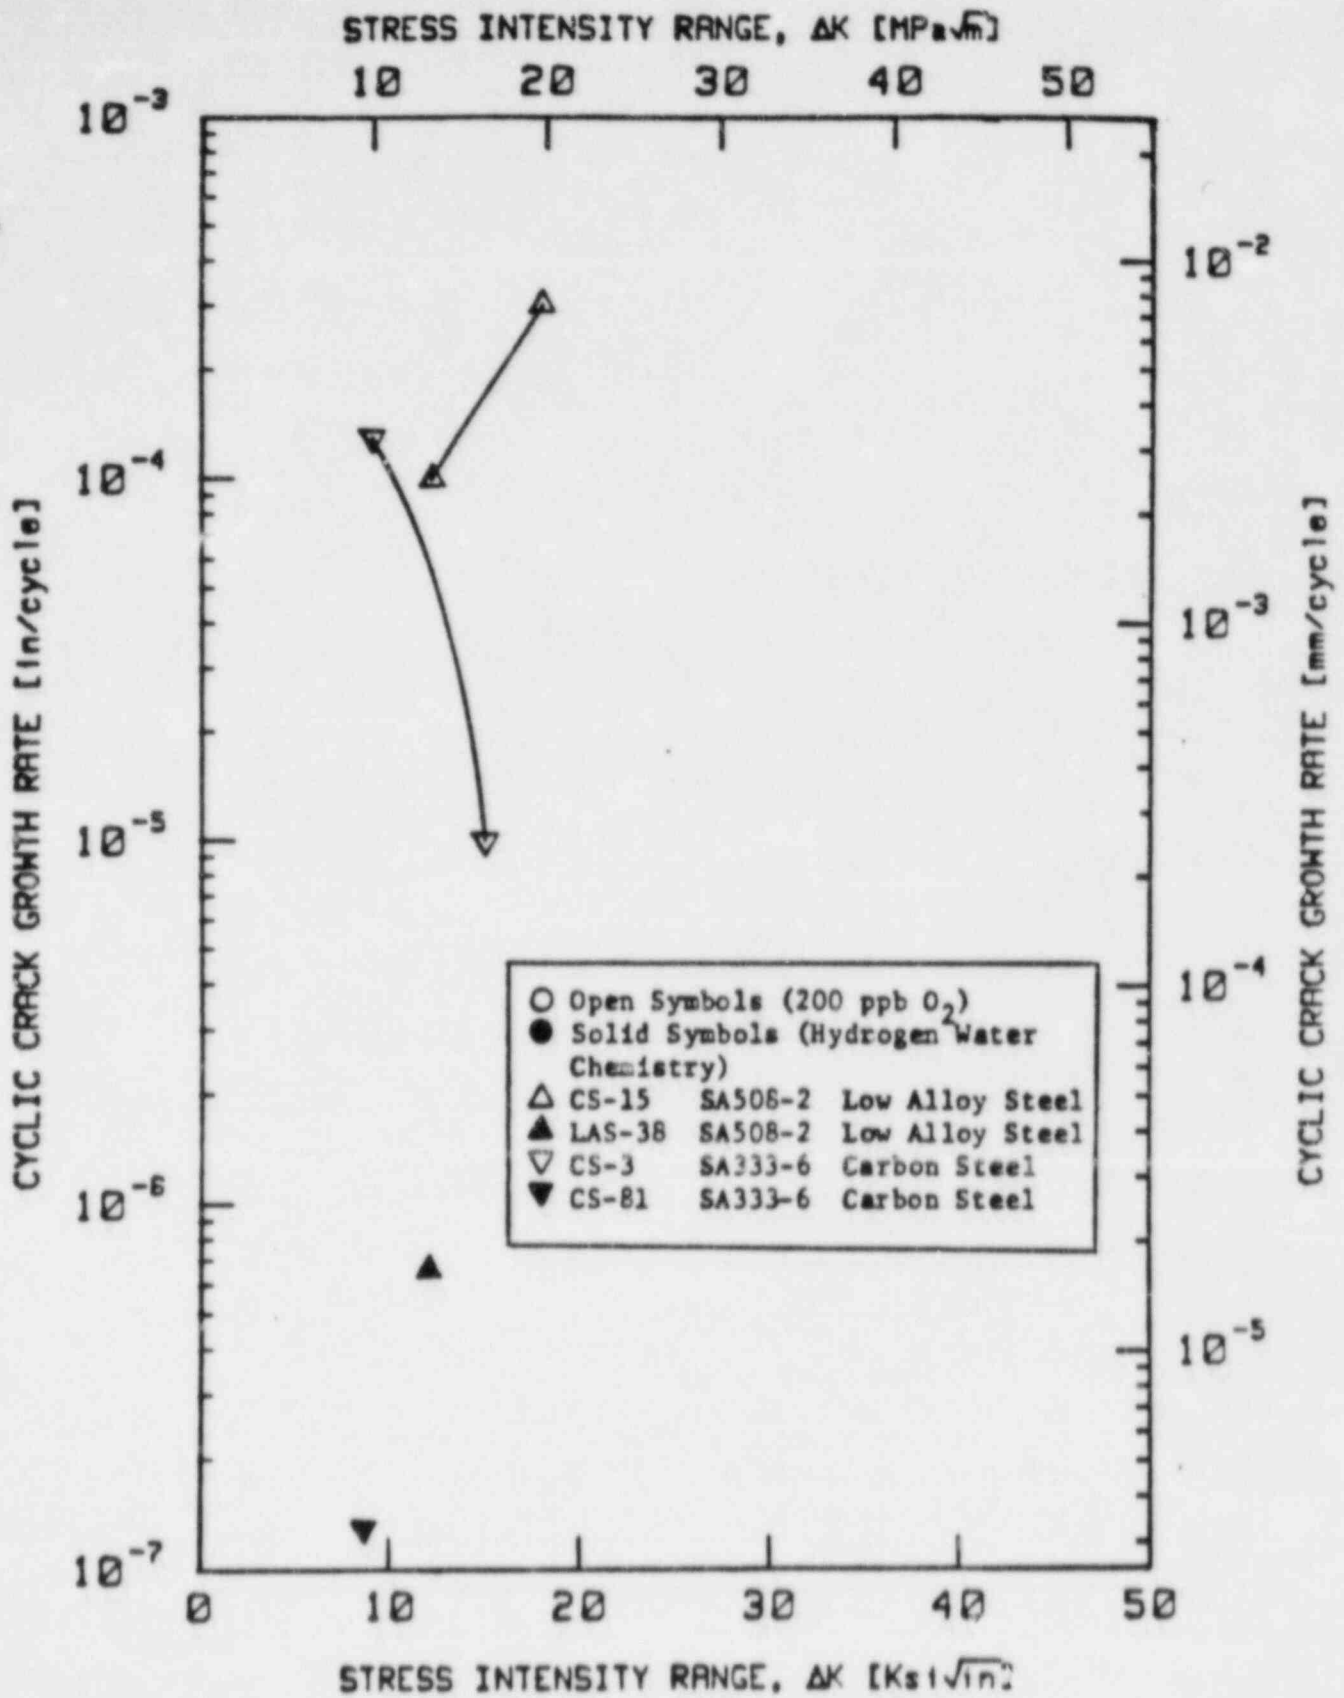
Figure 3.5-10. Comparison of Cyclic Crack Growth Data (7.5 cph, R=0.6) in H₂WC versus Nominal Environment for Carbon and Low Alloy Steel

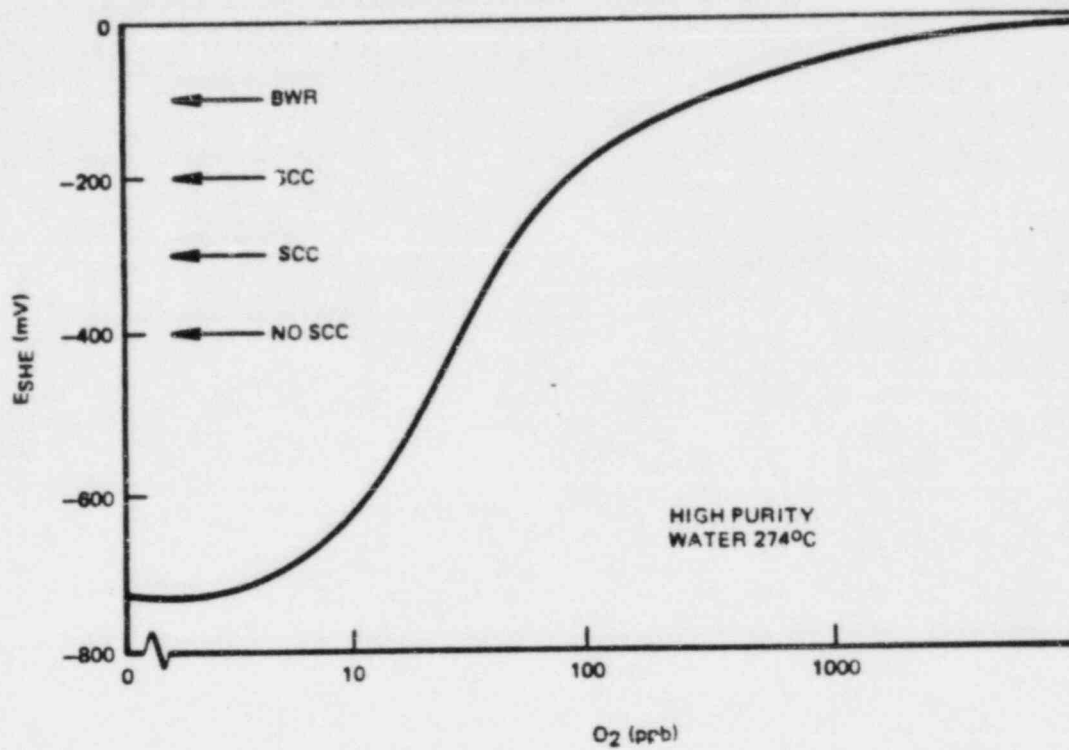
Figure 3.5-11. Relationship Between Dissolved Oxygen and Potential to IGSCC of Welded Type 304 Stainless Steel

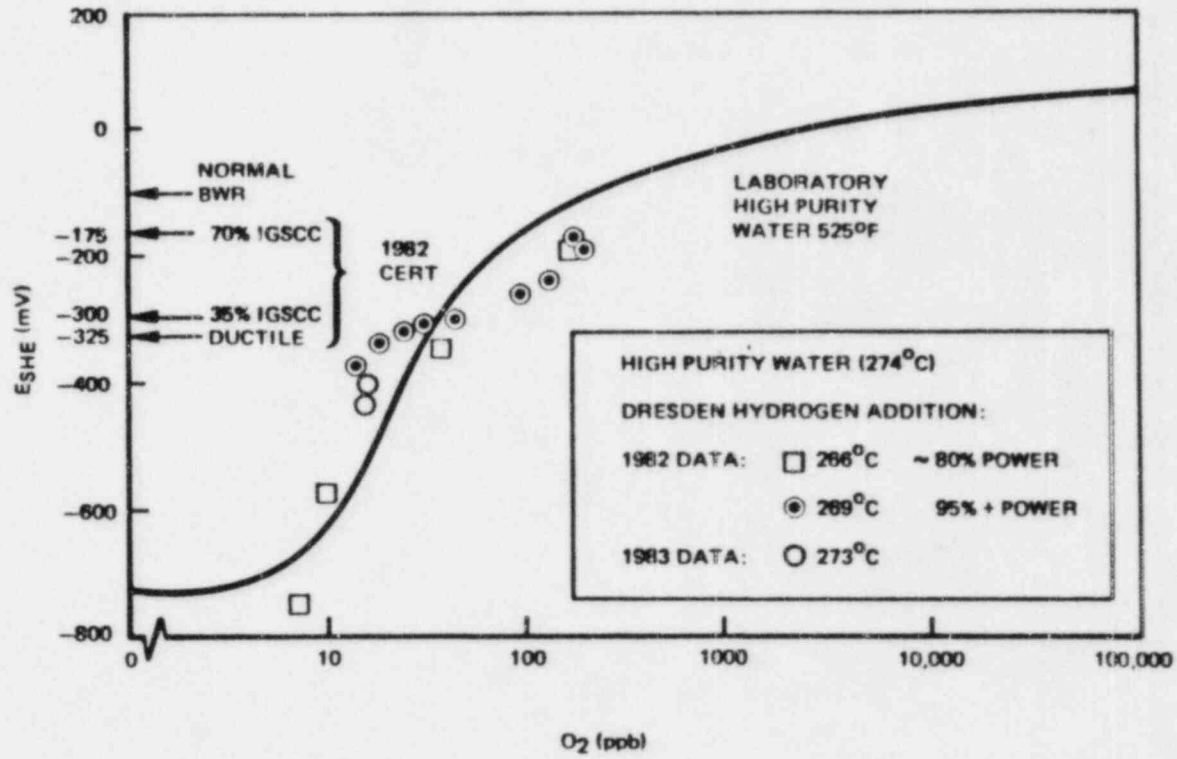
Figure 3.5-12. The Effect of Dissolved Oxygen on the Corrosion Potential of Type 304 Stainless Steel in High Purity Water at 274°C (525°F)

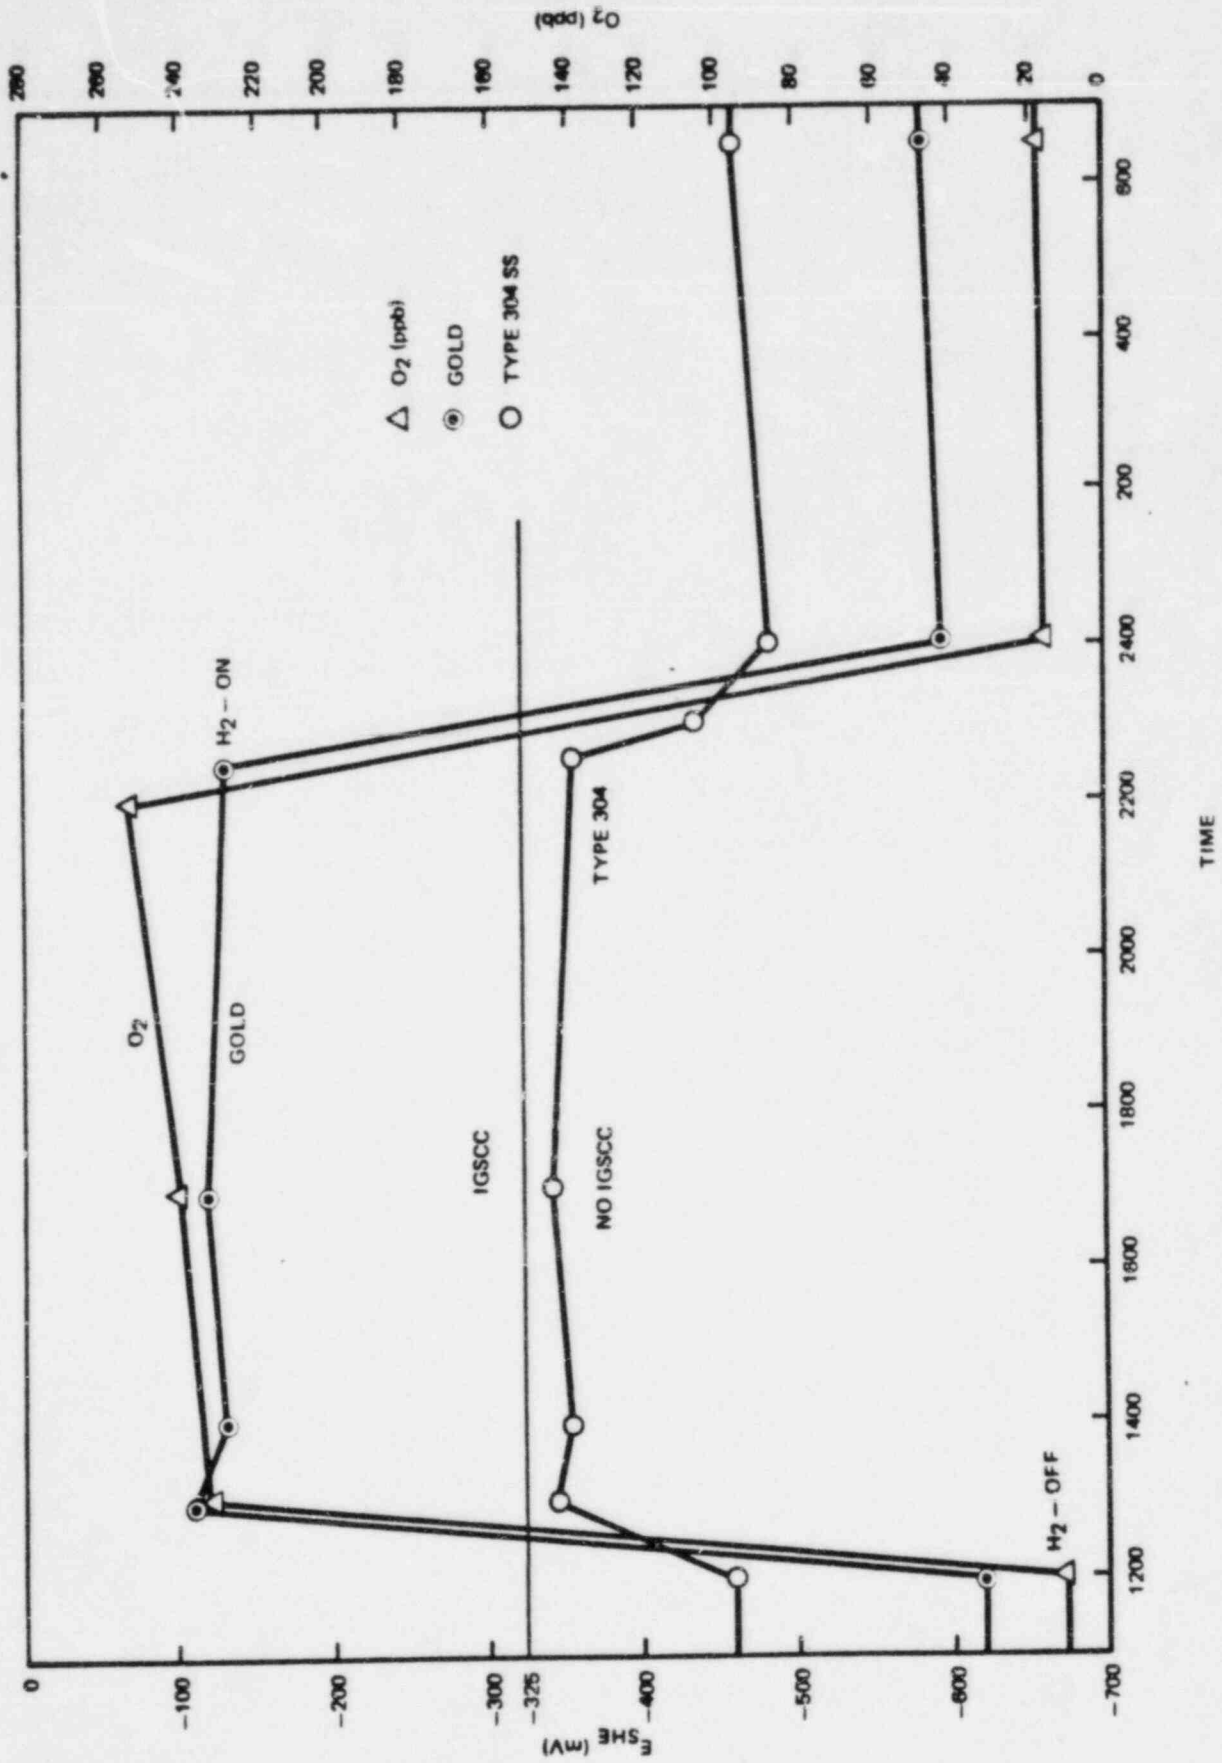
Figure 3.5-13. Example of ECP Memory Effect During H₂WC

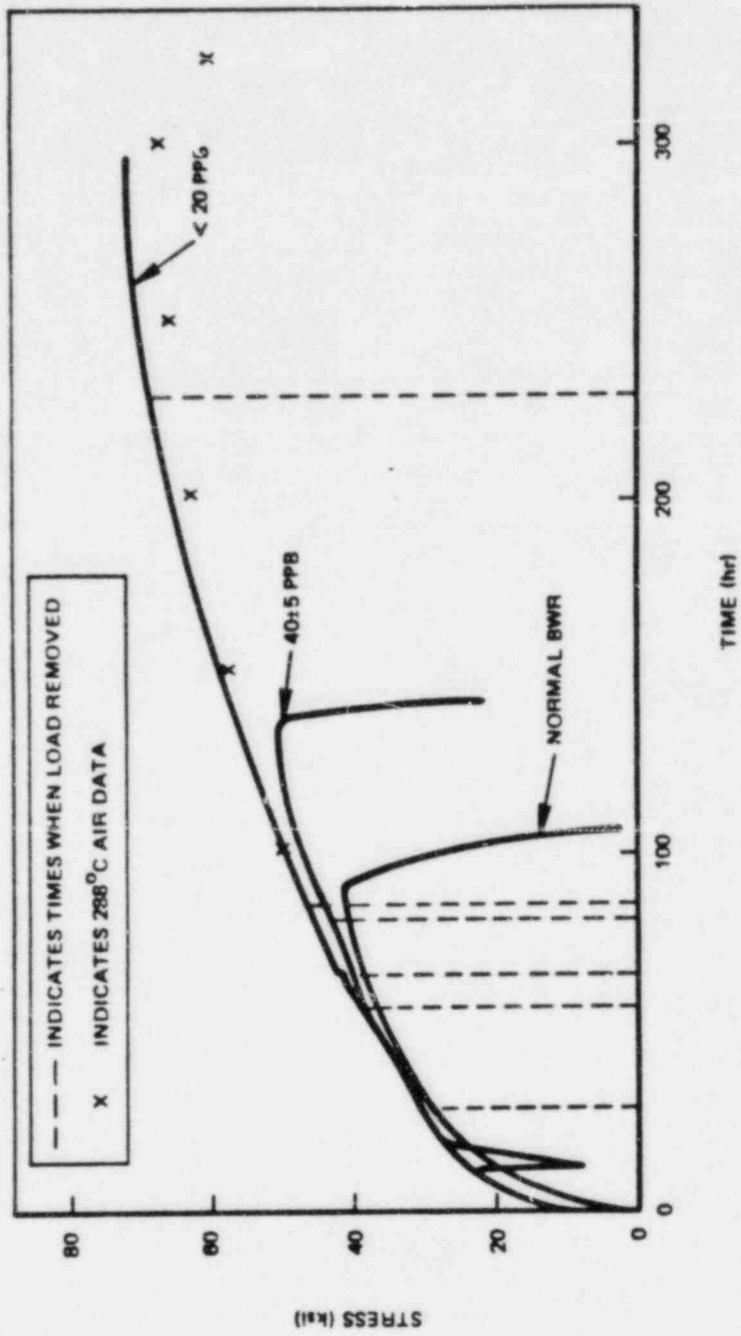
Figure 3.5-14. IGSCC Behavior of Sensitized Stainless Steel in Dresden-2 Tests

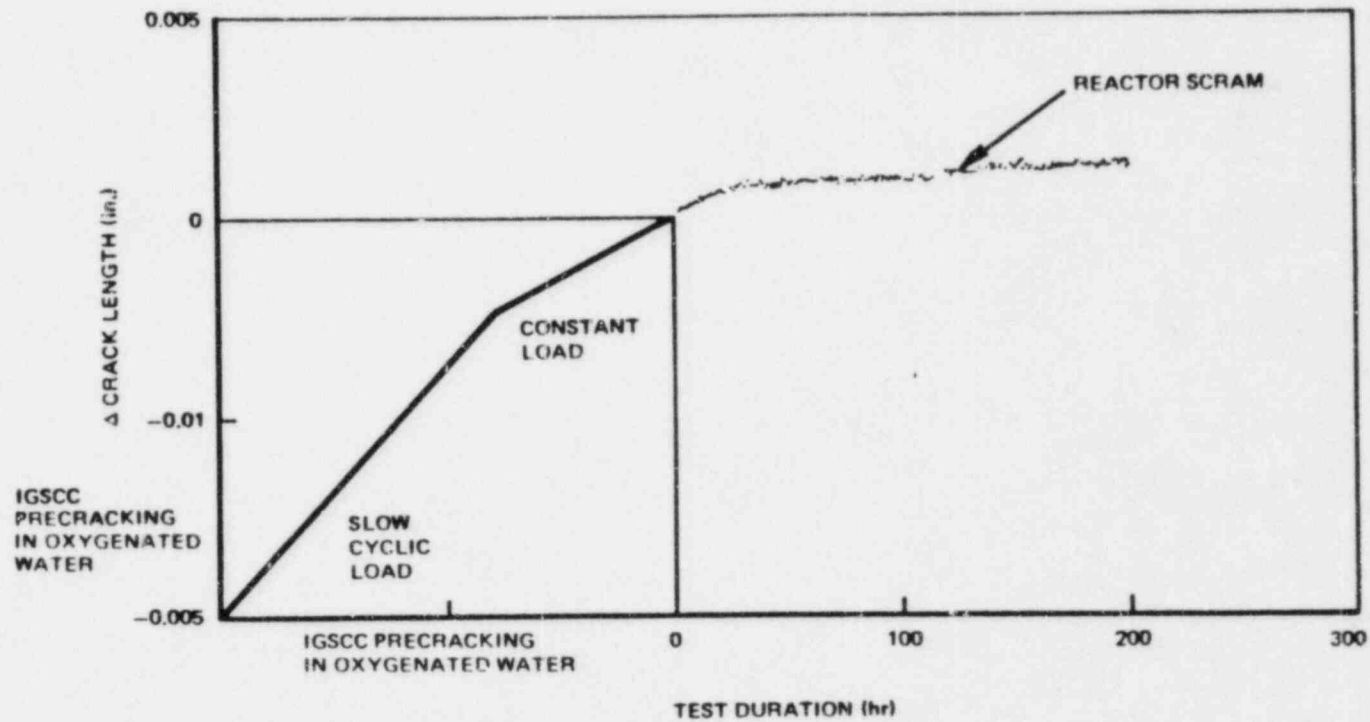
Figure 3.5-15. Dresden-2 H₂WC Crack Growth Test - Furnace Sensitized Type 304 SS
(K = 25 ksi $\sqrt{\text{in.}}$)

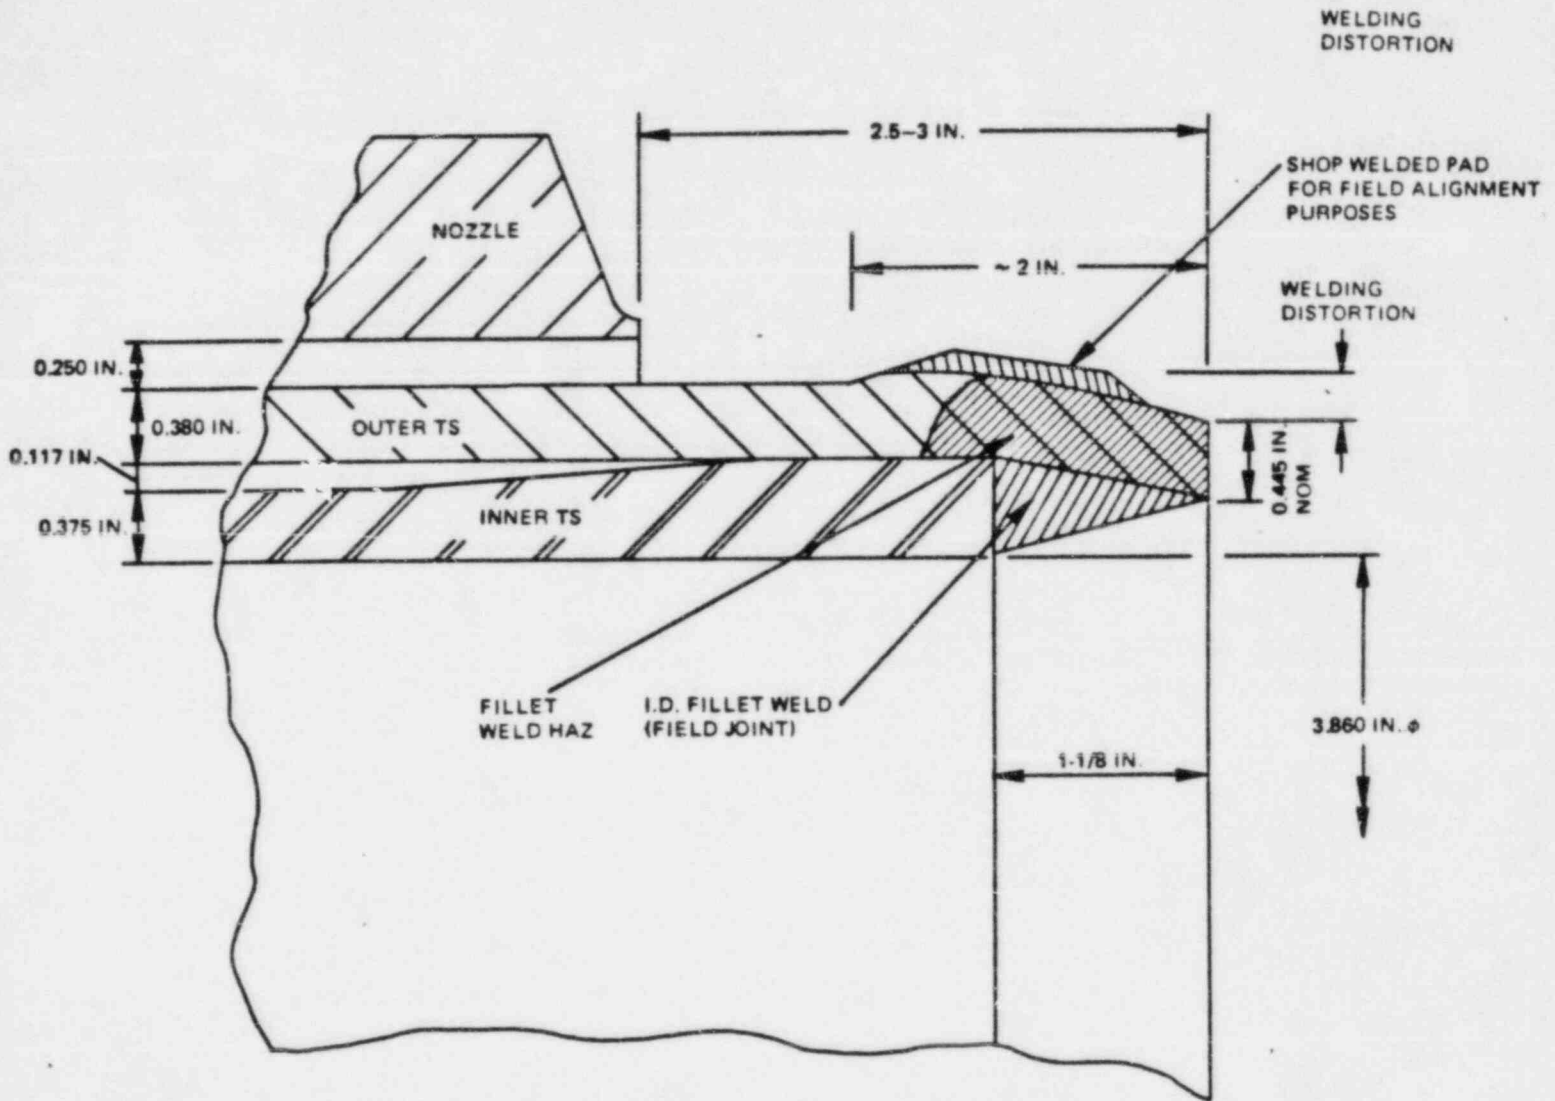
Figure 4.0-1. Cross-section of Pilgrim Recirculation Inlet Thermal Sleeve/Nozzle at Alignment Pad Locations

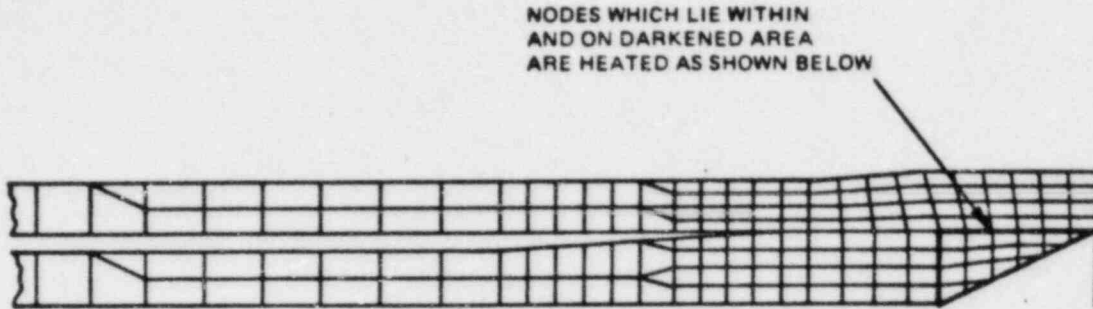
Figure 4.2-1. Nuggett Area Modelling

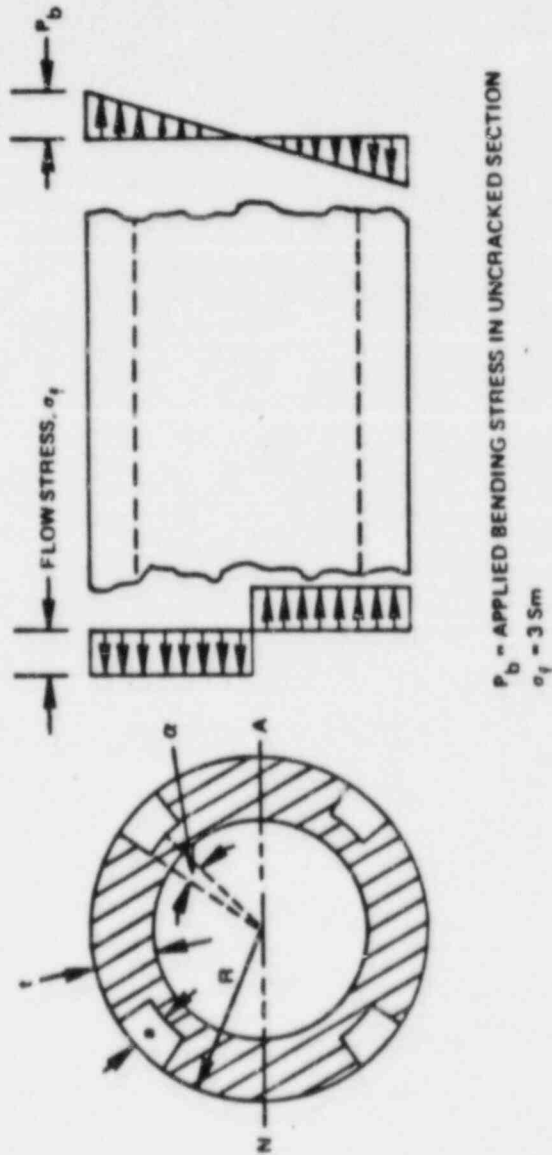
Figure 4.3-1. Crack Configuration for Four Separate Indications

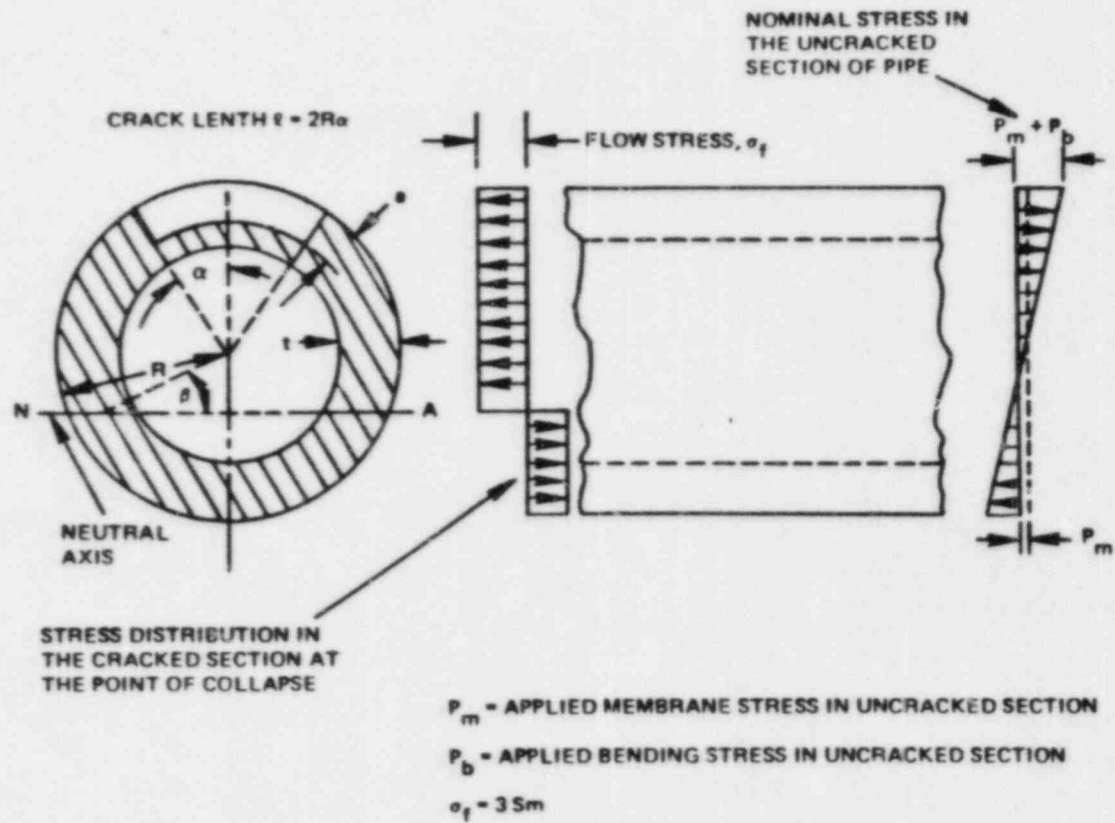
Figure 4.3-3. Crack Configuration for One Continuous Indication

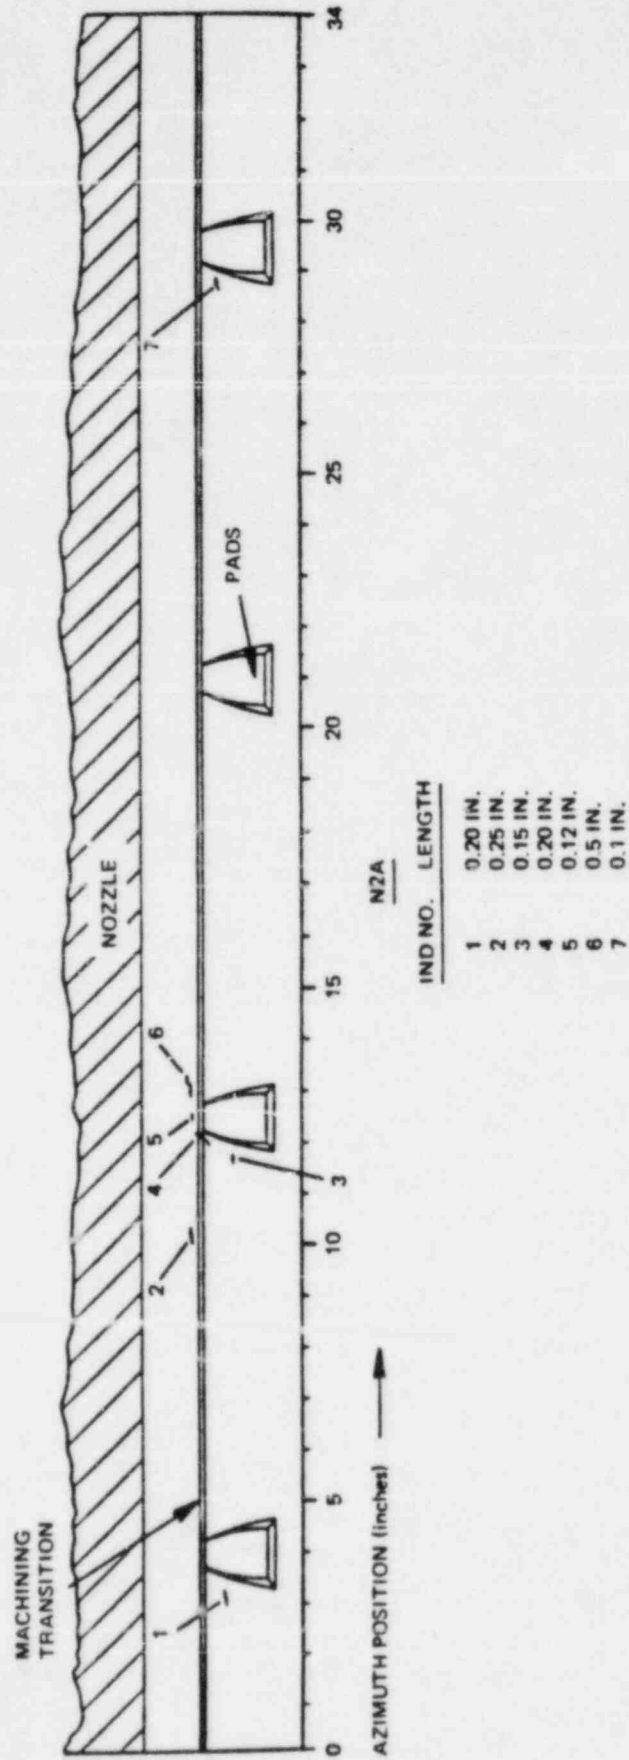
J-1

Figure J-1. Thermal Sleeve - PT Cracking Map - N2-A
