NEDO-30730
DRF B31-00106
Class I
September 1984

PILGRIM NUCLEAR POWER STATION
RECIRCULATION NOZZLE REPAIR PROGRAM
AND HYDROGEN WATER CHEMISTRY
MATERIALS QUALIFICATION

NUCLEAR ENERGY BUSINESS OPERATIONS • GENERAL ELECTRIC COMPANY
SAN JOSE, CALIFORNIA 95125

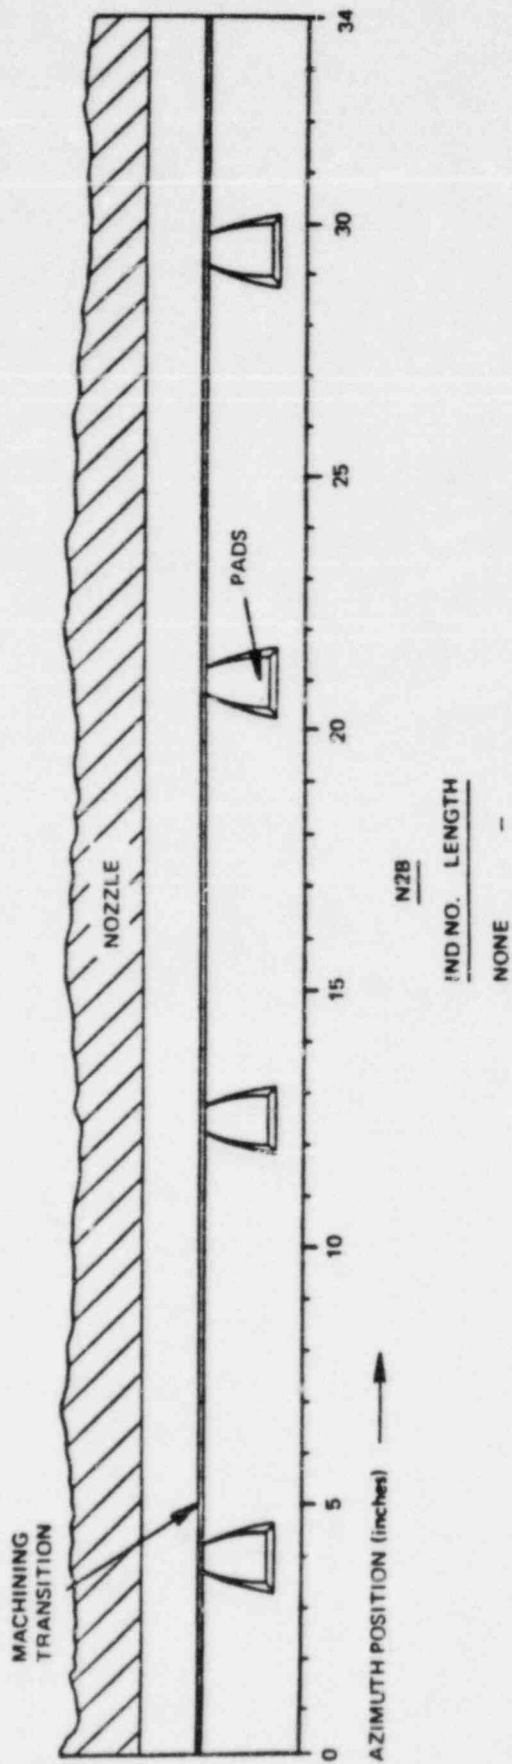
J-2

Figure J-2. Thermal Sleeve - PT Cracking Map - N2-B

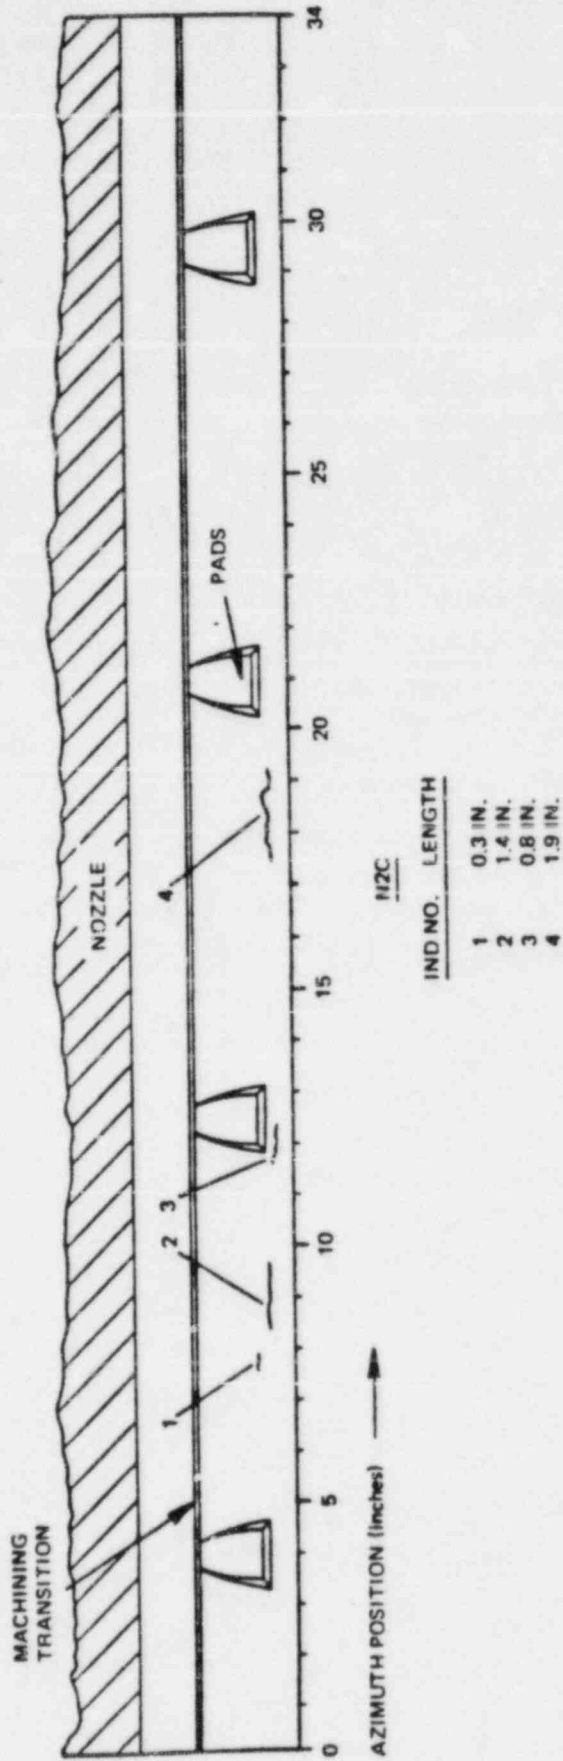
J-3

Figure J-3. Thermal Sleeve - PT Cracking Map - N2-C

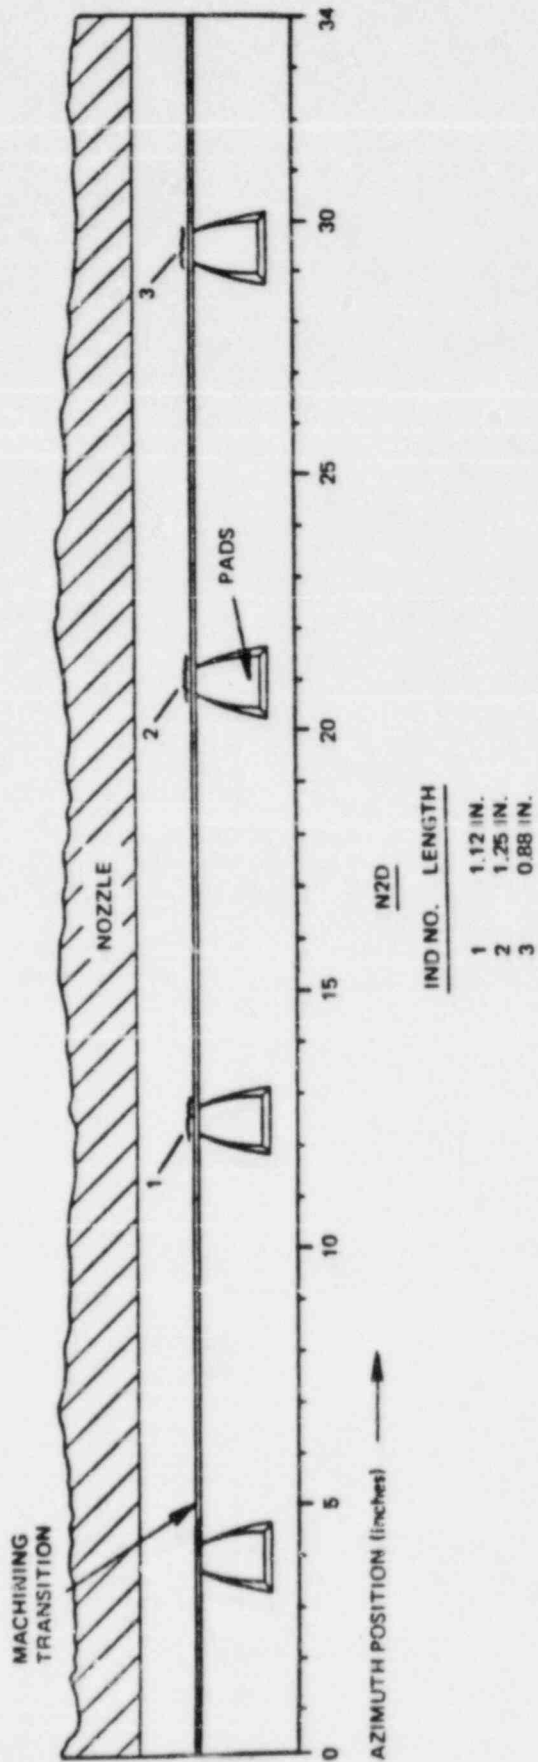
J-4

Figure J-4. Thermal Sleeve - PT Cracking Map - N2-D

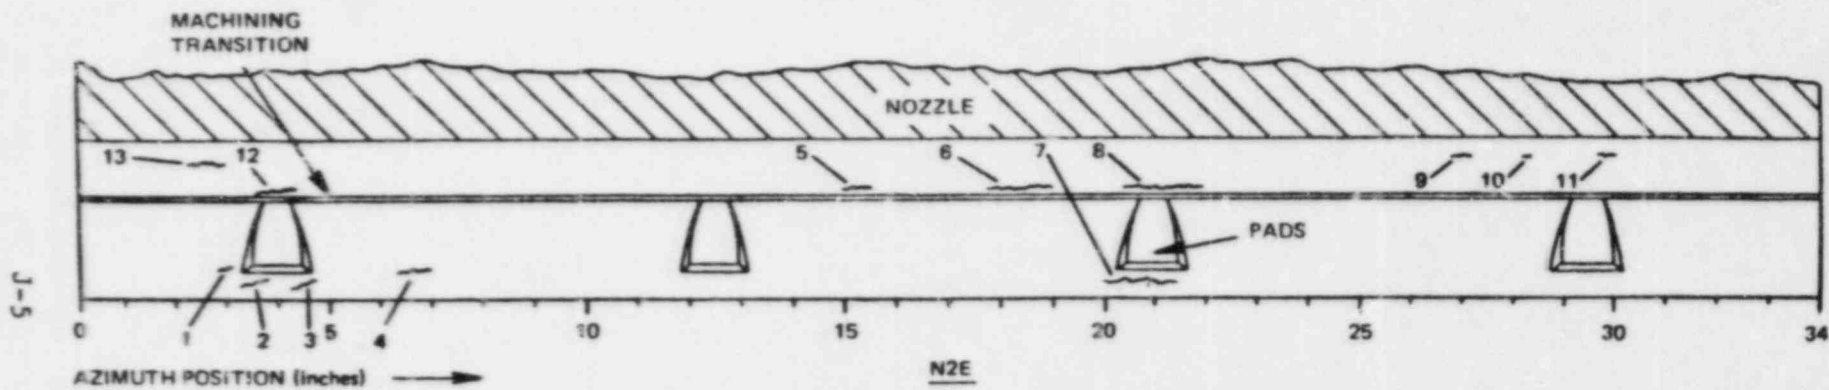
IND NO.	LENGTH	IND NO.	LENGTH
1	0.4 IN.	8	1.75 IN.
2	0.7 IN.	9	0.5 IN.*
3	0.75 IN.	10	0.12 IN.*
4	0.88 IN.*	11	0.38 IN.*
5	0.75 IN.	12	0.66 IN.
6	1.38 IN.	13	0.6 IN.
7	1.5 IN.

*VERY LIGHT INDICATIONS

Figure J-5. Thermal Sleeve - PT Cracking Map - N2-E

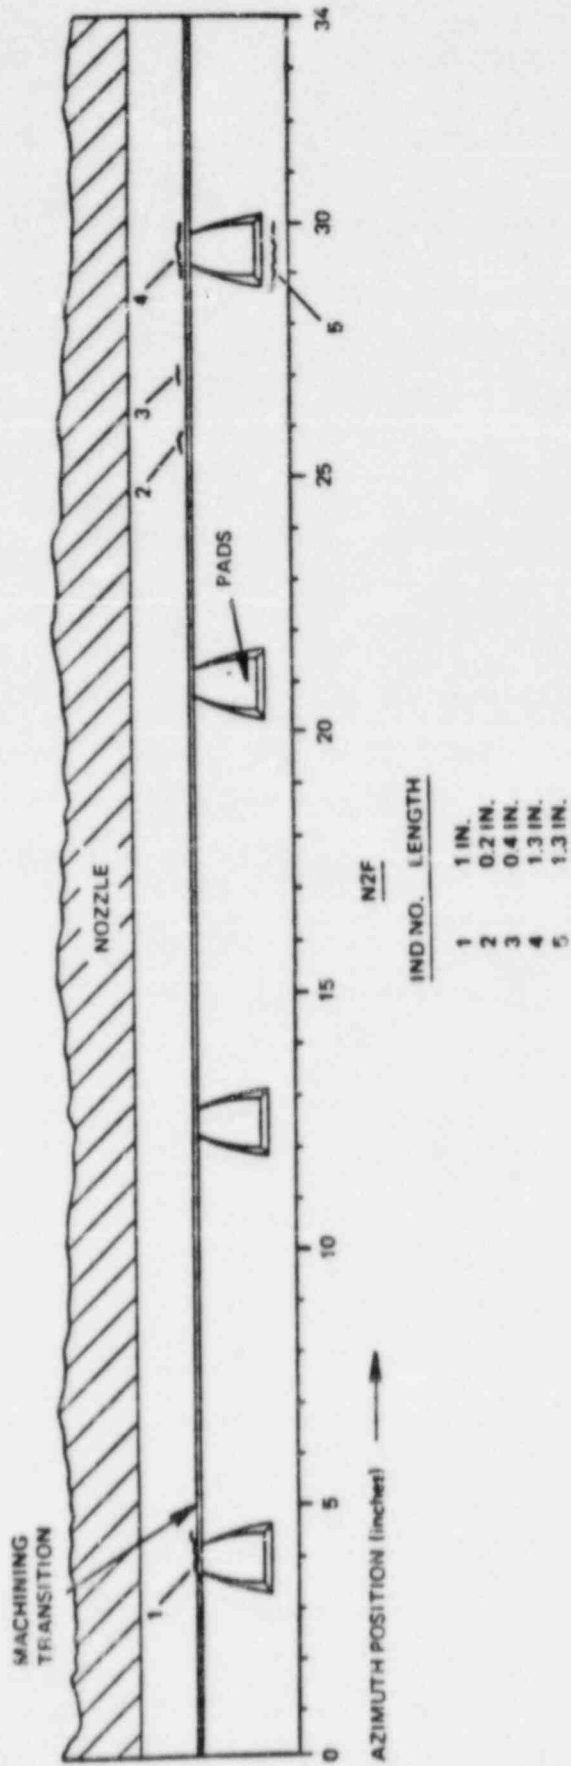
J-6

Figure J-6. Thermal Sleeve - PT Cracking Map - N2-F

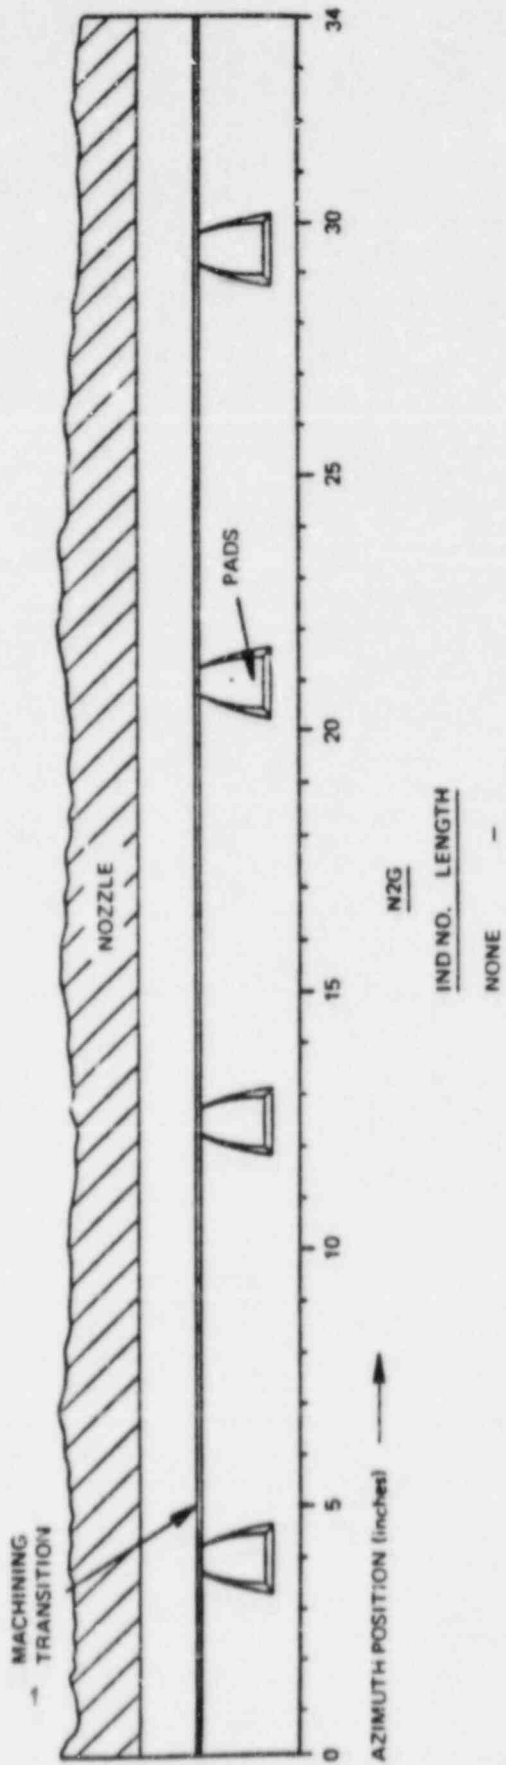
J-7

Figure J-7. Thermal Sleeve - PT Cracking Map - N2-G

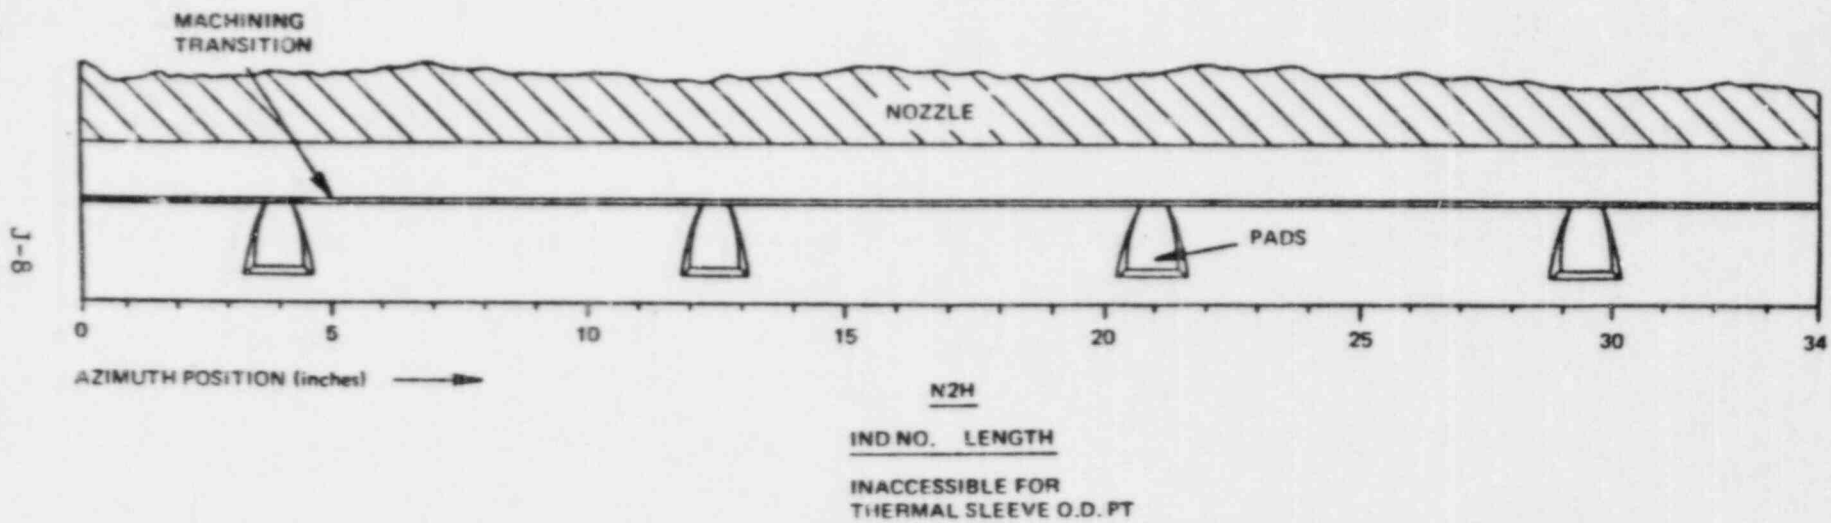
Figure J-8. Thermal Sleeve - PT Cracking Map - N2-H

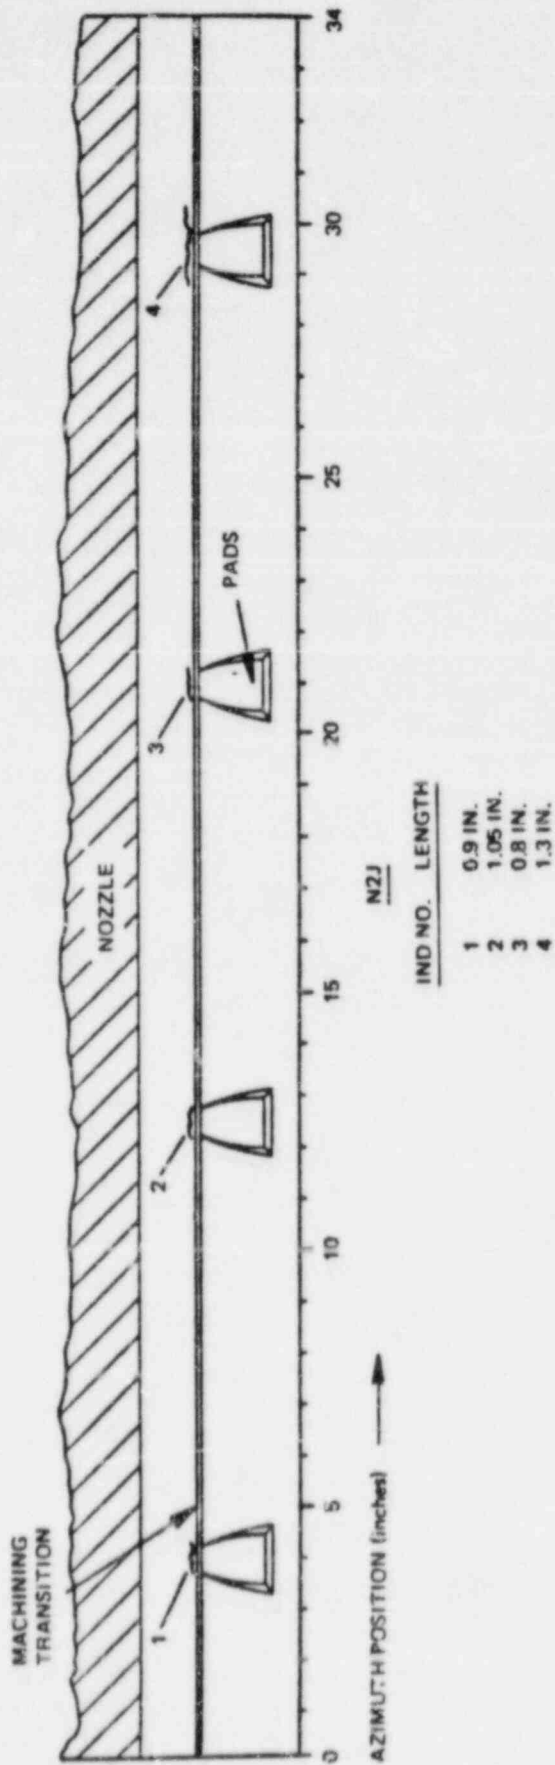
J-9

Figure J-9. Thermal Sleeve - PT Cracking Map - N2-J

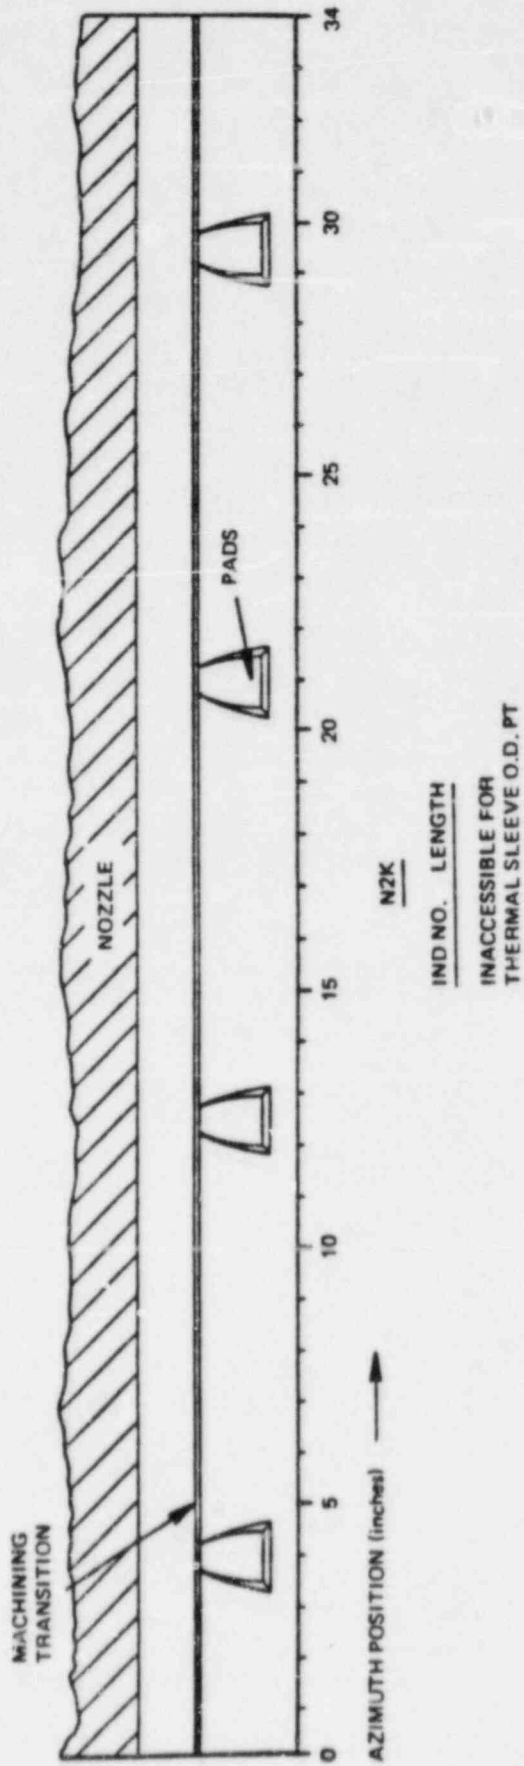
J-10

Figure J-10. Thermal Sleeve - PT Cracking Map - N2-K

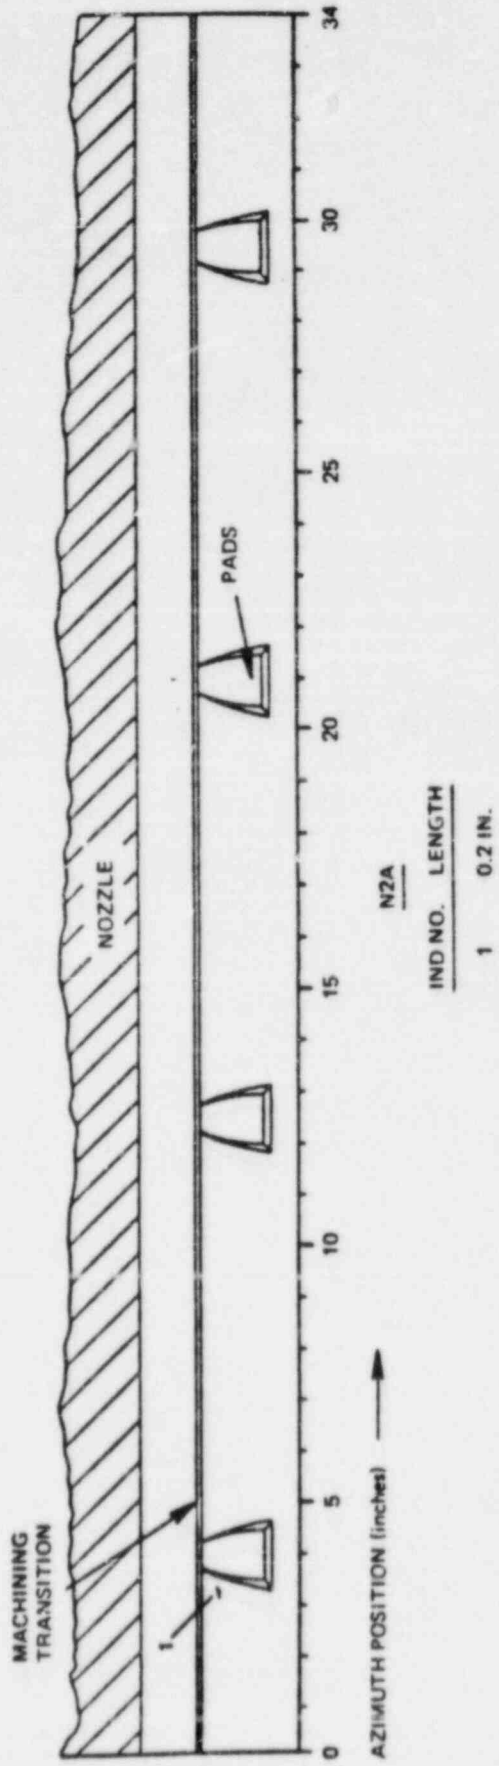
J-11

Figure J-11. Thermal Sleeve - RT Cracking Map - N2-A

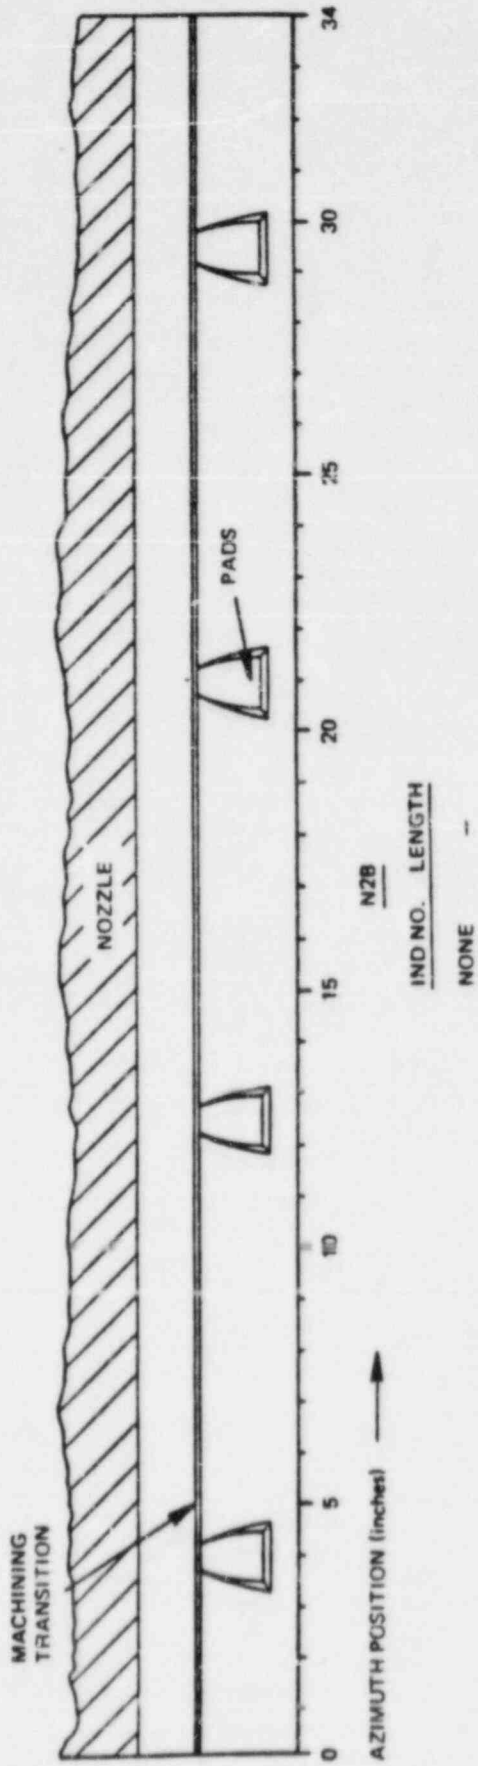
J-12

Figure J-12. Thermal Sleeve - RT Cracking Map - N2B

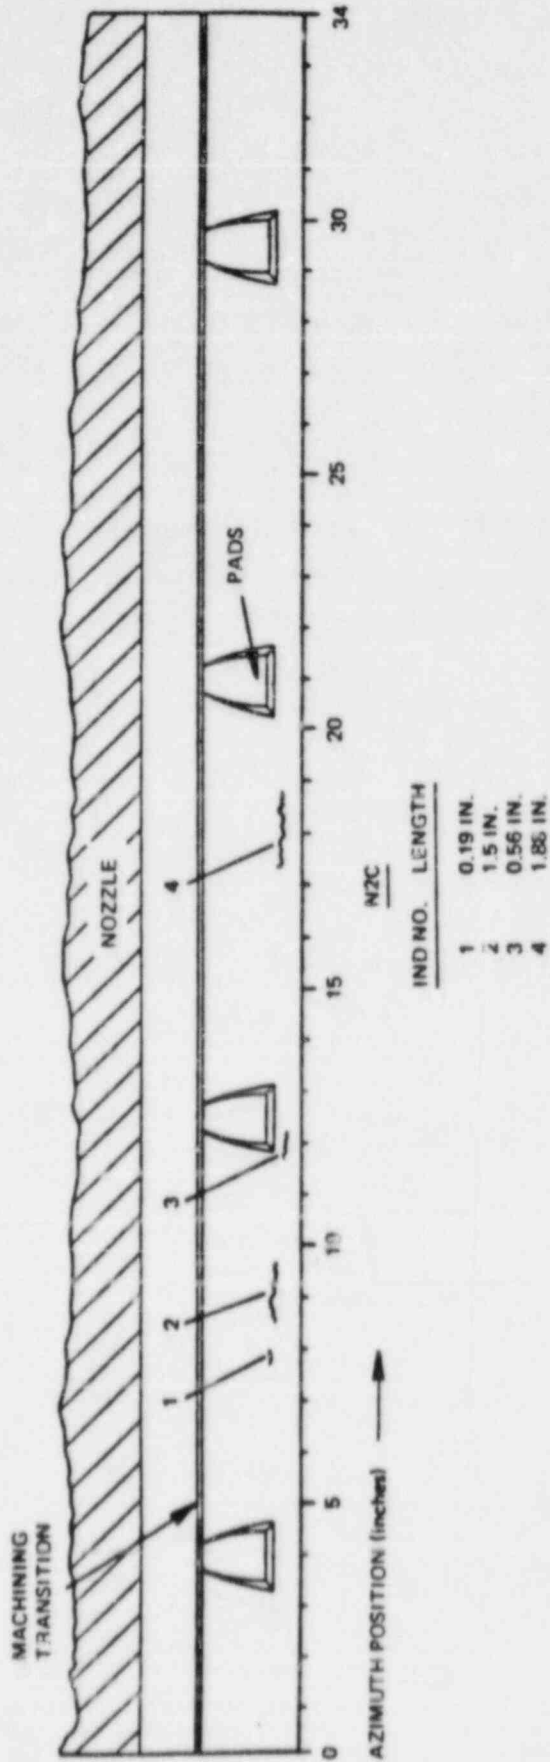
Figure J-13. Thermal Sleeve - RT Cracking Map - N2-C

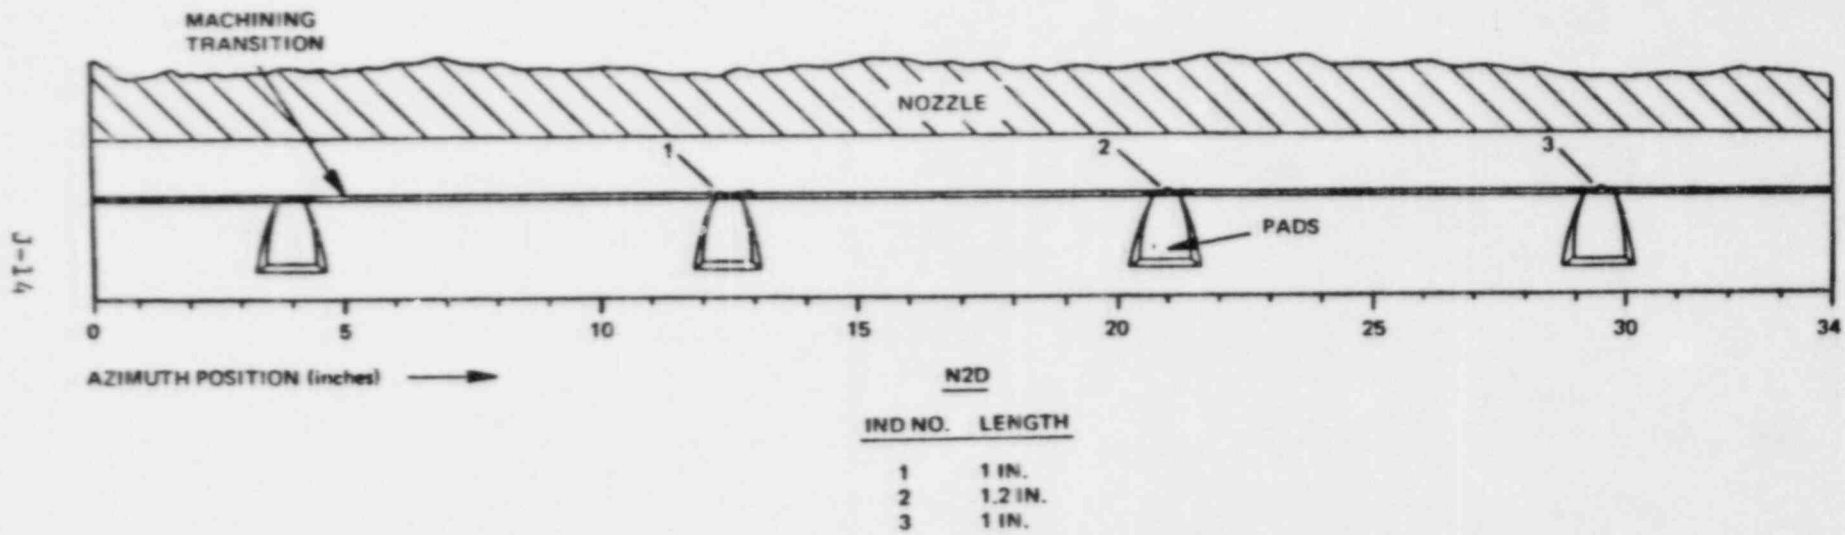
Figure J-14. Thermal Sleeve - RT Cracking Map - N2-D

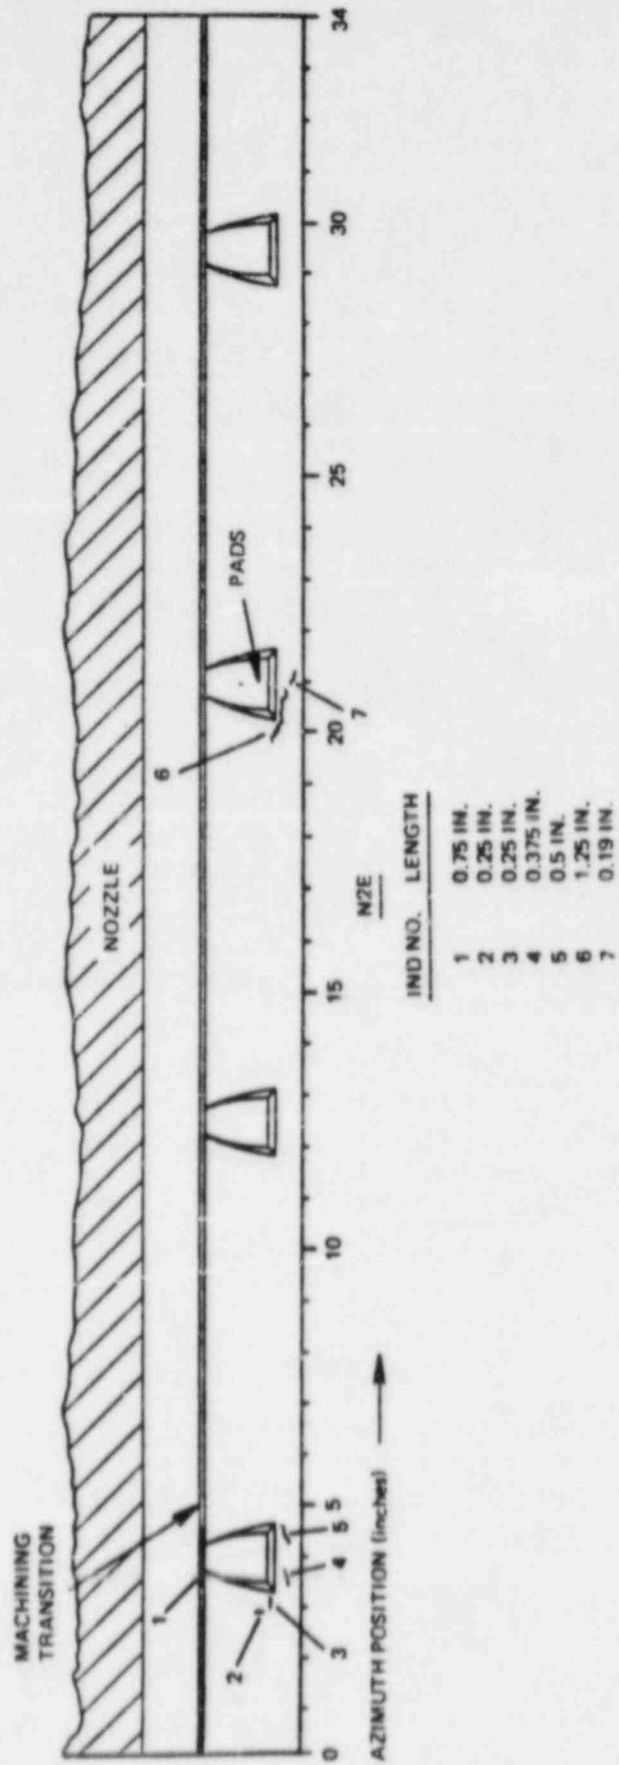
J-15

Figure J-15. Thermal Sleeve - RT Cracking Map - N2-E

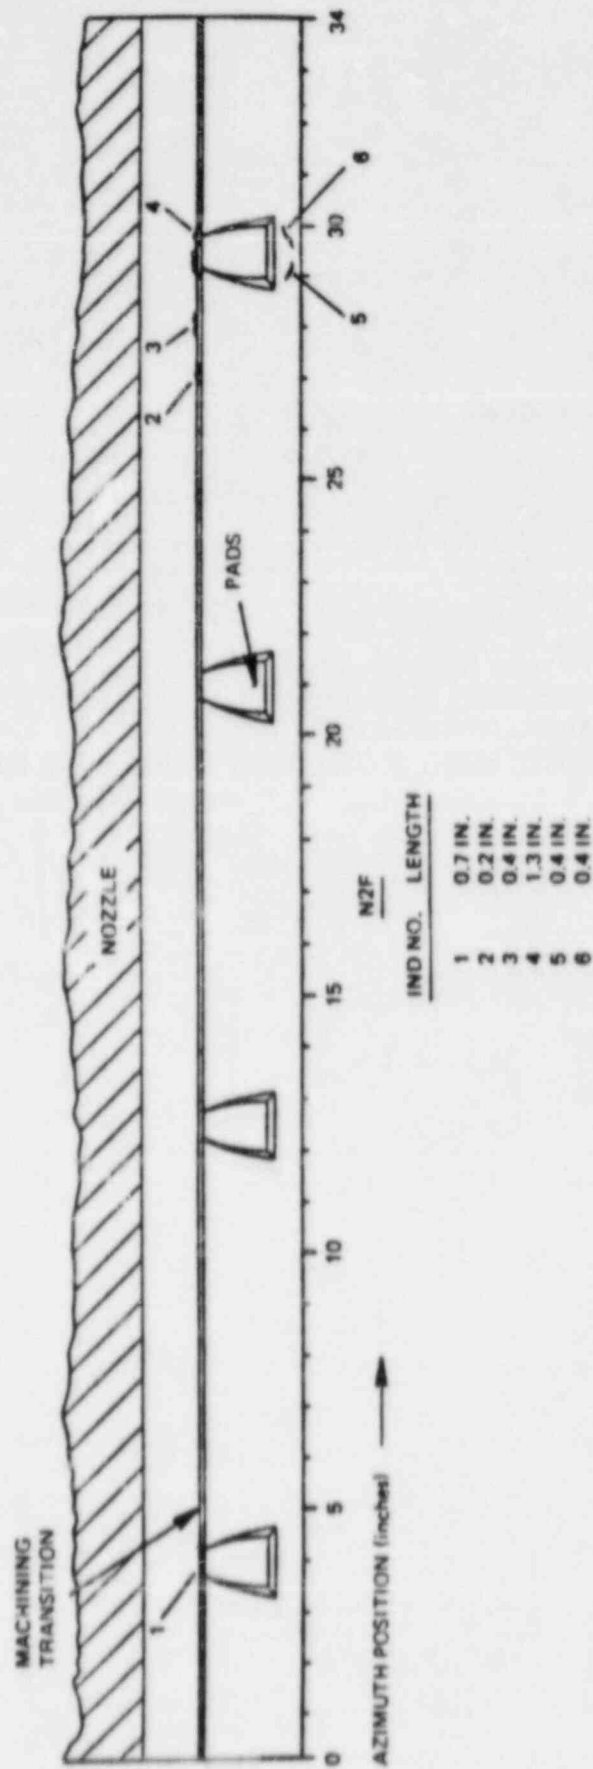
J-16

Figure J-16. Thermal Sleeve - RT Cracking Map - N2-F

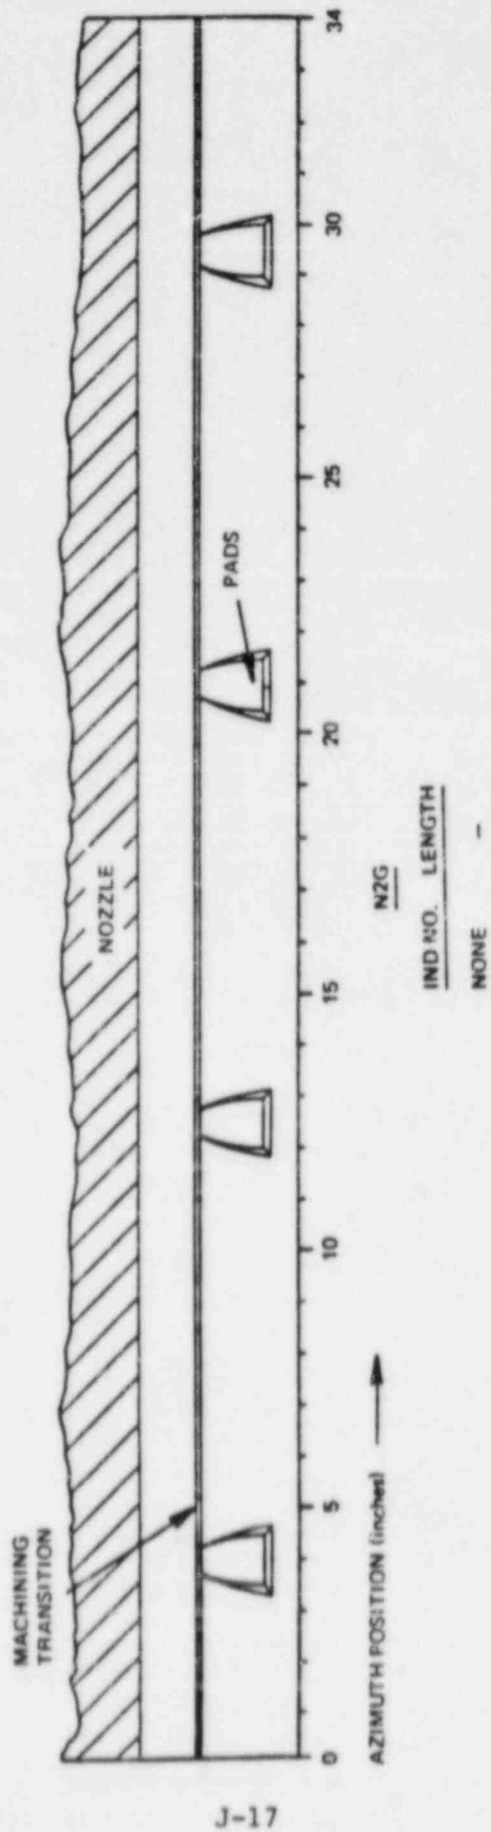
J-17

Figure J-17. Thermal Sleeve - RT Cracking Map - N2-G

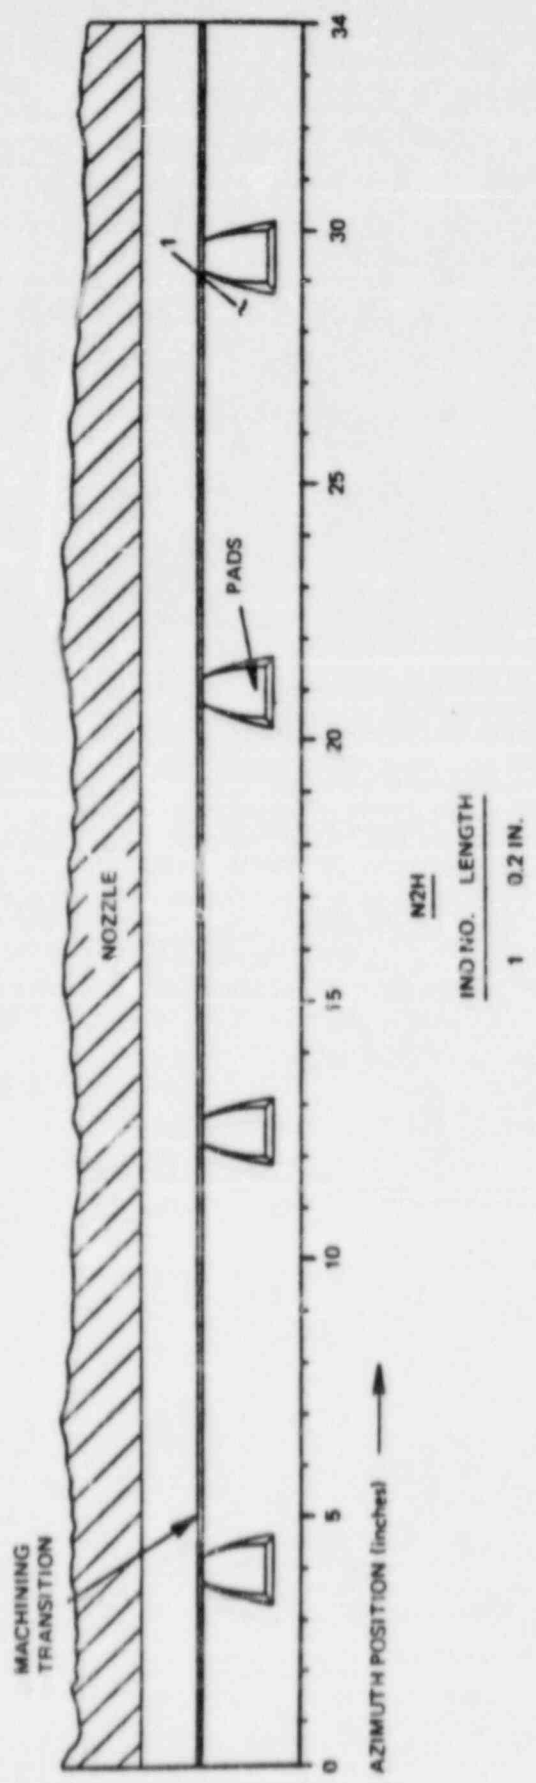
J-18

Figure J-18. Thermal Sleeve - RT Cracking Map - N2-H

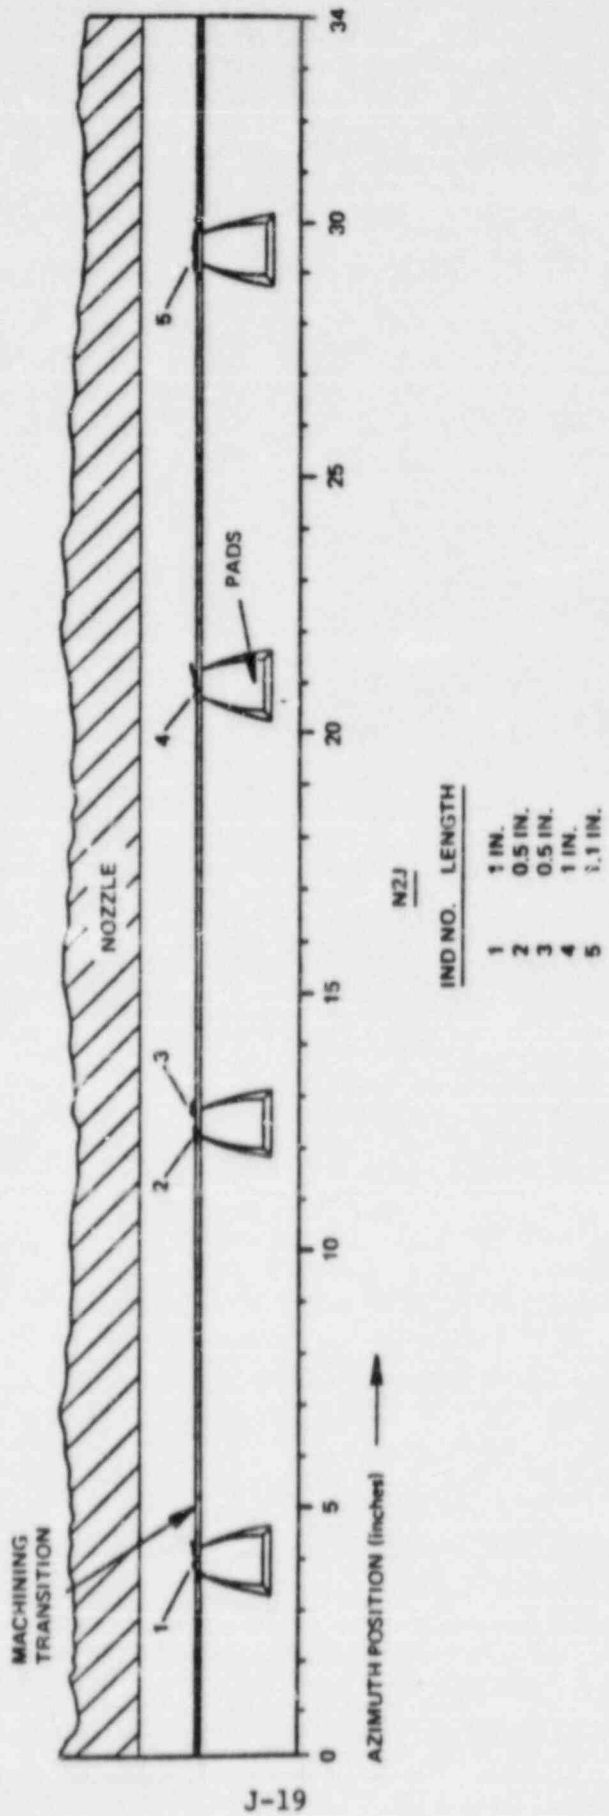
J-19

Figure J-19. Thermal Sleeve - RT Cracking Map - N2-J

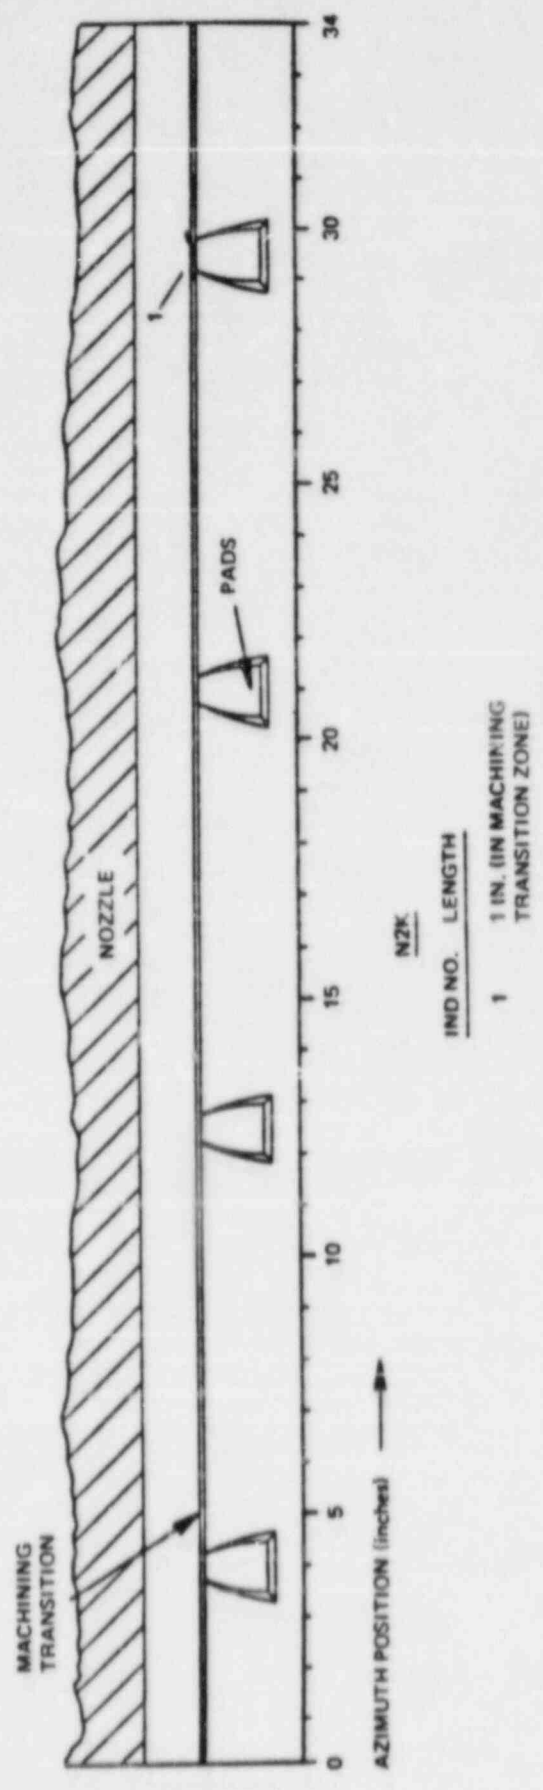
J-20

Figure J-20. Thermal Sleeve - RT Cracking Map - N2-K
