Attached are the Incidental Take Reports and Data Collection Forms for four sturgeon collected on 04/24/2020 at the Salem Generating Station cooling water intake. This incidental take is authorized under Biological Opinion NER-2010-6581.

Subject: [External_Sender] SALEM GENERATING STATION-INCIDENTAL TAKE OF ATLANTIC & SHORTNOSE STURGEON
Sent Date: 4/24/2020 7:58:47 PM
Received Date: 4/24/2020 7:59:13 PM
From: Strait, Kenneth A.

Site of Collection: PSEG Salem Generating Station; SGS Unit 1, intake 11A

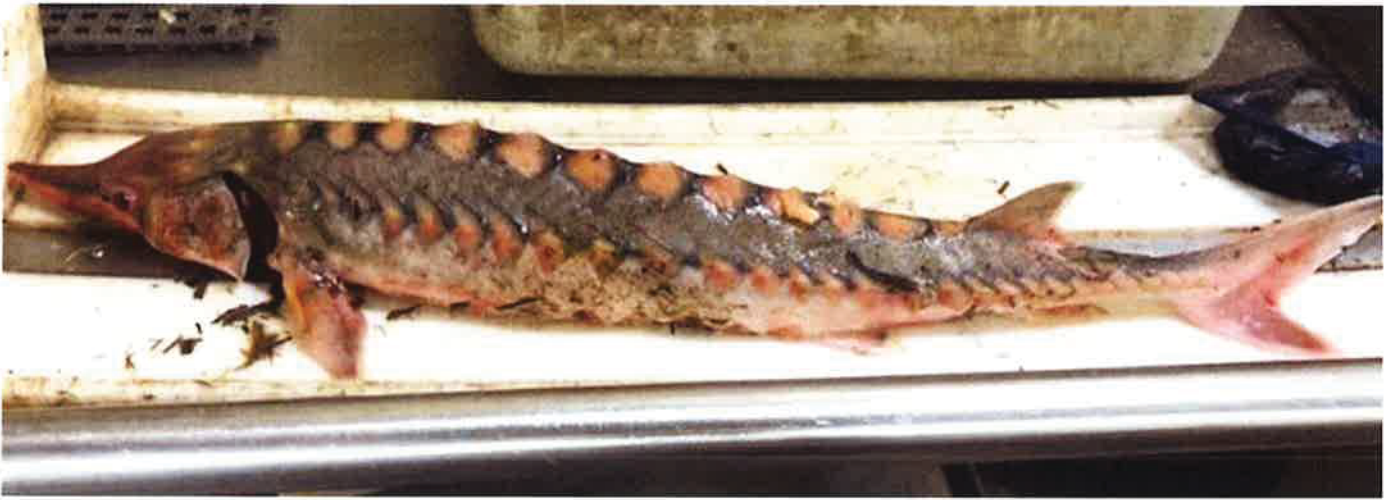
A dorsolateral view showing the size and condition of a deceased, Atlantic sturgeon (*Acipenser oxyrinchus*), retrieved at approximately 09:00am on 04/24/2020 from the Salem Circulating Water Intake Structure by Salem Yard Crew personnel during routine trash rack cleaning at Salem Nuclear Generating Station (04/24/2020).

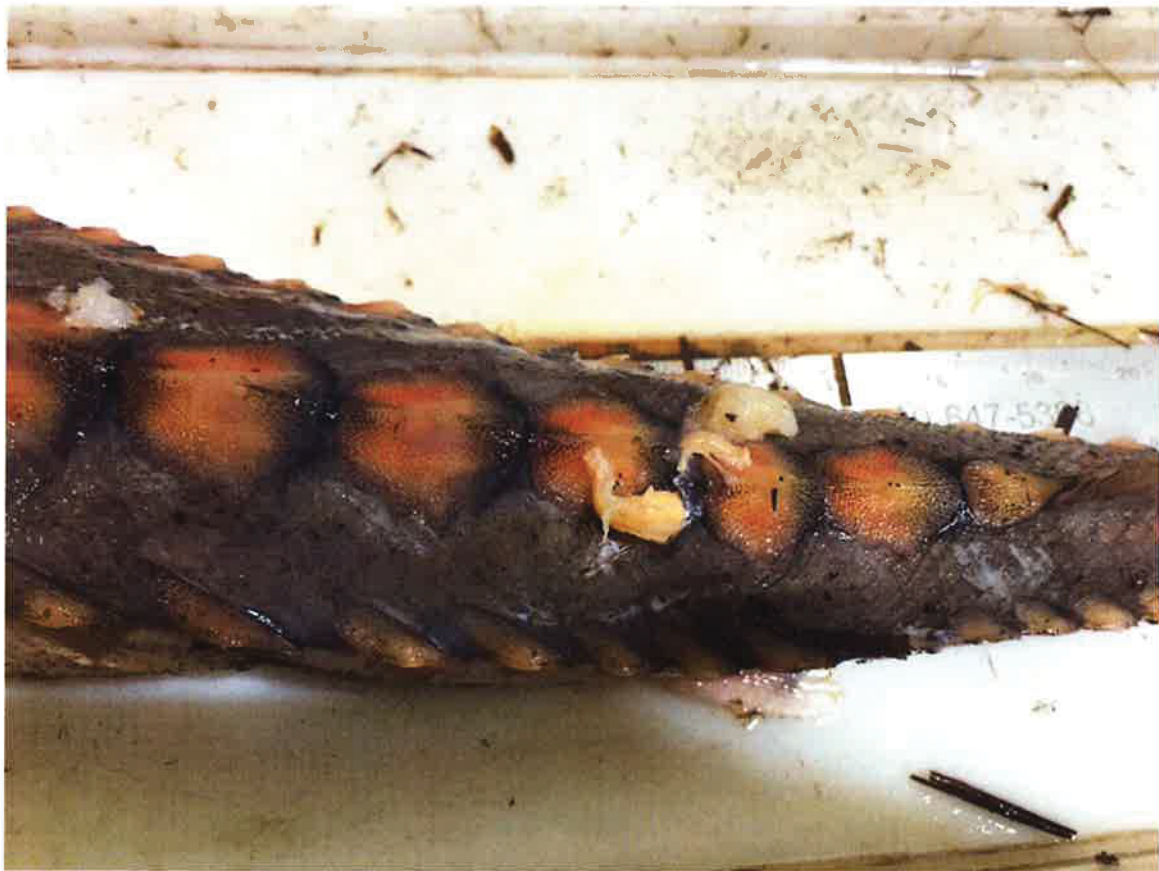
View of the lower torso, showing a small laceration located along the spinal scutes, just prior to the dorsal fin. Some bruising was also evident on the head, rostrum, and the edges of the larger fins (04/24/2020).

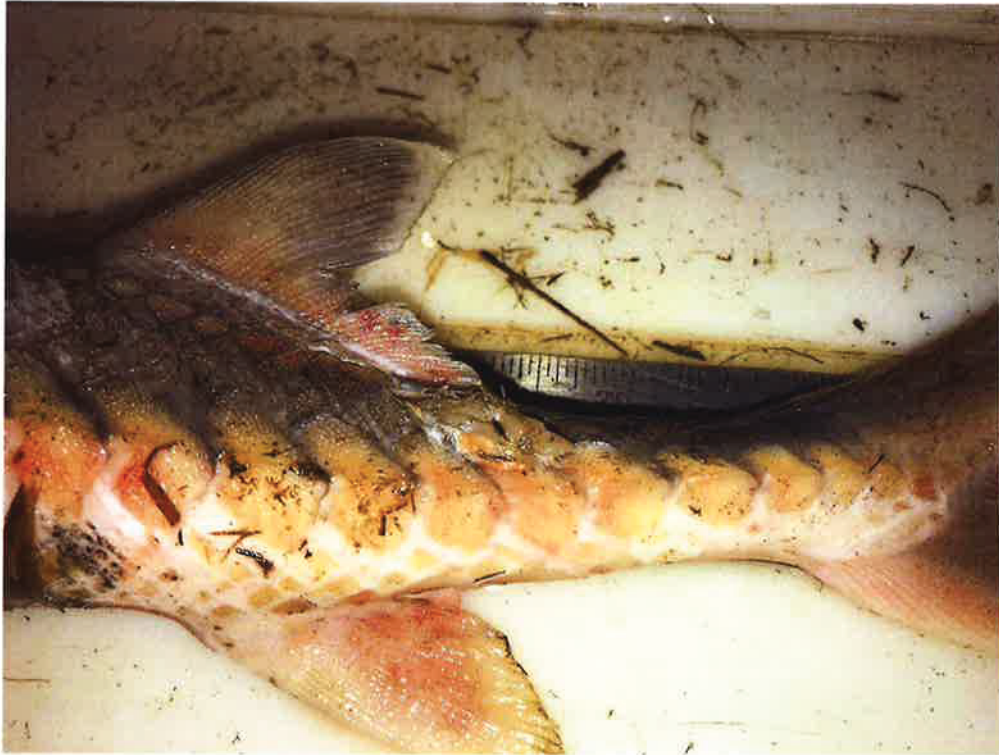
View of the upper caudal peduncle, showing the location of a small laceration or puncture wound immediately adjacent to the dorsal fin. Also shown in the photo is evidence of missing fin-rays on the dorsal fin, in what appears to be the location of a prior fin clip collection (04/24/2020).

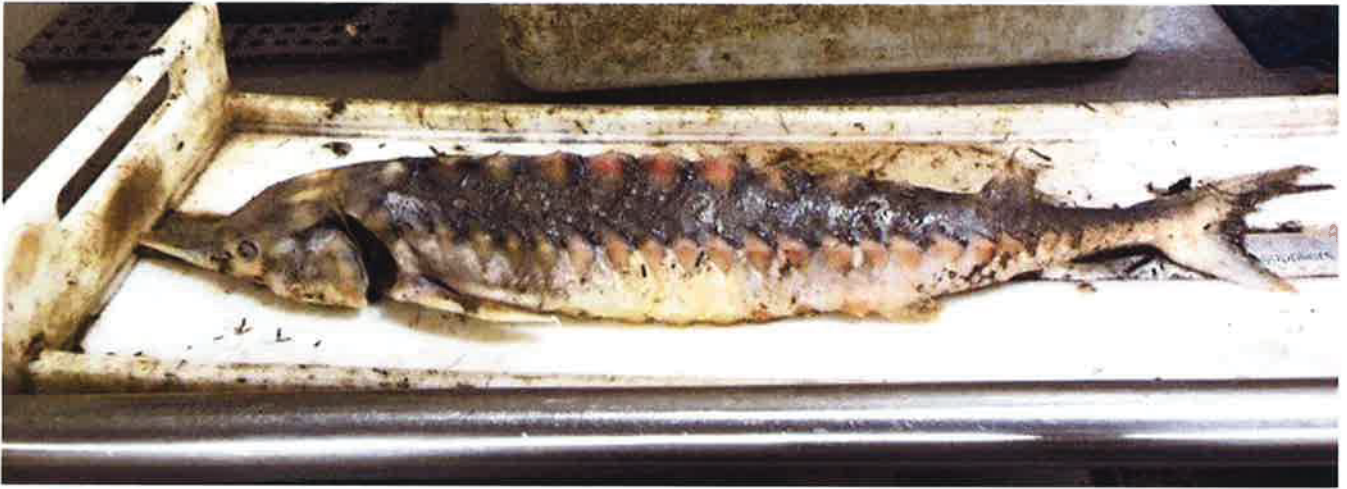
A dorsolateral view showing the size and condition of a second, deceased Atlantic sturgeon (*Acipenser oxyrinchus*), retrieved at approximately 09:50am on 04/24/2020 from the Salem Circulating Water Intake Structure by Salem Yard Crew personnel during routine trash rack cleaning at Salem Nuclear Generating Station (04/24/2020).

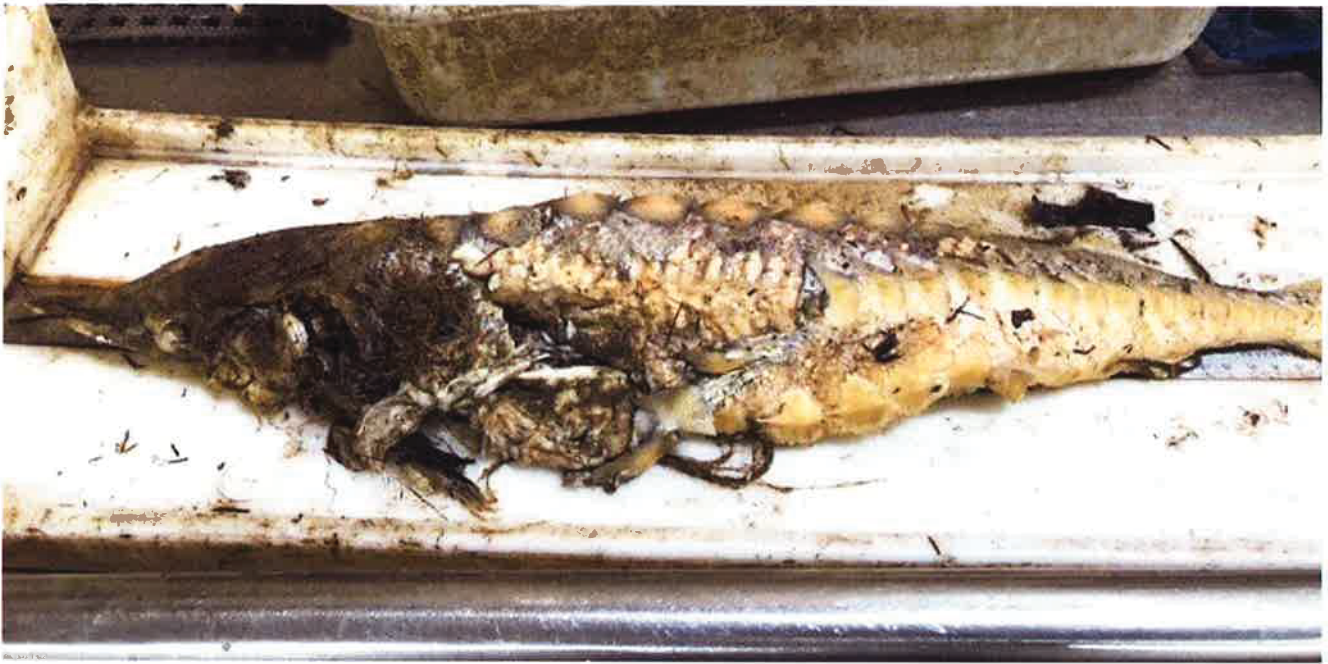
A dorsolateral view showing the size and condition of a third deceased, Atlantic sturgeon (*Acipenser oxyrinchus*), retrieved at approximately 10:15am on 04/24/2020 from the Salem Circulating Water Intake Structure by Salem Yard Crew personnel during routine trash rack cleaning at Salem Nuclear Generating Station (04/24/2020).

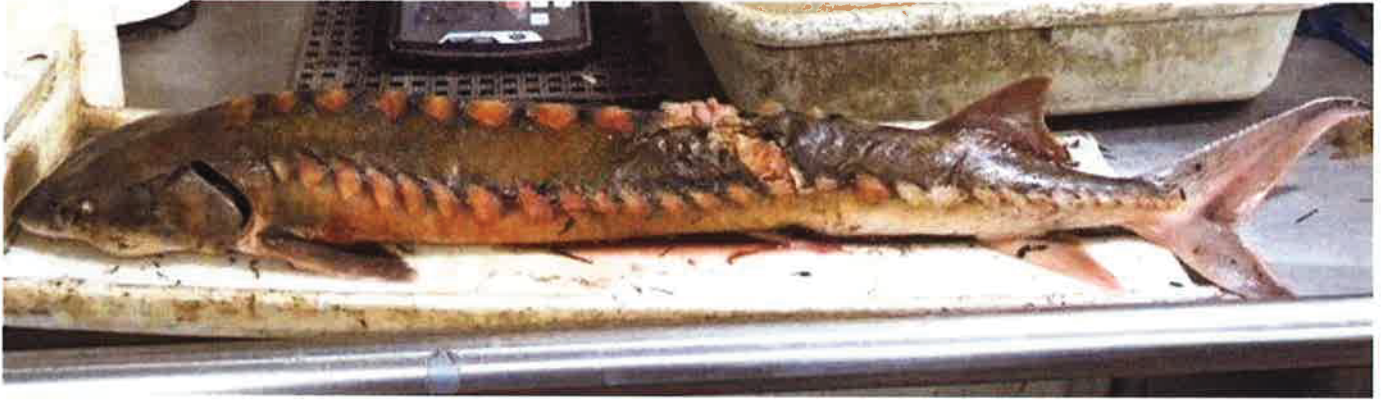
A dorsolateral view showing the size and condition of a deceased shortnose sturgeon (*Acipenser brevirostrum*), retrieved from the Salem Circulating Water Intake Structure on (04/24/2020) at approximately 10:15am by Salem Yard Crew personnel, during routine trash rack cleaning (04/24/2020).

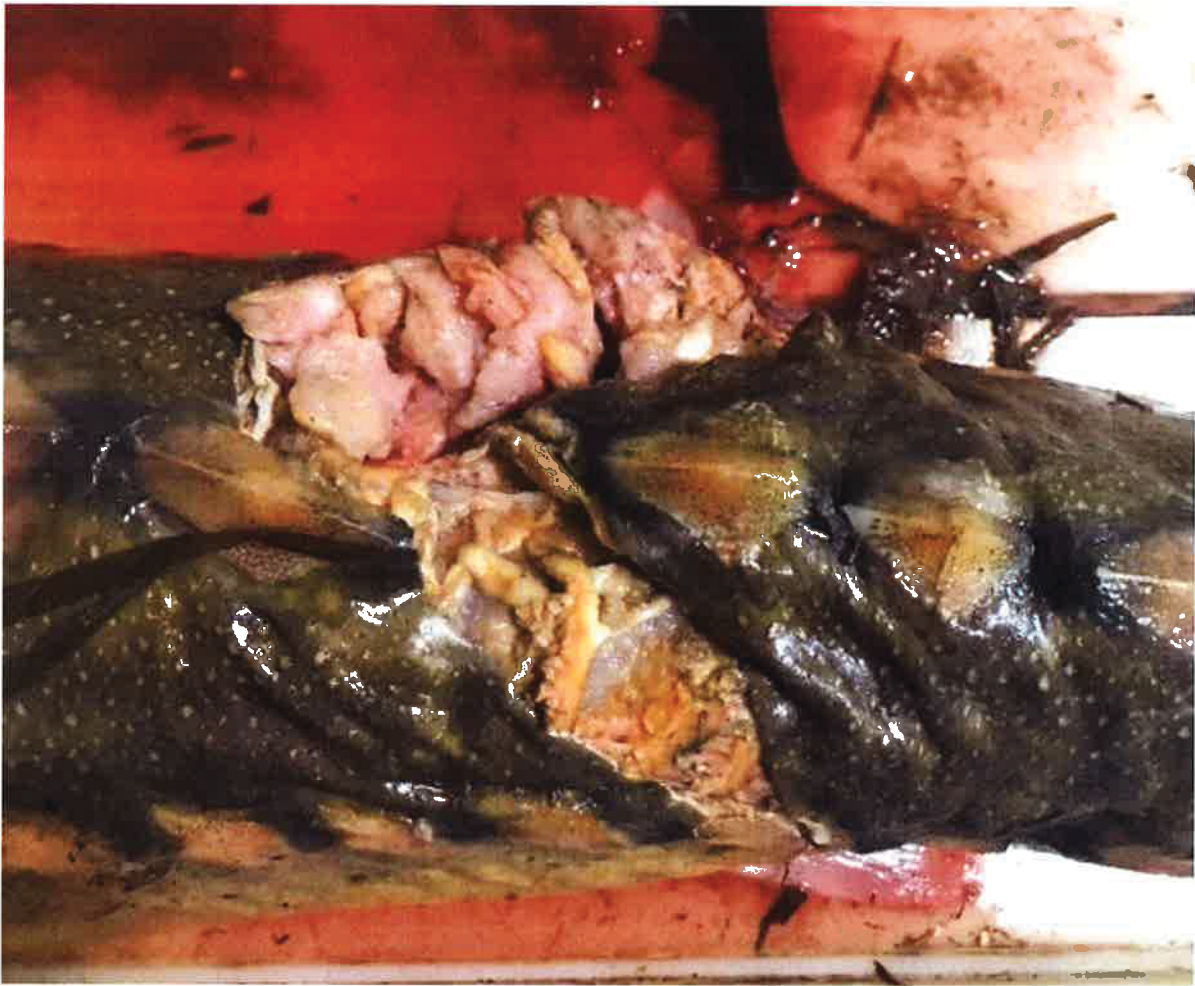
A dorsal view of the specimen, showing the extent of damage caused by a large laceration extending across the specimen's back, at approximately mid-torso. The existence of a quantity of blood indicated the wound was likely fresh (04/24/2020).
