NUREG/CR-3863  
SAND84-1264  
RV

# Assessment of Class 1E Pressure Transmitter Response When Subjected to Harsh Environment Screening Tests

David T. Furgal, Charles M. Craft, Edward A. Salazar

Sandia National Laboratories  
Albuquerque, New Mexico  
Operated by  
Sandia Corporation  
for the  
U. S. Department of Energy

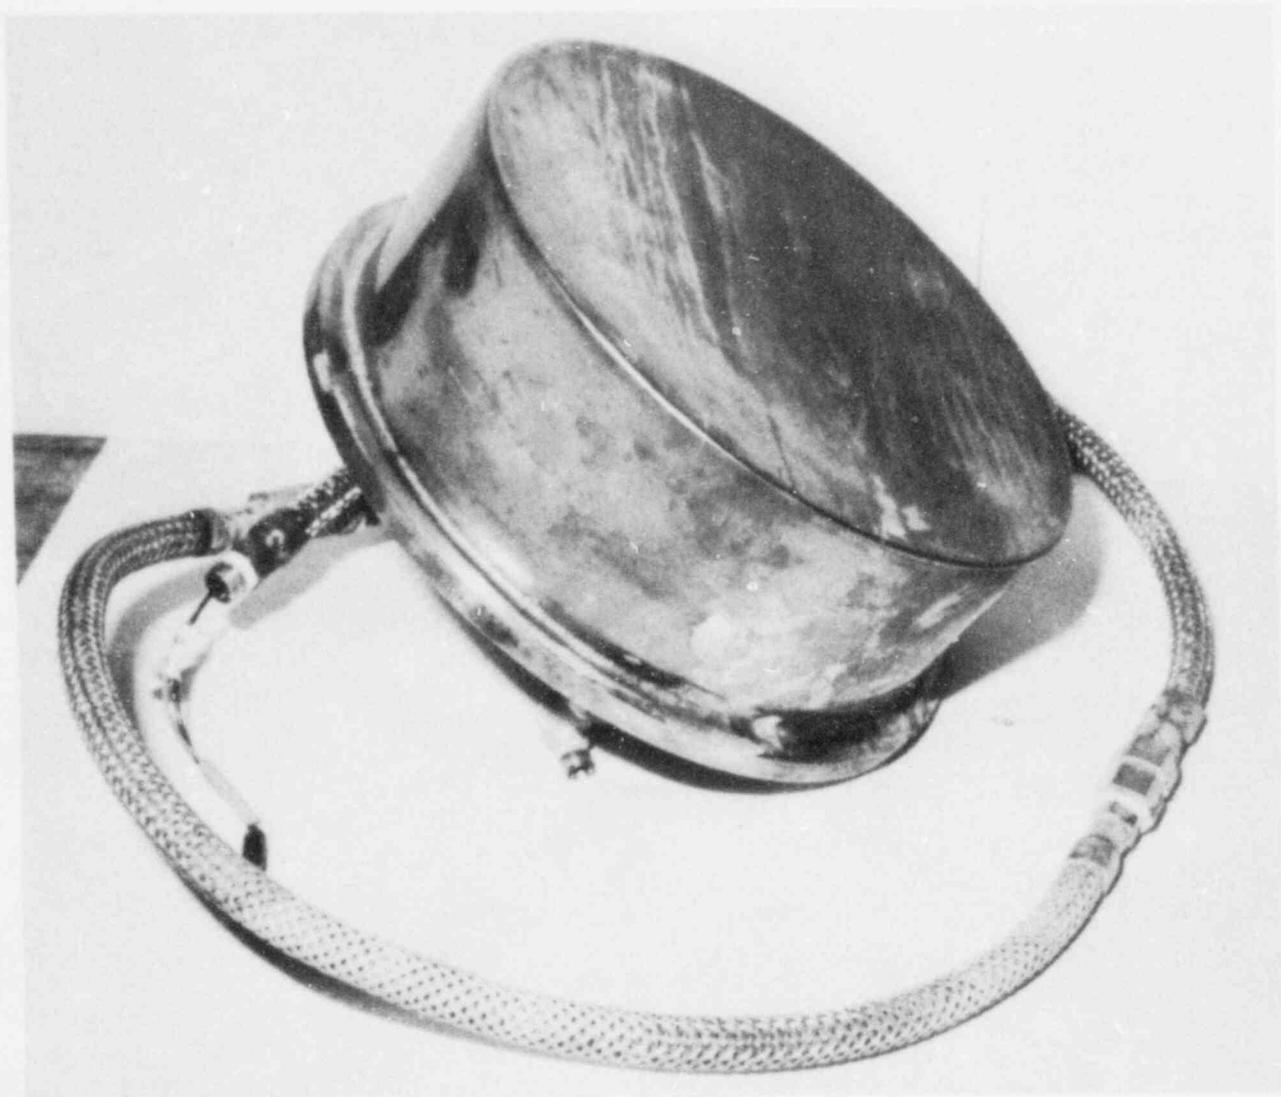
Figure 3-1 Transmitter T4 in Stainless Steel Enclosure

Transmitter T4 (S/N 1484) was exposed simultaneously to a Cobalt-60 radiation and a DBE LOCA temperature environment. To achieve the radiation and temperature (no steam) environment, the transmitter was sealed inside a stainless steel enclosure (see Figure 3-1) that was in turn placed inside the steam chamber located in the radiation cell. Radiation exposure was approximately 482 megarads (air) TID at 603 kilorads per hour. For the chamber inside the radiation cell, the LOCA exposure lasted 33 days.

During post-test inspection, we found that the seal between the transmitter and the stainless steel enclosure shown in Figure 3-1 had failed, allowing water to enter the enclosure. Therefore, the intended objective--to isolate the transmitter from the steam environment--was not maintained throughout the entire test sequence (see Section 10.5).

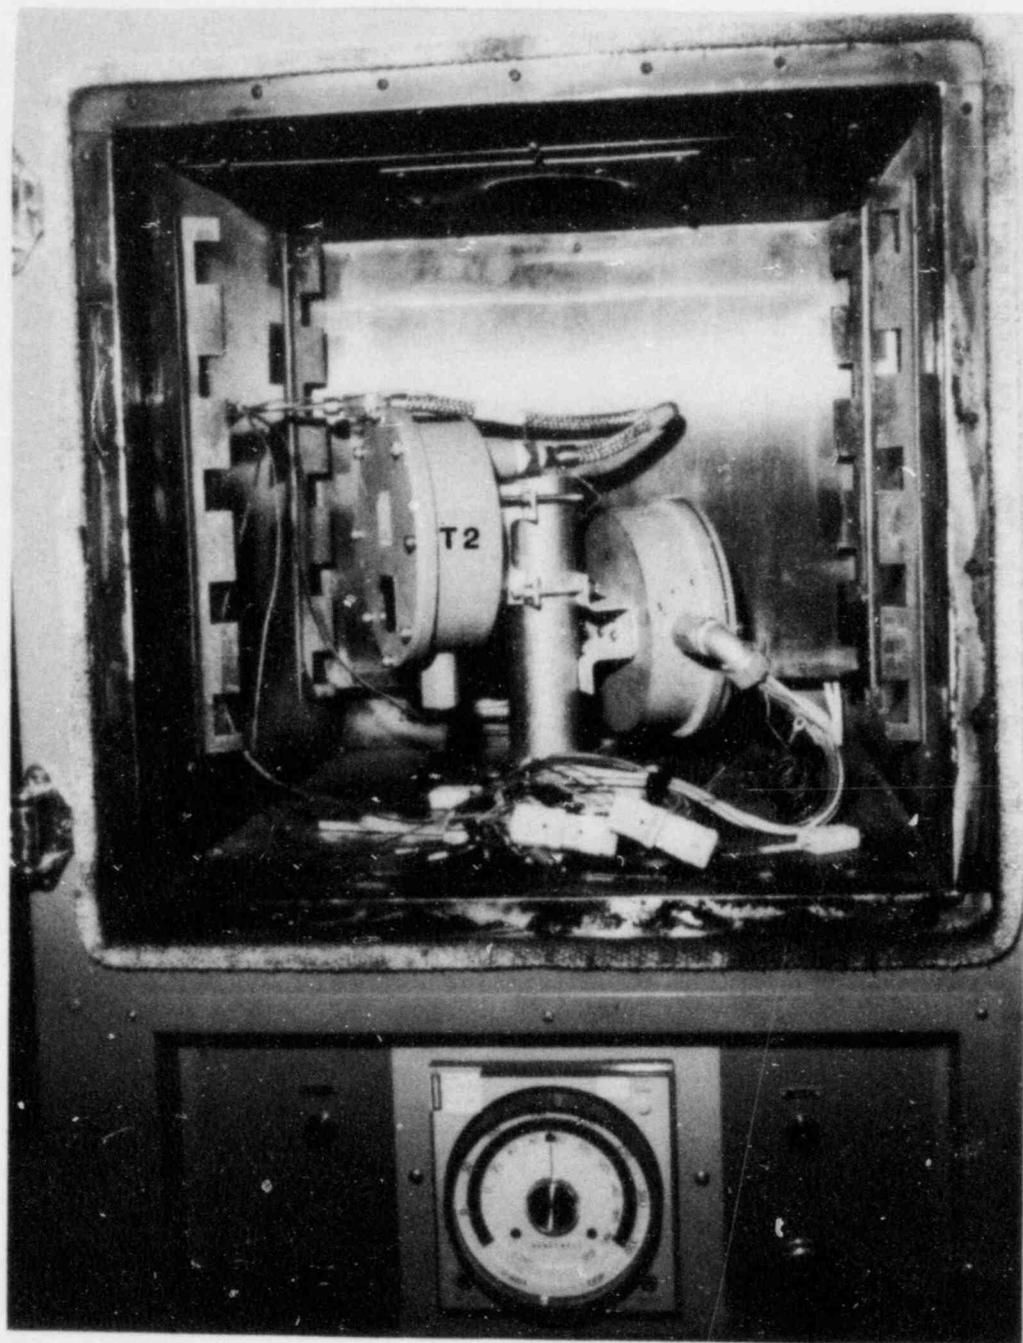
Figure 4-3 Transmitter T2 Test Configuration. The second transmitter shown was modified to allow thermocouples to be inserted and was used only to monitor temperatures of electronic components inside the transmitter. It served no other purpose in this test.

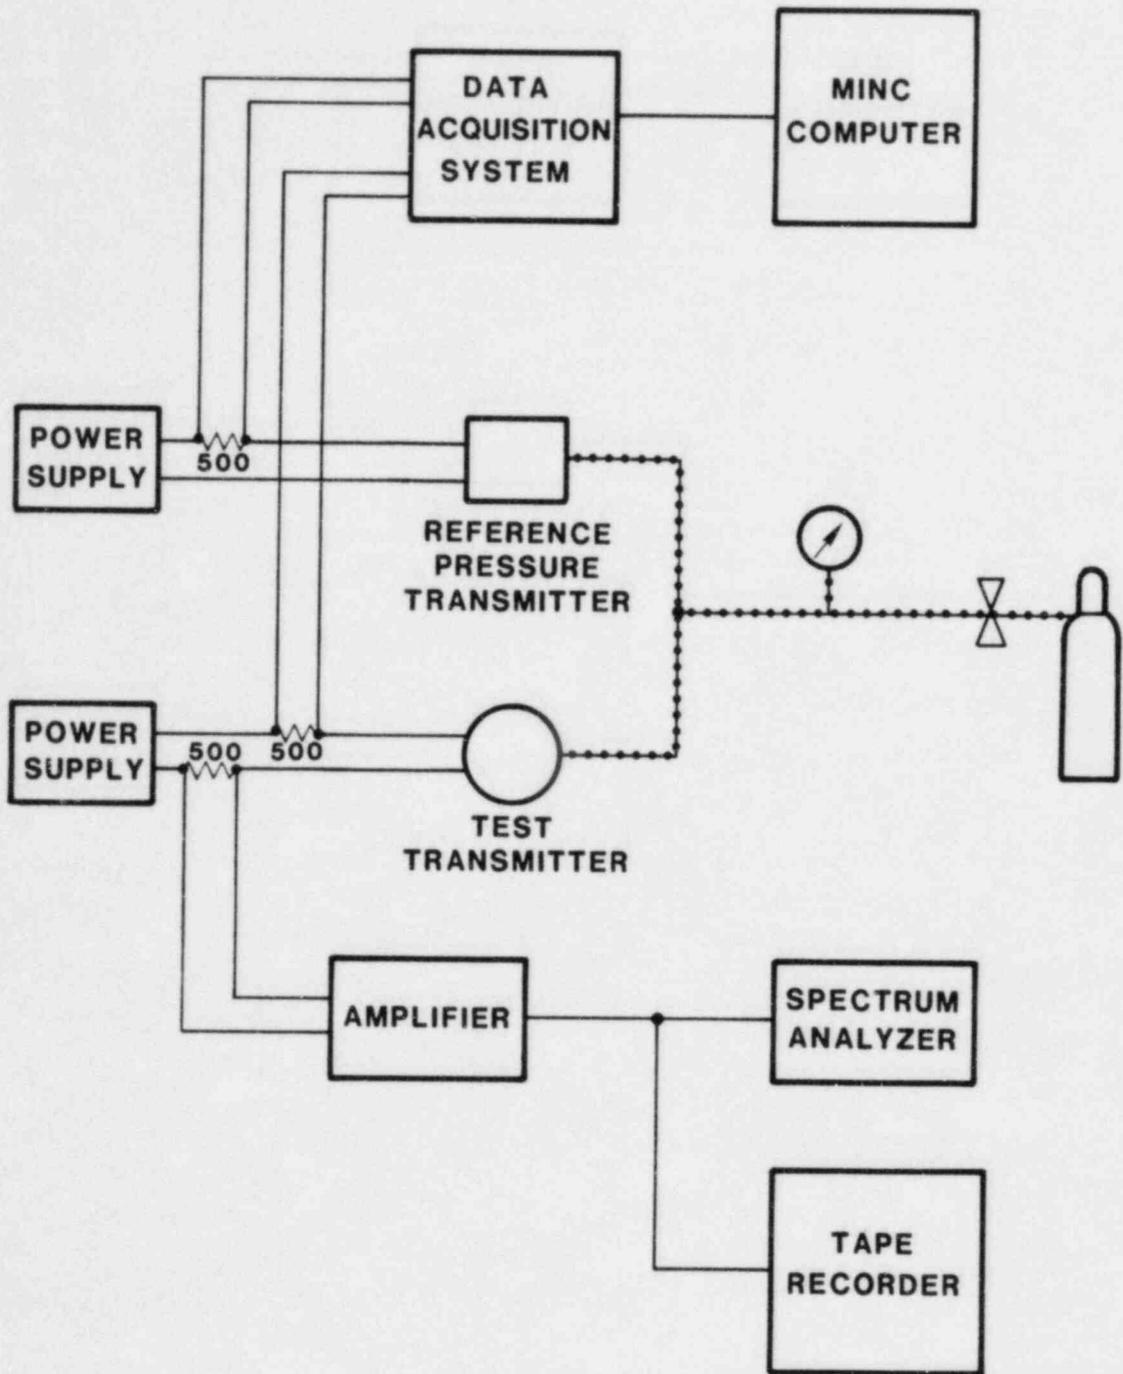
Figure 4-4 Test Configuration Schematic

The test configuration of each transmitter is shown schematically in Figure 4-4. The pressure transmitters were connected in series to two 500-ohm (nominal) resistors and a 40 volt dc power supply. The current in the instrumentation loop was monitored by measuring the voltage drop across one of the 500-ohm resistors. The voltage appearing across the second resistor was connected to the input of an ac-coupled EG&G PAR Model 103 adjustable gain amplifier to obtain circuit noise data. The amplifier outputs from all five transmitter circuits were recorded using a Honeywell 101 Wideband II FM recorder. Noise data in the dc to 25 kHz frequency spectrum was simultaneously viewed on a Hewlett Packard Model 3532 fast Fourier transform spectrum analyzer. Analysis of the noise data is not included in this report.

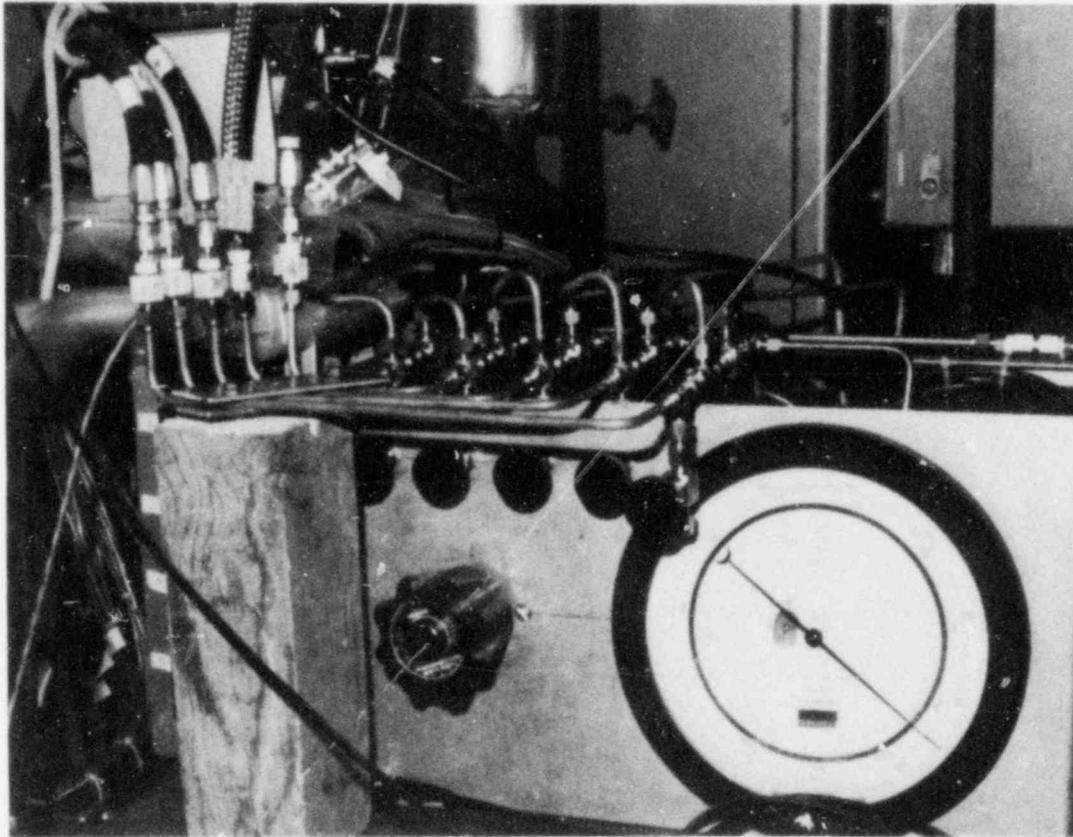
Figure 4-5 Pressure Station

The test pressure applied to the sensing element of each transmitter was controlled by a pressure station. That pressure station, shown in Figure 4-5, consisted of a valving network which connected a pressure header to each transmitter's pressure port. A main pressure regulator allowed adjustment of header pressure between 0 and 1000 psig. The valving at the pressure station allowed each transmitter to be independently pressurized, vented, and isolated from the pressure header.

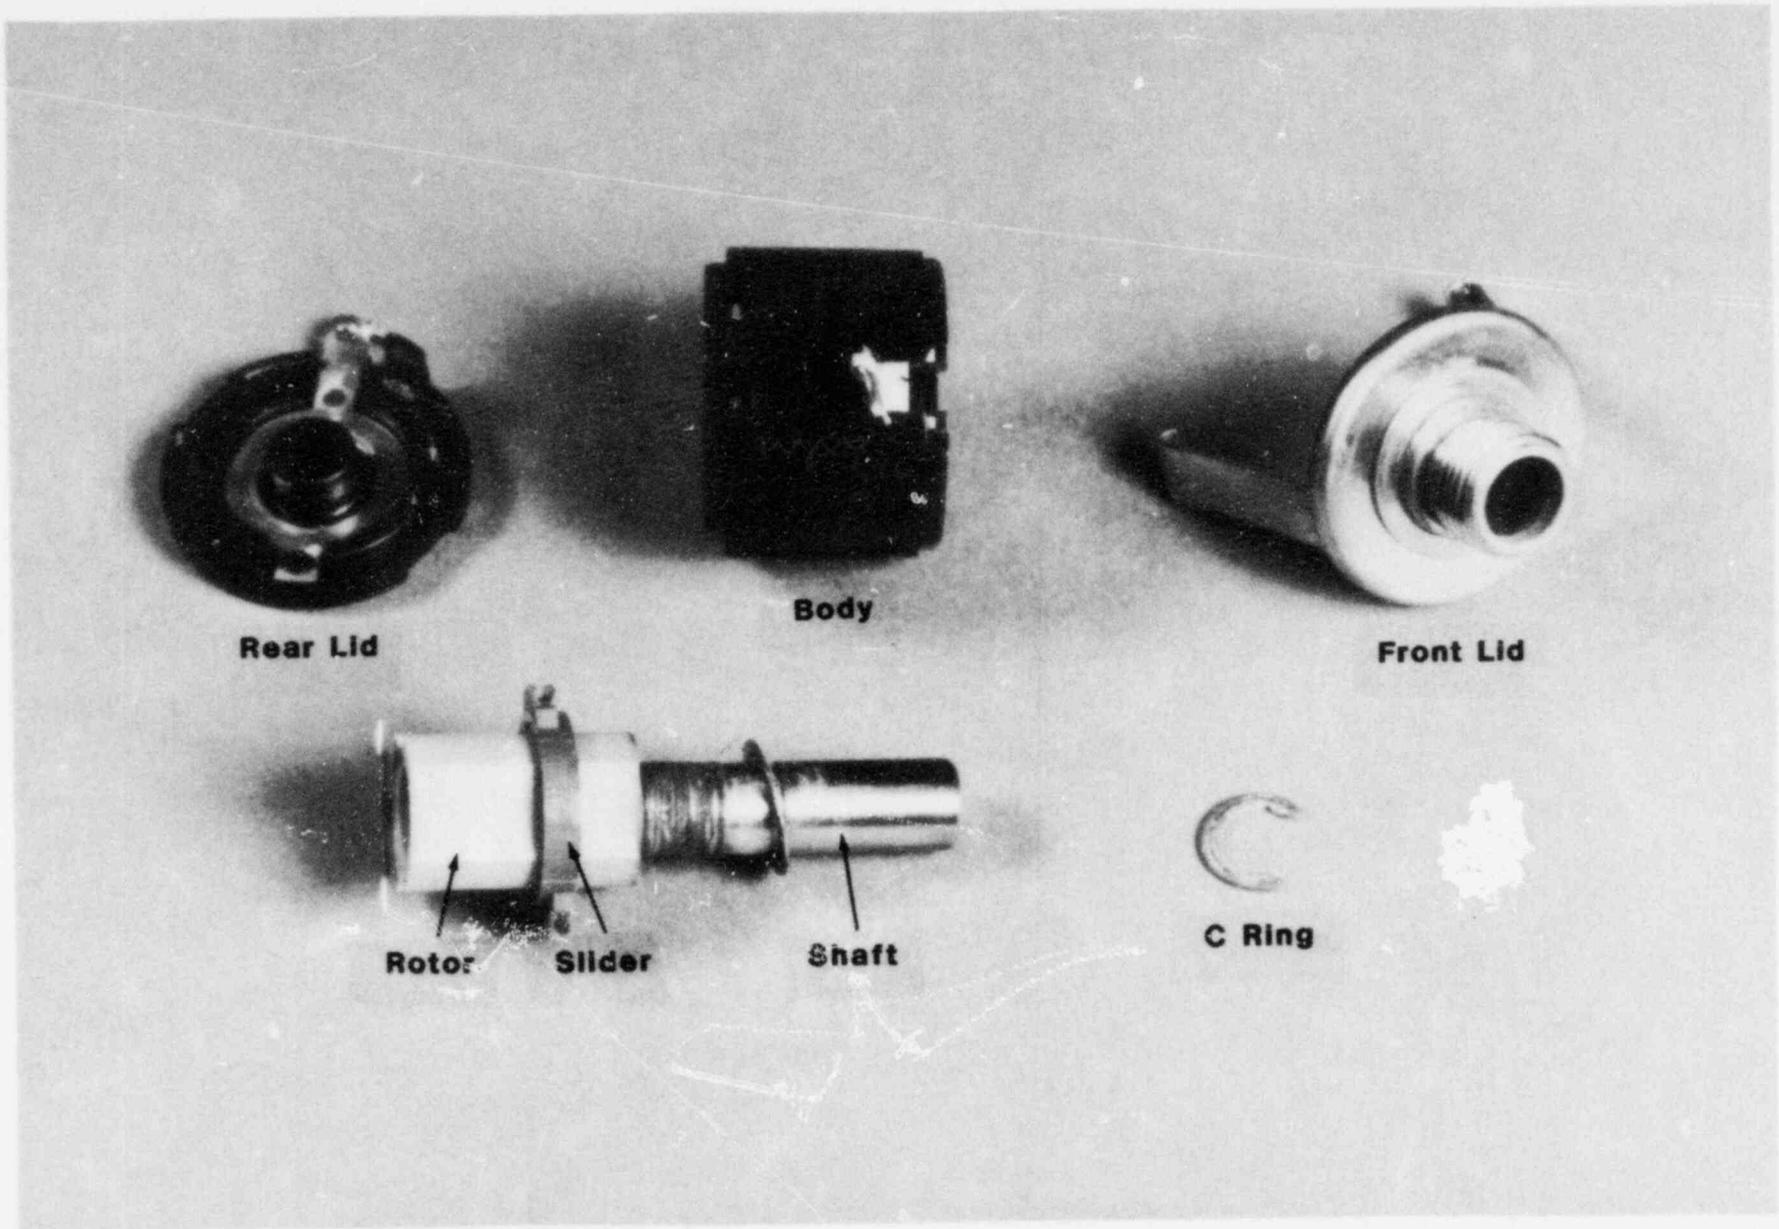
Figure 7-1 Disassembled Potentiometer From Transmitter T1

<u>Item</u>	<u>Materials</u>
Front Lid & Shaft.....	Stainless Steel with Nickel Plated Bushings
Body.....	Phenolic-Fiberite FM400S
Rotor.....	Nylon 6/10-Short Fiberglass Filled
Slider and.....	Nylon 6/6-25 percent Glass Spheres
Rear Lid	-15 % Short Fiberglass Filled
Terminals.....	Brass
Resistive Element	
100K.....	Moleculoy (Molecule Wire Corp.) 75% Ni, 20% Ca, 3% Al, 2% Co
2K.....	Evenohm (Amax Speciality Metals Corp.) 54% Fe, 29% Ni, 17% Co, less than 1% Mn
Mandrel.....	20 AWG heavy insulated Dupont polyimide
Resistive Element.....	BASD 36238-EP (Ball Bros.)
Lubricant	
Shaft Lubricant.....	Royco 27A Aircraft & Inst. Grease

Comments on two of these materials are pertinent. First, nylon is not the best material for use in dielectric applications above 150°C (300°F) [12]. Since nylon has a hydrogen-bonded molecular structure, it has a strong affinity to absorb moisture. Some of this absorbed moisture ionizes and at elevated temperatures, these hydrogen ions become more mobile. Consequently, the dielectric properties of the nylon decrease and more conduction can occur. However, at elevated temperatures, a competing process also occurs. Absorbed moisture is outgassed from the nylon causing a reduction in the ion concentration and an improvement in nylon dielectric properties. The desorption of moisture is relatively rapid, but slow in comparison to the increase in ion mobility. Thus when submitted to a rapid temperature rise, the dielectric properties of nylon initially decrease and then, if the elevated temperature is maintained, begin to improve. When the nylon is returned to lower temperatures, the reduced ion mobility plus the now lower ion concentration combine to give improved dielectric properties over those that existed before the exposure to elevated temperature. Since the moisture content of the nylon is the result of an equilibrium process, the desorption of moisture is not permanent and at lower temperatures a reabsorption of desorbed moisture occurs. This process is slow in comparison to the elevated temperature desorption process, but eventually tends to restore equilibrium amounts of absorbed moisture and hence the initial equilibrium values of dielectric properties. Thus the dielectric properties of nylon are dependent upon temperature and temperature history [12].

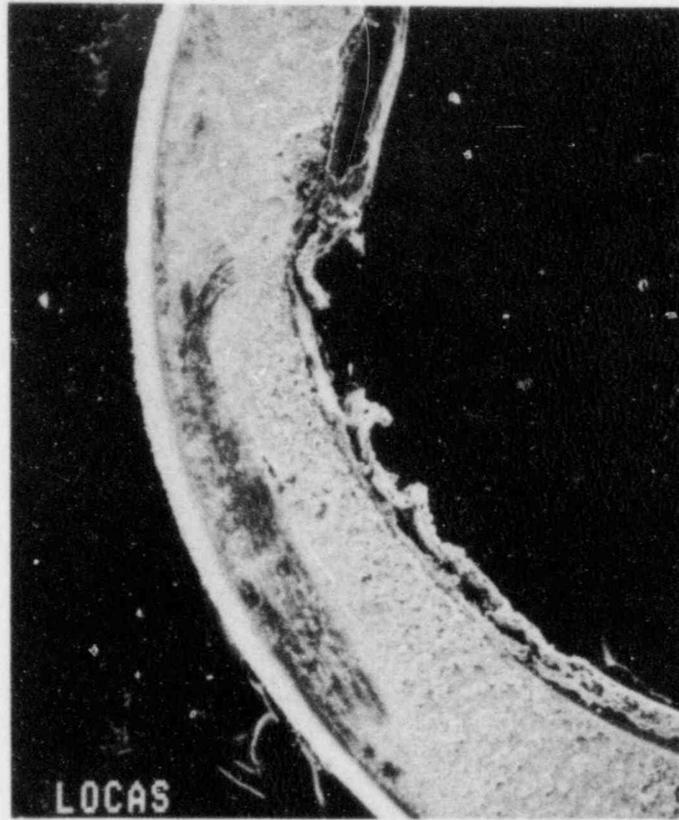
Figure 9-1 Scanning Electron Micrograph (SEM) of C-Ring (20x)

The failed potentiometer was disassembled and inspected. The most observable macroscopic features were: (1) the buildup of a whitish powder on the C-ring and (2) appearance of a dark residue on the shaft, the front of the rotor assembly, the flat washer, and mounting lid. Residue samples were analyzed by laser raman microprobe technique and scanning electron microscopy. Figures 9-1 and 9-2 show a scanning electron micrograph (SEM) at 20x magnification of the C-ring and its energy dispersive X-ray analysis (EDXA) spectrum, respectively. Figures 9-3 and 9-4 show an SEM of the flat washer at 20x magnification and its EDXA spectrum, respectively. Of note is the appearance of chlorine, sulphur and potassium on the C-ring.

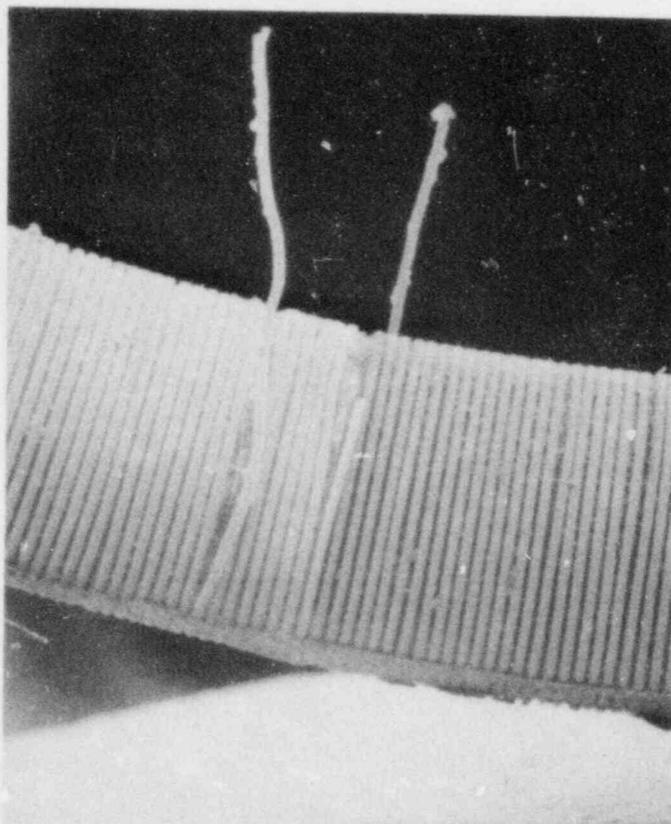
Figure 9-5 SEM of the Break Occurring in the Active Circuit  
Portion of the Potentiometer Resistive Element  
(40x)

We also found that the wire forming the potentiometer's resistive element had three breaks in it. One of these breaks had occurred in the portion of the winding that was part of the circuit, and two of the breaks had occurred beyond the set point of the slider and hence had no effect on the transmitter's operation. Figure 9-5 is a SEM at 40x magnification of the break occurring in the active portion of the resistive wire. The protrusion of the resistive element wire from the mandrel wire was not the result of the breaking process, but rather was caused by the analysis procedure. Figure 9-6 shows a SEM end view of this break at 2000x magnification. An EDXA elemental analysis spectrum of this break is shown in Figure 9-7. For comparison purposes, a good section of the resistive element wire was manually stressed to the ductile fracture point. The 2000x magnification SEM end view of this break is shown in Figure 9-8 and the corresponding elemental analysis is shown in Figure 9-9. Comparing Figures 9-6 and 9-8, we see that the character of these two breaks is different. As expected, the elemental analyses show

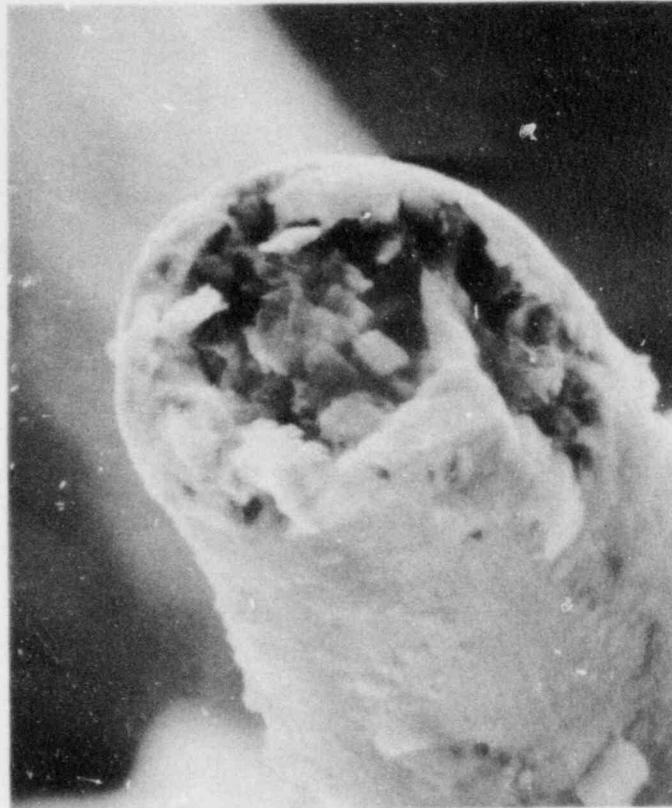
Figure 9-6 SEM of the Wire Cross Section From the Test-Induced Break Occurring in the Active Portion of the Potentiometer Resistive Element (2000x)

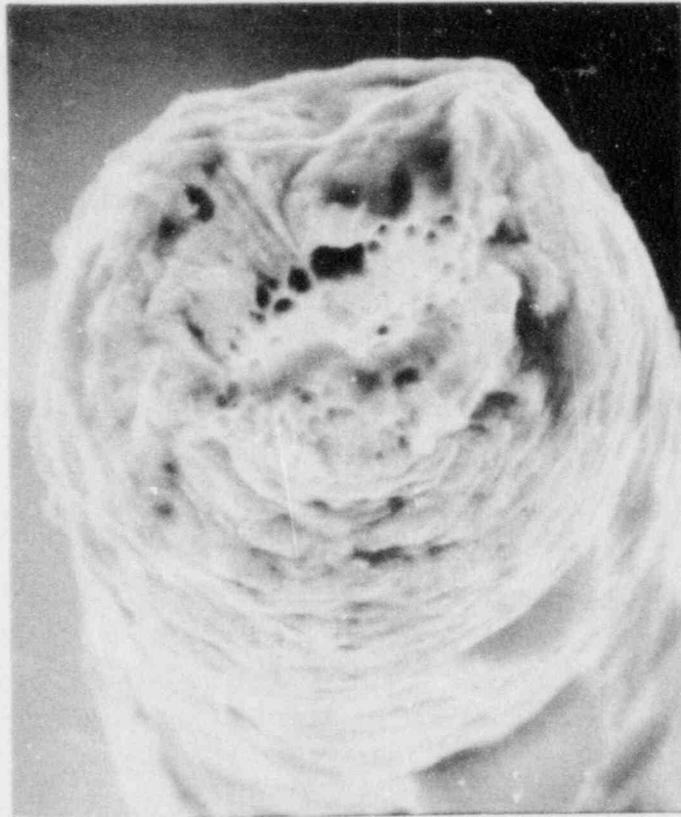
Figure 9-8 SEM of the Wire Cross Section Resulting From the Ductile Fracture of an Intact Portion of the Potentiometer Resistive Element (2000x)

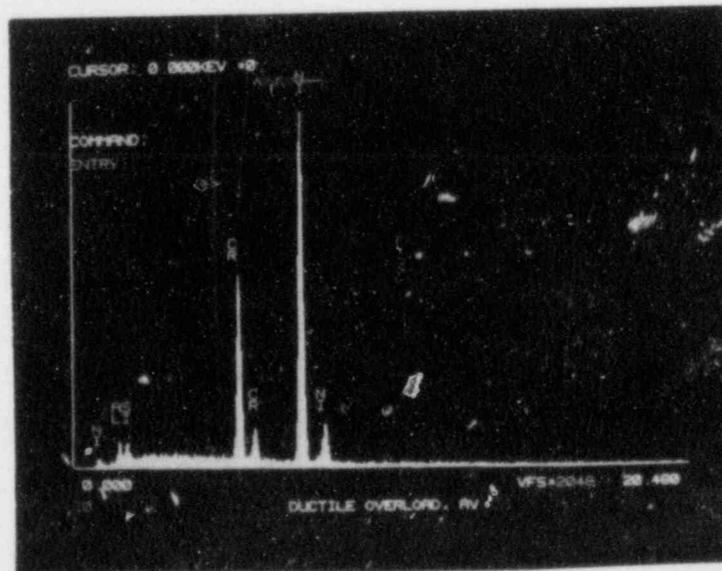
Figure 9-9 Elemental Analysis of Ductile Fracture Break Wire End Shown in Figure 9-8

the major constituents of the wire which was 75 percent nickel, 20 percent chromium, 3 percent aluminum, and 2 percent cobalt [17]. In addition, the spectrum for the test-induced break shown in Figure 9-7 indicates the presence of chlorine, sulphur, and potassium.

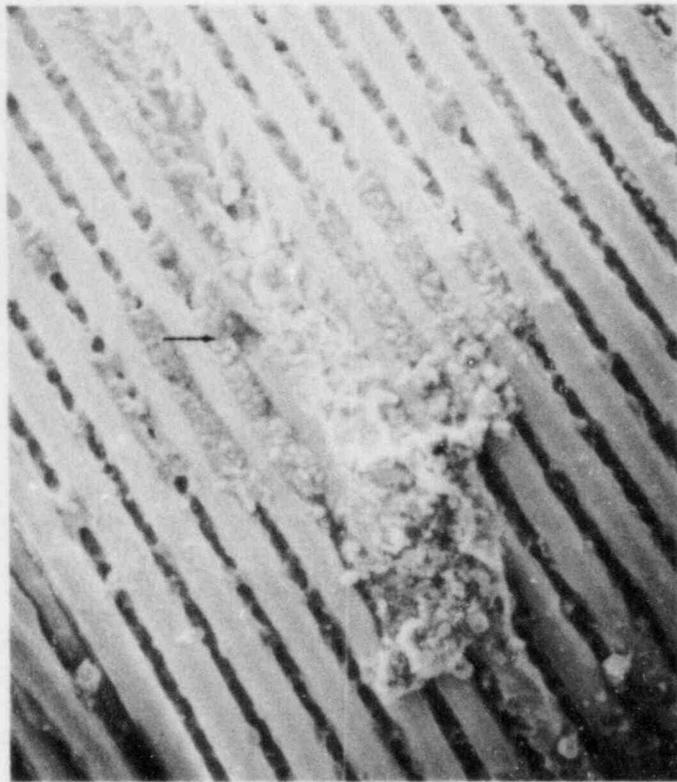
Figure 9-10 SEM of Foreign Material Found Near Wire Break Shown in Figure 9-5 (150x). Partially corroded winding is indicated by arrow.

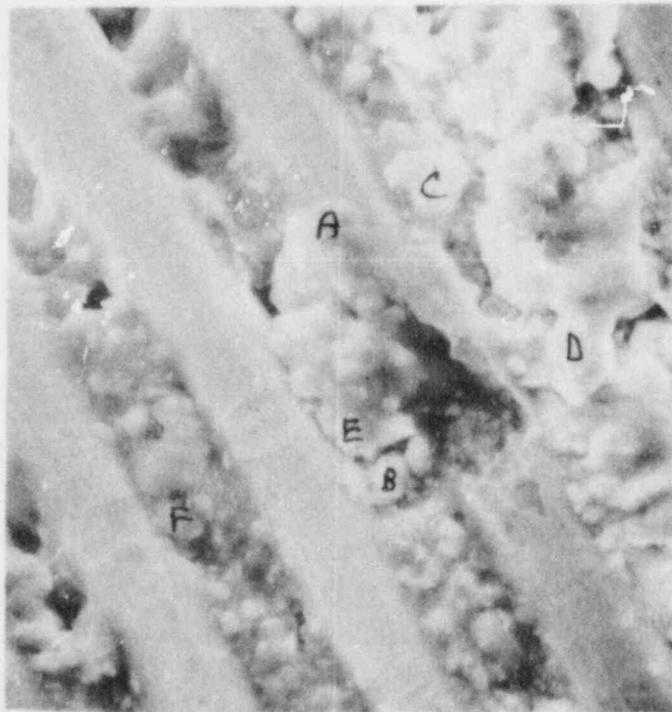
Figure 9-11 Enlarged View of Partially Corroded Winding Shown in Figure 9-10 (500x)

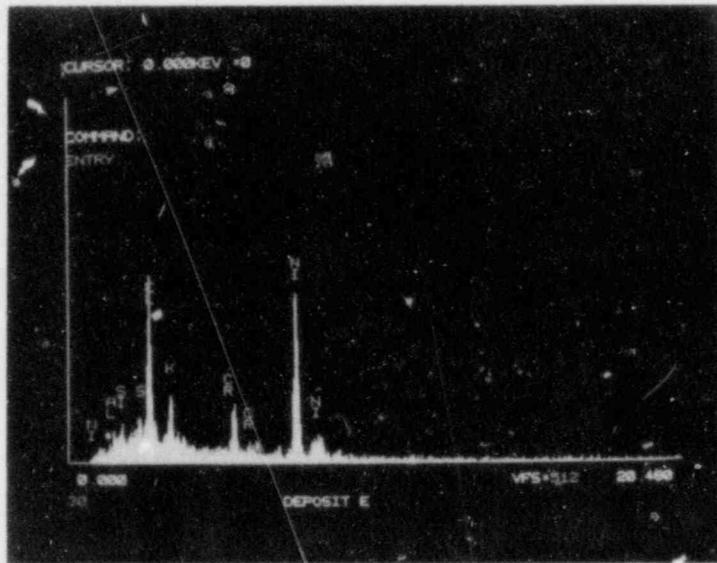
Figure 9-12 Elemental Analysis of Area E as Indicated in Figure 9-11

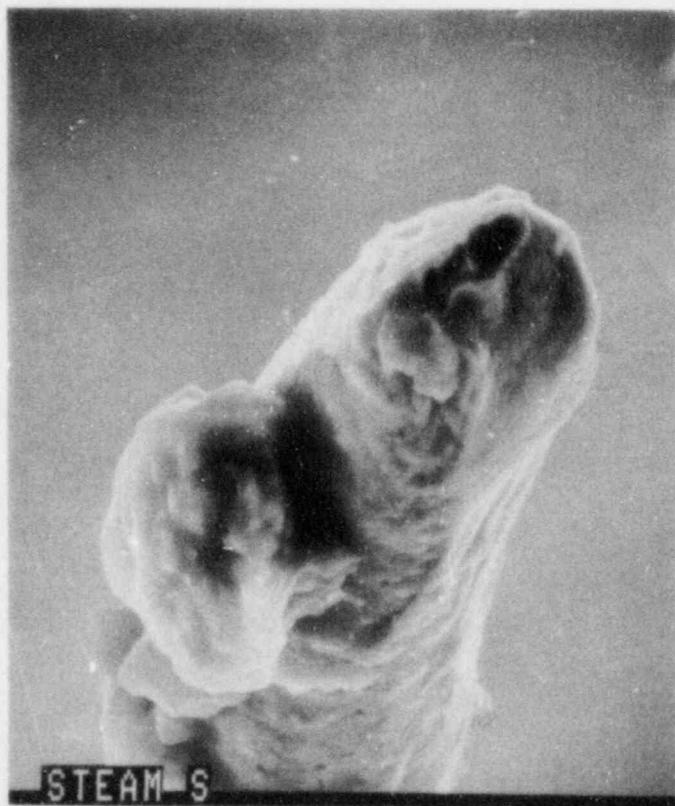
Figure 9-14 SEM End View of One of the Broken Wires Shown in Figure 9-13 (1500x)

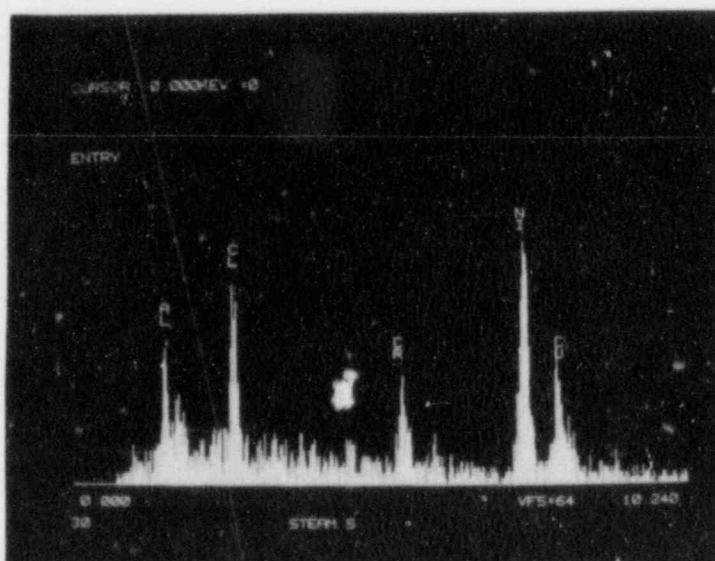
Figure 9-15 Elemental Analysis of One Portion of the Break Area Shown in Figure 9-13

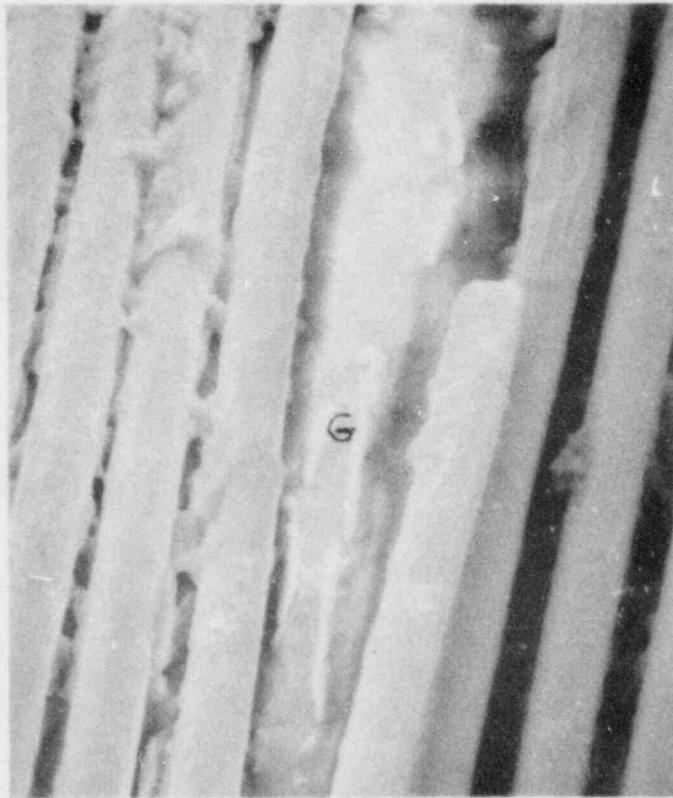
Figure 9-16 SEM of a Purposely Broken Segment of the Potentiometer Resistive Element

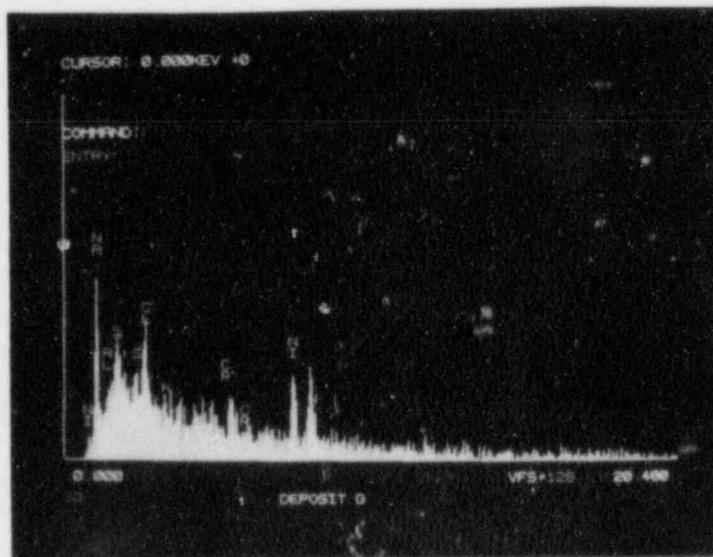
Figure 9-17 Elemental Analysis of Deposit Found Under the Wire Break Shown in Figure 9-16

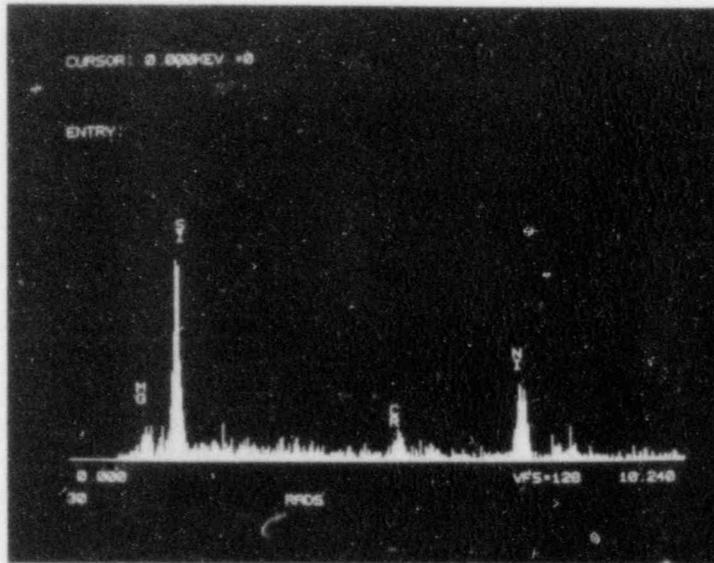
Figure 9-18 Typical Elemental Analysis of Non-Failed  
Potentiometers

and T5. The span and zero adjustment potentiometers from transmitters T3 and T5 were analyzed along with the zero adjustment potentiometer from transmitter T1. Scanning electron microscope analysis of these potentiometers showed no signs of corrosion; neither were concentrations of chlorine, sulphur or potassium found. EDXA analyses of these potentiometer windings (Figure 9-18) showed only high concentrations of silicon and small concentrations of manganese.

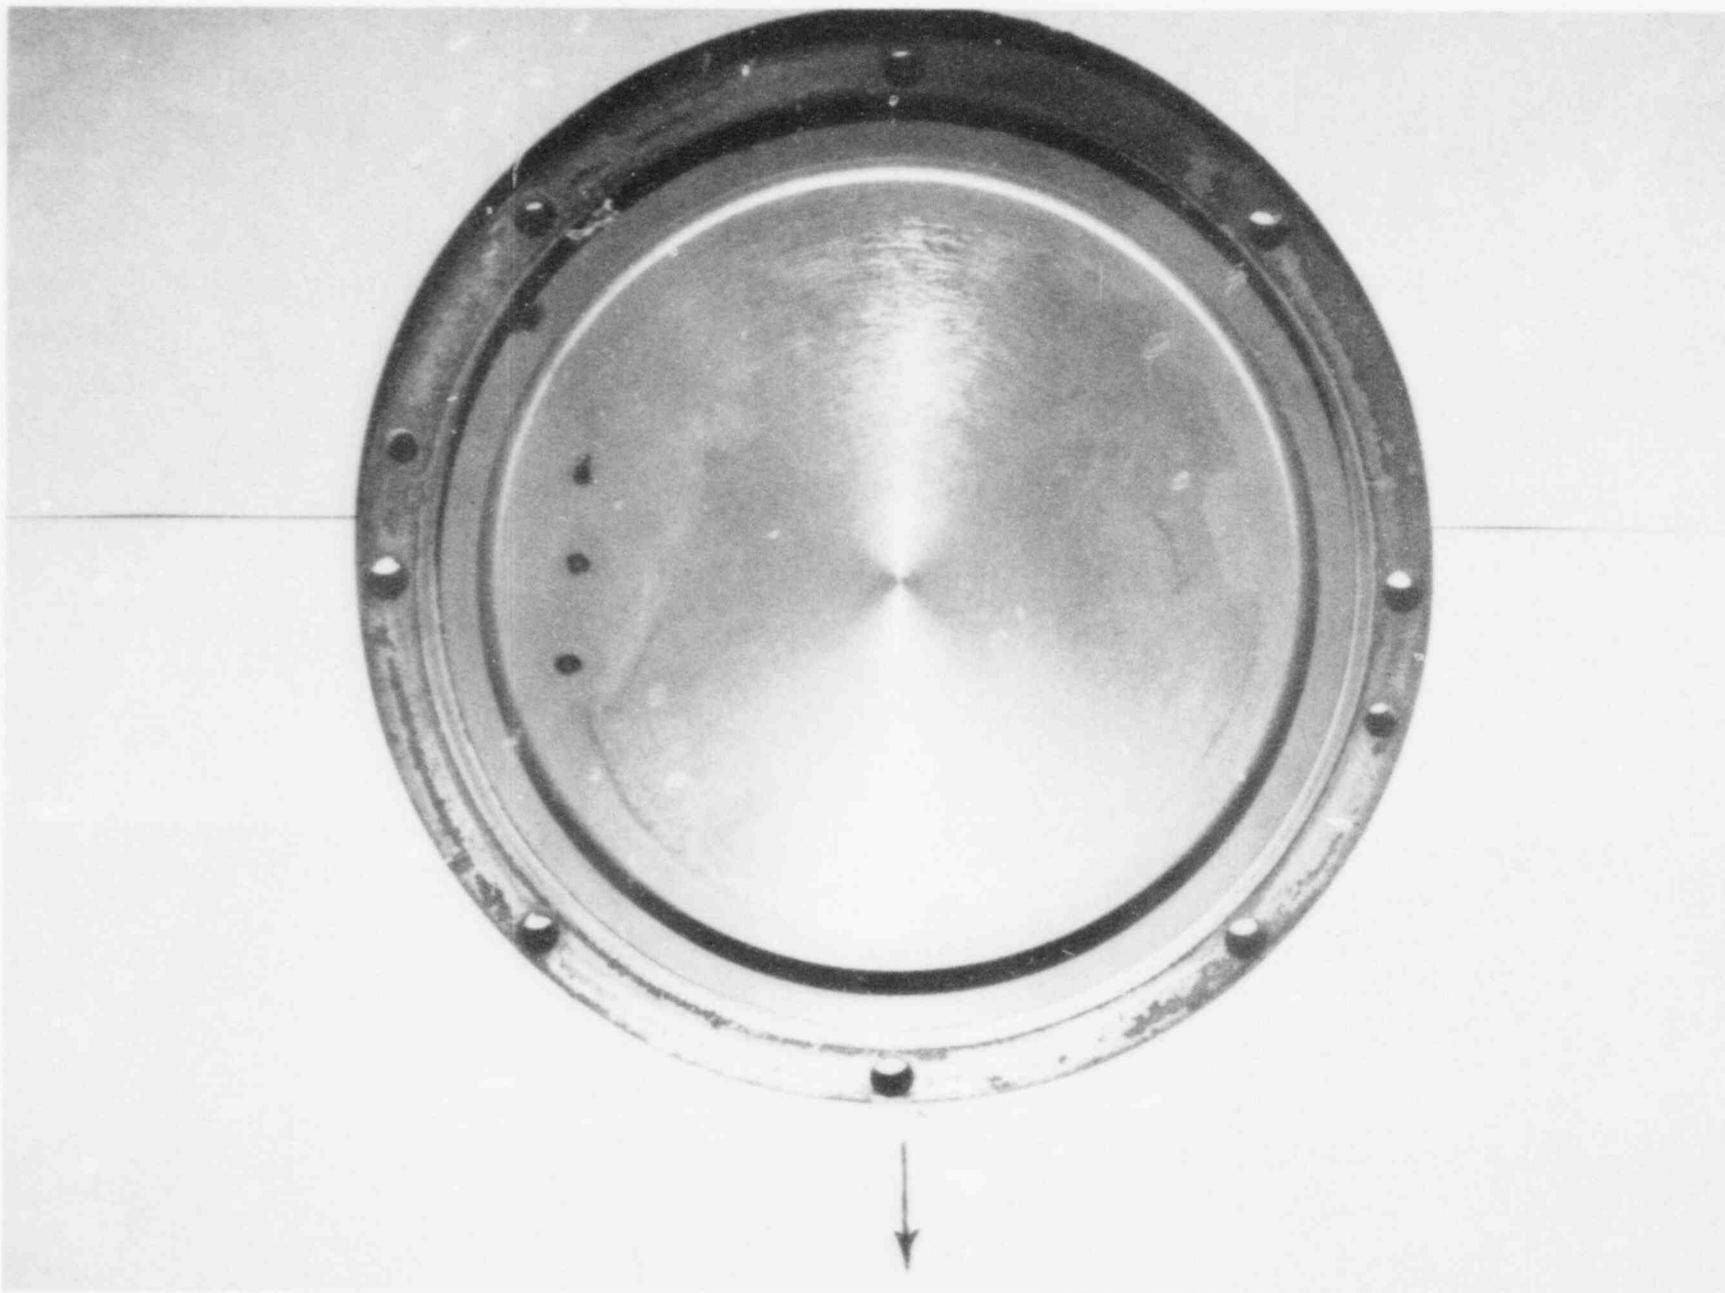
Figure 10-1 Transmitter T1 Cover Showing Moisture Intrusion

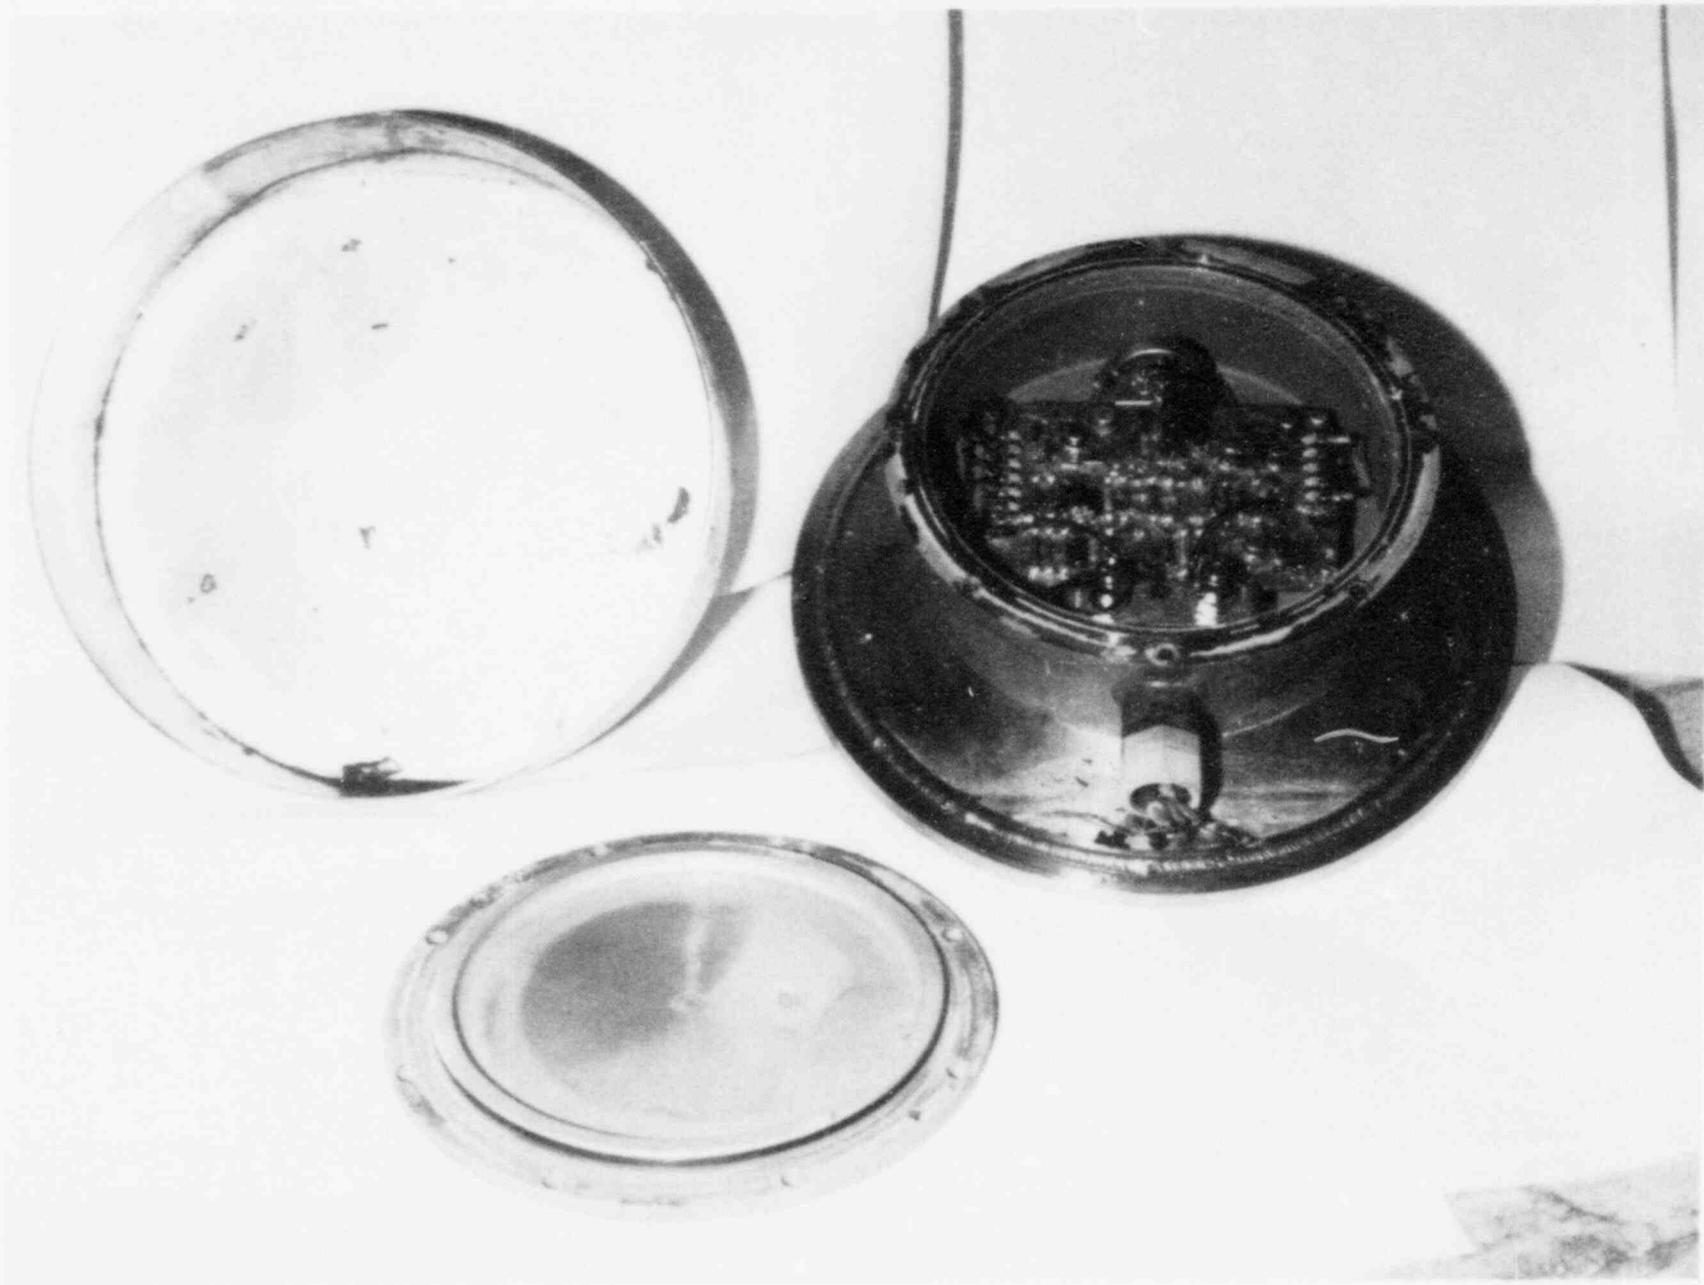
Figure 10-2 Transmitter T4 Cover Showing Moisture Intrusion

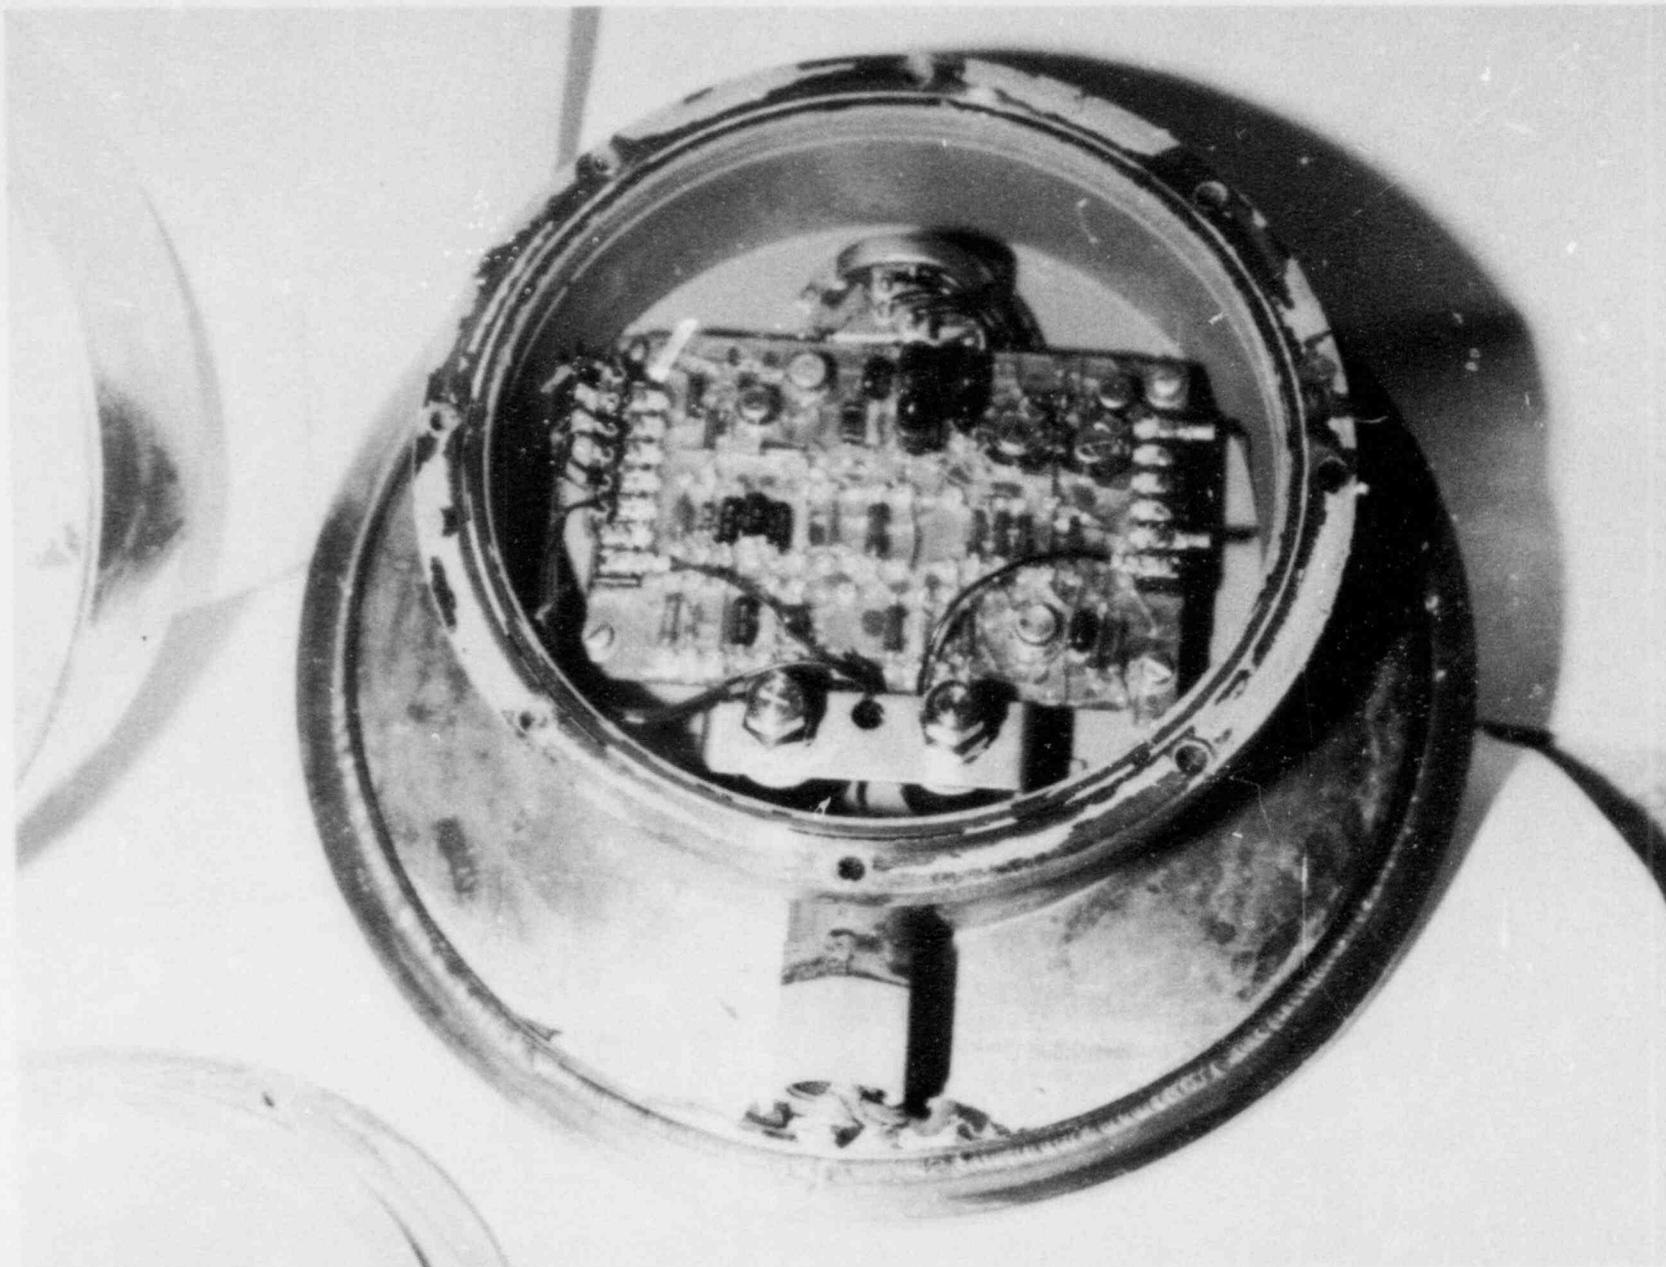
Figure 10-4 Transmitter T4 Showing Cracks in Circuit Board  
Conformal Coating
