NUREG/CR-3863  
SAND84-1264  
RV

# Assessment of Class 1E Pressure Transmitter Response When Subjected to Harsh Environment Screening Tests

David T. Furgal, Charles M. Craft, Edward A. Salazar

Sandia National Laboratories  
Albuquerque, New Mexico  
Operated by  
Sandia Corporation  
for the  
U. S. Department of Energy

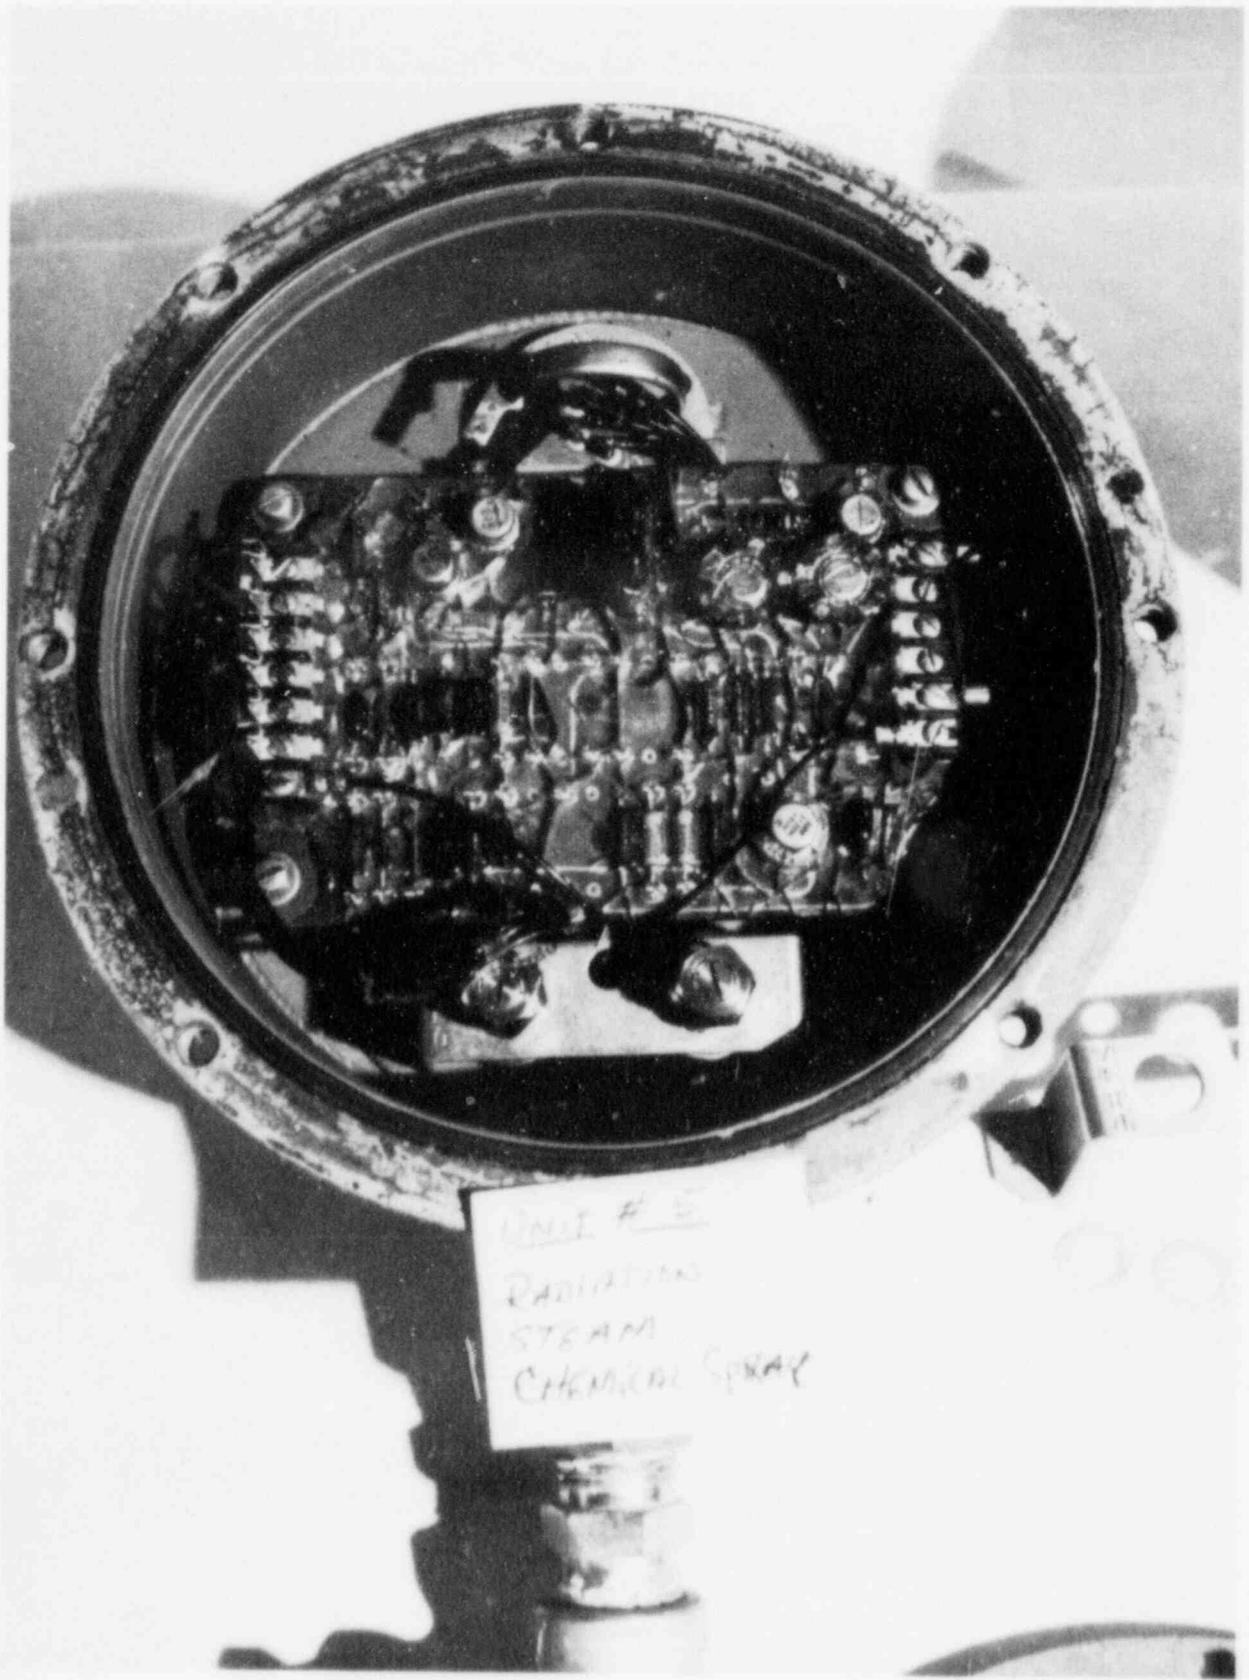
Figure 10-5 Transmitter T5 Showing Cracks in Circuit Board  
Conformal Coating

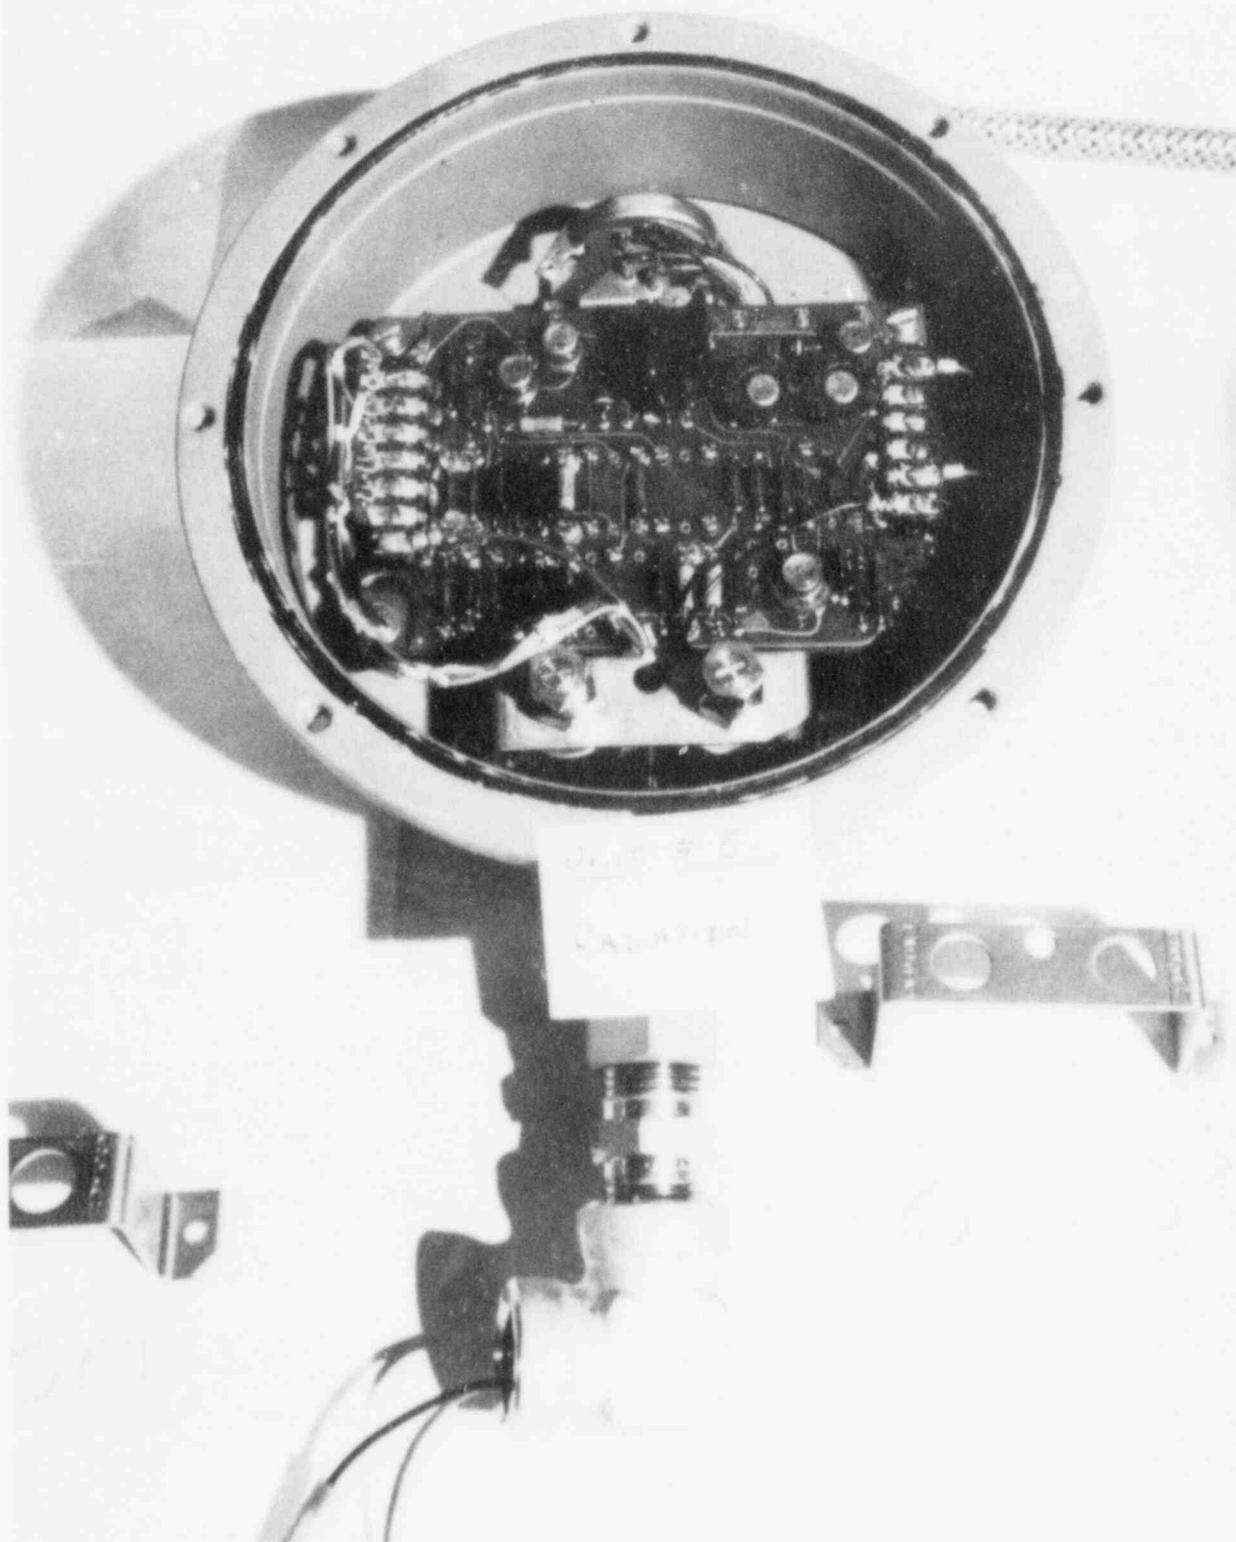
Figure 10-6 Transmitter T3 Showing Darkening of PC Board Material
