**PRAIRIE ISLAND INDEPENDENT SPENT FUEL STORAGE INSTALLATION**  
Docket No. 72-10  
Materials License No. SNM-2506

**Final Response to Bulletin 96-04**  
**Chemical, Galvanic, or Other Reactions in**  
**Spent Fuel Storage and Transportation Casks**

**Final Response to NRC Bulletin 96-04**

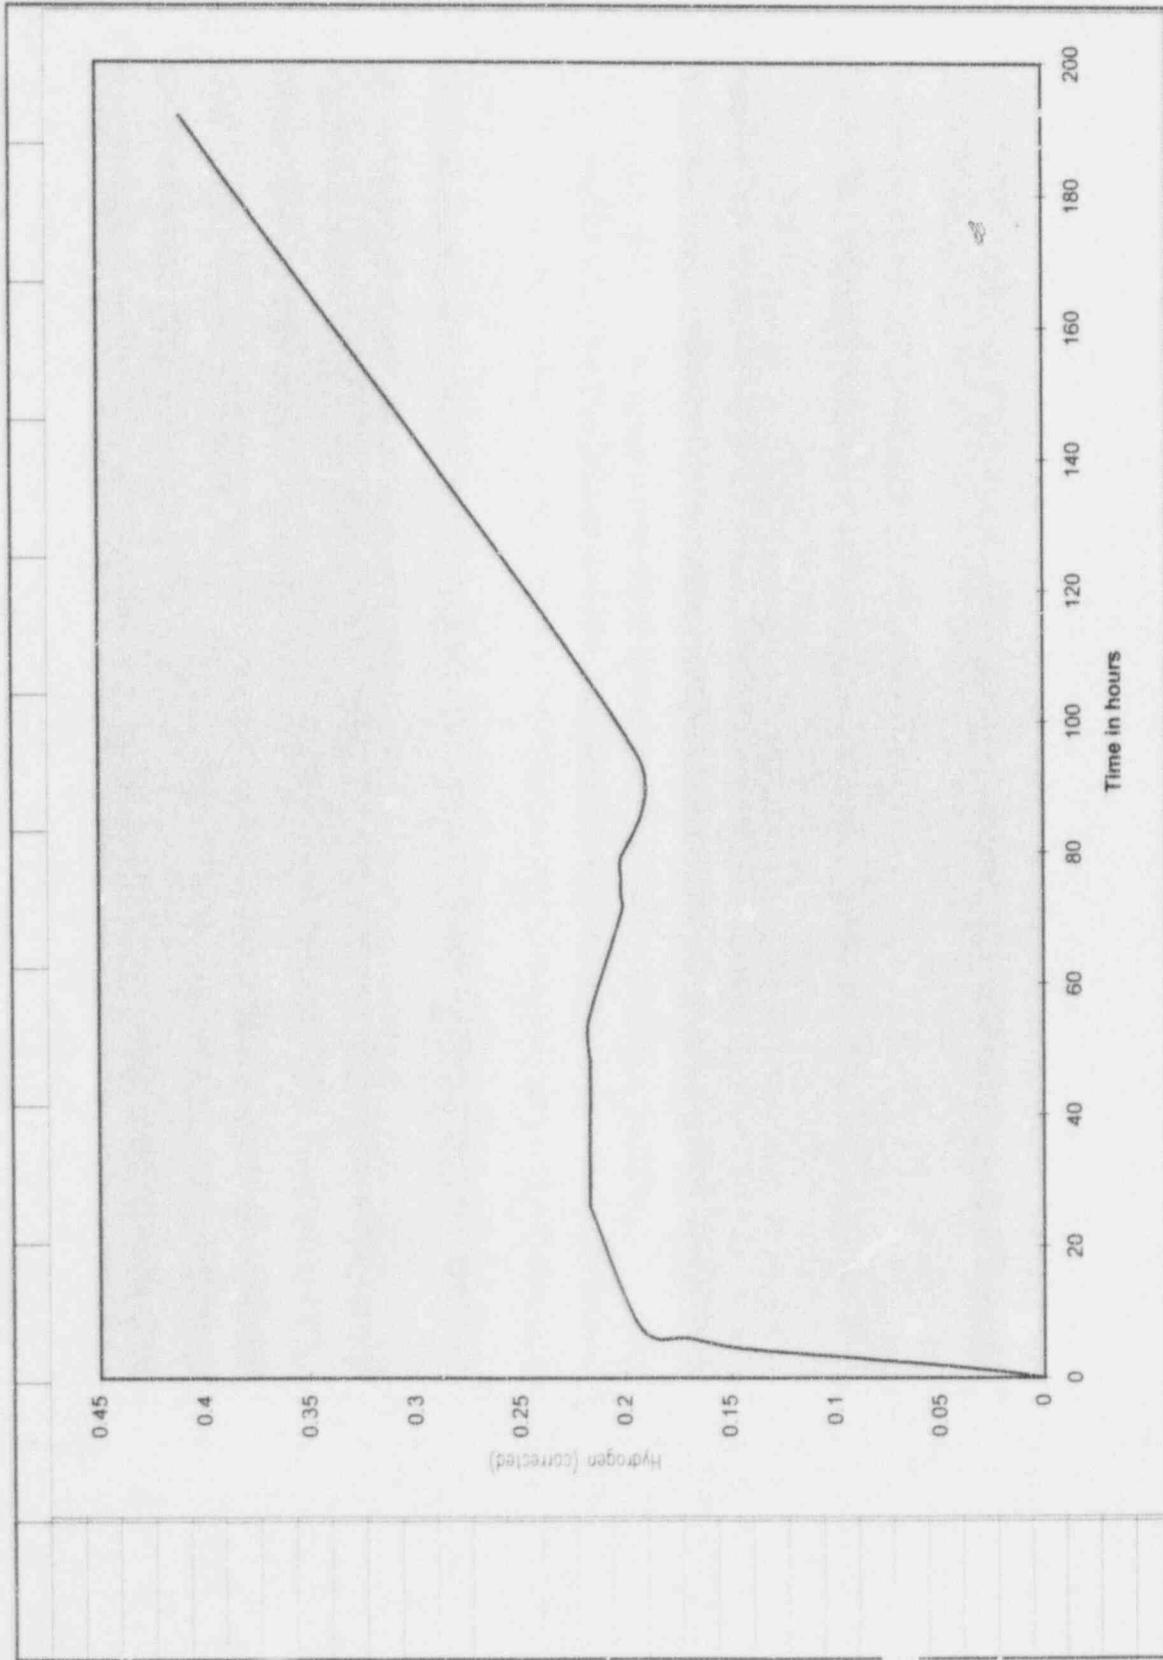
Graph 3

Table one presents the raw data as transcribed from the lab worksheet. The table also includes calculations for correcting the observed gas volumes. The corrections take into account changes in barometric pressure, the partial pressure of water vapor and temperature. A graph of this corrected data, over time, is also included.
