INSPECTION OF NUCLEAR REACTOR WELDING BY ACOUSTIC EMISSION

Final Report November 1974 through November 1977

GARD, Inc.

Prepared for U.S. Nuclear Regulatory Commission

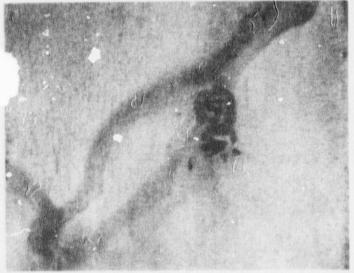
FIGURE A3. Porosity with Moderate Slag Entrapment at 21 Inches in Back Cover Pass 6 of Weld 14. Illustration Shows Closeup Radiograph of Flawed Area, Absolute Frequency Response, Tracing of Weld, Relative Frequency Response, Metallographic Section of Flawed Area
