IMPROVING MOTOR RELIABILITY IN NUCLEAR POWER PLANTS

VOLUME 2: FUNCTIONAL INDICATOR TESTS
ON A SMALL ELECTRIC MOTOR
SUBJECTED TO ACCELERATED AGING

November 1987

ENGINEERING TECHNOLOGY DIVISION
DEPARTMENT OF NUCLEAR ENERGY, BROOKHAVEN NATIONAL LABORATORY
UPTON, LONG ISLAND, NEW YORK 11973

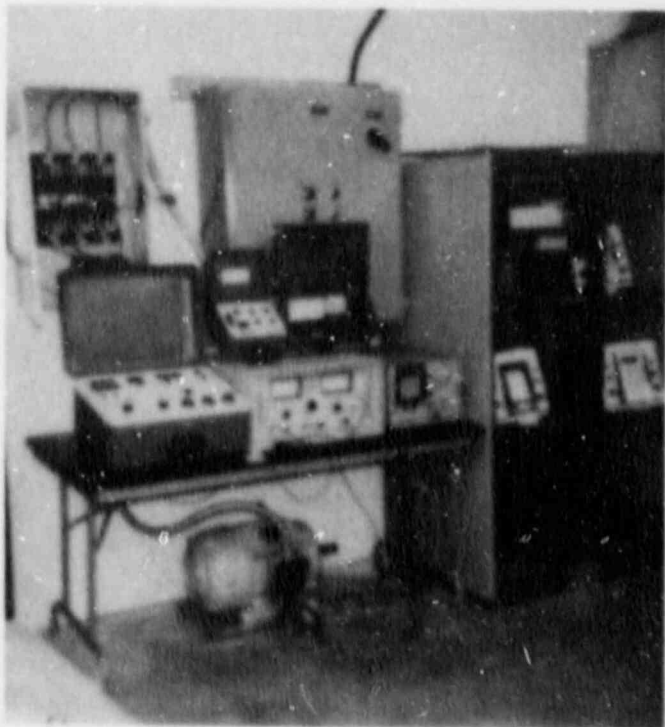
Figure 2.6 - Assembled motor with instruments and test panels.

Photographs of the motor and the test arrangements are shown in Figures 2.2, 2.3, 2.4, and 2.6. Figure 2.3 shows a close-up of the accelerometer which is epoxied to the end turn. In Figure 2.4 the thermocouple junctions are shown mounted to the end turn.

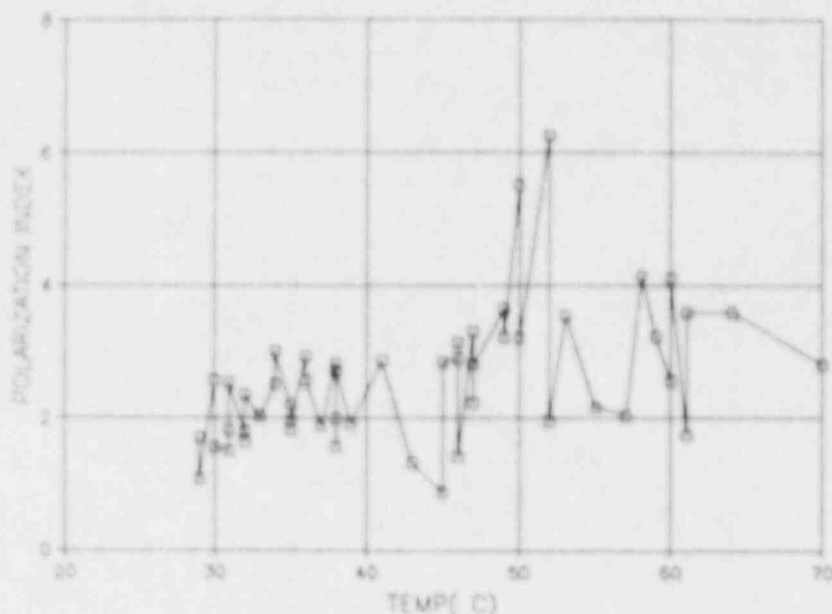
Figure 4.3 - Effect of temperature on polarization index.

The temperature dependency of the test motor polarization index was also examined. Figure 4.3 shows PI plotted against winding temperature. It should be noted that PI tests were performed during the motor shutdown period after the windings had time to cool down from operating temperature. As shown, the results indicate a very slight increase in PI with temperature. This may be characteristic of the insulation system used, however, the scatter obtained in the data is felt to be too large to draw any firm conclusions regarding temperature dependency.

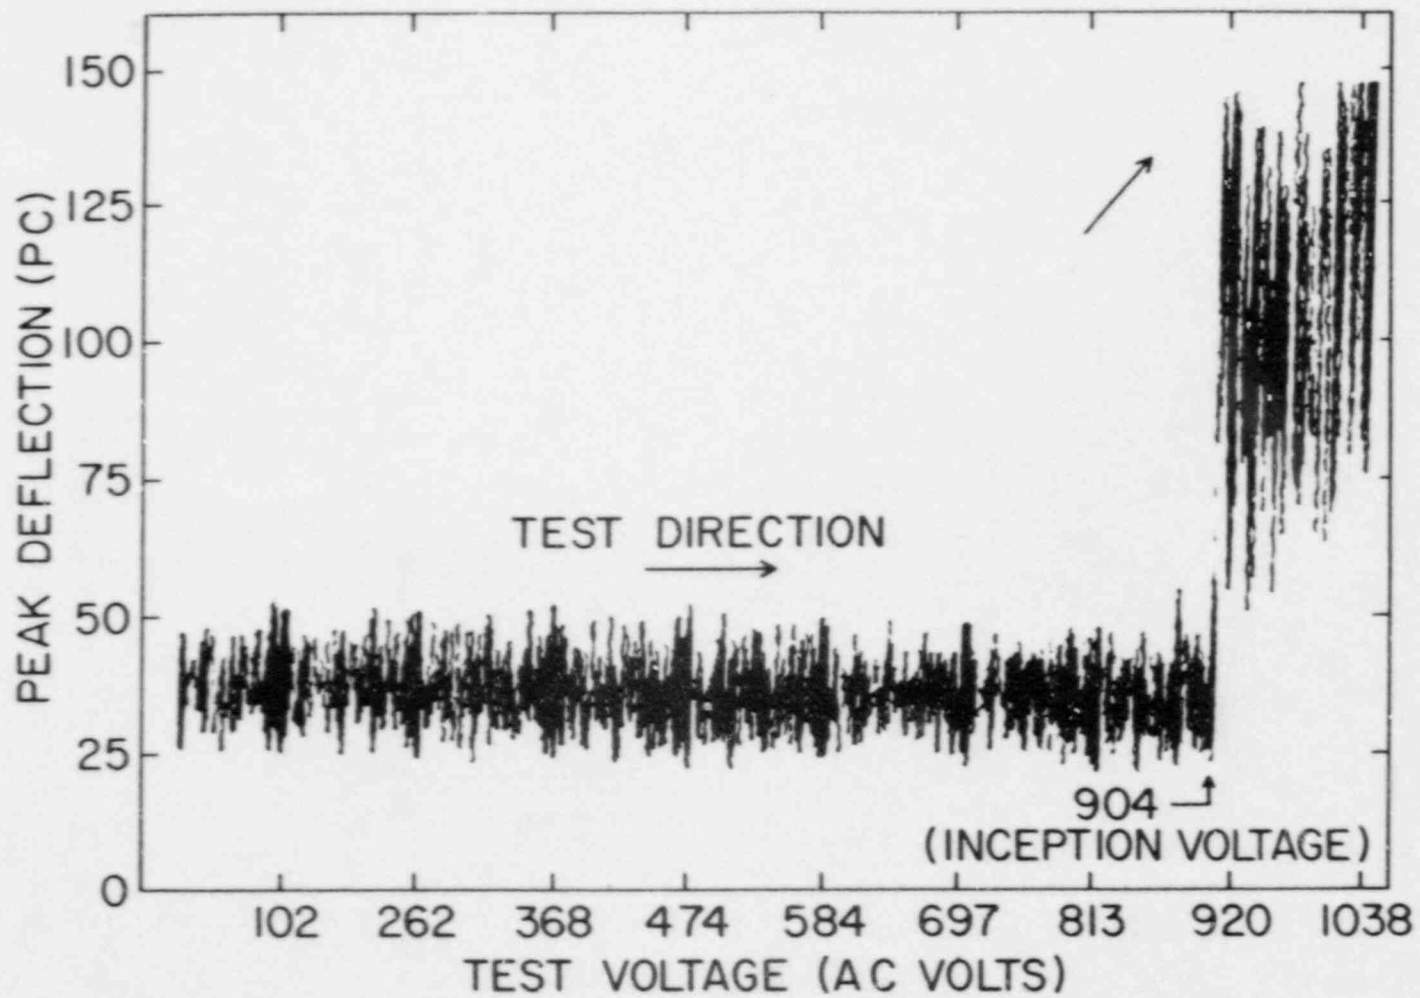
Figure 4 .8 - Variation of peak discharge with increasing ac voltage.

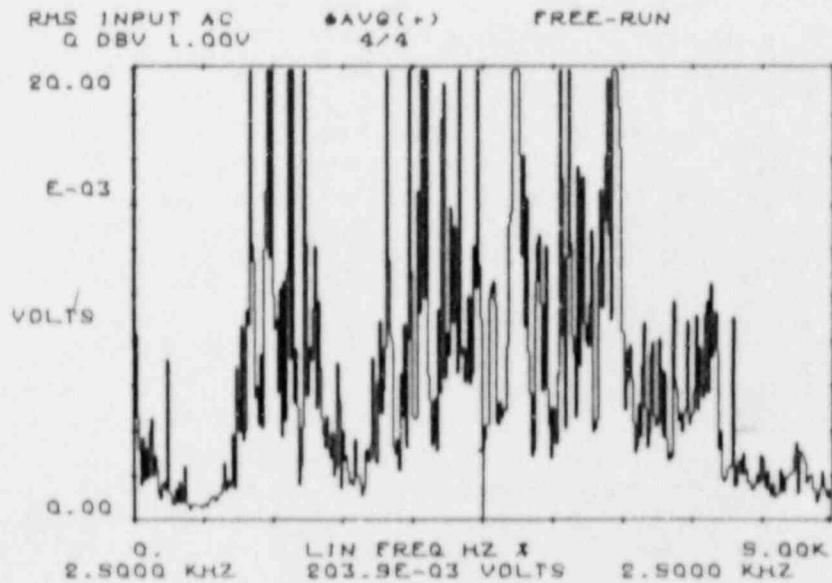
Figure 4.12 - Spectral analysis of the end turn acceleration for the pulley end.

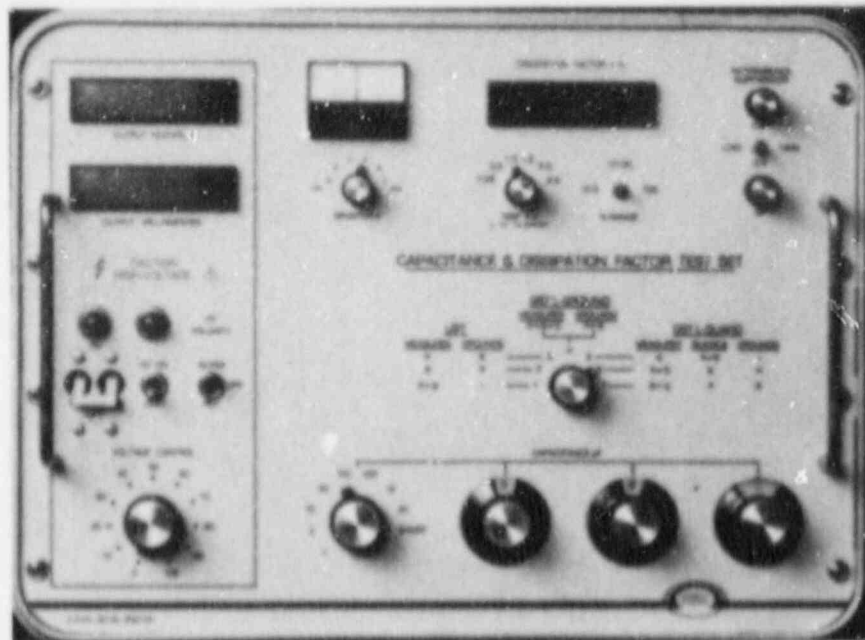
Figure A.2 - Biddle Model 670025 Capacitance and Dissipation Factor Test Set.
