# RELEVANCE OF FATIGUE TESTS TO COLD LEG PIPING

M. E. Mayfield E. C. Rodabaugh  
R. J. Eiber

Battelle Columbus Laboratories

Prepared for  
U. S. Nuclear Regulatory Commission

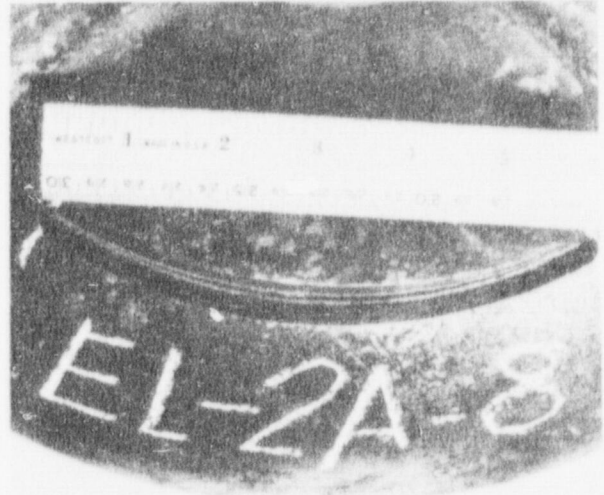
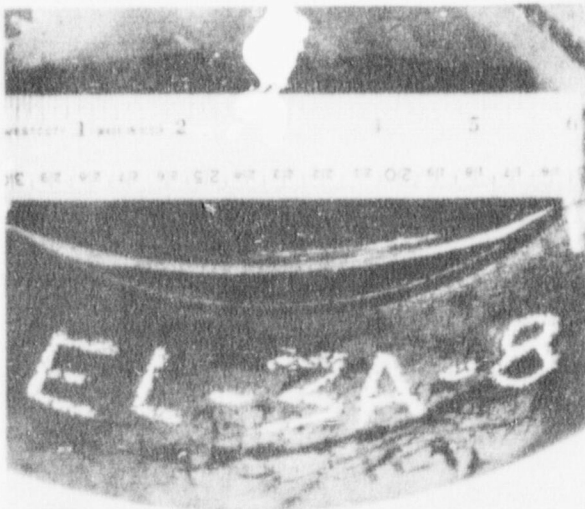
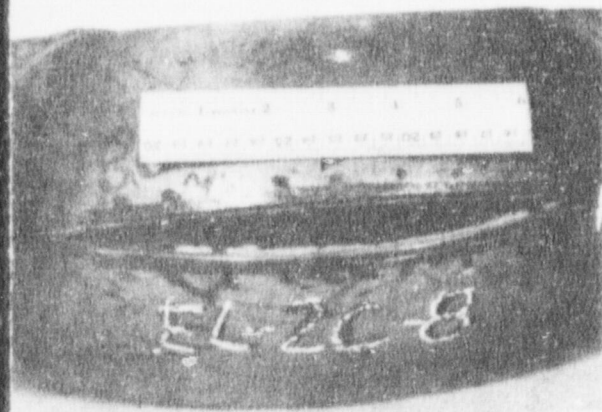
FIGURE 12. FAILURE APPEARANCES, F

"Only in those cases in which the pressure load limit was greater than 60 percent of that for an unflawed fitting did the fracture propagate beyond the ends of the original flaw. Review of the load limit data for axial part-through flaws in straight pipe segments shows that to produce a given reduction in pressure load limit, a more severe flaw is required in a tee or elbow than in a straight pipe segment. The limited number of fittings experiments done indicates that, as was the case with straight pipe segments, elbows and tees are most sensitive to flaws if the plane of the flaw is perpendicular to the maximum principal stress. In elbows, flaws of Types A and C behave much the same as axial part-through flaws of similar length in pipe segments, if corrections are made for differences in principal stress ratios at the flaw location.

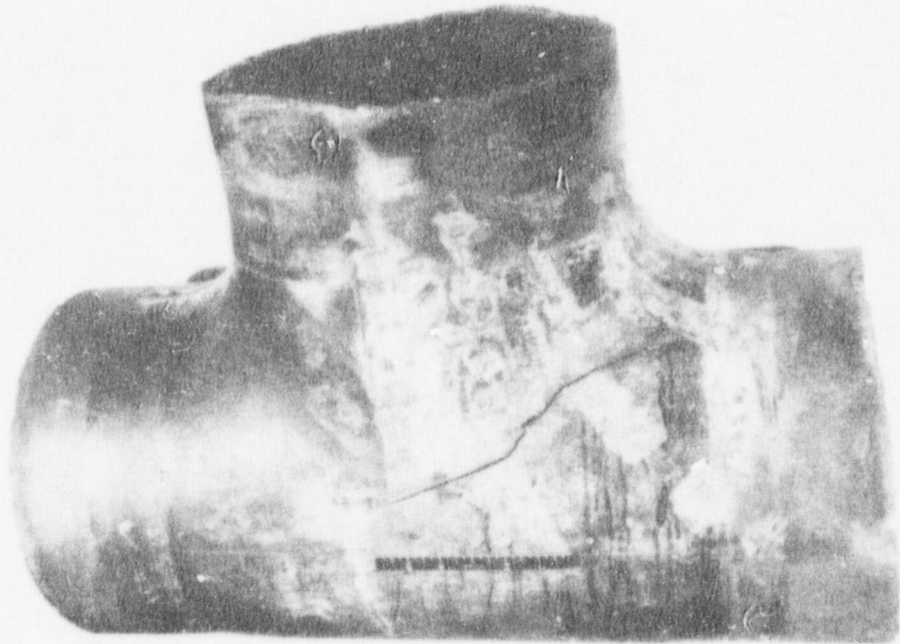
FIGURE 15. CRACK IN T-6 AFTER A LEAK FAILURE AT  
1309 CYCLES<sup>(14)</sup>

Although it is not possible to state conclusively whether the cracks were of a critical size, it is important to note that a cyclic internal pressure causes cracks that are of a critical orientation (in terms of burst test results). Further, these cracks may be substantially longer on the inner surface than they are on the outer surface:

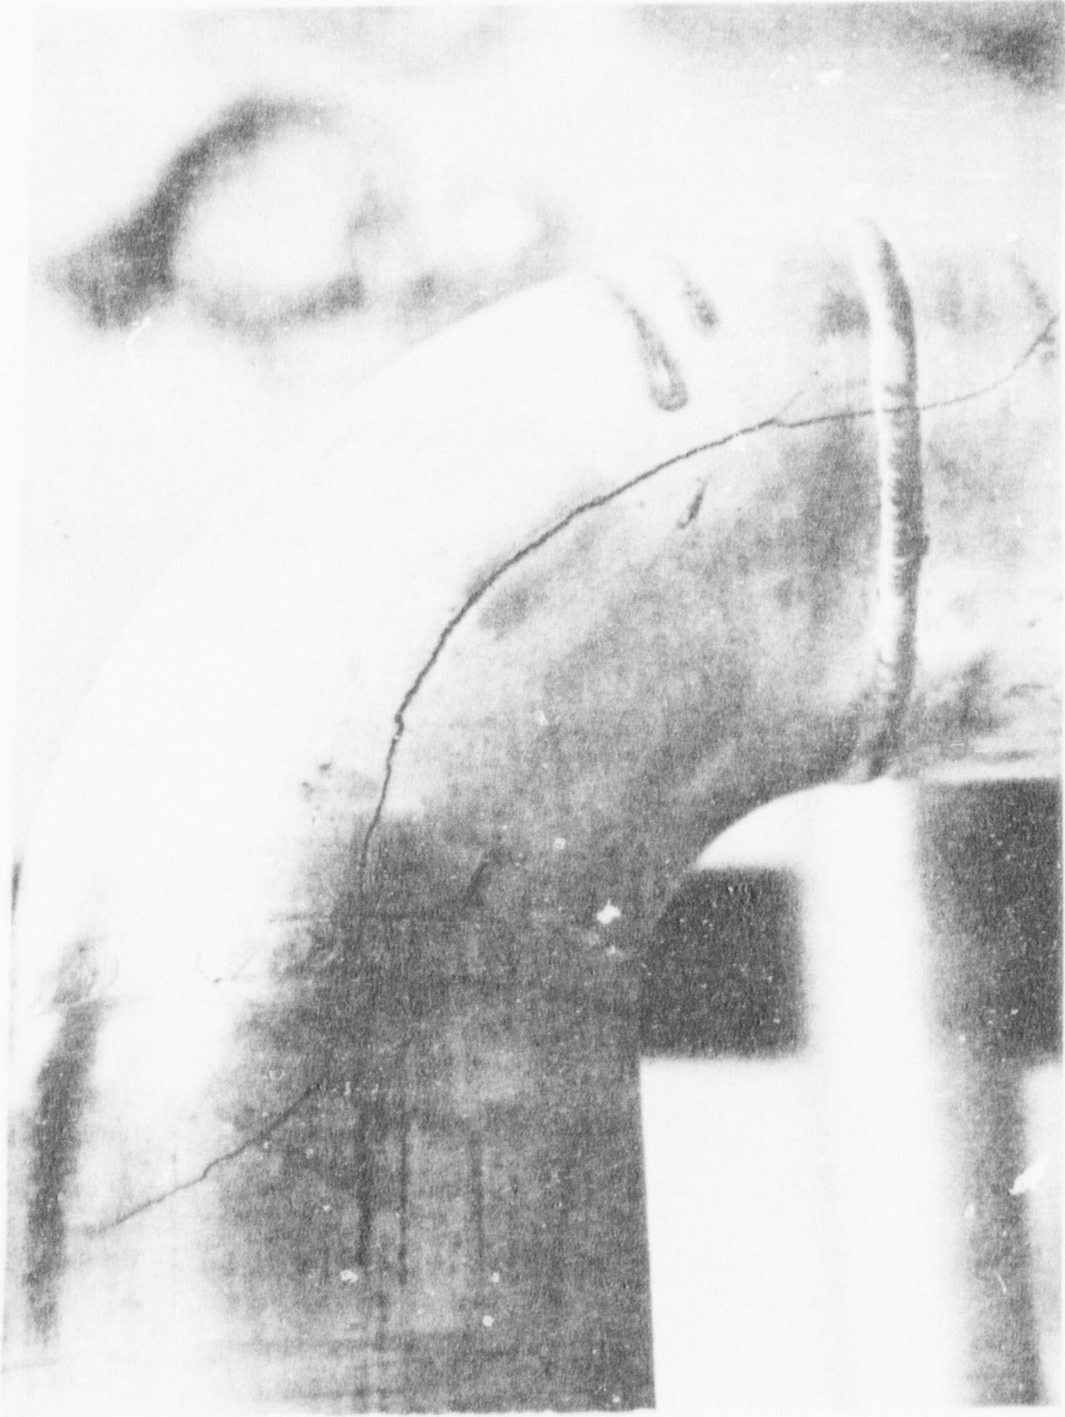
FIGURE 22. ELBOW IN-PLANE COMPLETION OF TEST (37)

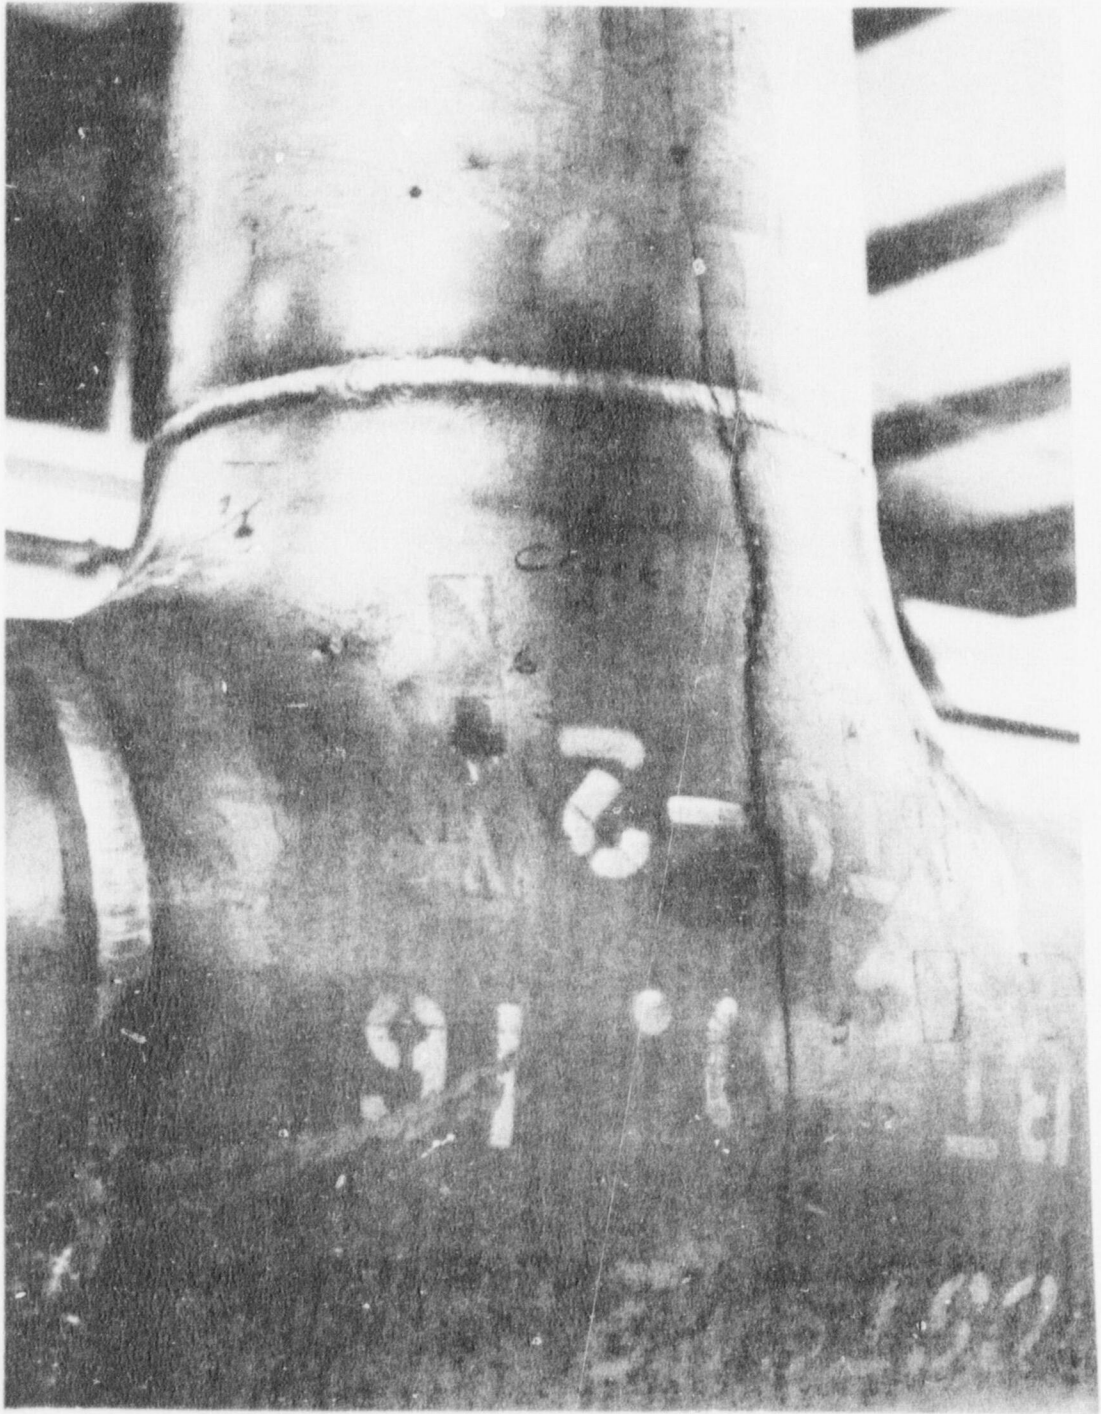
FIGURE 23. TEE, LOADED IN-PLANE (RUN), AT COMPLETION OF TEST<sup>(37)</sup>
