NUREG/CR-0166

SUSTAINED MOLTEN STEEL/CONCRETE INTERACTIONS TESTS

A Preliminary Report on the Feasibility of
Experimental Techniques

June 1978

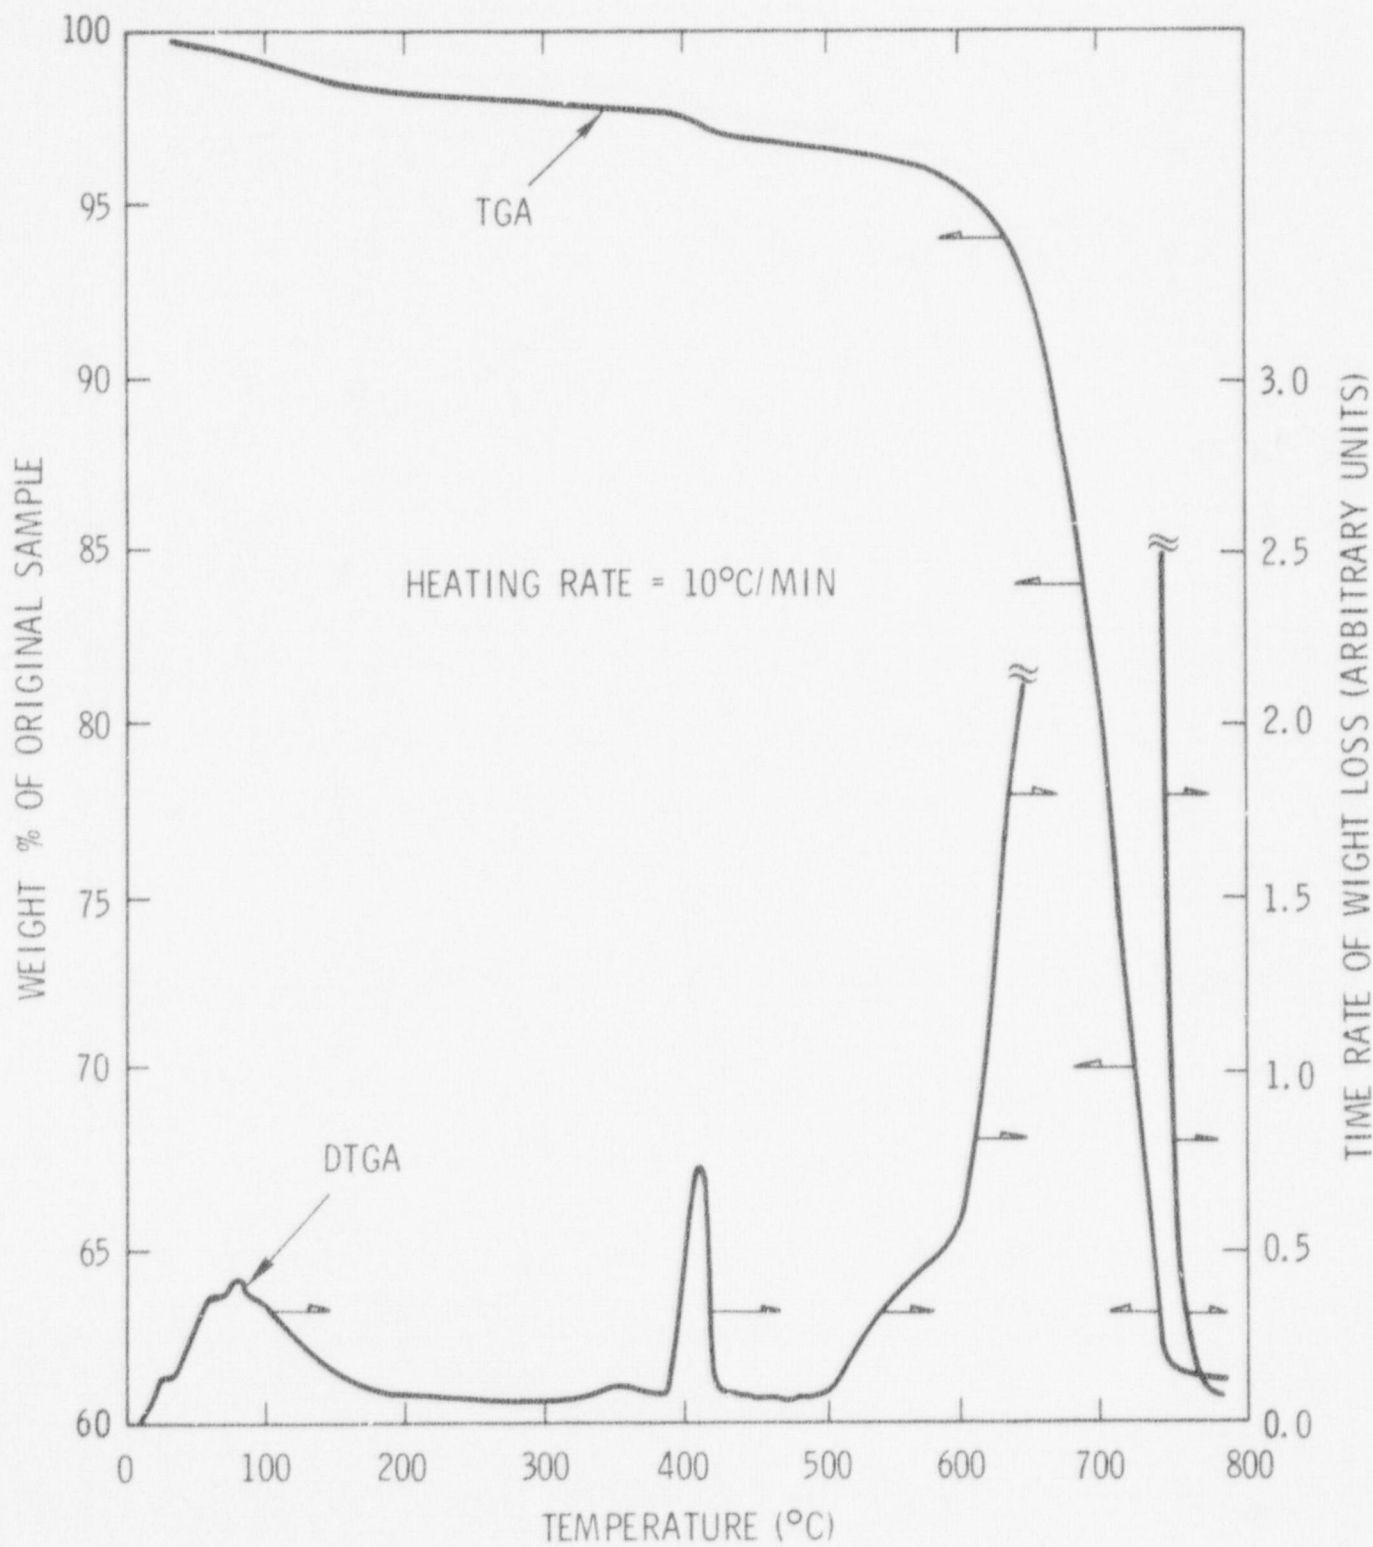
FIGURE 3. THERMOGRAM OF CONCRETE USED IN TEST COIL-1.

As temperature is increased this concrete undergoes decomposition to yield volatile products in three distinct steps. The thermogram in Figure 3 shows a weight loss of about 3% in the temperature range of 30-230°C which may be assigned to loss of evaporable water. A weight loss of about 1% centered at 420°C may be assigned to the loss of water from calcium hydroxide in the cementitious phases of the concrete. The final weight loss, which amounts to 36.5% of the sample, is due to decarboxylation of cement and aggregate in the concrete. The molar ratio of water to carbon dioxide in the concrete is about 0.27.

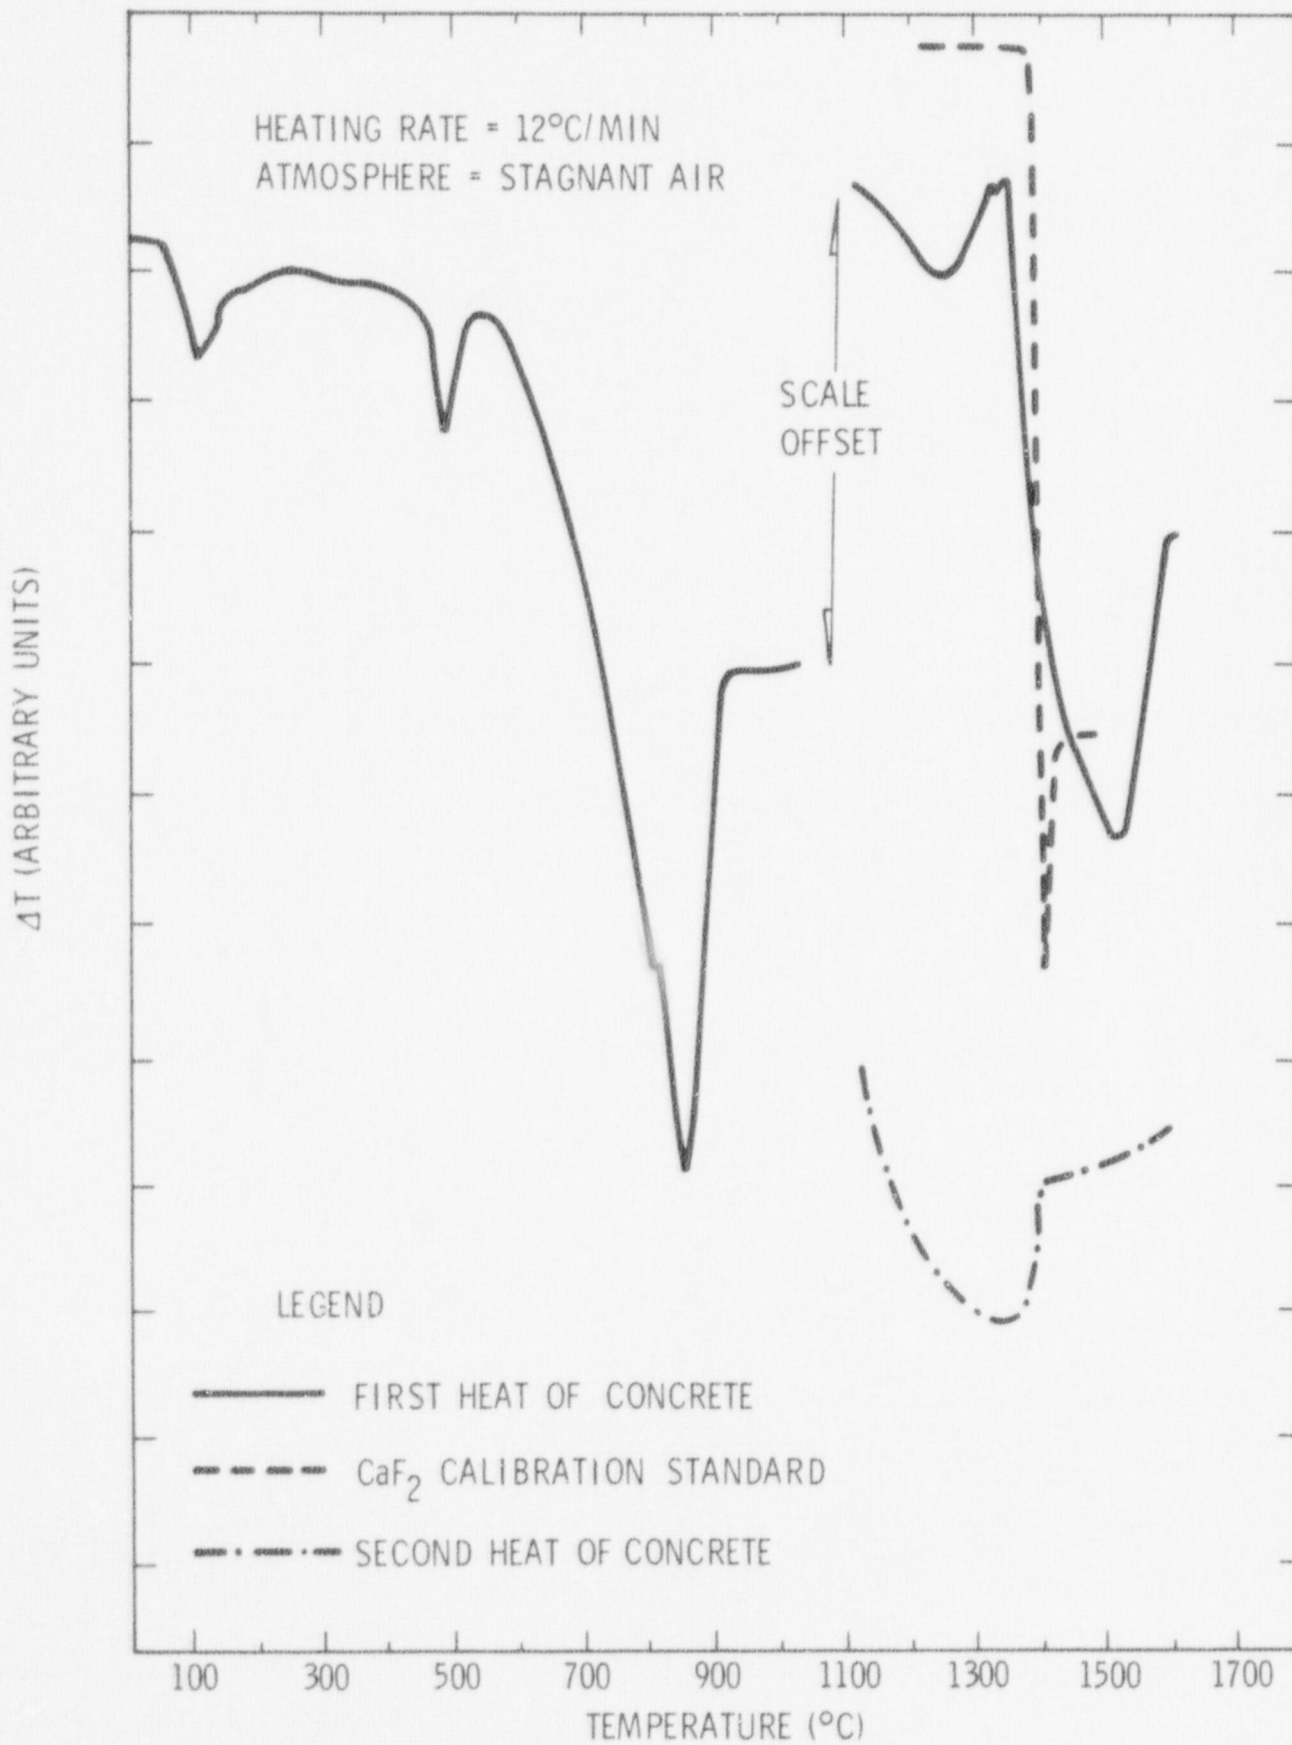
FIGURE 4. DIFFERENTIAL THERMOGRAM OF CONCRETE USED IN TEST COIL-1.

A differential thermogram of the concrete is shown in Figure 4. Endotherms at ~ 100, 470 and 650°C are due to the three decomposition reactions described above. A small endothermic peak at 800°C may be due to decomposition of dolomite ($\text{MgCa}(\text{CO}_3)_2$)⁽¹⁰⁾ known to contaminate the calcareous aggregate. No endotherm due to the $\alpha \rightarrow \beta$ phase change of free silicon dioxide could be detected at the sensitivity used in acquiring this thermogram. Weak endotherms which peak at 1240 and 1320°C may be due to reactions among the very heterogeneous solid decomposition products of concrete. The final, intense endotherm is due to melting of these decomposition products. The onset of melting occurs at $1340 \pm 10^\circ\text{C}$. Liquidus temperature of the mixture is difficult to determine accurately but appears to occur at $1600 \pm 30^\circ\text{C}$.

The product of fusing concrete is a heterogeneous material which, upon solidification and reheating, undergoes a second order phase change at 1370°C (see Figure 4).

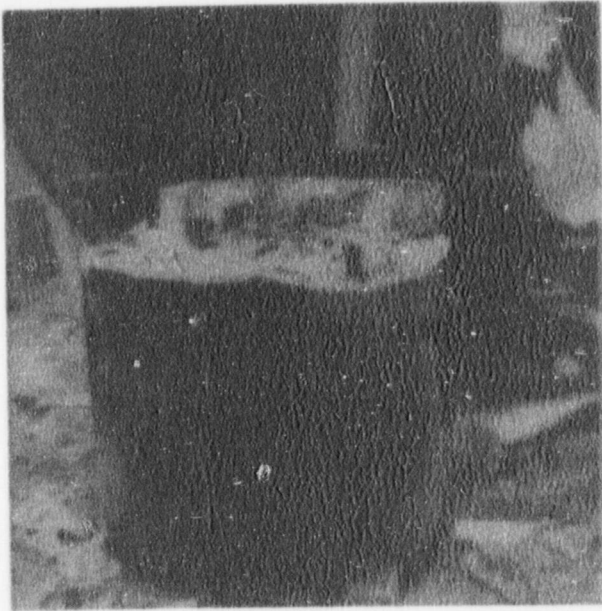
FIGURE 13 - POST TEST PHOTOGRAPHS OF THE CRUCIBLE

(a) Plane of cracking in the crucible after the loose concrete had been removed.

The concrete crucible sustained major horizontal cracks even with the top of the embedded induction coil. This portion of the crucible was not reinforced. It was particularly weak since it contained fireclay blocks used to support the induction coil during fabrication of the test fixture. The horizontal cracks passed completely through the crucible wall and large concrete pieces could be readily pulled from the top of the crucible at the end of the test (see Figure 13a). These horizontal cracks were above the molten pool during the test and liquid had not entered the fissures.

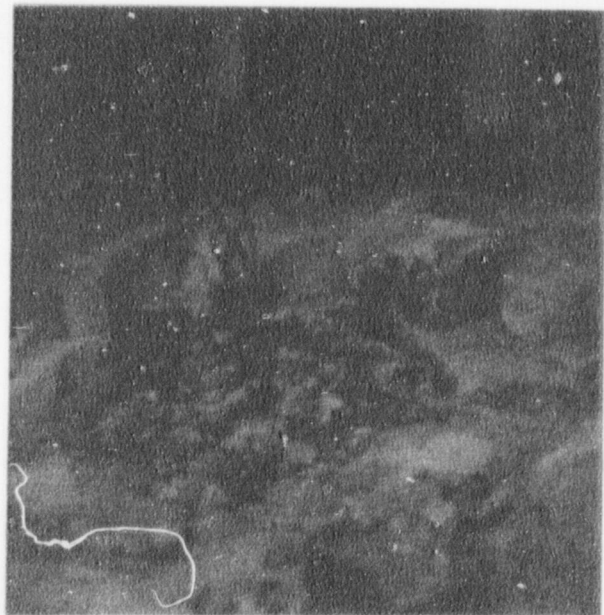
(b) Top view of the partially removed metal slug

The solidified metal slug was wedged tightly into the crucible, but had not bonded to nor wetted the concrete. The upper surface of the slug was coated with a dense, dark-brown slag which was no more than 1 cm thick except where the fireclay block used to locate the in situ melt thermocouple had floated to the surface (see Figure 13b). Metal near the surface of the solidified slug appeared to be badly oxidized.

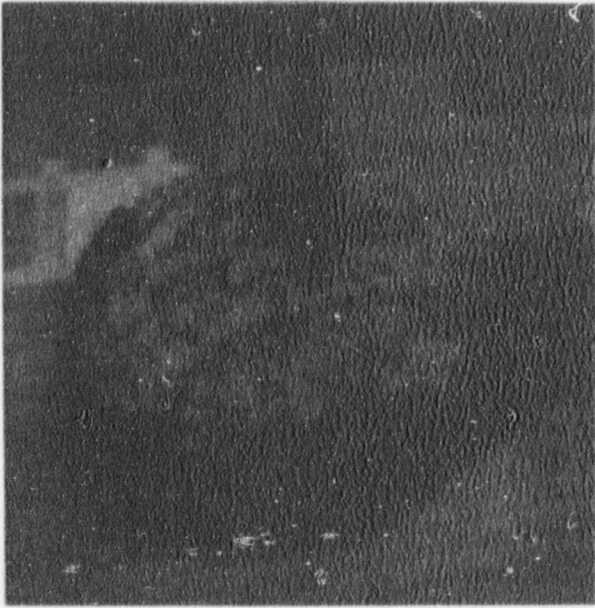
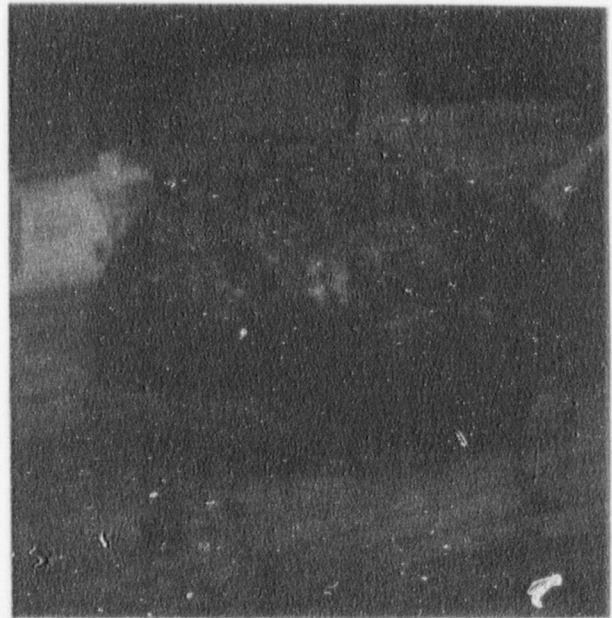
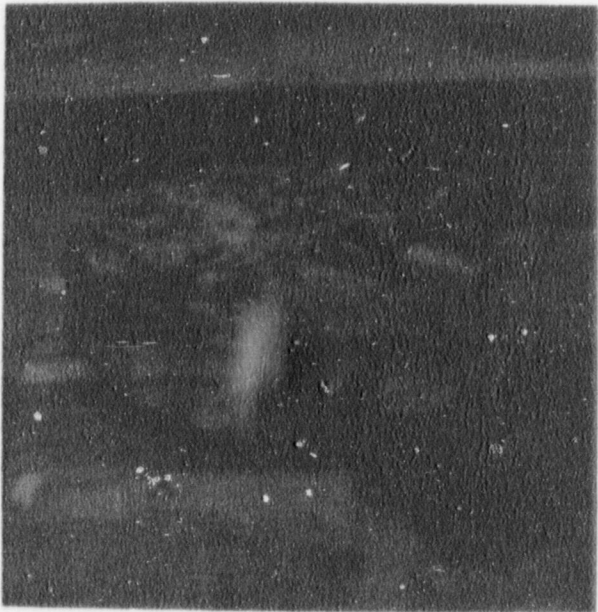
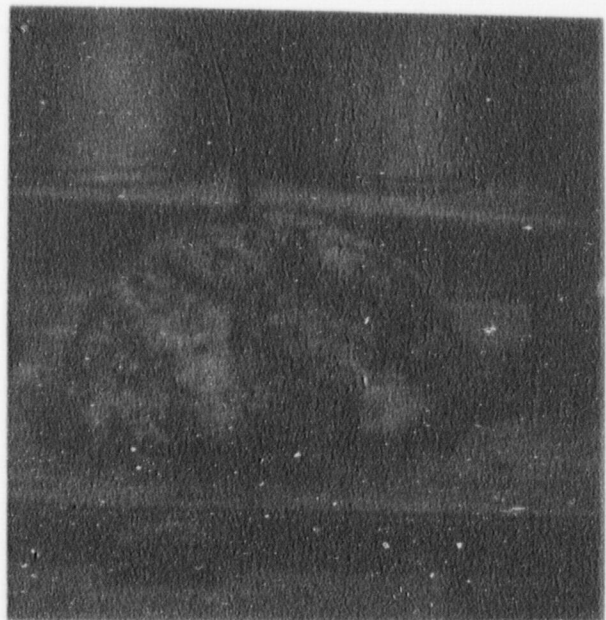
a) Bottom of metal slug
after it has been
sectioned

b) Side view of the slug

Figure 14 Post-Test Photographs of
Solidified Metal from Test
Coil-1

c) Side view showing interior of slug. Note voids at the top and compact metal near the bottom of the slug

d) Top view of the slug

Sectioning of the slug showed it to be of compact metal. Near the top surface voids and inclusions were noticeable, some of which passed a few centimeters into the slug (see Figure 14).

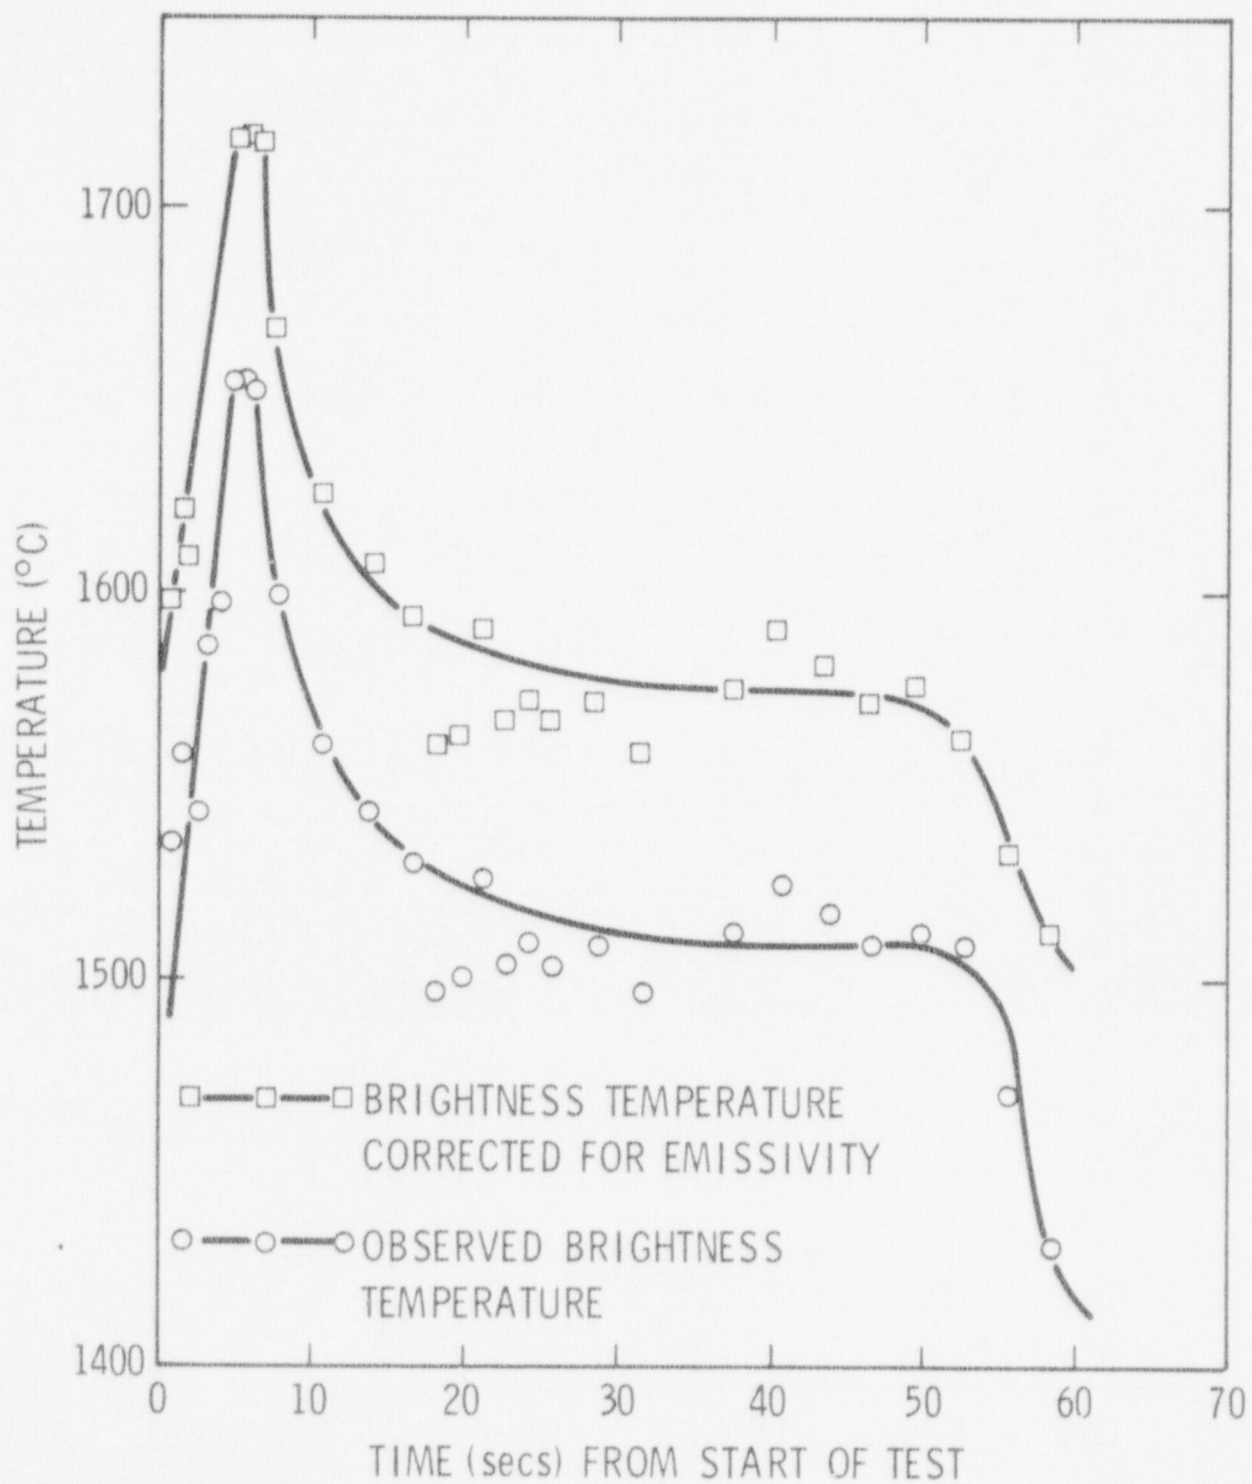
FIGURE 15. MELT TEMPERATURE DATA FROM PYROMETER OBSERVATION IN TEST COIL-1 VERSUS TIME.

Pyrometric data from the test is plotted in Figure 15 as brightness temperature versus time. It is unclear whether the energy received by the pyrometer detector came from melt or flame

emissions. The shape of the temperature-time curve in Figure 15 does not mimic well the shapes of similar curves produced by the gas phase temperature sensors (see Figure 20). Under the assumption that the melt temperature was being monitored by the pyrometer, the maximum observed brightness temperature (1656°C) was set equal to the known melt temperature at the start of the test (1720°C) and an emissivity value determined. The derived value, 0.87, agrees well with the literature value, 0.85, reported for oxidized 18-8 stainless steel (11). The brightness temperatures, corrected for emissivity effects, are also shown in Figure 15. At best these corrected results describe the temperature of the melt surface, which is likely to be the coolest part of the melt.

After about 60 seconds, output from the pyrometer dropped sharply, though flames above the melt cavity were still fairly bright and the temperature of the melt was still quite high at this point in the test. Melt expulsion from the crucible and concrete erosion may have combined to substantially reduce the level of melt in the crucible cavity--possibly below the line-of-sight of the pyrometer.

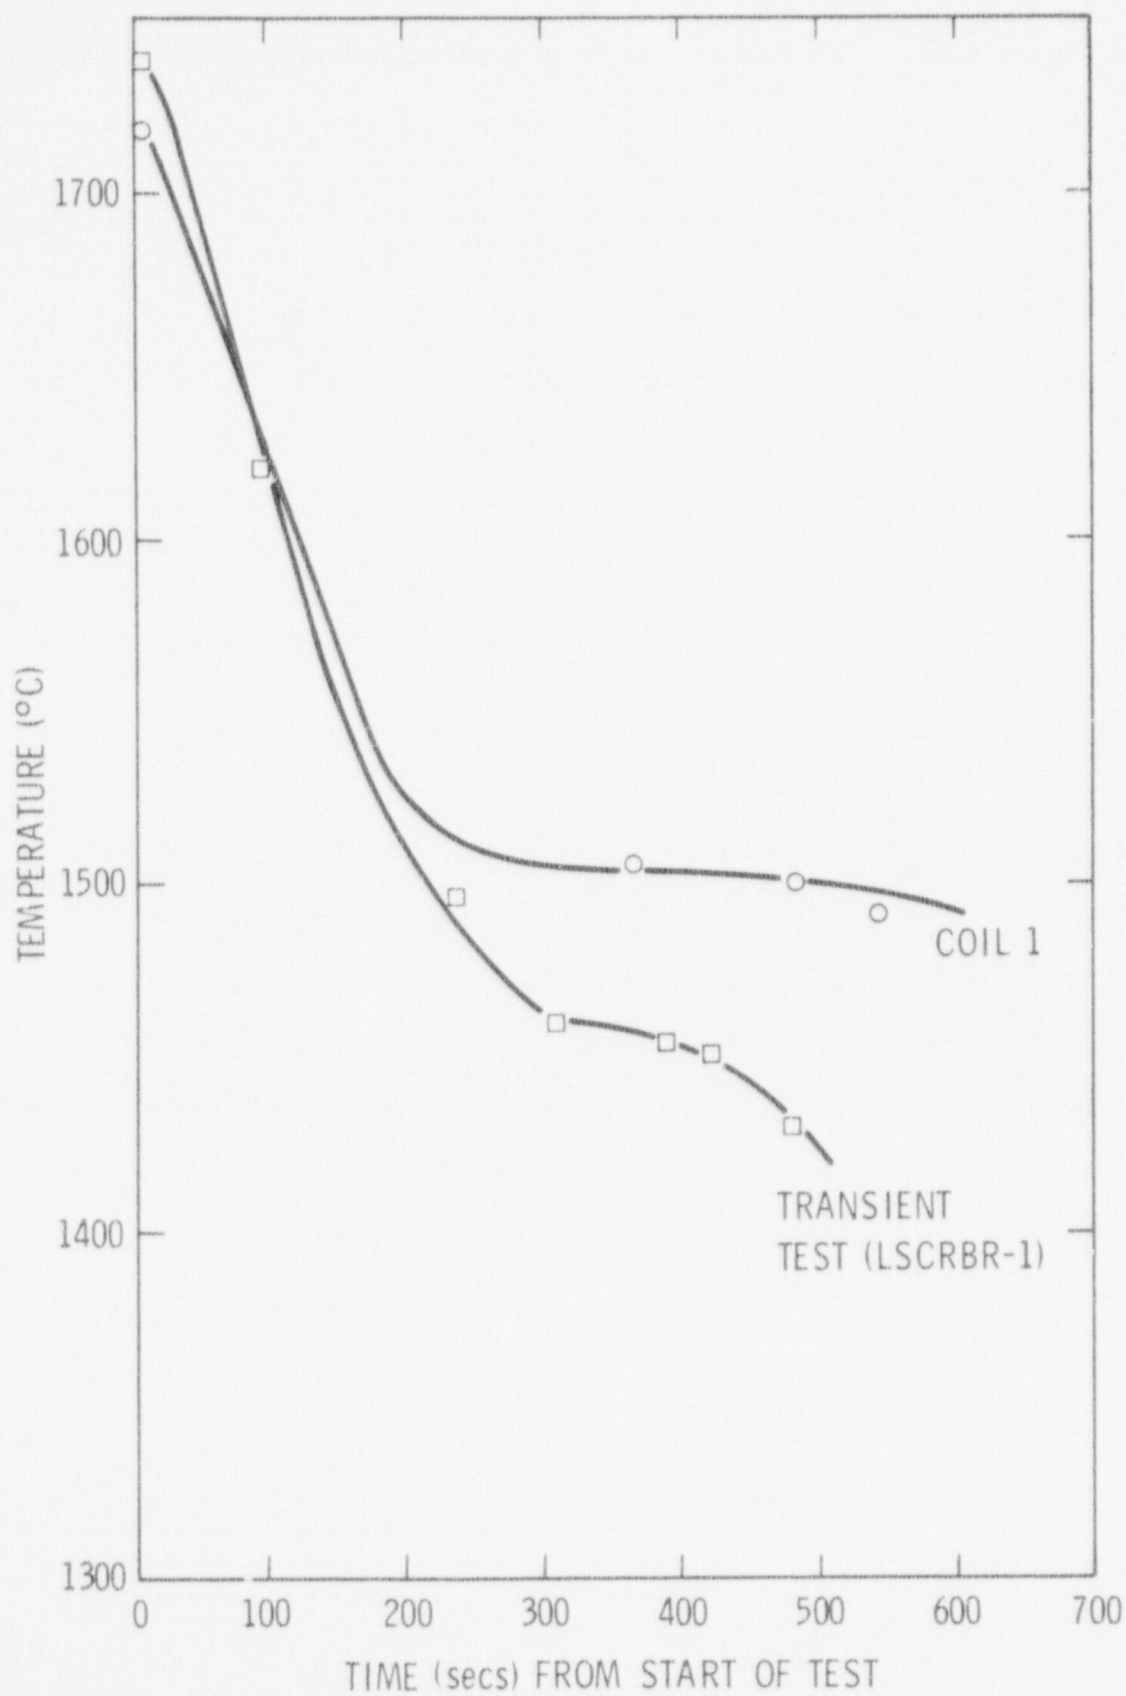
FIGURE 17. MELT TEMPERATURE DATA OBTAINED WITH IMMERSION THERMOCOUPLES IN TEST COIL-1 AND A SIMILAR TRANSIENT MELT/CONCRETE INTERACTION TEST.

These temperatures are plotted in Figure 17 along with melt temperature data from a similar, though transient, test with a melt and concrete identical to that used in test COIL-1. Cooling in the transient test is arrested at about 1460°C where solidification of the melt begins and the heat of crystallization makes up for heat losses from the melt. Cooling in test COIL-1 was arrested at about 1500°C where heat input from the induction coil balances heat losses from the melt. Electrical coupling between the melt and the coil was not sufficient to maintain temperatures above the liquidus of the concrete. The sustained temperature was greater than the solidus temperature of this particular variety of concrete.

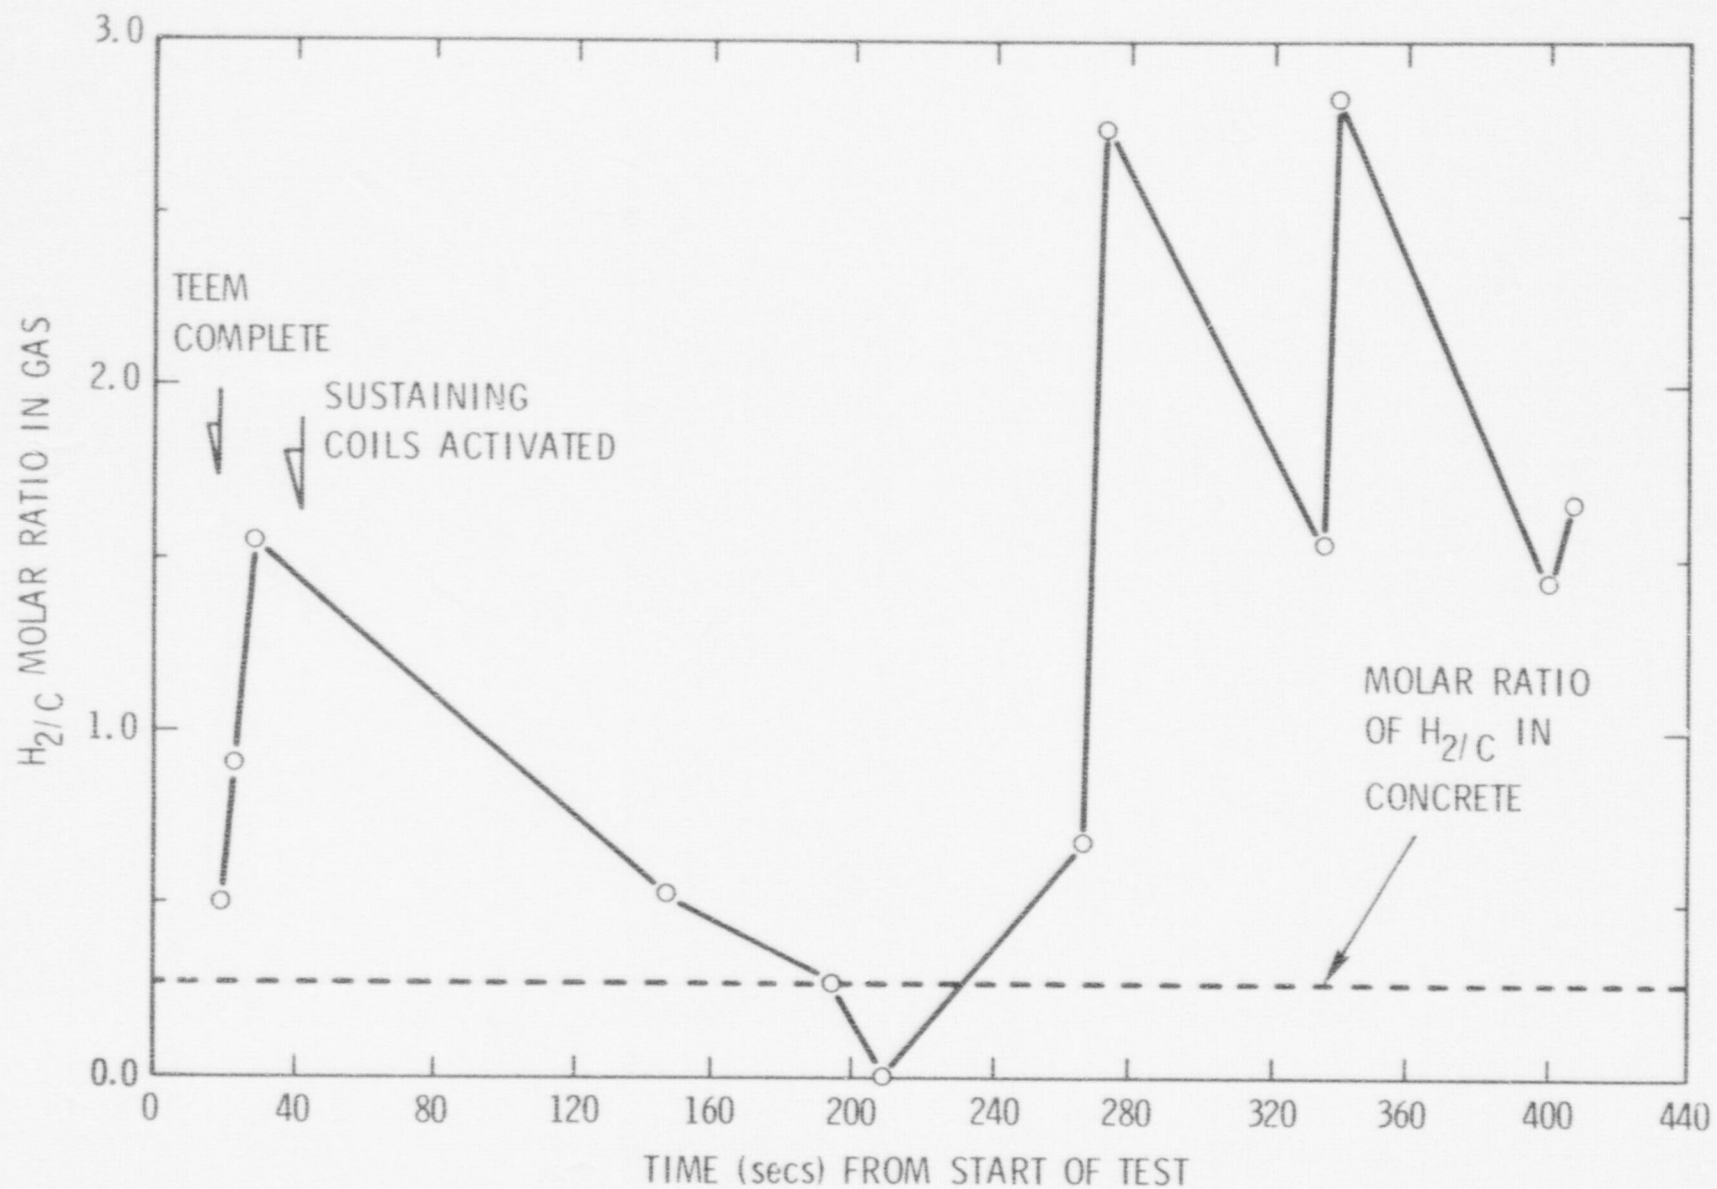
FIGURE 18. MOLAR RATIO OF H₂/C IN GAS STREAM PRODUCED IN TEST COIL-1 VERSUS TIME.

The molar ratios of hydrogen to carbon from all constituents in the gas mixtures are plotted versus time in Figure 18. In all cases, save two, these ratios are greater than the H_2/C ratio in the concrete. The disparity between the gas and concrete H_2/C ratios is believed to be a consequence of the nature of heat transfer from the melt into the concrete. Thermal alteration of concrete to yield gaseous species does not occur at the melt/concrete interface except at the very start of the interaction. Once surface concrete material is destroyed, further gas generation occurs below the melt/concrete interface at depths dictated by the temperature profile in the concrete. Dehydration of concrete is essentially complete at 500°C . Decarboxylation of the concrete is not significant until temperatures in excess of 600°C are reached. The gas data suggest that the lower temperature dehydration front penetrates into the concrete more rapidly than does the decarboxylation front. In a sufficiently prolonged melt/concrete interaction the H_2/C ratio would eventually fall to zero when dehydration of the concrete was complete. This hypothesis is consistent with previous experiments dealing with heat-transfer in concrete (13).

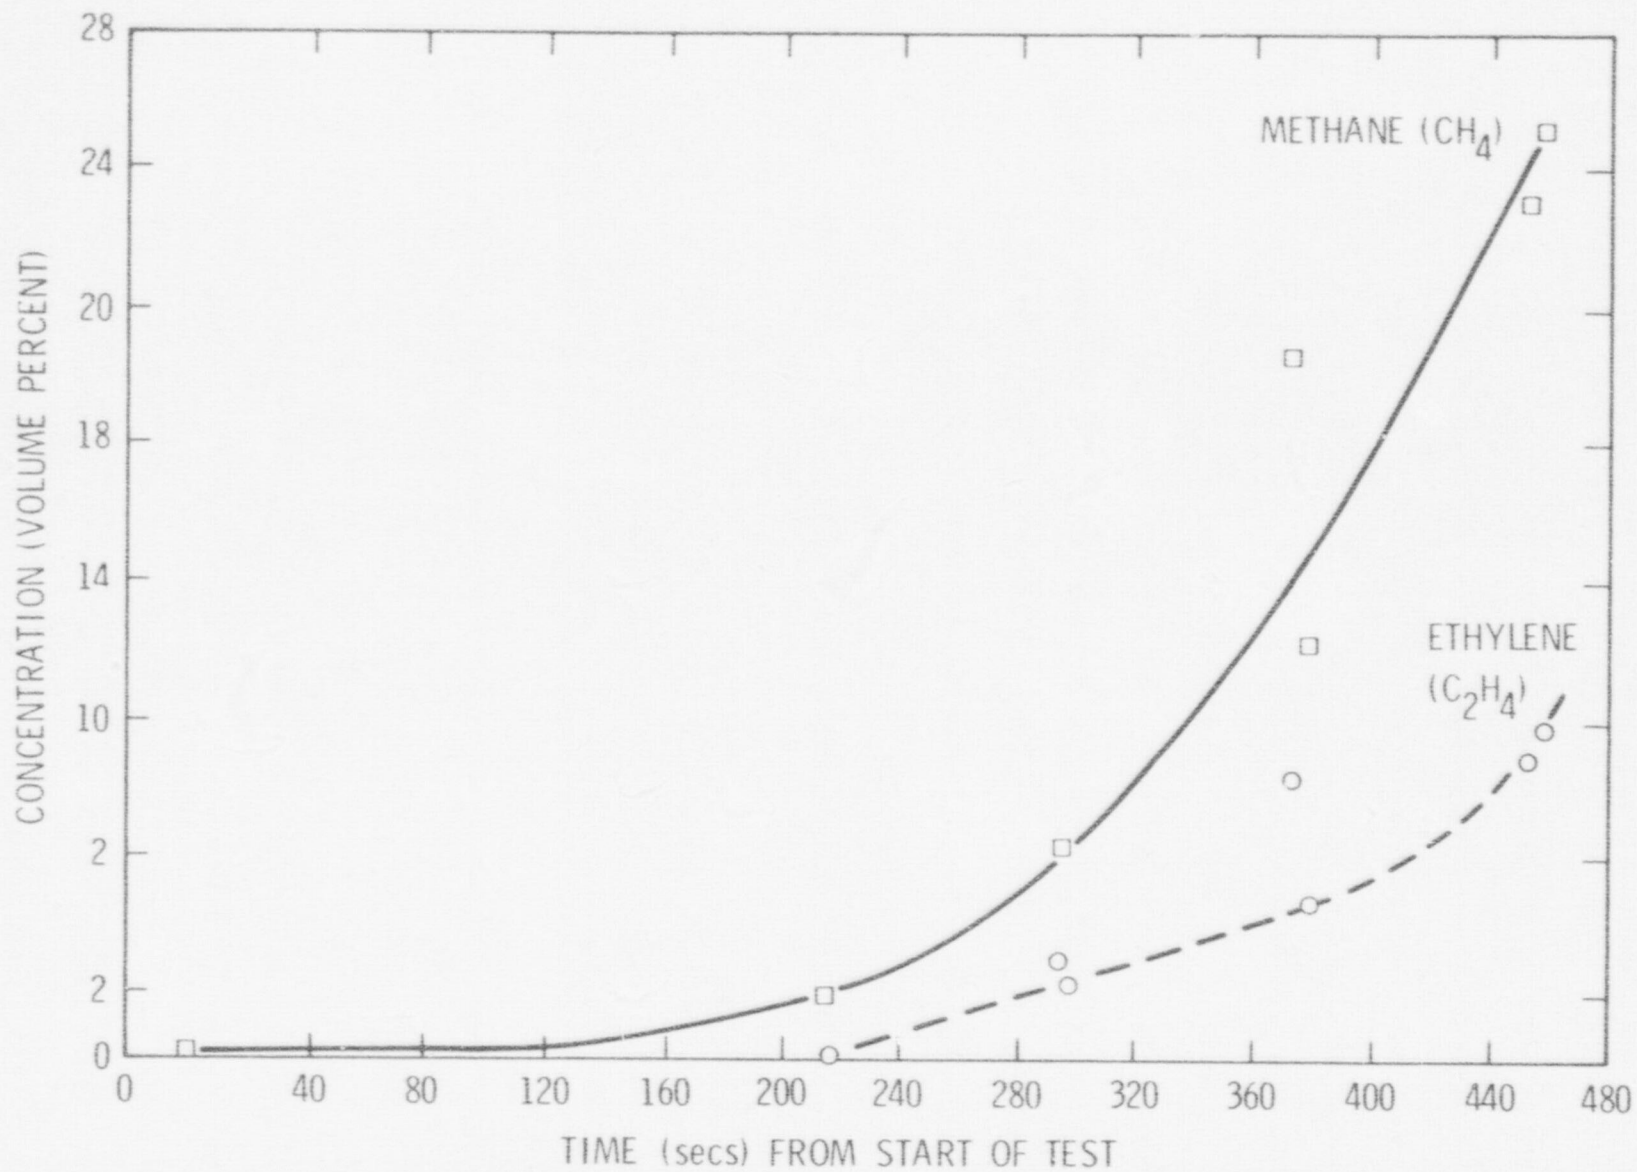
FIGURE 19. HYDROCARBON CONCENTRATION IN GASES SAMPLED DURING TEST COIL-1 VERSUS TIME FROM THE START OF THE TEST.

Methane, ethene and even traces of ethane appear in the gas samples three minutes after the start of the test. As shown in Figure 19, the concentrations of methane and ethene increase with time eventually reaching maximum values of about 25 and 10 volume percent, respectively.

It is likely that catalytic activity of the gas sampling probe was responsible for the hydrocarbons. The gas sampling probe used in the experiment was located close to the orifice of the crucible cavity where it could be heated by the melt. The gas sampling line could easily have reached temperatures at which hydrogenation reactions proceed rapidly with catalytic aid and the products are thermodynamically stable. As the test proceeded a greater length of sampling line could have been heated to this temperature range. This would give sampled gas
