NUREG/CR-4778
ORNL/TM-10273

Preliminary Studies of the
Morphology of Thermal Gradient
Tube Deposits from Fission Product
Release Experiments

Chemical Technology Division

Manuscript Completed - December 1986
Date Published - March 1988

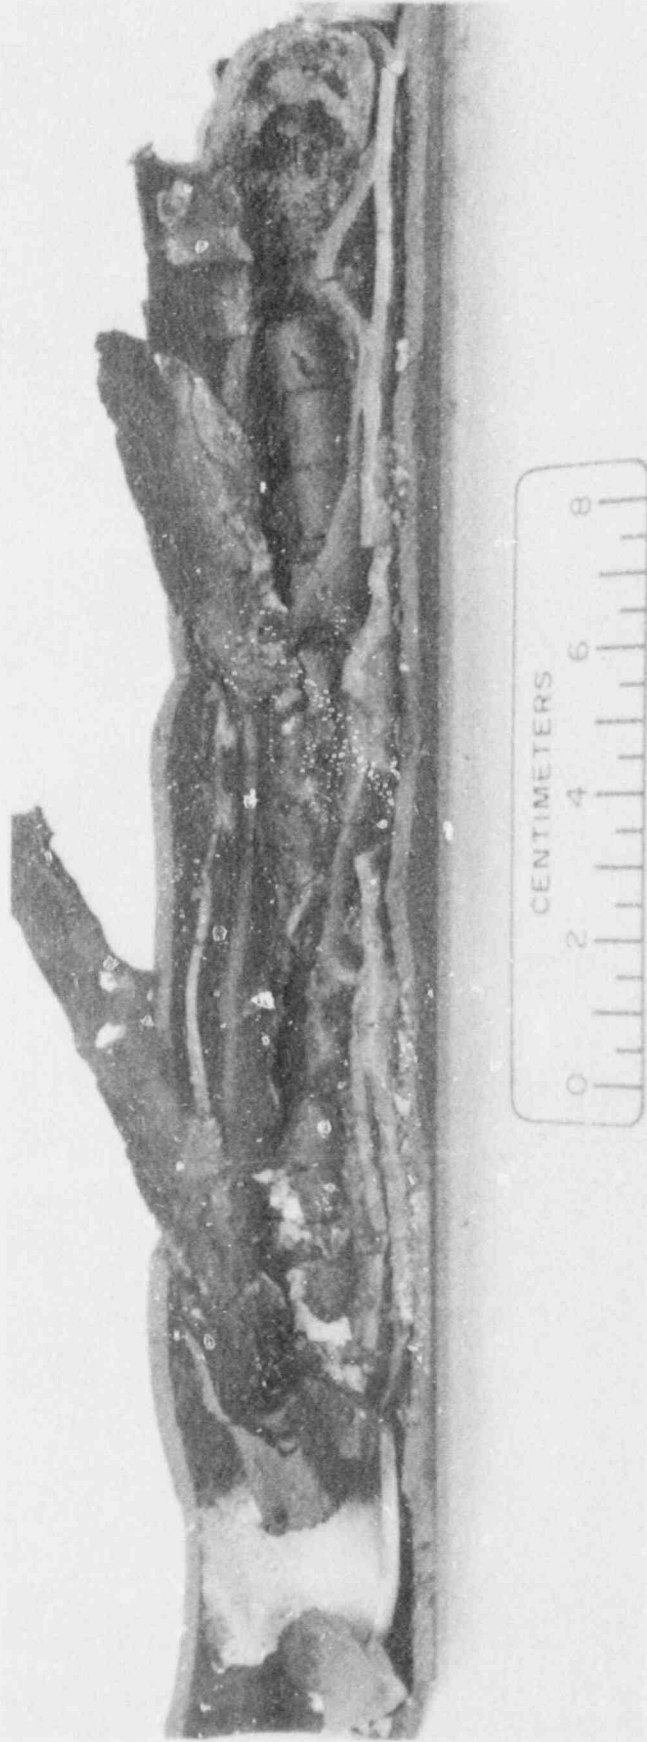
ORNL-PHOTO 7705-84

Fig. 10. Posttest view of the simulated fuel specimen used in test HS-4.

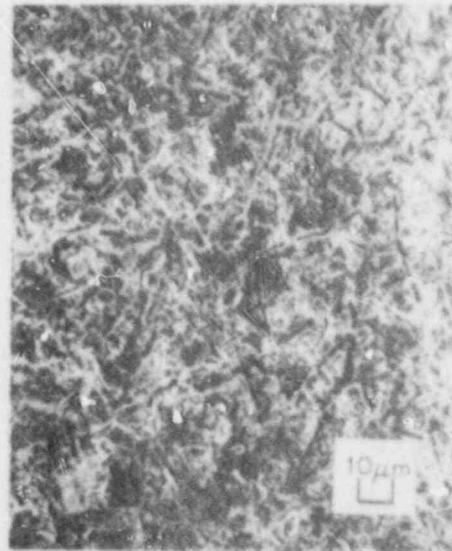
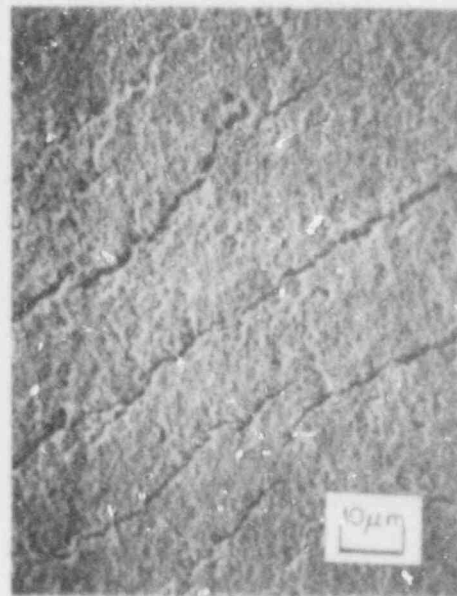
ORNL-PHOTO 329-86

At 6 cm into TGT C (730°C) [Fig. 21 (a) and (b)], the matted surface was seen again. The deposits were heavy (platinum signal was repressed), and a great deal of cesium was found, along with substantial amounts of sulfur; rather less tin and silicon were located than before. Whiskers similar to those at the inlet region of TGT B, although not as heavily reacted, were also observed. It was not possible to positively identify cesium-rich particles.

Fig. 21. SEM photomicrographs of surface deposits at 6 cm, (a) and (b), and 15 cm, (c), into TGT C (test VI-1). The view in (d) shows the surface at 15 cm after it was leached in basic and acidic leaches.

At 15 cm into TGT C (550°C) [Fig. 21 (c)], heavy, porous, coral-like deposits containing Cs, S, and Sn were found. The platinum signal was severely repressed. The deposits were very uniform and were observed to lift off in chunks. Analysis beneath these areas showed higher levels of tin. Several reacted "whiskers" were found lying on top of the main deposits.

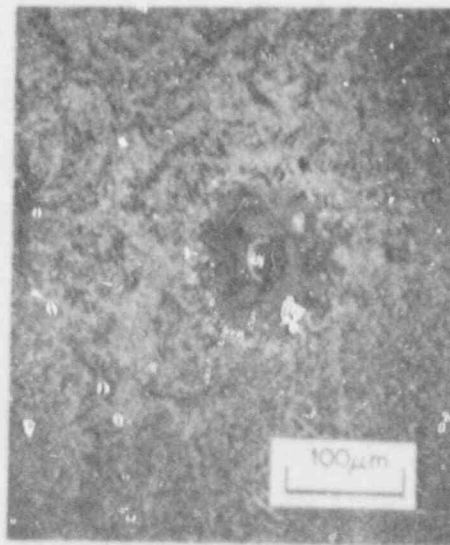
ORNL-PHOTO 331-86

Samples were cut from the TGT at 1, 6, 15, and 36 cm. Deposits were quite light in all regions except at the outlet end where a slight discontinuity in the smoothness of the platinum foil appeared to have trapped a small pile of particles. These resembled the platinum-rich whiskers seen in TGTs B and C of VI-1. They were also present on the prefilter surface, and contained varying amounts of silicon and platinum with little evidence for the presence of sulfur. Deposits at 1, 6, and 15 cm into the TGT had a similar appearance [Fig. 22 (a), (b), and (c)], with the density of the deposits being the major difference. Some spherical particles (5-20 μm) composed mainly of calcium were located as well as smaller irregular lumps containing mostly silica. These often appeared to be at the center of a reacted area of the surface [Fig. 22 (b)]. A zone of surface disruption surrounded these particles with "reaction fronts" extending up to 0.2 mm from the center. A few platinum-containing whiskers were located in these regions. The platinum surface appeared to have become porous in the reaction zones; adjacent regions had not been affected. Some sulfur was located at the 15-cm location.

Fig. 22. SEM photomicrographs of surface deposits at 1 cm, (a), 6 cm, (b), 15 cm, (c), and 36 cm, (d), into the TGT used in pretest VI-2.
