NUREG/CR-4380
ORNL-6226

**Evaluation of the Motor-Operated
Valve Analysis and Test System
(MOVATS) to Detect Degradation,
Incorrect Adjustments, and
Other Abnormalities in
Motor-Operated Valves**

Engineering Technology Division

Manuscript Completed - December 18, 1985
Date Published - January 1986

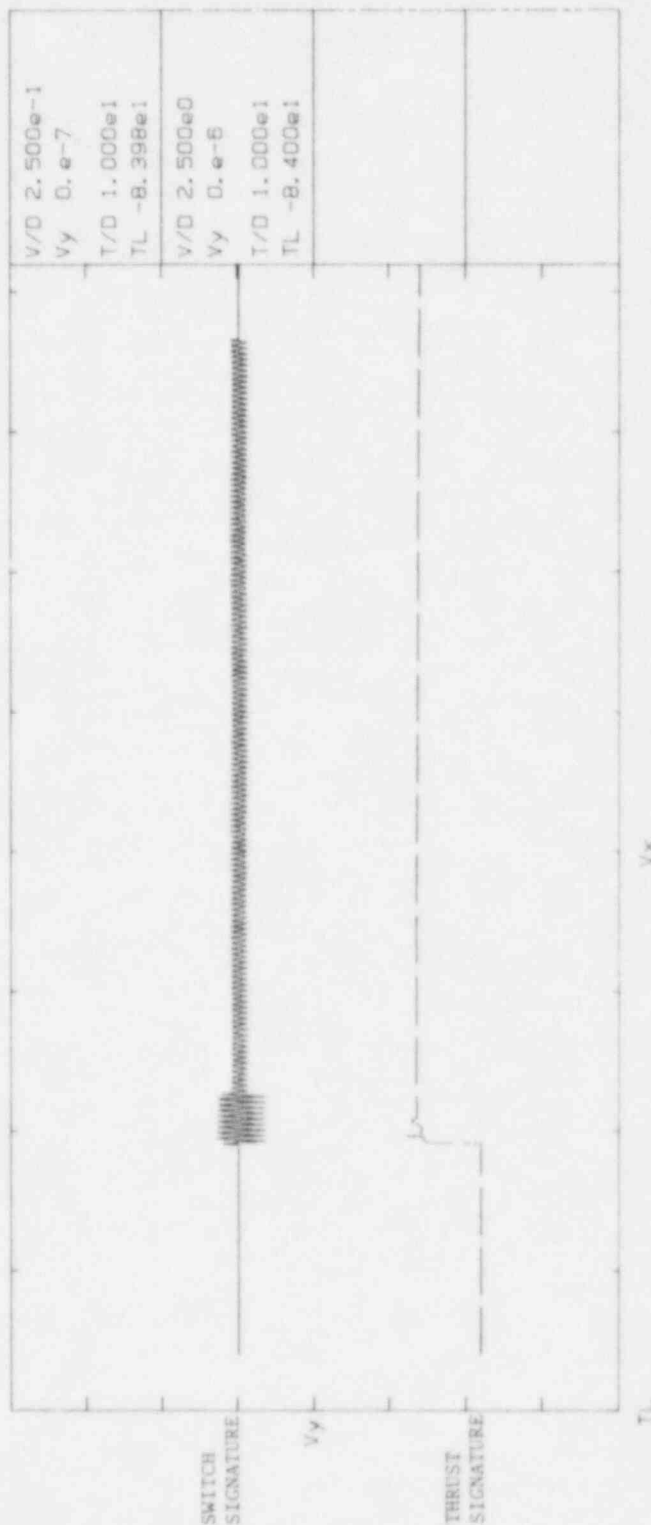
THD & SWITCHES: CLOSE TO OPEN

STROKE TIME : 57.4 SECONDS AVE RUN THRUST : 2293 #
 BYPASS TIME : 3.54 SECONDS MAX RUN THRUST : 2994 #
 UNSEATING TIME : 1.78 SECONDS UNSEATING THRUST : 5161 #
 PROTECTION MARGIN : 1.76 SECONDS THRUST AT CST : N/A
 TORQUE SW. SETTING: 3.0/3.0

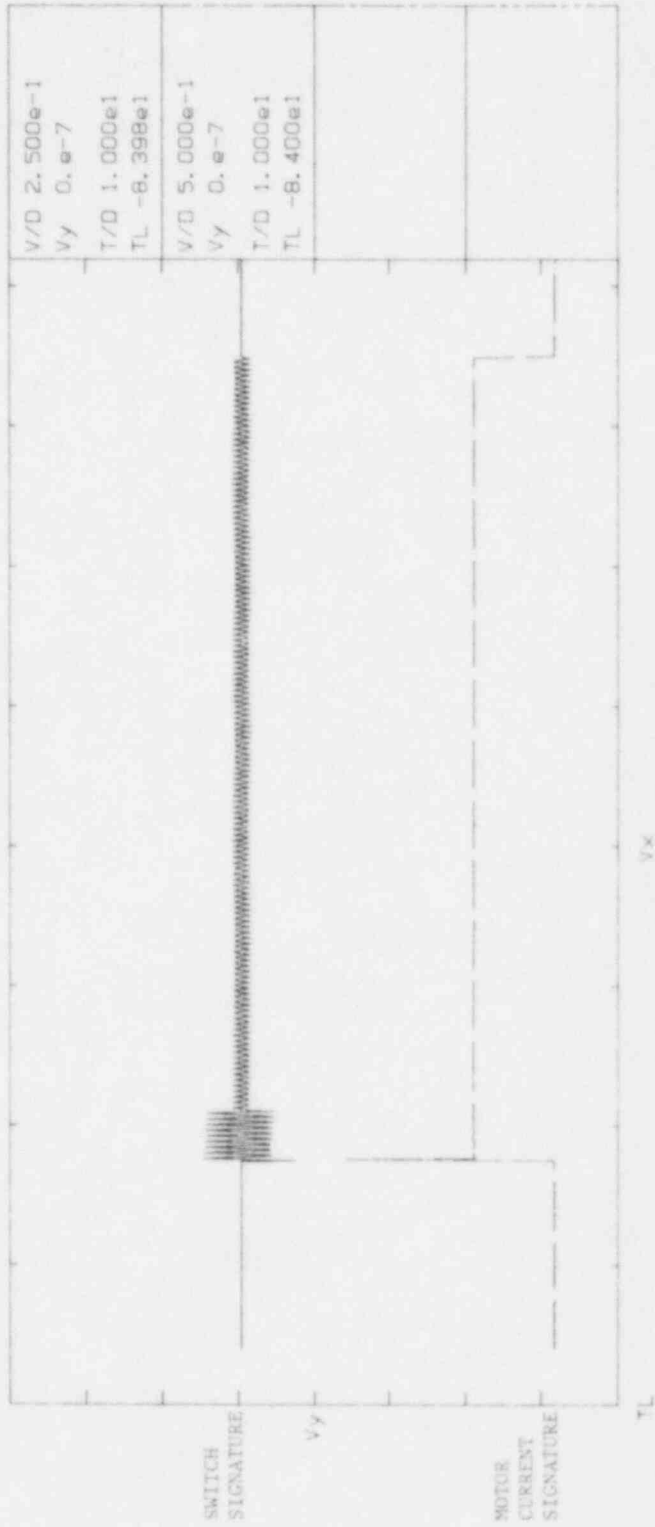
STROKE TIME : 57.4 SECONDS

PEAK INRUSH : 20.05 AMPERES
 AVE. RUN CURRENT : 5.35 AMPERES
 MAX. RUN CURRENT : 5.35 AMPERES
 END CURRENT : 5.31 AMPERES

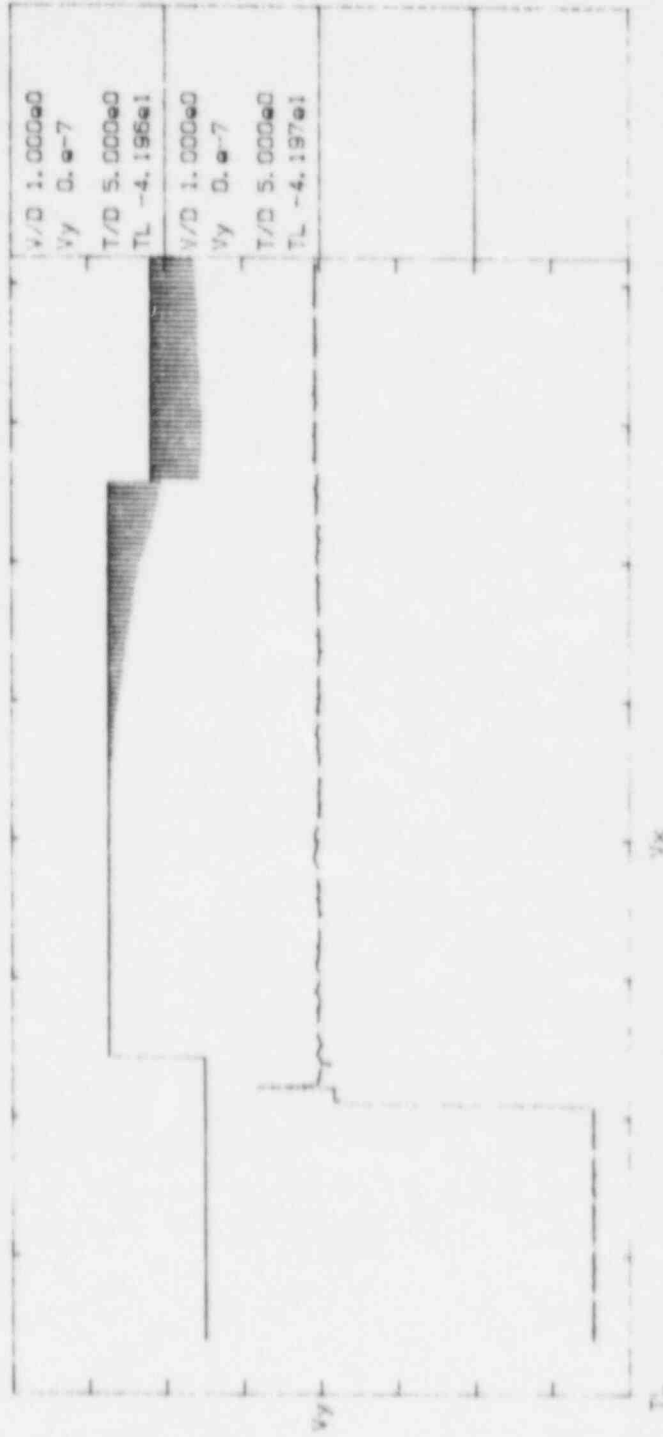
TMC & SWITCHES: CLOSE TO OPEN

STROKE TIME : 22.45 SECONDS AVE RUN THRUST : 0.284 V
 BYPASS TIME : 1.72 MAX RUN THRUST : 0.334 V
 UNSEATING TIME : 0.81 SECONDS UNSEATING THRUST : 1.204 U
 PROTECTION MARGIN : 0.91 SECONDS THRUST AT CST : N/A
 TORQUE SW. SETTING: 2.0/2.0

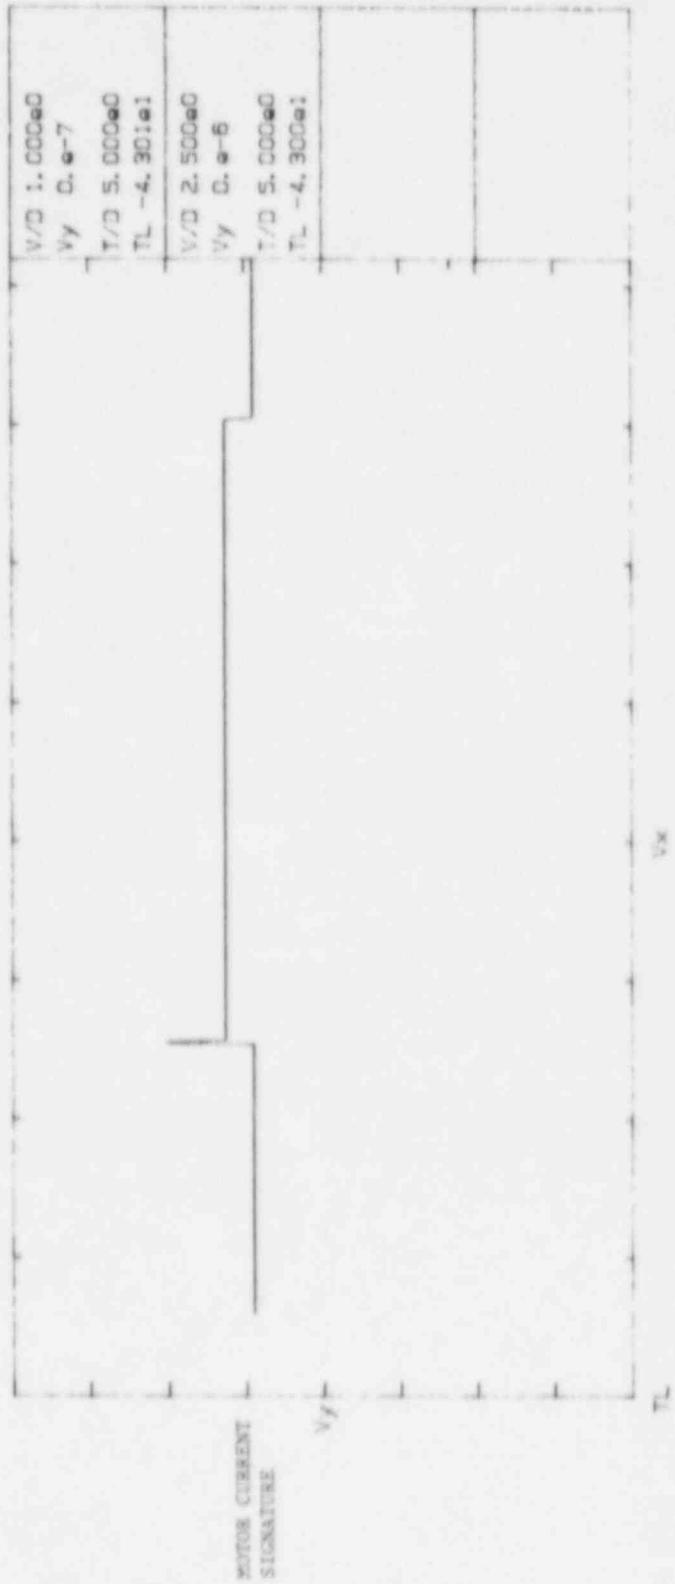
MOTOR CURRENT : CLOSE TO OPEN

STROKE TIME	: 22.47	SECONDS	PEAK INRUSH	: 12.7	AMPERES
			AVE. RUN CURRENT	: 3.66	AMPERES
			MAX. RUN CURRENT	: 3.66	AMPERES
			END CURRENT	: 3.66	AMPERES

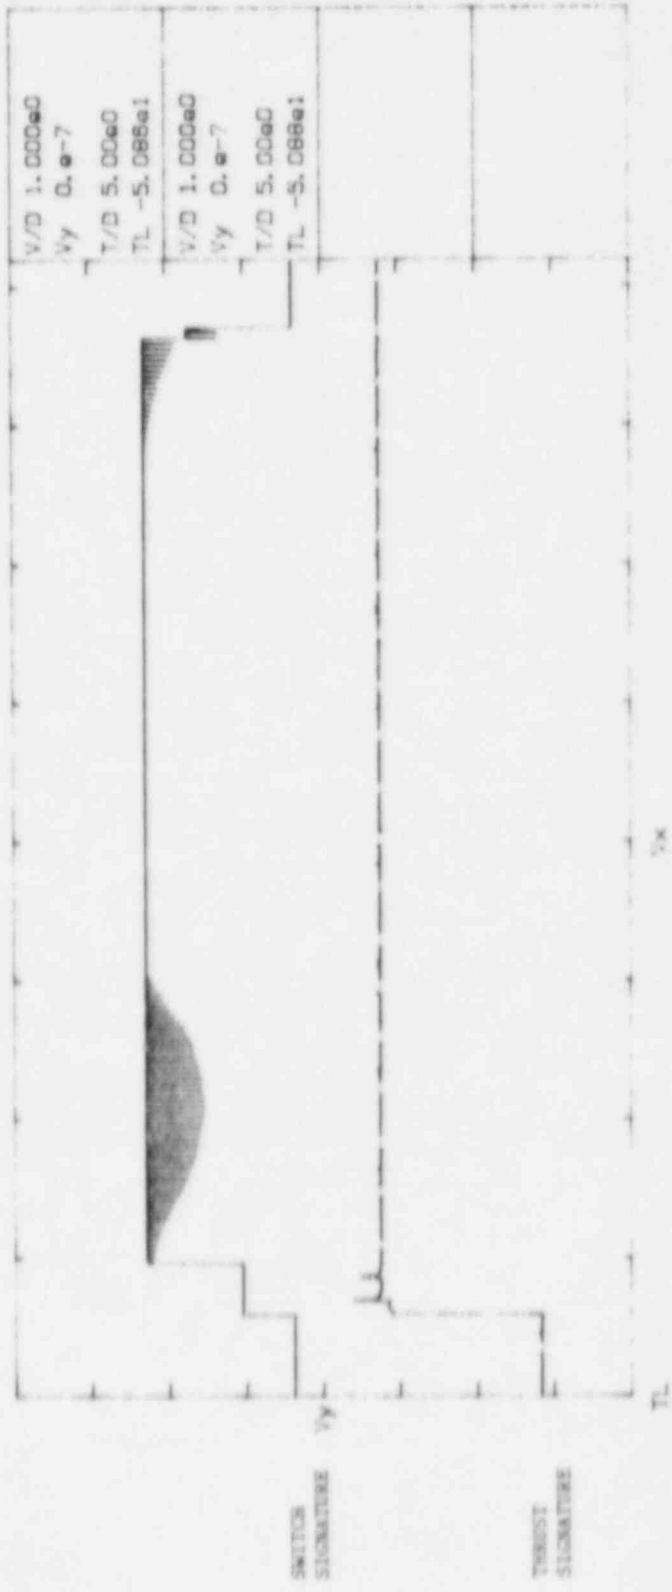
TRND & SWITCHES: CLOSE TO OPEN

STROKE TIME : 29.04 SECONDS MAX RUN THRUST : 0.026 U
 BYPASS TIME : 1.3 SECONDS MIN RUN THRUST : 0.026 V
 UNSEATING TIME : 0.54 SECONDS UNSEATING THRUST : PRELOAD
 PROTECTION MARGIN : 0.76 SECONDS THRUST AT CST : N/A
 TORQUE SM. SETTING: 2.25/2.25

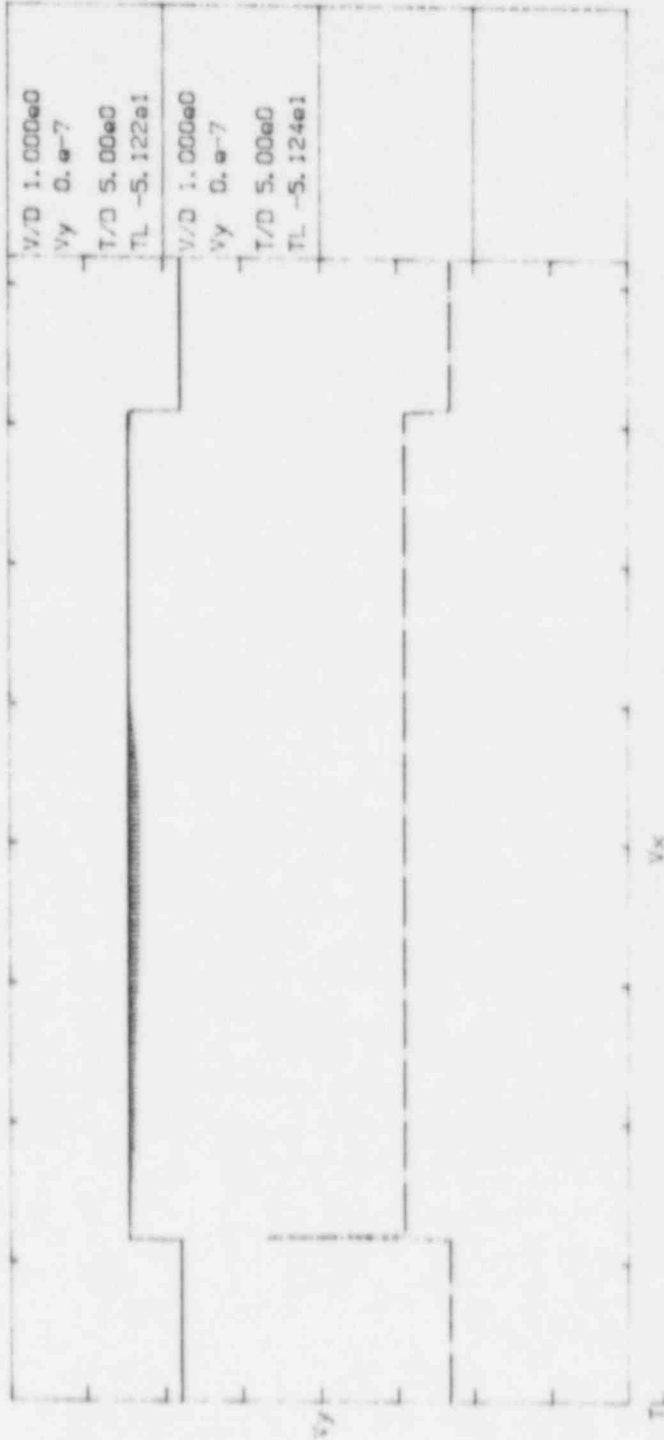
MOTOR CURRENT & SWITCHES: OPEN TO CLOSE

STROKE TIME : 29.64 SECONDS
 PEAK INRUSH : 23.7 AMPERES
 AVE. RUN CURRENT : 5.96 AMPERES
 MAX. RUN CURRENT : 5.96 AMPERES
 SEATING CURRENT : 5.88 AMPERES

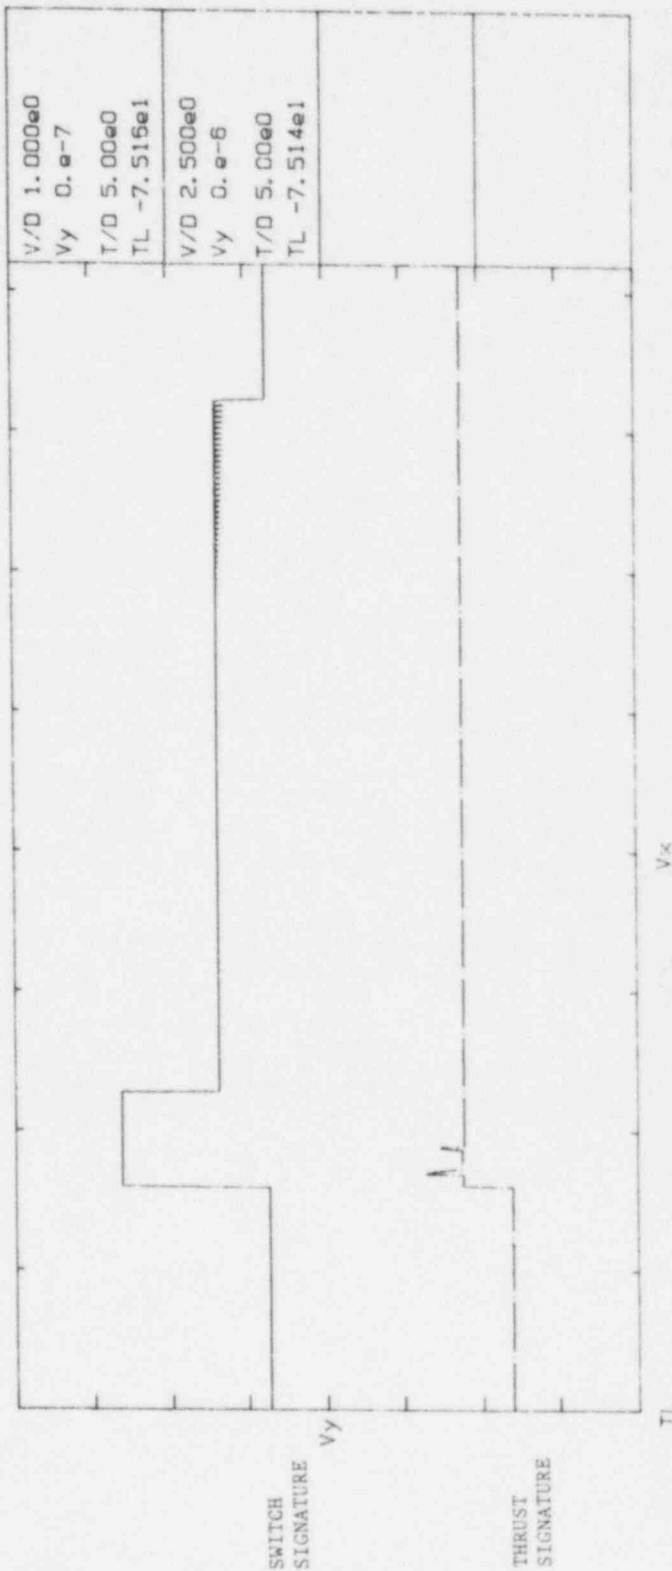
TMD & SWITCHES: CLOSE TO OPEN

STROKE TIME	: 28.12	SECONDS	AVE RUN THRUST	: <PRELOAD
BYPASS TIME	: 5.32	SECONDS	MAX RUN THRUST	: <PRELOAD
UNSEATING TIME	: 3.46	SECONDS	UNSEATING THRUST	: 6330 #
PROTECTION MARGIN	: 1.86	SECONDS	THRUST AT CST	: N/A
			TORQUE SW. SETTING	: 2.25/2.5

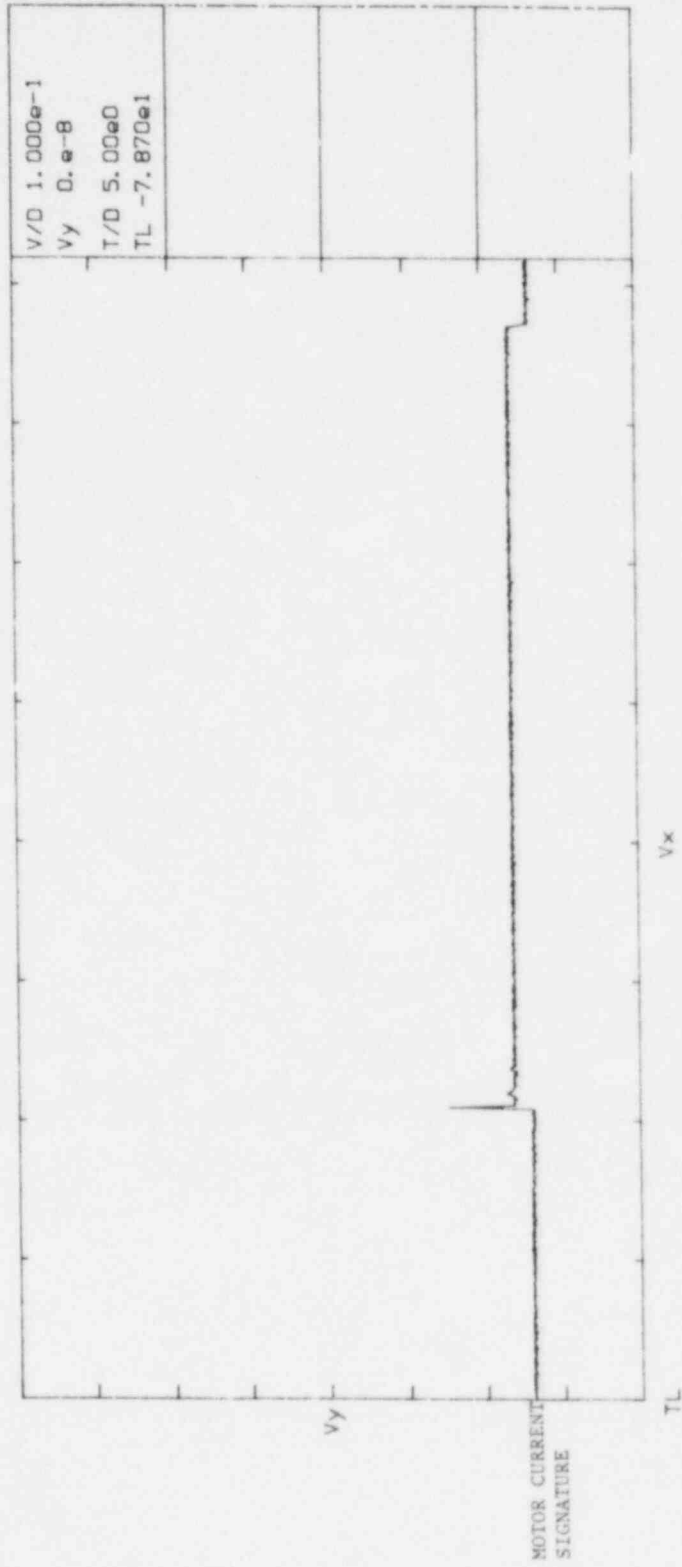
MOTOR CURRENT & SWITCHES: CLOSE TO OPEN

STROKE TIME : 28.28 SECONDS PEAK INRUSH : 9.56 AMPERES
AVE. RUN CURRENT : 2.2 AMPERES
MAX. RUN CURRENT : 4.4 AMPERES
END CURRENT : 5.1 AMPERES

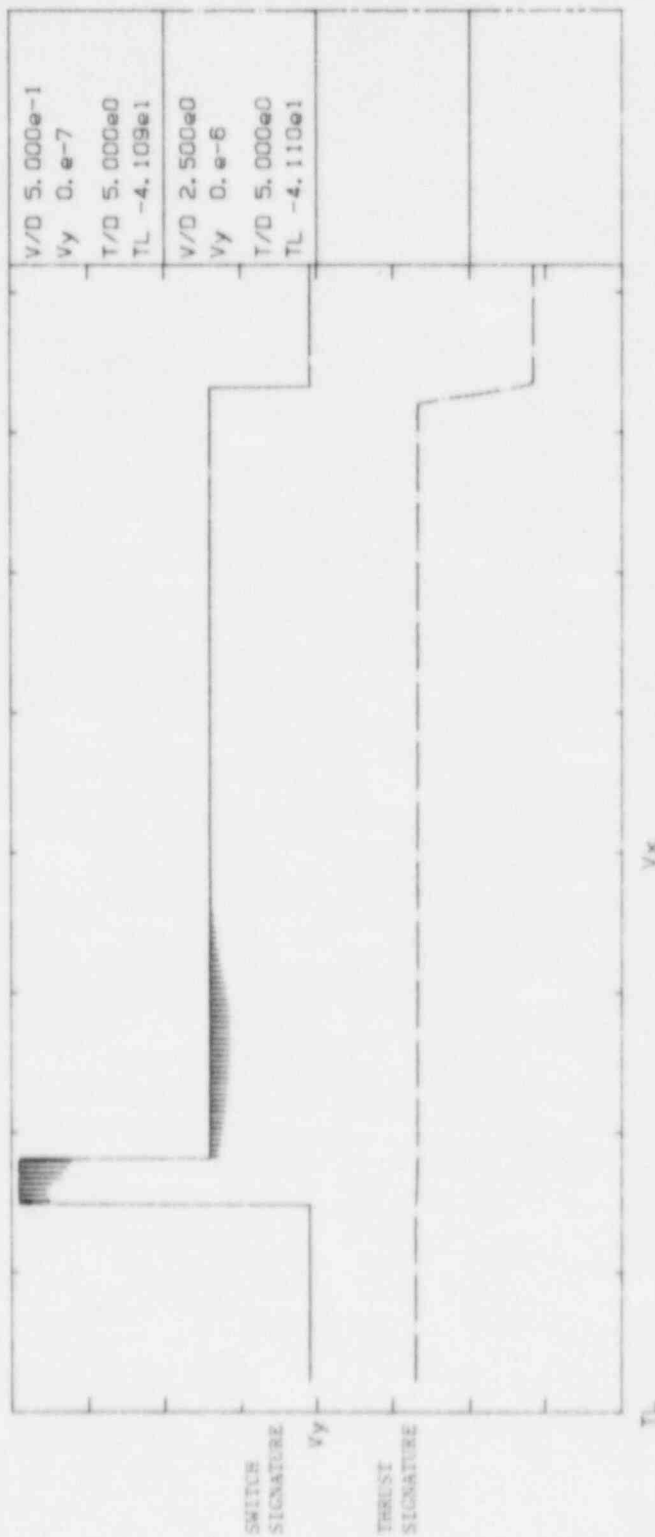
STROKE TIME : 29.13 SECONDS
 BYPASS TIME : 1.6 SECONDS
 TORQUE SW. SETTING: 2.5/2.5

A/E RUN THRUST : <PRELOAD
 MAX RUN THRUST : <PRELOAD
 THRUST AT CST : 72042 #
 SEAT THRUST AT CST: 72042 #
 INERTIAL THRUST : 18 %
 TOTAL THRUST : 83980 #

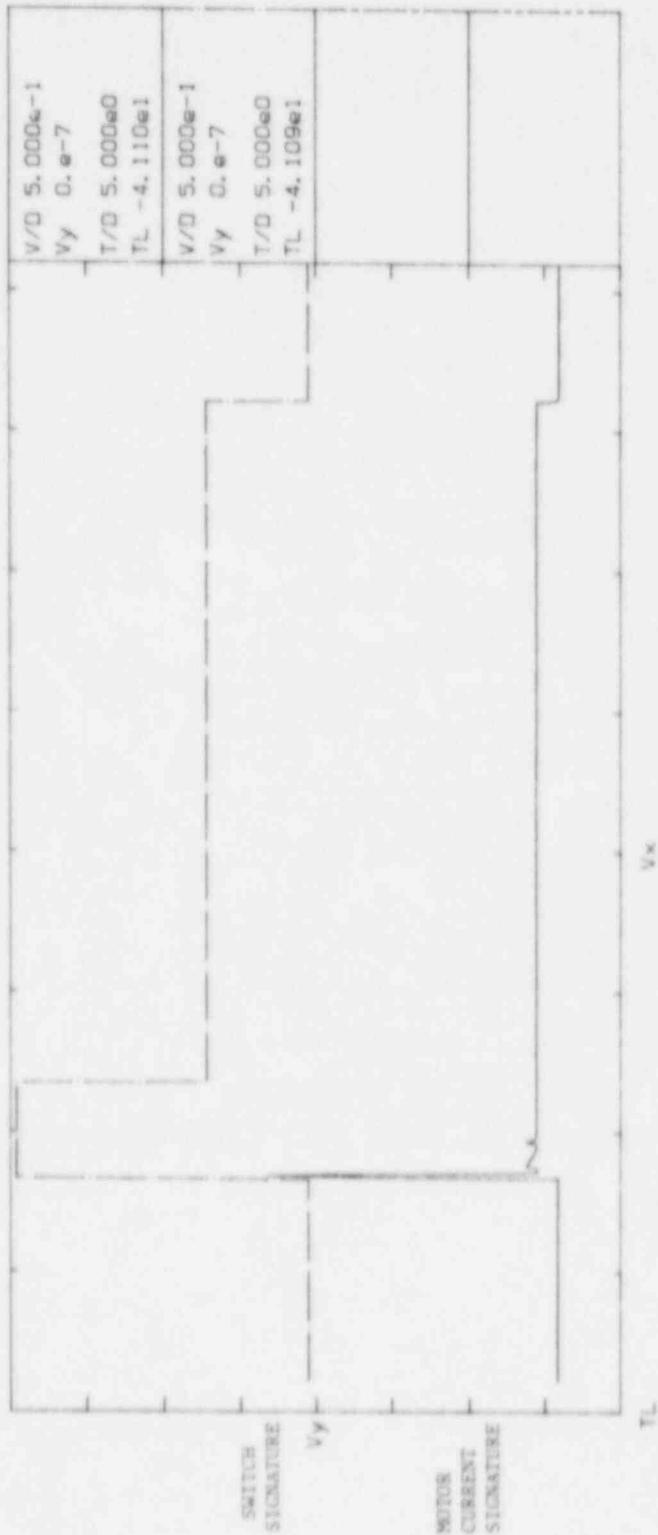
MOTOR CURRENT & SWITCHES: CLOSE TO OPEN

STROKE TIME : 27.71 SECONDS
PEAK INRUSH : 190.3 AMPERES
AVE. RUN CURRENT : 14.3 AMPERES
MAX. RUN CURRENT : 14.3 AMPERES
END CURRENT : 13.8 AMPERES

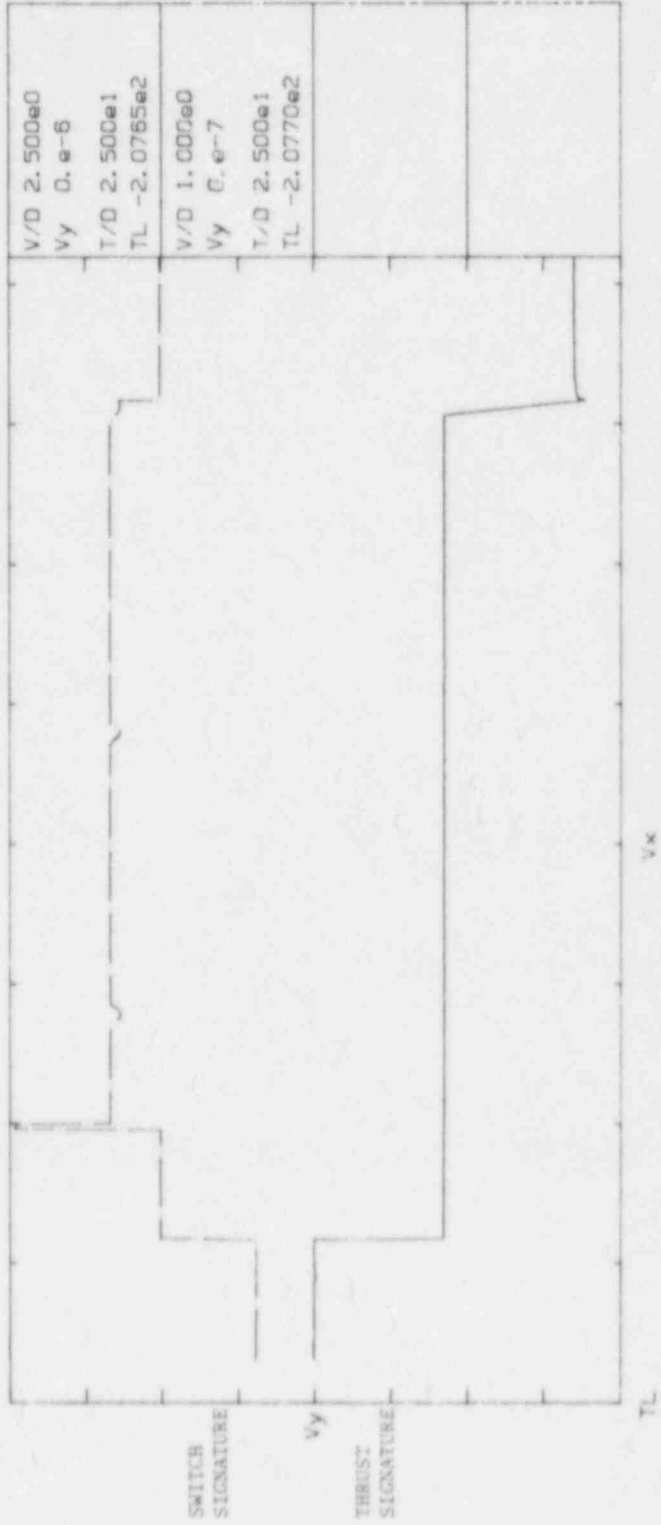
STROKE TIME : 130.2 SECONDS
 BYPASS TIME : 0.95 SECONDS
 TORQUE SH. SETTING: 3.2/3.2

W/E RUN THRUST : <PRELOAD
 MAX RUN THRUST : <PRELOAD
 THRUST AT CST : 127982 #
 SEAT THRUST AT CST: 127982 #
 INERTIAL THRUST : 3%
 TOTAL THRUST : 131807 #

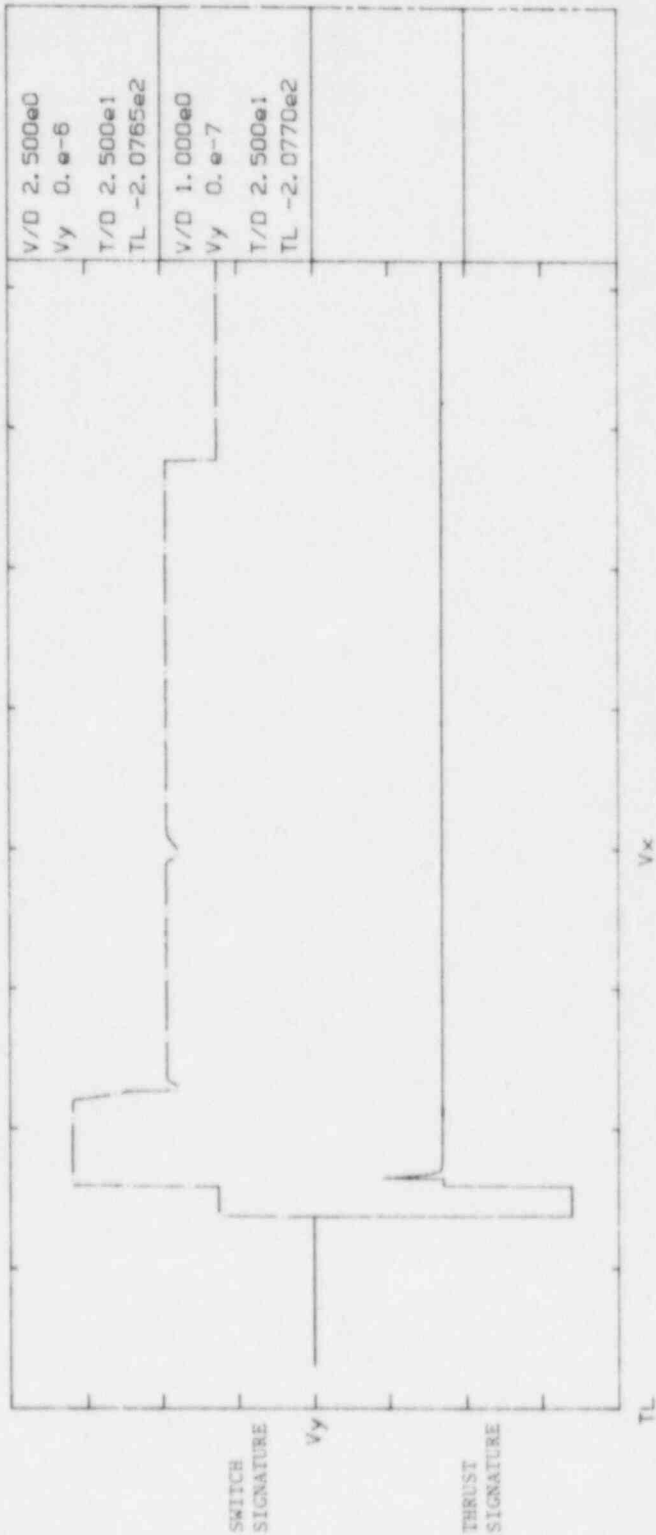
TMD & SWITCHES: CLOSE TO OPEN

STROKE TIME	: 129.35	SECONDS	AVE RUN THRUST	: 0.000e0
BYPASS TIME	: 17.05	SECONDS	MAX RUN THRUST	: 0.000e0
UNSEATING TIME	: 3.4	SECONDS	UNSEATING THRUST	: 70264 #
PROTECTION MARGIN	: 13.65	SECONDS	THRUST AT CST	: N/A
			TORQUE SW. SETTING:	: 3.2/3.2

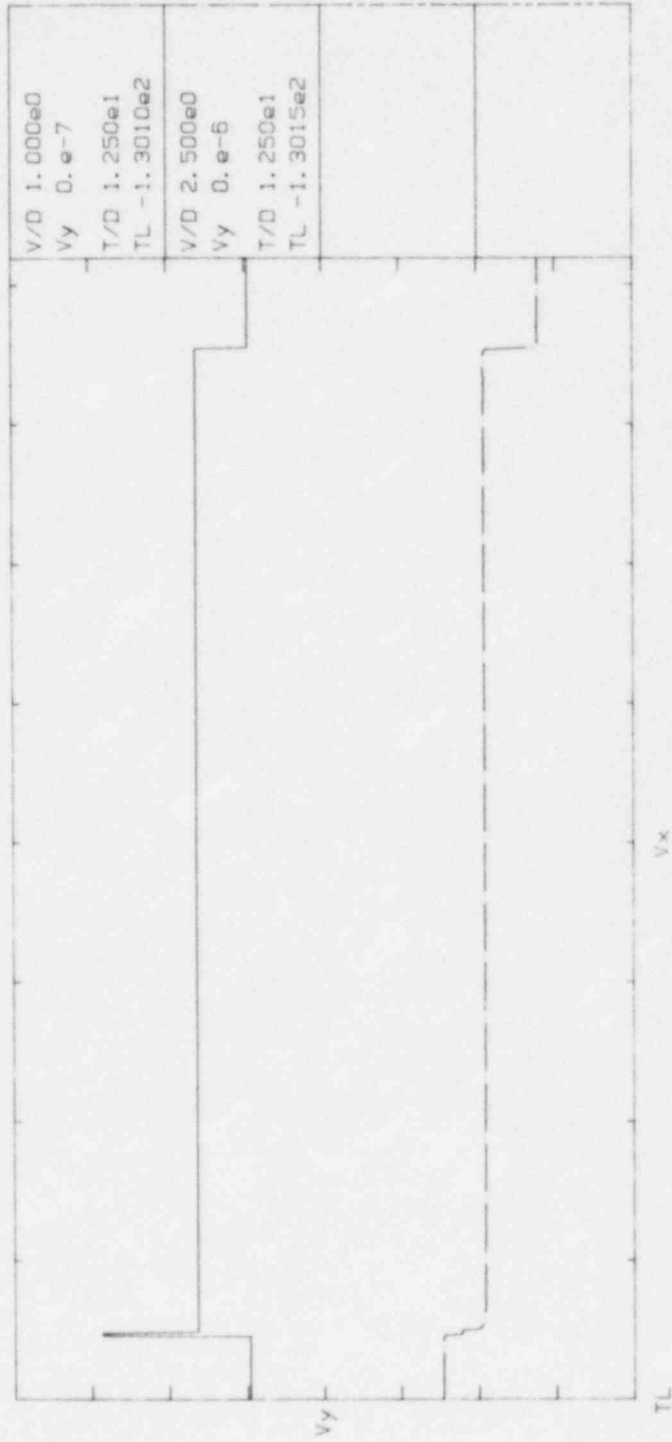
TMC & SWITCHES: OPEN TO CLOSE

STROKE TIME : 88.5 SECONDS AVE RUN THRUST : 4081 #
 BYPASS TIME : 0.25 SECONDS MAX RUN THRUST : 4164 #
 TORQUE SW. SETTING: 2.5/1.5 THRUST AT CST : 8991 #
 SEAT THRUST AT CST: 4909 #
 INERTIAL THRUST : 51 %
 TOTAL THRUST : 13652 #

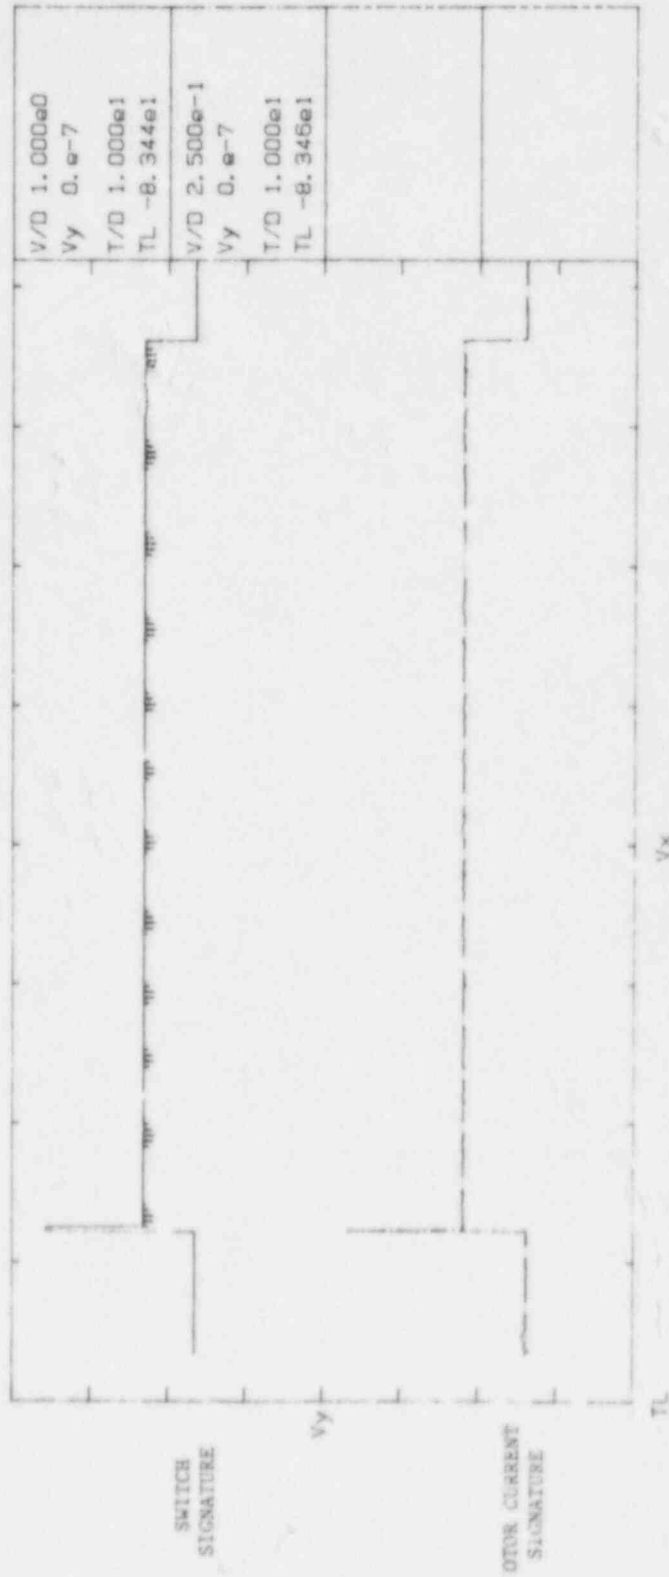
MOTOR CURRENT & SWITCHES: OPEN TO CLOSE

STROKE TIME : 03.84 SECONDS PEAK INRUSH : 7.15 AMPERES
 AVE. RUN CURRENT : 2.28 AMPERES
 MAX. RUN CURRENT : 2.28 AMPERES
 SEATING CURRENT : 2.35 AMPERES

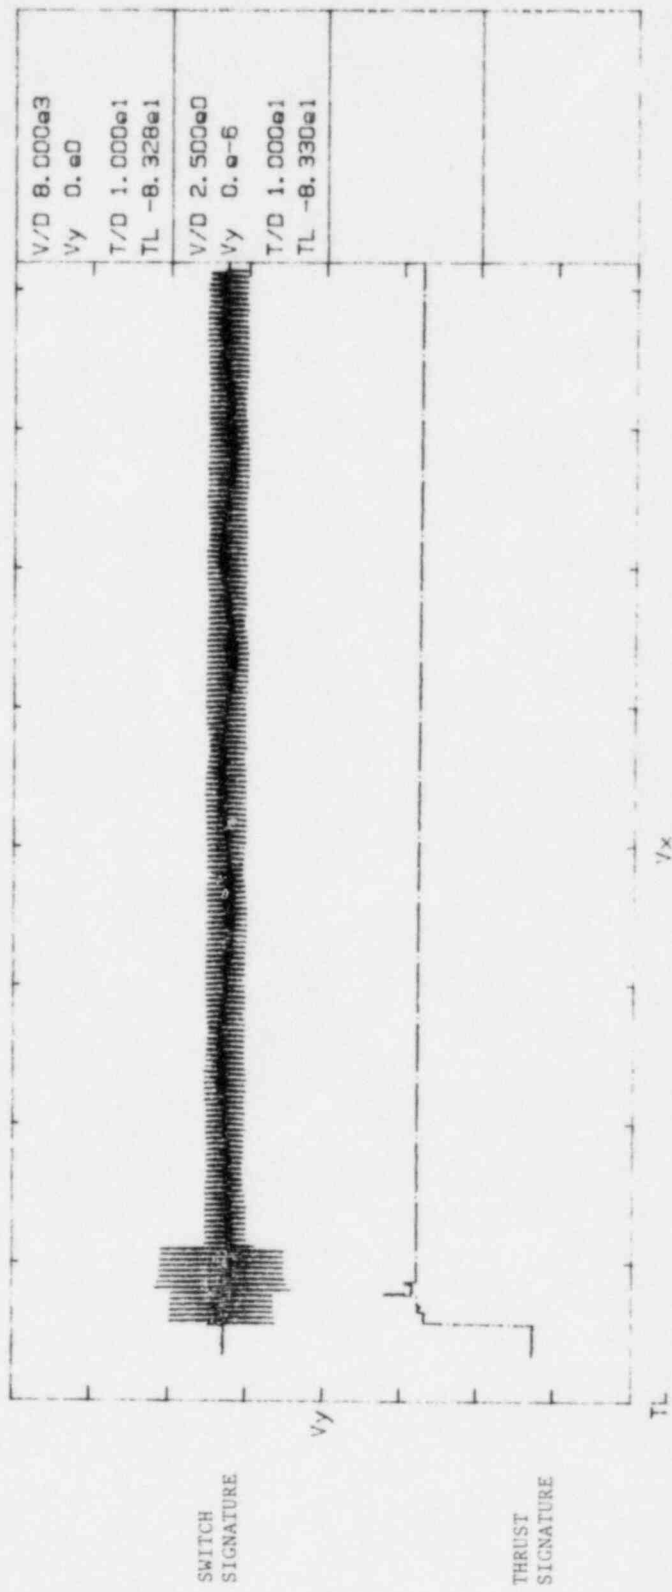
TMD & SWITCHES: CLOSE TO OPEN

STROKE TIME	: 75.6	SECONDS	AVE RUN THRUST	: 0.215	V
BYPASS TIME	: 5.6	SECONDS	MAX RUN THRUST	: 0.265	V
UNSEATING TIME	: 3.06	SECONDS	UNSEATING THRUST	: 0.66	V
PROTECTION MARGIN	: 2.54	SECONDS	THRUST AT CST	: N/A	
			TORQUE SW. SETTING	: 2.0/2.0
