NUREG/CR-4324

Testing of Nuclear Qualified Cables and Pressure Transmitters in Simulated Hydrogen Deflagrations to Determine Survival Margins and Sensitivities

Vincent J. Dandini

Prepared by
Sandia National Laboratories
Albuquerque, New Mexico 87185 and Livermore, California 94550
for the United States Department of Energy
under Contract DE-AC04-76DP00789

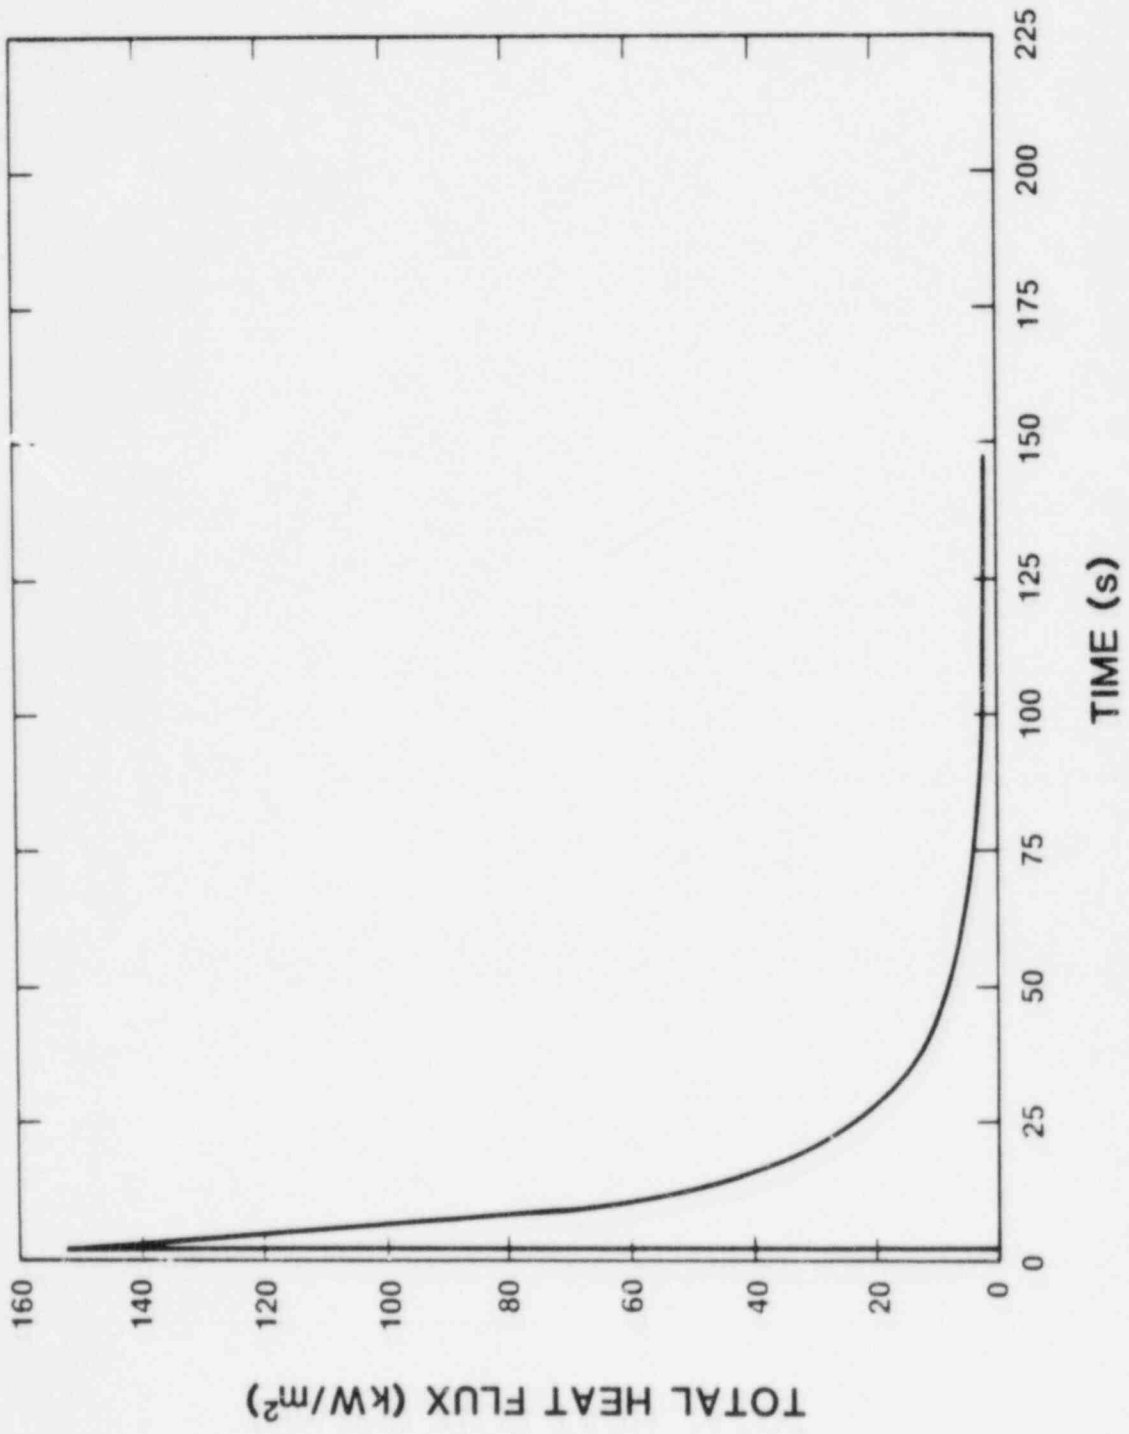
Figure 2-1. Average Total Heat Flux During the EPRI-NTS P20 Burn

The average total and average radiant heat fluxes produced by the EPRI-NTS 13 percent burn were determined using the SMOKE data reduction and analysis code.¹¹ These fluxes, the results of some of the earliest SMOKE analyses, are shown in Figures 2-1 and 2-2. The convective heat flux was taken to be the difference between the total and radiative fluxes.

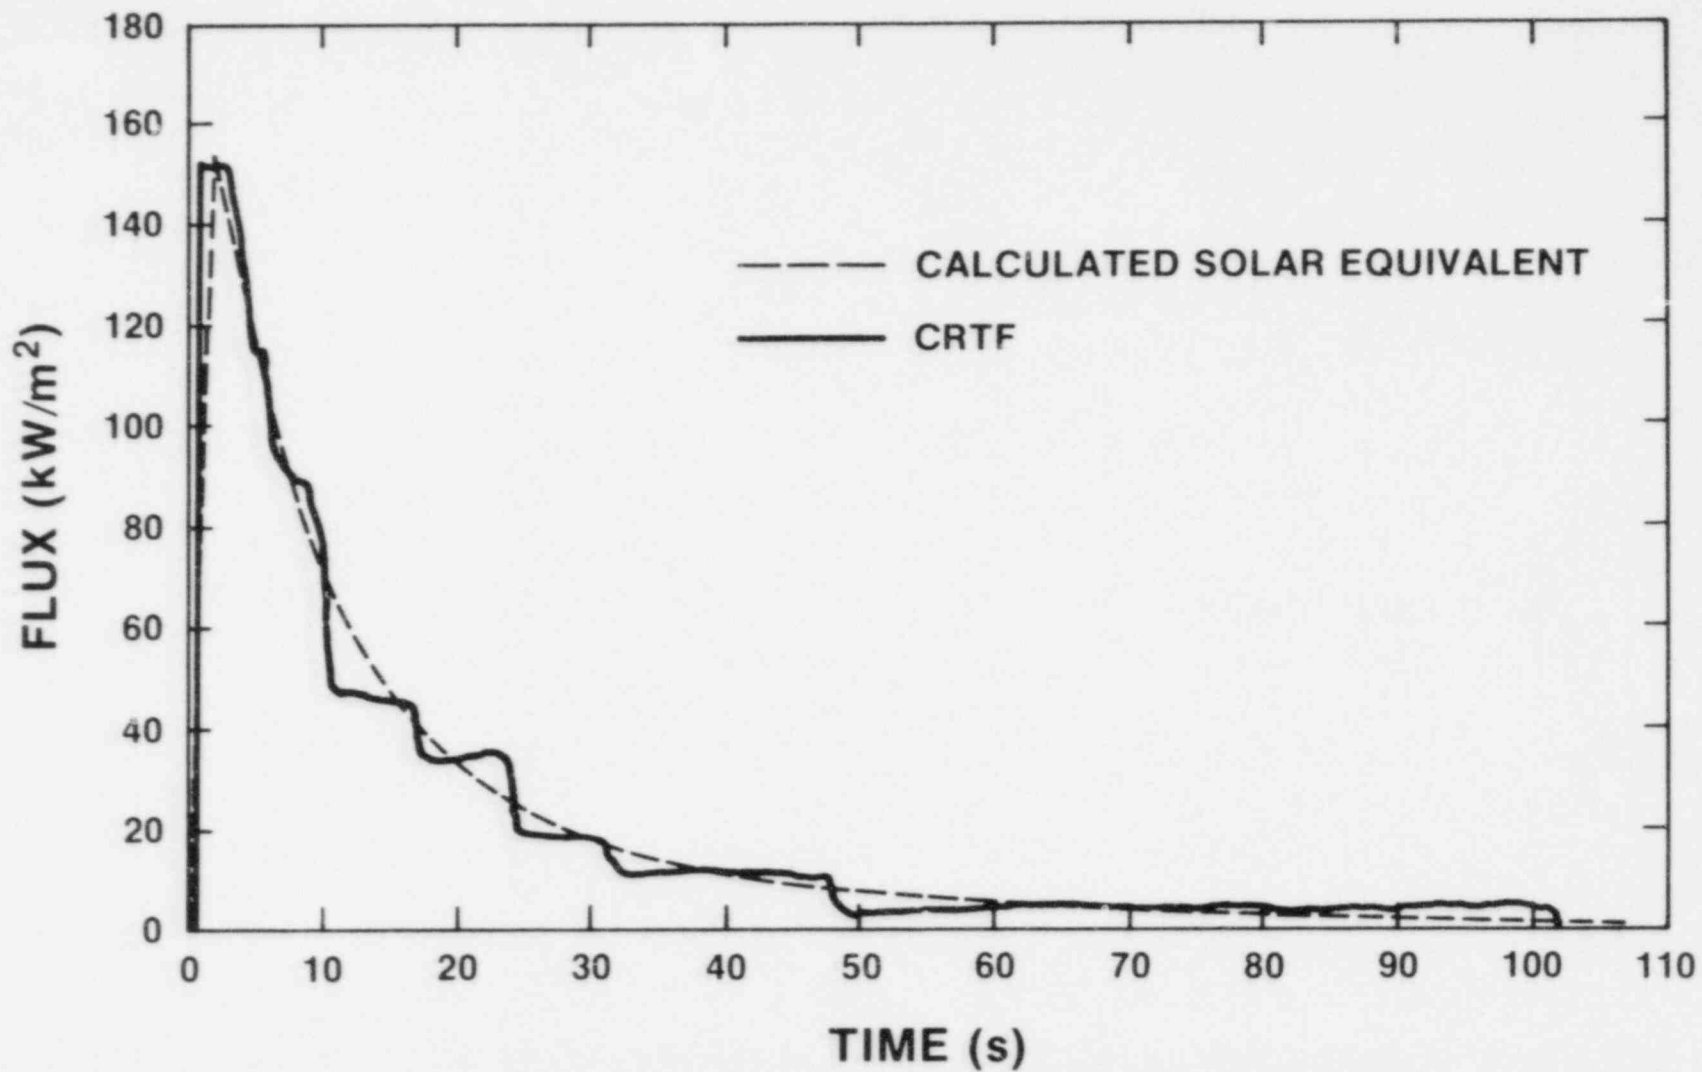
Figure 2-3. Cable Factor 1.0 CRTF Heat Flux Profile

Using the methods introduced in Reference 6, a separate set of solar heat flux profiles was determined for the transmitter and cable samples. The severity of the first profile corresponded to the EPRI-NTS P20 test and is equivalent to the sum of incident radiative and convective heat fluxes during that test. Subsequent profiles increased the heat flux at corresponding times in the pulse in 50 percent increments of the first pulse flux. Thus, at a given time in the second pulse the flux level was 1.5 times that of the first pulse. At the same time in the third pulse the flux level was 2.0 times the first pulse flux level and so on.

Once the equivalent solar heat flux profiles were calculated, appropriate heliostats (solar reflecting mirrors) were selected from the CRTF heliostat array whose sum of flux-on-target capabilities was equal to the peak calculated flux. A removal scheme for these heliostats, corresponding to the flux decay of the calculated solar pulse, was then programmed into the CRTF heliostat control computer. The first flux profile in the cable profile sequence is shown in Figure 2-3. This profile corresponds in severity to the EPRI-NTS P20 test and in the sequence of cable profiles was designated the Cable Factor 1.0 Profile. The profile whose flux levels throughout the pulse were 1.5 times as great as the P20 base pulse fluxes was designated Factor 1.5, and so on. Thus, the integrated incident heat flux for each pulse, when compared to the base pulse, also corresponds to its factor designation.

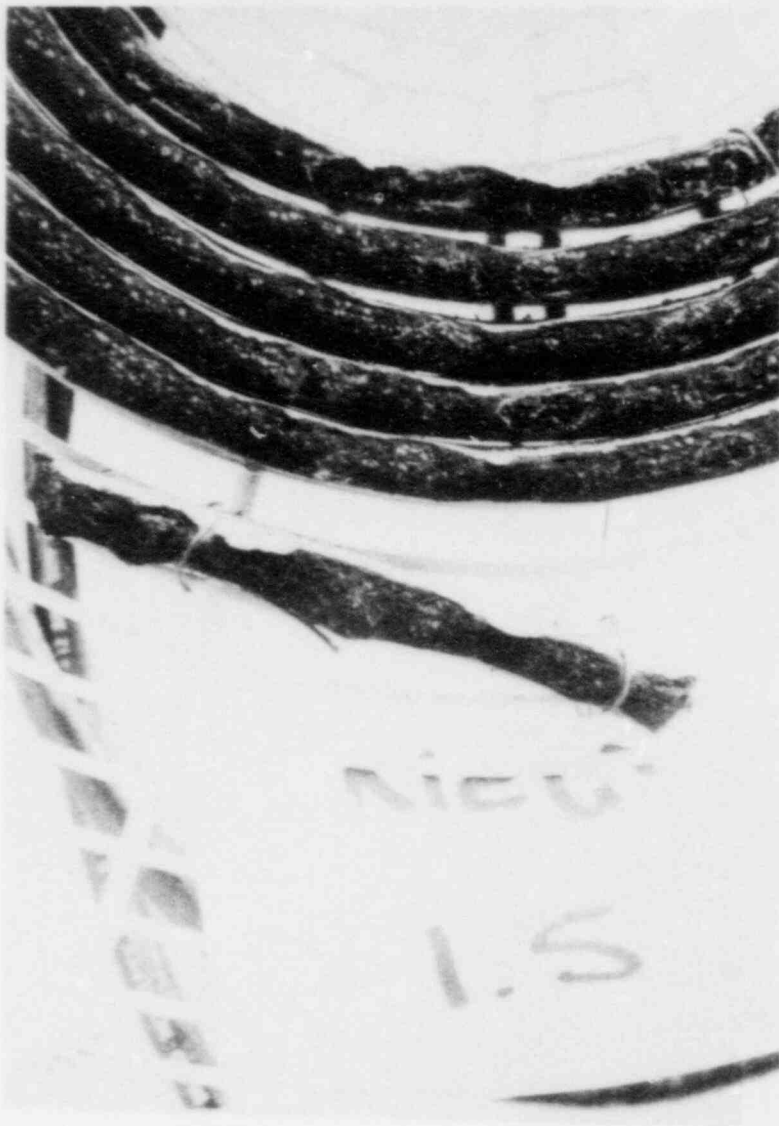
Figure 4-2. Factor 1.5 Cables After Exposure

After exposure, all samples exhibited charring and blistering. The degree of visible damage varied with the severity of the pulse (i.e., factor 1.0 damage was less severe than factor 1.5 damage) and the preconditioning of the sample (aged or unaged). Observed damage is summarized in Table 4-1. Posttest photos of the cable specimens are shown in Figures 4-1 through 4-5. All samples and their sample mount fixtures showed evidence of combustion to varying degrees. The factor 1.0 and 1.5 sample mounts had some scorch marks and light soot deposits on them. Beyond factor 1.5 the soot deposits were heavier with increasing flux factors. For both of the factor 1.0 samples the small wires used to hold the cables on the sample mount provided some very localized protection from the test environment. A shadow effect from the test bay shutter cable which hung a few inches in front of the samples is also evident on these two cable specimens. At exposures above factor 1.5 the combustion of the cable jacket material negated the shielding provided by the mount wires and shutter cable shadow. Generally, for each pair of samples, the damage was somewhat more severe for the unaged samples than for the aged samples. This may be due to the effects of the artificial aging. The aged cables were brought to that condition by baking them in an oven at 277°F for 168 hours. This technique of achieving accelerated aging has been adopted as a standard for equipment qualification.¹⁵ However, in terms of cable ignitability, this aging environment may have driven off many of the flammable jacket constituents which, in the unaged samples, were liberated and which ignited upon exposure to the heat flux pulse. The ignition of this additional fuel in the vicinity of the unaged cable samples would have resulted in a more severe local environment for those specimens. The flux levels of the higher factor pulses compensated for the missing cable jacket constituents and the damage to the aged and unaged cable specimens during the 2.5 and 3.0 exposures is more nearly the same.

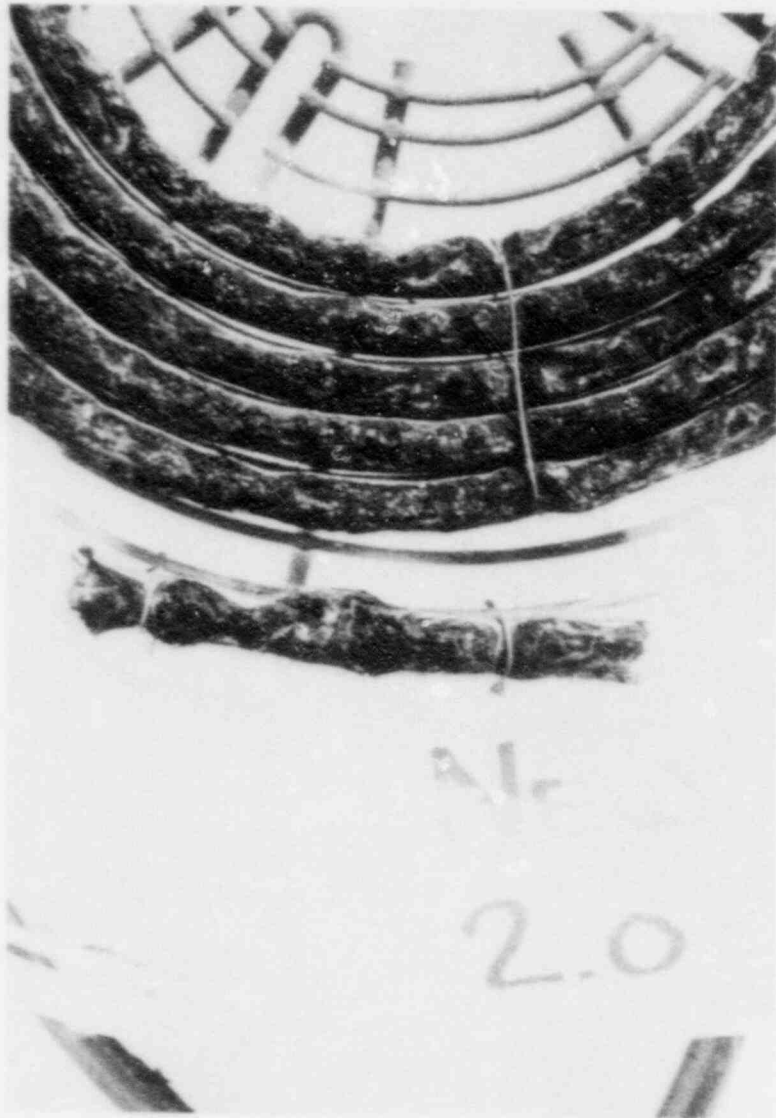
Figure 4-3. Factor 2.0 Cables After Exposure

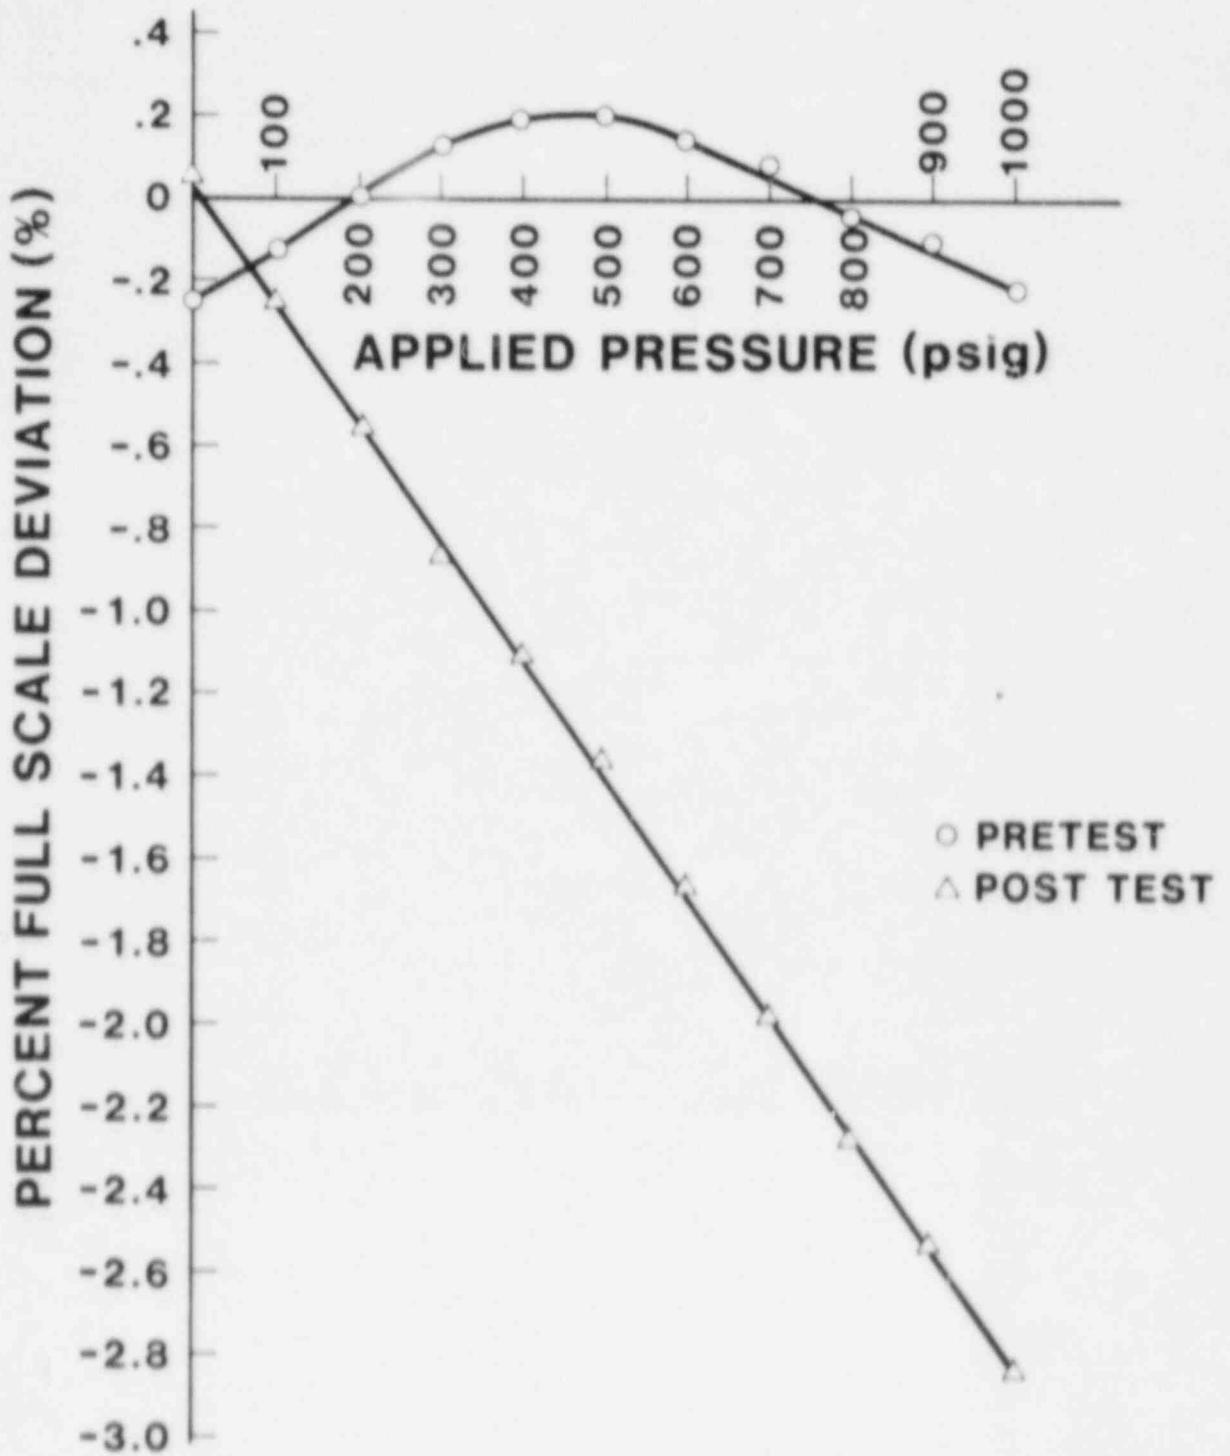
Figure 4-14. Unaged Transmitter Percent of Full-Scale Deviation From Pretest Calibration (Lab Check Results)

Applying this criteria to the unaged transmitter performance during the lab checks, Figure 4-14 shows that, prior to testing, the unaged instrument was well within specification over its full range of operation. After completion of the entire test series the deviation of the unaged transmitter fell outside the 0.8 percent range for applied pressures above approximately 300 psig. The maximum PFSD for the unaged instrument was -2.85 percent at 1000 psig applied pressure. The magnitude of this deviation is comparable to that of another unaged Barton Model 763 tested previously.⁹ That specimen was exposed to four simulated hydrogen burns whose severity was equal to a factor 1.0 exposure in the present test series. The largest deviation in that series was 2.4 percent at 1000 psig. Thus, though the present series of endurance tests was, *in toto*, much more severe than those described in Reference 9, the effect on the calibration of the unaged Barton Model 763 transmitter was about the same.

The aged transmitter's posttest PFSD curve is also different. The unaged transmitter's posttest deviation curve is a straight line. The aged transmitter's deviation curve is not linear. It is, however, approximately piecewise linear over two sections, 0 to 200 psig and 200 to 600 psig.

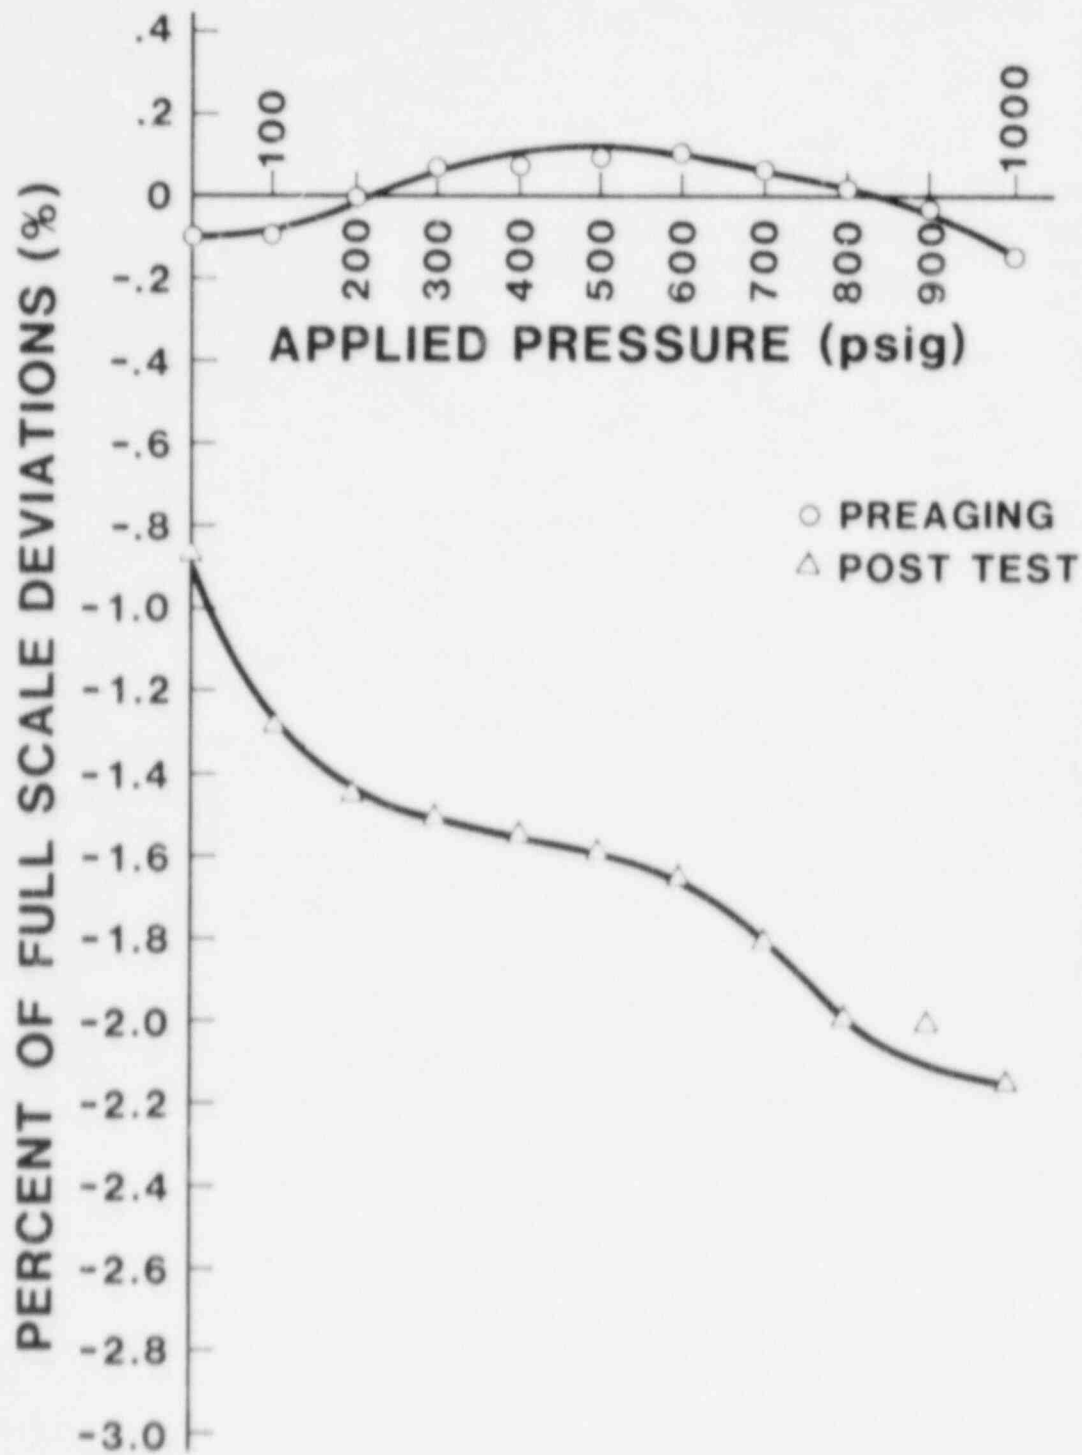
Figure 4-15. Aged Transmitter Percent of Full-Scale Deviation From Preaging Calibration (Lab Check Results)

The PFSD results for the aged Barton transmitter are shown in Figure 4-15. Prior to aging and testing, the PFSD characteristics of the sample were the same as those of the sample that was not aged. After testing the PFSD characteristics were different from those of the unaged sample. The aged transmitter was outside the ± 0.8 percent criterion over the entire range of operation. However, the magnitude of the largest PFSD is somewhat less than that of the unaged transmitter. The aged transmitter's largest posttest deviation is also at 1000 psig but it is only -2.15 percent as opposed to the -2.85 percent for the unaged instrument.
