FAILURE ANALYSIS AND STRUCTURAL INTEGRITY EVALUATION
OF LEAKING ALUMINUM-BRONZE
CAST VALVE BODIES AND FITTINGS IN THE ECW SYSTEM

Report for
Houston Lighting and Power Company
South Texas Project

Tech. Report No. 8804-06 FA
BLN No. 8804-07

May 11, 1988
Revision 0

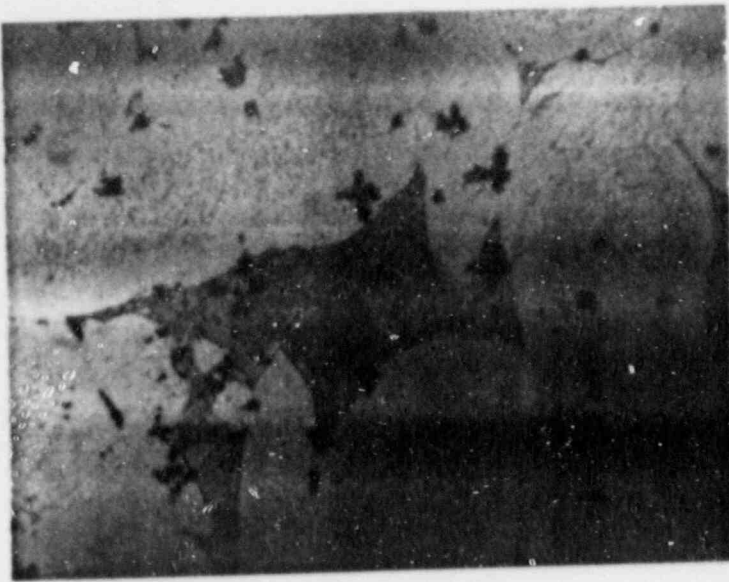
FIGURE 1.2b Typical Microstructures

Heat at 1150°F one hour
Water Quench

Source: Bechtel Valve 269

Heat at 1220°F one hour
Air Cool - Fan

Source: Bechtel Elbow
Heat No. H95-28-36

Heat at 1250°F one hour
Furnace Cool

Source: Bechtel Valve EW 269

- 2. Heat treating three samples from a valve, and cooling them in water, air and in the furnace, and comparing their microstructures.
- J. Metallurgical plastic replicas were taken from a laboratory specimen and directly from an elbow. A comparison of the photomicrographs taken at 480X of the lab specimen and the two replicas shows them to be essentially the same.

- B. In order to properly interpret the microstructure of Al-bronze, two actions were taken. The supplier of the raw castings was asked to send us photomicrographs of the typical microstructures of Al-bronze. Figure 1.2a is the information from them. Second, three small samples from Valve EW-0269 (serial No. 61-382) were heated above 1100°F for one hour. One sample was cooled in water, one in air and one was left in the furnace and slow cooled by turning off the power. Figure 1.2b shows the microstructure of the three specimens.

1. The valves and elbows contain gamma₂ phase, which indicate that the forced air cooling per the supplier's procedure did not prevent its formation.
 2. The microstructure of a fitting that was tempered and forced air cooled by Bechtel was identical to the as-received material. This confirms that forced air cooling does not prevent the formation of gamma₂.

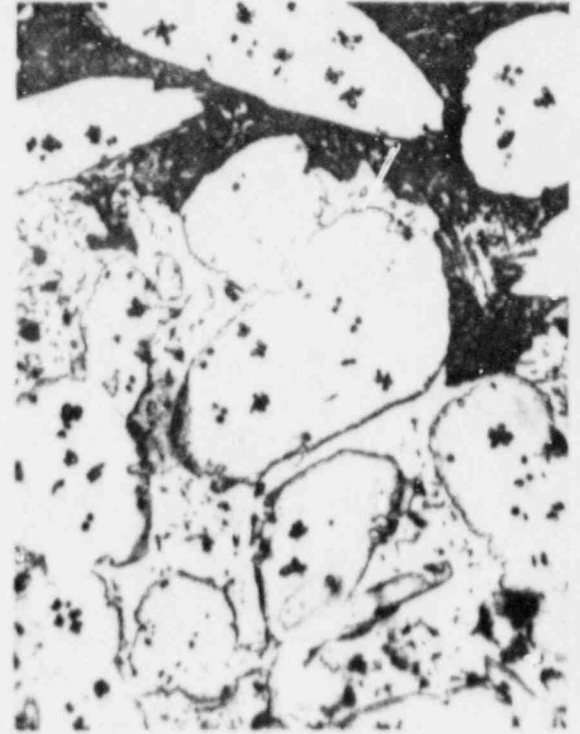
FIGURE 1.3 Valve EW 269

Mount 7040
2X
NH₄OH - H₂O₂ etch

Mount 7040
480X
NH₄OH - H₂O₂

Mount 7041
5X
NH₄OH - H₂O₂

- C. Cross sections were taken through the valve that leaked, the fitting (elbow) that leaked and the valve that did not leak. Table 1.1 compiles all the information obtained from this work and references the applicable figures that show the microstructures and macrostructures.

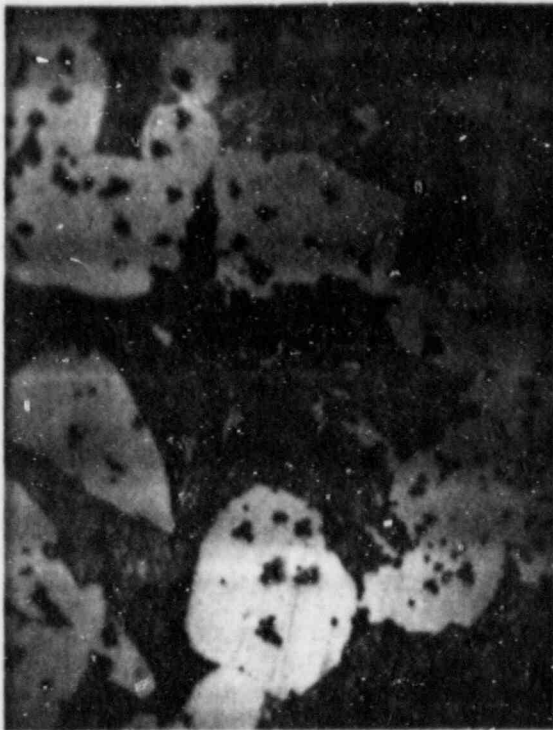
FIGURE 1.6 Comparison of replica micrograph with laboratory micrographs, Valve EW 269

480X Replica

Replica

480X

Laboratory Mount

- G. It is common practice to use a technique called replication at a field location, when a metallurgist wants to know the microstructure of a piece of equipment but can't cut out a sample of material. This method is well understood for carbon and stainless steels. In case it was needed in the field, a test was made to be sure that the techniques also work for Al-bronze. The standard field replication techniques for grinding, polishing and etching work quite well. Replicas were taken from a laboratory specimen and from an elbow polished and etched as if it was being done in the field. The photomicrographs of the two replicas and of the actual piece of material are almost identical (see Figure 1.6).

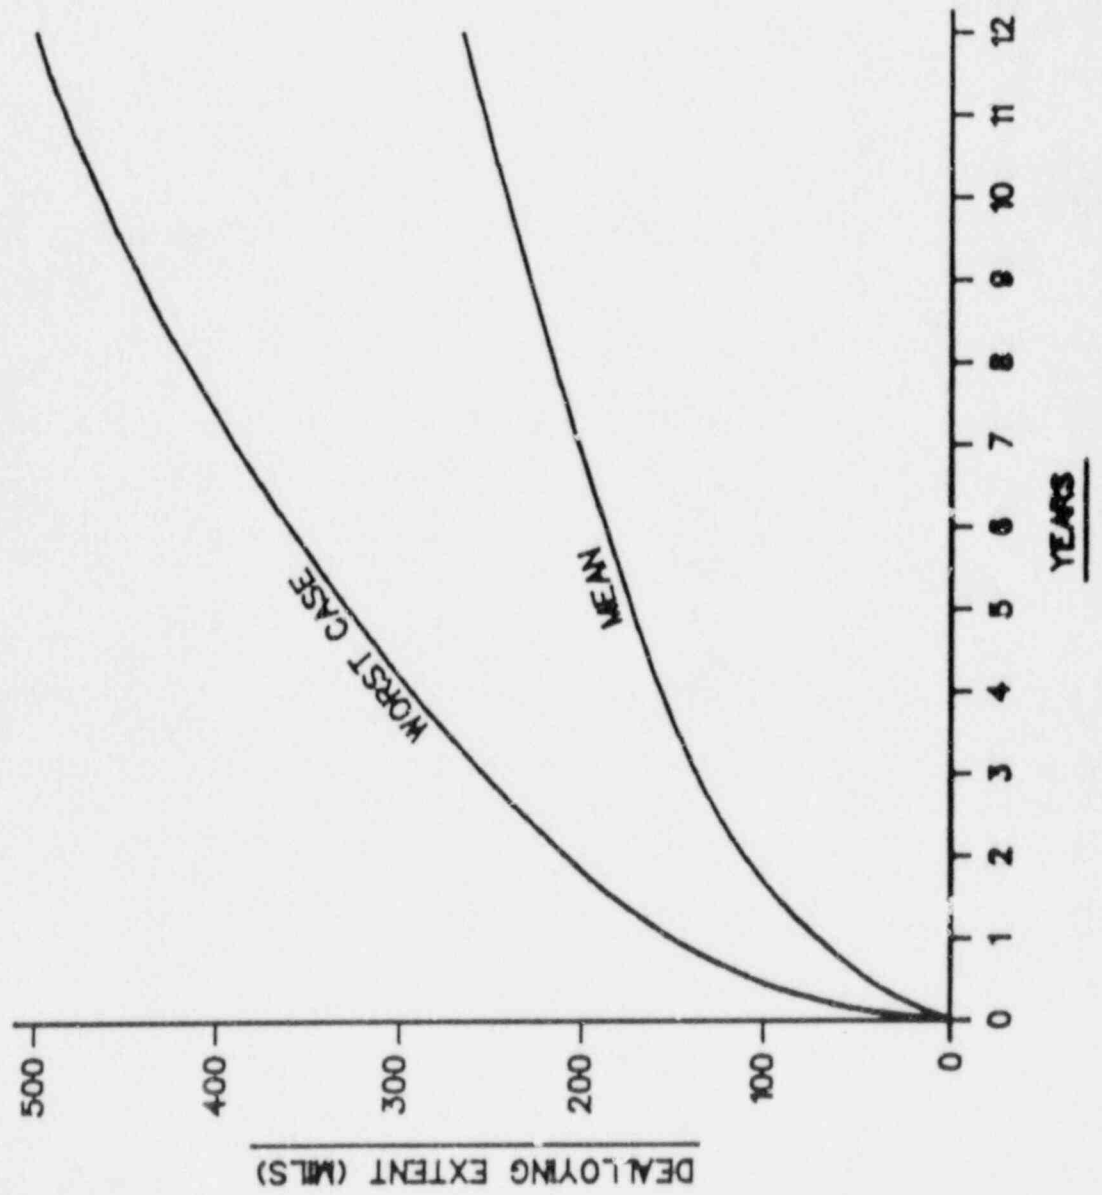
Ferrara and Caton report in reference 10 a maximum dealloying rate of 30 mpy after one year and 22.5 mpy after two years. Both Upton's and Ferrara's results are lower than the 44 mpy average and 83 mpy maximum estimated at STP. The maximum rates are based on the assumption that dealloying occurred in 3 years to 100 percent of the wall and the average rate assumes 50 percent. The STP socket data are plotted in Figure 2.6 based on the commonly used expression for corrosion rate:

DEALLOYING OF LEAKING
ALUMINUM BRONZE SOCKETS
