SARGENT & LUNDY Calc. For Establishing Required
 ENGINEERS Raceway/Cable Separation Distances
 CHICAGO

Calc.No. 19-BDA-1
 Rev.3 Date 2-11-86
 Page 1 of 22

Client: Illinois Power Company	Prepared by	Date
Project: Clinton Power Station	Reviewed by	Date 11-16
Proj.No.: 4536-35	Equip.No.	Approved by Date 11-86

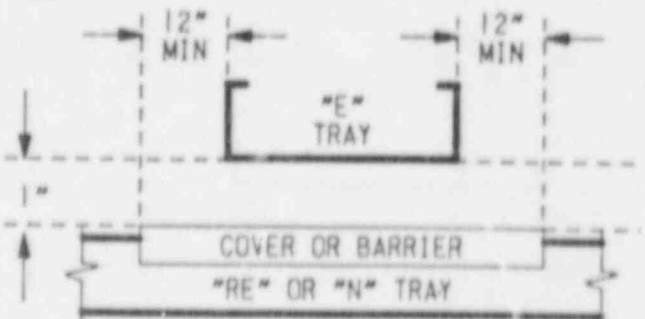
- (3) SAFETY TRAY CROSSING ABOVE REDUNDANT SAFETY OR NON-SAFETY TRAY WITH COVER OR BARRIER

CLEARANCE REQUIRED:

VERTICAL.....1"

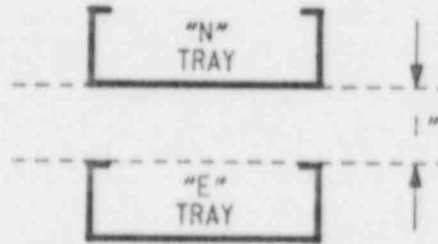
(4) NON-SAFETY TRAY ABOVE OR TO THE SIDE OF SAFETY TRAY

CLEARANCE REQUIRED:
VERTICAL.....1"

- A. Non-safety-related cable tray above safety-related cable tray (Figure 1-4).

Vertical.....(1")
