NUREG/CR-4219
Vol. 5, No. 1
ORNL/TM-9593/V5&N1

Heavy-Section Steel Technology Program Semiannual Progress Report for October 1987-March 1988

Engineering Technology Division

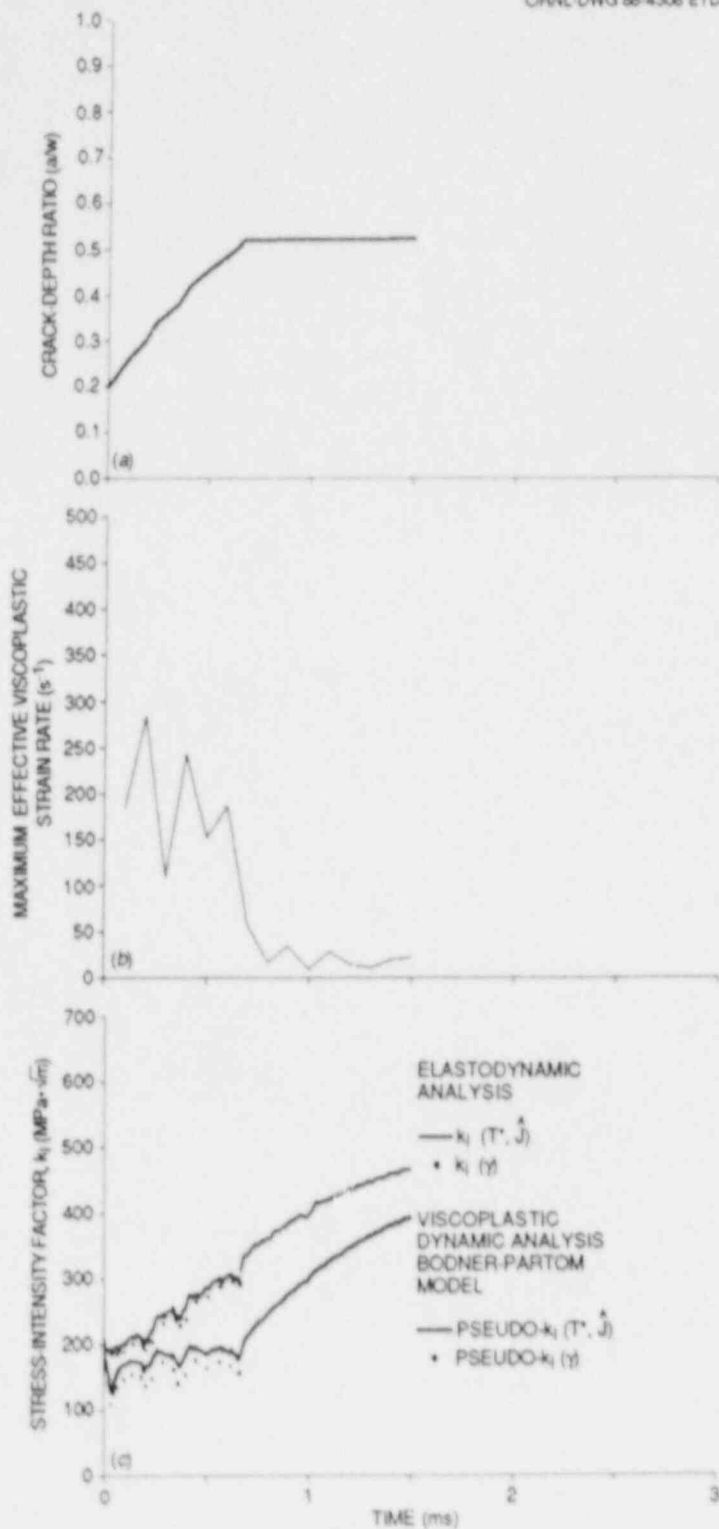
Fig. 2.9. Time histories of crack-depth ratio, maximum effective viscoplastic strain rate, and fracture parameters from analysis of wide-plate test WP-1.7. (a) Crack-depth ratio, (b) maximum effective viscoplastic strain rate, (c) fracture parameters.

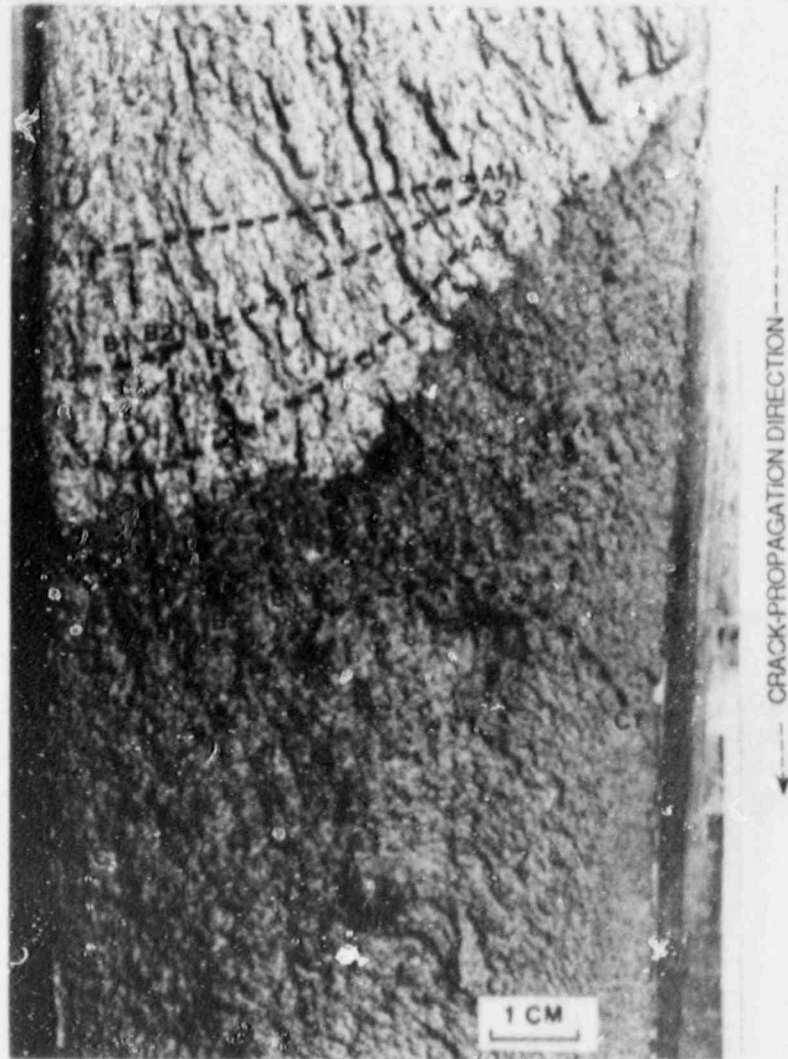
Figure 2.22 shows the area of the fracture surface used for topographic analysis and the location of the lines along which height measurements were made. Relative heights were determined along seven lines.

Fig. 2.22. Area of the fracture surface of WP-CE-1 specimen selected for optical topographic analysis.

Lines A1, A2, and A3 were estimated crack-front contours in the cleavage region. Lines B1, B2, and B3 were estimated forward-crack-extension lines crossing the crack arrest. Line C1 was an estimated crack-front contour line in the region of fibrous tearing. For each of the mating fracture surfaces, one surface point was selected for reference. All height measurements were made relative to the surface height at that point.

Figure 2.23 shows measurement results on lines A1, A2, and A3. The results are arranged as if the upper and lower fracture surfaces were held a small distance apart. The ordinate scale measures the separation of measurement points from a flat surface (the middle line) held above it

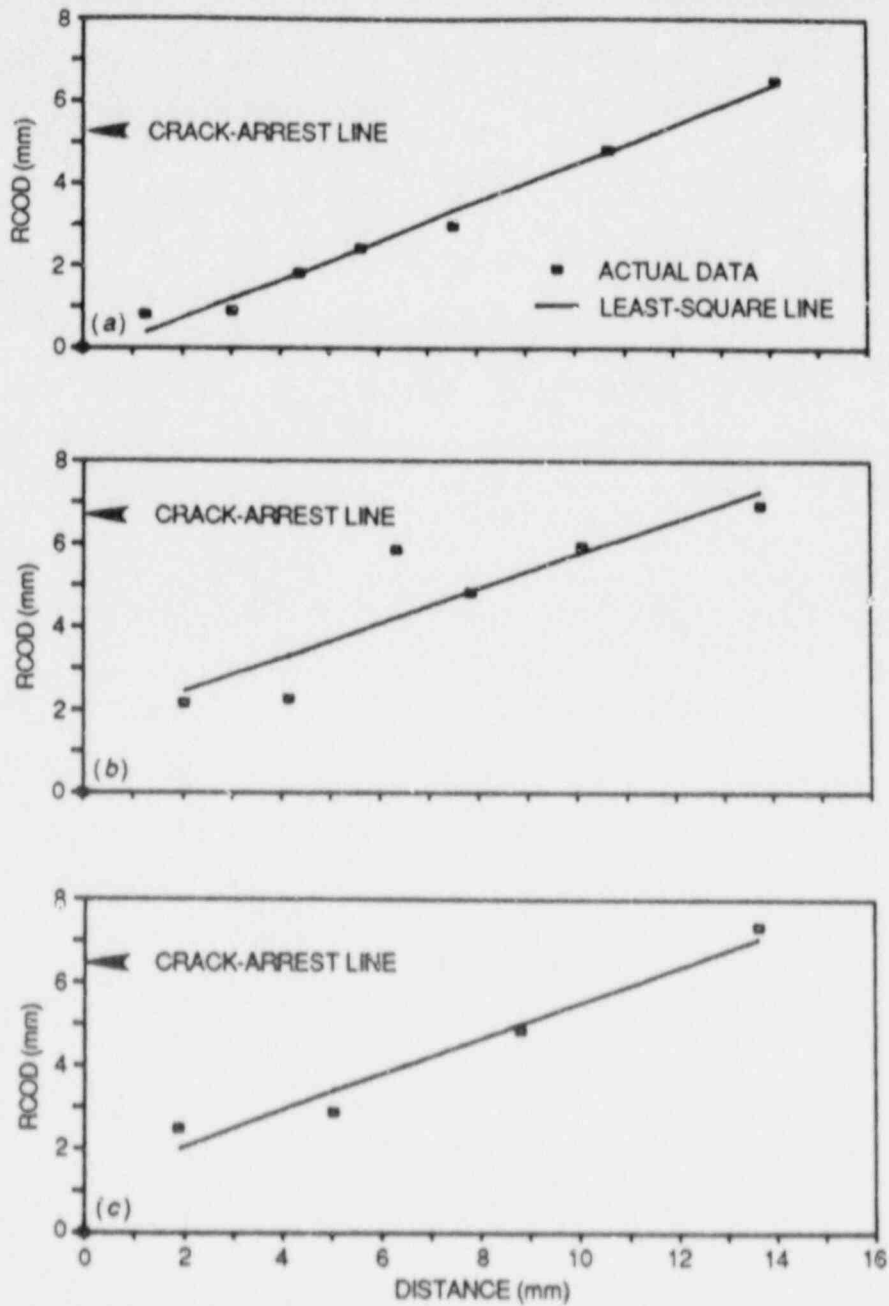
Fig. 2.26. RCOD vs distance from crack-arrest line for specimen WP-CE-1. (a) Line B1, (b) line B2, (c) line B3.

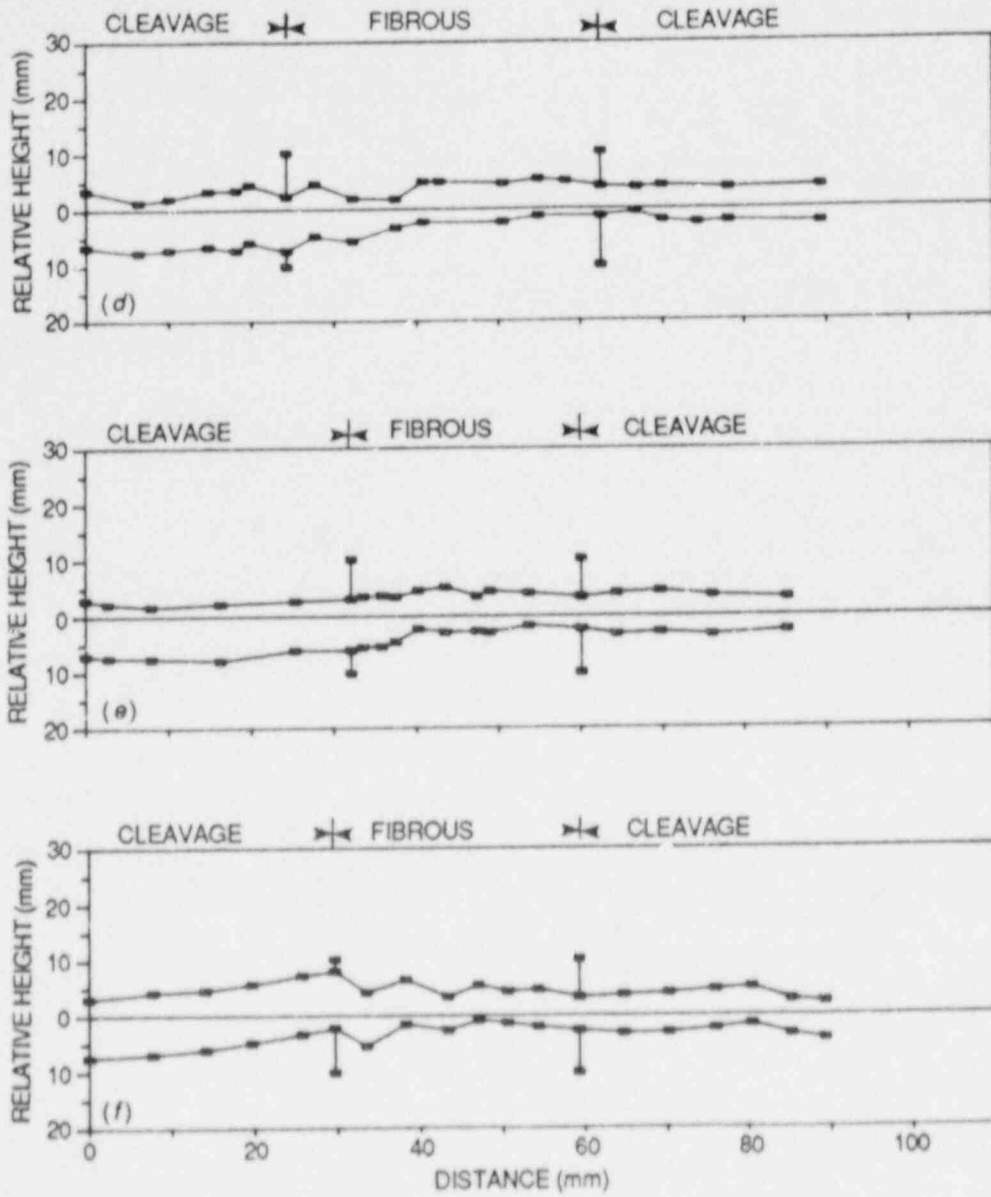
Fig. 2.29. Fracture surface contours along lines 1-6 in Fig. 2.28 for specimen WP-1.7. (a) Line 1-1, (b) line 2-2, (c) line 3-3, (d) line 4-4, (e) line 5-5, (f) line 6-6.

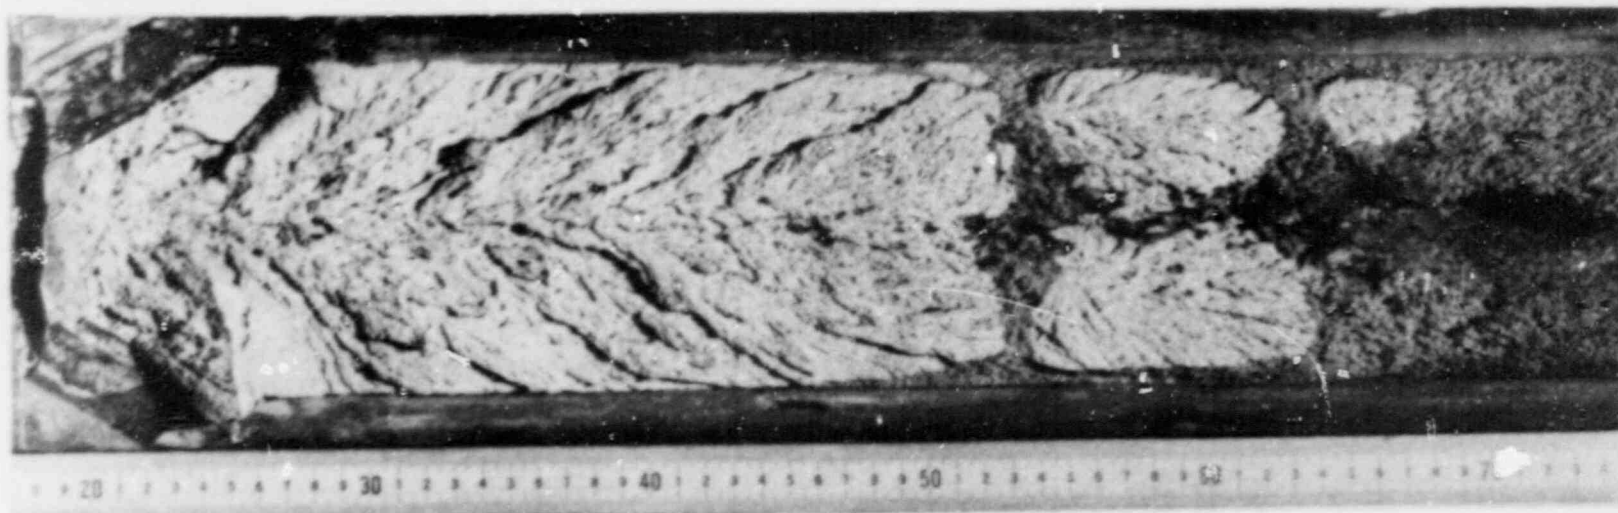
Fig. 5.13. Fracture surface for specimen WP-1.7. (a) Overall fracture surface and (b) close-up of initial crack, cleavage run-arrests, and loss-of-cleavage region (the scale is at the specimen back surface).

5.2.4.1 Test WP-1.7. The entire fracture surface of WP-1.7 is shown in Fig. 5.13(a), and a close-up of the cleavage and loss-of-cleavage regions is presented in Fig. 5.13(b). As noted in the figure, two cleavage crack run-arrest events occurred during the test. A region of fibrous fracture averaging 10 mm in width separates the two events. Also, there is a significant island of cleavage beyond the second arrest. It is about 30 mm in diameter and extends to a point 673 mm from the cold edge of the plate (i.e., to a point where the plate temperature was about 97°C). The cleavage crack started in the plane of the side grooves; however, as it progressed, it deviated from this plane. The maximum deviation was 15 mm below the plane of the side grooves on the lower half of the plate at a position corresponding to the second arrest point.

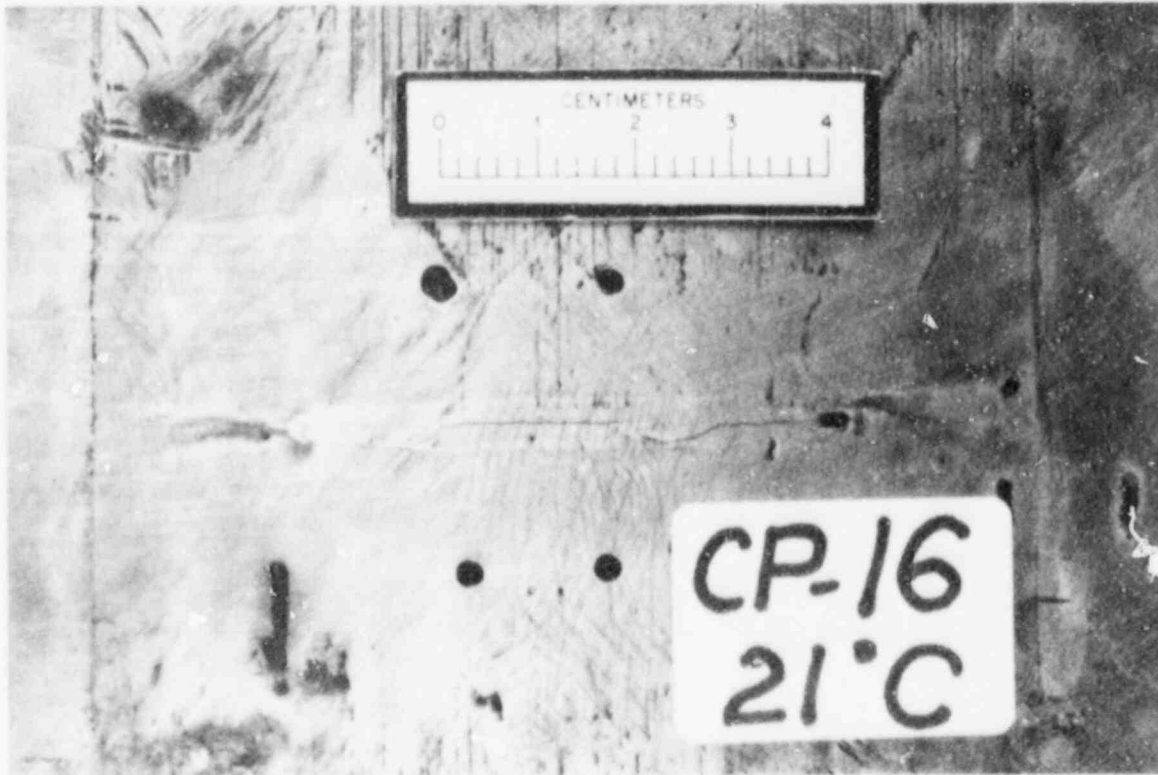
Fig. 7.4. Flaw in EB-weld HAZ after the first event. No evidence of propagation along the surface can be seen. Note dimpling that extends from crack ends to cladding.

The flaw in the EB-weld HAZ was now more easily discernible, Fig. 7.4, but no evidence of propagation along the surface could be seen. However, dimpling that extended from the crack ends to the cladding (Fig. 7.4) indicated the presence of a subsurface flaw. The flaw area was examined with dye penetrant (Fig. 7.5), but no surface crack other than that in the EB-weld HAZ could be detected. In Fig. 7.5, the two parallel lines normal to the flaw were added to mark the start of the cladding.
