THE EFFECTS OF ROLLER EXPANDING SLEEVES  
INSIDE OTSG TUBES AFFECTED BY INTERGRANULAR CORROSION

RESEARCH AND DEVELOPMENT DIVISION  
LYNCHBURG RESEARCH CENTER

SPONSORED BY  
ARKANSAS POWER & LIGHT COMPANY

RDD:85:5290-03-00:01

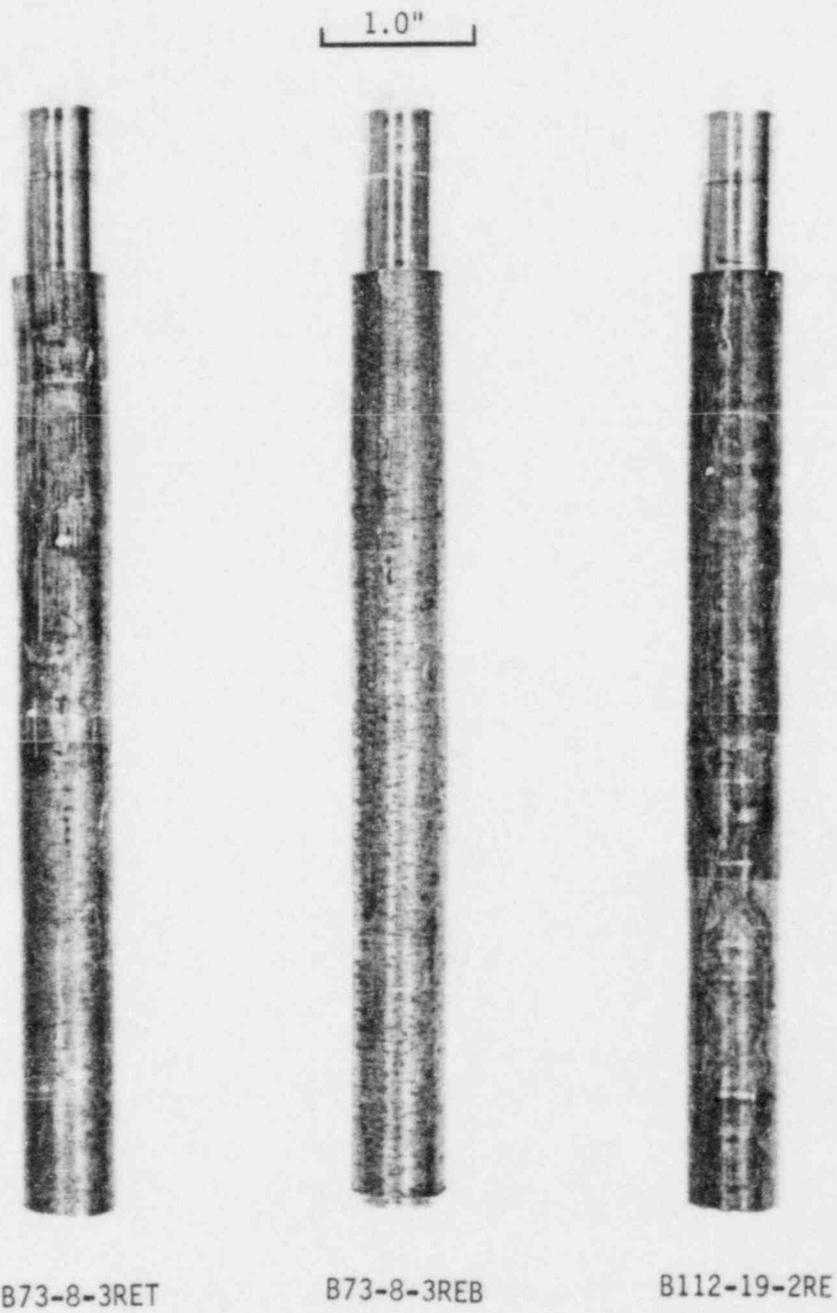
Figure 2-2. Photographs of Sleeved Tube Samples

Diameter values are discussed in detail in Sections 2.3 and 2.4. Figure 2-1 shows the sleeved tube sample configuration and photographs of each sample are shown in Figure 2-2.

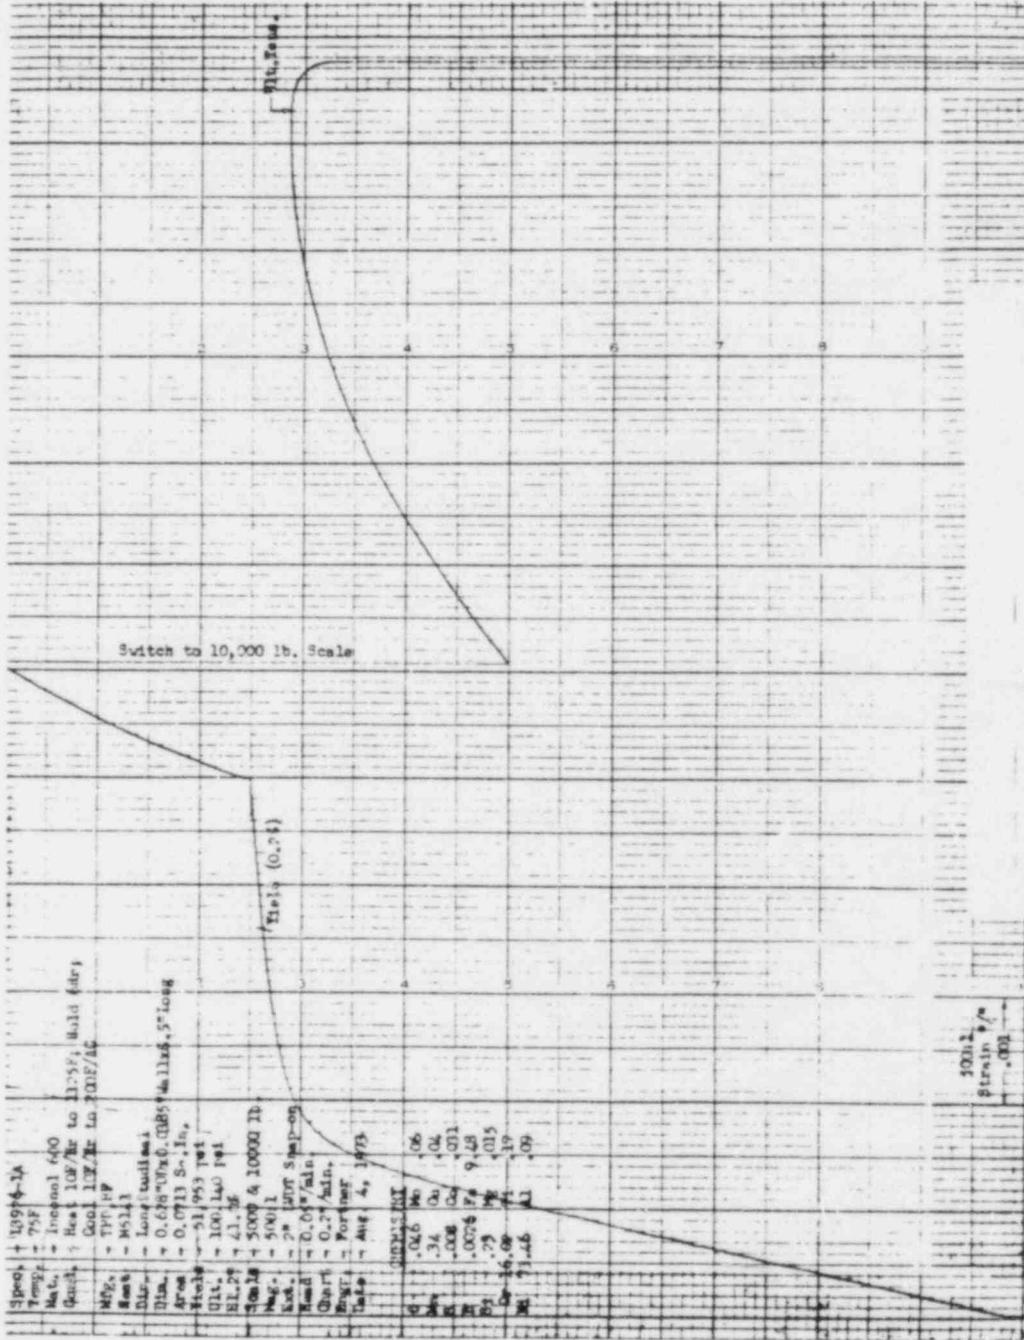
Figure 2-3. Stress-Strain Curve for OTSG Tubing

Shown in Figure 2-3 is a stress-strain curve for Alloy 600 material thermally treated similar to that which a tube experiences during OTSG manufacture. Since plastic strain occurs above approximately 0.35 percent, strain values experienced by the sleeve and tube samples were well into the plastic regime.

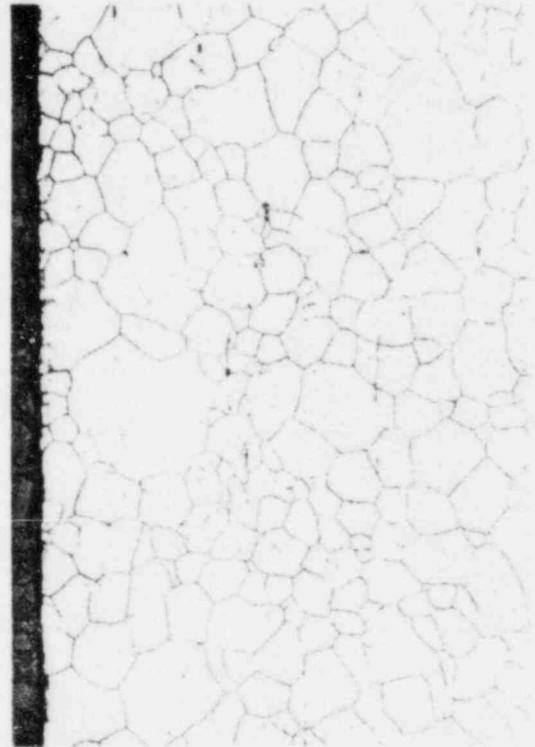
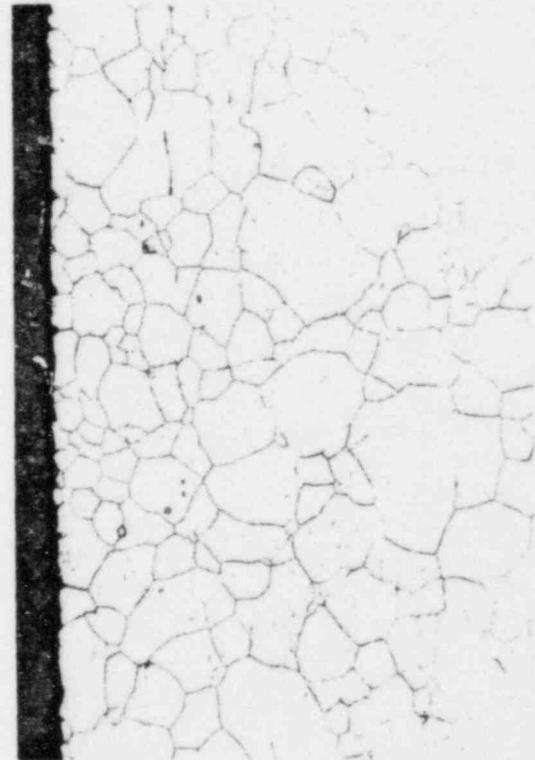
Figure 2-7. Photomicrographs of Tube Sample B73-8-3RET Control Specimens  
- Outer Surface

Transverse and longitudinal views were used to inspect each control specimen in the as-received condition. Typical photomicrographs of the outer surface of the control specimens from each tube sample are shown in Figures 2-7, 2-8, and 2-9. While no excessive IGA was observed on any specimen, grain boundary penetrations were present, to some extent, on each specimen. In all cases, penetrations were less than 0.001-inch in depth. During the 1983 tube examination, the shallow penetrations became more pronounced only after bending the specimens with the tube outer surface in tension.<sup>(1)</sup> Therefore, it is not expected that these unstressed control specimens would exhibit more than that observed previously. Additional characterization of the control specimens was performed using scanning electron microscopy and is presented in Section 2.7.1.

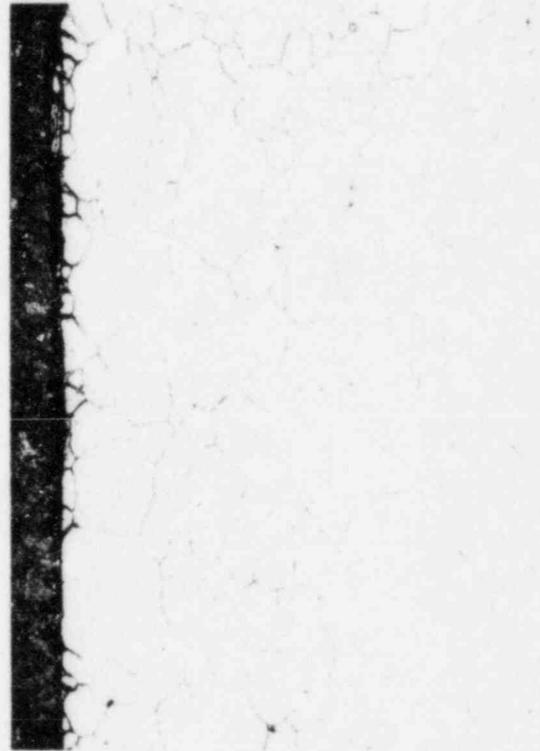
Figure 2-10. Typical Photomicrographs of Control Specimen Inner Surface

Shown in Figure 2-10 are typical photomicrographs of the inner surface of the control specimens depicting the mill-pickled condition of the tubes. Grain boundary penetrations of approximately 1 grain diameter or less were present on each specimen.

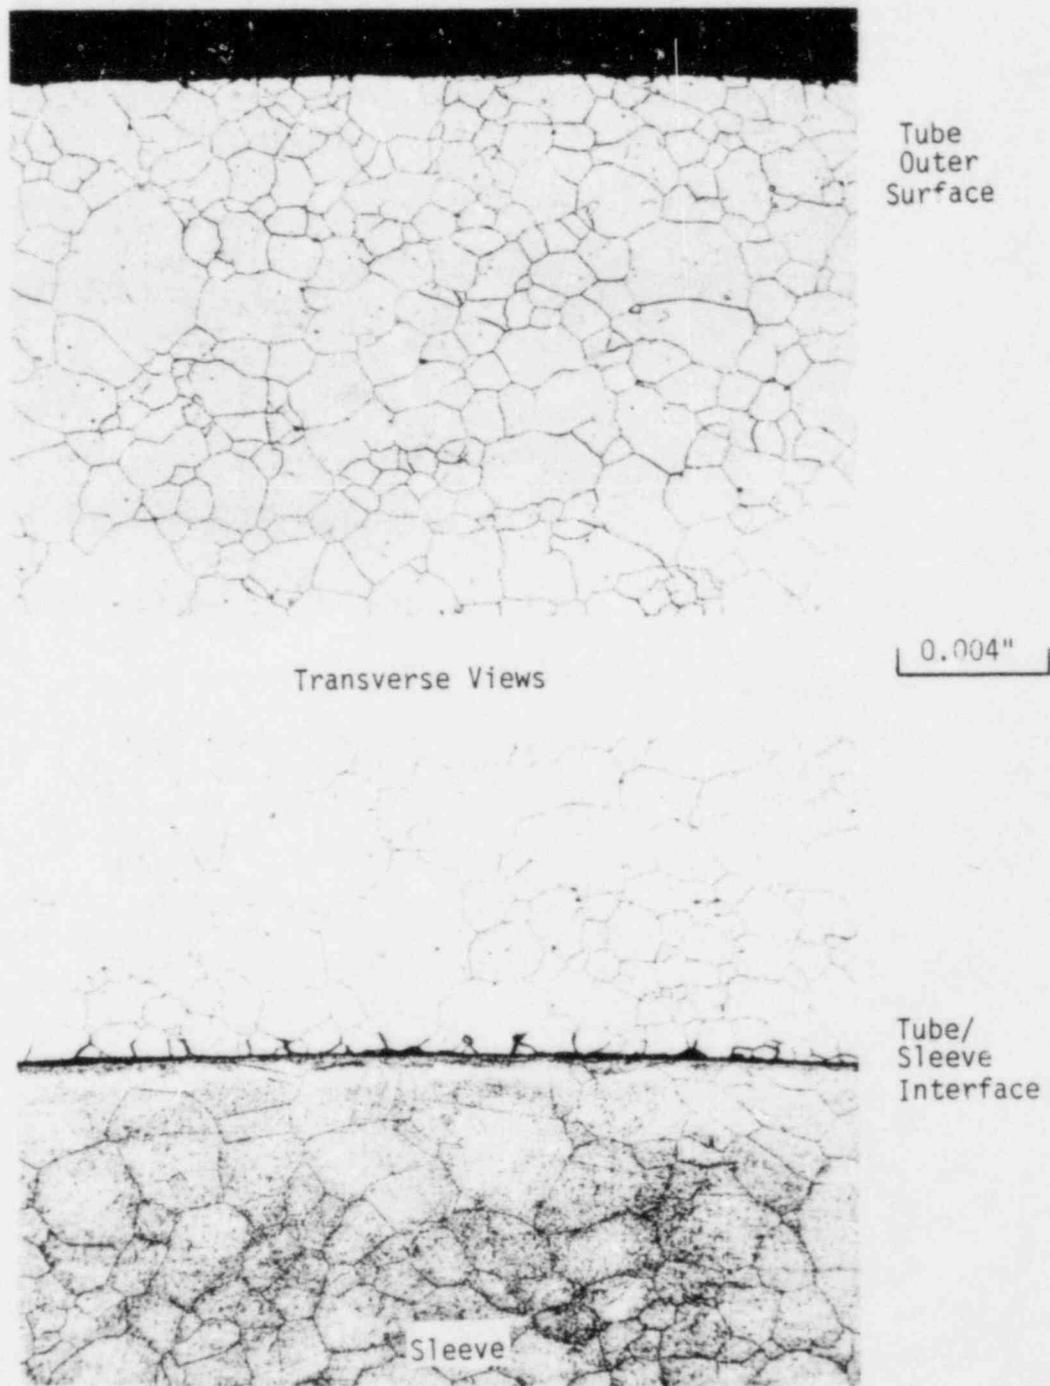
Figure 2-11. Photomicrographs of Tube Sample B73-8-3RET Specimen C-1

2.6.2.1 Roll Centers. Transverse photomicrographs taken of the outer surface of the roll center regions are shown in Figures 2-11 through 2-16. Upon comparing these photomicrographs to those from the control specimens, no measurable amount of grain boundary inward radial propagation was observed. A slight amount of grain boundary opening in the circumferential direction, however, was observed on specimens from tube samples B73-8-3RET and B73-8-3REB, Specimens from tube sample B112-19-2RE were the photomicrographs in Figures 2-15 and 2-16 of which exhibited little, if any, difference in grain boundary opening compared to those of the control specimens shown in Figure 2-9.

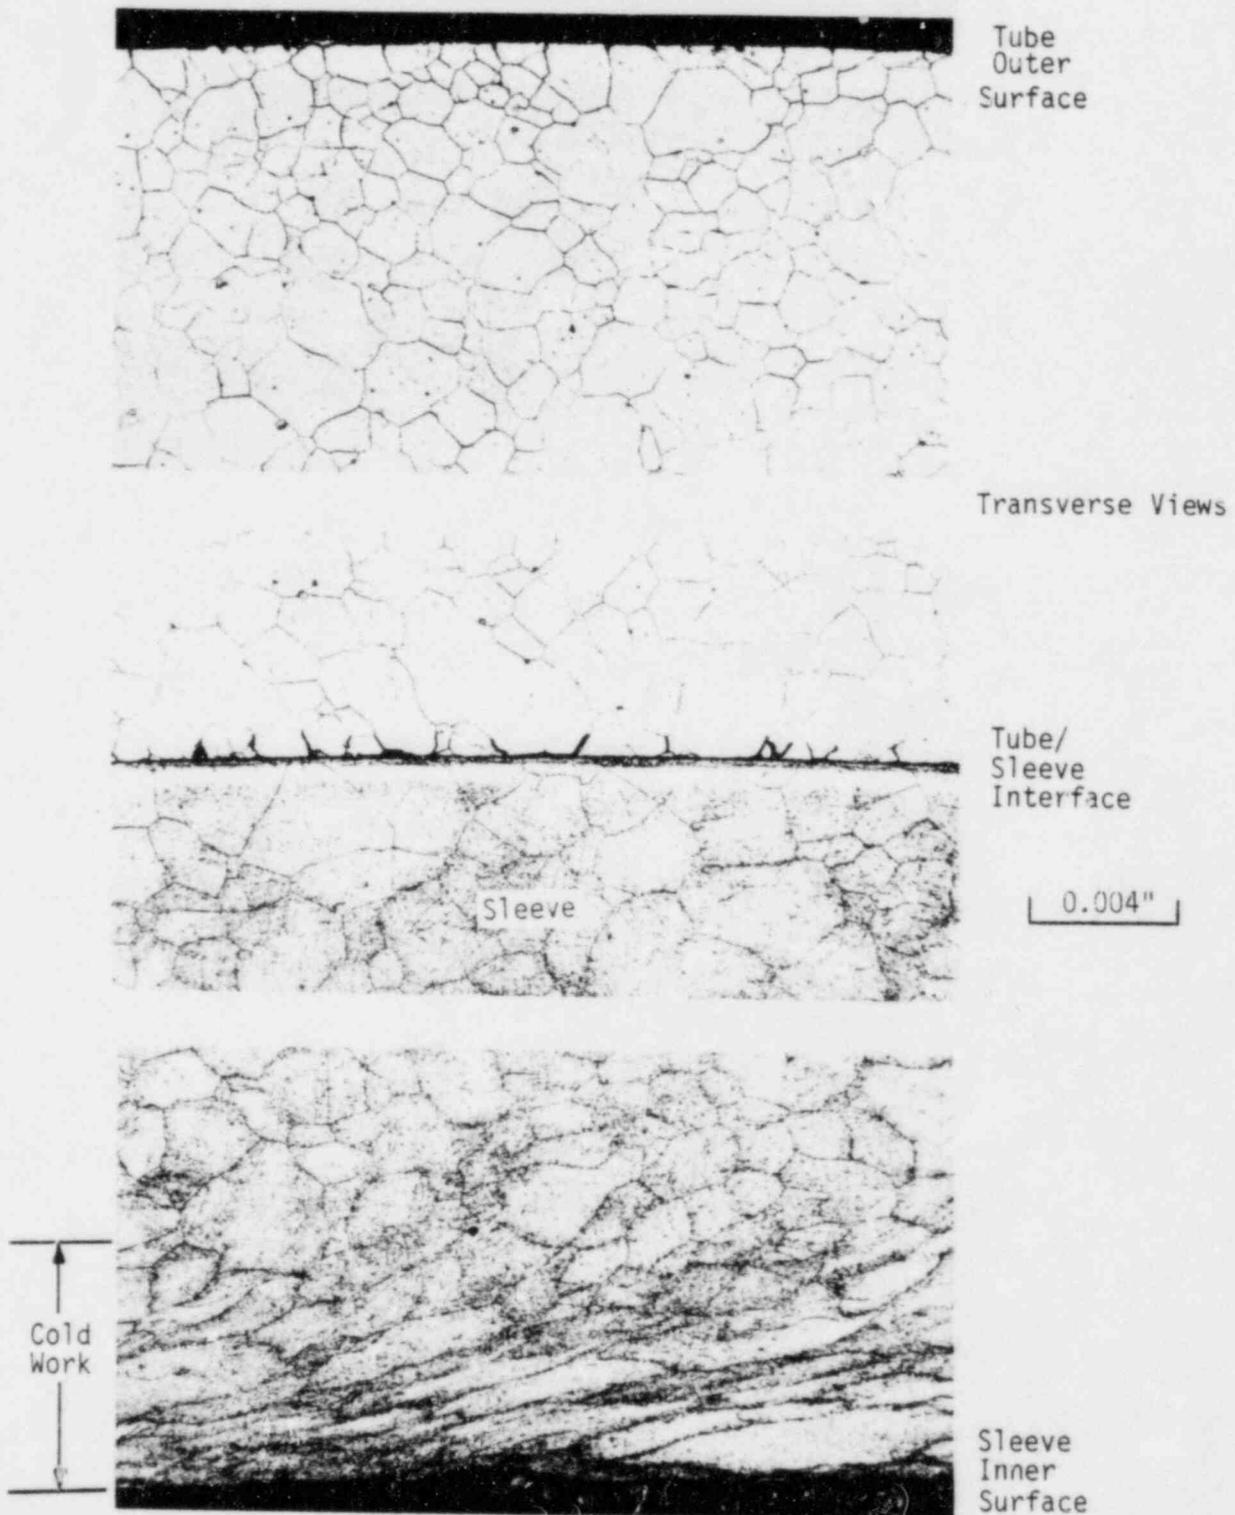
Figure 2-12. Photomicrographs of Tube Sample B73-8-3RET Specimen C-2

Figures 2-12 and 2-16 also include photomicrographs of the sleeve inner surface showing the cold-worked layer caused by the rollers contacting the sleeve during sleeve installation.

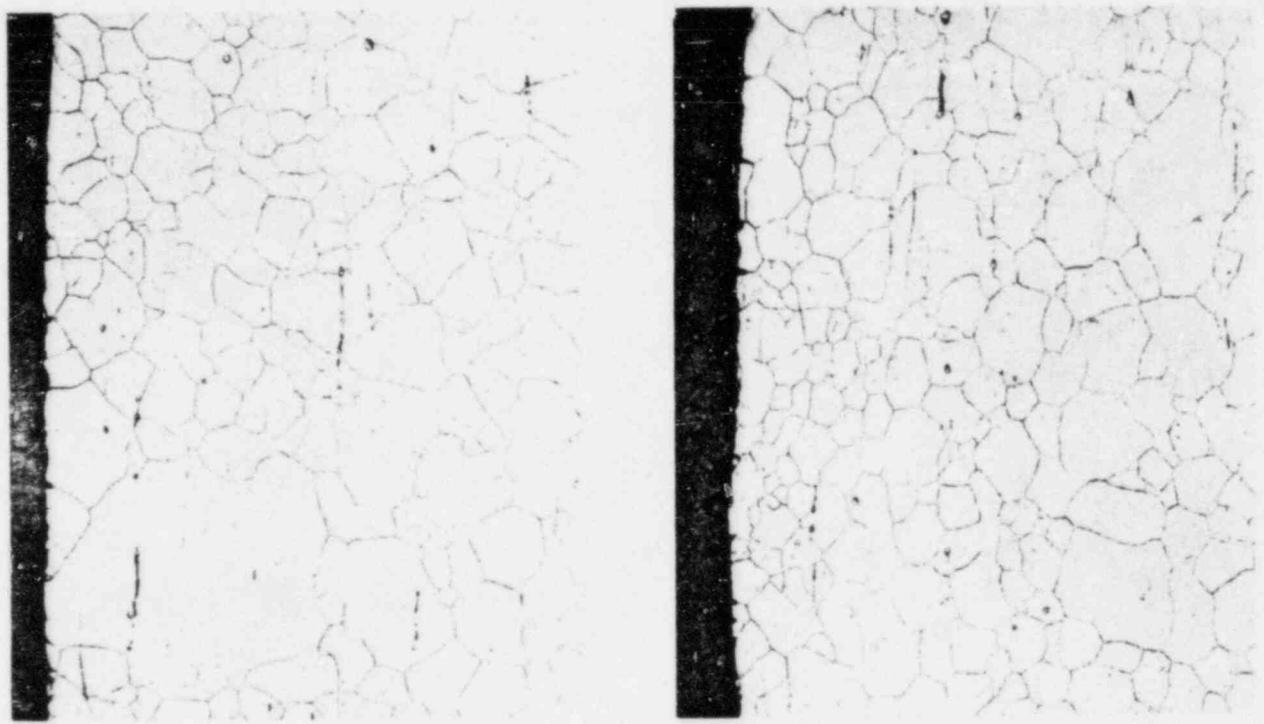
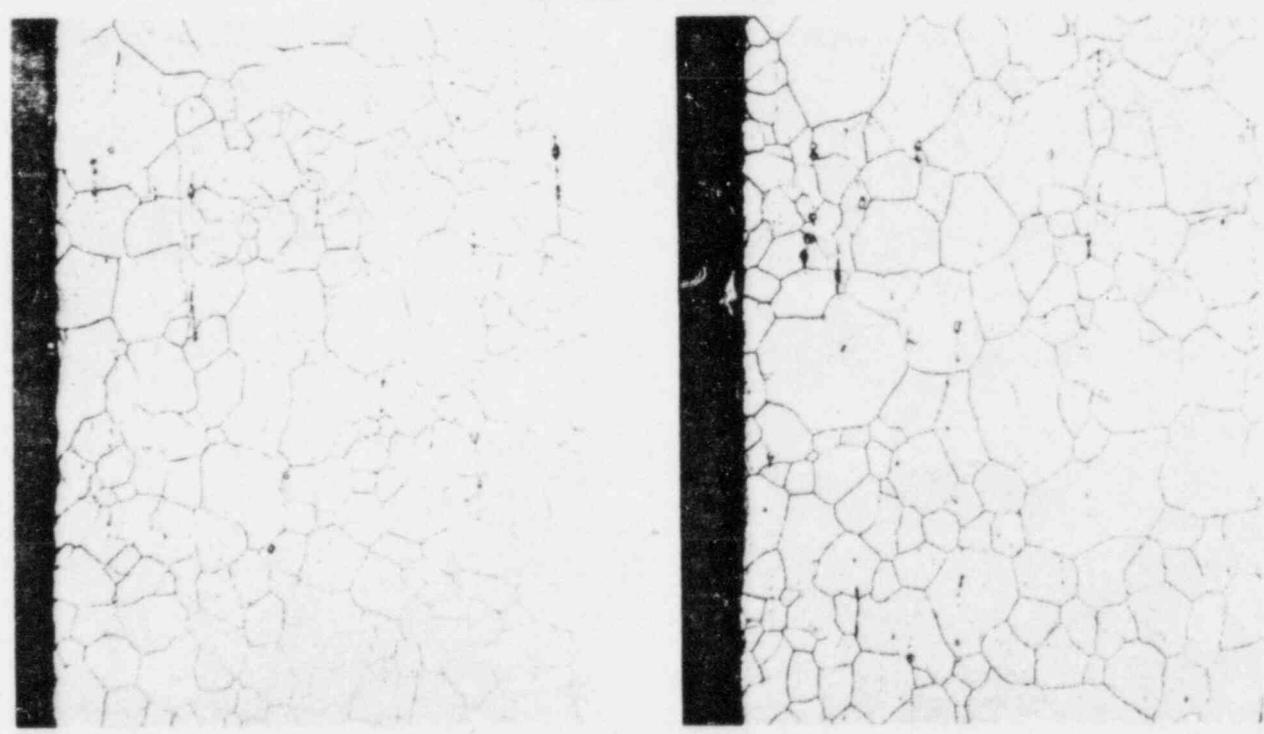
Figure 2-17. Photomicrographs of Tube Sample B73-8-3RET Specimens LT-1 and UT-2

Longitudinal photomicrographs were taken in the rolled and unrolled regions of each roll transi-

tion specimen and are shown in Figure 2-17, 2-18, and 2-19. The results were consistent with those observed previously in the roll centers; i.e., higher strains resulted in more grain boundary separation. The unrolled regions of specimens LT-1 and UT-2 from sample B73-8-3RET (shown in Figure 2-17) exhibited the most obvious axial separation due to the higher hoop strain values in the roll center regions. Little, if any, separation was observed on specimens from tube samples B73-8-3REB and B112-19-2RE.

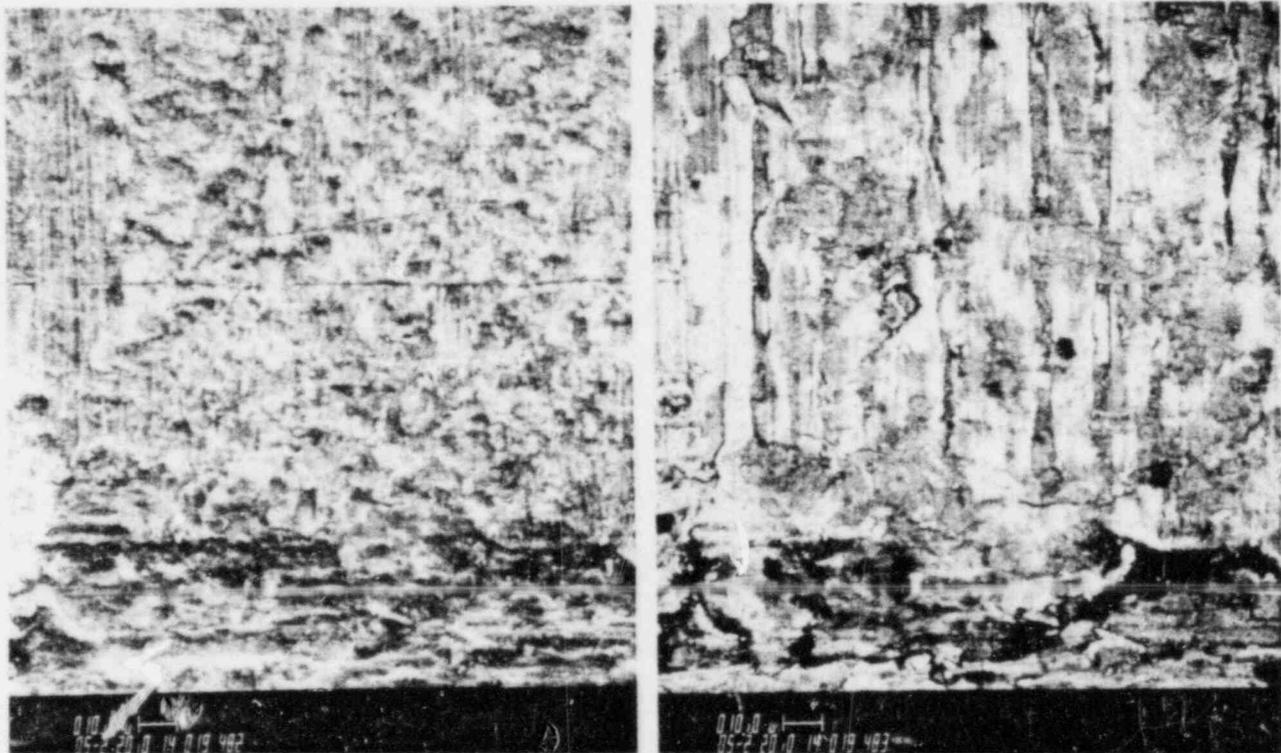
Figure 2-20. SEM Photomicrographs of Tube Sample B112-19-2RE Outer Surface Deposit

A control specimen from tube sample B112-19-2RE was initially examined in the SEM to document the "as-received" condition of the tube outer surface. As seen in the photomicrographs in Figure 2-20, the surface was covered with deposit which prevented inspecting the tube material. Therefore, it became necessary to descale the specimens in order to proceed with the inspection. A descaling procedure using an ultrasonic bath of inhibited hydrochloric acid (500 ml 6N HCl + 1g hexamethylene tetramine) is commonly used on Alloy 600 tubing at the LRC. To insure that this solution would not attack the base material of ANO-1 OTSG tubes, a small piece of archive OTSG tubing was descaled for 15 minutes at 140° F. Photomicrographs of this piece before and after descaling are shown in Figure 2-21, which illustrates that the solution had no effects on the base tube material. The contrast difference between photomicrographs is a result of exposure time and not related to the procedure.

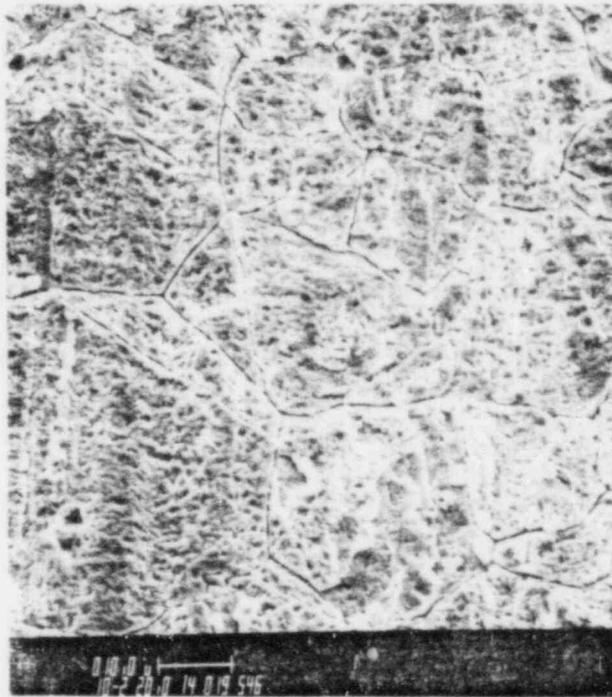
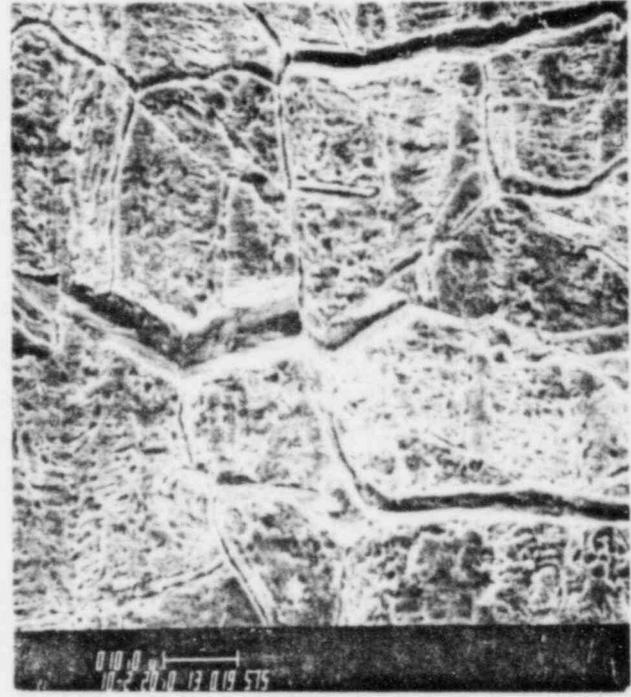
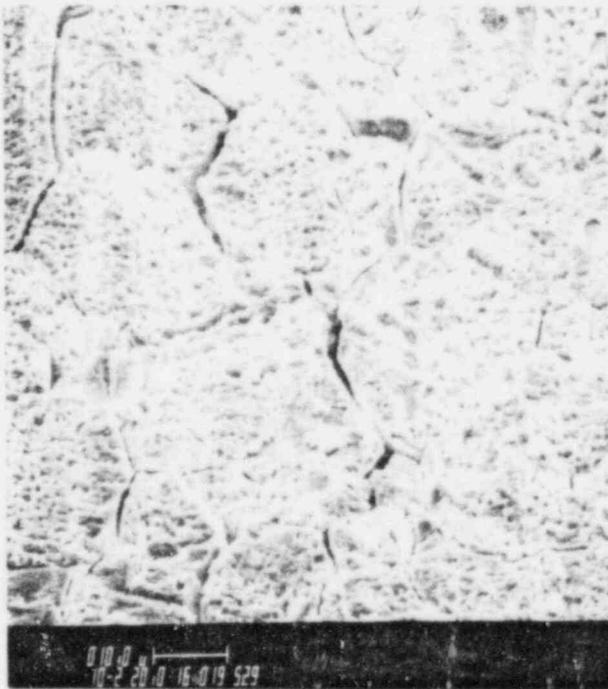
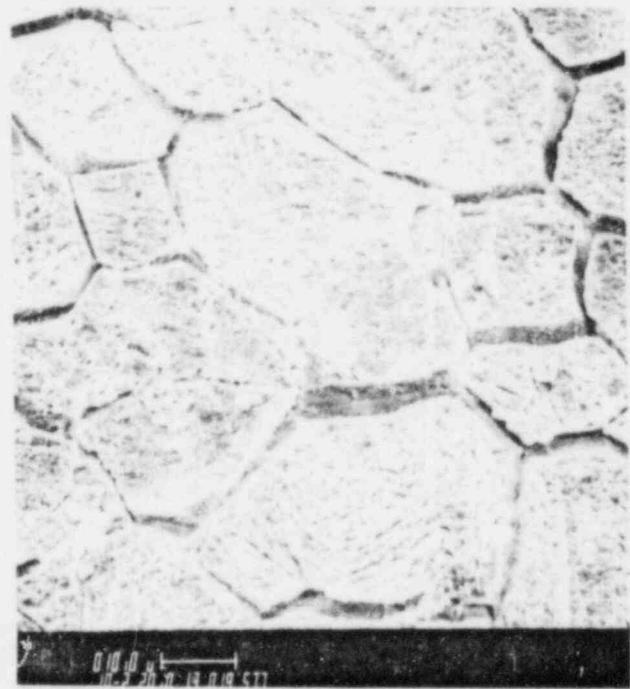
Figure 2-22. SEM Photomicrographs of Tube Sample B73-8-3RET "A" Control Specimens

To expedite inspection of the control specimens, one half of each specimen was descaled using the above procedure and then examined in the SEM. These specimens were labeled "A" control specimens. Figures 2-22, 2-23, and 2-24 show SEM photomicrographs of the outer surface of each of the "A" specimens. Deteriorated grain boundaries were visible on each specimen, similar to that observed on descaled specimens examined during the 1983 tube examination.<sup>(1)</sup> Therefore, it appears that the tube samples selected for sleeve installation were from areas containing representative amounts of IGA damage.

For further comparison, each of the "A" control specimens was bent inward about the tube axis, placing tensile stress on the tube outer surface, and re-examined in the SEM. Photomicrographs of the bent specimens are also shown in Figures 2-22, 2-23, and 2-24. Bending caused grain boundaries to open primarily in the direction of highest tensile stress; i.e., parallel to the tube axis. These photomicrographs appear almost identical to those of specimens bent and examined during the 1983 examination.<sup>(1)</sup> Additional photomicrographs

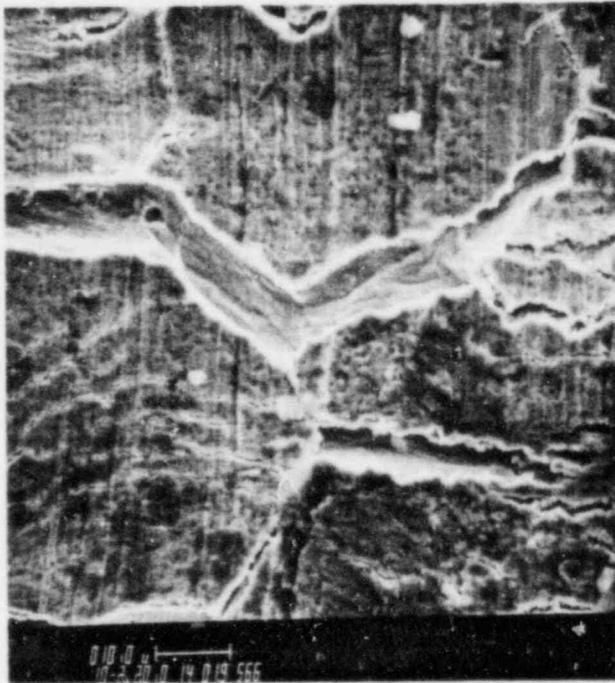
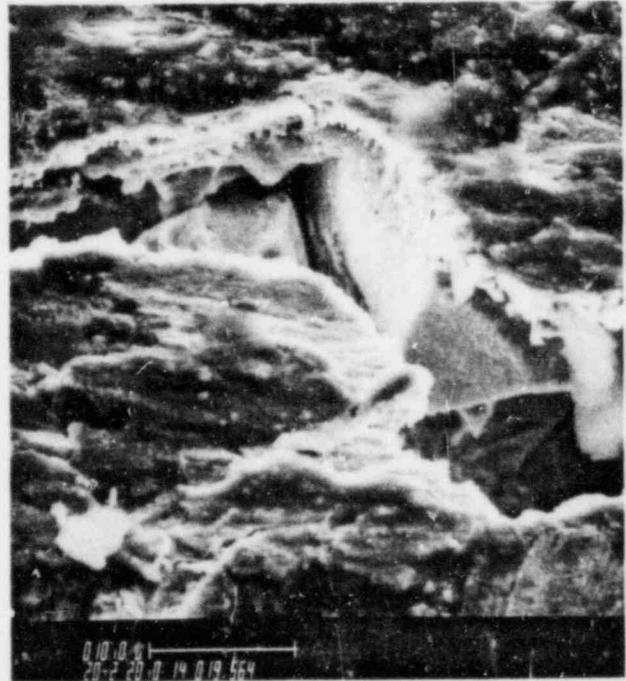
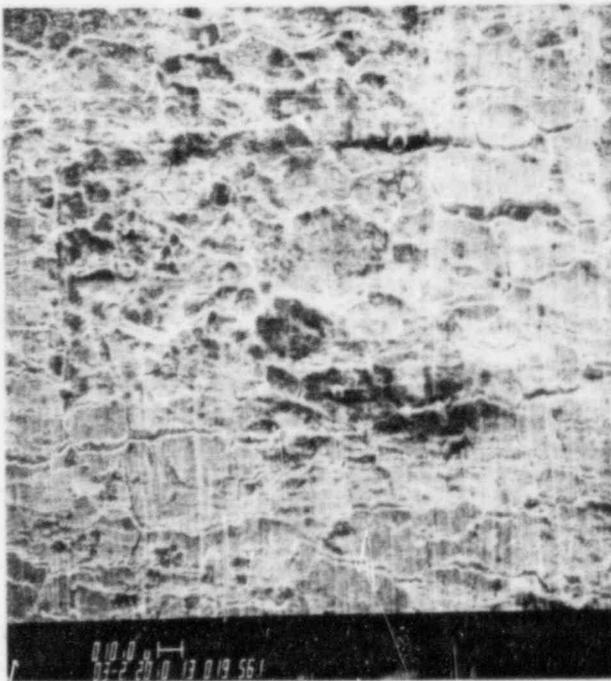
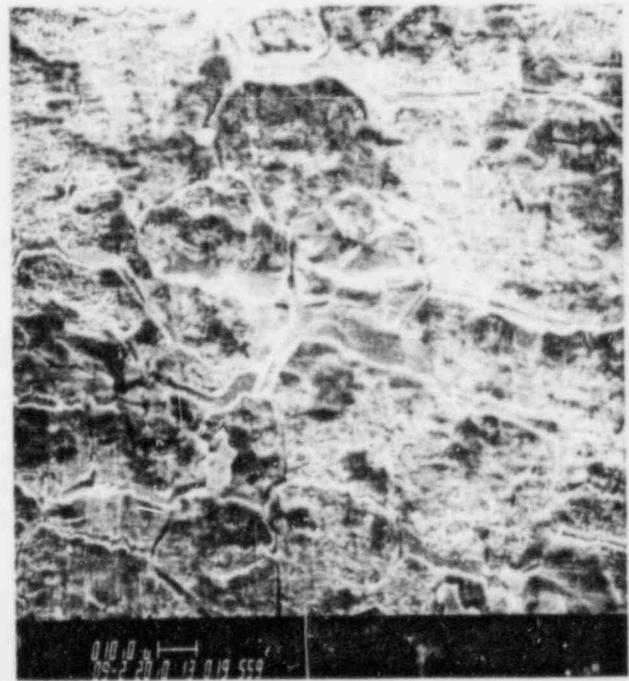
Figure 2-25. SEM Photomicrographs of Tube Sample B73-8-3RET "B" Control Specimens

The other half of each of the control specimens, labeled "B" specimens, was bent and not descaled. Photomicrographs of these specimens in Figures 2-25, 2-26, and 2-27 simply confirm that bending the tube causes the outer surface deposit to split along underlying grain boundaries, much the same as that observed during the 1983 examination.<sup>(1)</sup>

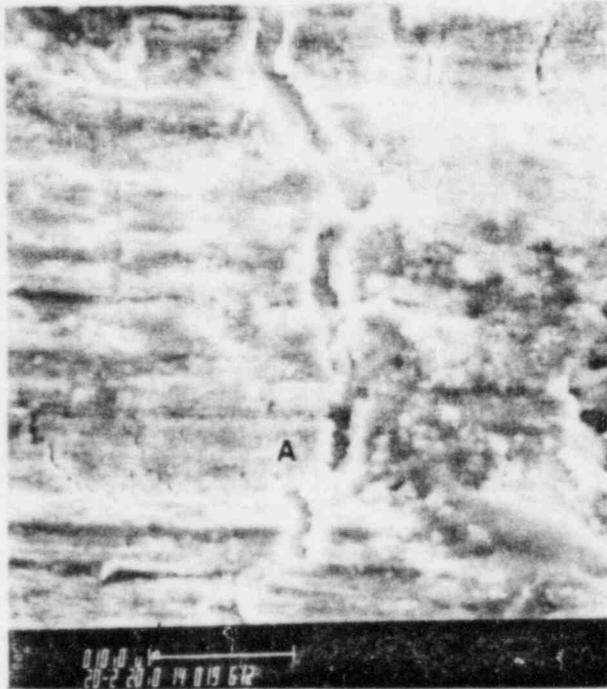
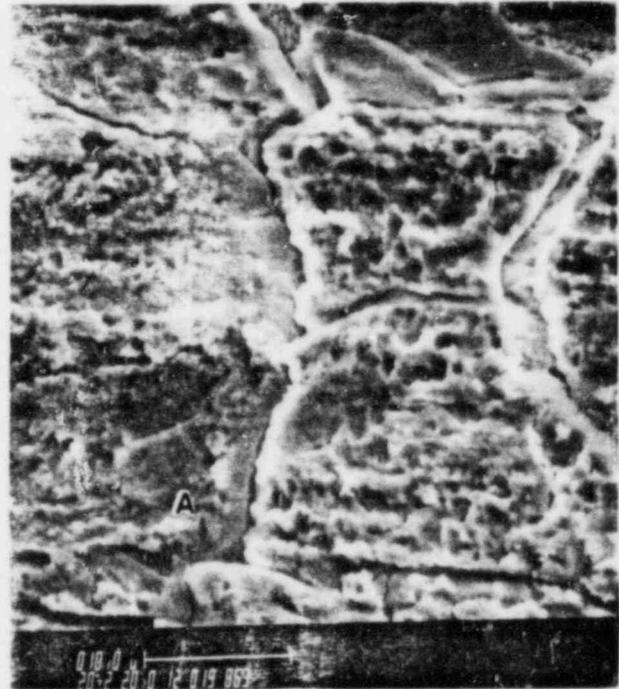
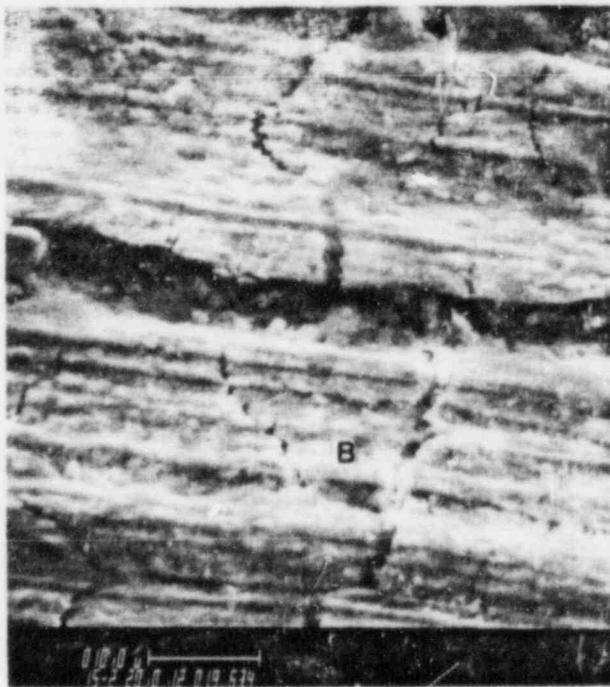
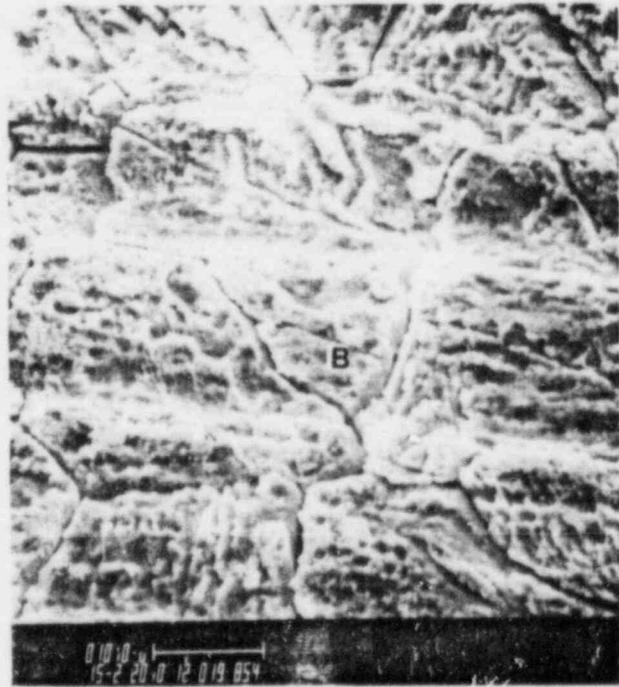
Figure 2-28. SEM Photomicrographs of Tube Sample B73-8-3RET Roll Center Specimens

2.7.2.1 Roll Centers. Specimens from the roll centers were inspected using the SEM to determine the effects of the rolling operation in regions of highest hoop stress. A scribe mark was placed on the specimen outer surface to be used as a locator. After an initial SEM characterization of deposit appearance, each specimen was descaled using the same procedure as described in Section 2.6.1. Re-examination of the specimens in the SEM at the same location as before using the locator permitted complete characterization of deposit splitting along grain boundaries.

The results are clearly depicted in the photomicrographs shown in Figures 2-28, 2-29, and 2-30. When comparing photomicrographs of the roll center specimens in the "as-rolled" and descaled conditions, it becomes obvious that deposit splitting occurred along grain boundaries due to sleeve installation. Strain induced during sleeve installation causes displacement of the tube material and deposit layer(s) in the direction of least resistance; i.e., along axially oriented deteriorated grain boundaries intersecting the tube outer surface.

Horizontal lines visible in the "as-rolled" photomicrographs represent tube surface grinding marks caused during a manufacturing process. These lines become less obvious upon descaling, when slightly etched grain matrices and stretched grain boundaries become visible.

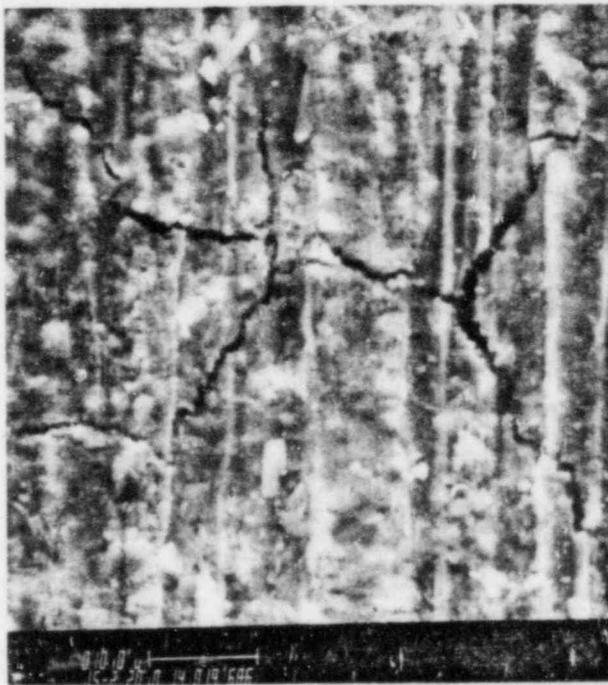
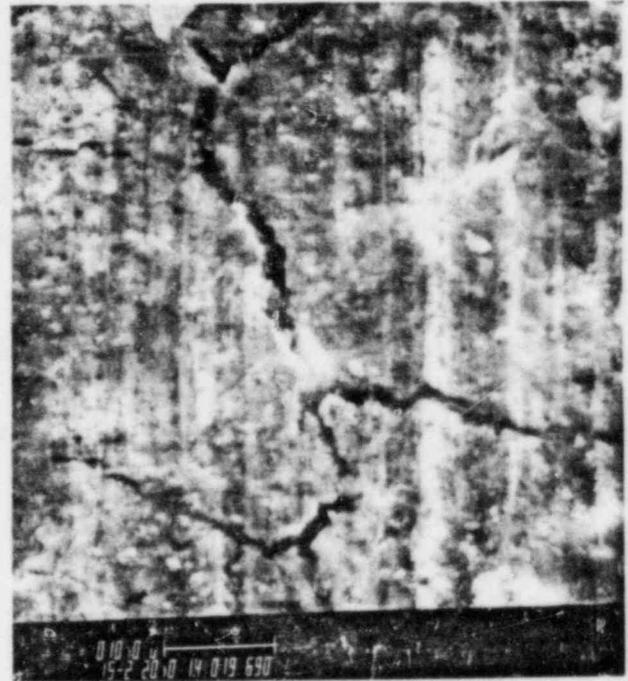
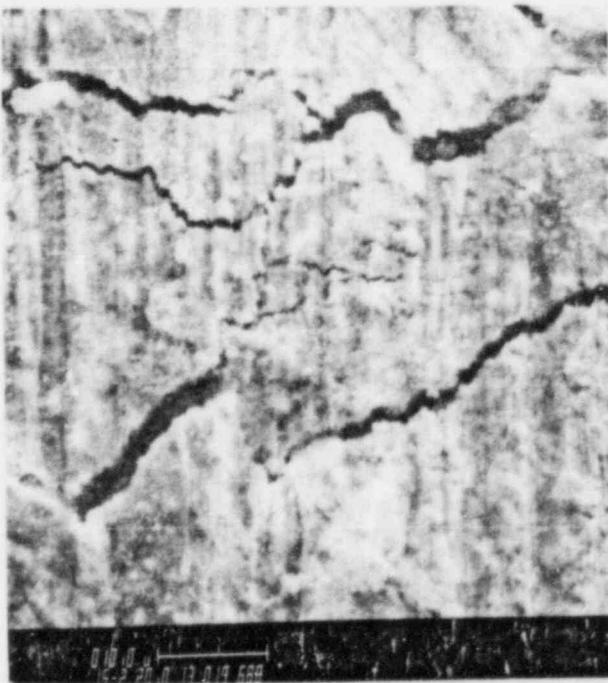
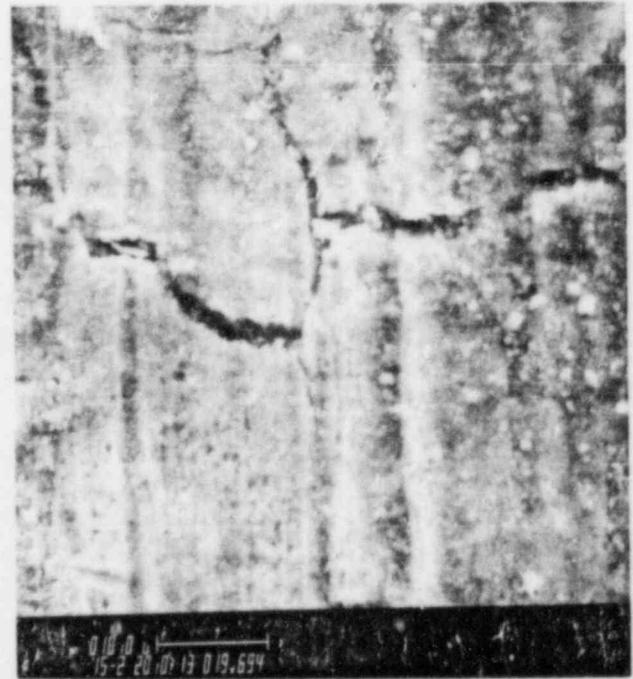
Figure 2-31. SEM Photomicrographs of Tube Sample B73-8-3RET Roll Transition Specimens

2.7.2.2 Roll Transitions. For each tube sample, regions encompassing the lower transition of Roll 1 and the upper transition region of Roll 2 were examined in the SEM. Photomicrographs of these specimens in the "as-rolled" condition are shown in Figures 2-31, 2-32, and 2-33. The results are consistent with those presented throughout this report; i.e., outer surface deposit splitting occurred along grain boundaries oriented perpendicular to the direction of highest tensile stress. On the rolled end of the roll transition specimens where tensile stress was in the hoop direction, splitting occurred

axially. On the opposite end of the specimen adjacent to the roll transition, stresses were in the axial direction which caused circumferential splitting. Vertical lines in the deposit layer on these specimens represent the surface grinding marks caused during manufacture. It was not deemed necessary to descale and re-examine these specimens since the previous roll center specimens clearly showed that deposit splitting occurred along grain boundaries.

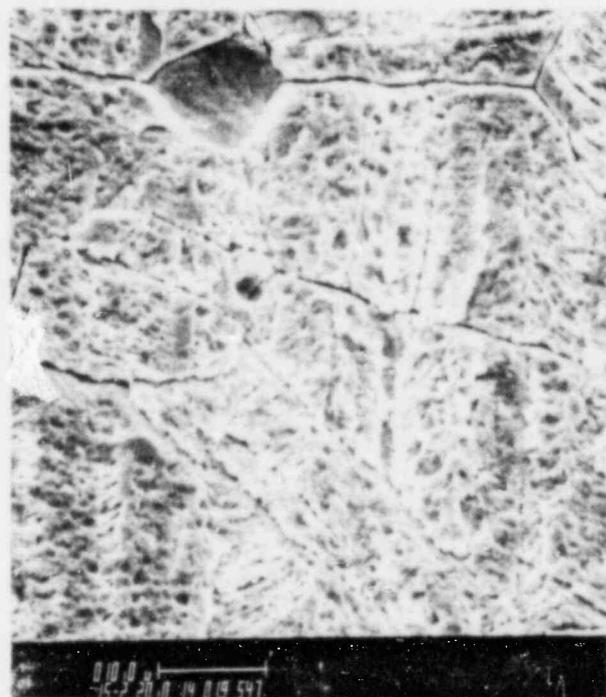
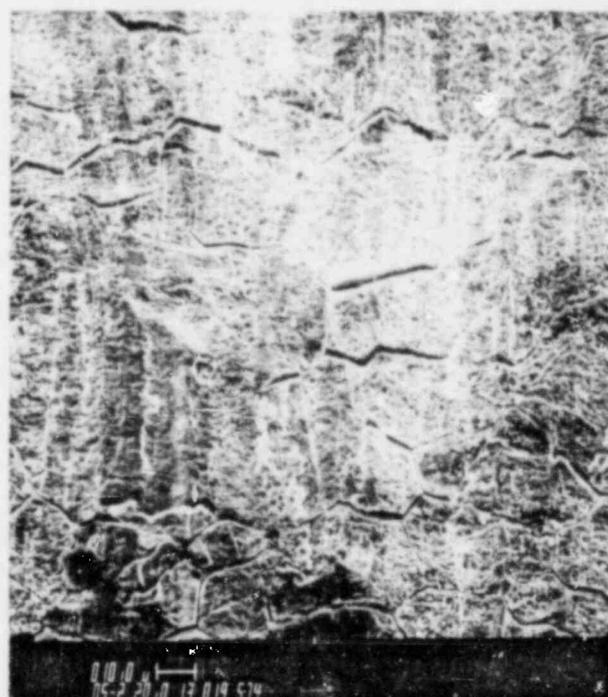
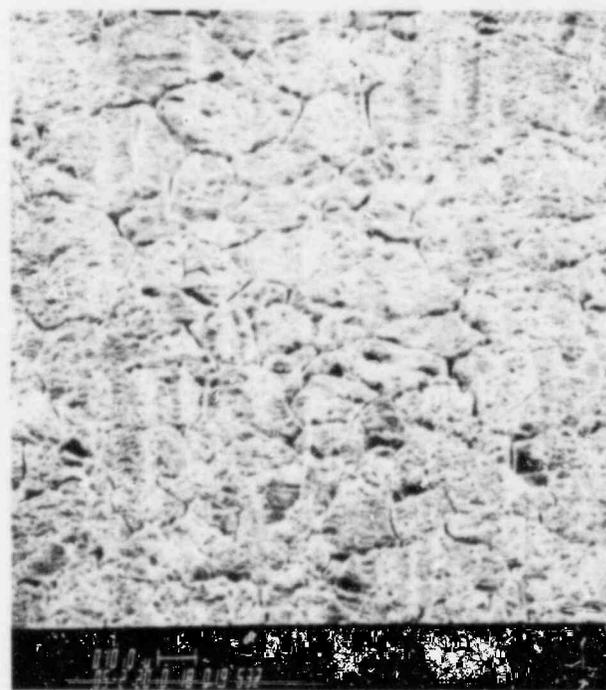
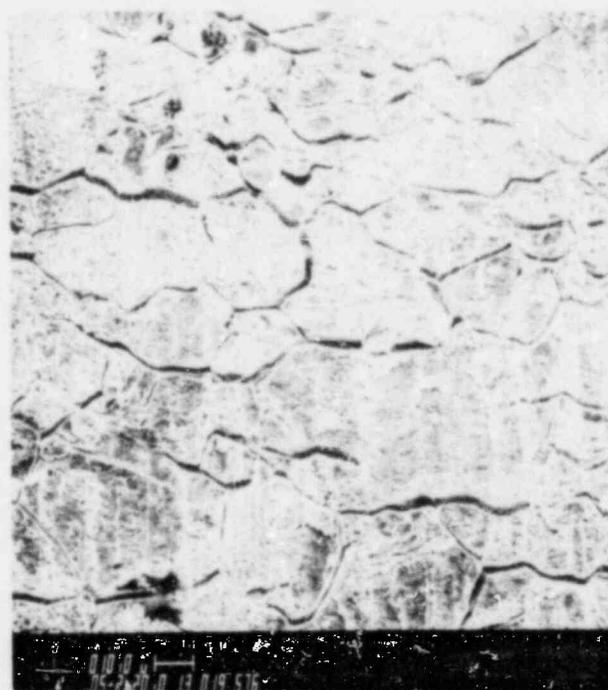
Figure C-1. SEM Photomicrographs of Tube Sample B73-8-3RET Control Specimens

of descaled and bent control specimens are presented in Figures C-1, C-2, and C-3 in Appendix C.
