FINAL RADIOLOGICAL SURVEYS  
OF  
SELECTED BUILDING 2 LABORATORIES  
FOR  
RELEASE TO UNRESTRICTED USE

"GROUP 11"

July 1999

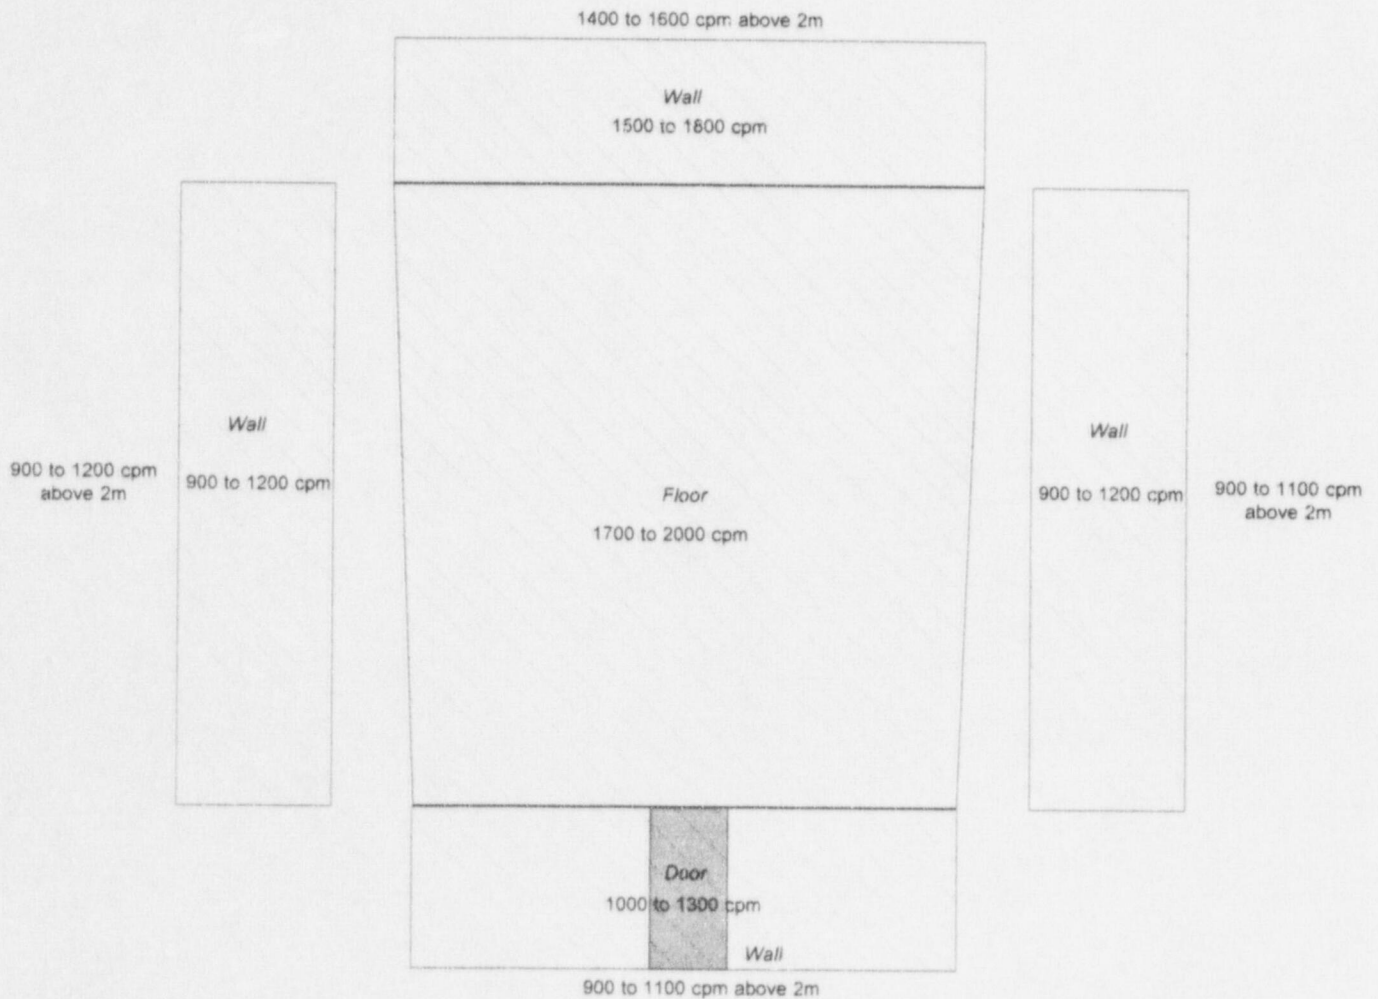
**Figure 4: Lab 216: Beta Scan**

1. Survey results are provided in Table 5.
2. ~100% of the Floor and Walls (2m up) were scanned for Beta. Scan results in cross hatched area.  
~10% of the walls (above 2m) were scanned for Beta.
3. All concrete, cement block, sheetrock, and drywall surfaces.

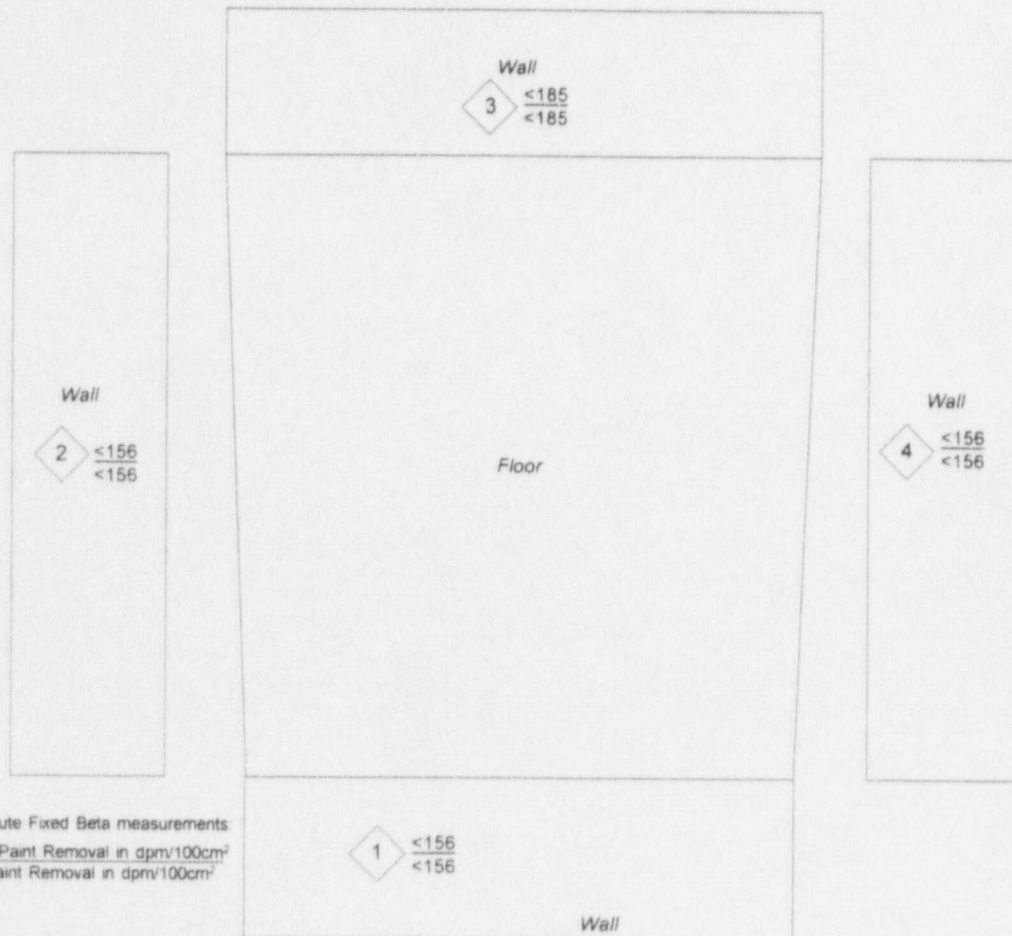
**Figure 6:** Lab 216: Locations and Results of Fixed Beta Measurements at Paint Sample Locations

Paint Sample =

1. Final survey results are provided in Tables 5.
2. The values are in dpm/100cm² and indicate the approximate locations of measurements taken using a 100cm² Beta detector except where noted. Two minute (cp2m) fixed Beta readings were taken.
3. All concrete surface.

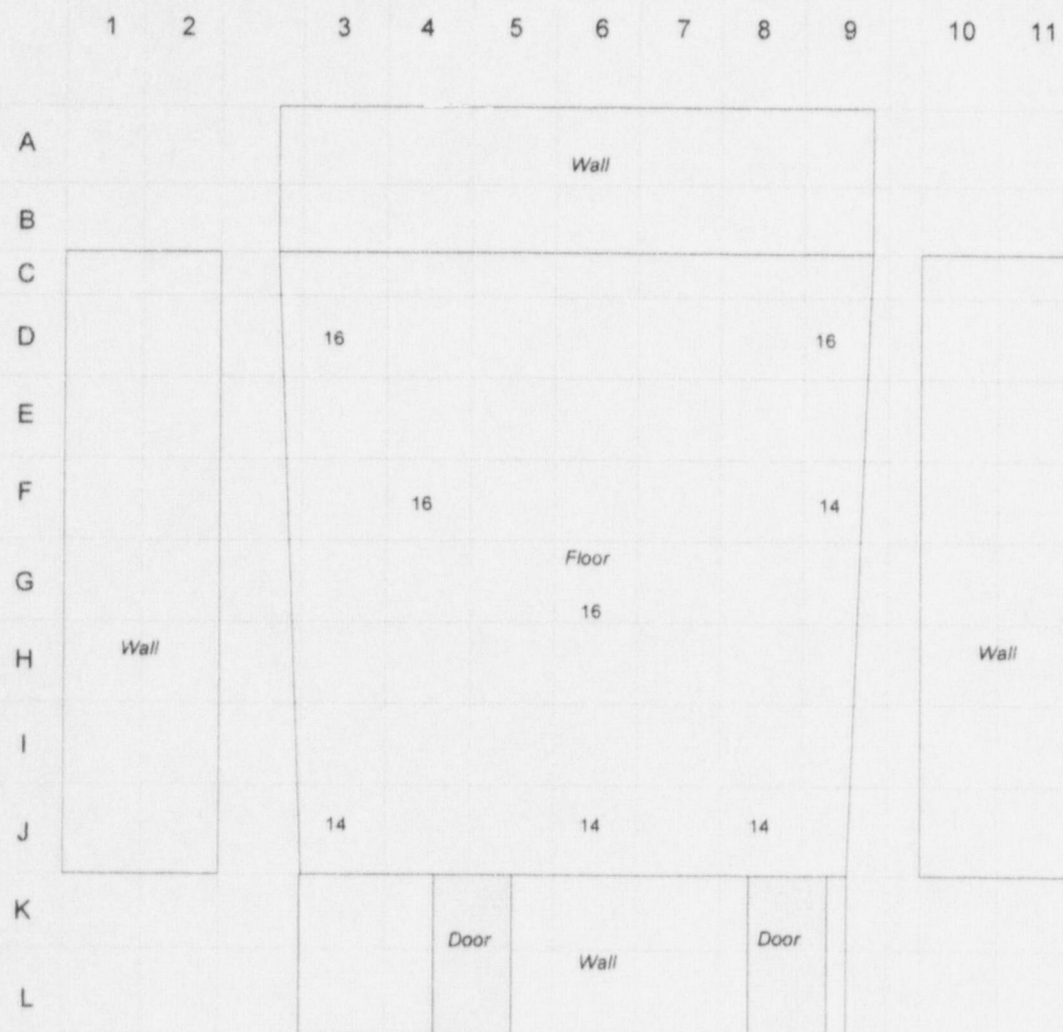
**Figure 17A:** Labs 238/240: Locations and Results of **Final** Exposure Rate Measurements

1. The values are exposure rate measurements in  $\mu\text{R/hr}$  at the approximate locations indicated. Each measurement was taken  $\sim 1\text{m}$  above ground surface.
2. All concrete surface.

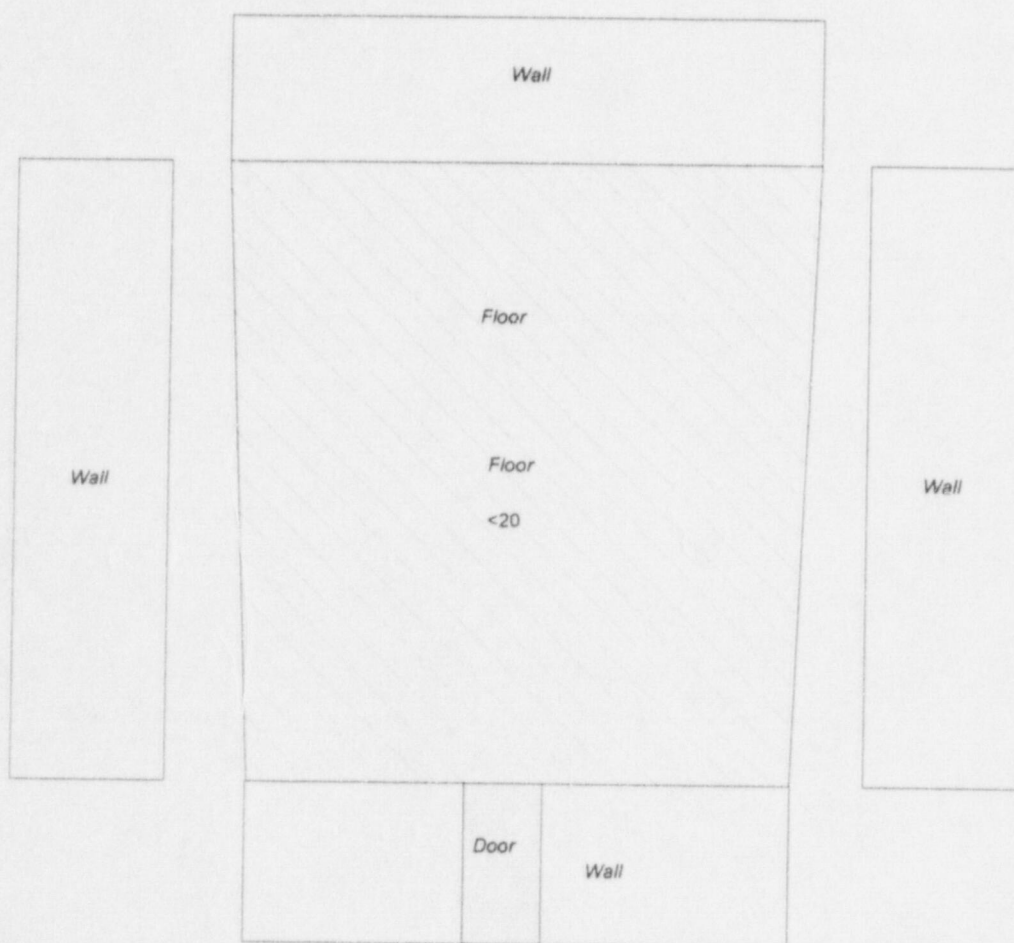
Figure 33: Lab 242: Alpha Floor Scan

1. Survey results are provided in Table 5.
2. ~100% of the floor was scanned for Alpha with a 434cm<sup>2</sup> Alpha detector. Scan results in cross hatched area are in cpm.
3. All concrete surface.

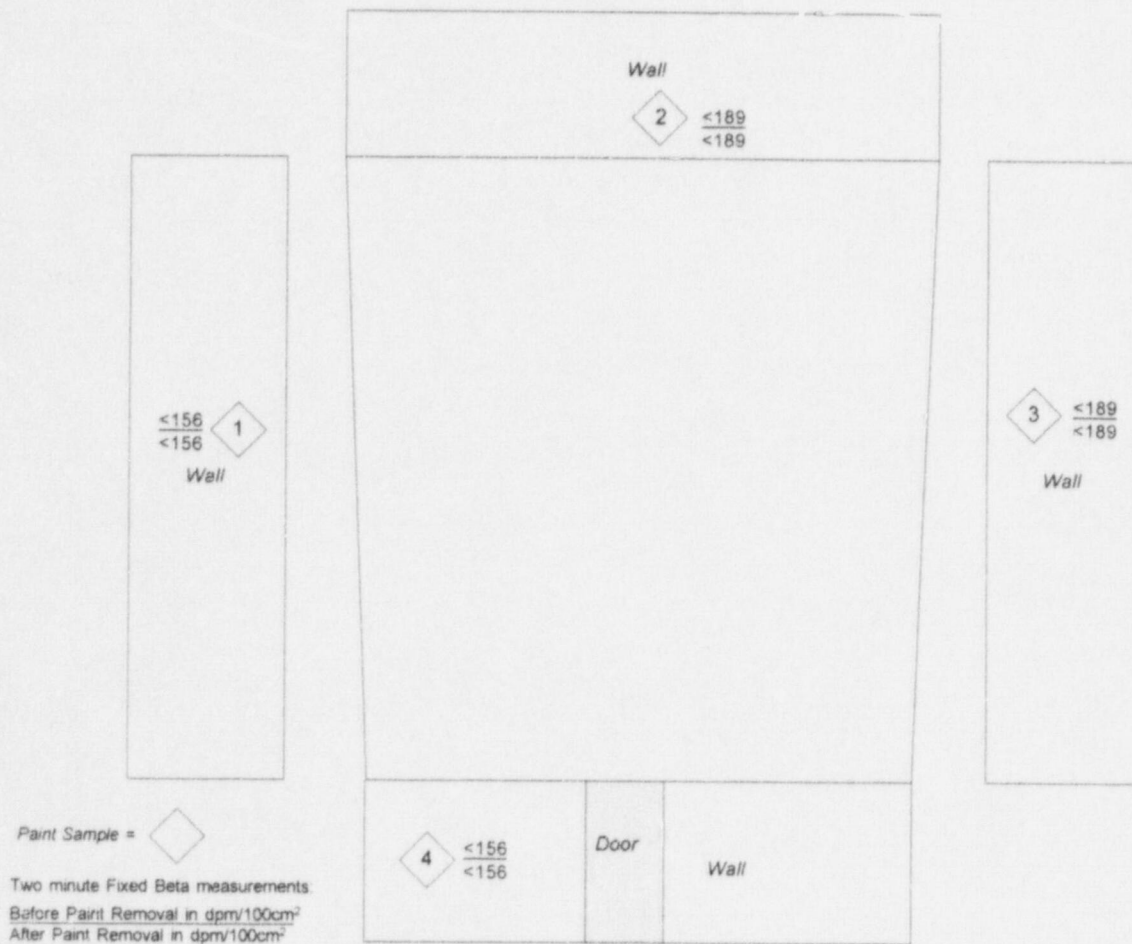
Figure 37: Lab 242: Locations and Results of Fixed Beta Measurements at Paint Sample Locations

1. Survey results are provided in Table 5.
2. The values are in dpm/100cm<sup>2</sup> and the diamonds indicate the approximate locations of paint samples taken. Two Minute fixed beta readings were taken before and after paint samples were removed.
3. All cement block and drywall surfaces

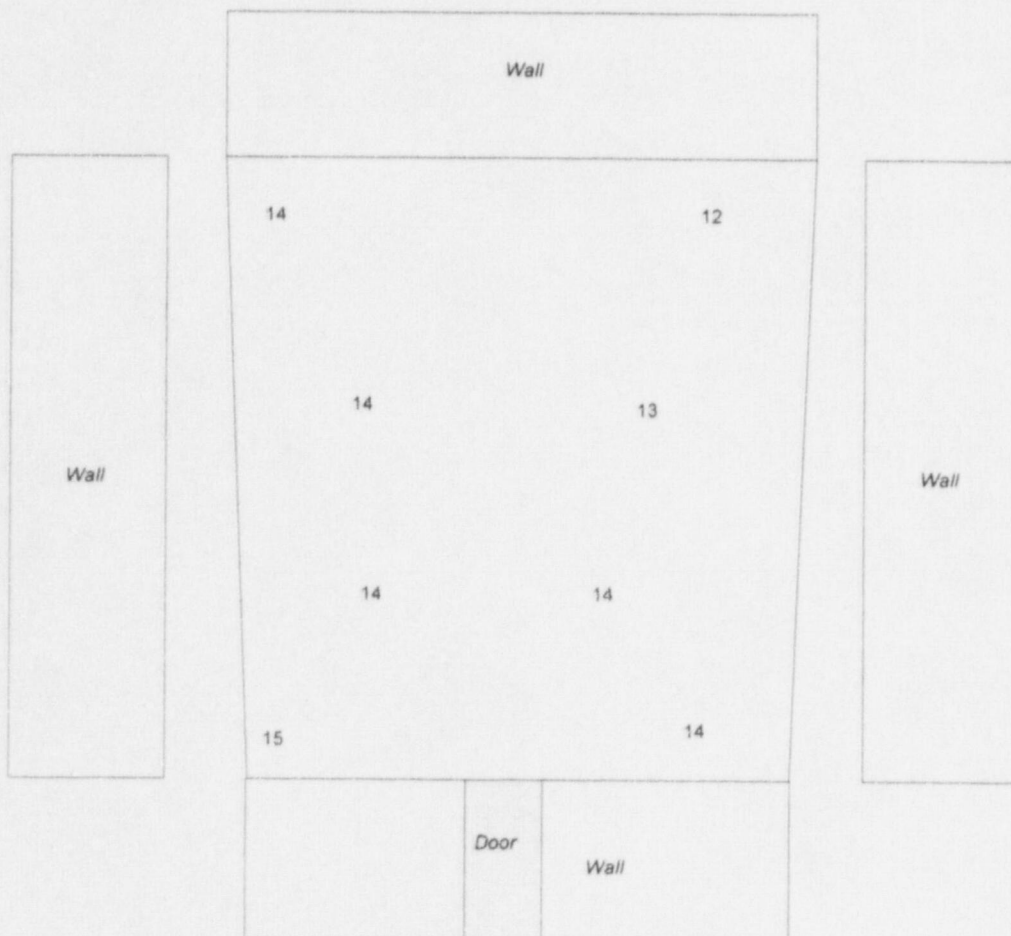
**Figure 38:** Lab 242: Locations and Results of Exposure Rate Measurements

1. The values are exposure rate measurements in  $\mu\text{R/hr}$  at the approximate locations indicated. Each measurement was taken  $\sim 1\text{m}$  above ground surface.
2. All concrete surface.

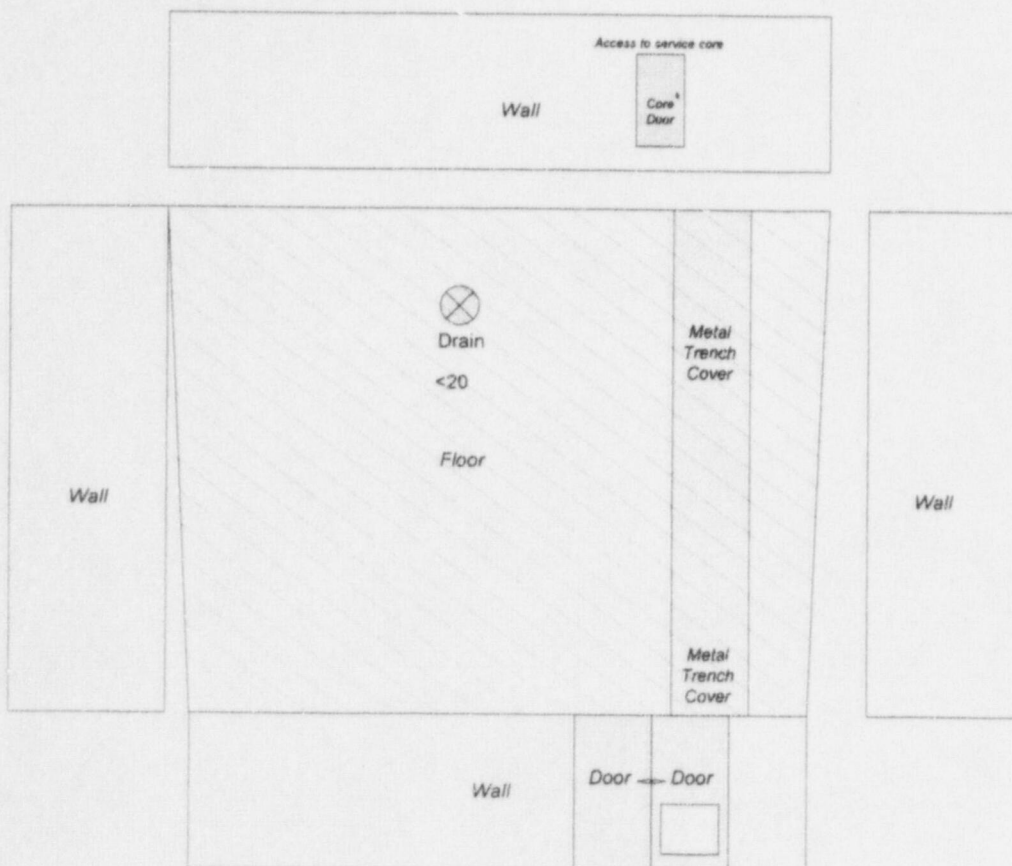
**Figure 41:** Lab 325: Alpha Floor Scan

1. Survey results are provided in Table 5.
2. ~100% of the floor was scanned for Alpha. Scan results in cross hatched area.
3. All metal and concrete surfaces.

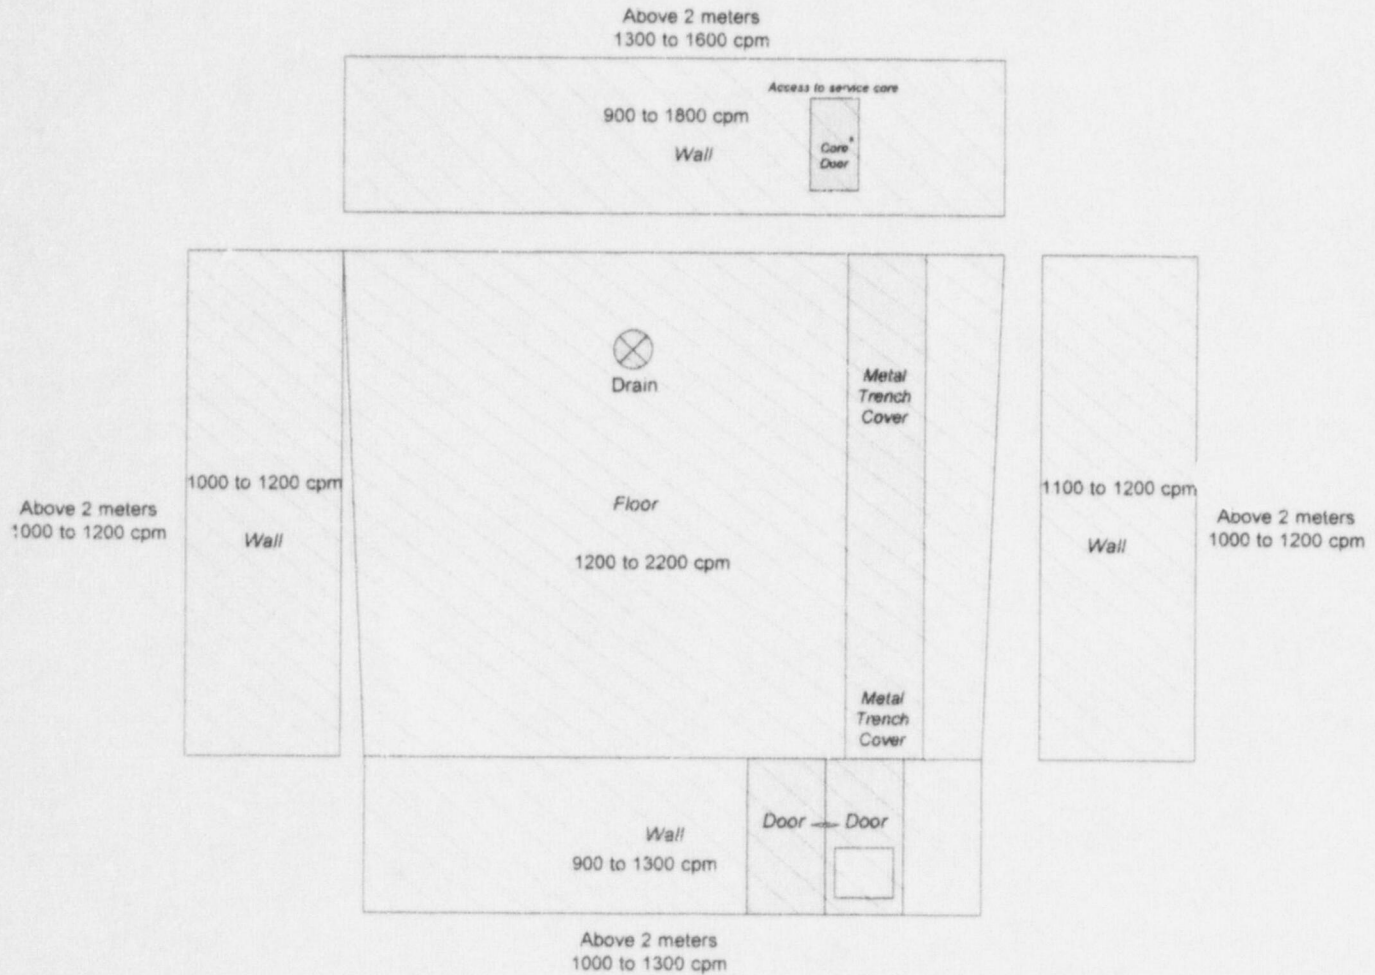
**Figure 42: Lab 325: Beta Scans of Floor and Walls**

1. Survey results are provided in Table 5.
2. ~100% Beta scan on the Floor and Walls (up 2 meters) were scanned for Beta. Scan results in cross hatched area.
3. ~10% above 2m on the walls were scanned for Beta. As noted, Scan results above 2m of walls.
4. All metal and concrete surface.

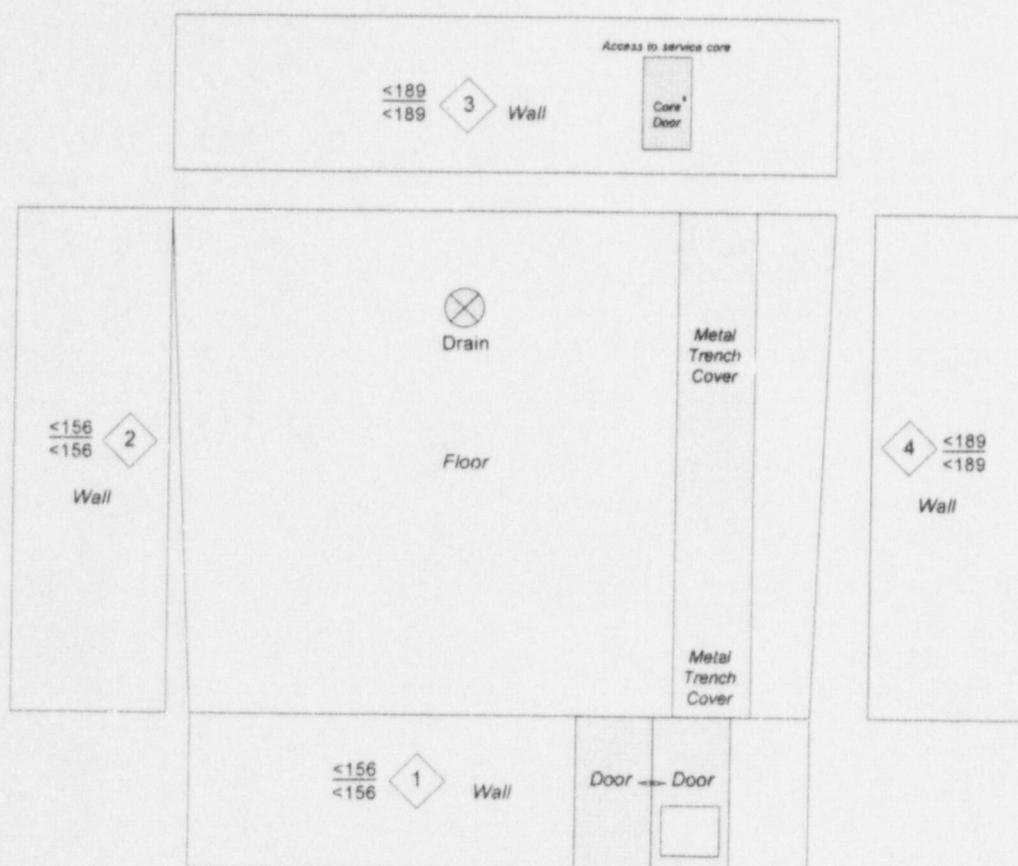
**Figure 45: Lab 325: Locations and Results of Fixed Beta Measurements at Paint Sample Locations**

Two minute Fixed Beta measurements:  
 Paint Sample =  $\diamond$  Before Paint Removal in dpm/100cm<sup>2</sup>  
 After Paint Removal in dpm/100cm<sup>2</sup>

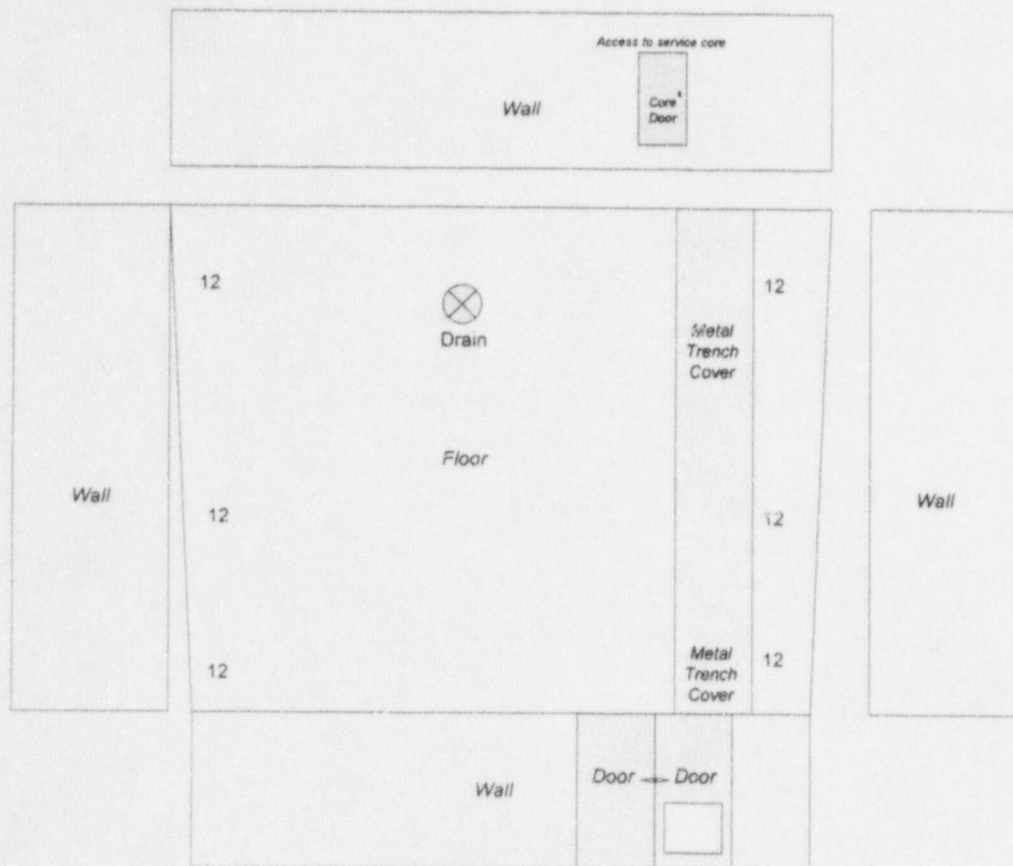
**Figure 46:** Lab 325: Locations and results of Exposure Rate Measurements

1. Survey results are provided in Table 6.
2. The values are  $\mu\text{R/hr}$  and indicate the approximate location of Exposure Rate measurements taken ~1m above ground surface.
3. All concrete surface.

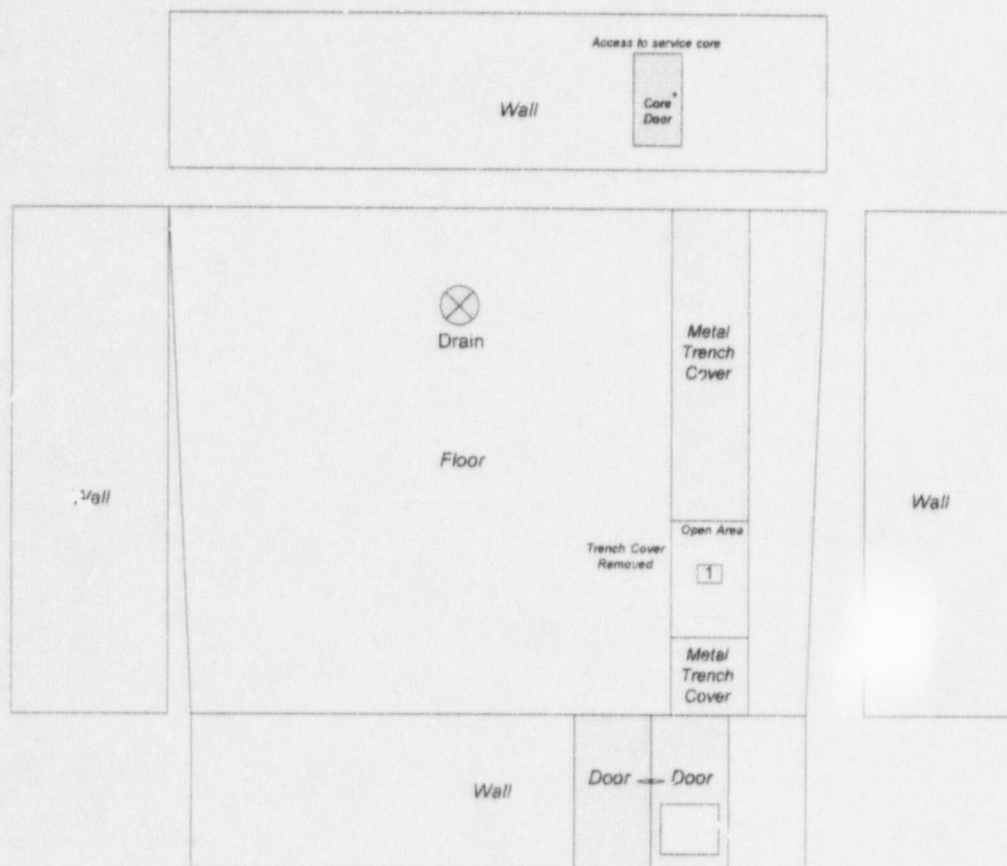
Figure 48: Lab 325: Large Area Masslinn Wipe Trench Survey

1. The numbered square shows the approximate location of large area masslinn wipe taken in the trench.
2. No activity above background was found.
3. All concrete surface.

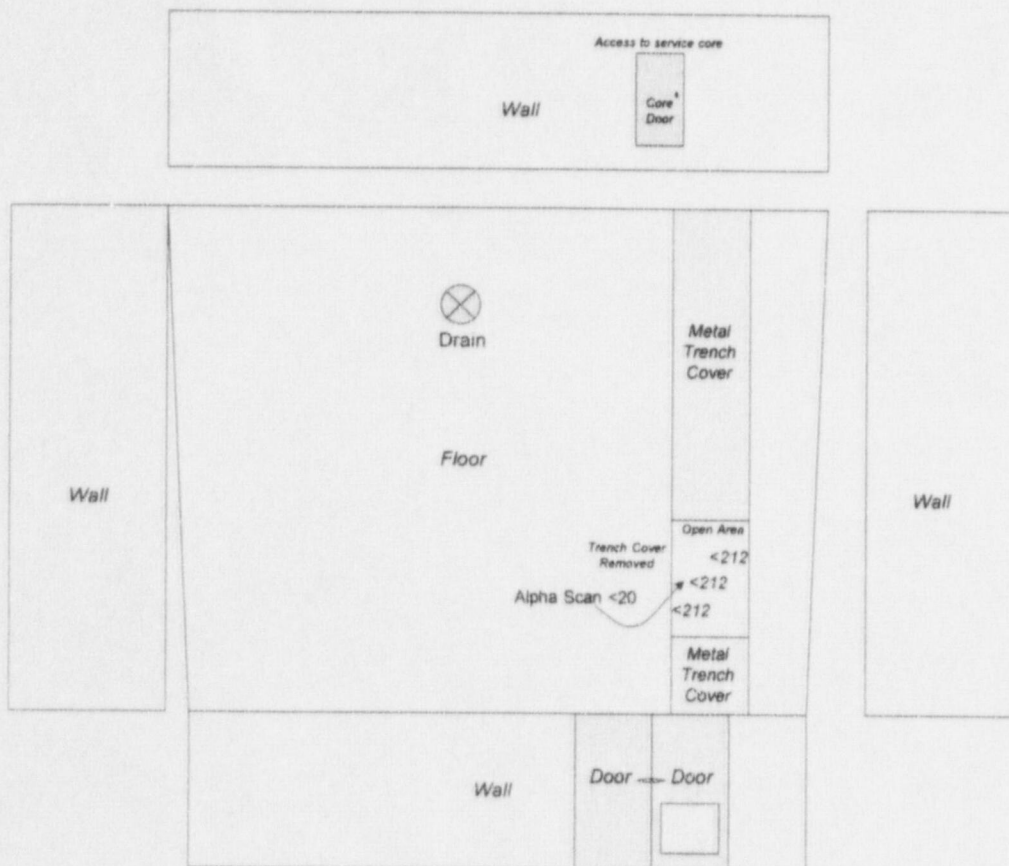
**Figure 49:** Lab 325: Scan open trench, 100% Alpha.  
Locations and Results of Two minute Beta Fixed Measurements

1. Survey results are provided in Tables 5.
2. 100% of Open Trench area was scanned for Alpha.
3. The values are in dpm/100cm<sup>2</sup> and indicate the approximate locations of measurements taken. Two minute (cp2m) fixed Beta readings were taken in the open trench.
4. All concrete surface.

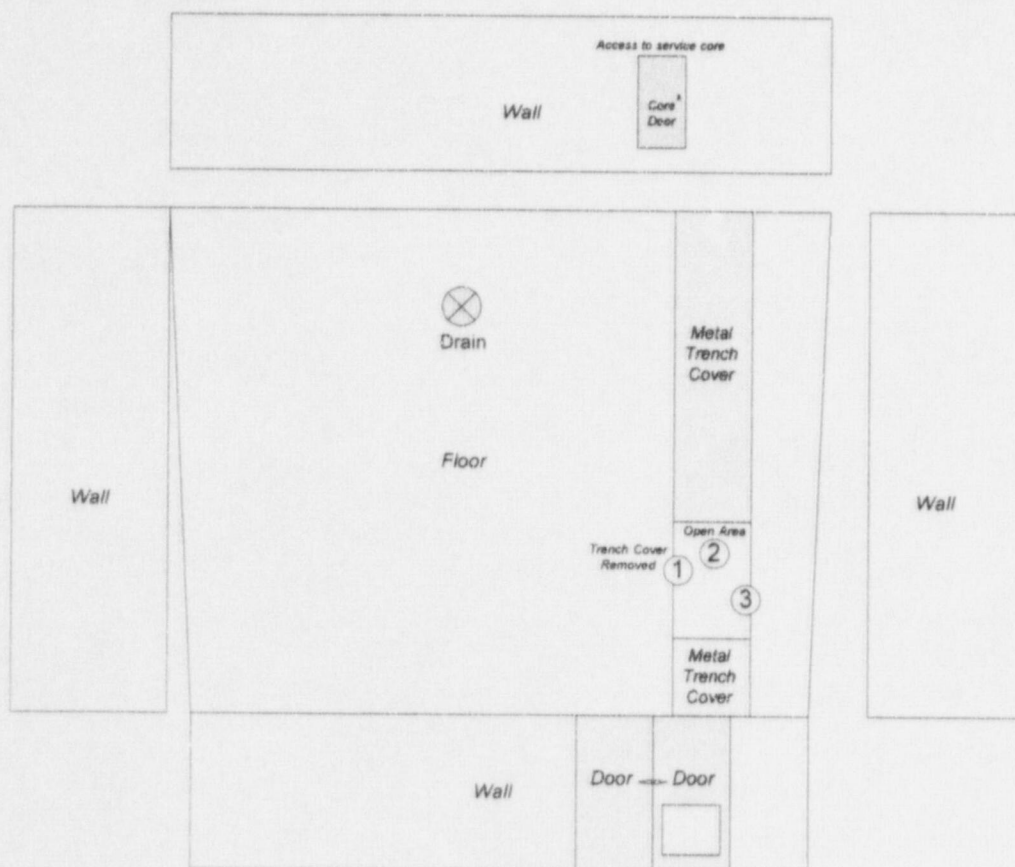
**Figure 50:** Lab 325: Locations of Removable Contamination Survey

1. The Numbers circled are the approximate locations of wipes taken inside the trench. Wipe results are provided in Table 7.
2. All concrete surface.

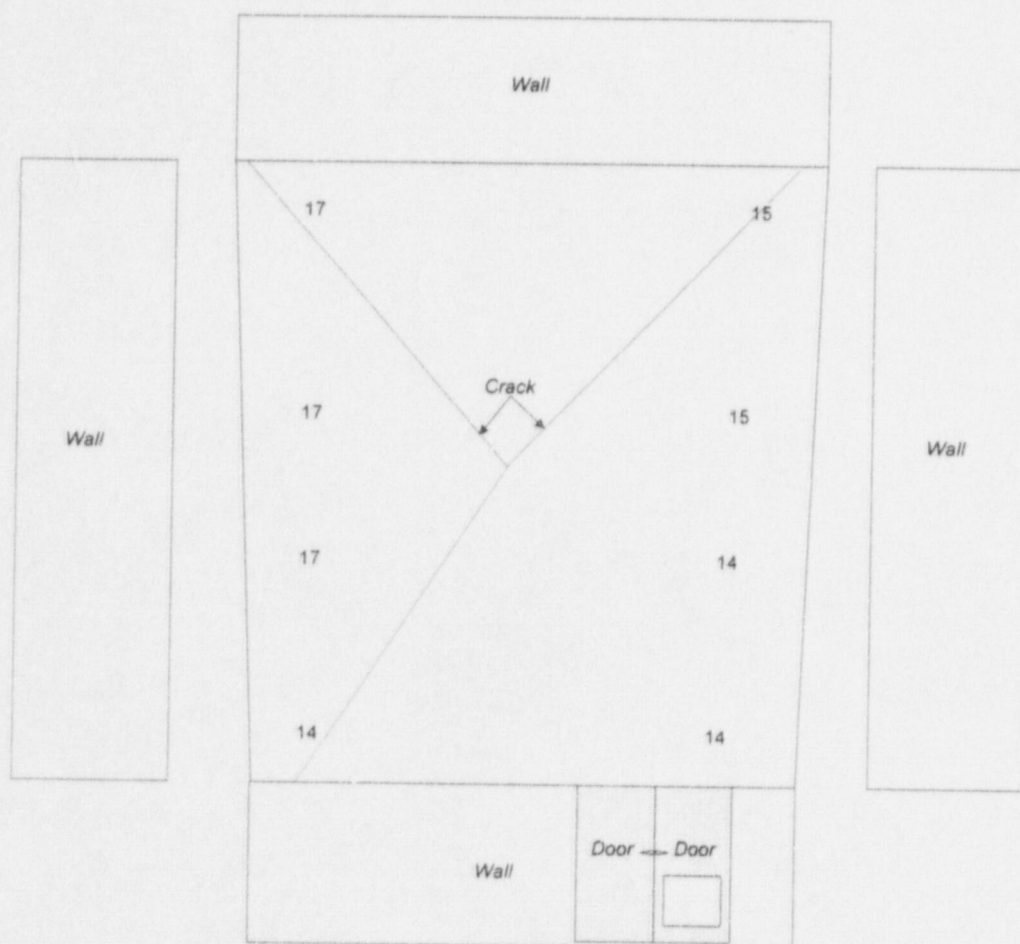
Figure 77: Lab 615: Locations and results of Exposure Rate Measurements

1. The values are exposure rate measurements in  $\mu\text{R/hr}$  at the approximate locations indicated. Each measurement was taken  $\sim 1\text{m}$  above ground surface.
2. All concrete surface.
