NUREG/CR-4512  
SAND86-0153  
R3/R4,R7  
Printed October 1986

## Pressurized Melt Ejection Into Scaled Reactor Cavities

PRESSURIZED MELT EJECTION INTO  
SCALED REACTOR CAVITIES

This report describes four tests performed in the High-Pressure Melt Streaming Program (HIPS) using linear-scaled cavities of the Zion Nuclear Power Plant. These experiments were conducted to study the phenomena involved in high-pressure ejection of core debris into the cavity beneath the reactor pressure vessel. One-tenth and one-twentieth linear scale models of reactor cavities were constructed and instrumented. The first test used an apparatus constructed of alumina firebrick to minimize the potential interaction between the ejected melt and cavity material. The remaining three experiments used scaled representations of the Zion nuclear plant geometry, constructed of prototypic concrete composition.

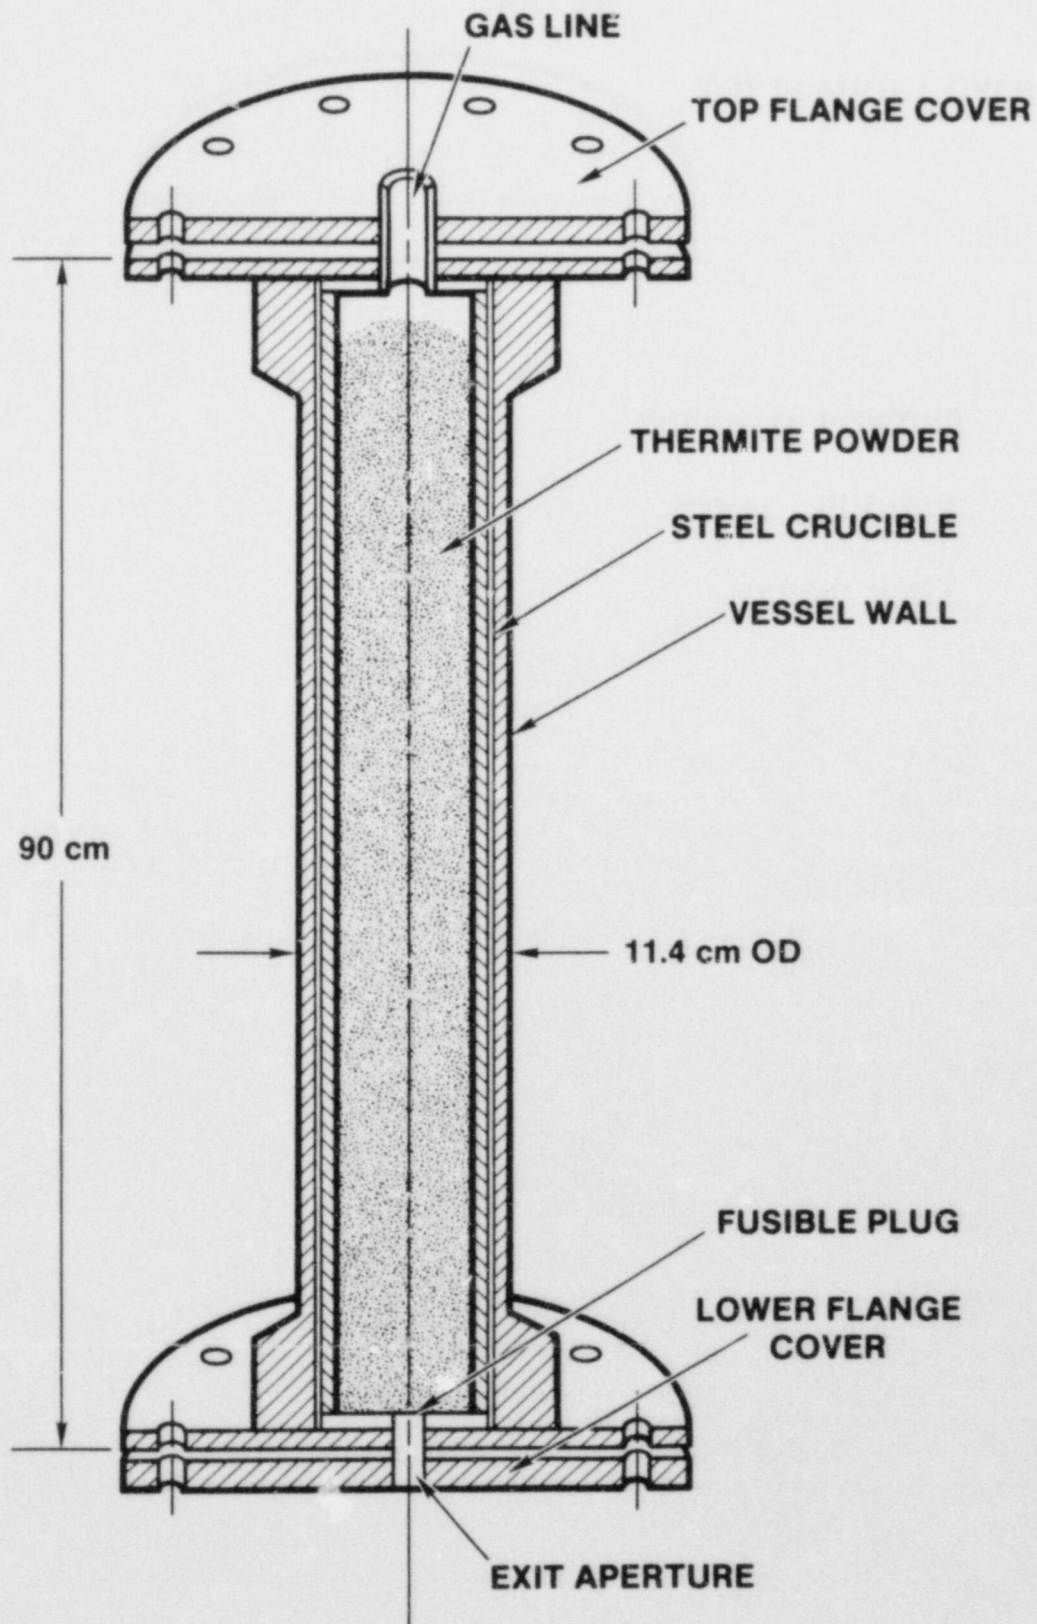
A sketch of the melt generator used for the SPIT series tests is shown in Figure 1. The melt generator was basically a pressure vessel to contain the metallothermic reaction that produced a mixture of molten iron and aluminum oxide. It was constructed of a mild steel pipe, 11.4 centimeter outer diameter by 90 centimeter long, with bolted flanges welded to each end. A second 10 centimeter diameter steel pipe was placed inside the first pipe to act as a crucible shell for the thermite powder. Graphite plates (1.2 centimeter thick) were placed at either end to complete the crucible. The bottom generator flange cover was machined to hold a replaceable insert plate. The insert plate was drilled and tapped to accept a fusible melt plug made from a

FIGURE 1. SCHEMATIC OF MELT GENERATOR USED ON THE SPIT TESTS

The upper melt generator flange cover was machined to accept a gas feed line (nominal 1/2-in diameter stainless steel tubing) to pressurize the vessel prior to the start of the thermite reaction. The thermite reaction was initiated by an igniter embedded in the upper portion of the powder bed. Gaseous contaminants released during the reaction plus heating of the overlaying gas layer normally contributed additional pressurization of the generator. The gas line was also connected to an accumulator vessel intended to mitigate the pressure increase during the thermite reaction. Even with the accumulator in place during previous tests, the pressure level at the time of ejection was typically 30% to 50% greater than the initial value. Reference 8 contains additional information on the melt generator construction and thermite reaction.

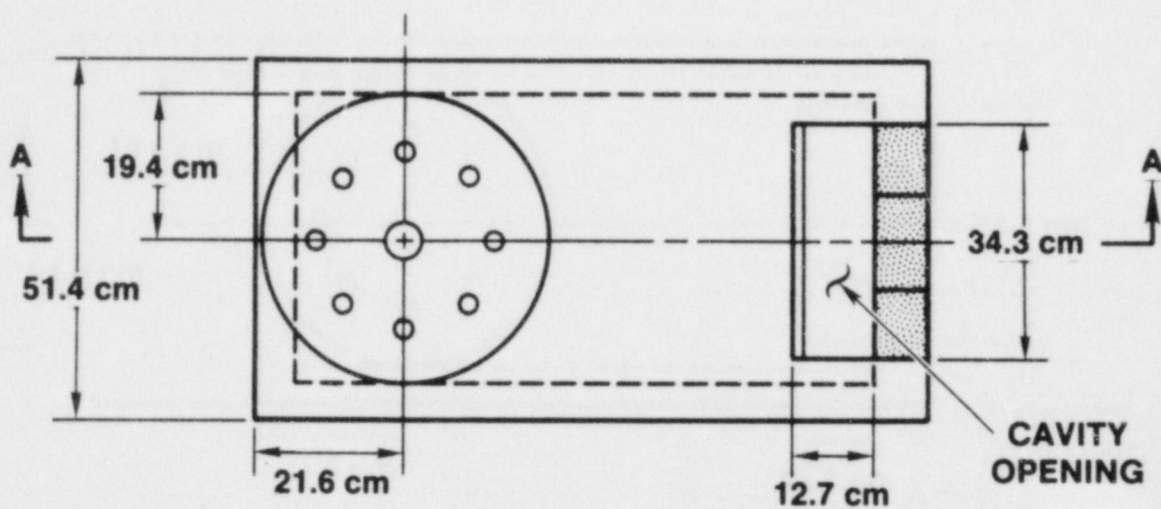
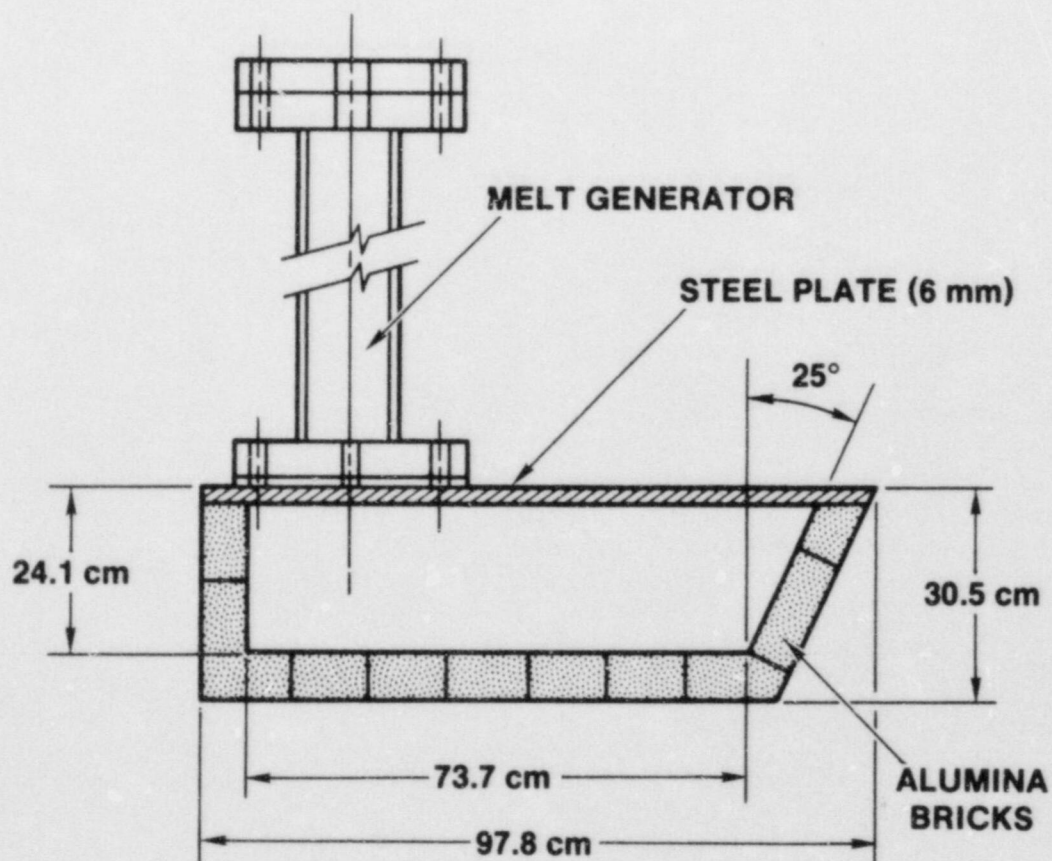
**FIGURE 2. SCHEMATIC OF SPIT-18 TEST APPARATUS**

The alumina brick selected for the SPIT-18 cavity was intended to eliminate the possible influence of a melt-concrete interaction on the debris dispersal processes. By using a refractory material in the cavity, the potentially disruptive effects of energetic concrete decomposition were reduced. Therefore, debris dispersal observed during this experiment should only be affected in the cavity by thermal and hydrodynamic phenomena. Likewise, using a simple cavity geometry simplified the flow patterns and regions where the debris could be trapped. To this end, the cavity was designed with a continuous cross-sectional area from the generator outlet to the exit of the cavity. The slightly reduced size of the cavity exit provided the only geometric restriction to the flow of gas and debris.

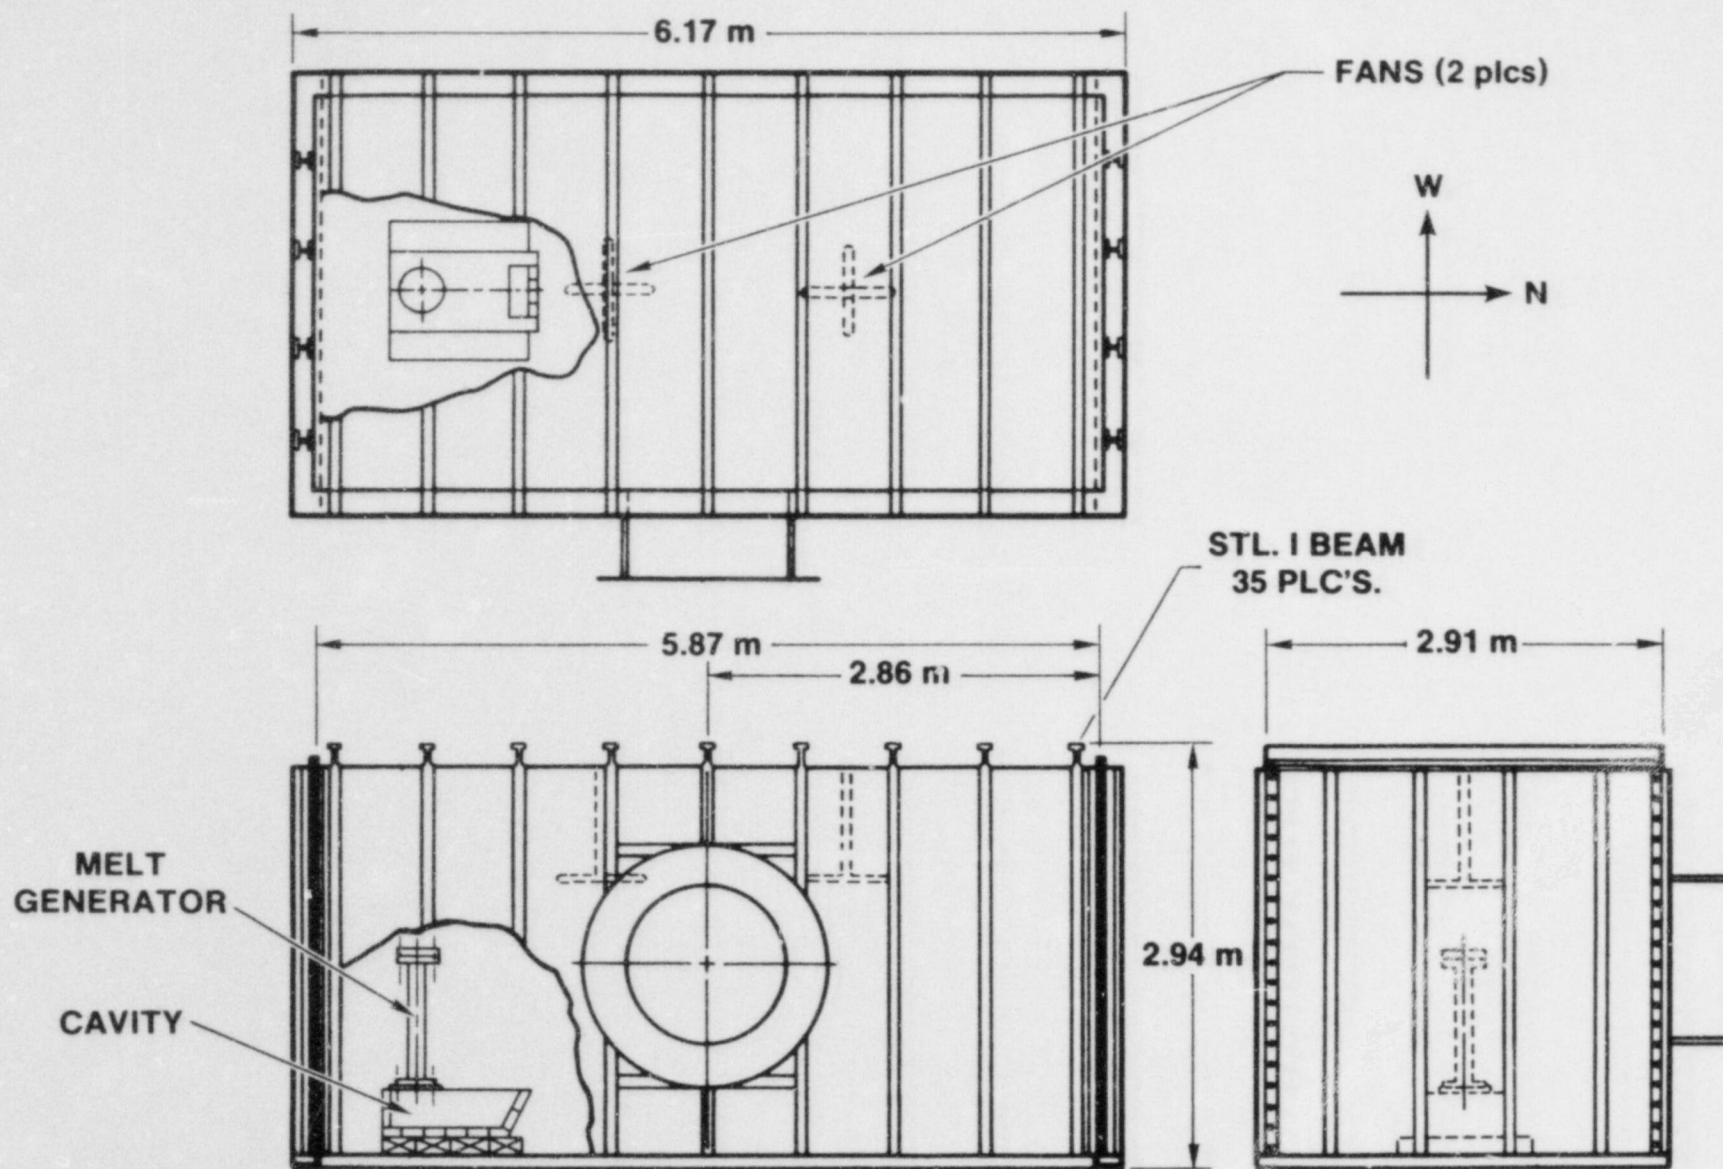
A schematic of the steel enclosure (known as the interaction chamber) is shown in Figure 3, along with the relative size of

FIGURE 3. SCHEMATIC OF SPIT-18 APPARATUS PLACED IN THE INTERACTION CHAMBER

Internally, the interaction chamber was almost devoid of structures except for a large instrumentation port. Two fans with six blades each driven by air motors were suspended from the ceiling to develop air circulation patterns. The capacity of these units was intended to cause a flow in one minute equivalent to the volume of the chamber. The fans were designed to create a uniform distribution of the material suspended in the atmosphere following melt ejection (aerosols). The objective was to make the aerosol samples representative of the actual generation of material. The chamber also incorporated several transparent ports in the sides and ceiling to allow camera coverage of the test events. A 600 Watt quartz lamp was placed near the ceiling and behind the apparatus to provide illumination before the start of the test sequence.

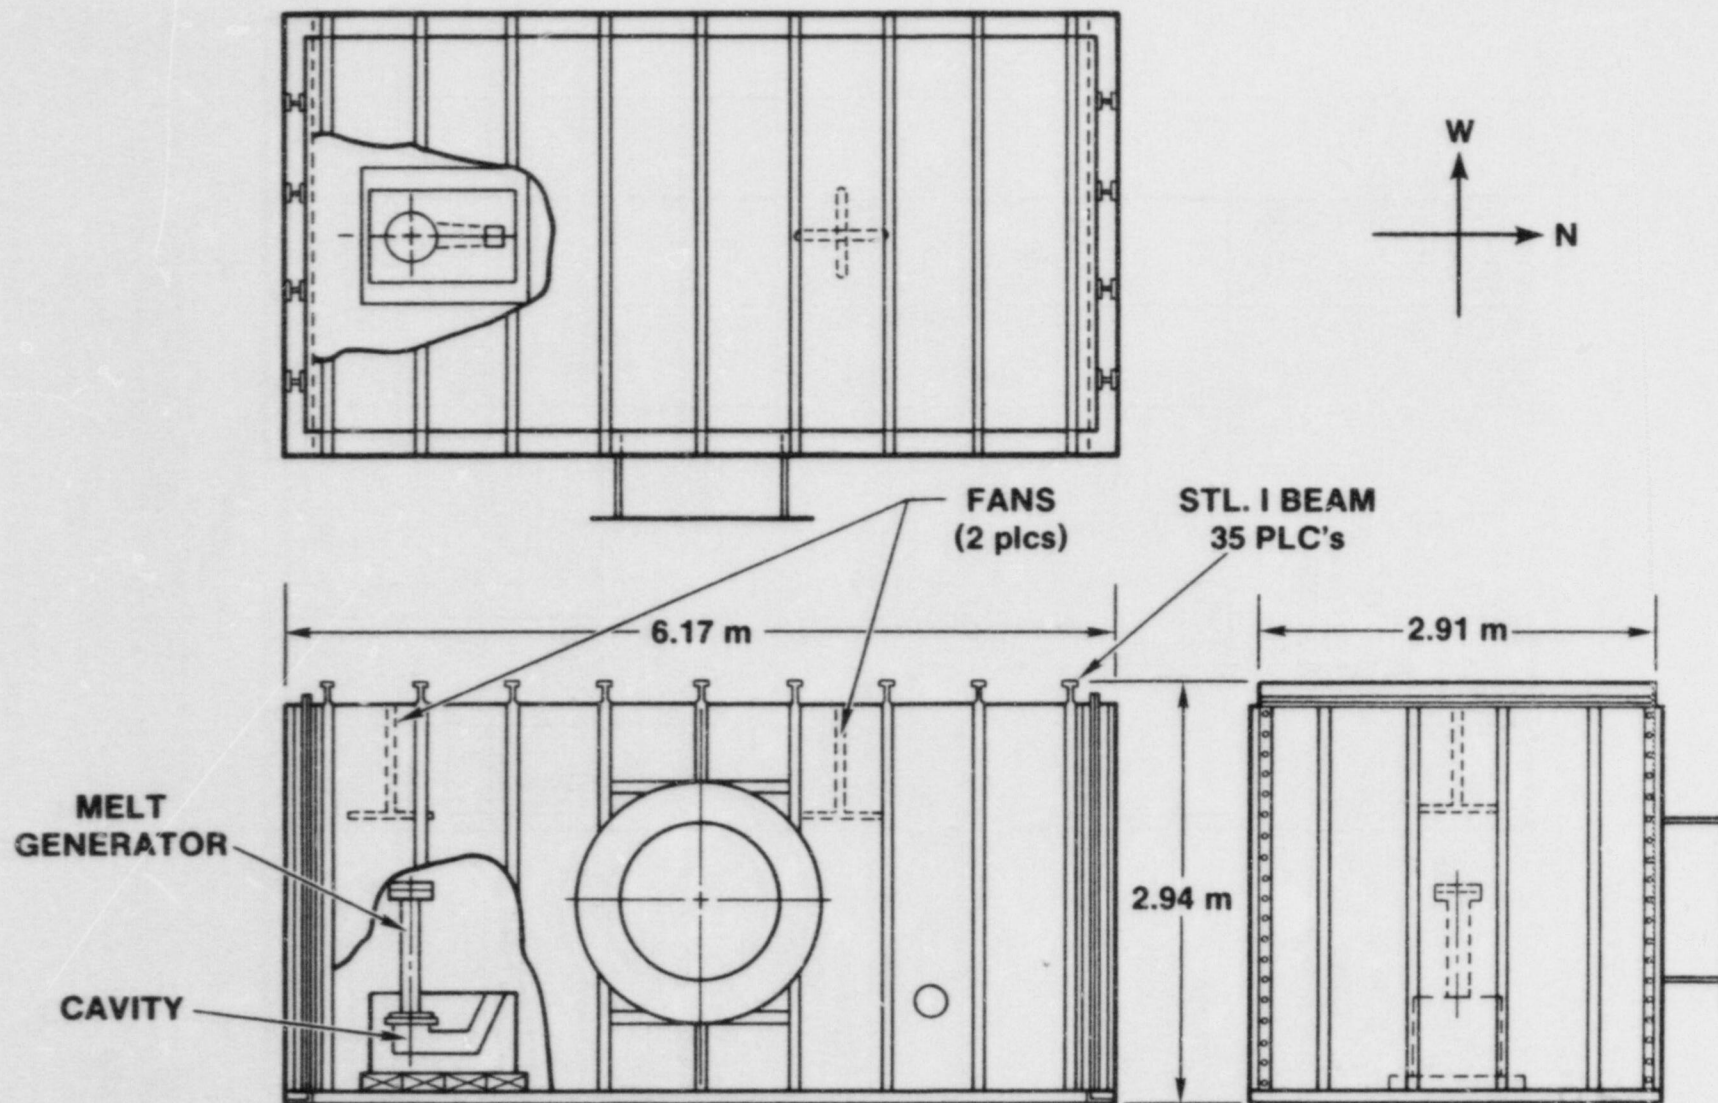
A schematic drawing showing the SPIT-19 apparatus placed in the interaction chamber is given in Figure 6. The chamber arrangement was similar to the SPIT-18 test except that the fans were moved to avoid the debris that emerged from the cavity. Several additional view ports were included (not shown on the drawing) to increase the camera coverage. A 600 Watt quartz lamp was placed near the ceiling of the chamber and behind the apparatus to provide illumination prior to the start of the ejection sequence. The lamp was not expected to survive if impacted by debris. The chamber was also modified to use flash X-ray equipment to monitor the material emerging from the cavity exit.

FIGURE 6. SCHEMATIC OF SPIT-19 APPARATUS PLACED IN THE INTERACTION CHAMBER

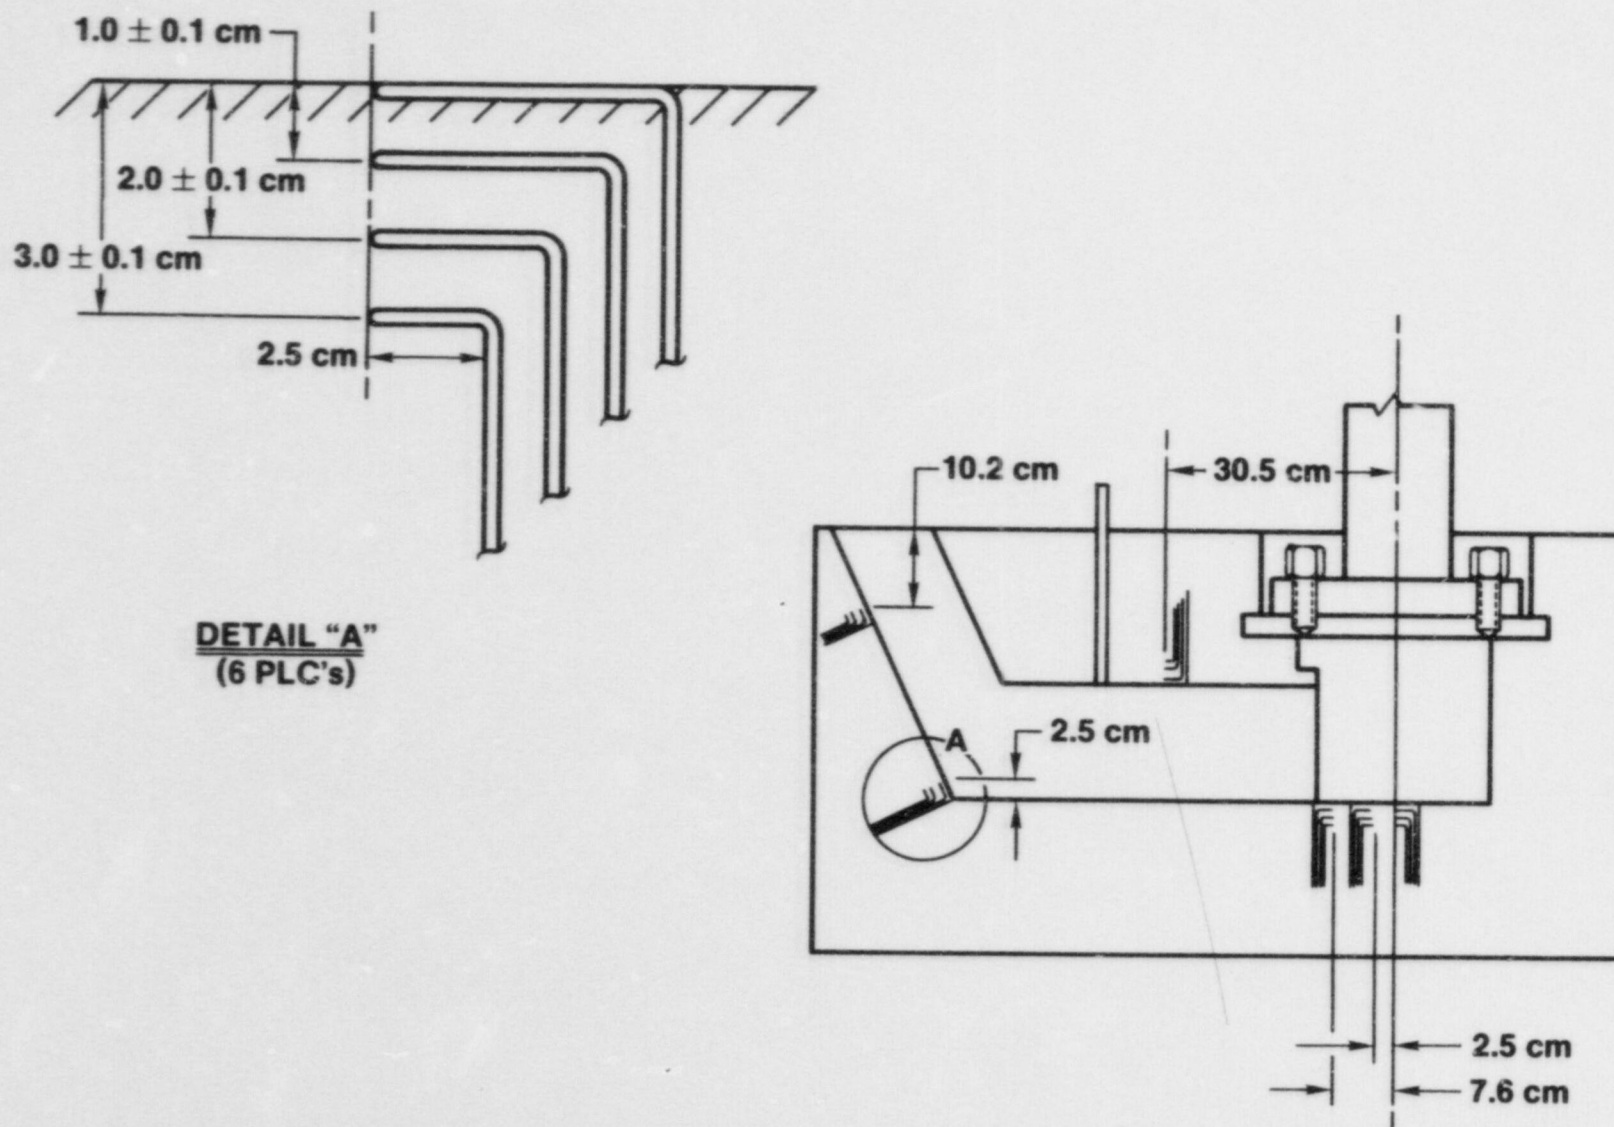
FIGURE 7. THERMOCOUPLE ARRANGEMENT IN SPIT-19 CAVITY

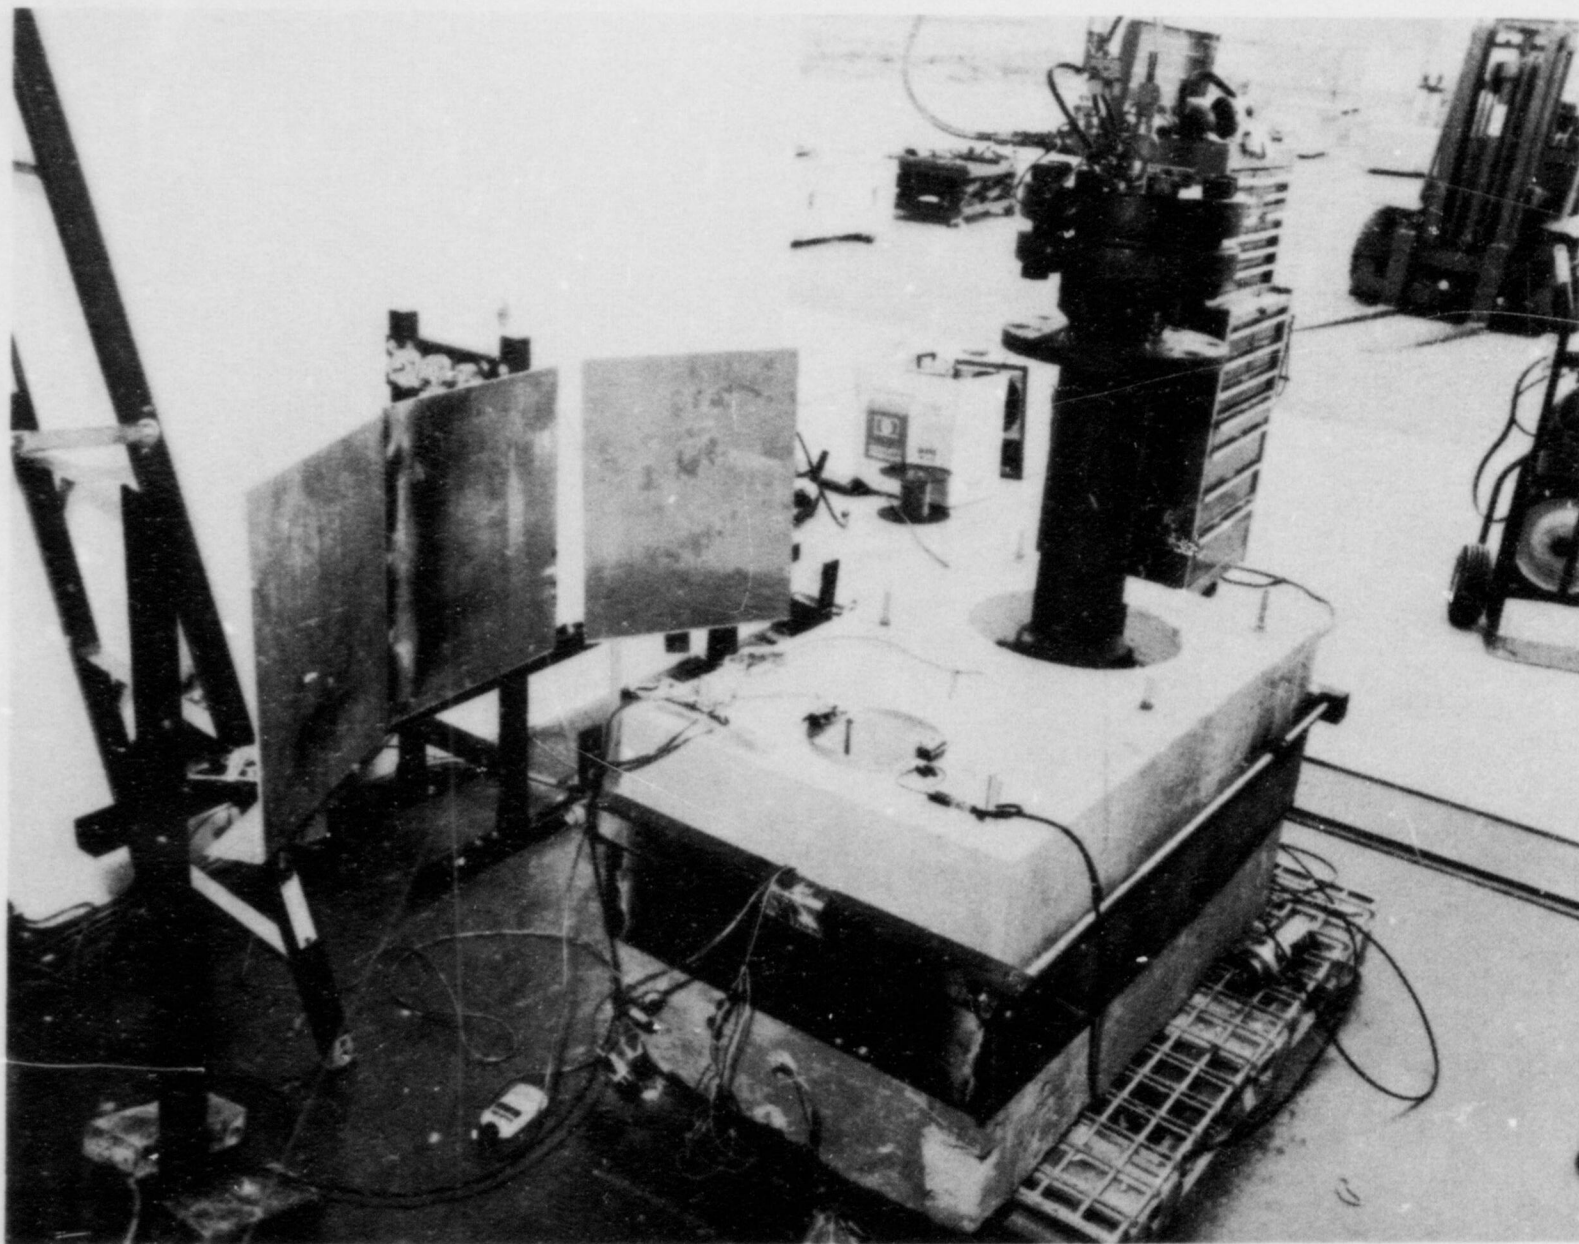
Figure 8 is a photograph of the SPIT-19 apparatus showing the position of the X-ray film cassettes near the cavity exit. The aluminum cassettes were insulated with a refractory blanket material to protect the film from the hot debris. The X-ray generators corresponding to each cassette were located just outside the interaction chamber (source to target distance- ~2 m, target to cassette distance- ~0.8 m), directed through windows made of relatively low X-ray adsorbing material. The center cassette was placed to give a view orthogonal to the direction of the flowing debris. The remaining two cassettes on either side of the center unit yielded somewhat oblique views of the emerging stream. The X-ray units were triggered by a breakwire placed across the exit opening. Each generator head

FIGURE 8. PRE-TEST PHOTOGRAPH OF SPIT-19 APPARATUS SHOWING PLACEMENT OF X-RAY CASSETTES

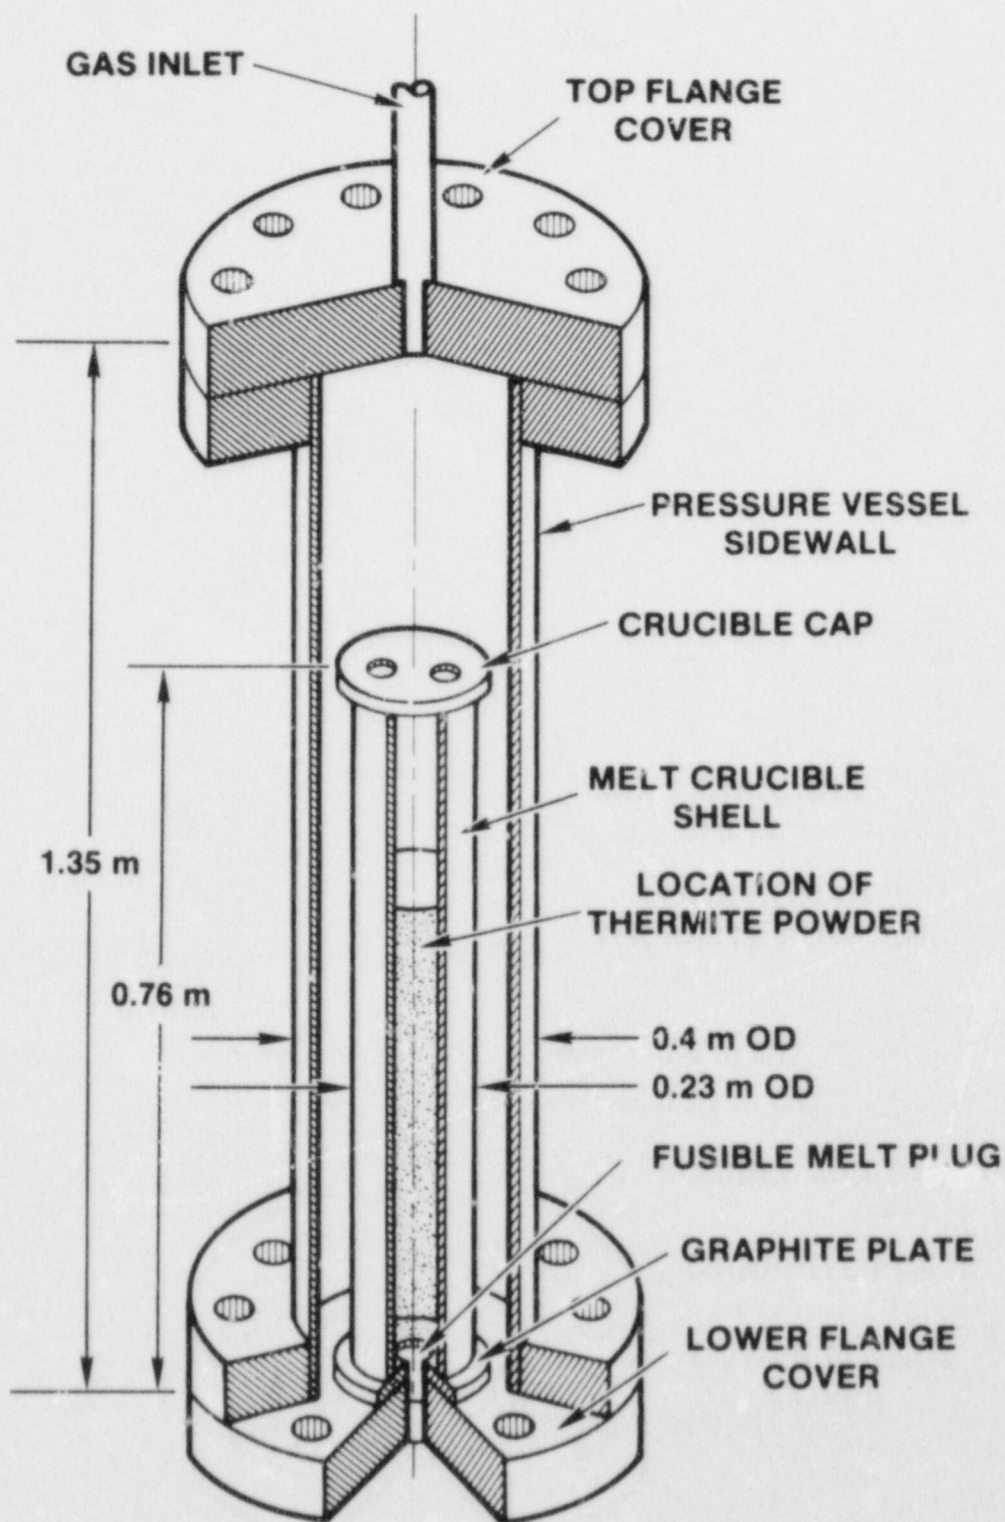
FIGURE 10. SCHEMATIC OF MELT GENERATOR USED FOR THE HIPS EXPERIMENTS

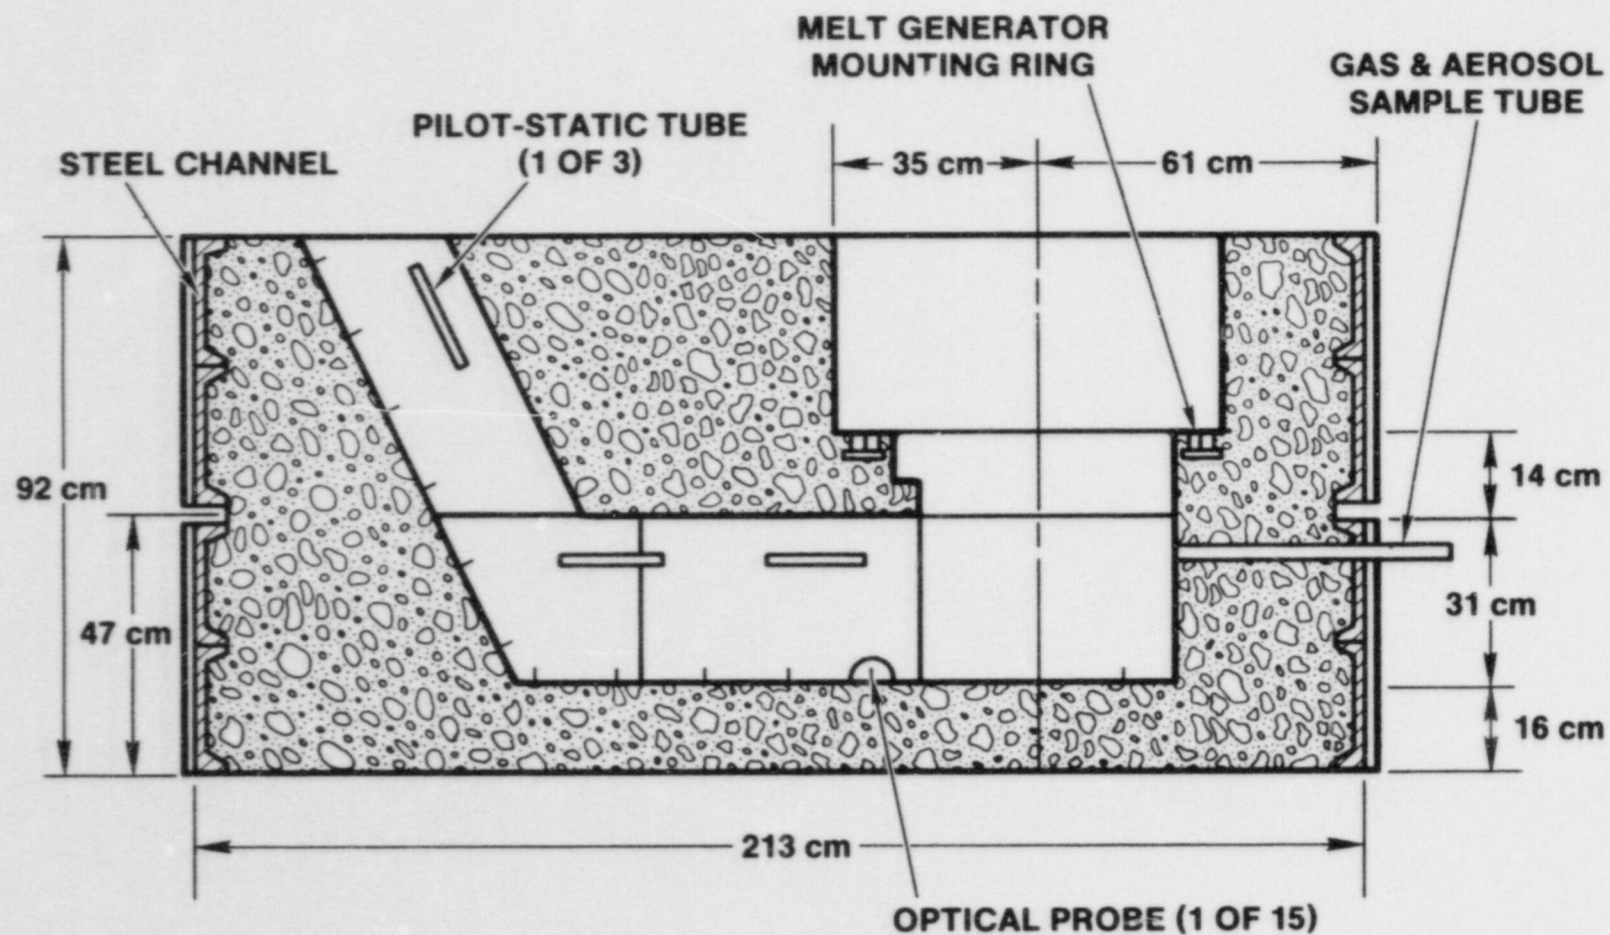
FIGURE 11. DETAILS OF THE HIPS CONCRETE CAVITY

The external dimensions of the cavity provided an adequate concrete thickness in all areas that could potentially be eroded by the impinging melt. The cavity was formed in two sections with a parting surface along the plane of the upper tunnel

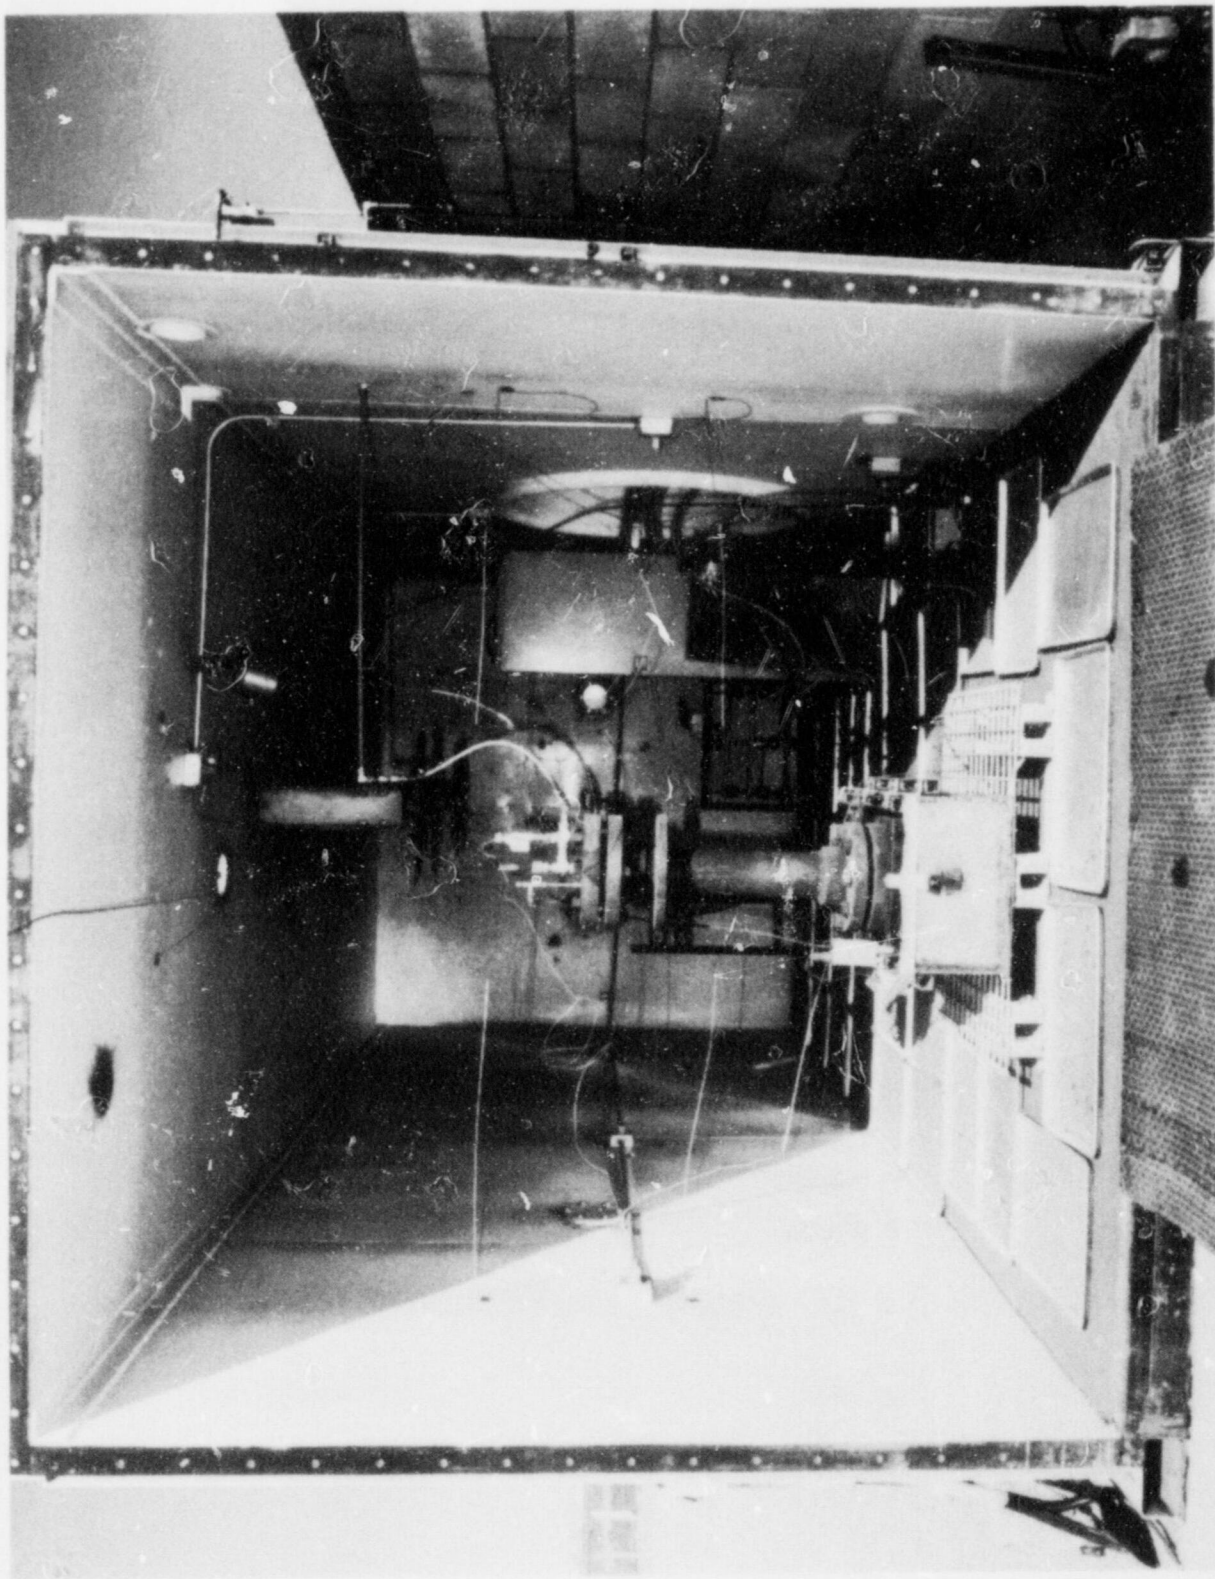
FIGURE 12. APPEARANCE OF INTERACTION CHAMBER FOLLOWING SPIT-18 TEST

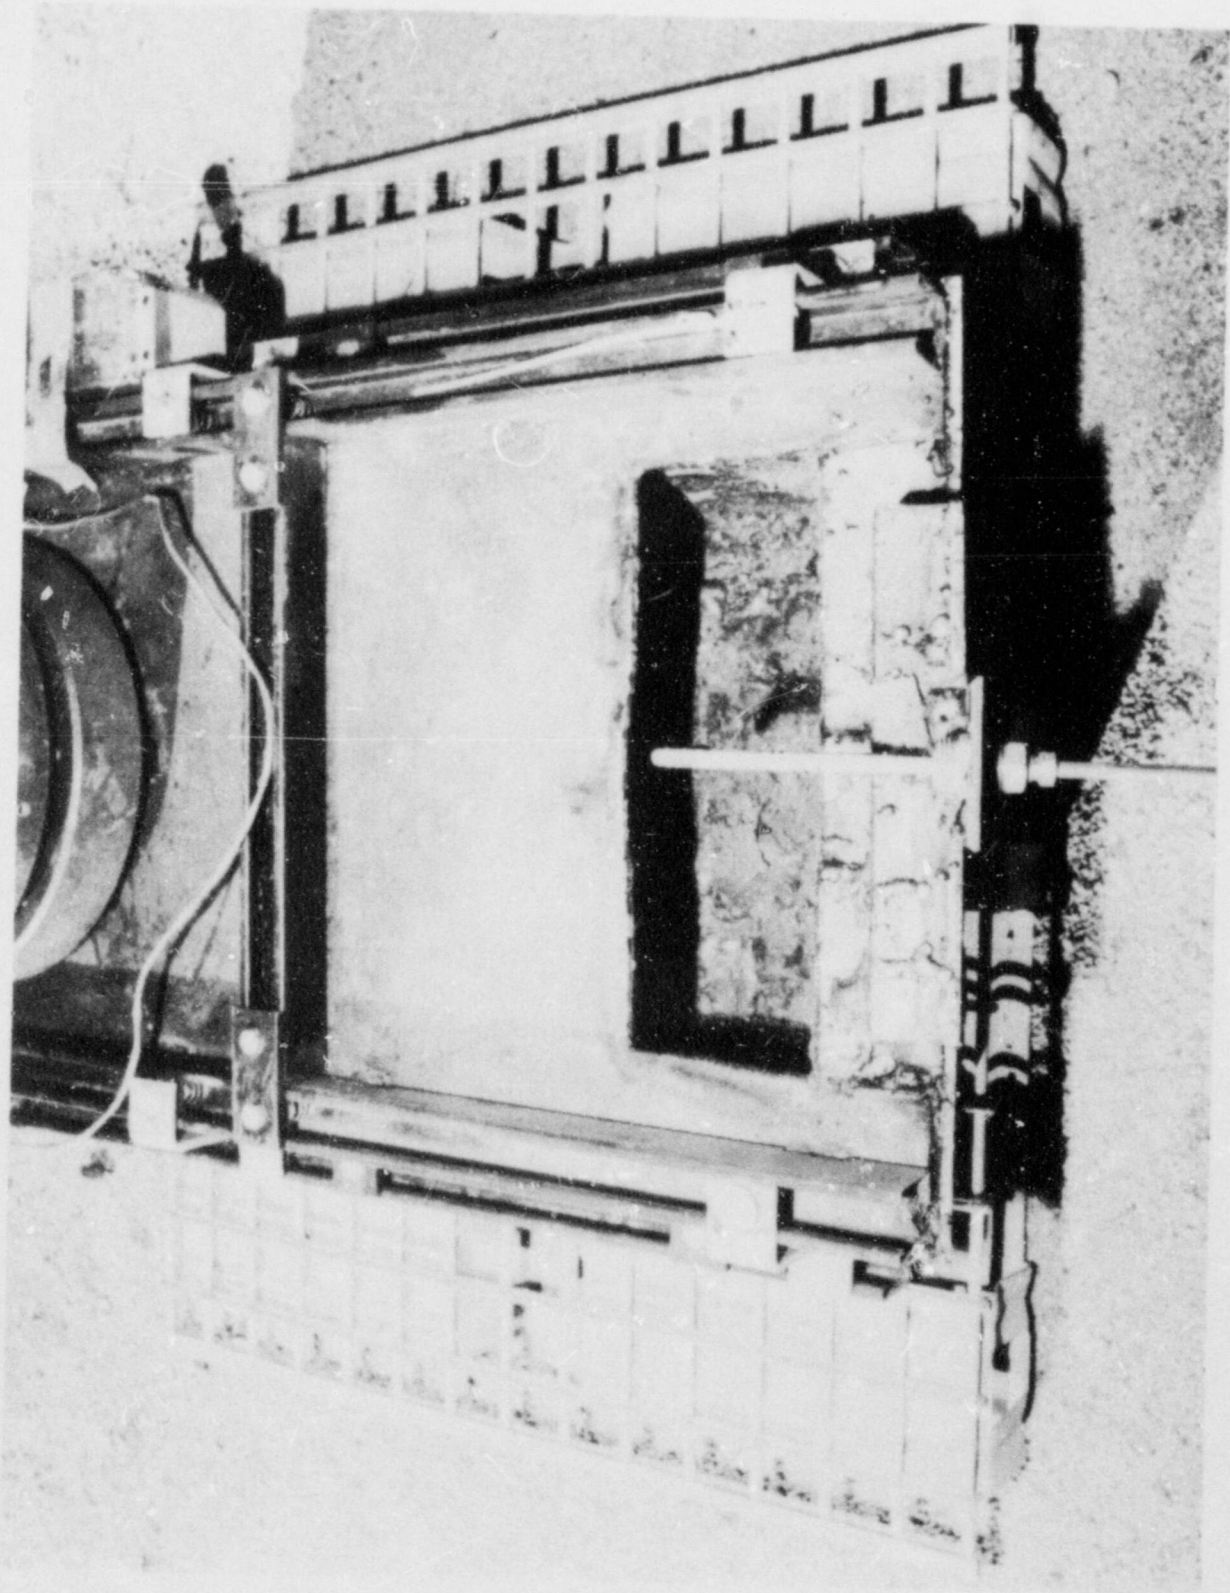
After the cavity apparatus was removed from the chamber, inspection showed several large irregularly shaped globules near the cavity exit (Figure 13). All other debris in the chamber was splash-like or in the form of small spheres. The relatively smooth exterior of these large globules near the exit suggested that they were not traveling at high velocity upon impact and were close to freezing. They were probably removed from the cavity late in the blowdown cycle when the gas velocities were much diminished.

FIGURE 13. PHOTOGRAPH OF CAVITY EXIT OPENING

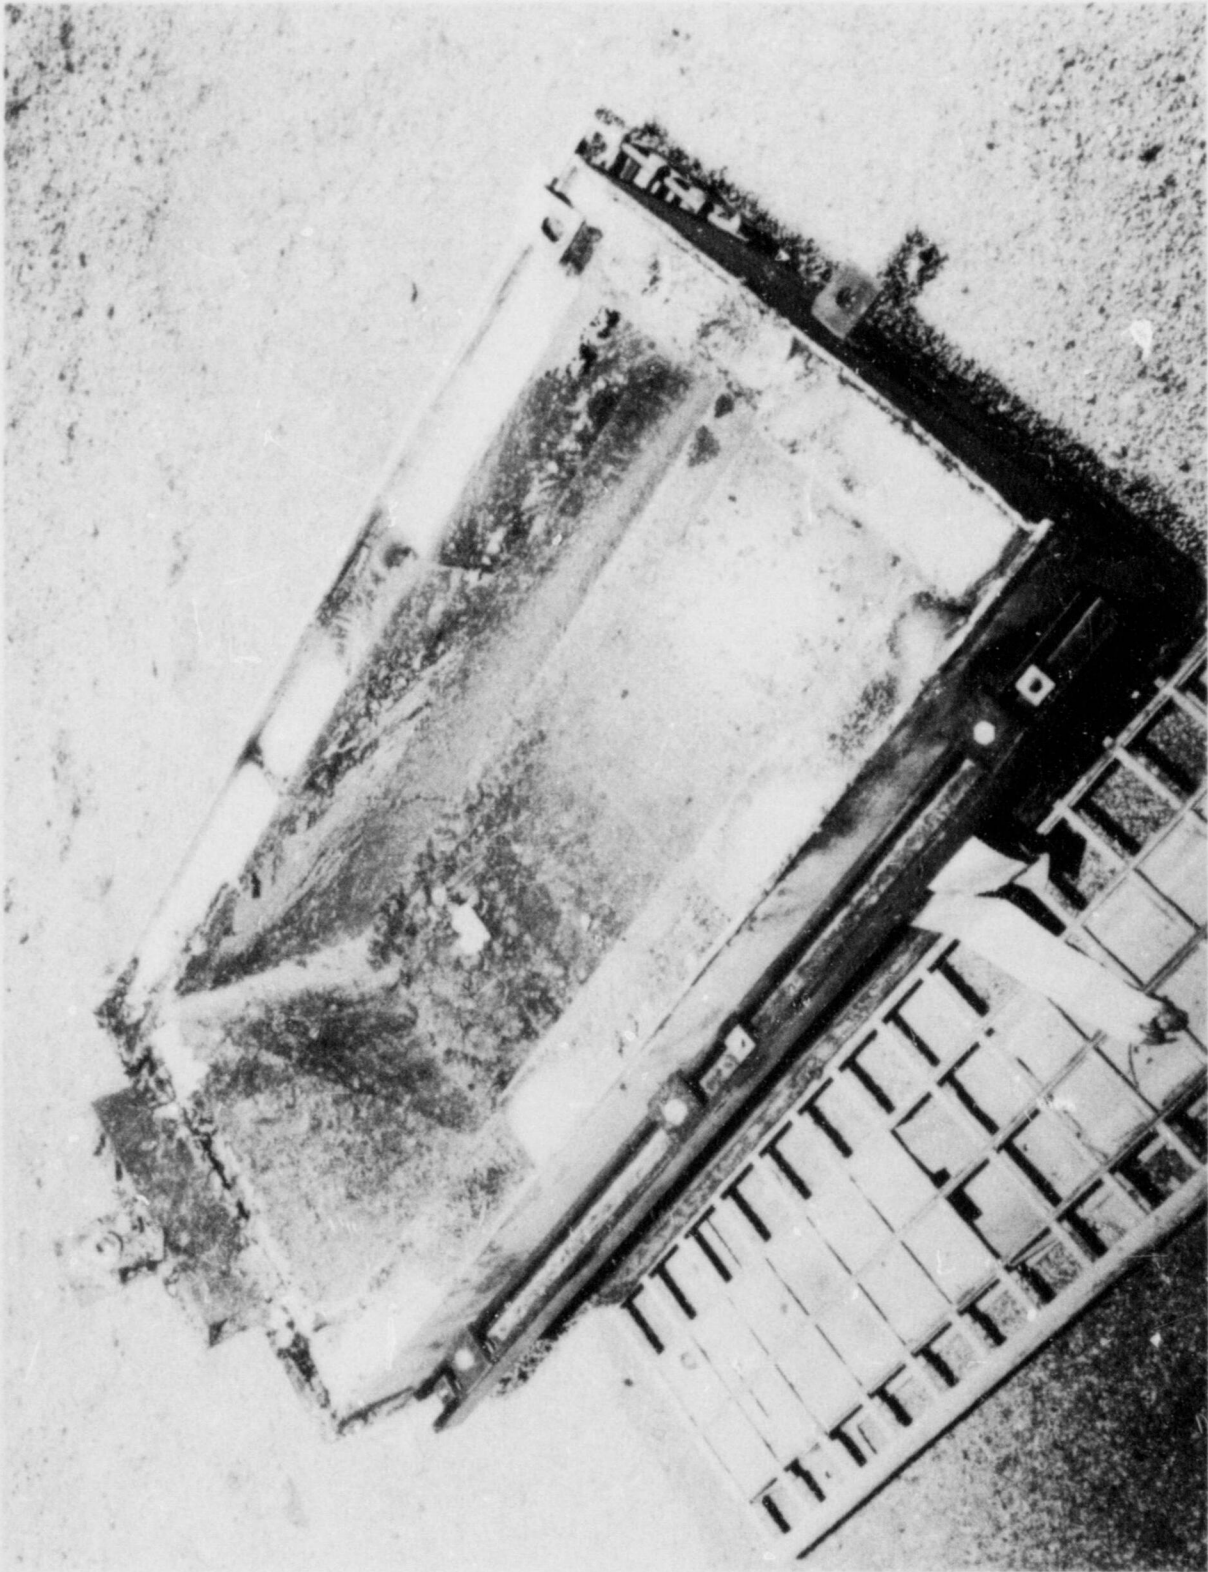
FIGURE 14. POST-TEST APPEARANCE OF CAVITY INTERIOR
