NUREG/CR-4512  
SAND86-0153  
R3/R4,R7  
Printed October 1986

## Pressurized Melt Ejection Into Scaled Reactor Cavities

PRESSURIZED MELT EJECTION INTO  
SCALED REACTOR CAVITIES

This report describes four tests performed in the High-Pressure Melt Streaming Program (HIPS) using linear-scaled cavities of the Zion Nuclear Power Plant. These experiments were conducted to study the phenomena involved in high-pressure ejection of core debris into the cavity beneath the reactor pressure vessel. One-tenth and one-twentieth linear scale models of reactor cavities were constructed and instrumented. The first test used an apparatus constructed of alumina firebrick to minimize the potential interaction between the ejected melt and cavity material. The remaining three experiments used scaled representations of the Zion nuclear plant geometry, constructed of prototypic concrete composition.

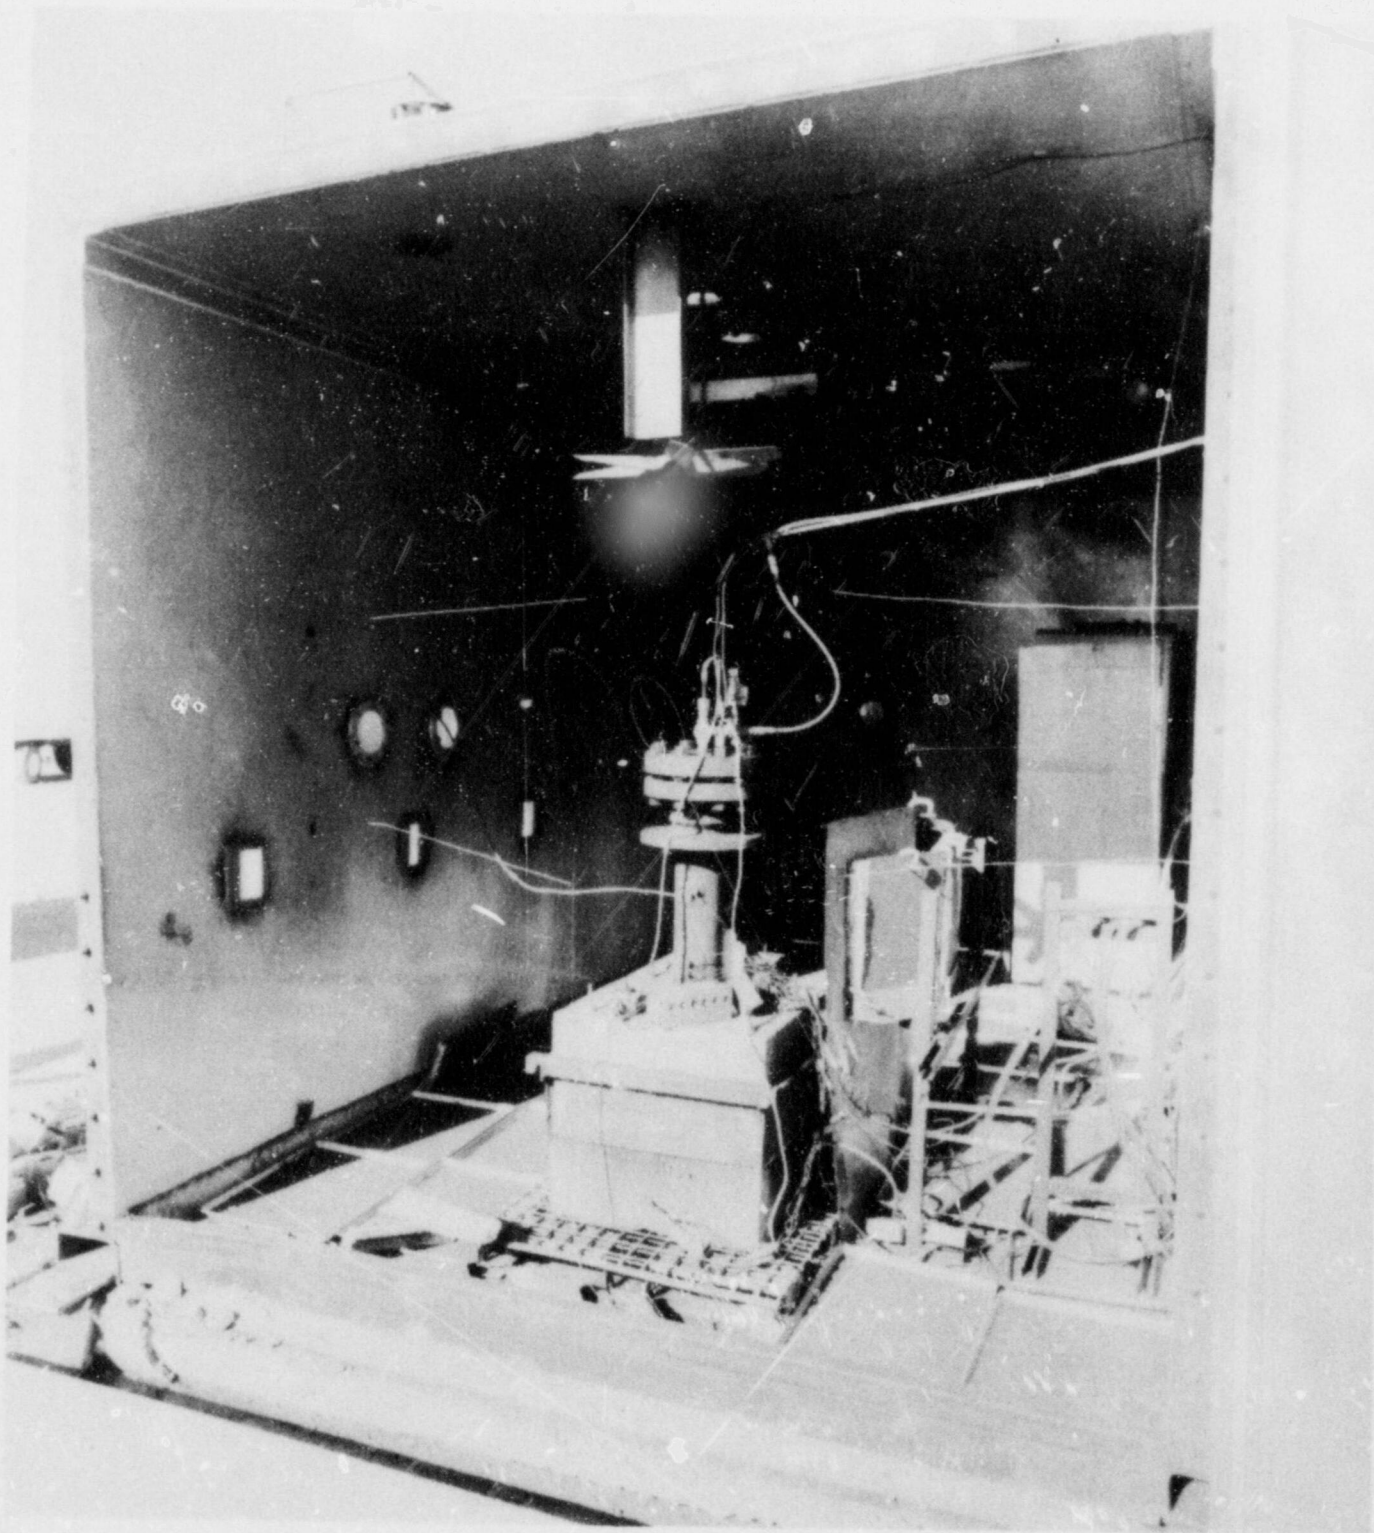
The interior appearance of the interaction chamber after removal of the south door is given in Figures 16 and 17. Large pieces of concrete from the interaction chamber pad were found

FIGURE 16. INTERIOR OF INTERACTION CHAMBER FOLLOWING SPIT-19 EXPERIMENT

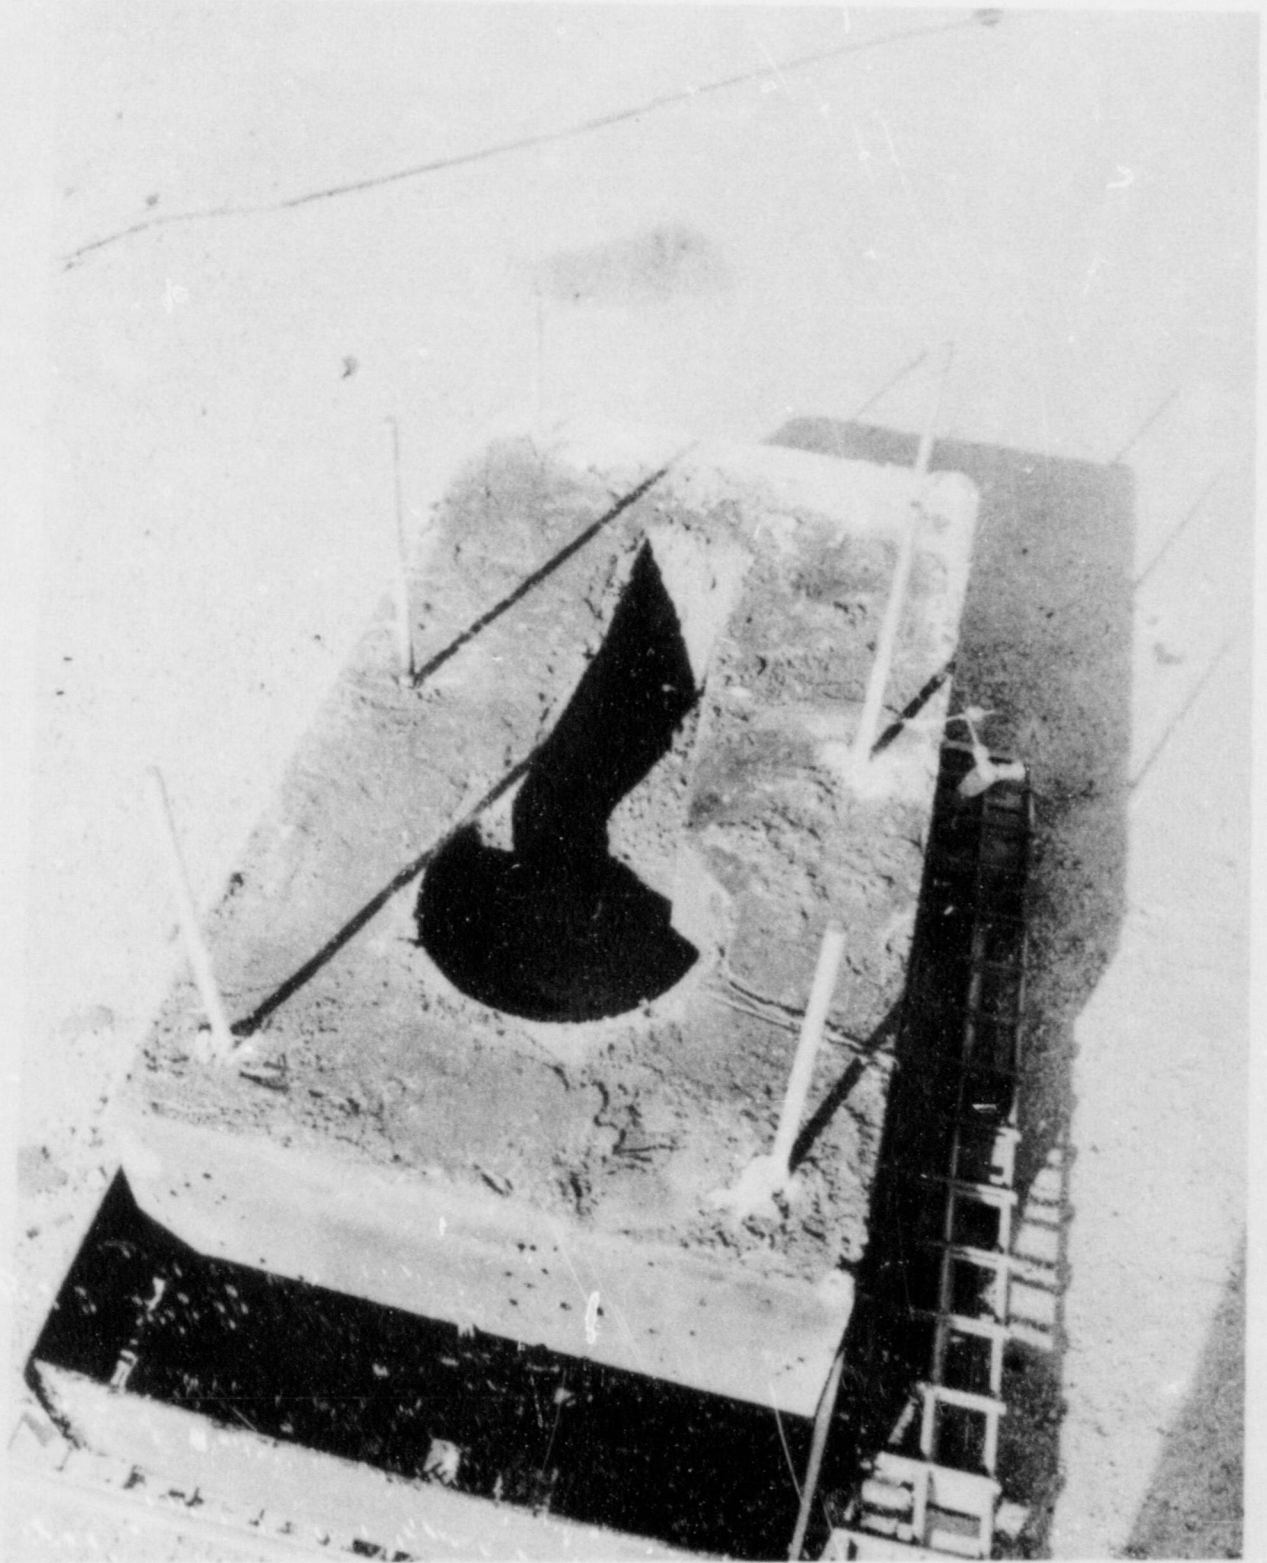
After the two halves of the cavity were separated, portions of the parting surfaces were covered by a thin, irregular layer of frozen melt. A photograph of the lower cavity half is given in Figure 20. The rough appearance of the mating surfaces was caused by the grout used between the two halves. The dark area near the circular cavity was created by melt that penetrated into the gap between the two cavity halves. The thickness of the material in this region was less than one millimeter.

FIGURE 20. LOWER HALF OF SPIT-19 CAVITY

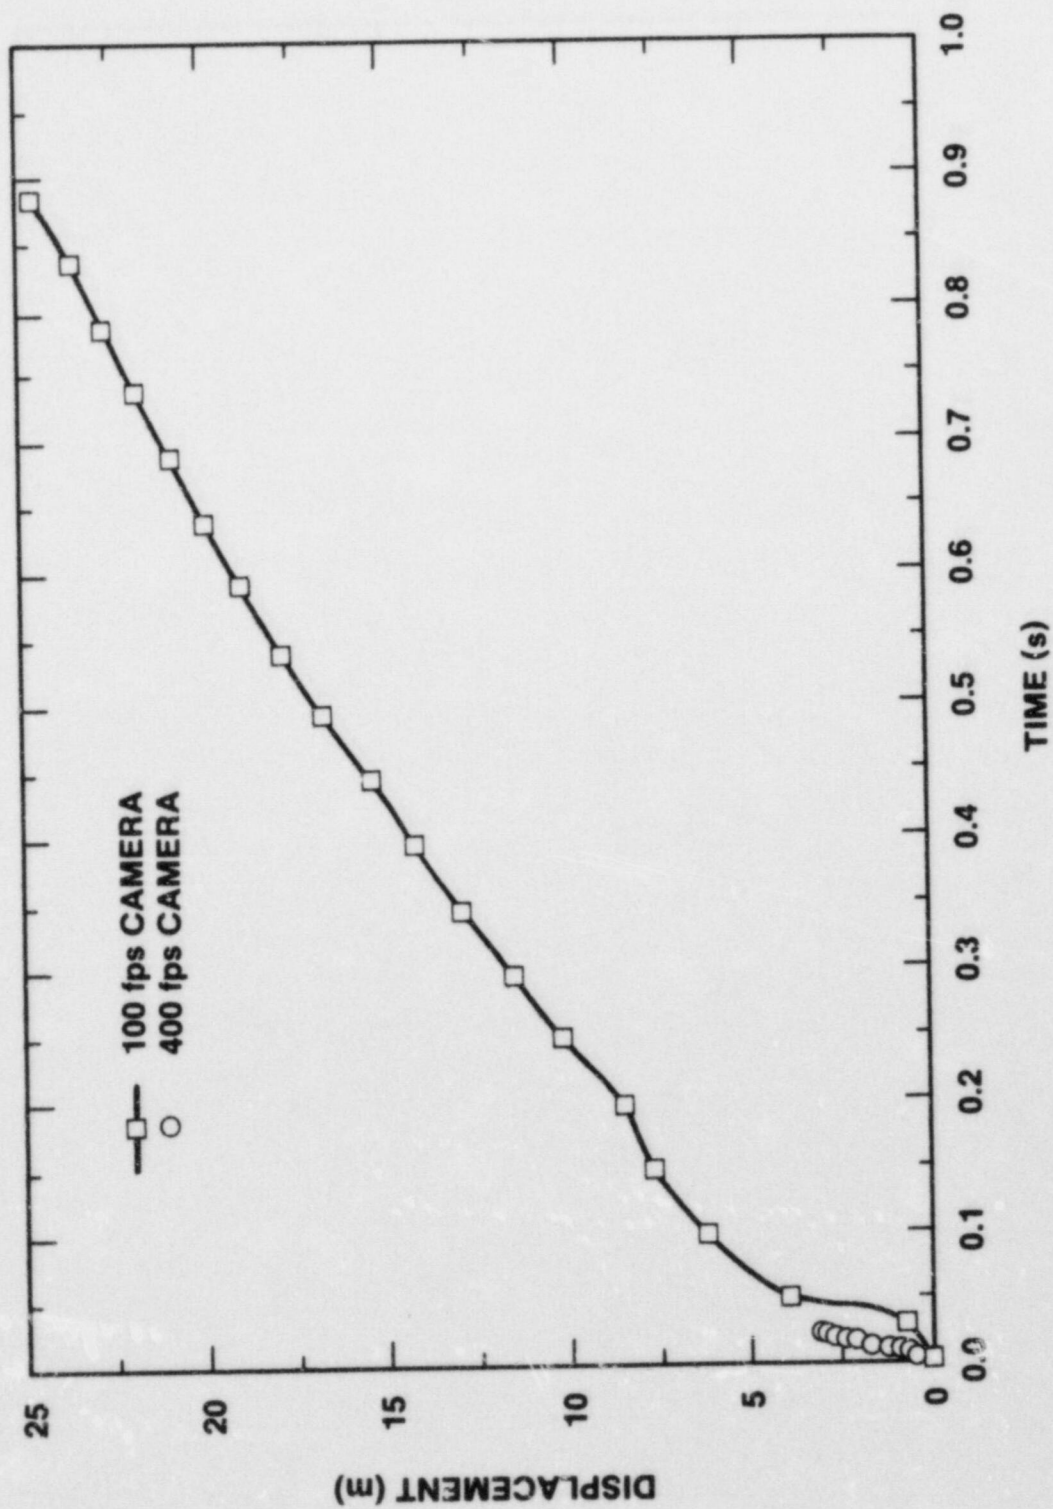
FIGURE 22. HIPS-2C LEADING EDGE OF DEBRIS DISPLACEMENT VERSUS TIME

The cameras near to the apparatus showed that the cavity failed along the parting line at approximately 330 milliseconds. The first indication of the failure was the appearance of melt escaping along the parting line between the upper and lower halves of the apparatus. The debris that emerged from the aperture in the cavity moved somewhat more slowly than the material from the exit. Comparison of the records from all

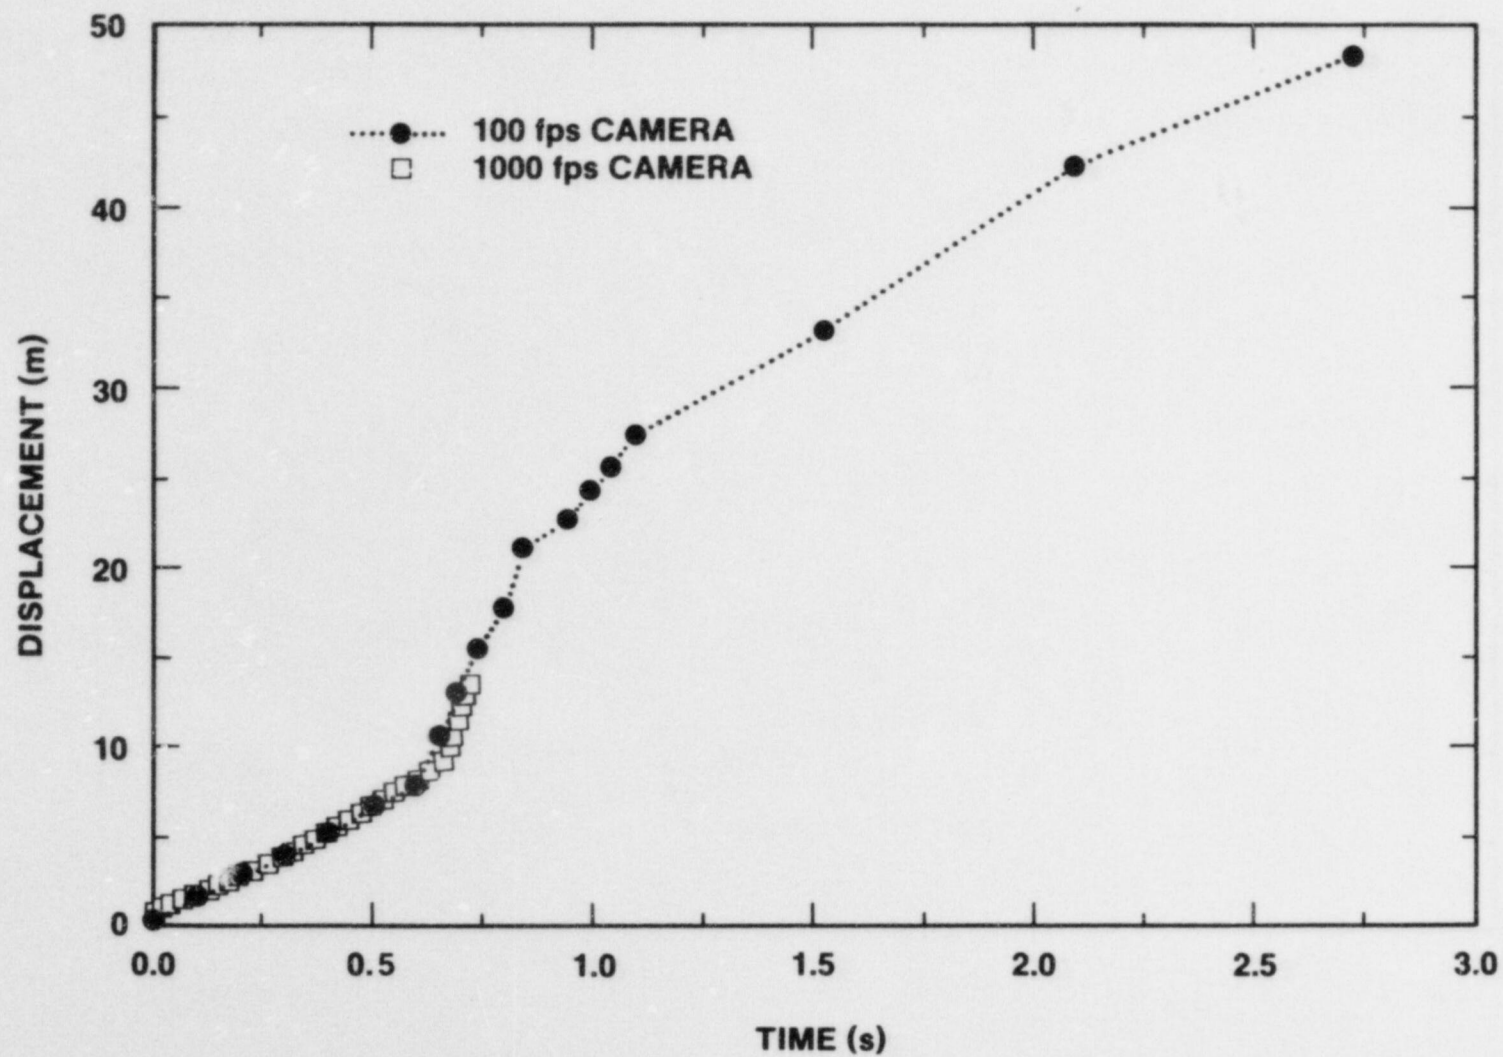
FIGURE 24. HIPS-5C DEBRIS DISPLACEMENT VERSUS TIME

Two other aspects of the HIPS-5C experiment differed from the HIPS-2C observations. First, the HIPS-5C cavity remained intact throughout the experiment so that all of the debris exited from the cavity opening. Second, the HIPS-5C debris may not have been molten when it impacted the ground. Shortly after the debris reached the apex of the trajectory, the luminosity of the material decreased to a point where it could not be seen in the camera records. Furthermore, the debris did not splash on impact as seen in the HIPS-2C test.

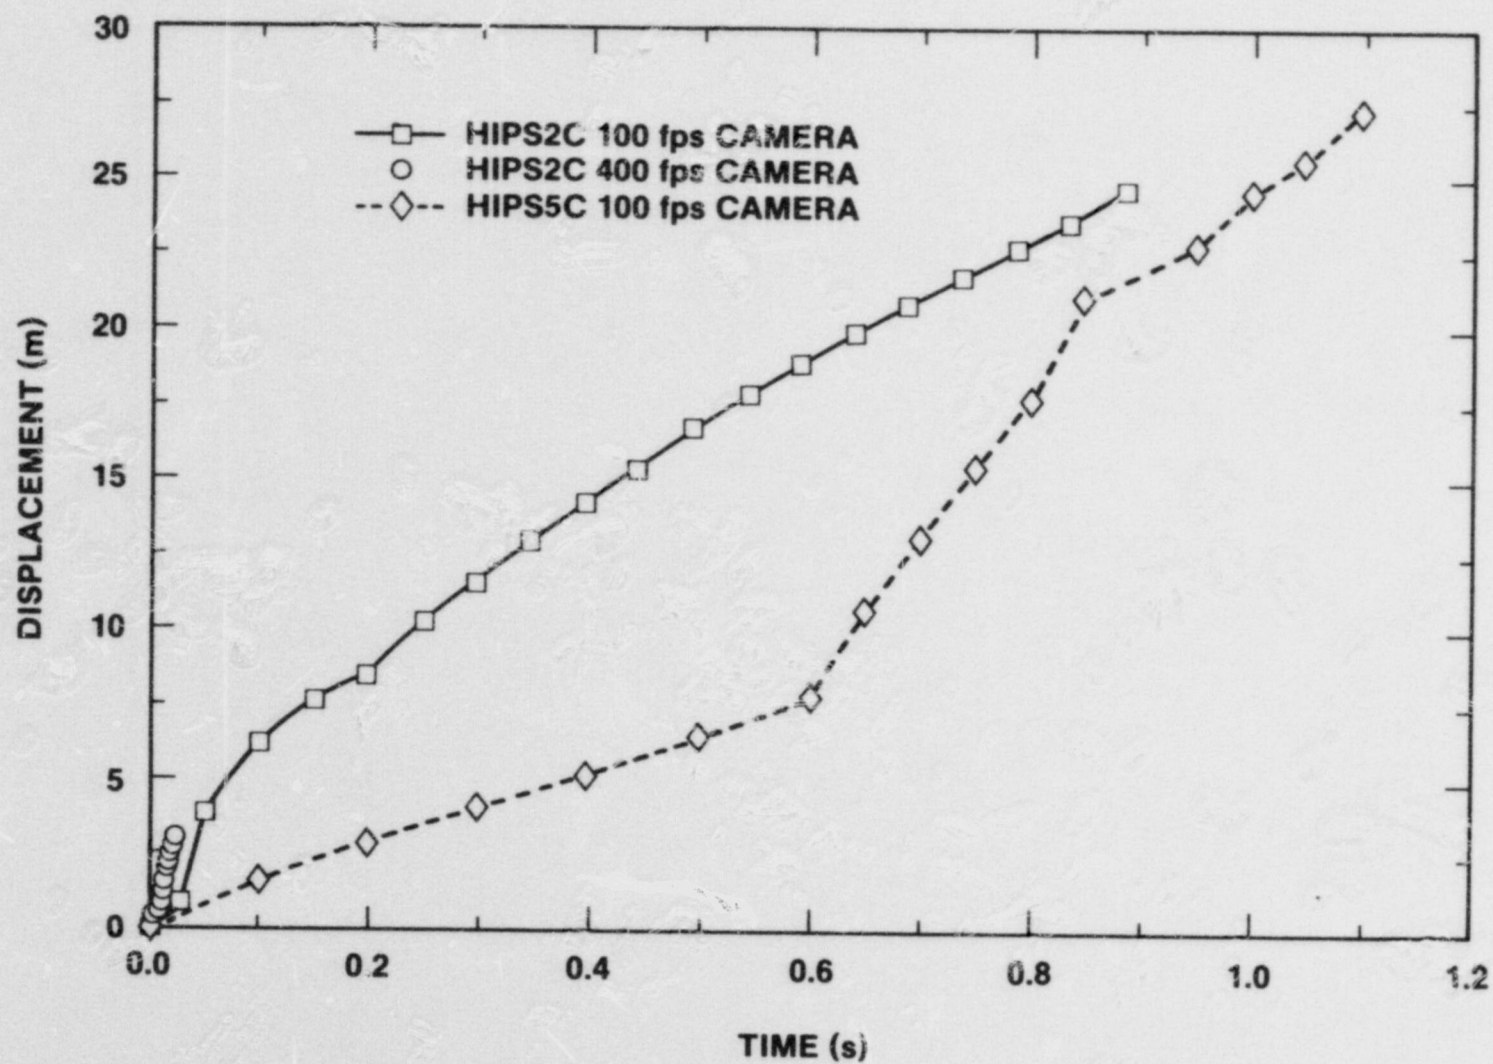
FIGURE 25. COMPARISON OF HIPS-2C AND HIPS-5C DEBRIS DISPLACEMENT

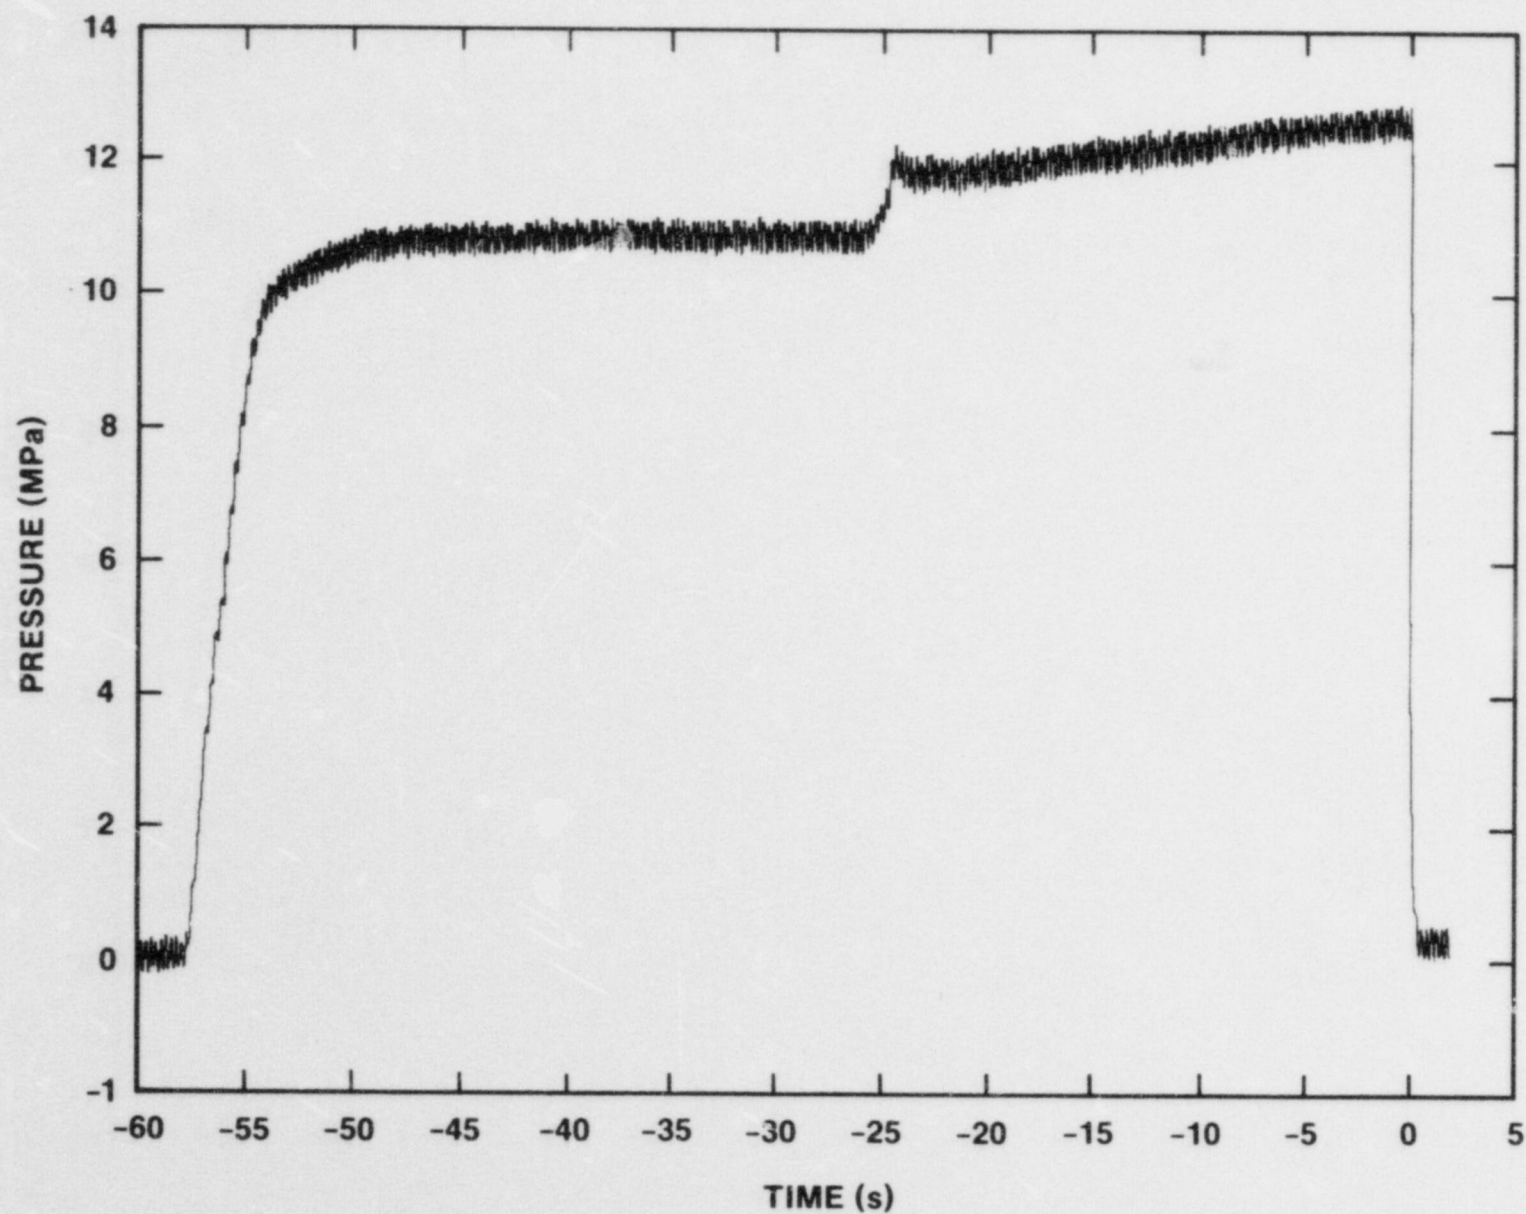
The pressure history for the SPIT-18 test is given in Figure 26. This record was characteristic of the behavior seen in most previous tests of this type with an initial slow increase in pressure to a stable value that subsequently increased upon the start of the thermite reaction. The influence of the

FIGURE 26. SPIT-18 PRESSURIZATION HISTORY

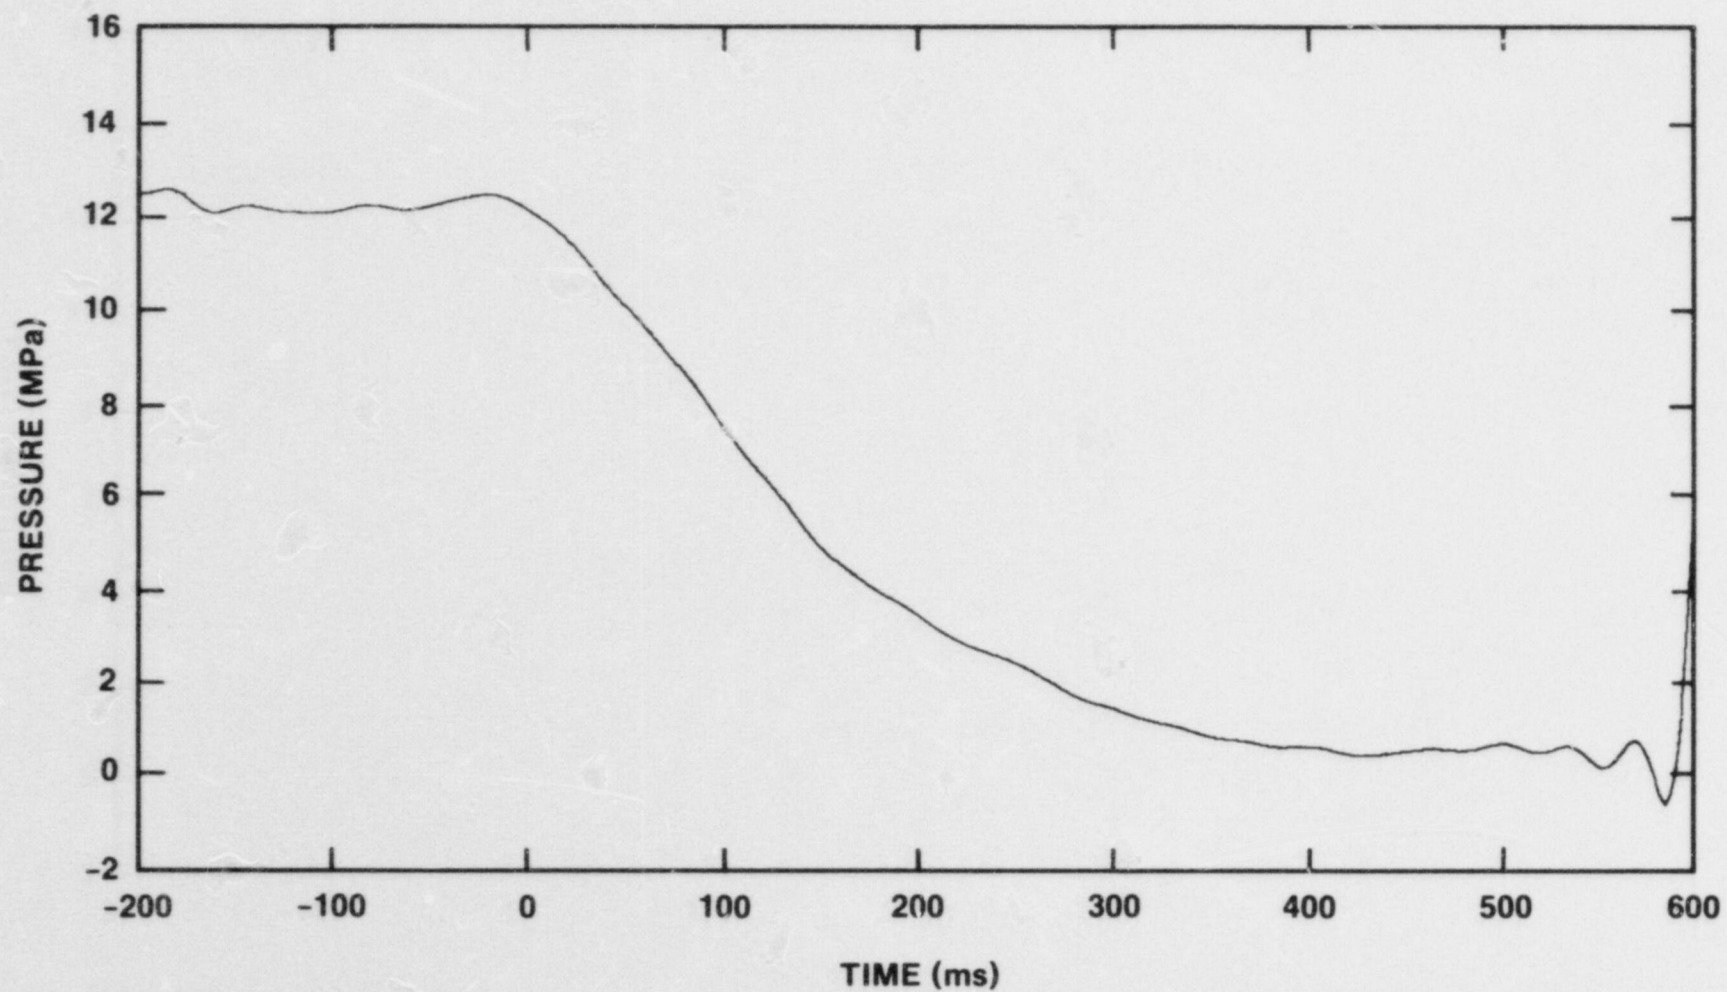
FIGURE 27. BLOWDOWN RECORD OF SPIT-18 MELT GENERATOR

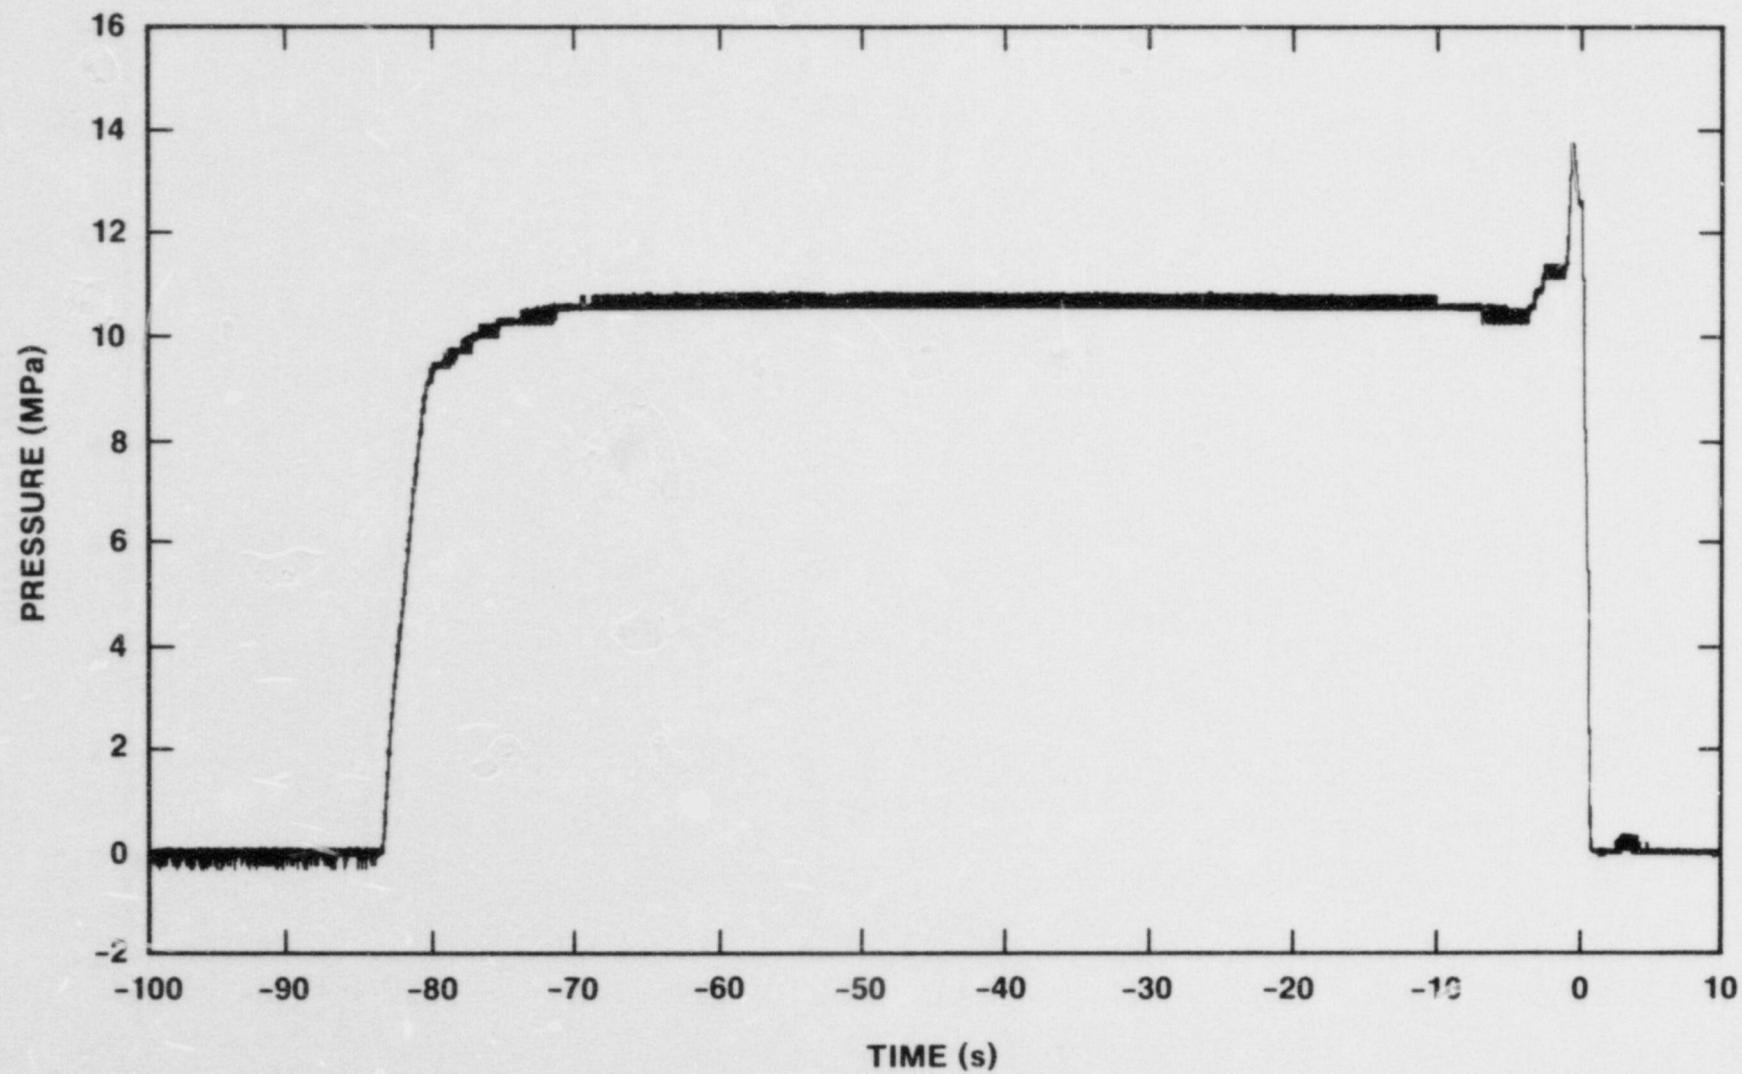
FIGURE 28. SPIT-19 PRESSURIZATION HISTORY

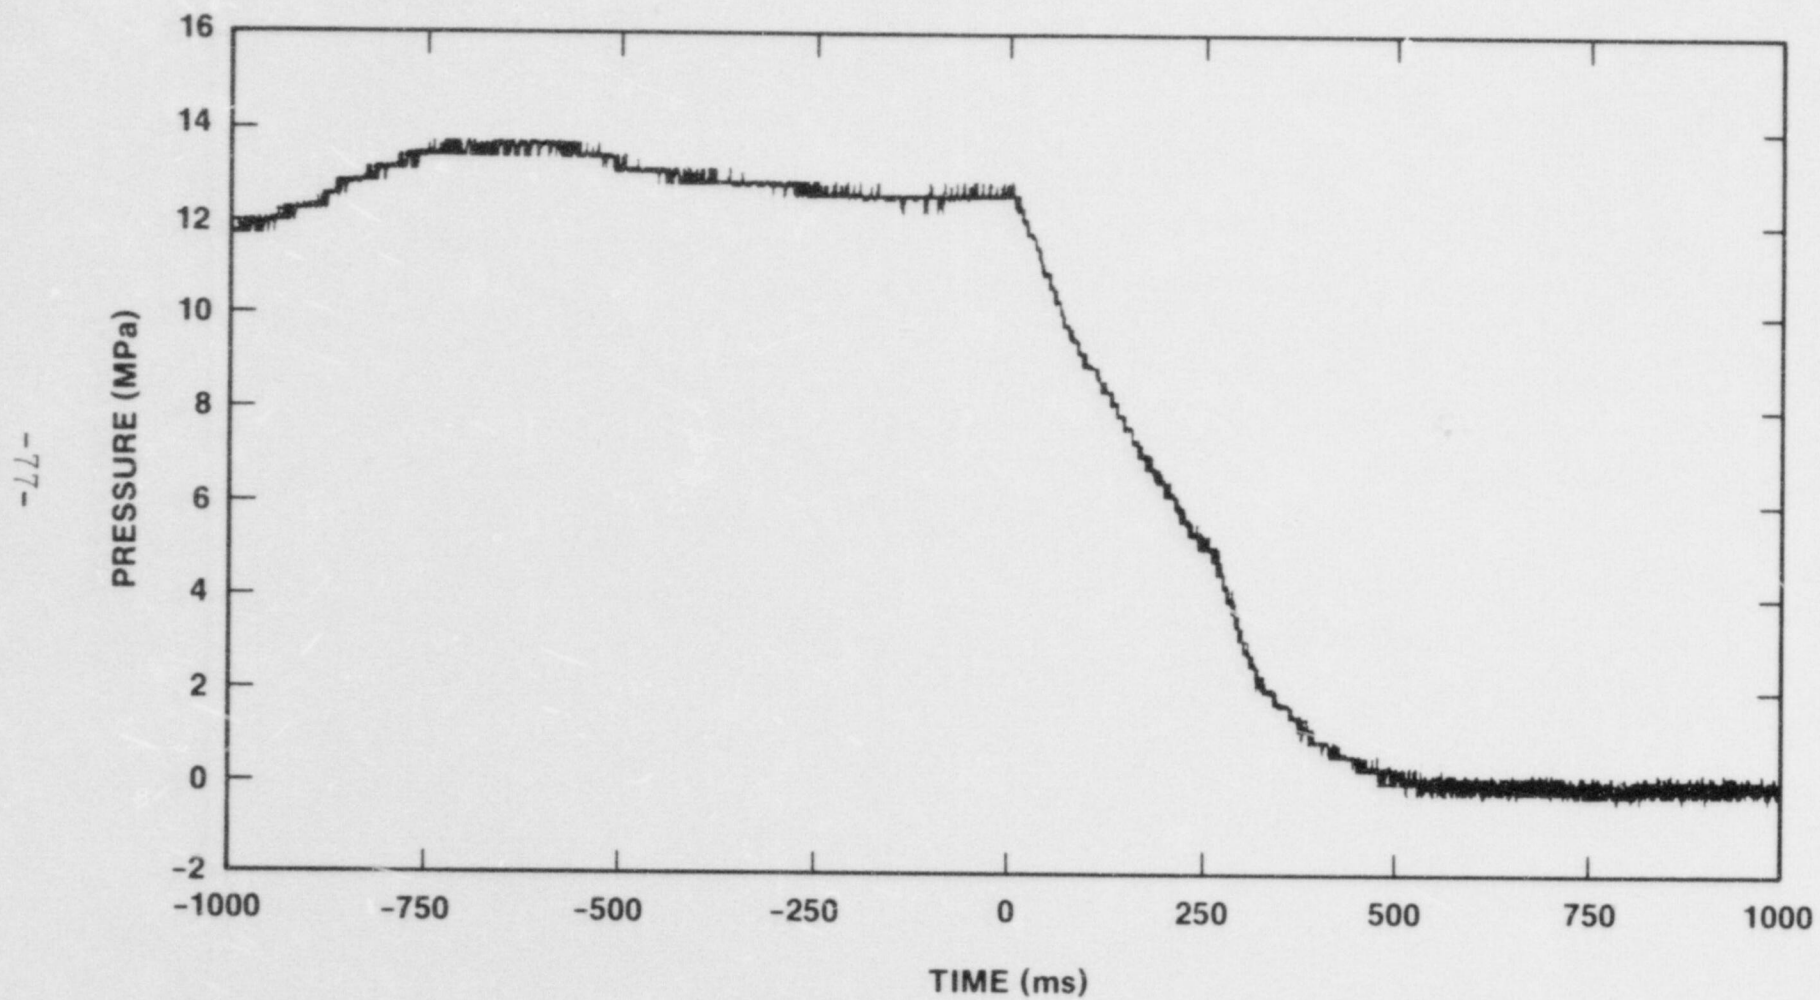
FIGURE 29. BLOWDOWN RECORD OF SPIT-19 MELT GENERATOR

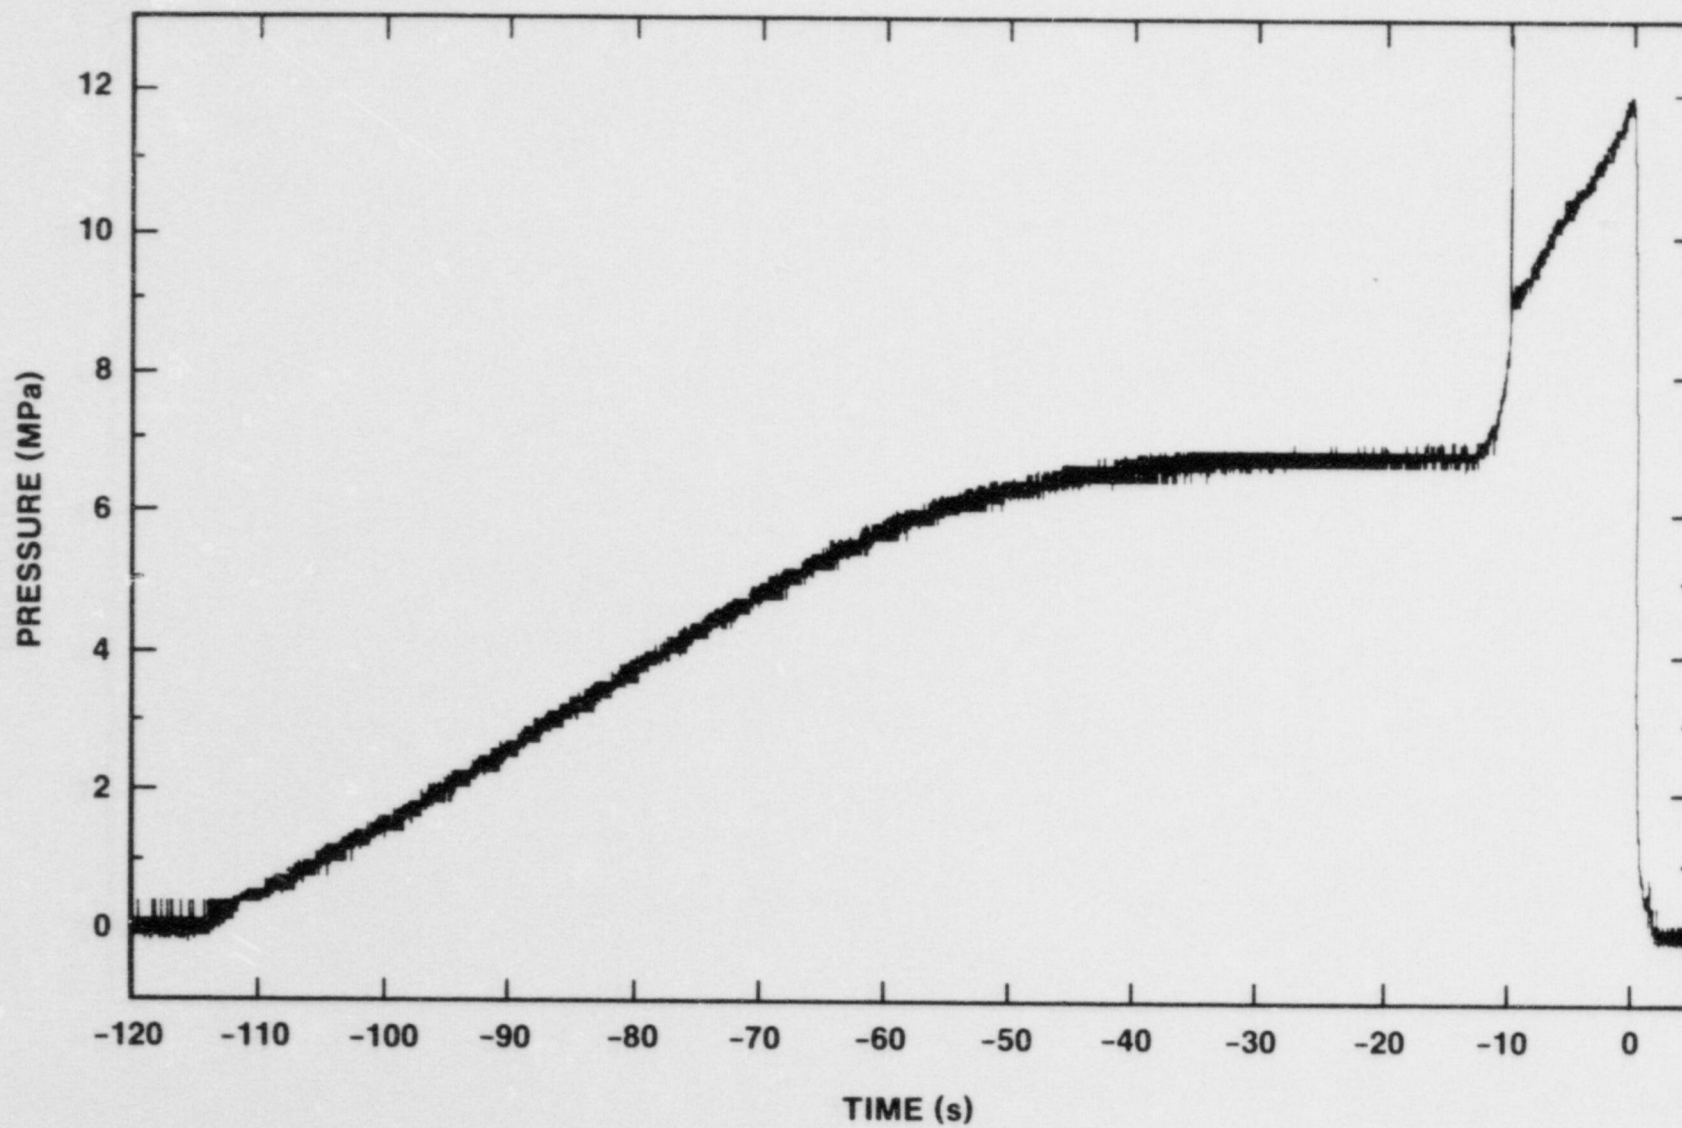
The pressurization record for the HIPS-2C and HIPS-5C experiments are given in Figures 30 and 31, respectively. In both cases the time required to achieve the initial pressure level was long, on the order of 100 seconds or more. This was

FIGURE 30. HIPS-2C PRESSURIZATION HISTORY

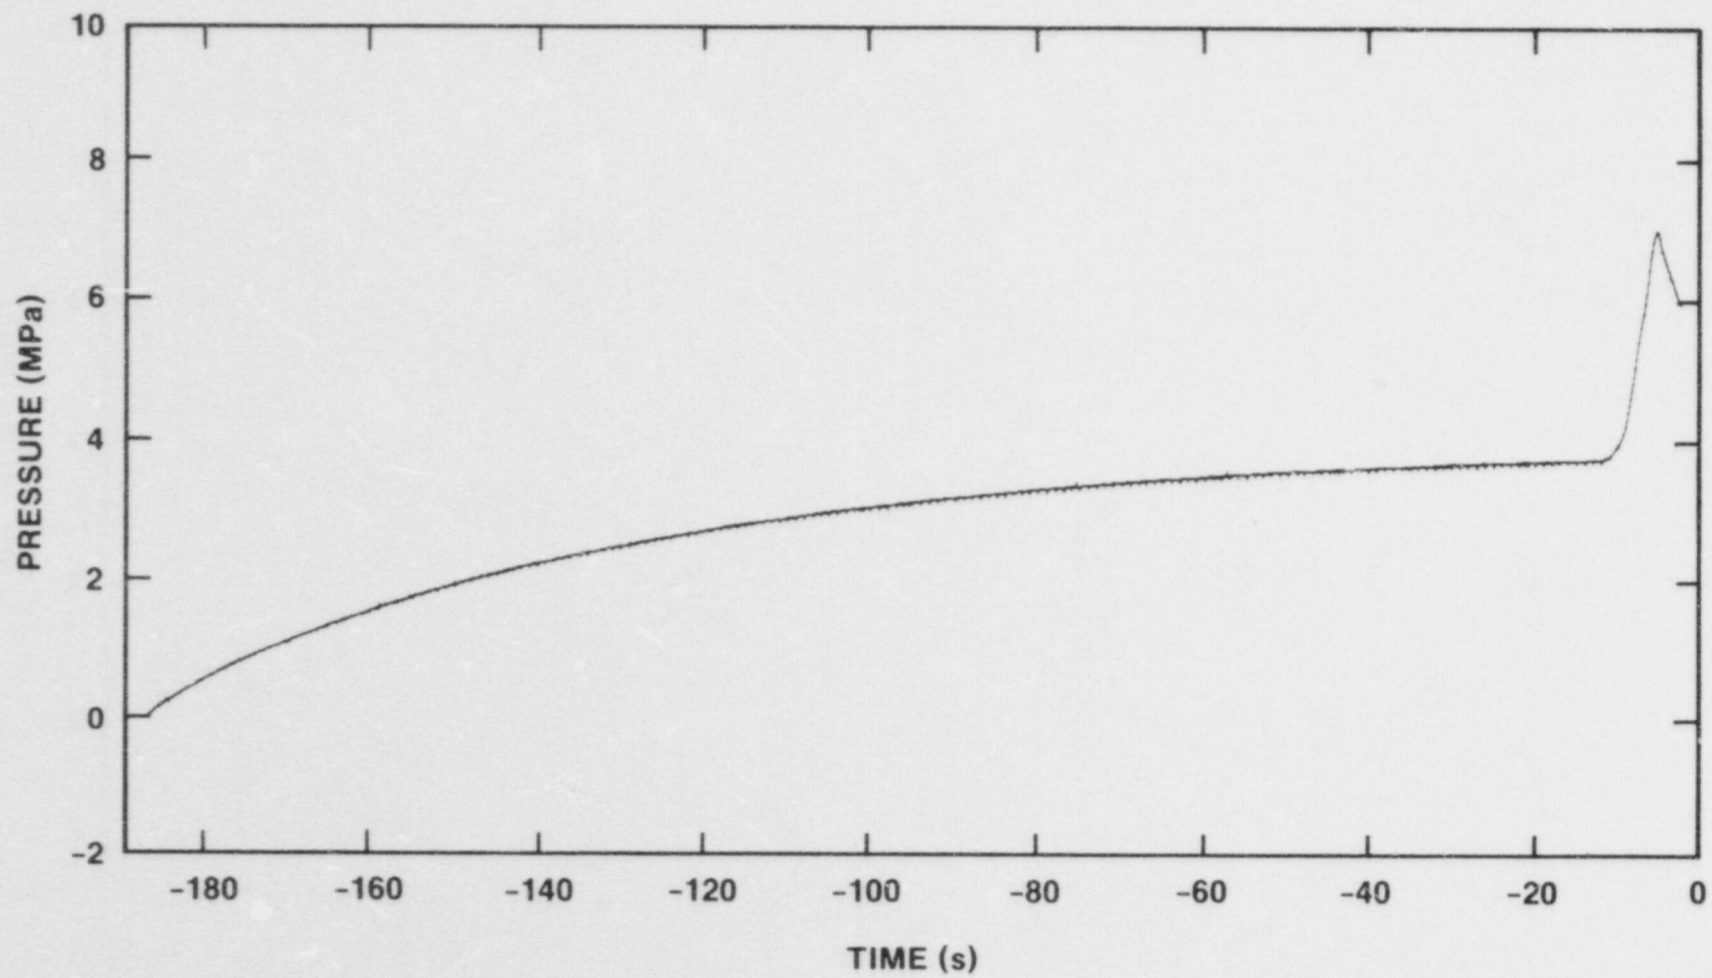
FIGURE 31. HIPS-5C PRESSURIZATION HISTORY

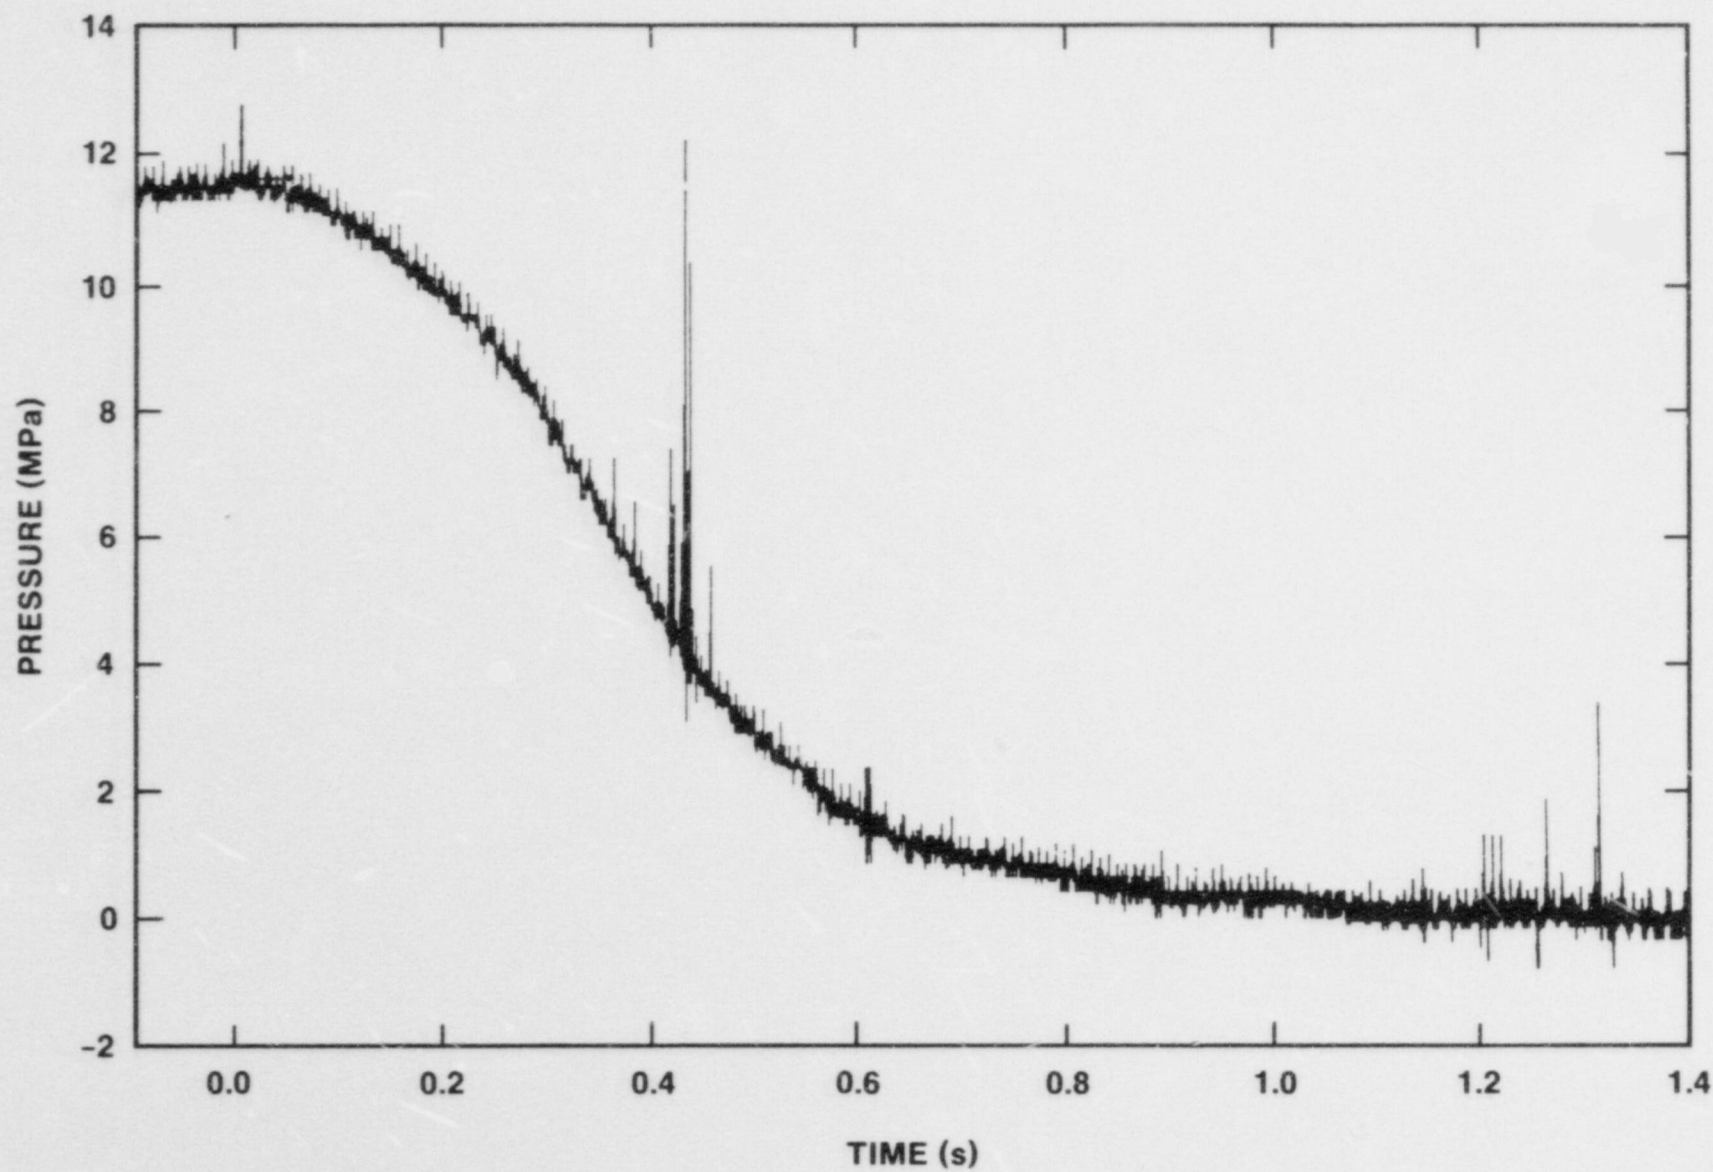
FIGURE 32. BLOWDOWN RECORD OF HIPS-2C MELT GENERATOR
