NUREG/CR-4512  
SAND86-0153  
R3/R4,R7  
Printed October 1986

## Pressurized Melt Ejection Into Scaled Reactor Cavities

PRESSURIZED MELT EJECTION INTO  
SCALED REACTOR CAVITIES

This report describes four tests performed in the High-Pressure Melt Streaming Program (HIPS) using linear-scaled cavities of the Zion Nuclear Power Plant. These experiments were conducted to study the phenomena involved in high-pressure ejection of core debris into the cavity beneath the reactor pressure vessel. One-tenth and one-twentieth linear scale models of reactor cavities were constructed and instrumented. The first test used an apparatus constructed of alumina firebrick to minimize the potential interaction between the ejected melt and cavity material. The remaining three experiments used scaled representations of the Zion nuclear plant geometry, constructed of prototypic concrete composition.

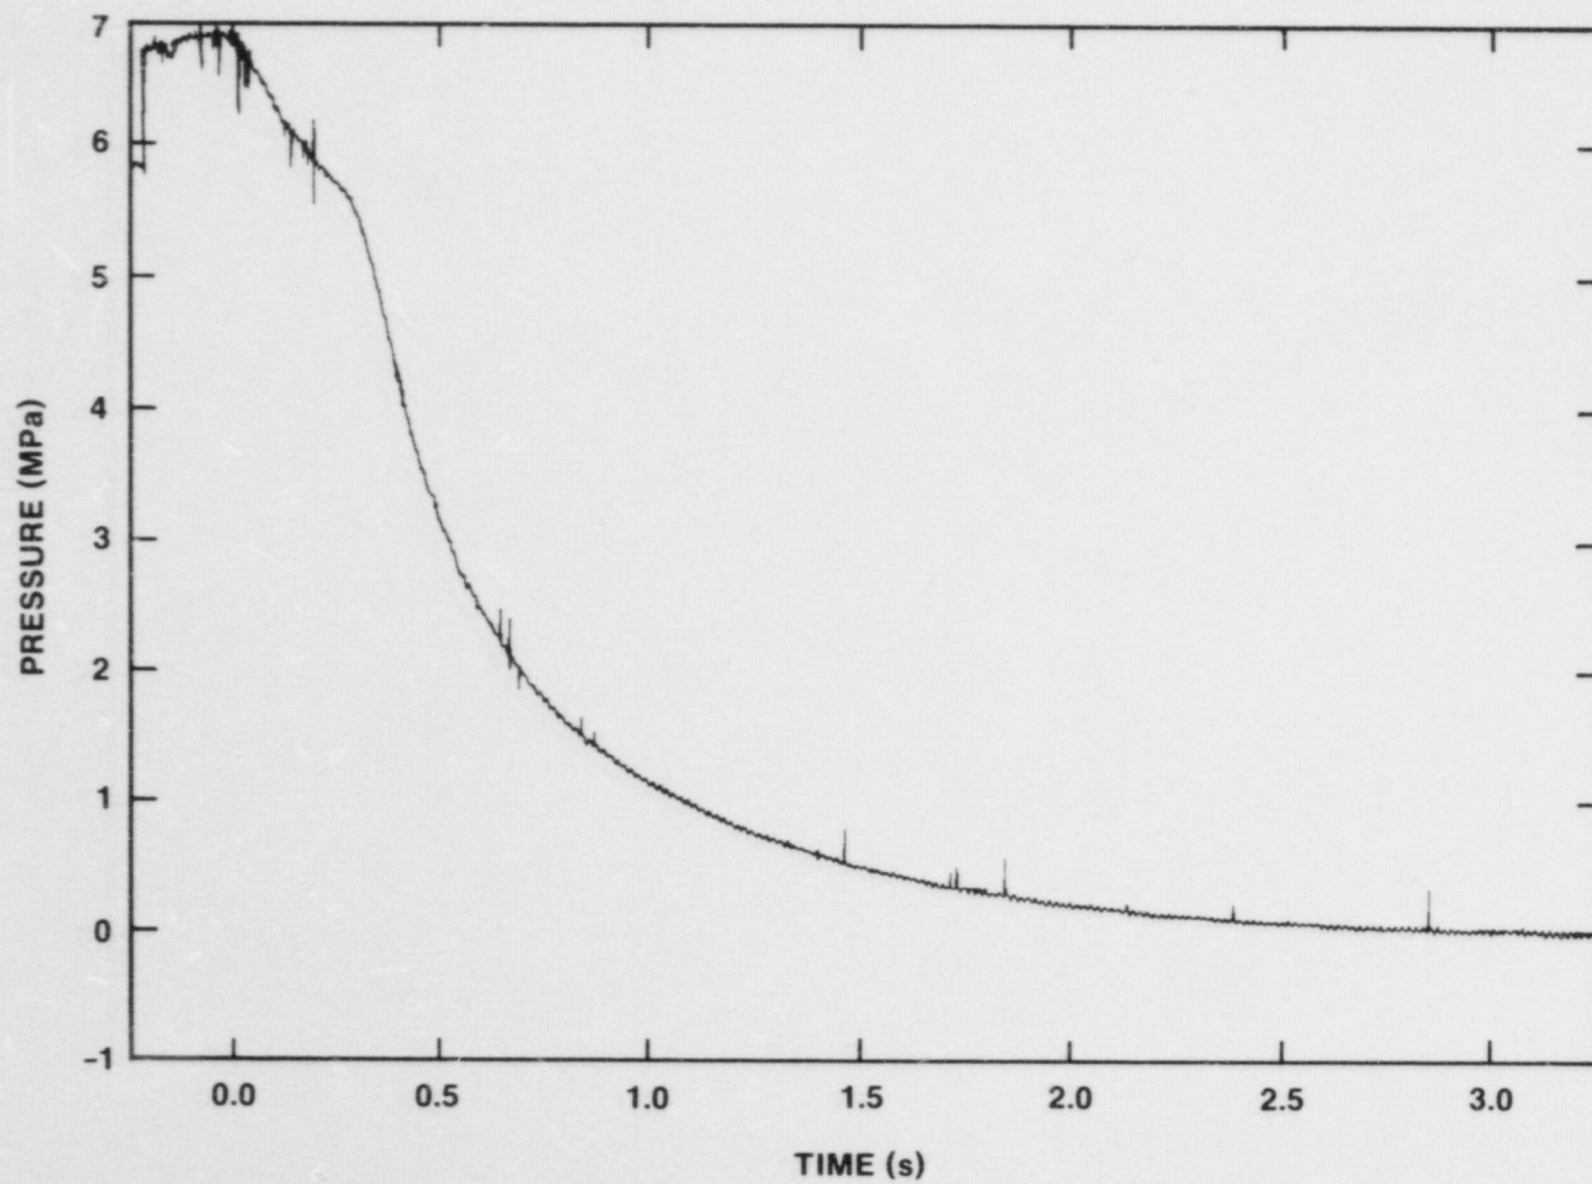
FIGURE 33. BLOWDOWN RECORD OF HIPS-5C MELT GENERATOR

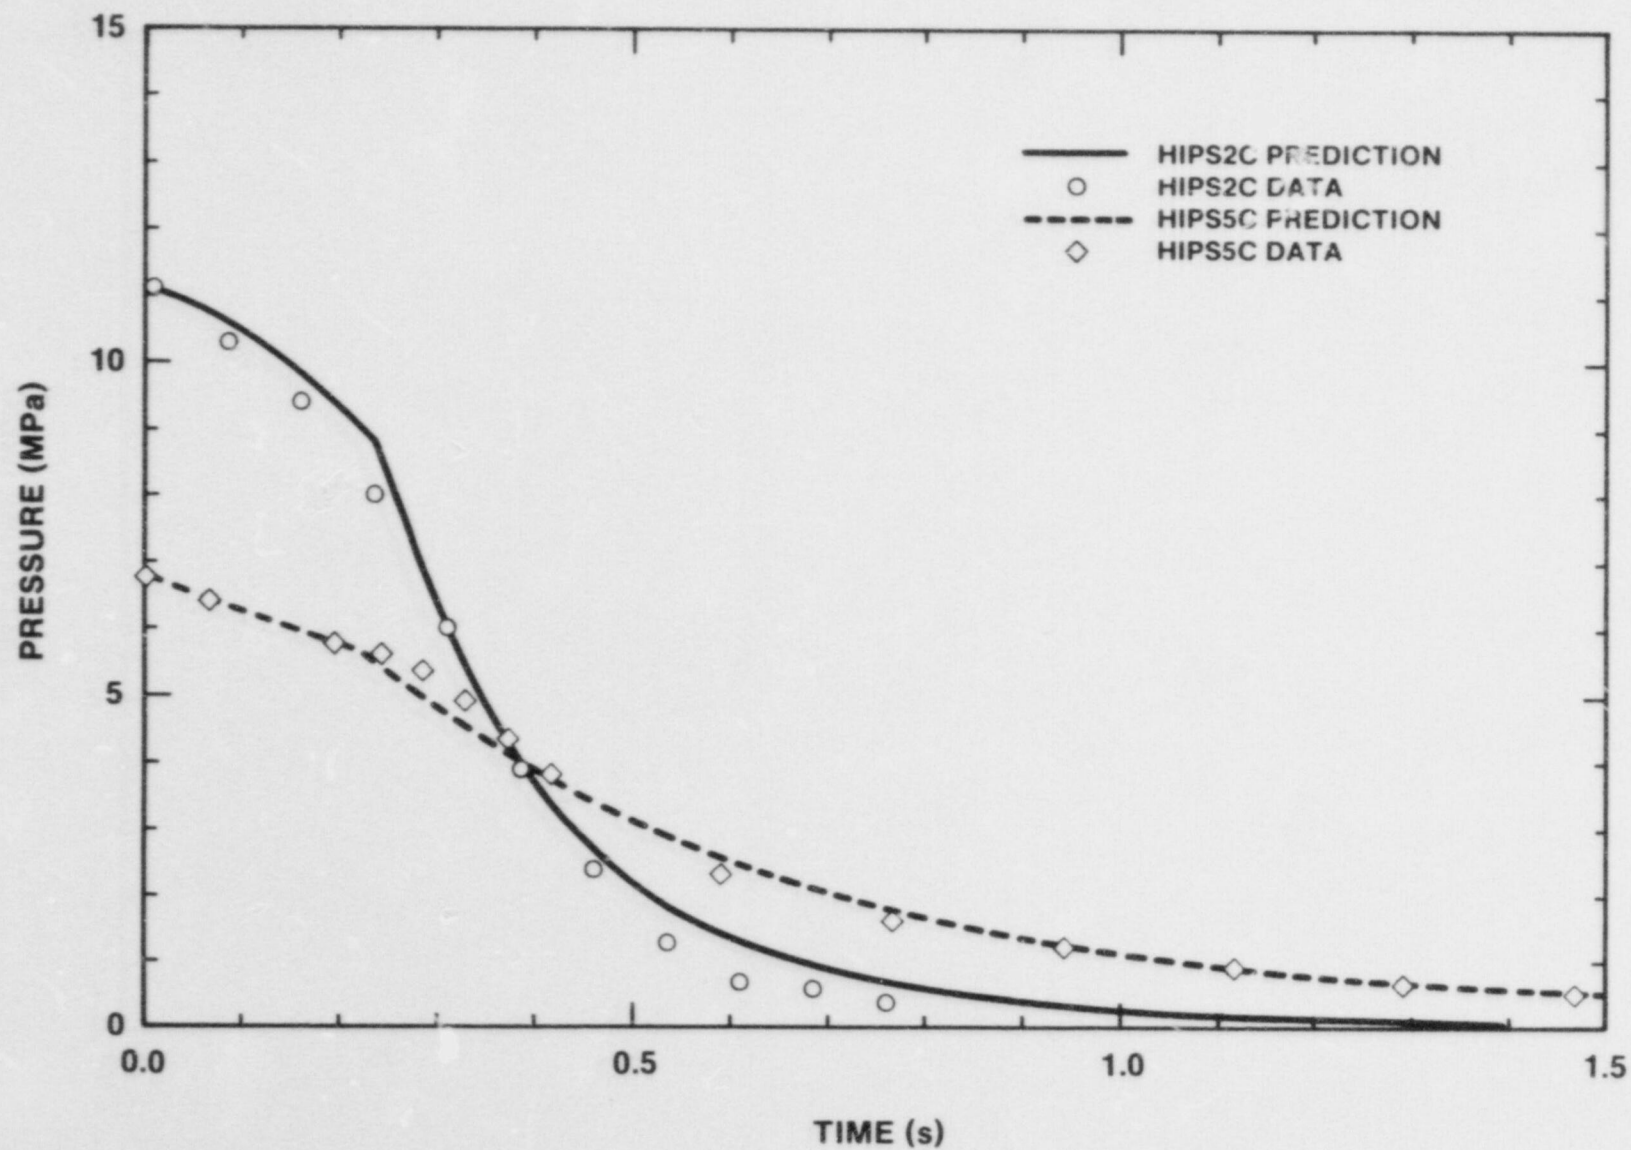
FIGURE 34. ANALYTICAL CORRELATION OF HIPS BLOWDOWN

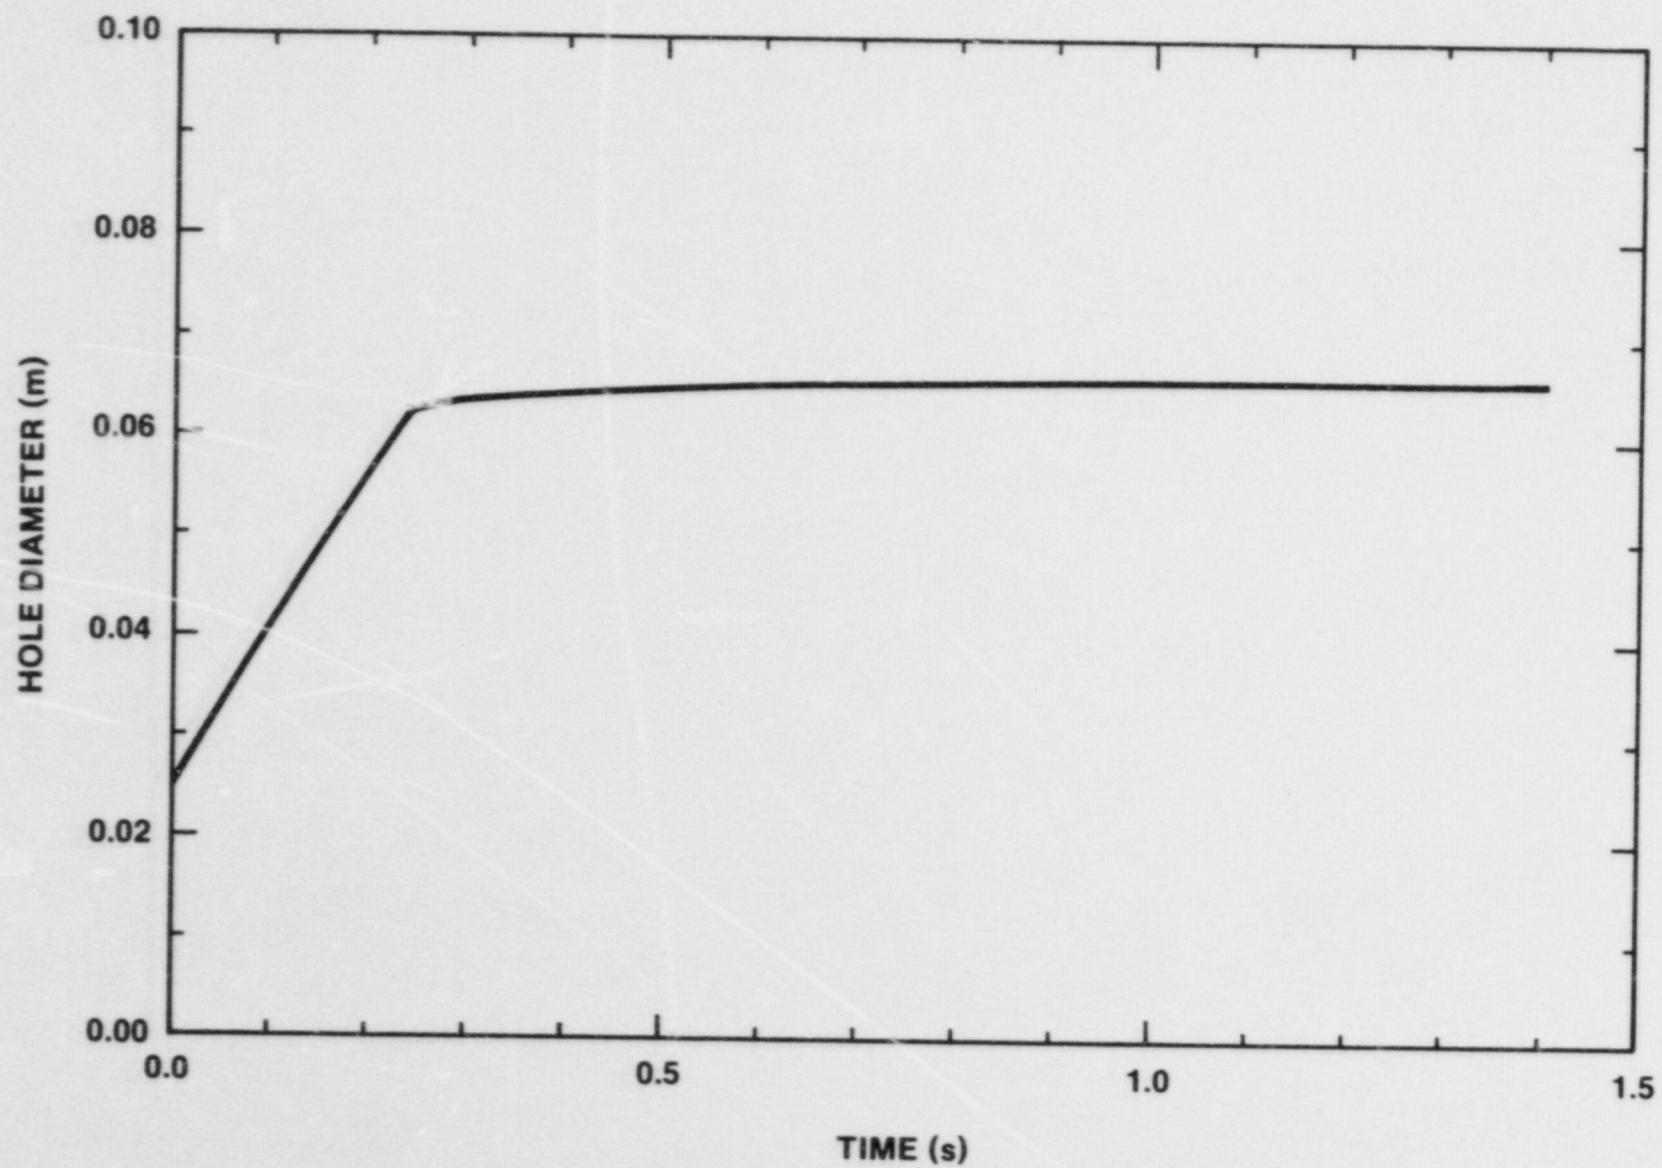
FIGURE 36. PREDICTED APERTURE GROWTH FOR THE HIPS-2C TEST

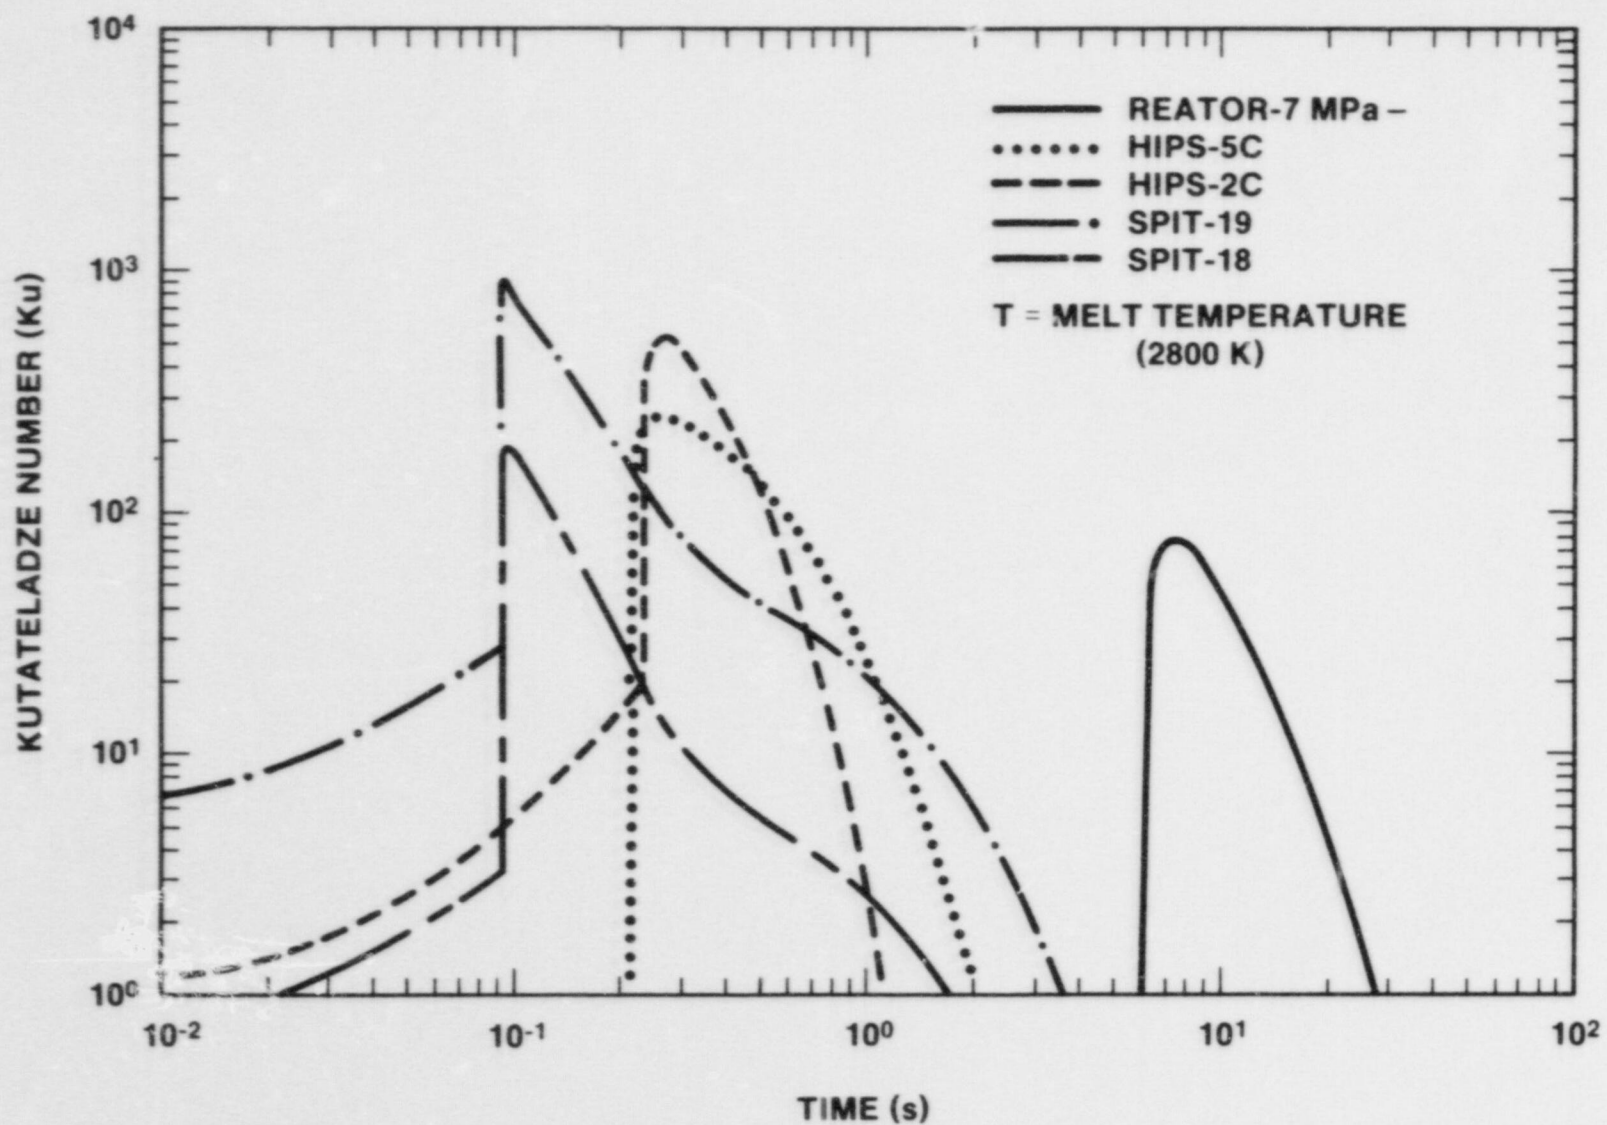
The plots show that the threshold for dispersal ( $Ku>10$ ) was not exceeded when only melt was flowing from the vessel, prior to gas blowdown. During this interval, the velocity of the

FIGURE 37. CALCULATED KUTATELADZE NUMBERS FOR EXPERIMENTS AND ACCIDENT ( $T = T_{\text{melt}}$ )

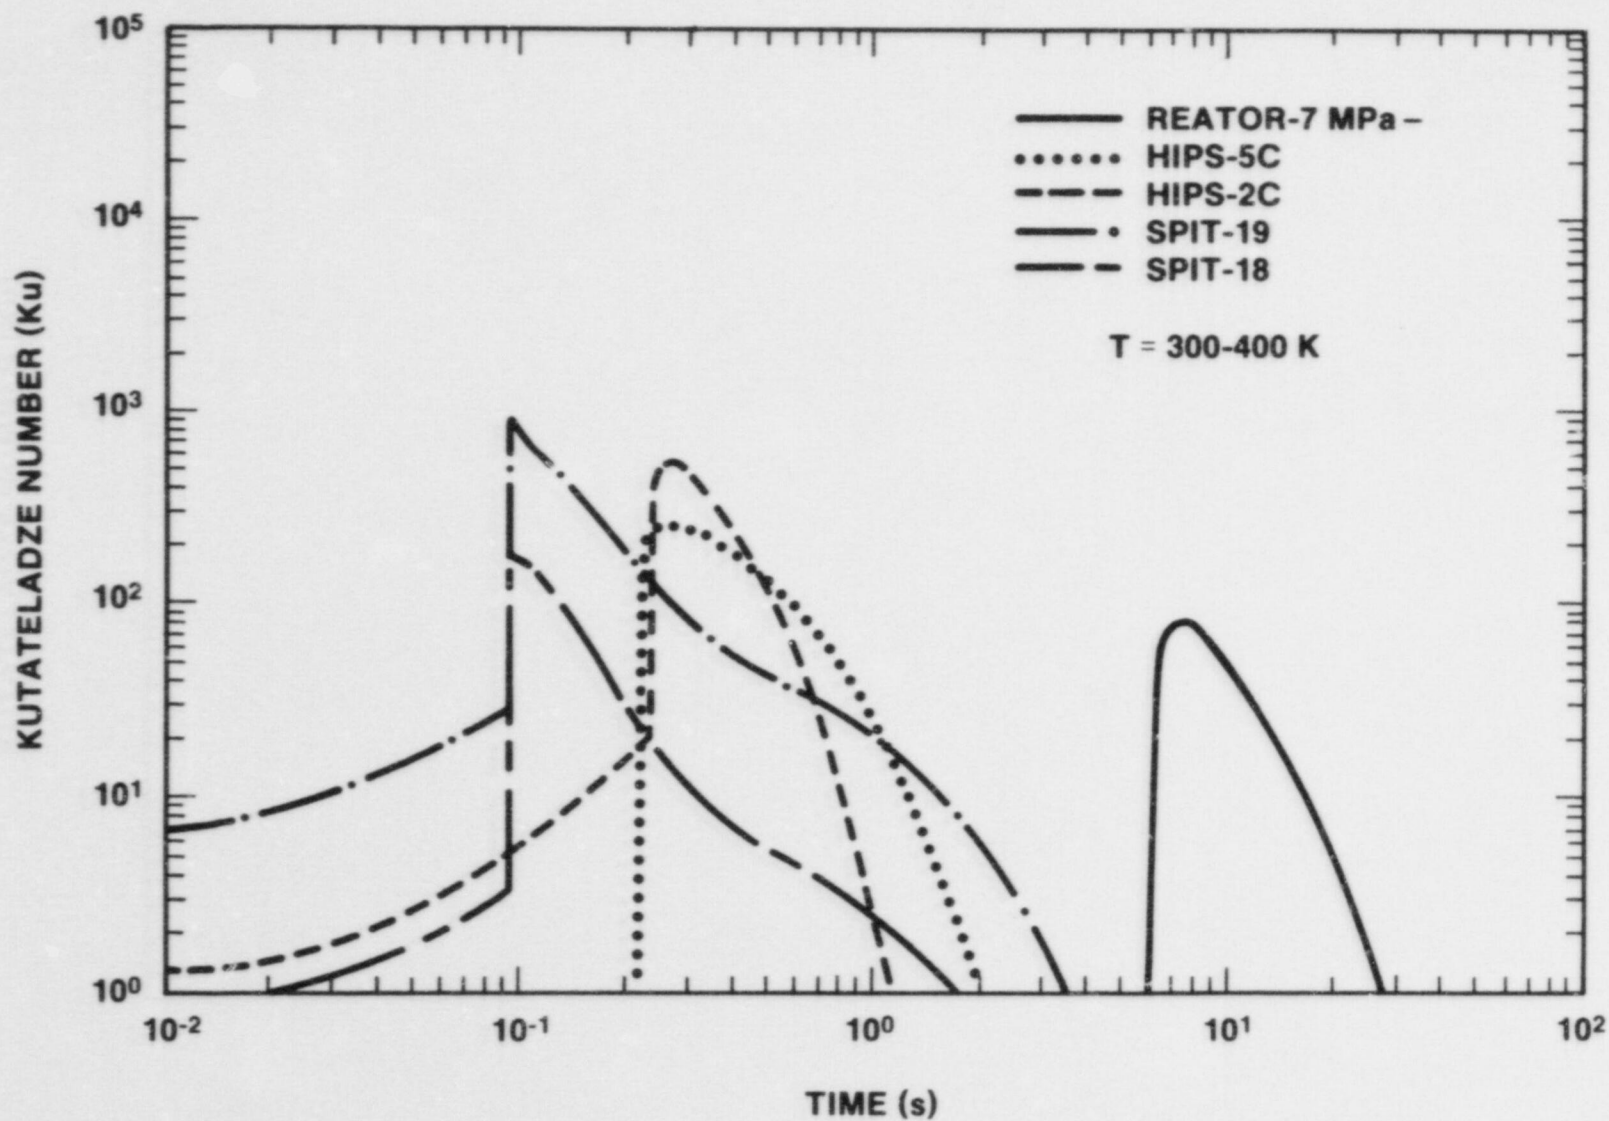
FIGURE 38. CALCULATED KUTATELADZE NUMBERS FOR EXPERIMENTS AND ACCIDENT ( $T=300-400 \text{ K}$ )

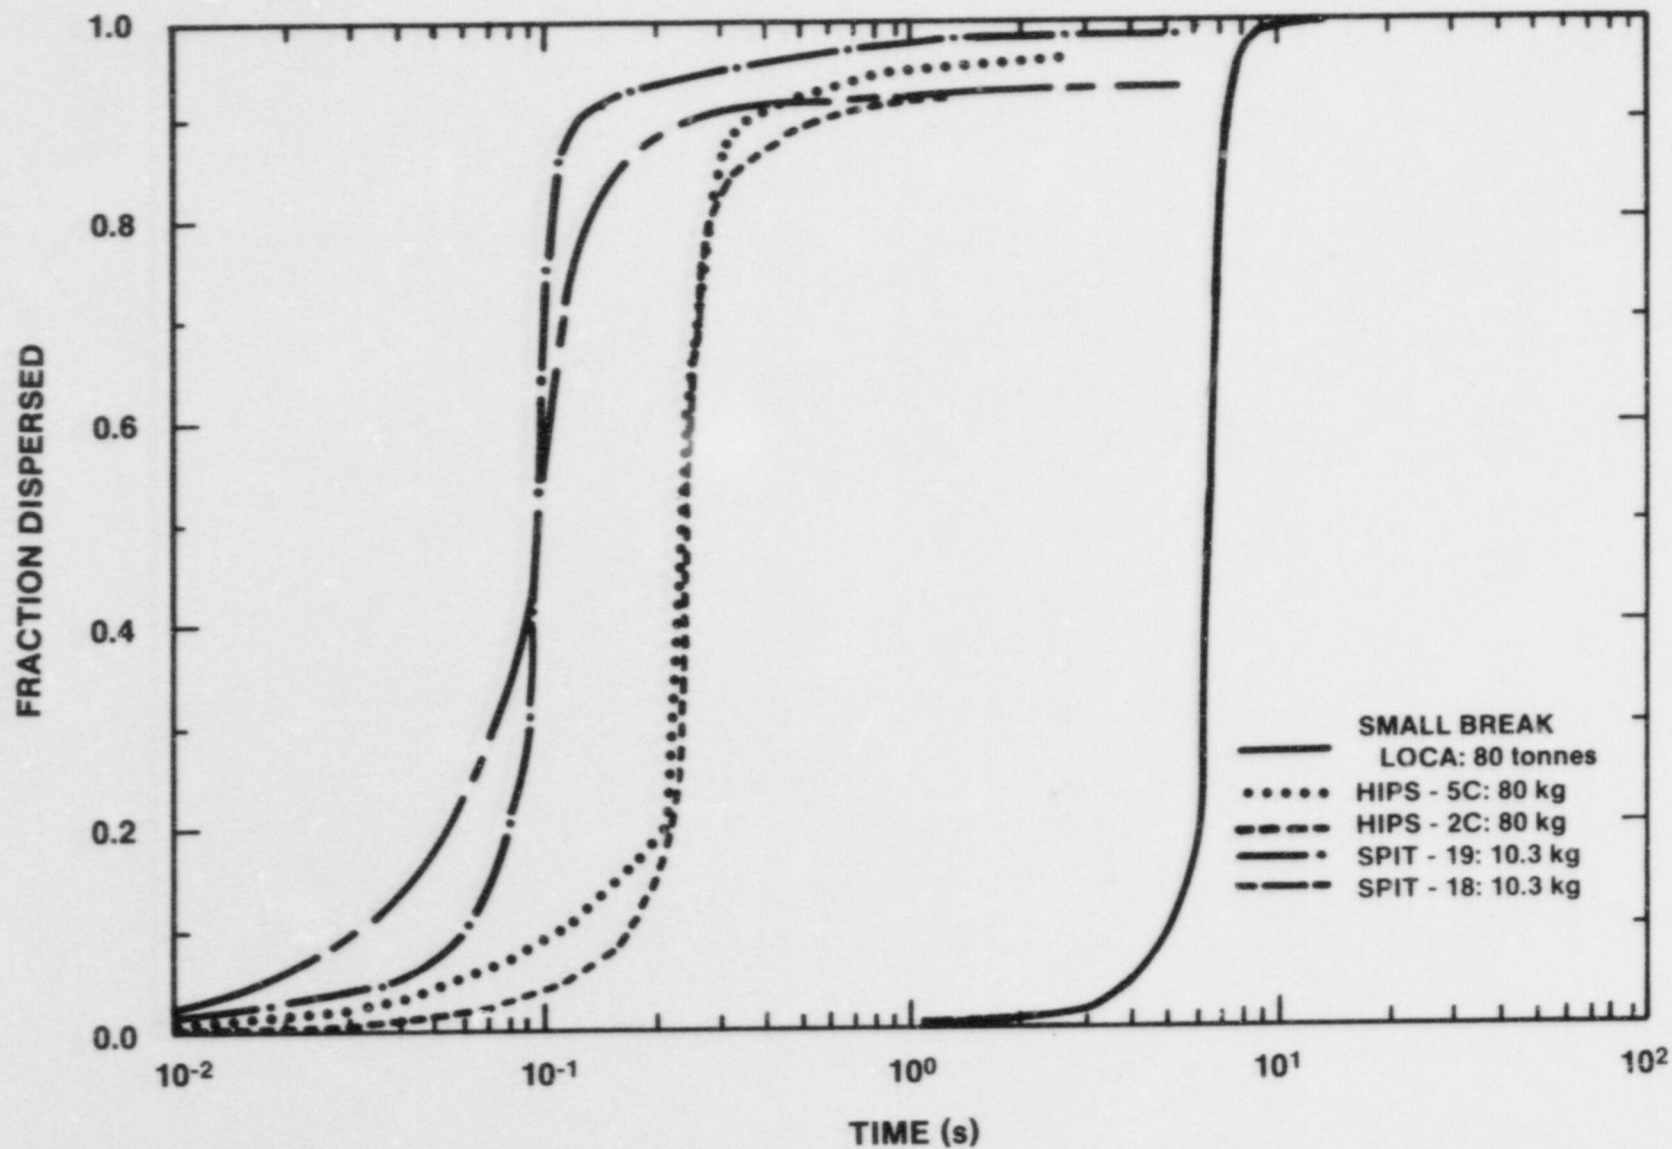
FIGURE 39. CALCULATED MASS EJECTED FROM EXPERIMENT AND REACTOR CAVITIES

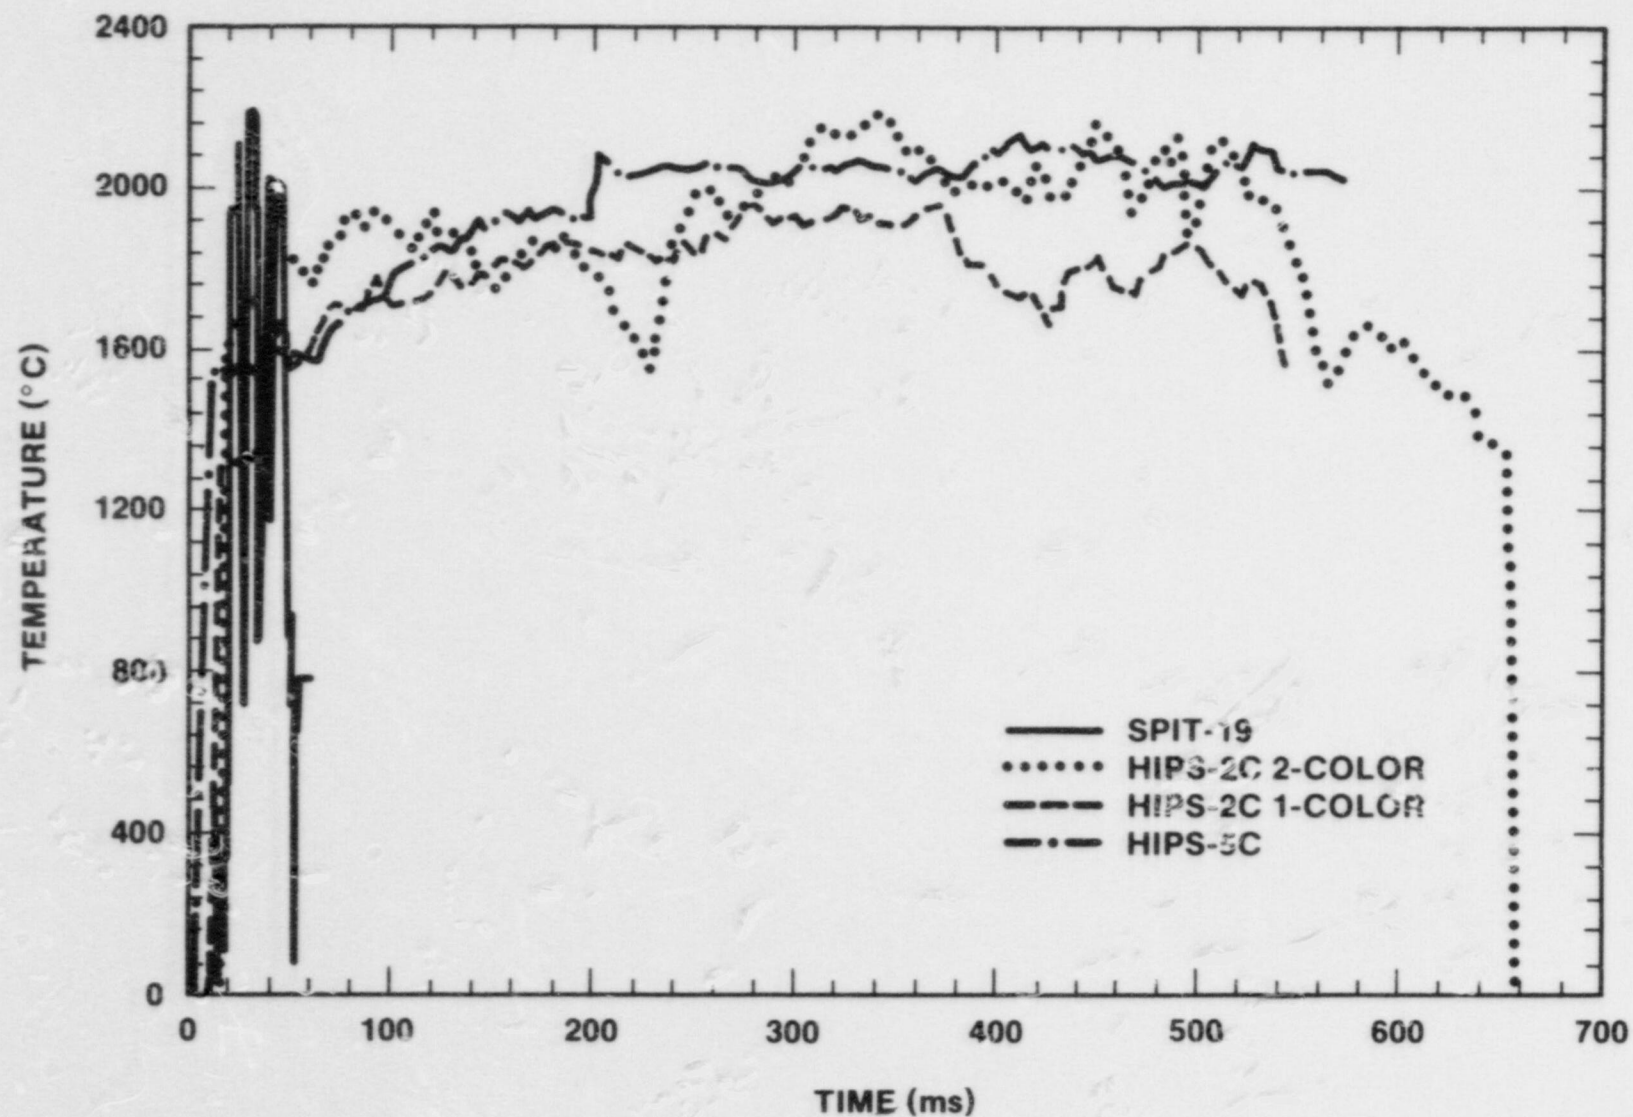
Debris temperature measurements were made in each test (except SPIT-18) as the material emerged from the cavity exit. The results are presented in Figure 41, where the time starts with the first appearance of the melt at the cavity exit. The same two-color device was used on the three experiments and was supplemented by a single-color pyrometer on HIPS-2C. The single-color device was also employed on HIPS-5C but it was damaged

FIGURE 41. MEASURED DEBRIS TEMPERATURES AT THE CAVITY EXIT

The pyrometer results indicated that the melt temperatures were lower than predicted for the thermite reaction and that the energy transferred to the concrete cavity was not substantial. The latter point was also evidenced from the slight degree of concrete decomposition seen in these tests. The cause of the lower than expected melt temperature may be from the energy given up to the melt crucible sidewalls and in melting of the aperture plate in the bottom of the melt generator. In addition, chemical analyses of the recovered debris showed unoxidized aluminum, which may have been present because the thermite reaction did not go to completion. Reactions less than 85 percent complete have been shown to directly affect the ultimate temperature.<sup>17</sup>

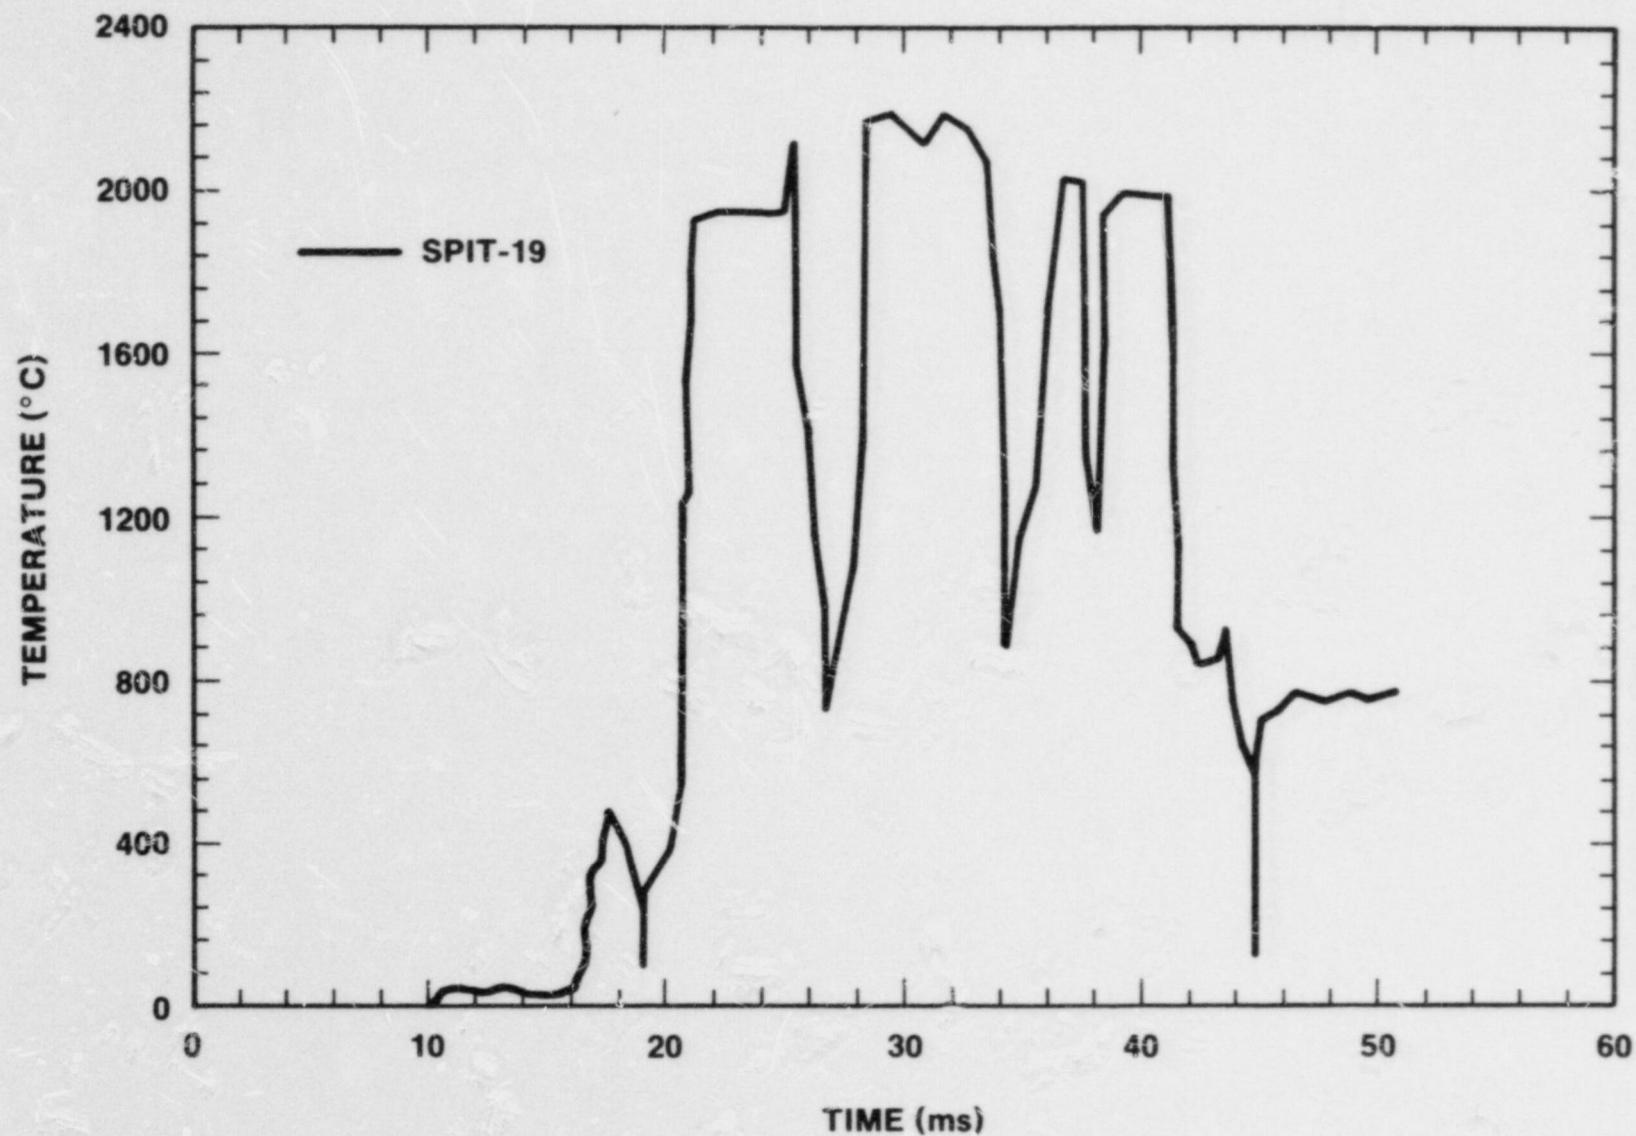
FIGURE 42. MEASURED DEBRIS TEMPERATURES IN THE SPIT-19 TEST

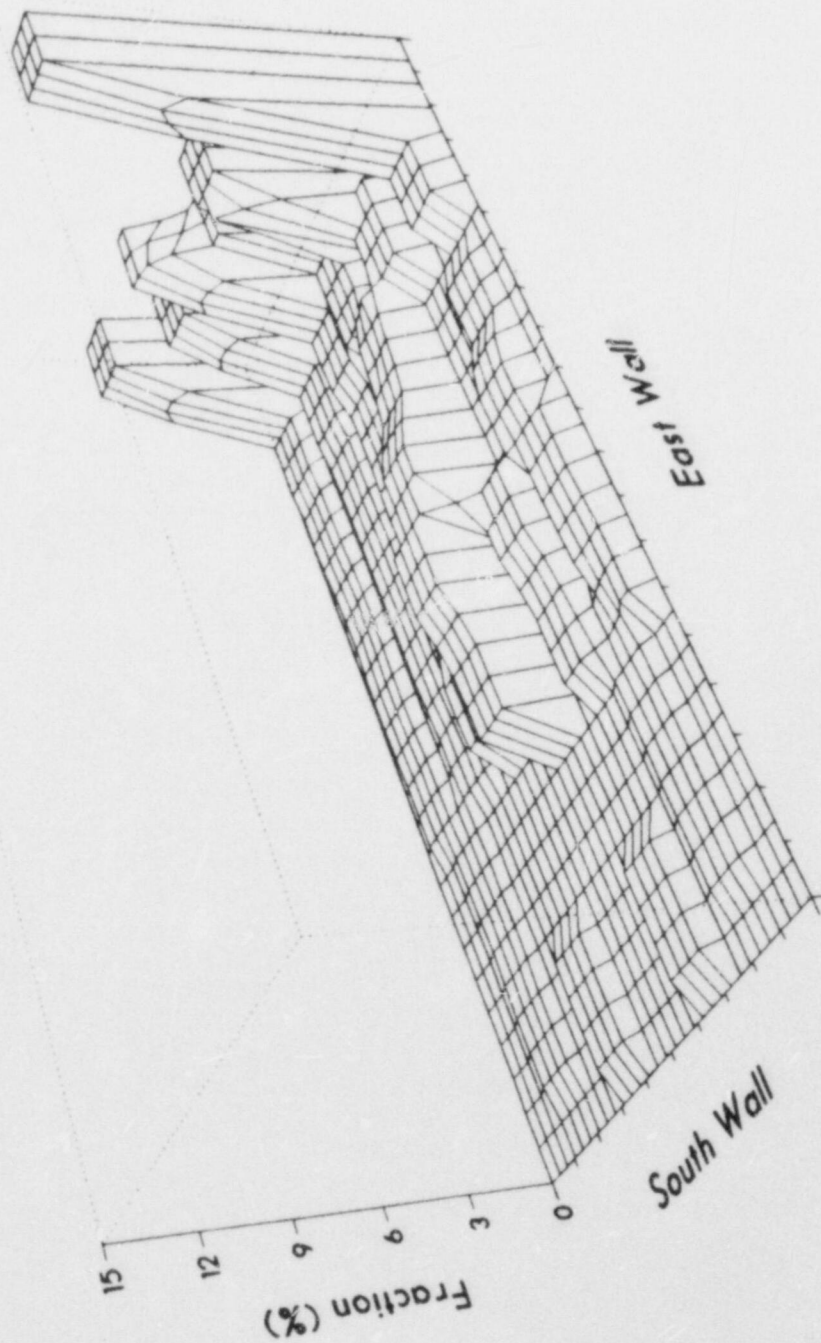
FIGURE 43. DISTRIBUTION OF DEBRIS DISPERSED DURING THE SPIT-18 EXPERIMENT

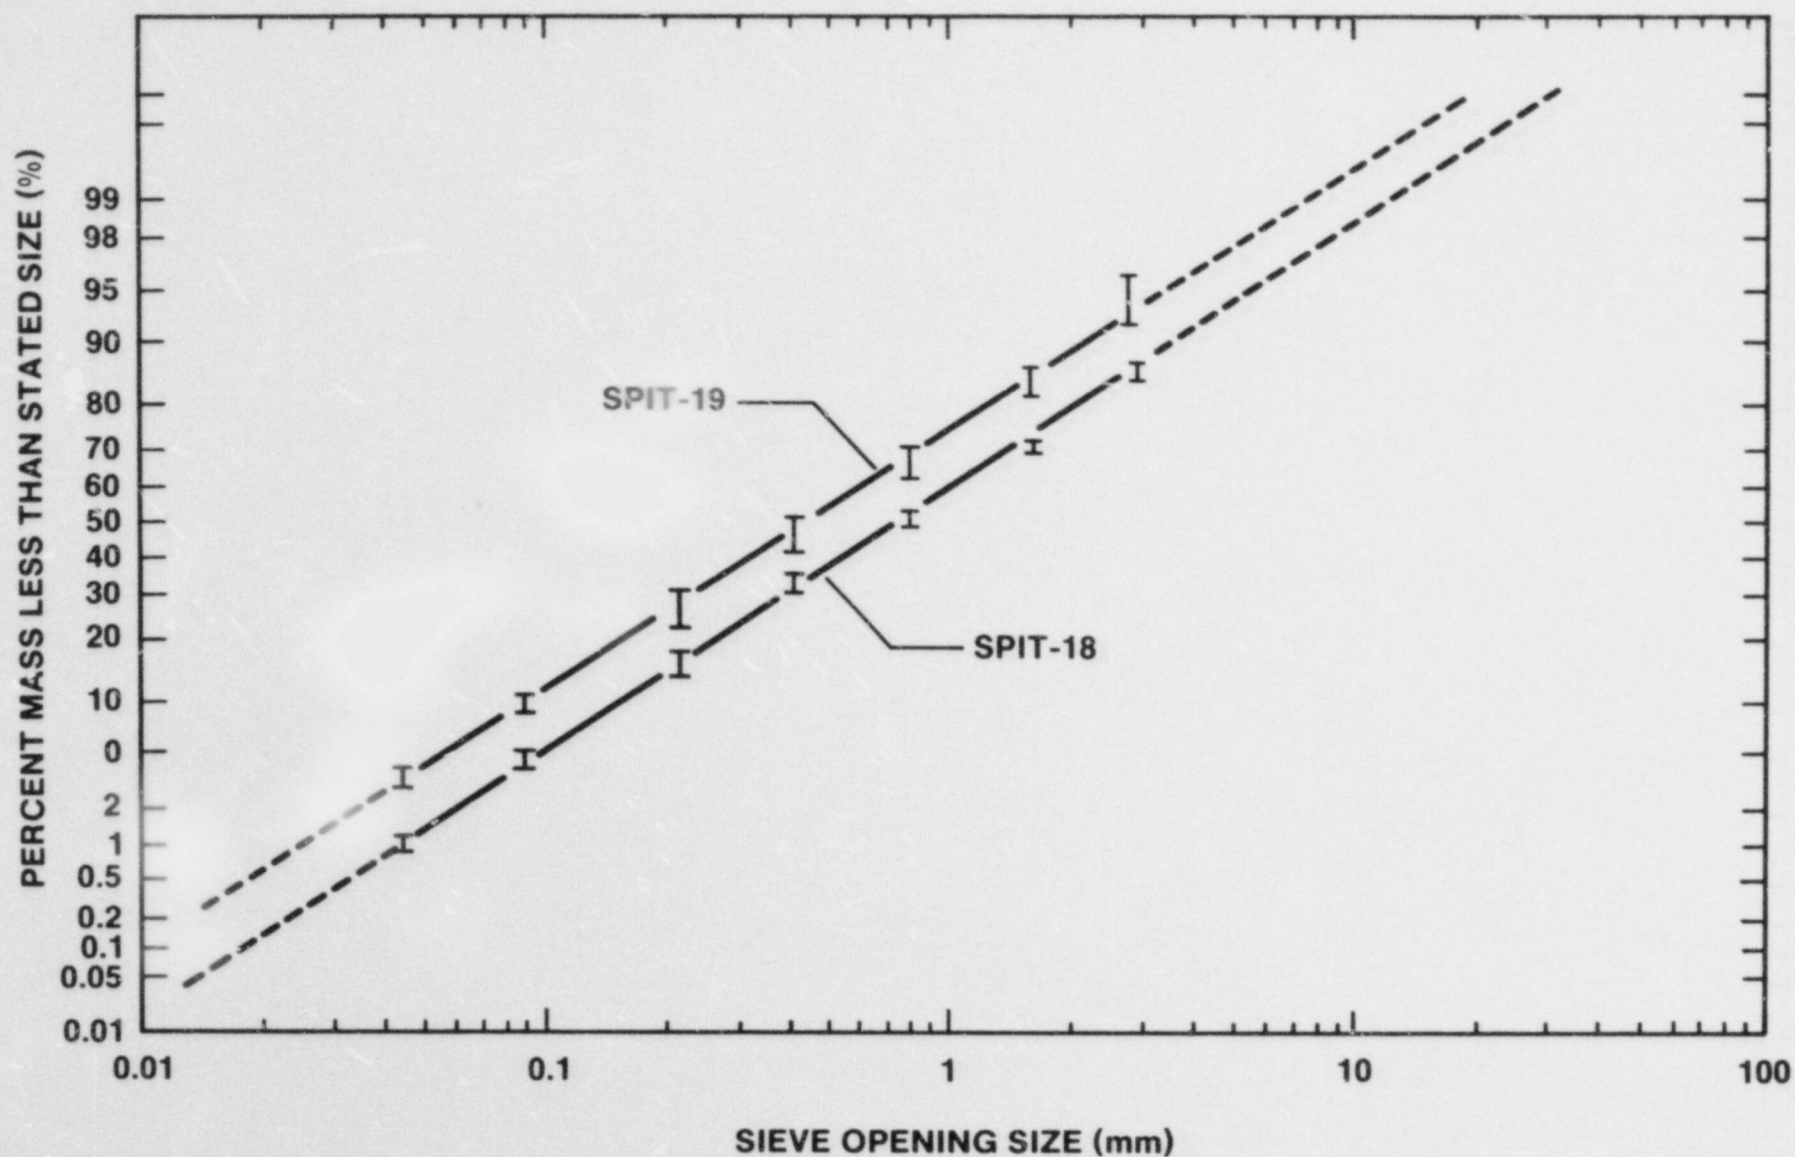
The lower velocities in the cavity of the SPIT-18 experiment were responsible for the relatively larger size of the debris compared to that from the SPIT-19 experiment. Entrained

FIGURE 49. PARTICLE SIZE DISTRIBUTION FROM THE DEBRIS COLLECTED DURING THE SPIT-18 AND SPIT-19 TESTS

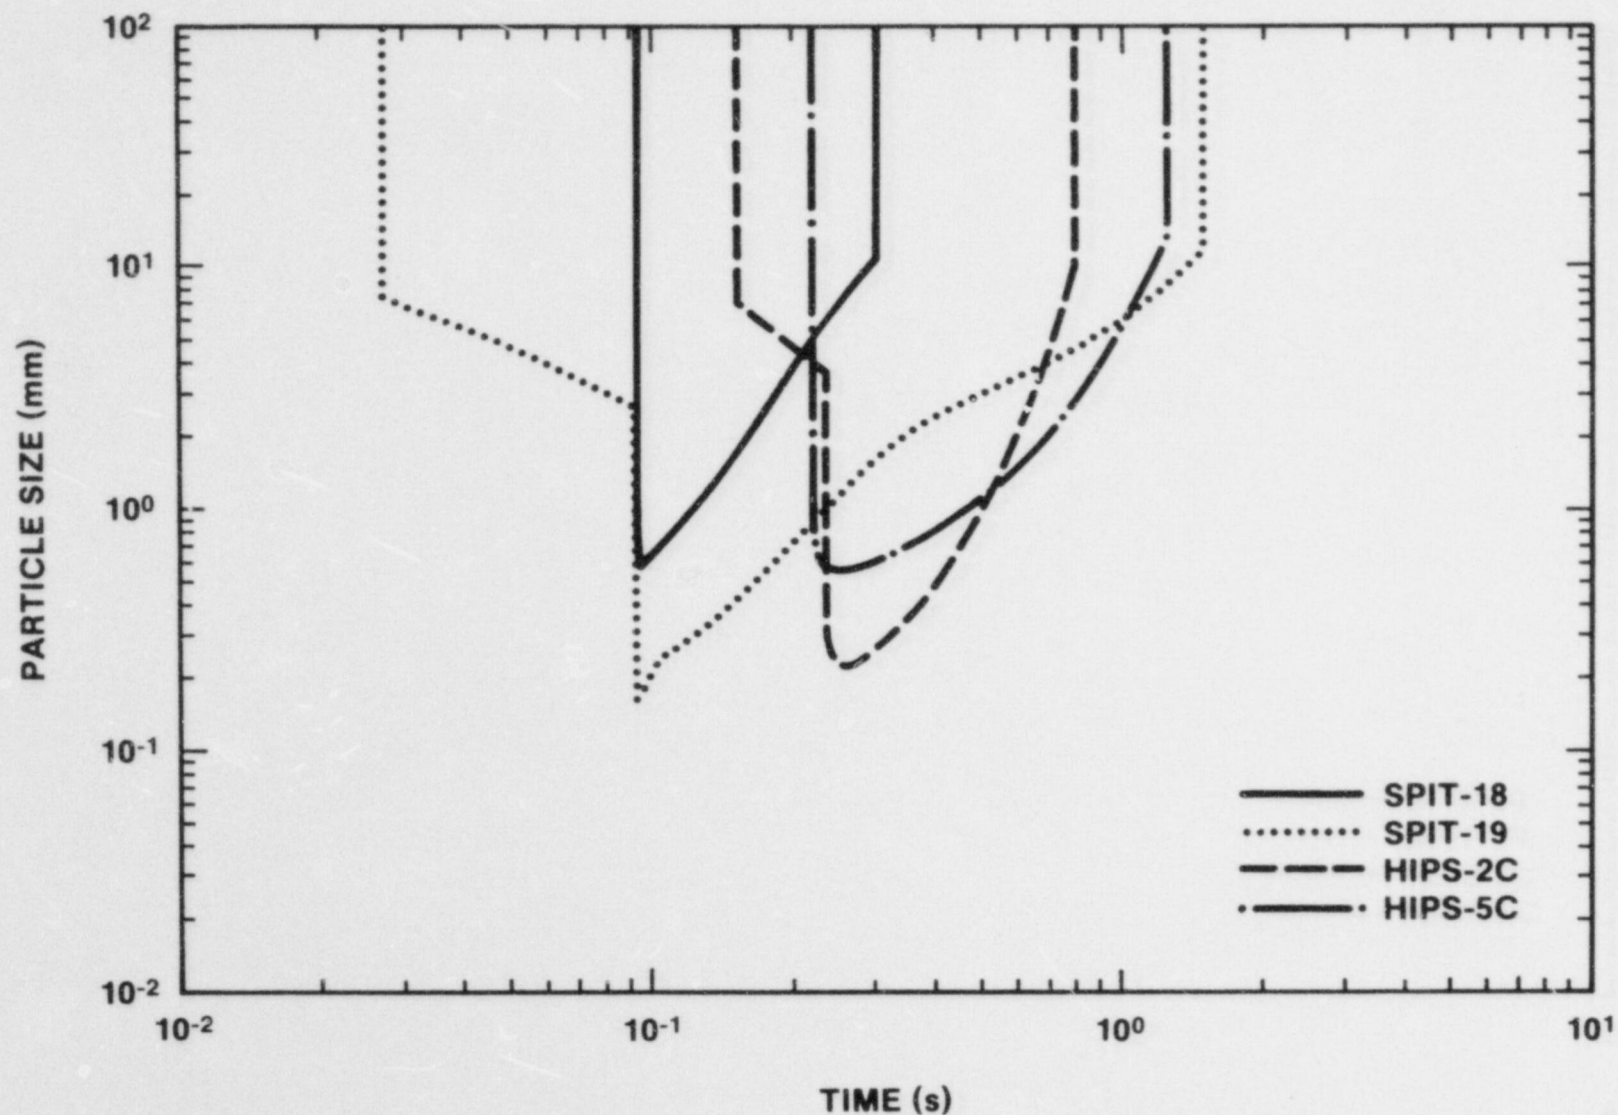
FIGURE 50. CALCULATED MAXIMUM STABLE PARTICLE SIZE  
LEAVING THE EXPERIMENTAL CAVITIES

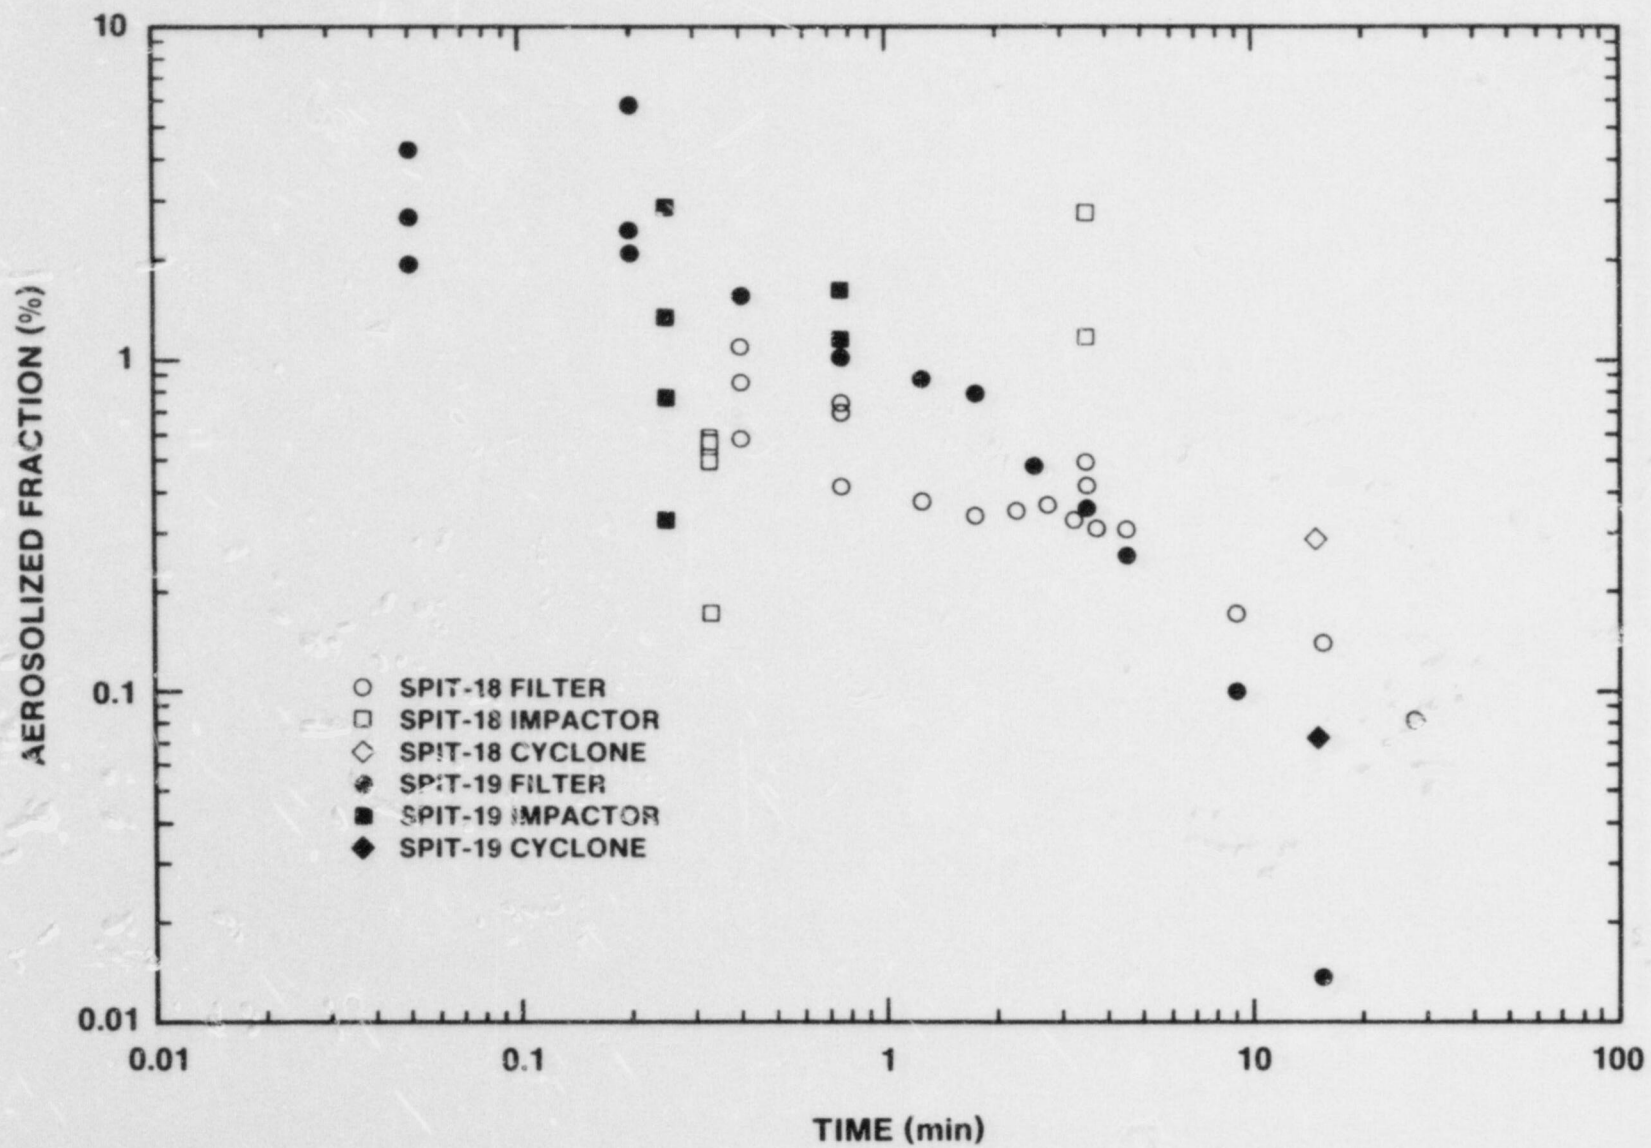
FIGURE 55. FRACTION OF MELT MASS AEROSOLIZED DURING THE SCALED CAVITY EXPERIMENTS
