NUREG/CR-4512  
SAND86-0153  
R3/R4,R7  
Printed October 1986

## Pressurized Melt Ejection Into Scaled Reactor Cavities

PRESSURIZED MELT EJECTION INTO  
SCALED REACTOR CAVITIES

This report describes four tests performed in the High-Pressure Melt Streaming Program (HIPS) using linear-scaled cavities of the Zion Nuclear Power Plant. These experiments were conducted to study the phenomena involved in high-pressure ejection of core debris into the cavity beneath the reactor pressure vessel. One-tenth and one-twentieth linear scale models of reactor cavities were constructed and instrumented. The first test used an apparatus constructed of alumina firebrick to minimize the potential interaction between the ejected melt and cavity material. The remaining three experiments used scaled representations of the Zion nuclear plant geometry, constructed of prototypic concrete composition.

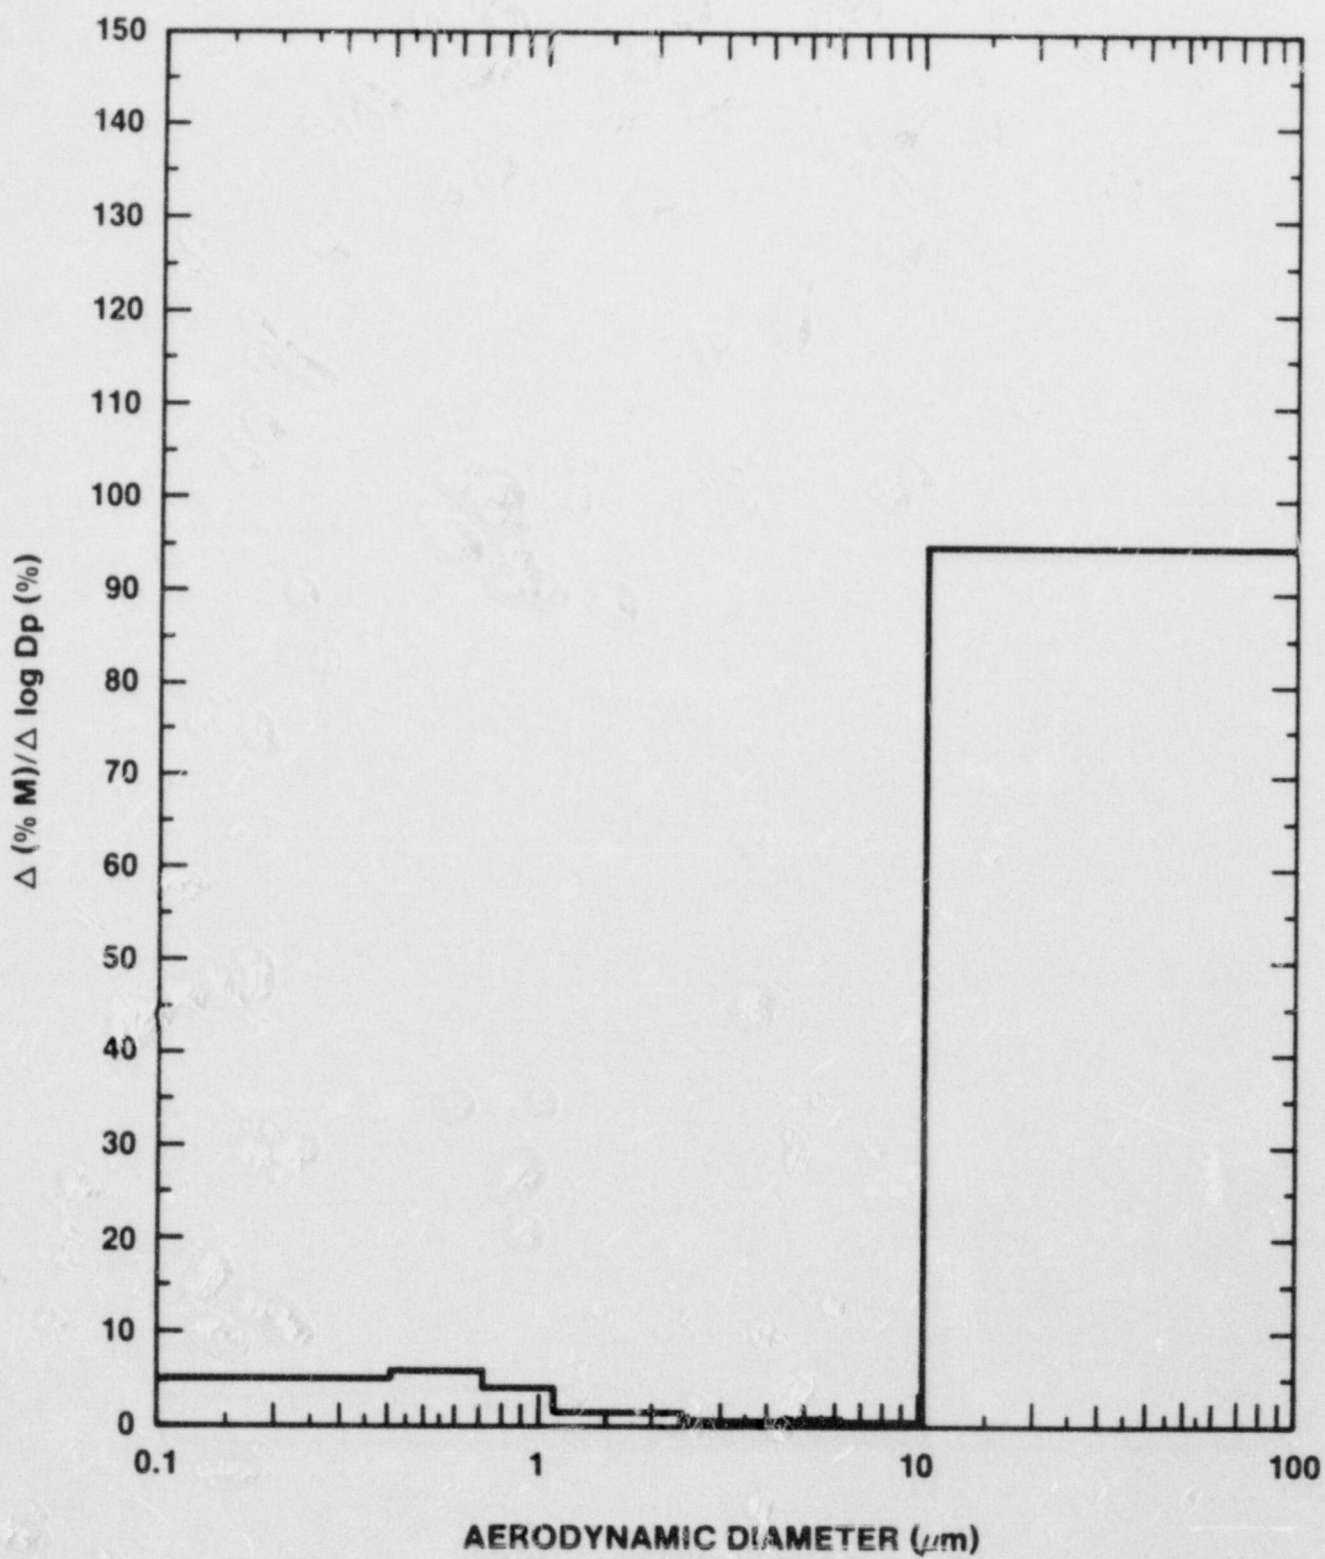
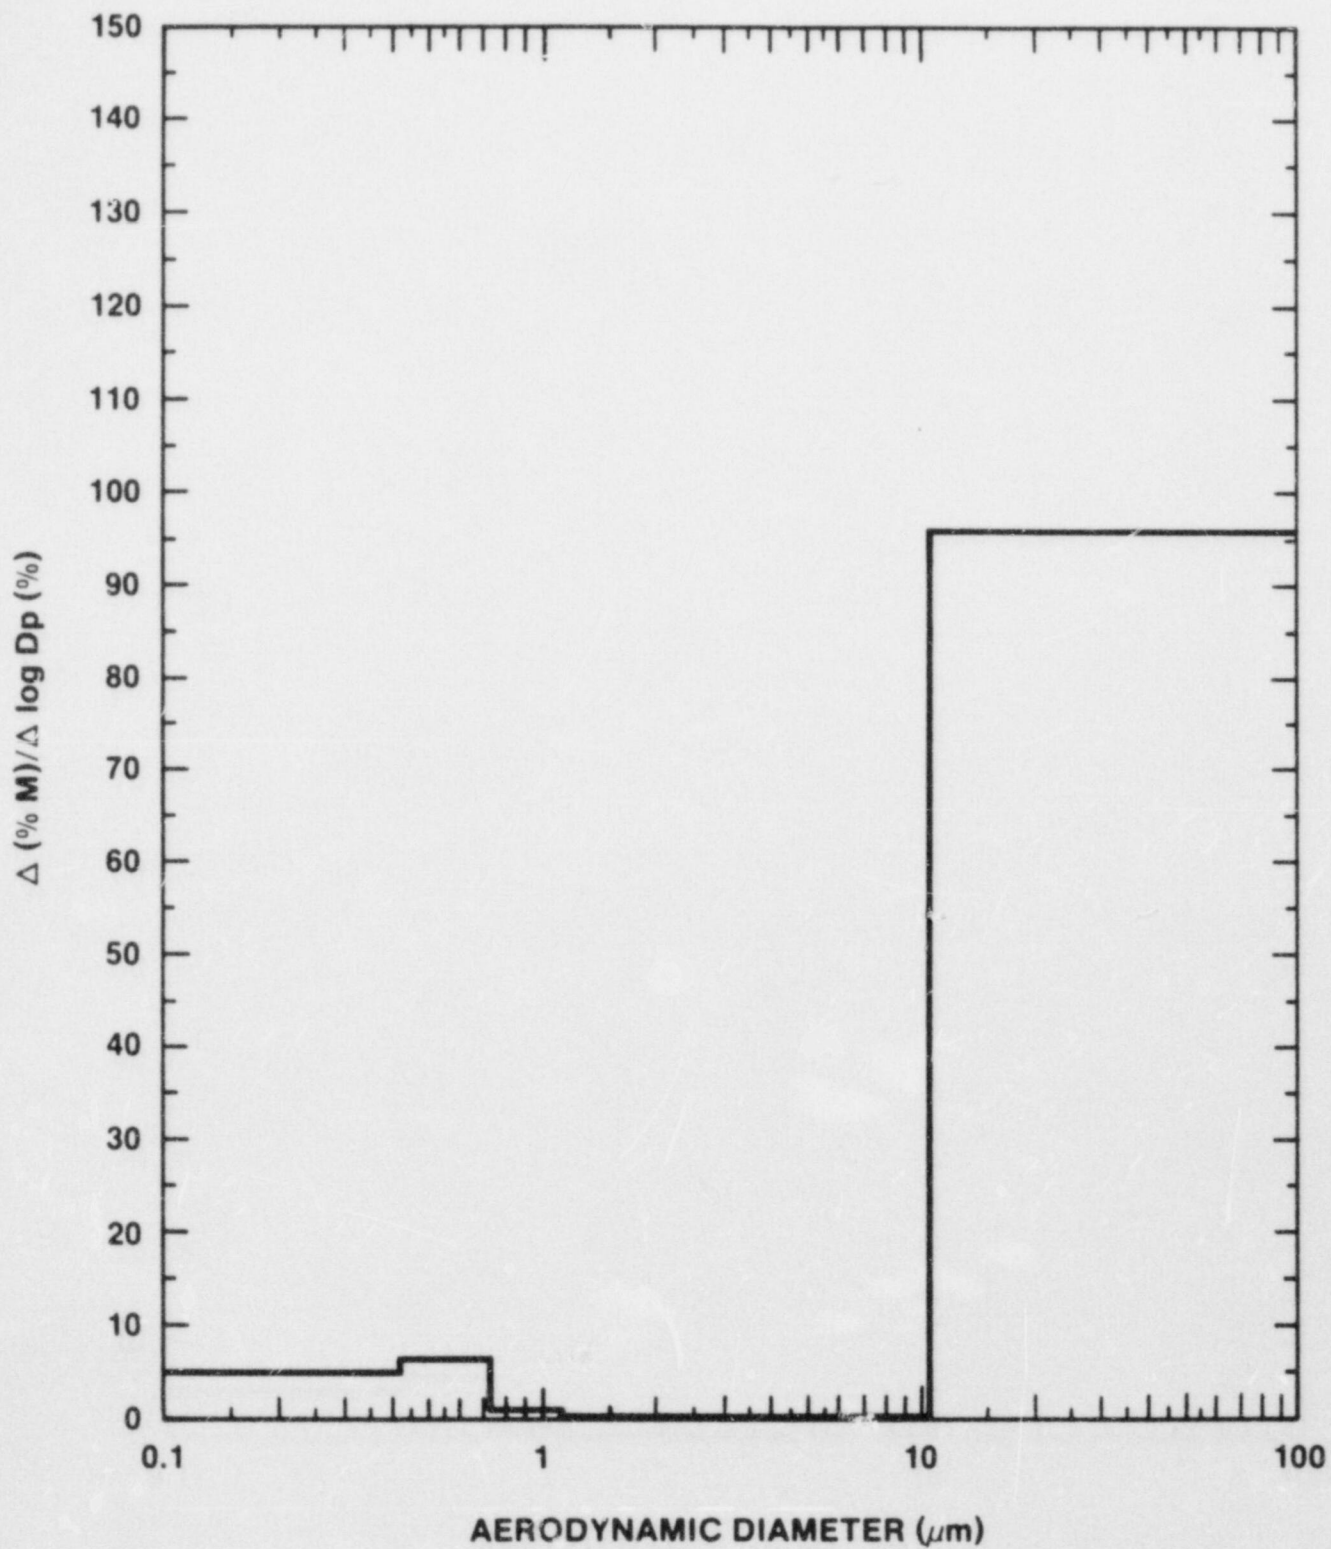
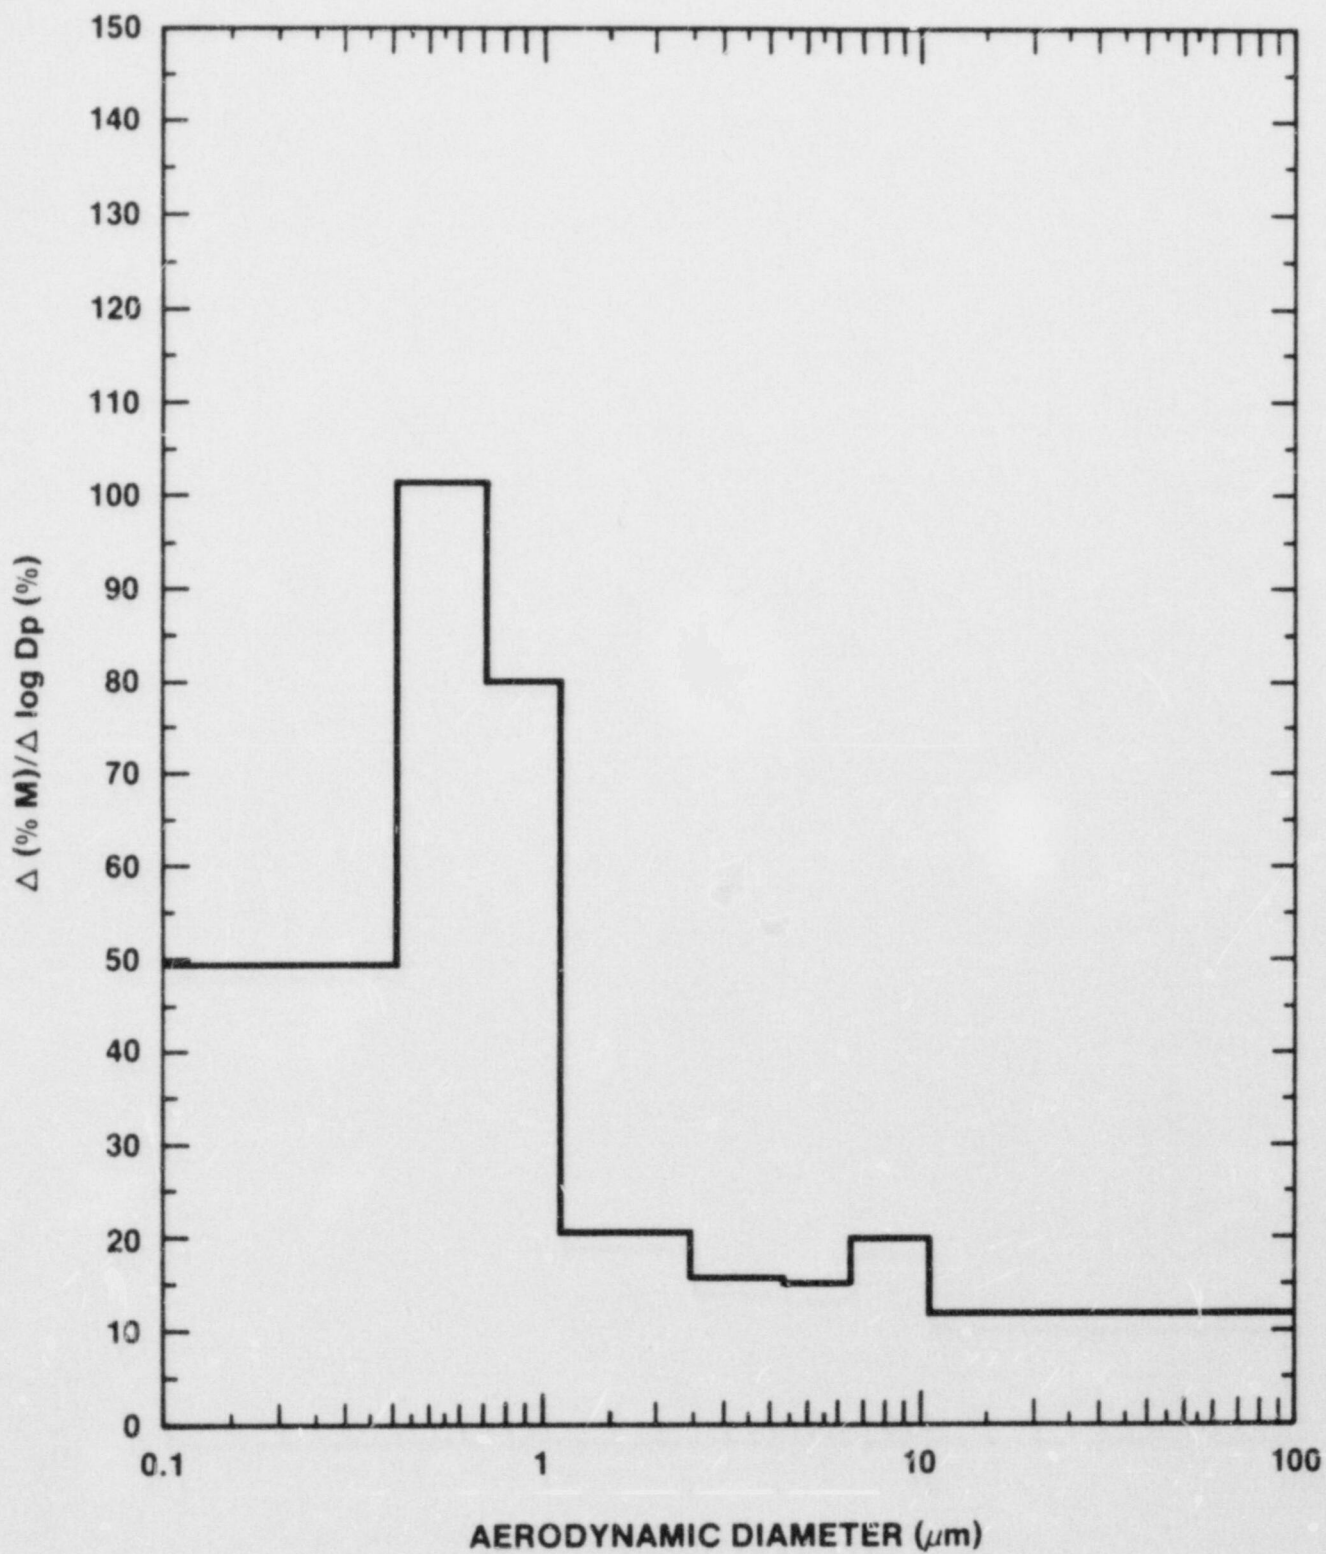
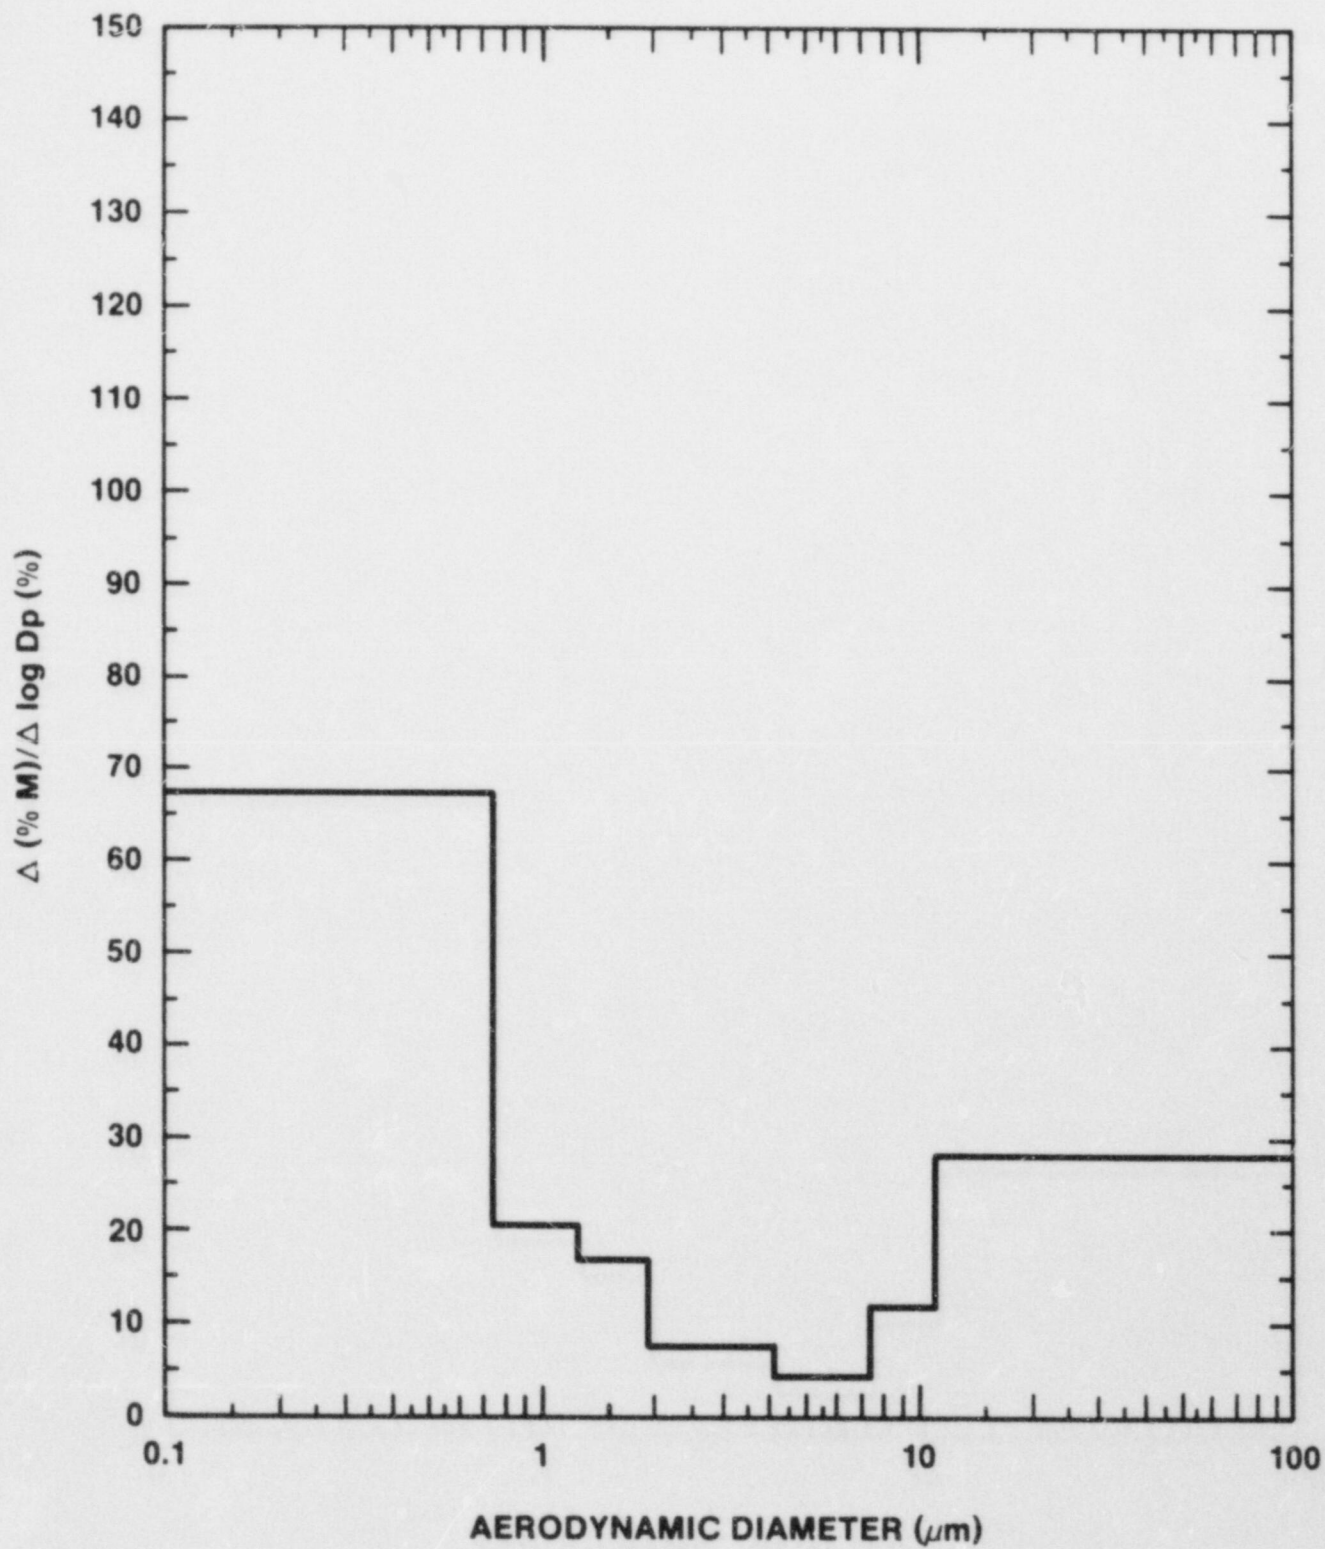
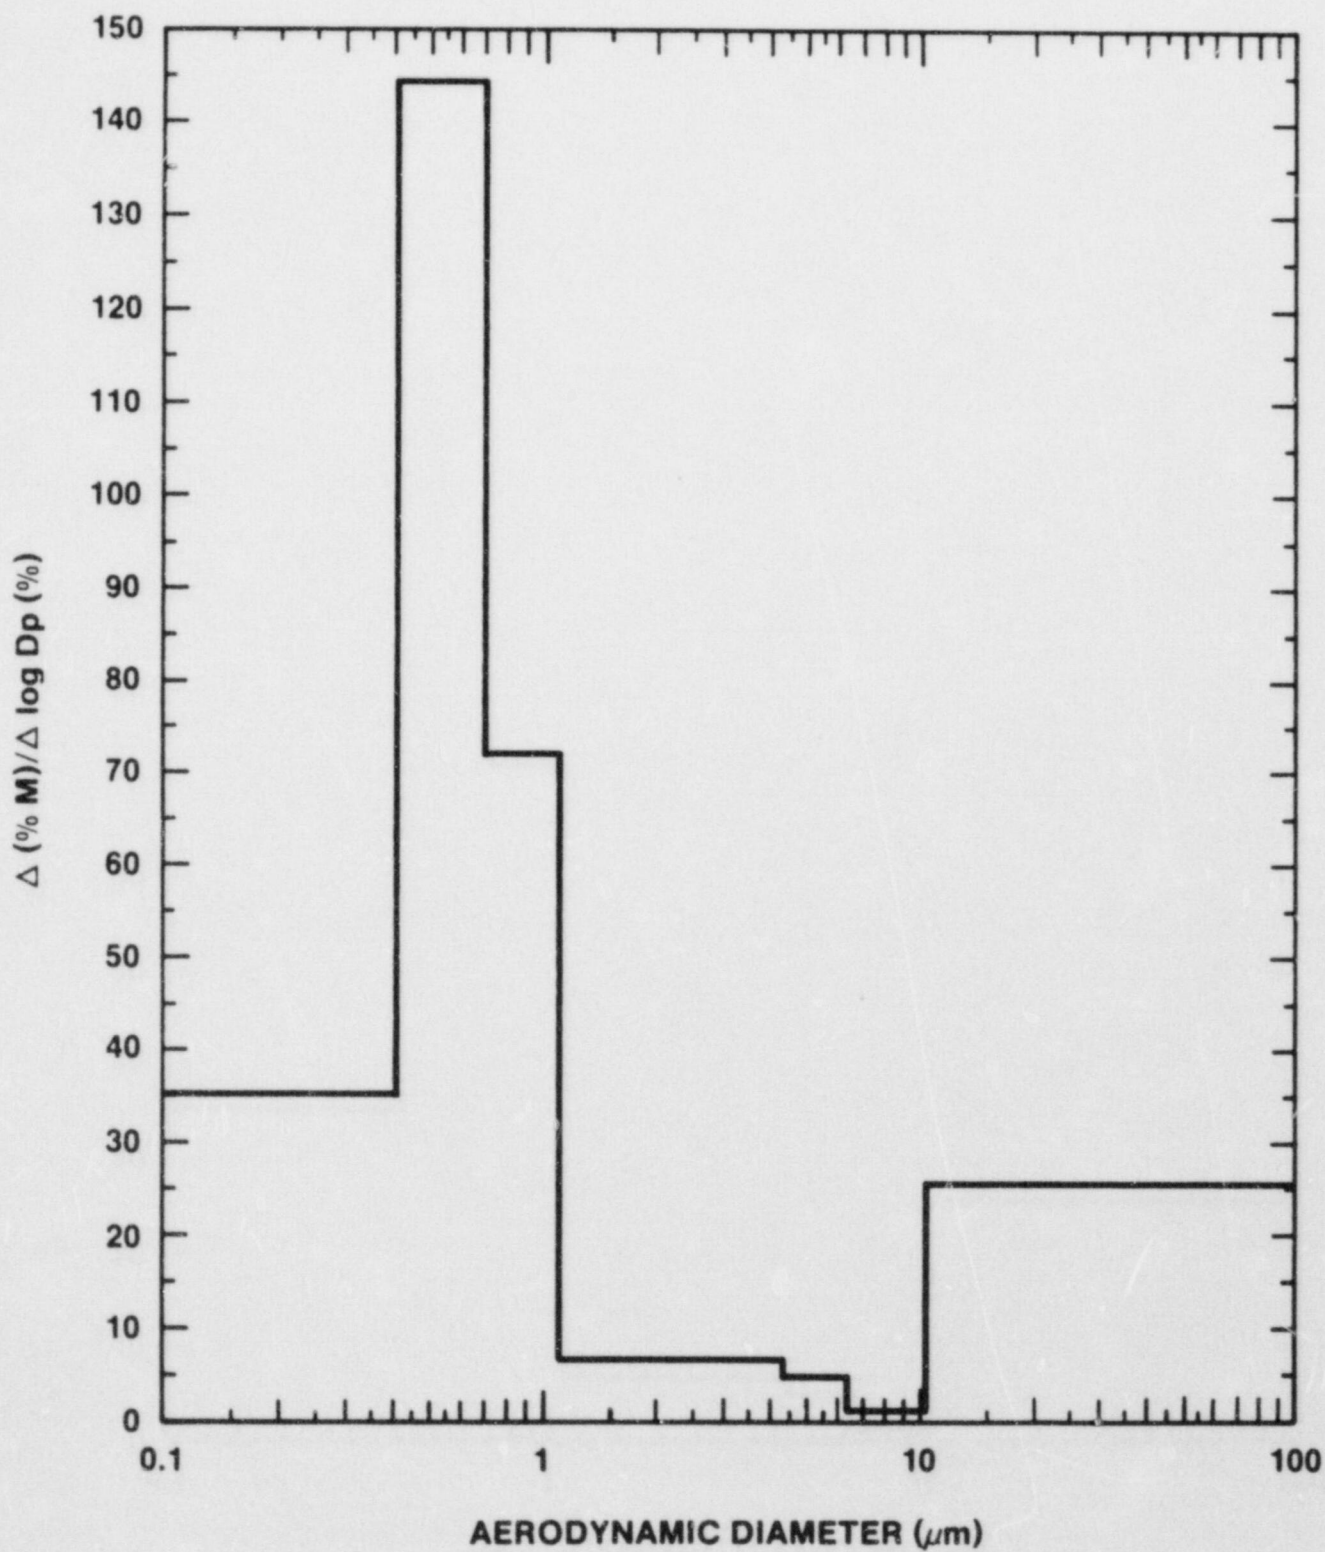
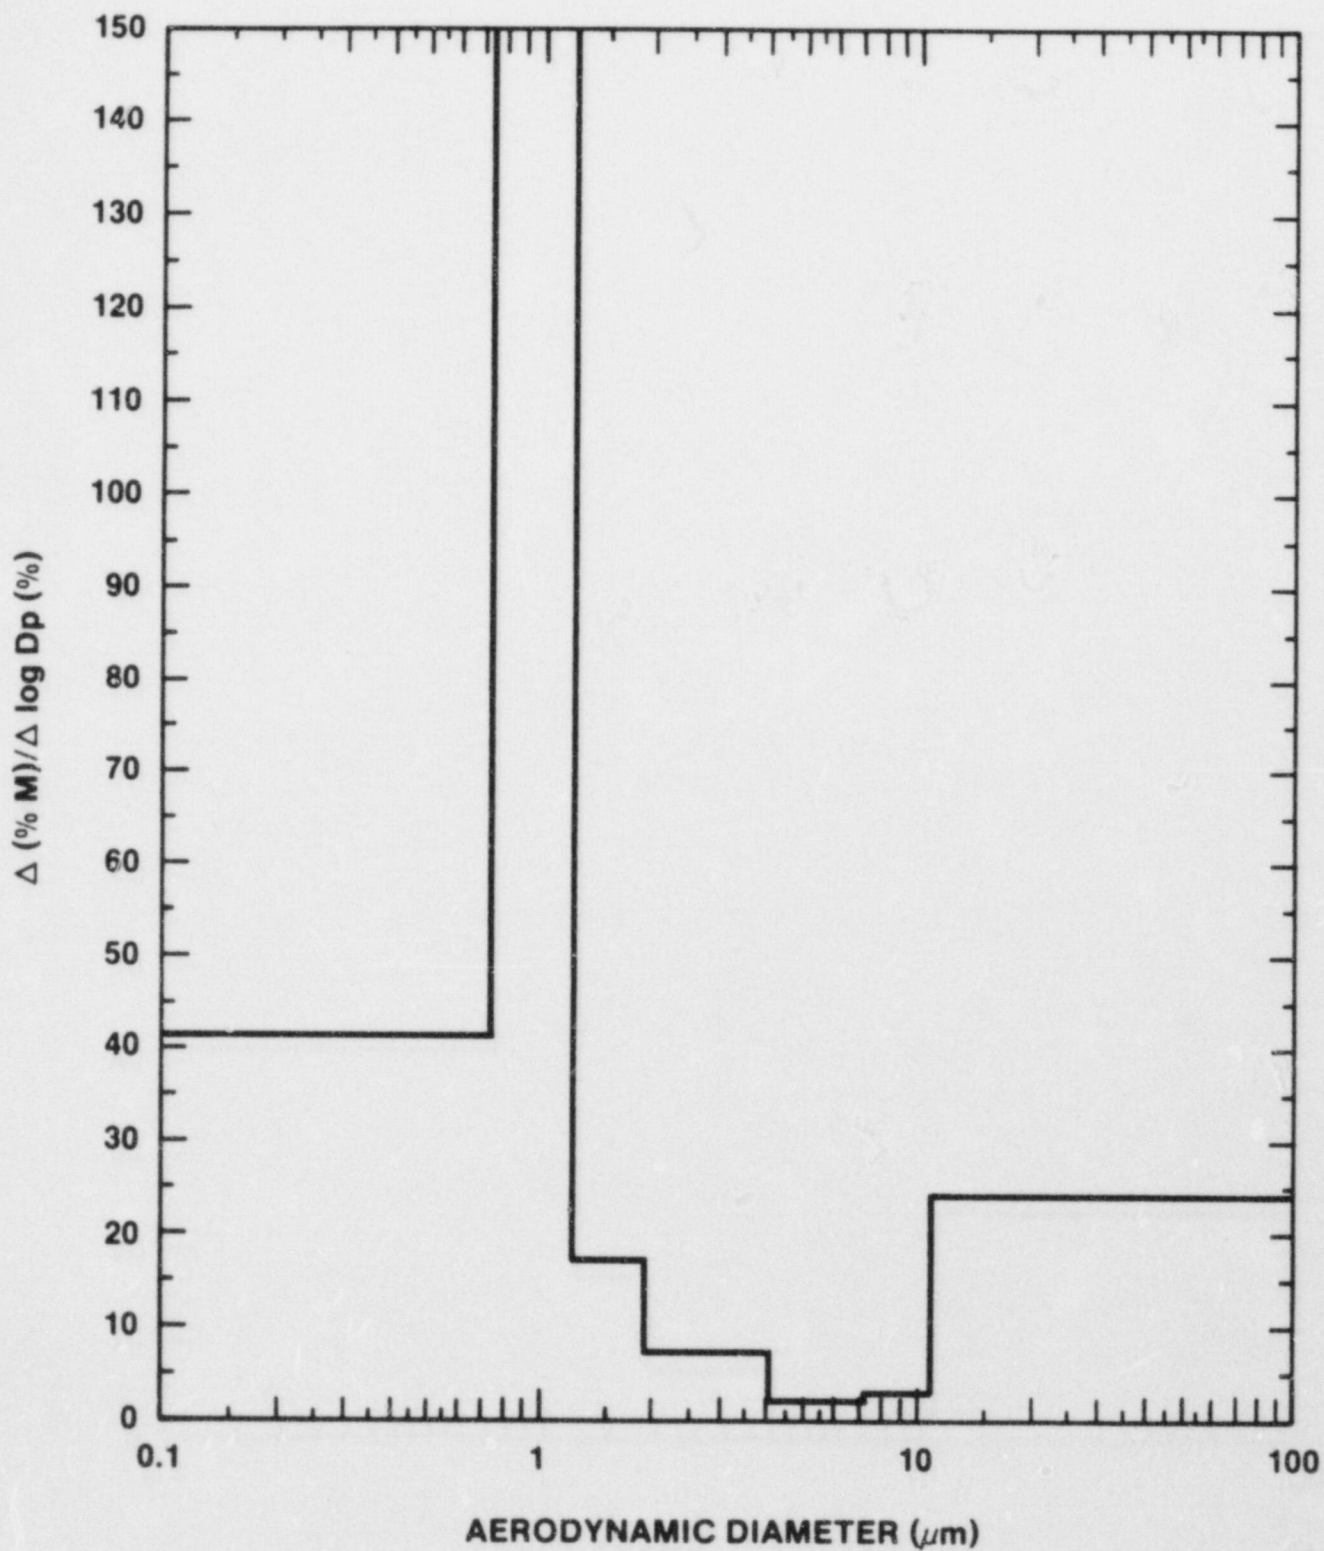
The size distribution data from the impactors used on the two SPIT tests are given in Figures 56 through 67. The plots are histograms of the mass distribution as a function of aerodynamic equivalent diameter. The vertical axis is a linear scale for the mass fraction in a size interval divided by the log
