NUREG/CR-4512  
SAND86-0153  
R3/R4,R7  
Printed October 1986

## Pressurized Melt Ejection Into Scaled Reactor Cavities

PRESSURIZED MELT EJECTION INTO  
SCALED REACTOR CAVITIES

This report describes four tests performed in the High-Pressure Melt Streaming Program (HIPS) using linear-scaled cavities of the Zion Nuclear Power Plant. These experiments were conducted to study the phenomena involved in high-pressure ejection of core debris into the cavity beneath the reactor pressure vessel. One-tenth and one-twentieth linear scale models of reactor cavities were constructed and instrumented. The first test used an apparatus constructed of alumina firebrick to minimize the potential interaction between the ejected melt and cavity material. The remaining three experiments used scaled representations of the Zion nuclear plant geometry, constructed of prototypic concrete composition.

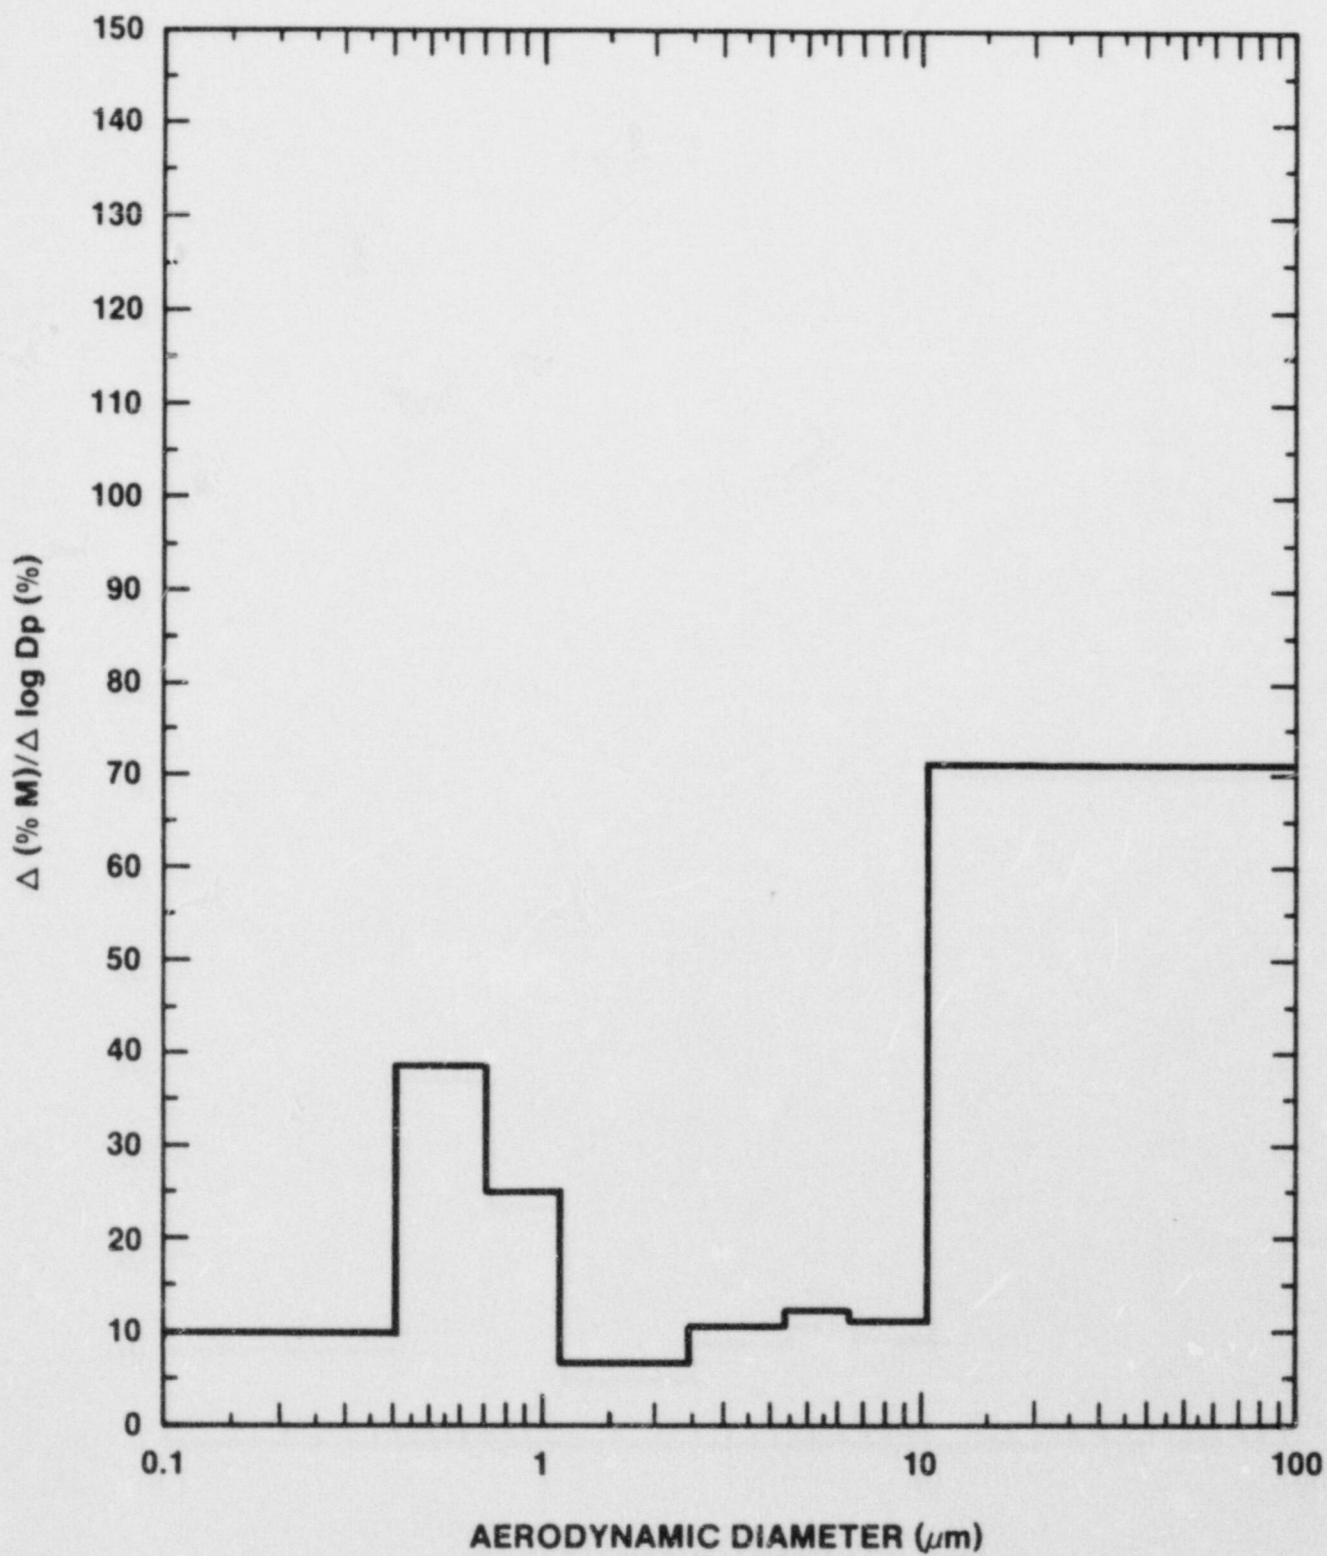
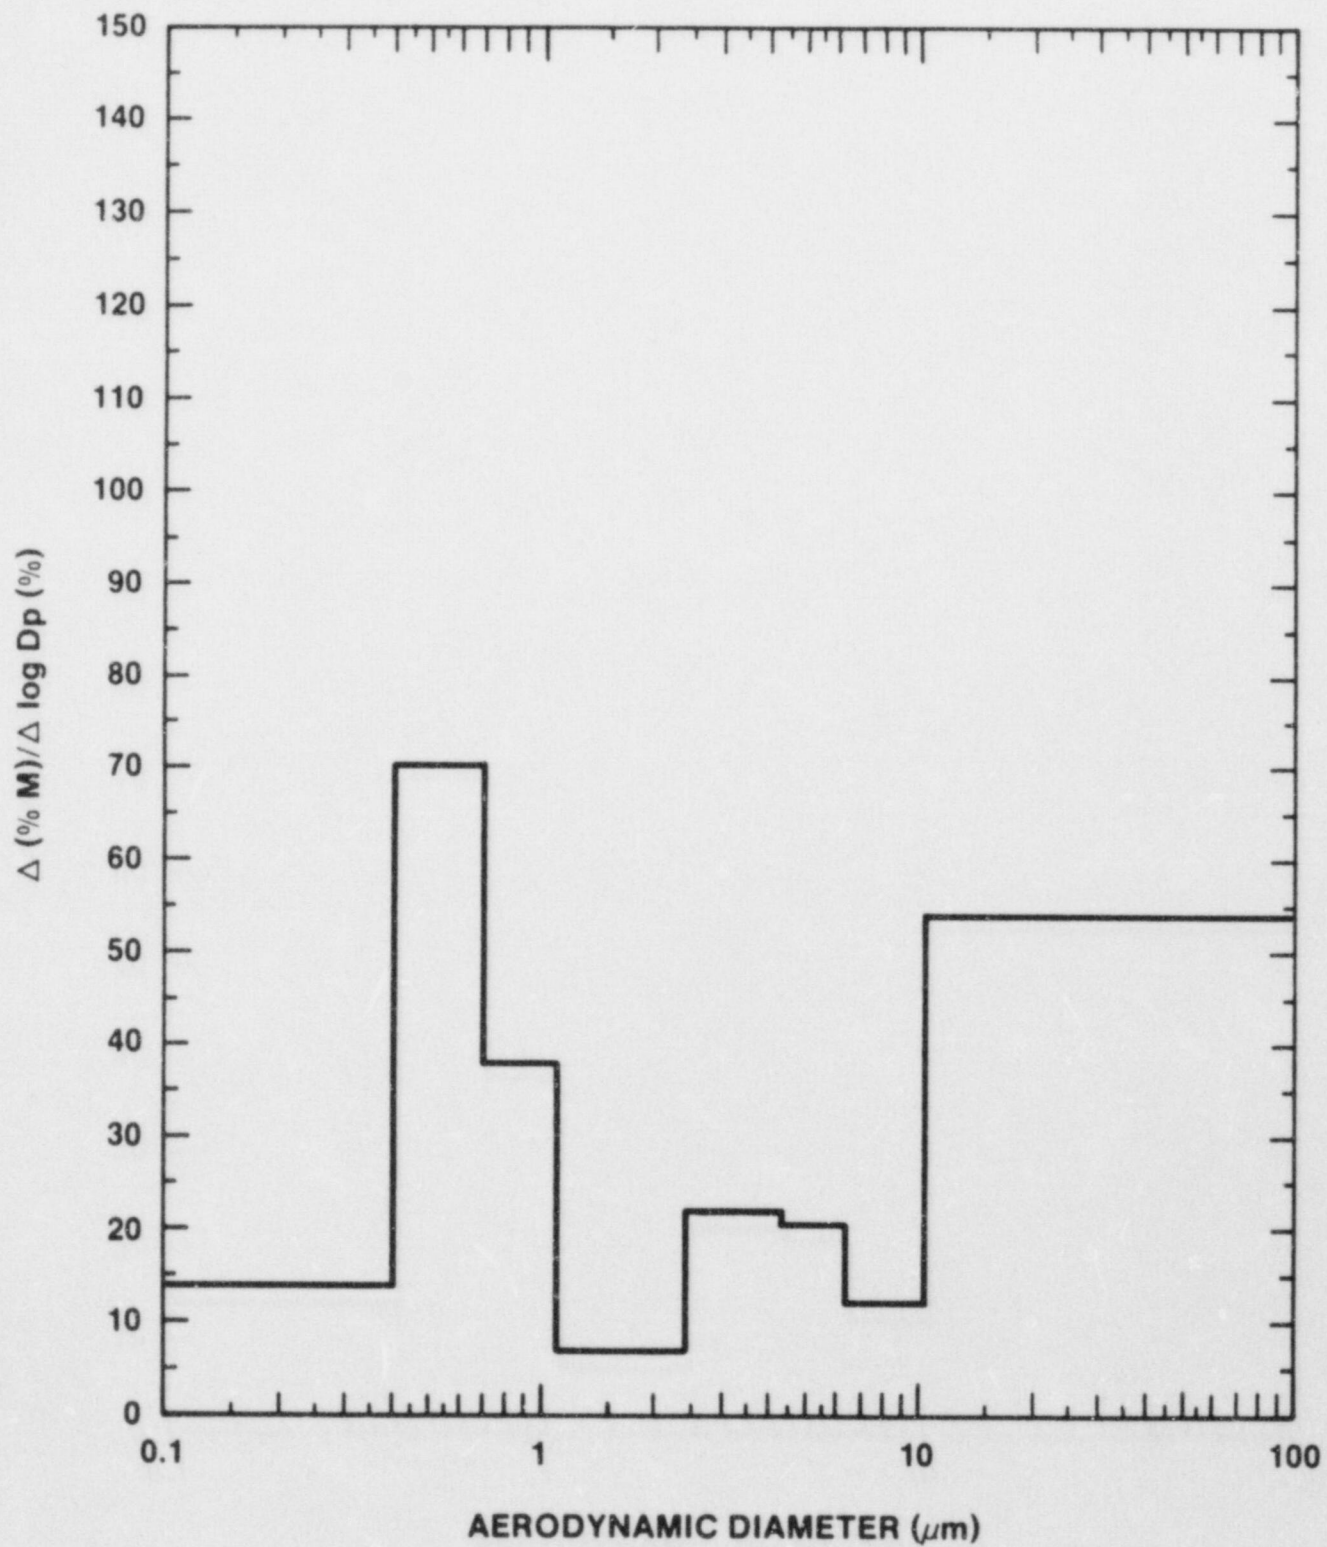
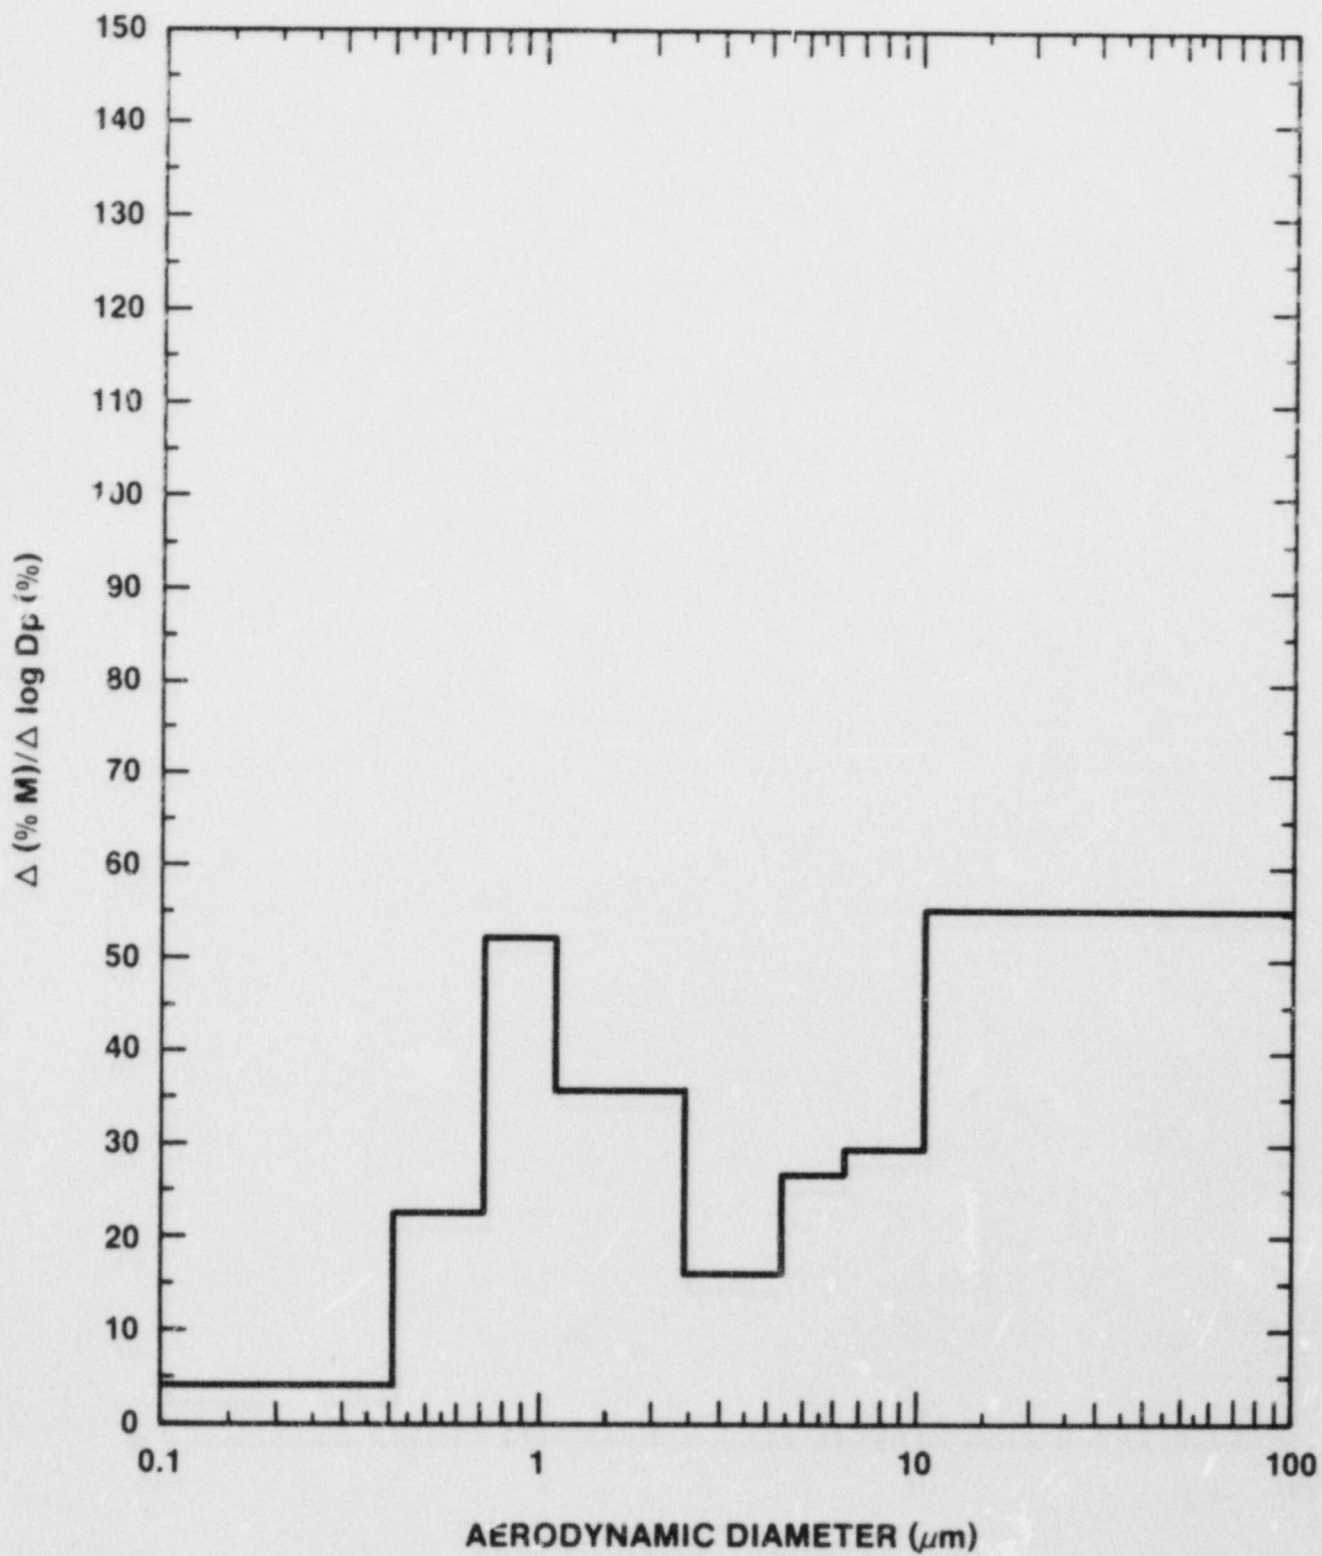
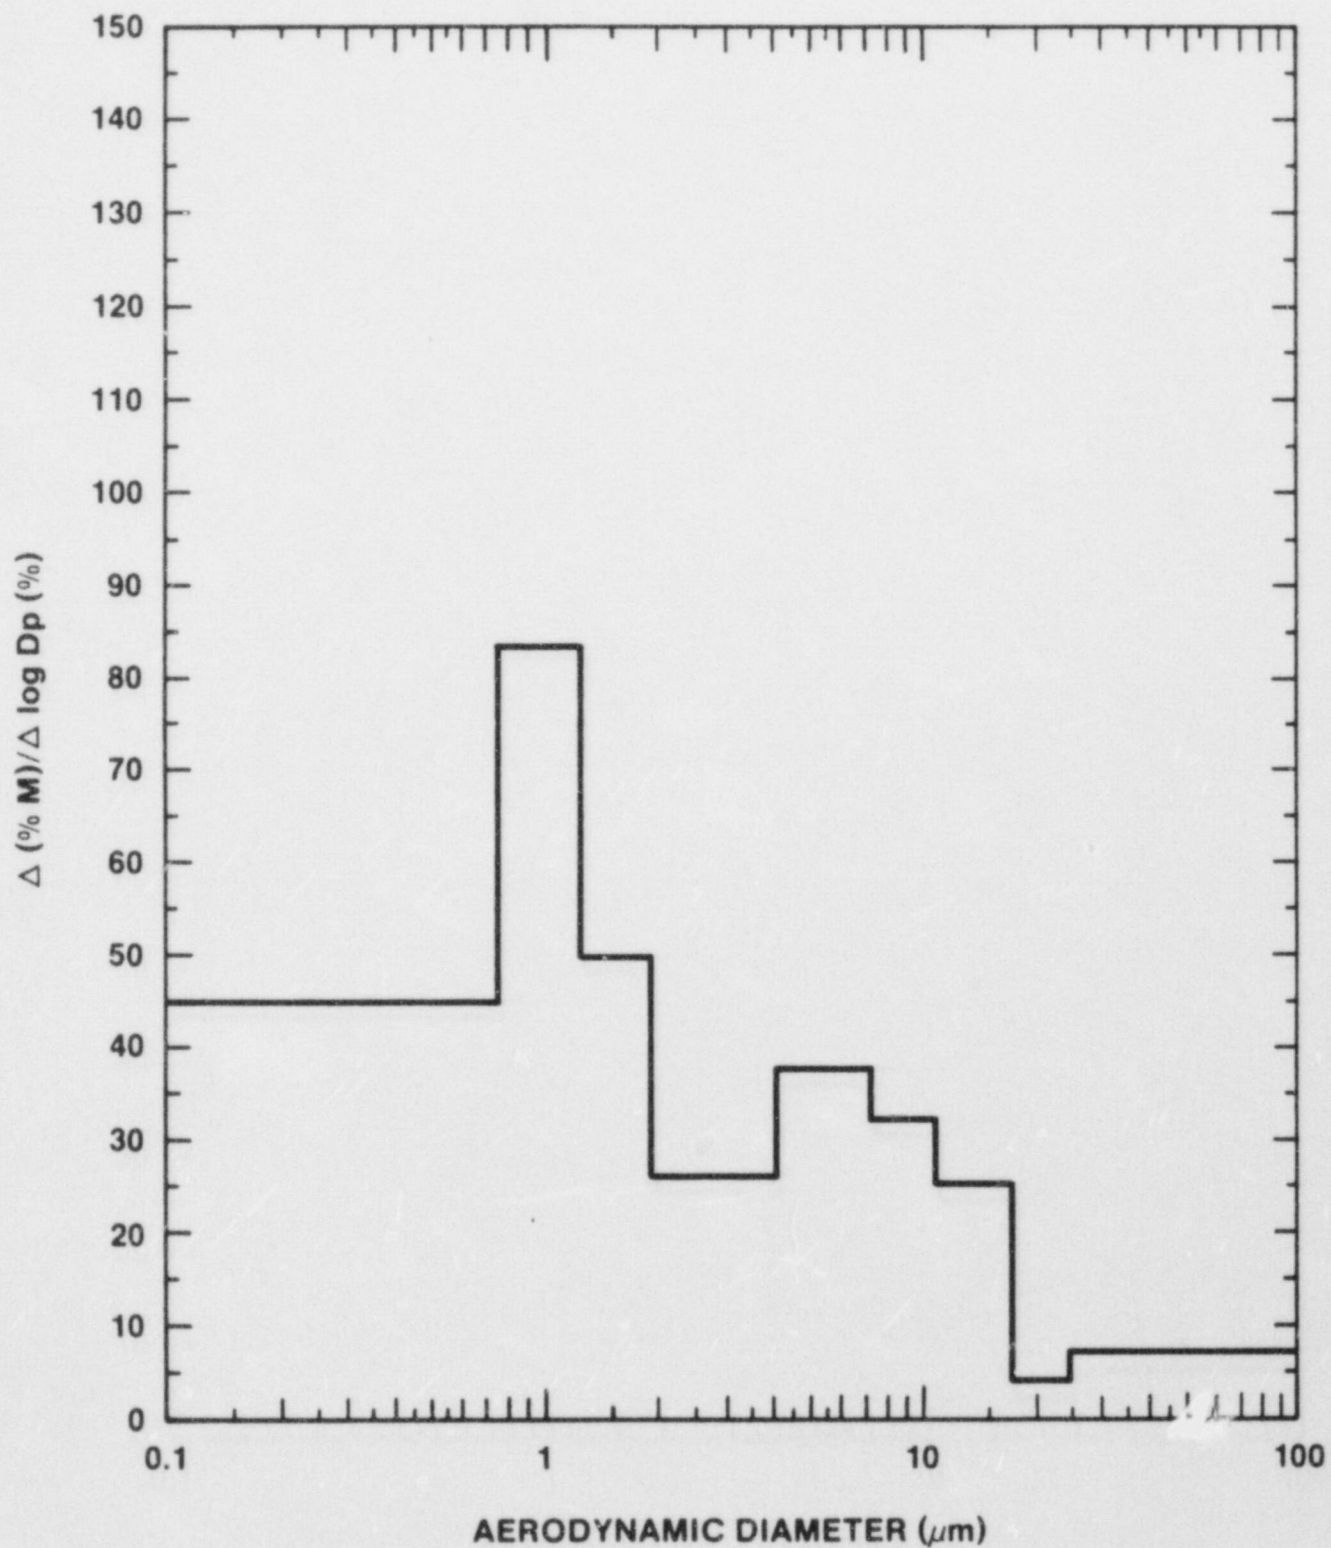
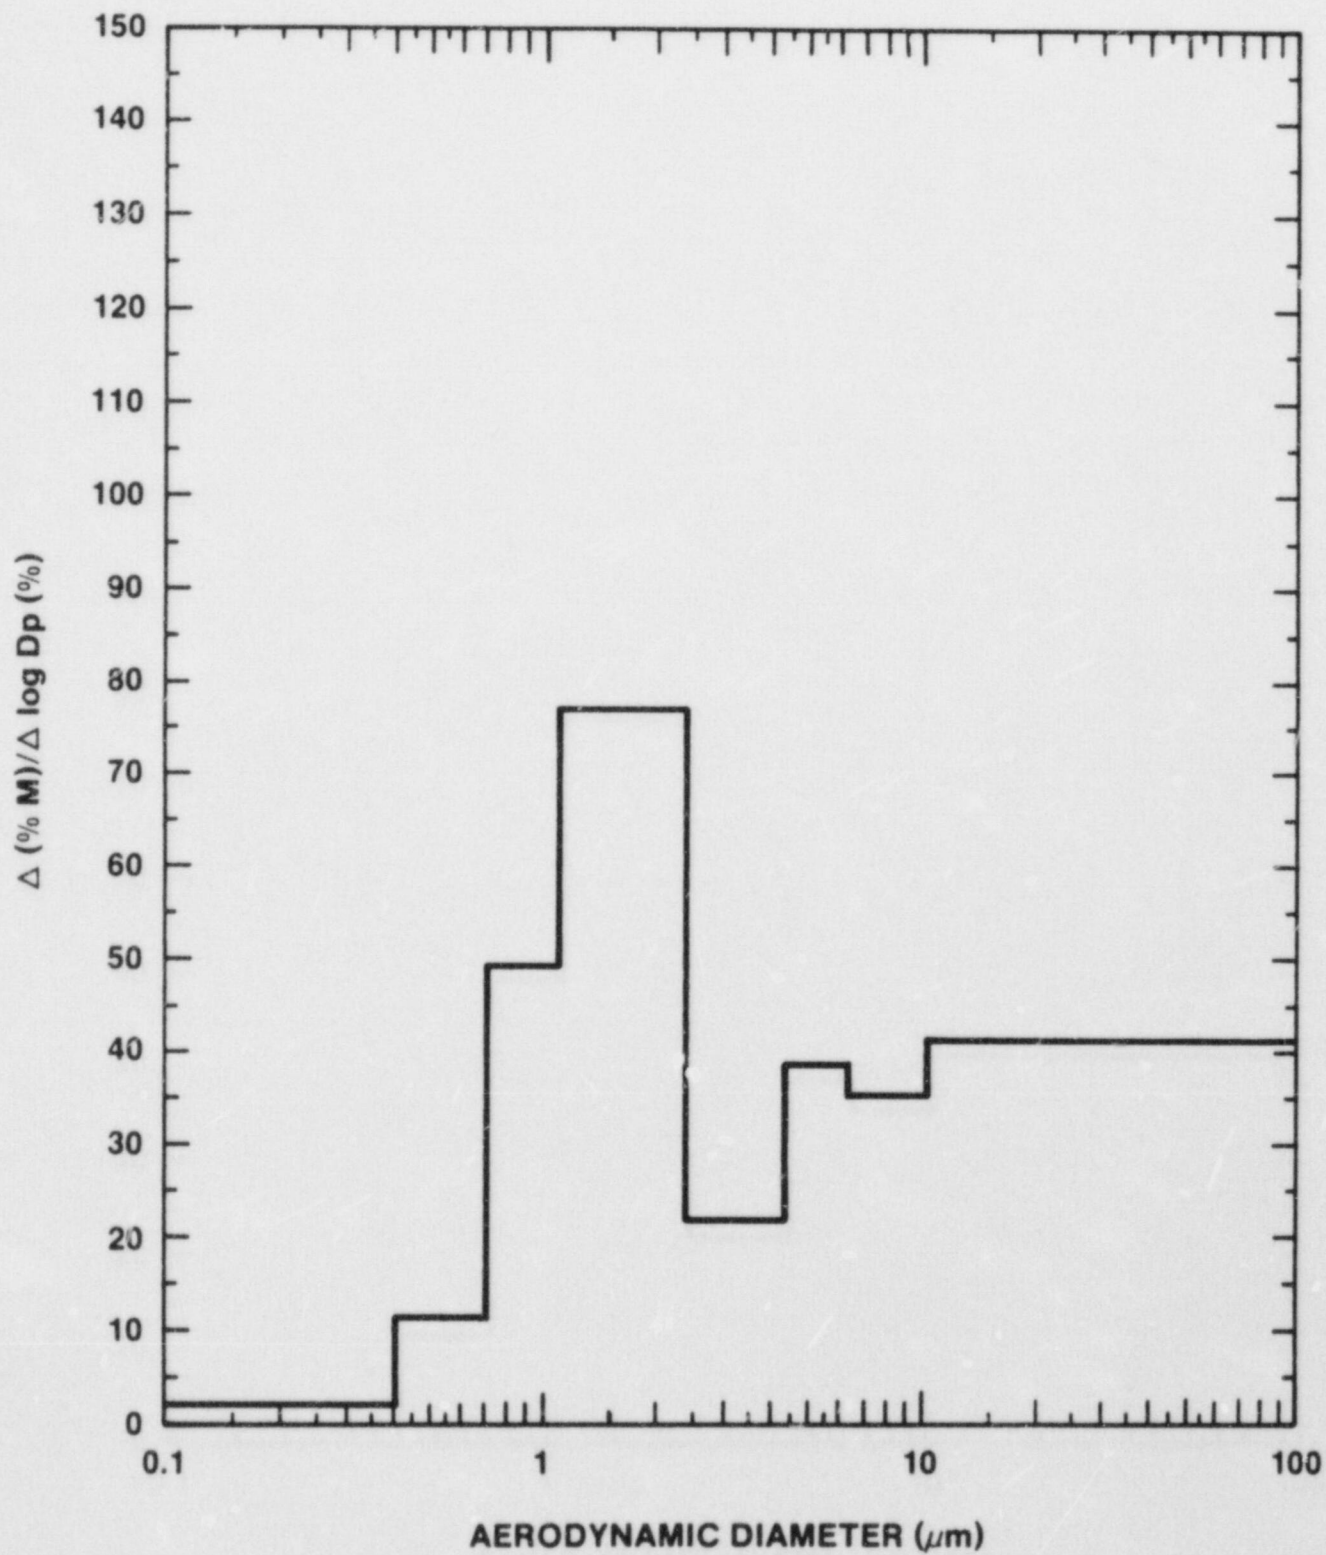
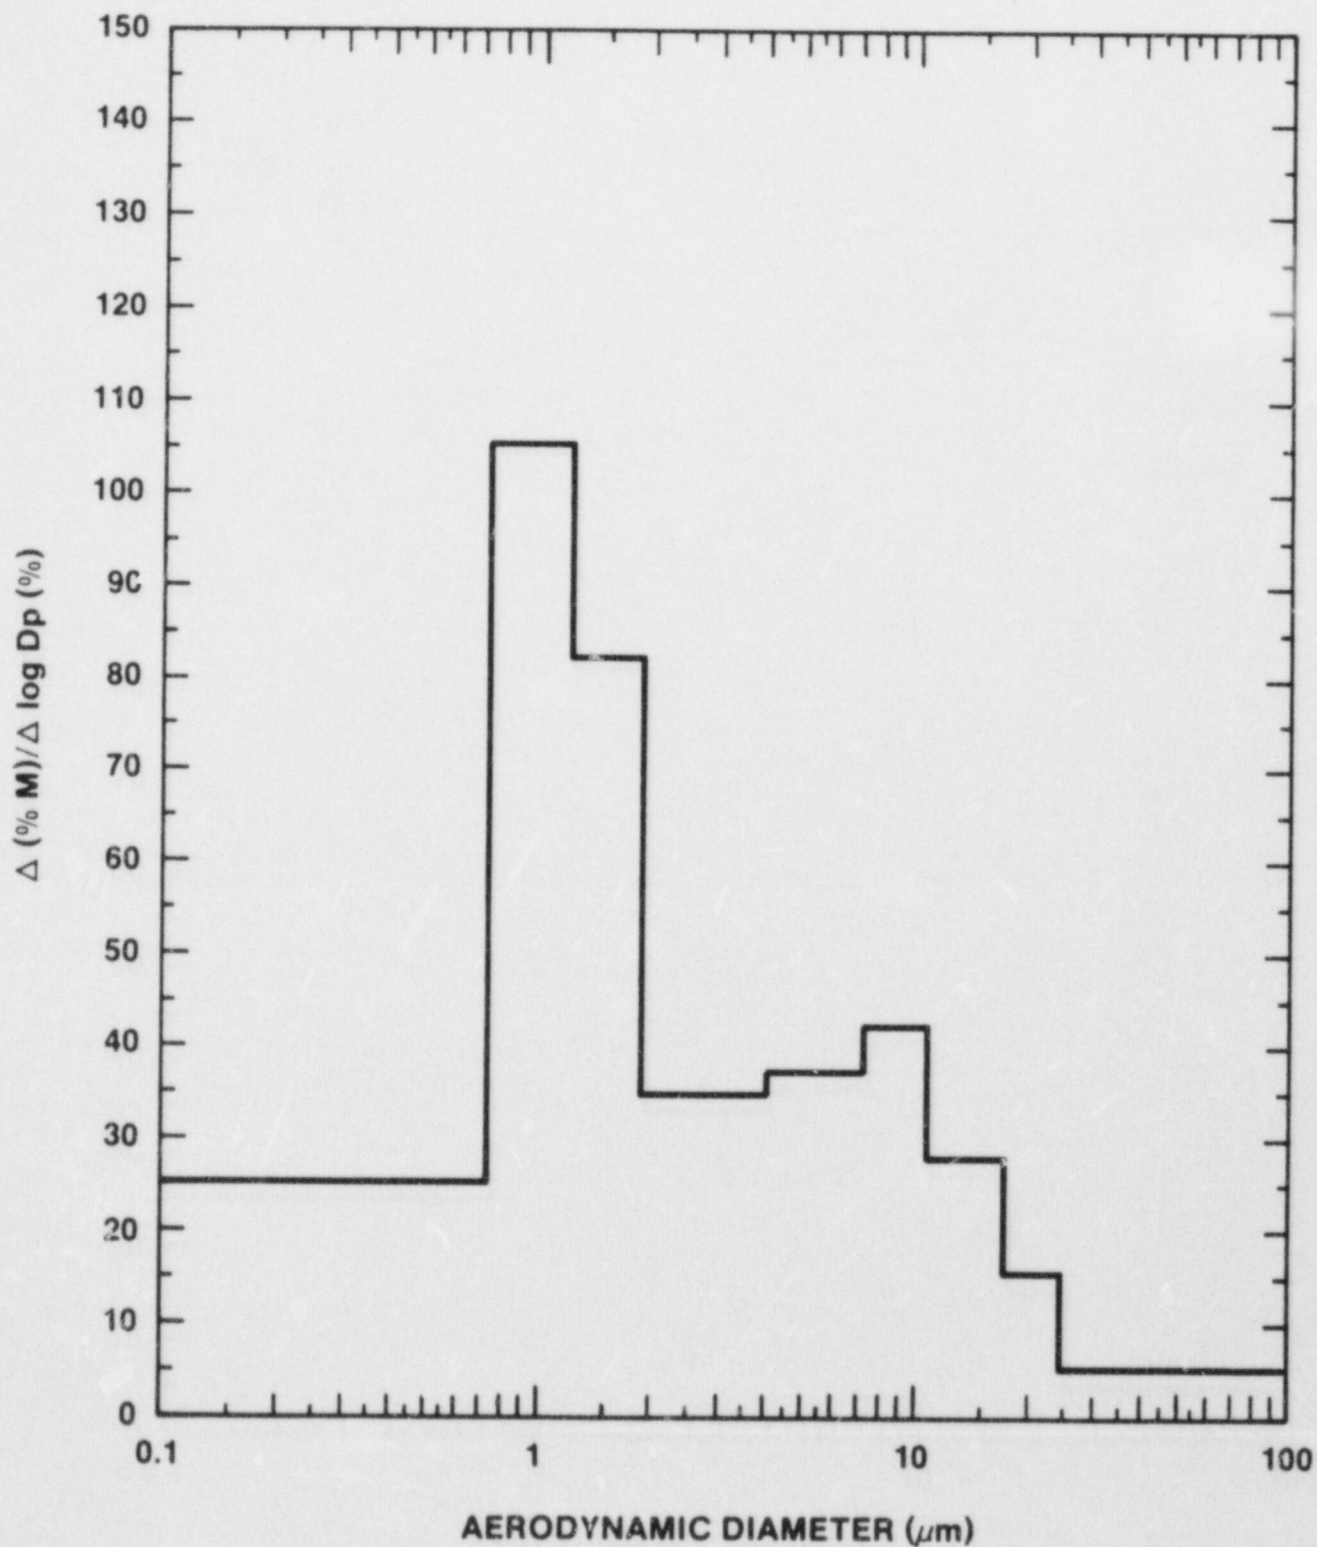
The size distribution data from the impactors used on the two SPIT tests are given in Figures 56 through 67. The plots are histograms of the mass distribution as a function of aerodynamic equivalent diameter. The vertical axis is a linear scale for the mass fraction in a size interval divided by the log

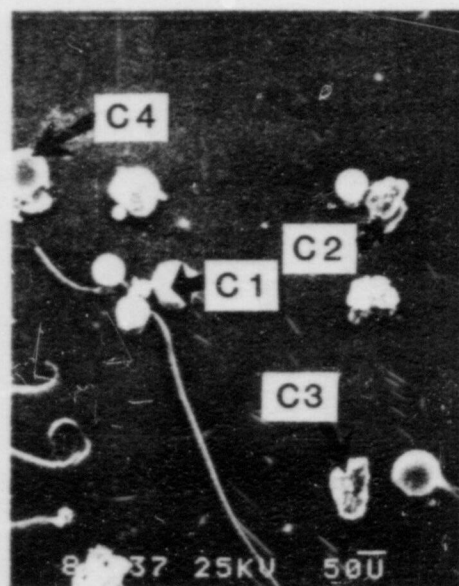
Dp = 65 MICRON

Electron photomicrographs of the collected aerosol (Figure 68) showed a difference in the character of each size range. The aerosol in the smallest range was an agglomerate of one-tenth micrometer and smaller particles. These were similar to condensation formed particles such as found in steel fumes. The material in the middle and largest sizes were both spherical single particles similar to aerosols formed by freezing of liquid droplets. A higher incidence of nonspherical and broken spheres in the largest range was consistent with the behavior of large drops that crust at the surface and then crack due to internal stress. These were similar in appearance to particles formed by steel droplets ejected from a melt pool by bubble bursting.

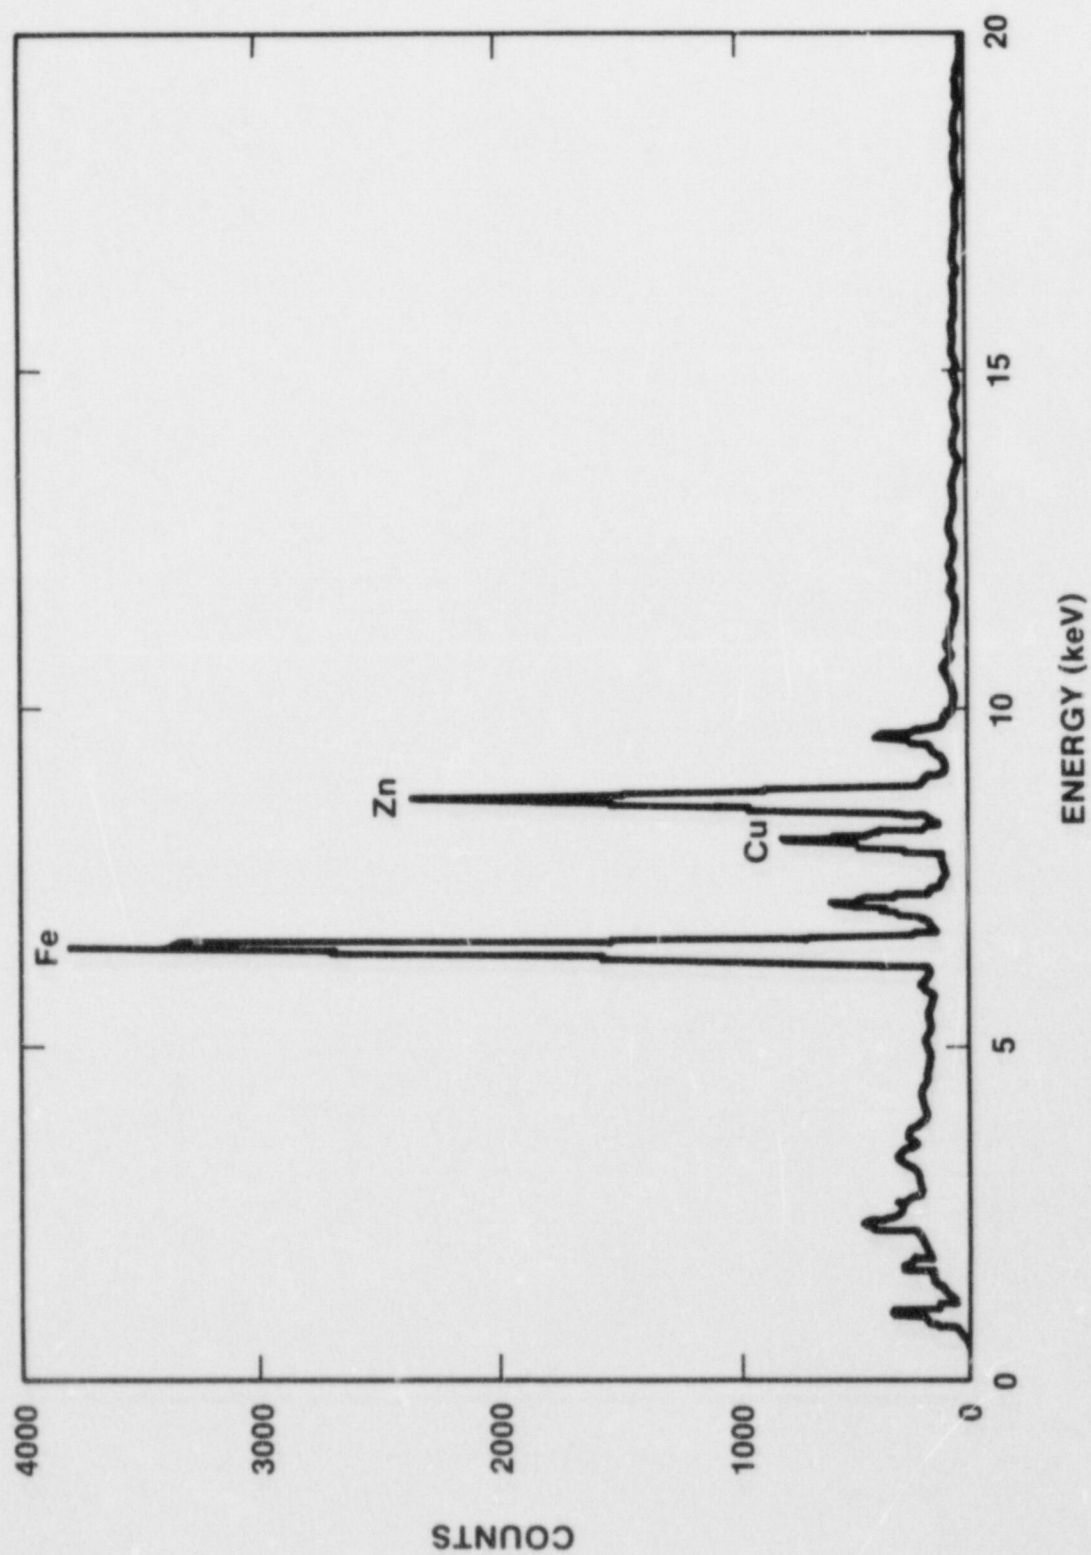
FIGURE 69. ENERGY DISPERSIVE SPECTROSCOPY RESULTS FOR A SUBMICROMETER PARTICLE FROM THE SPIT-18 TEST

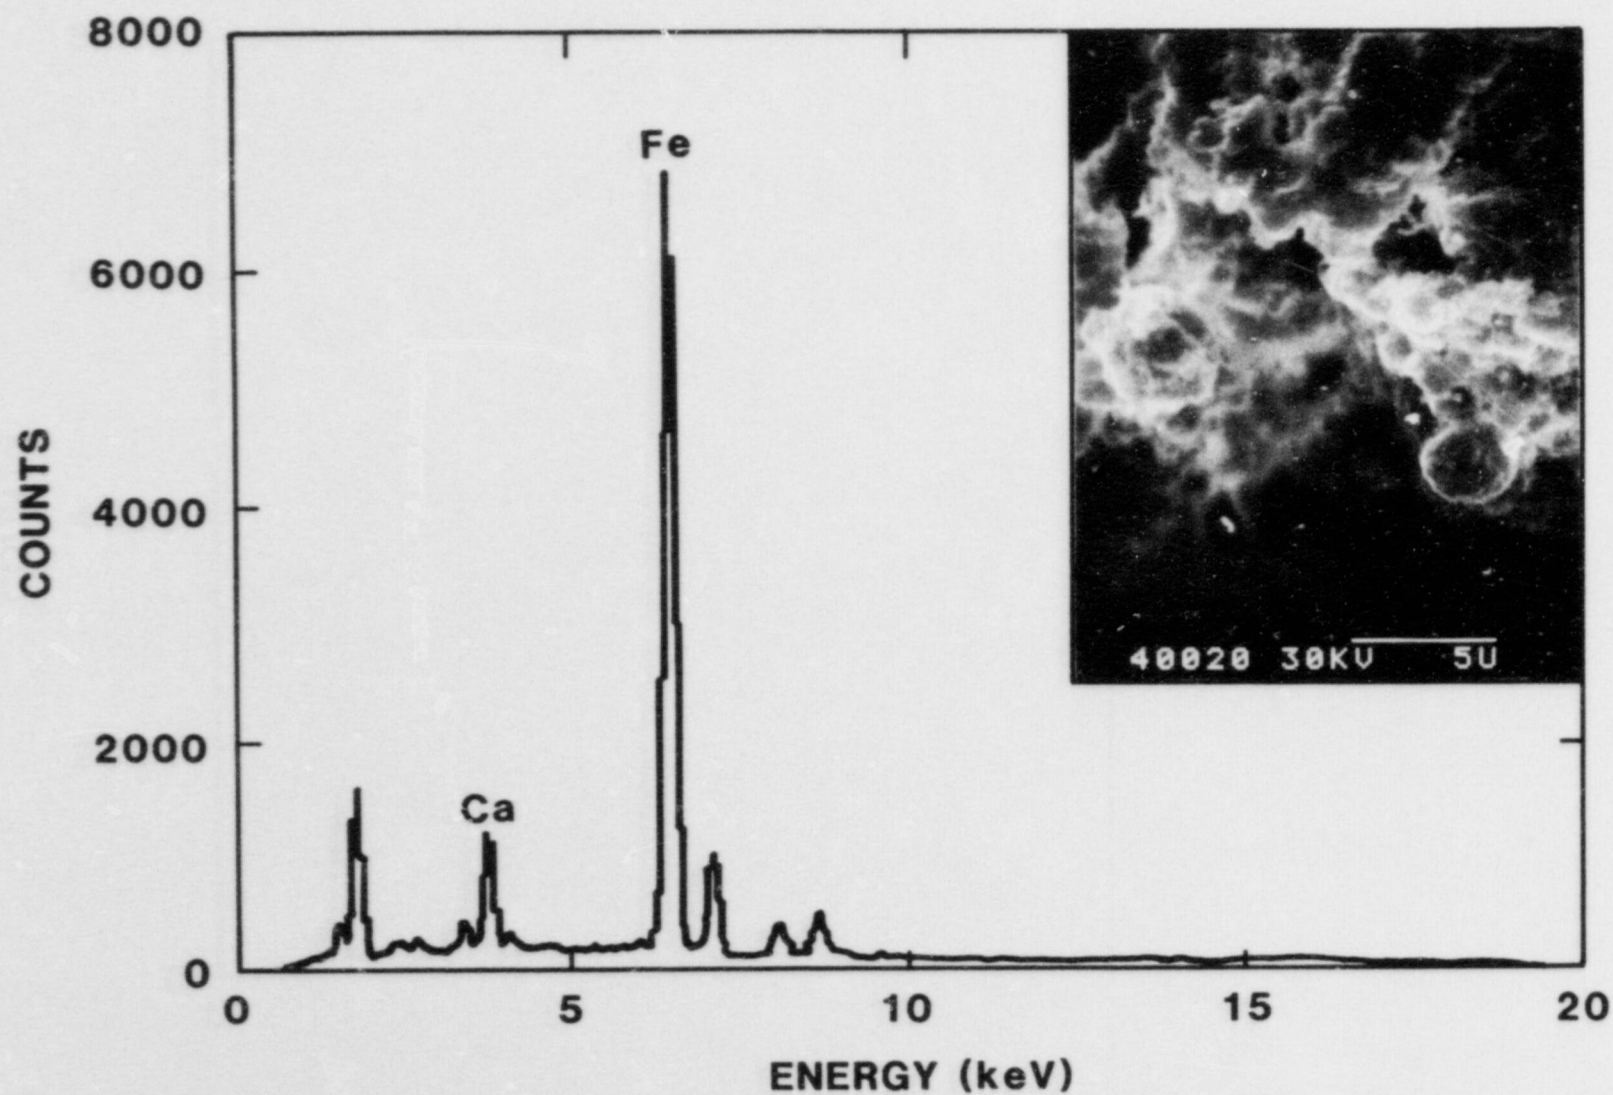
FIGURE 70. ENERGY DISPERSIVE SPECTROSCOPY RESULTS FOR A SUBMICROMETER PARTICLE FROM THE SPIT-19 TEST

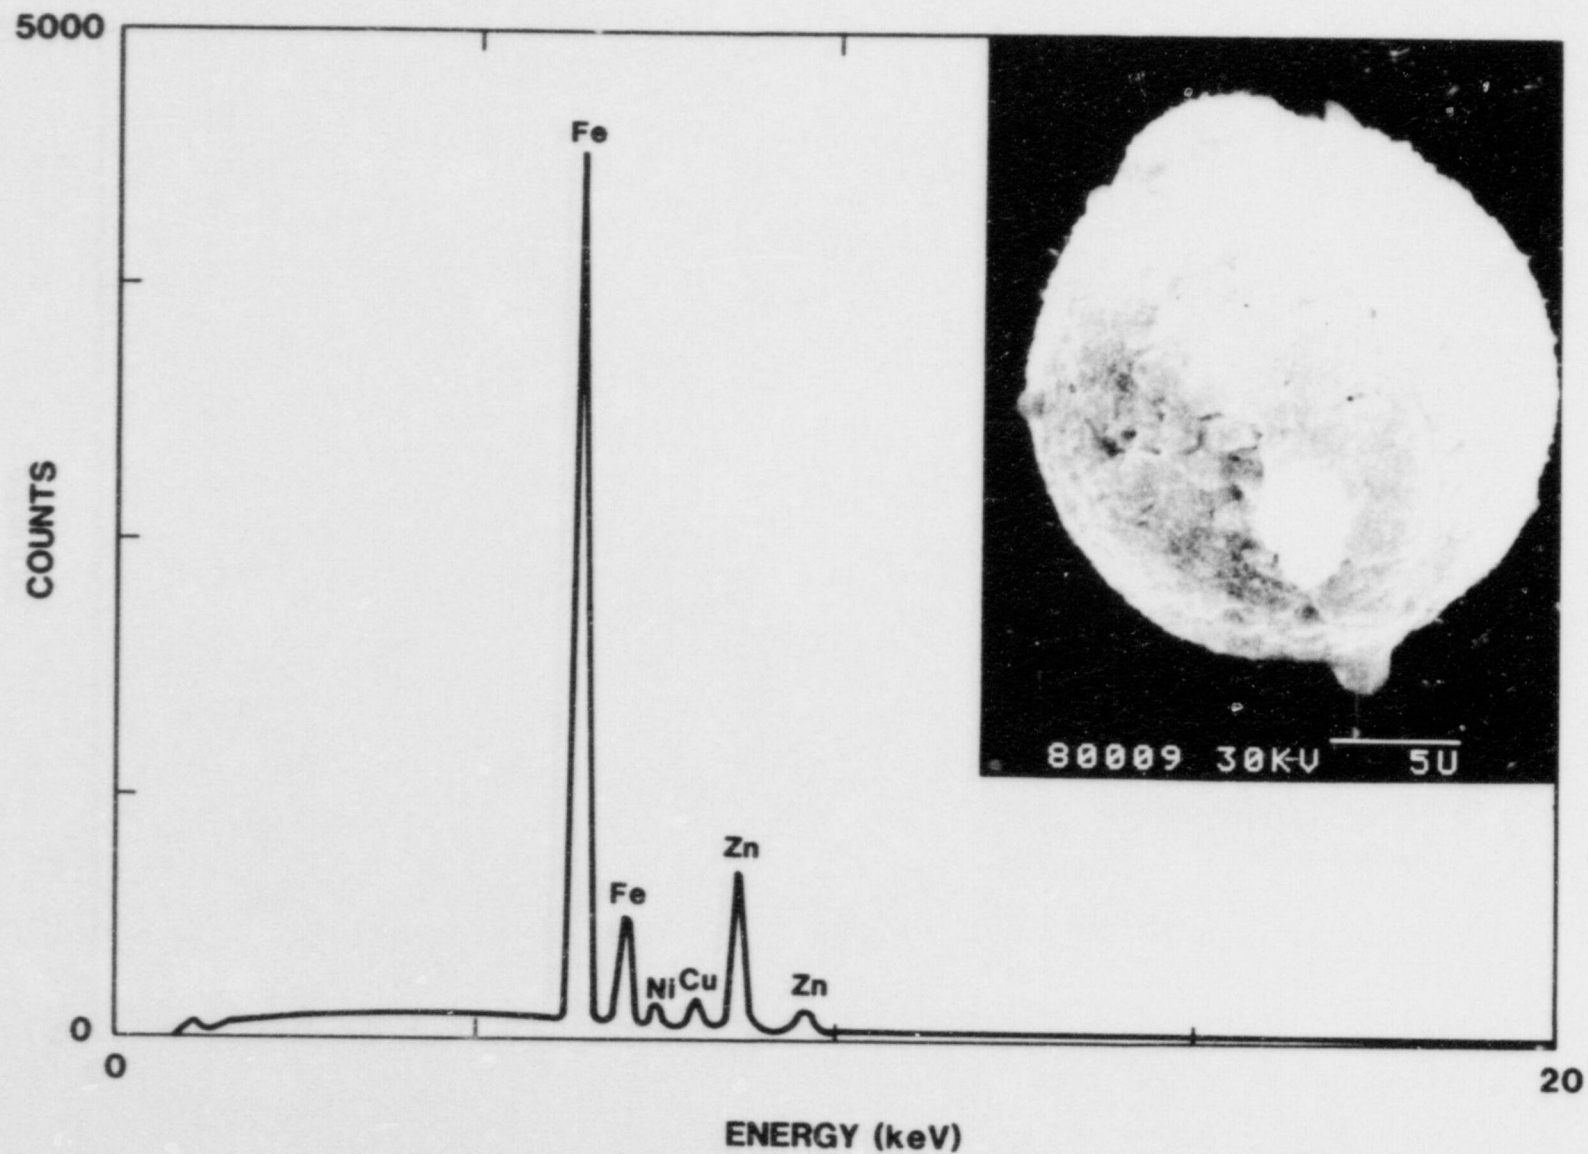
FIGURE 71. ENERGY DISPERSIVE SPECTROSCOPY RESULTS FOR A IRON-BEARING SUPERMICROMETER PARTICLE

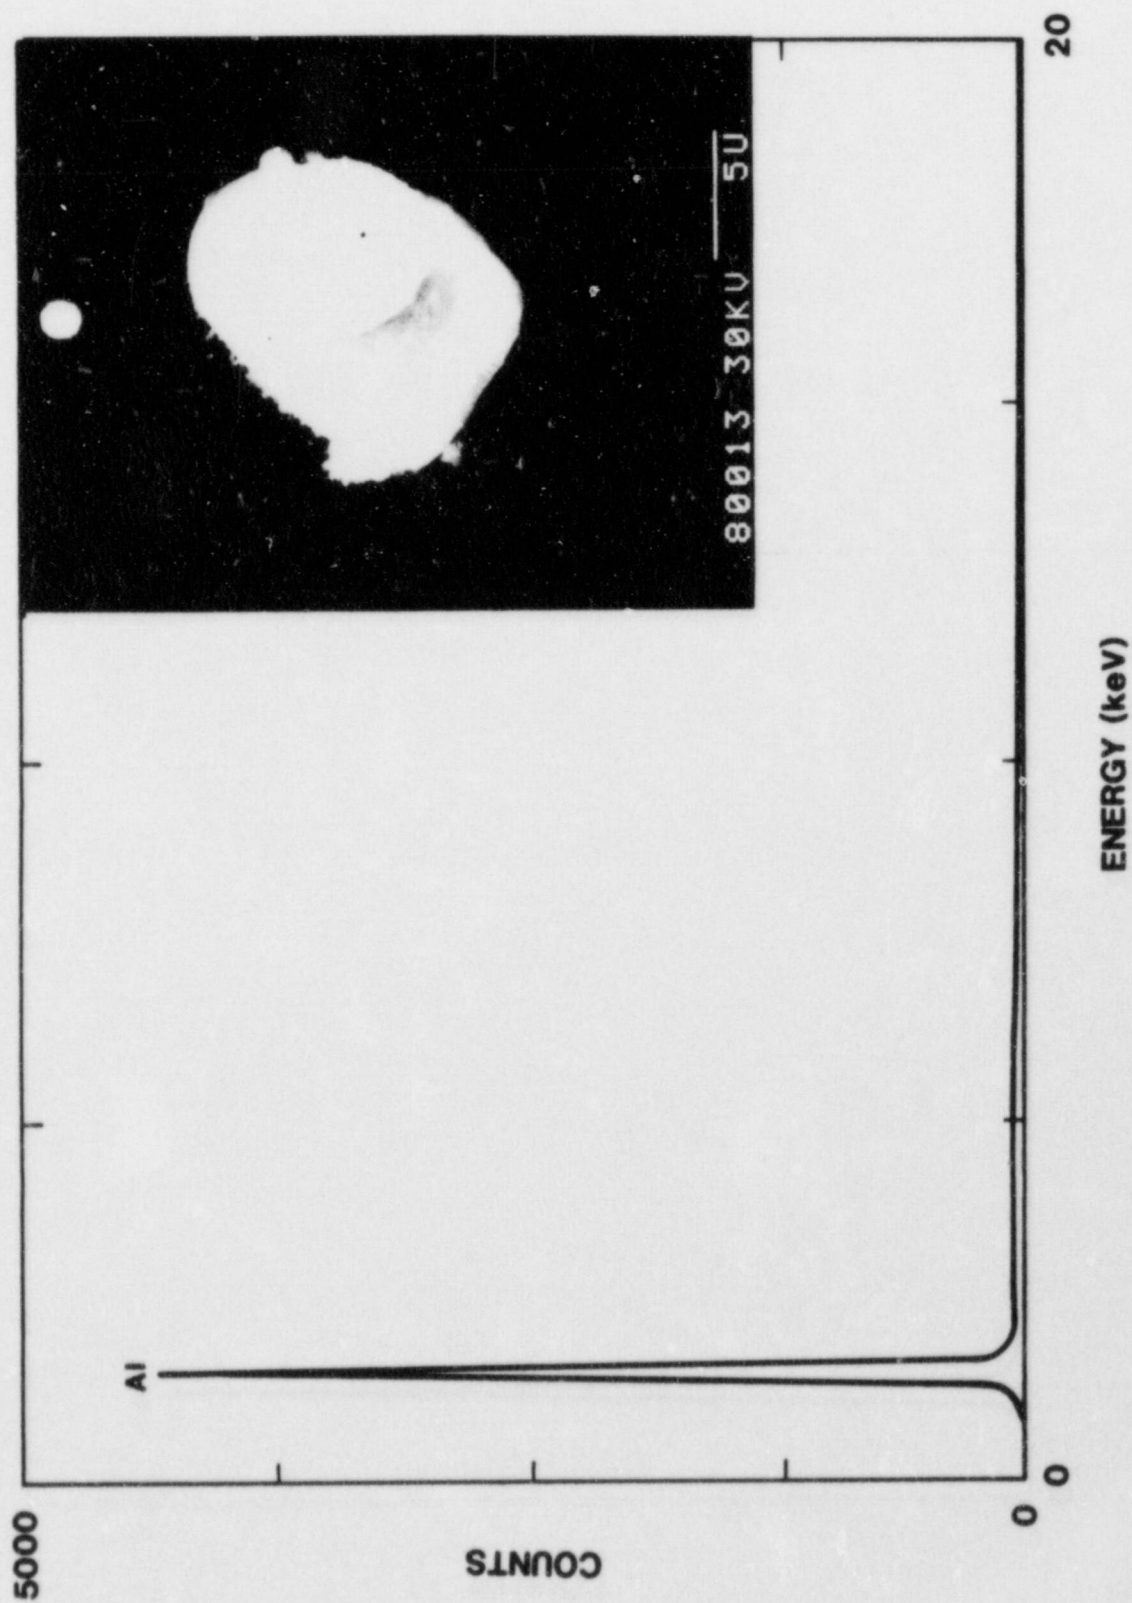
FIGURE 72. ENERGY DISPERSIVE SPECTROSCOPY RESULTS FOR A ALUMINUM-BEARING SUPERMICROMETER PARTICLE

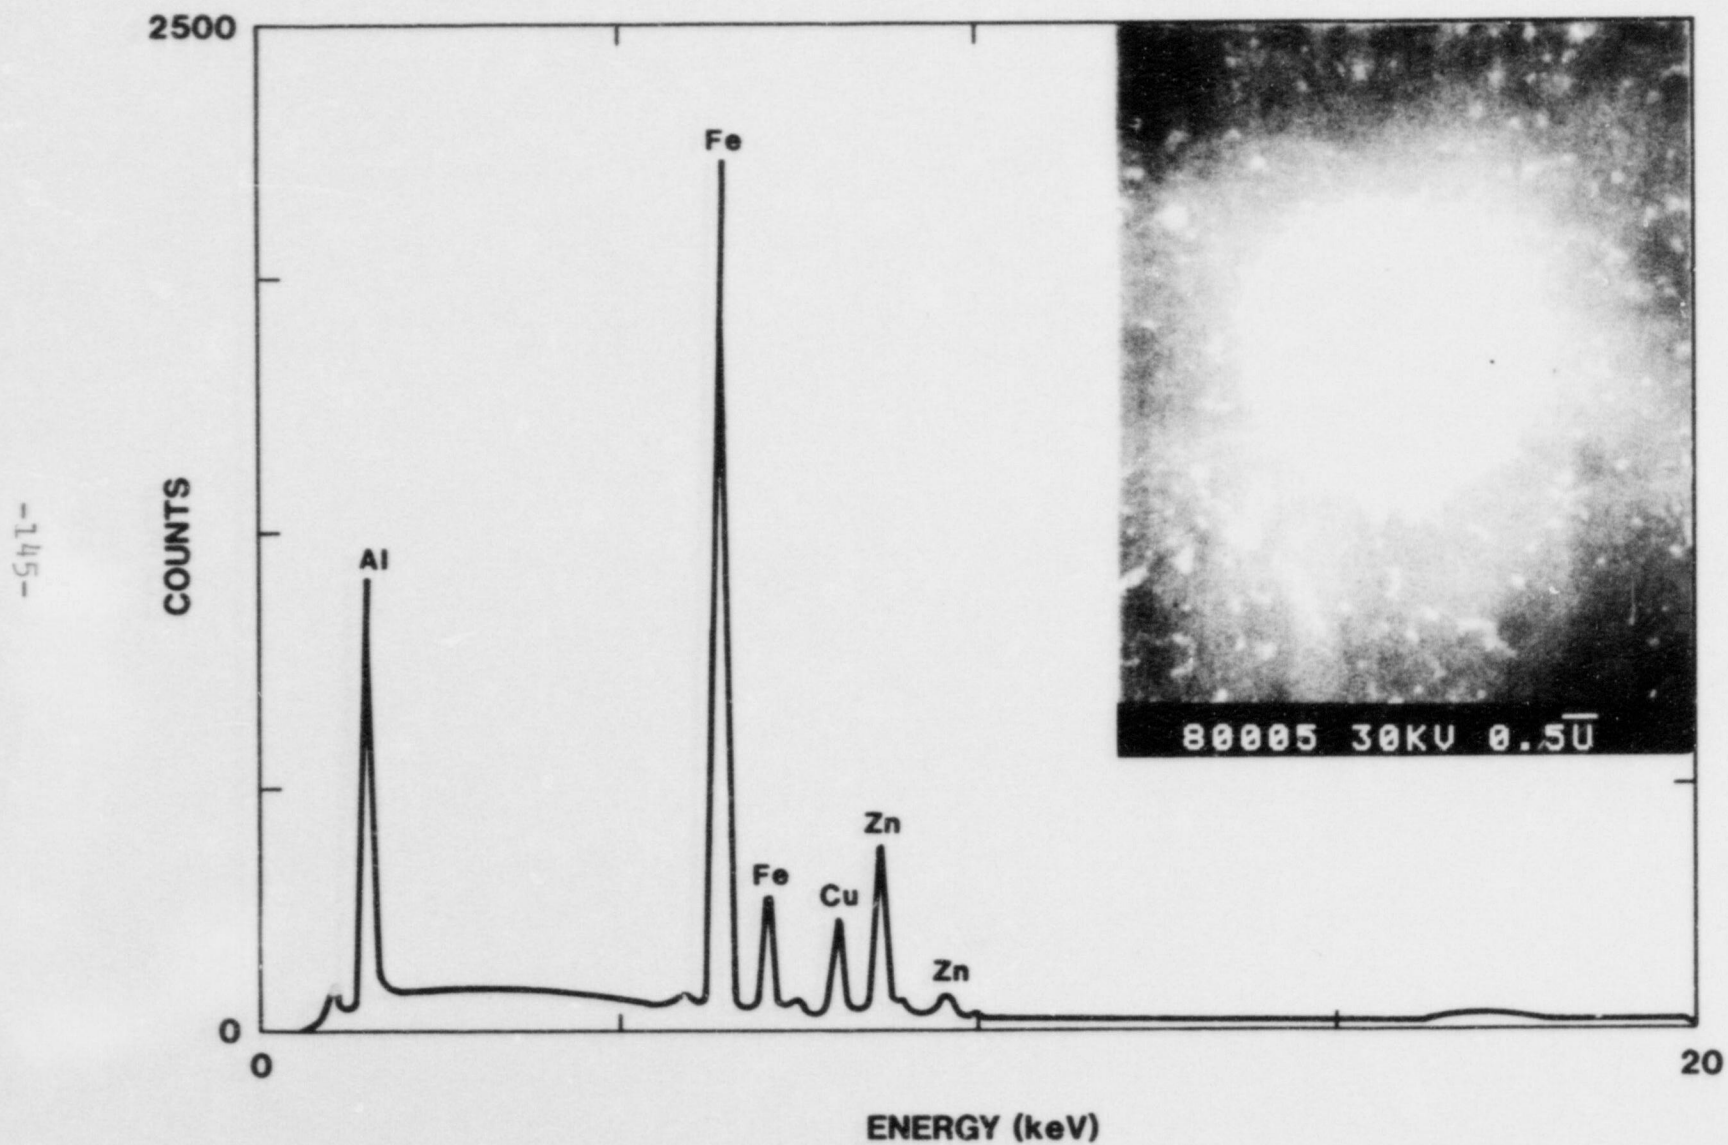
FIGURE 73. ENERGY DISPERSIVE SPECTROSCOPY RESULTS FOR A IRON- AND ALUMINUM-BEARING SUPERMICROMETER PARTICLE
