NUREG/CR-4512  
SAND86-0153  
R3/R4,R7  
Printed October 1986

## Pressurized Melt Ejection Into Scaled Reactor Cavities

PRESSURIZED MELT EJECTION INTO  
SCALED REACTOR CAVITIES

This report describes four tests performed in the High-Pressure Melt Streaming Program (HIPS) using linear-scaled cavities of the Zion Nuclear Power Plant. These experiments were conducted to study the phenomena involved in high-pressure ejection of core debris into the cavity beneath the reactor pressure vessel. One-tenth and one-twentieth linear scale models of reactor cavities were constructed and instrumented. The first test used an apparatus constructed of alumina firebrick to minimize the potential interaction between the ejected melt and cavity material. The remaining three experiments used scaled representations of the Zion nuclear plant geometry, constructed of prototypic concrete composition.

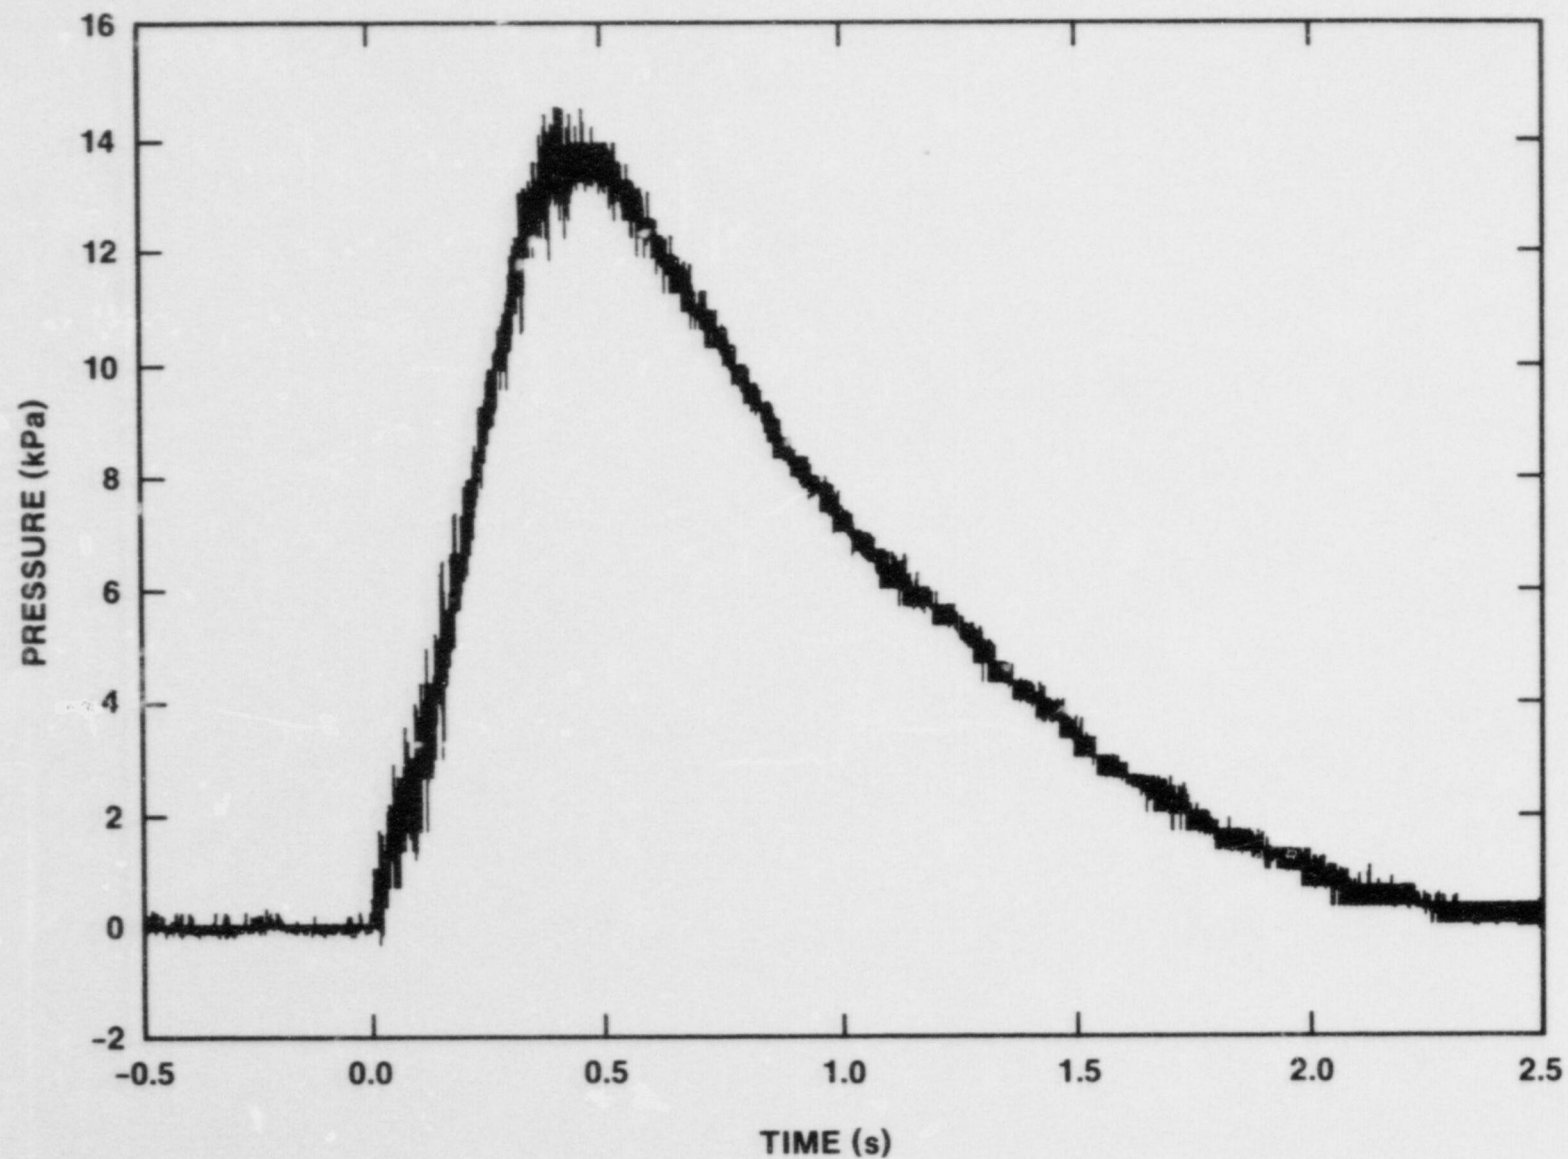
The chamber pressure history recorded by the gauge on the rear wall of the interaction chamber is shown in Figure 74. The peak pressure recorded was 13.9 kPa, occurring approximately 300 to 400 milliseconds after the start of melt dispersal. The

FIGURE 74. INTERACTION CHAMBER PRESSURE RECORD FROM THE SPIT-18 TEST

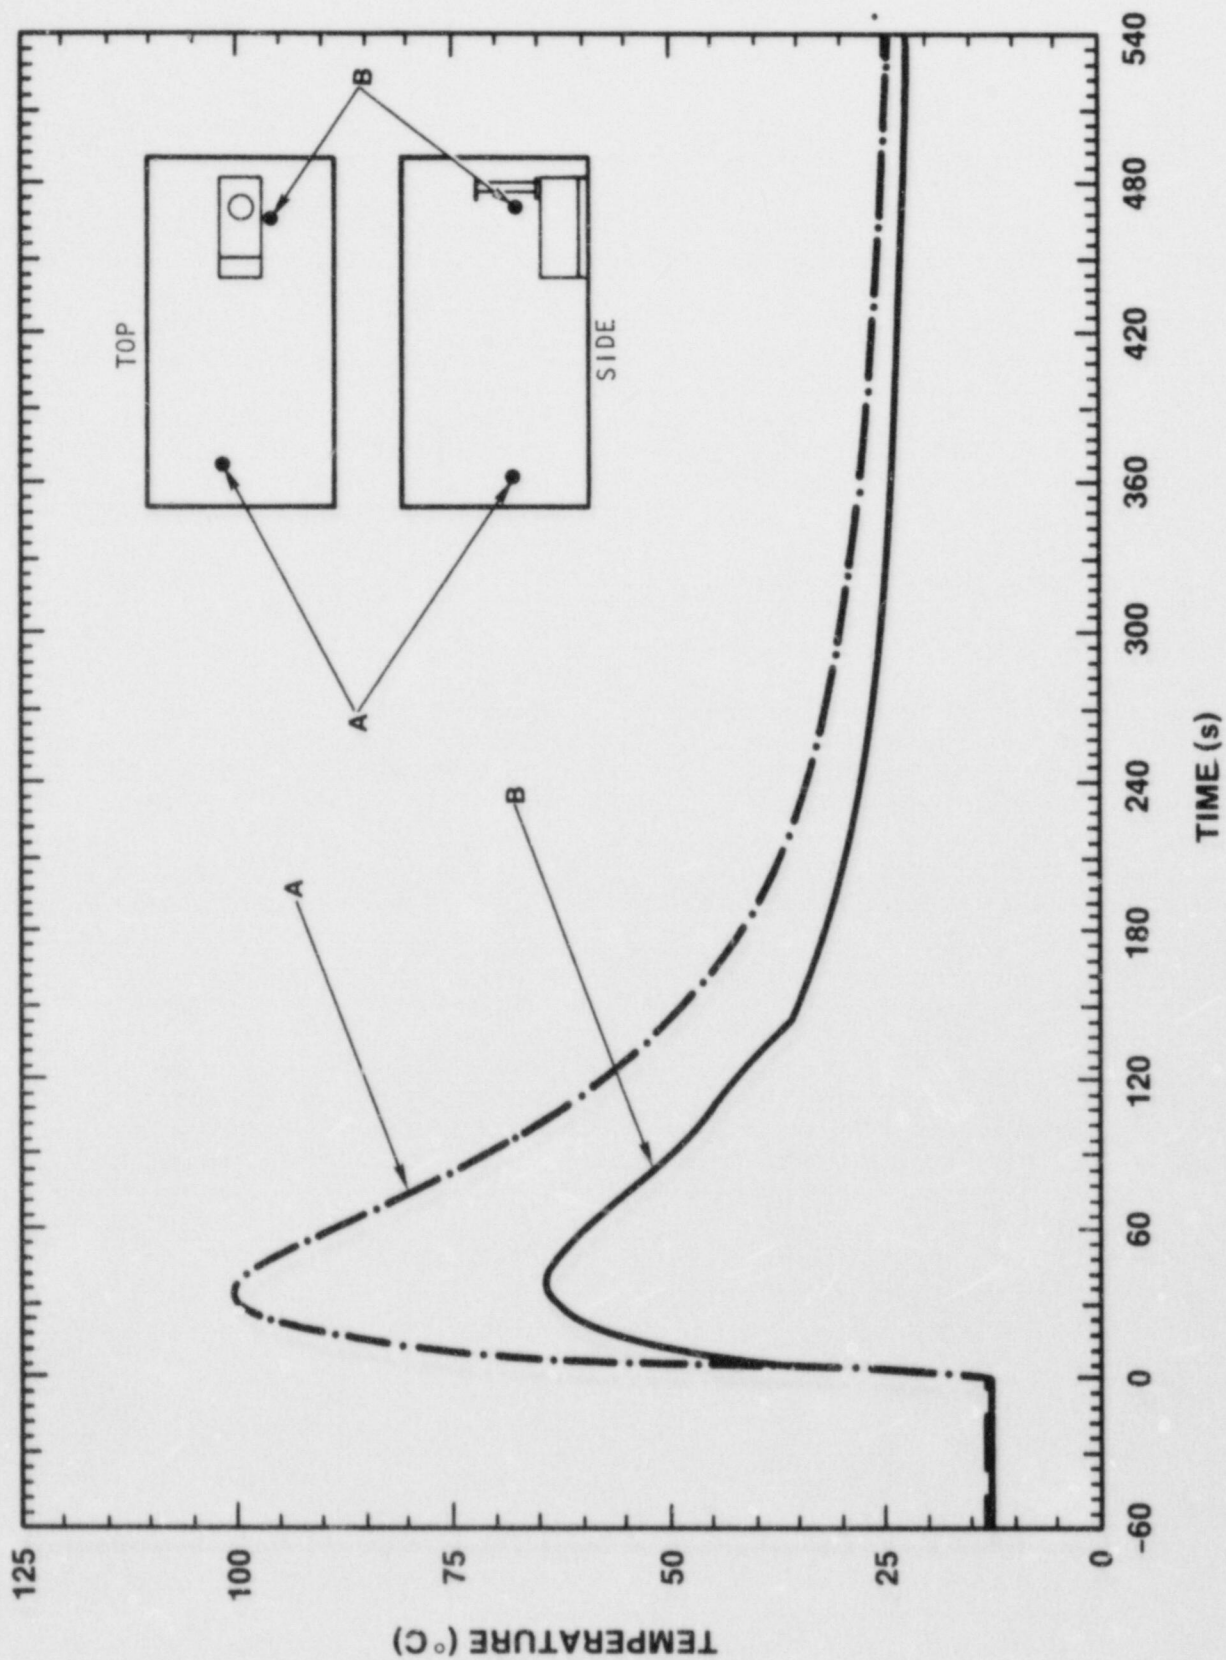
Figure 75 shows the recorded behavior from two thermocouples used to measure the temperature of the chamber atmosphere. As indicated above, the theoretical temperature increase for a three meter propagation distance was 838 K. The peak recorded temperatures were also less than expected based on a pressure rise from direct heating of 4.9 to 11.4 kPa. The relatively low measured temperatures suggested that the sensors were not capable of accurately monitoring the fast-rising temperature transient. In addition, the peak recorded temperature of all the thermocouple devices occurred approximately 50 seconds following ejection, well after the chamber pressure had returned to atmospheric level. The recorded rise times of the temperature histories were significantly shorter than specified by the manufacturer, indicating that the temperature change was very nearly a step change compared to the capability of the measuring device. The late time response was attributed to heating of the sensors by debris dispersed on the chamber floor.

FIGURE 75. SPIT-18 INTERACTION CHAMBER ATMOSPHERE THERMOCOUPLE RECORDS

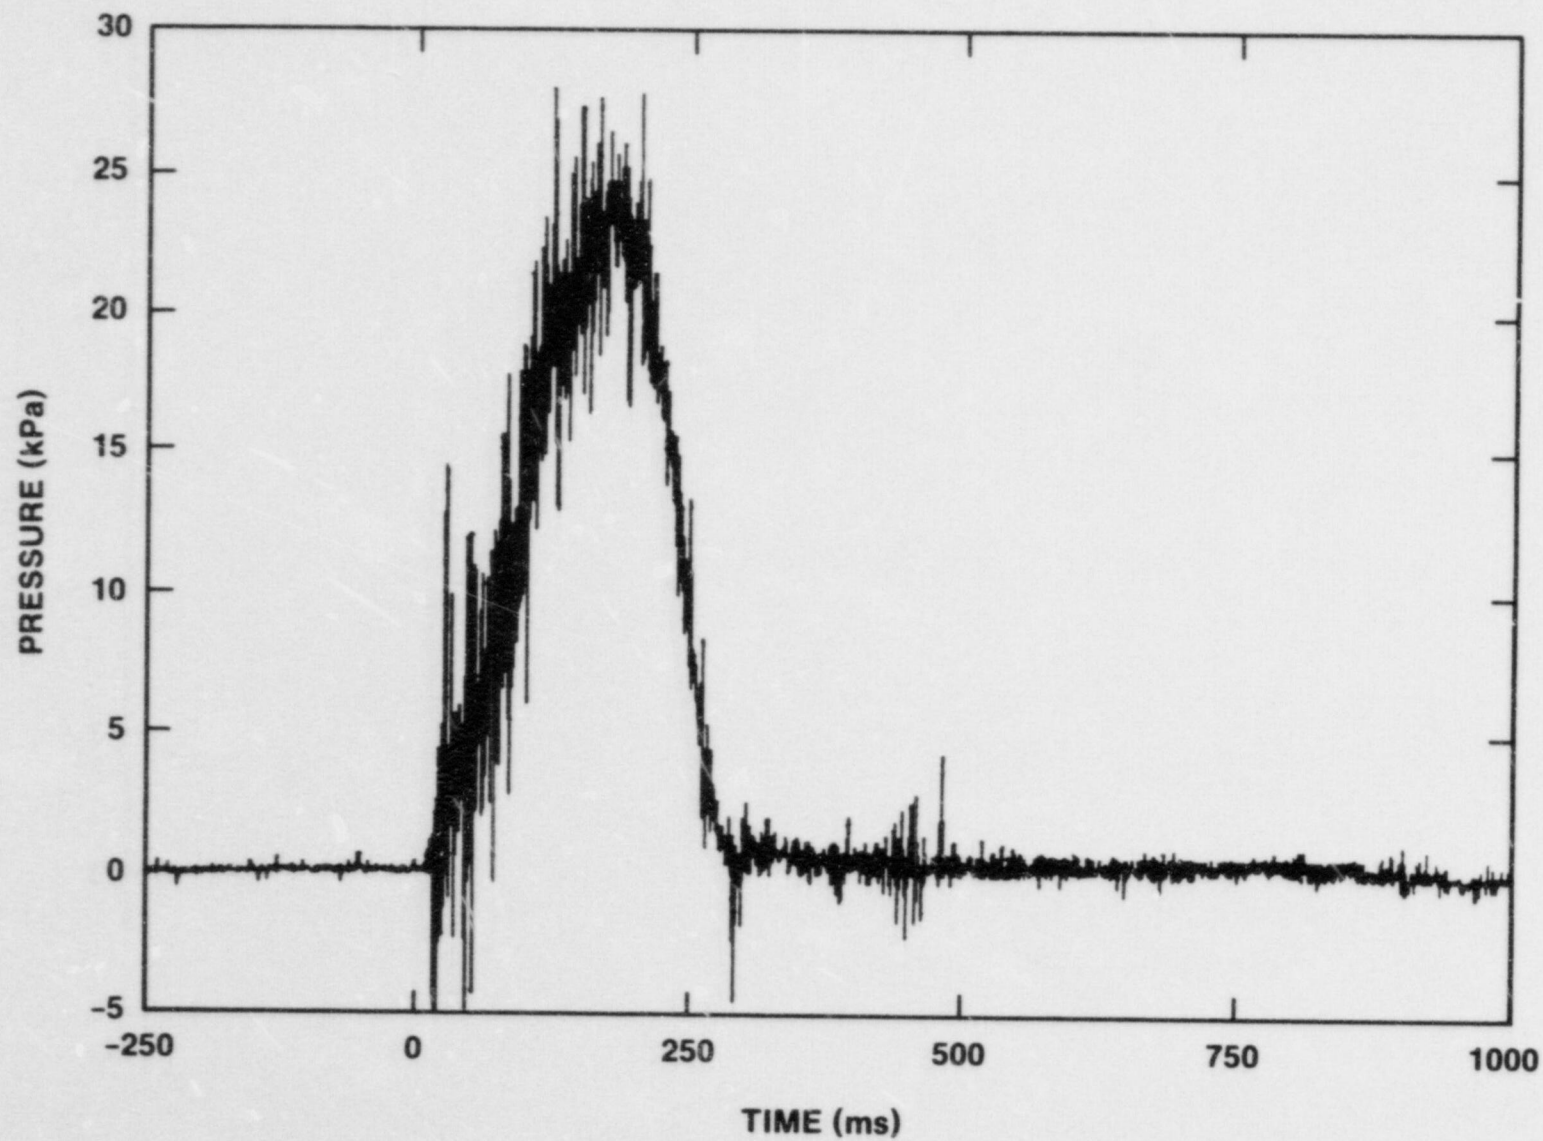
FIGURE 76. SPIT-19 INTERACTION CHAMBER PRESSURE RECORD - WEST WALL

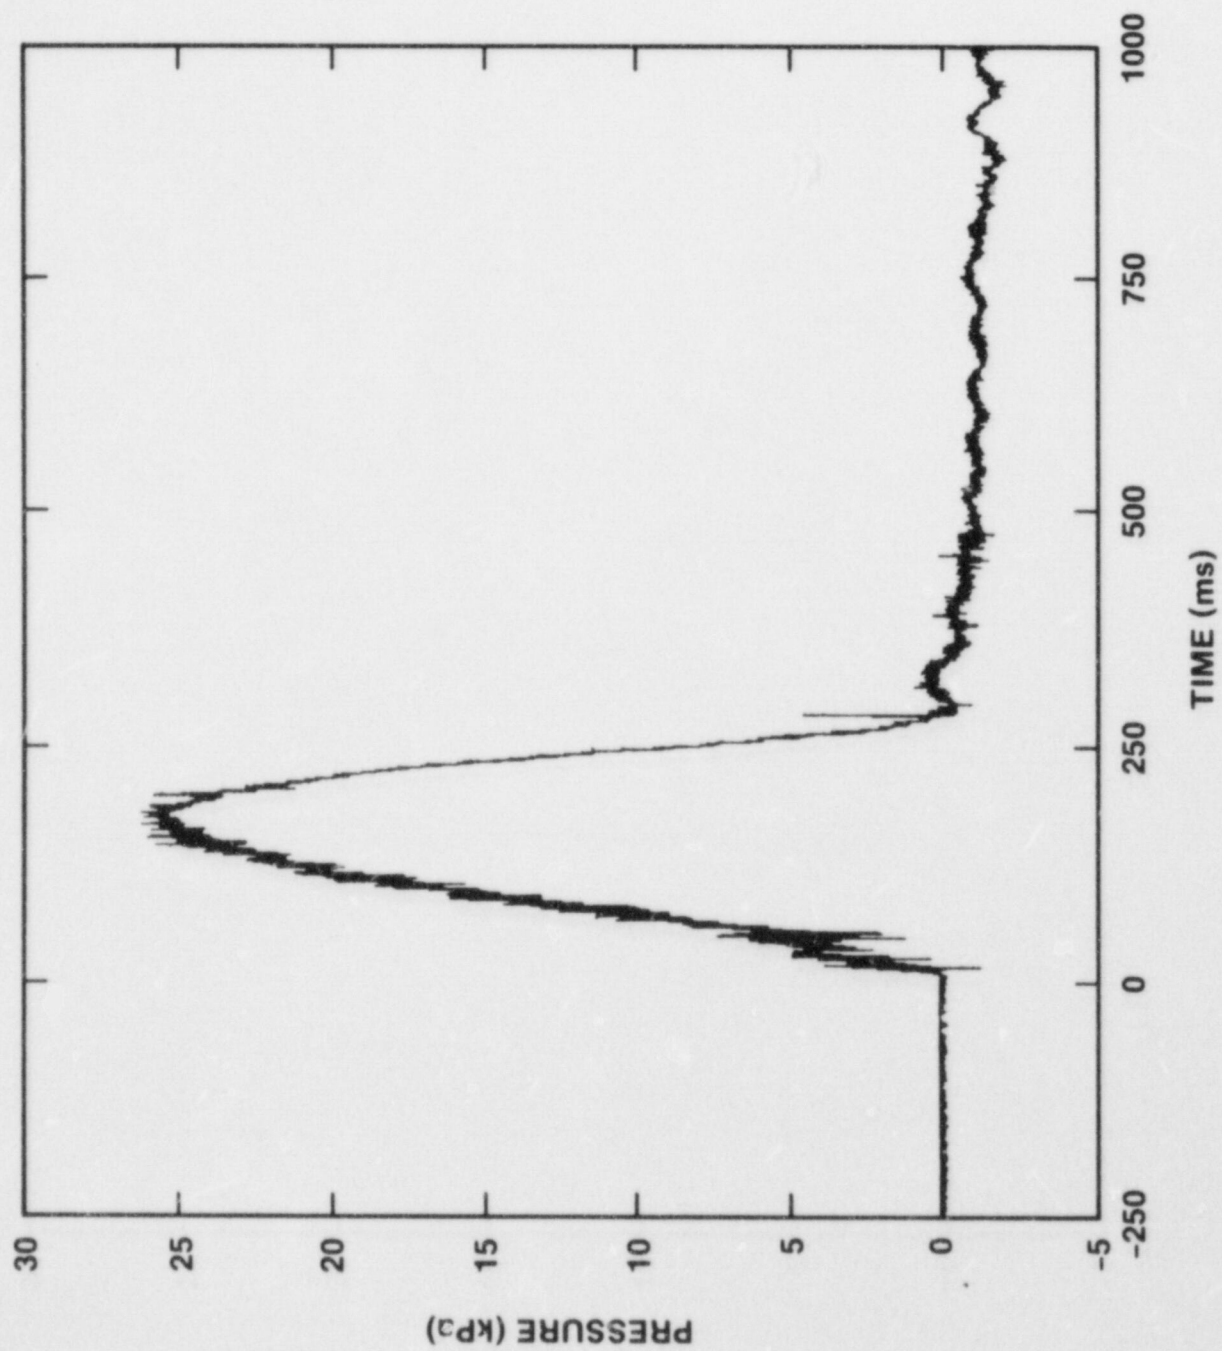
FIGURE 77. SPIT-19 IC PRESSURE RECORD - INSERTED INTO CHAMBER

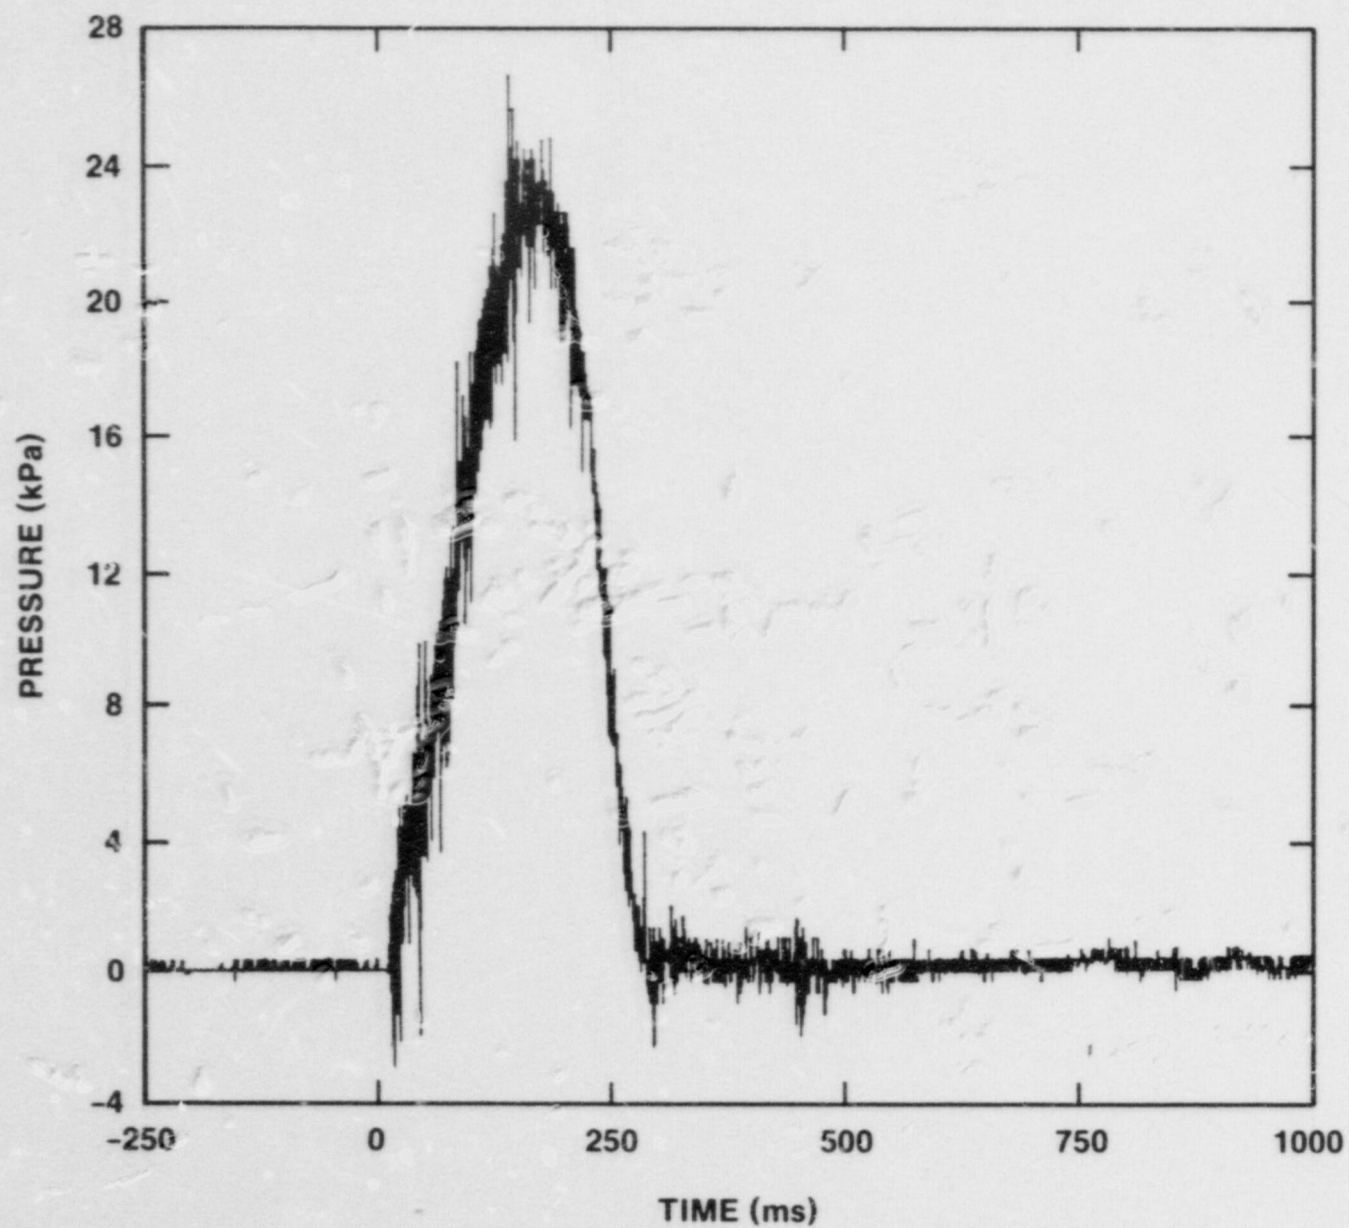
FIGURE 78. SPIT-19 IC PRESSURE RECORD - NORTH WALL

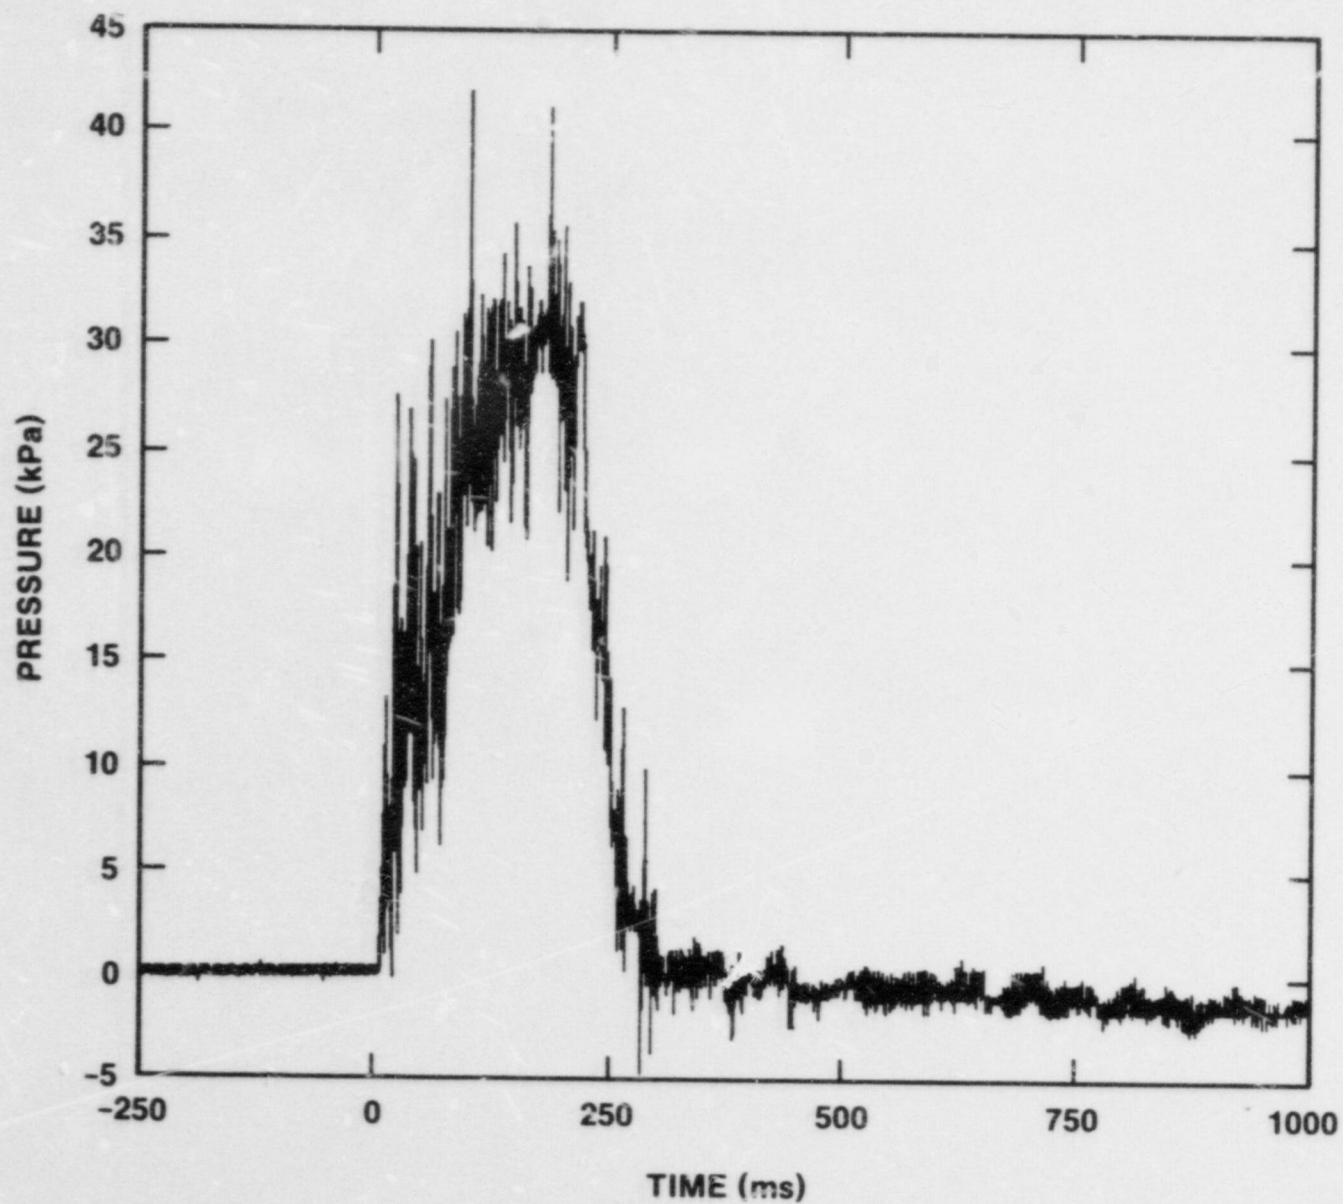
FIGURE 79. SPIT-19 IC PRESSURE RECORD - CEILING

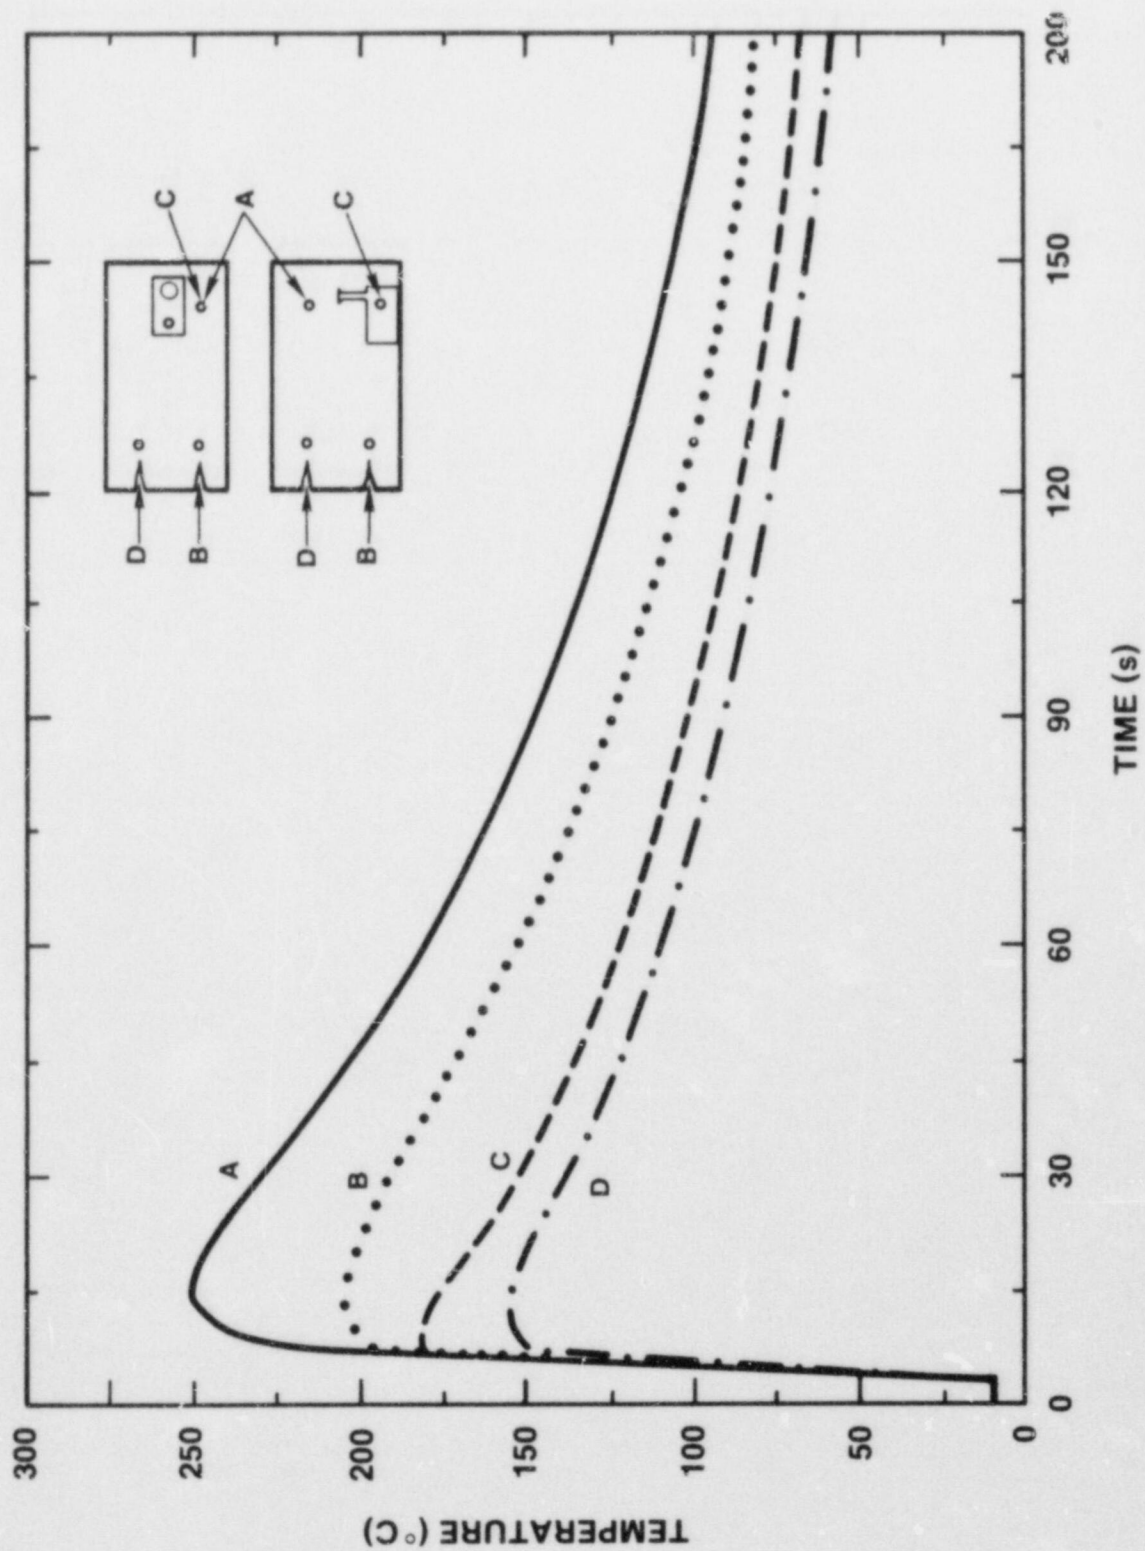
FIGURE 80. SPIT-19 IC ATMOSPHERE TEMPERATURE HISTORY
