EVALUATION OF  
PROPOSED TAILINGS DEPOSITION  
SOUTH CELL  
UNITED NUCLEAR CORPORATION  
CHURCH ROCK URANIUM MILL

Raney Geotechnical Job No. 053-003

EVALUATION OF  
PROPOSED TAILINGS DEPOSITION  
SOUTH CELL  
United Nuclear Corporation  
Church Rock Uranium Mill

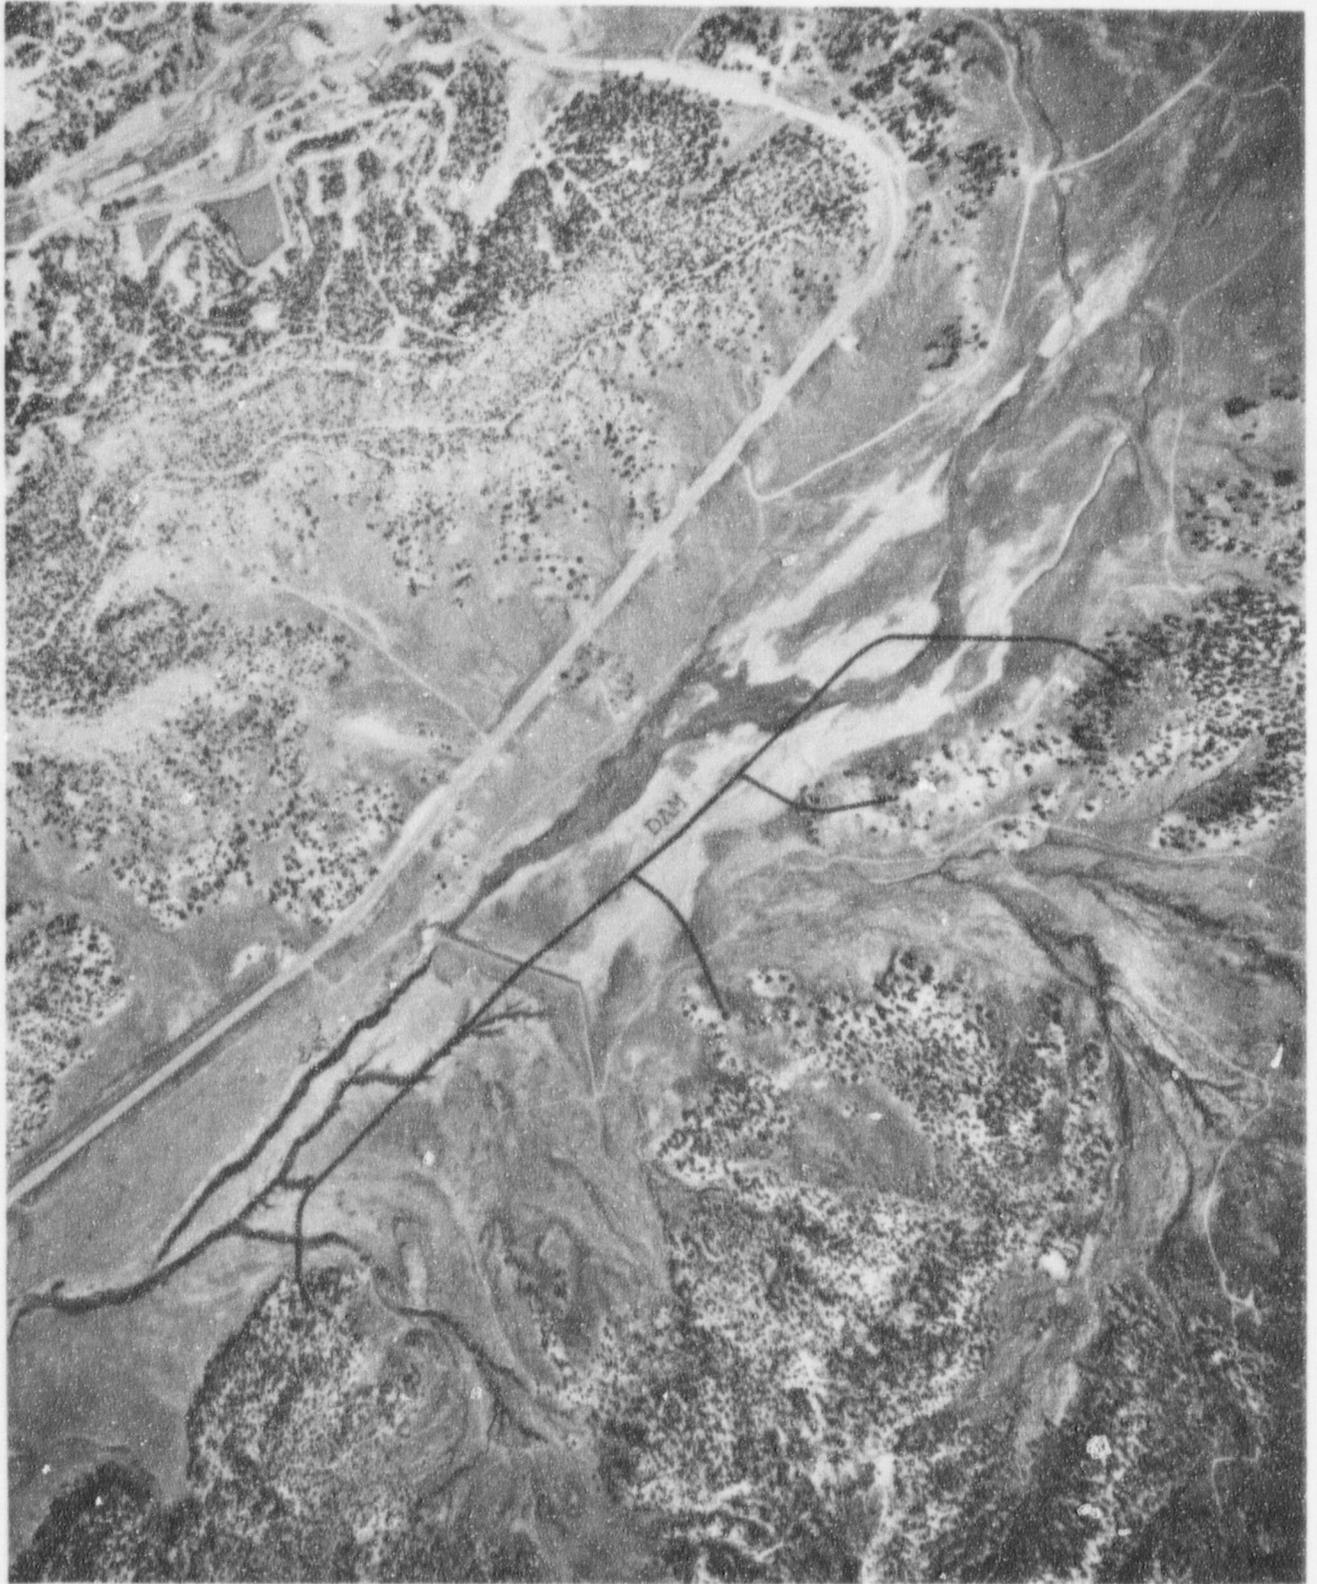
**EMBANKMENT FOUNDATION  
 MAY 1974**

REFERENCE: AERIAL PHOTOGRAPHY  
 DATED 5/5/74 BY  
 BOHANNAN-HUSTON.

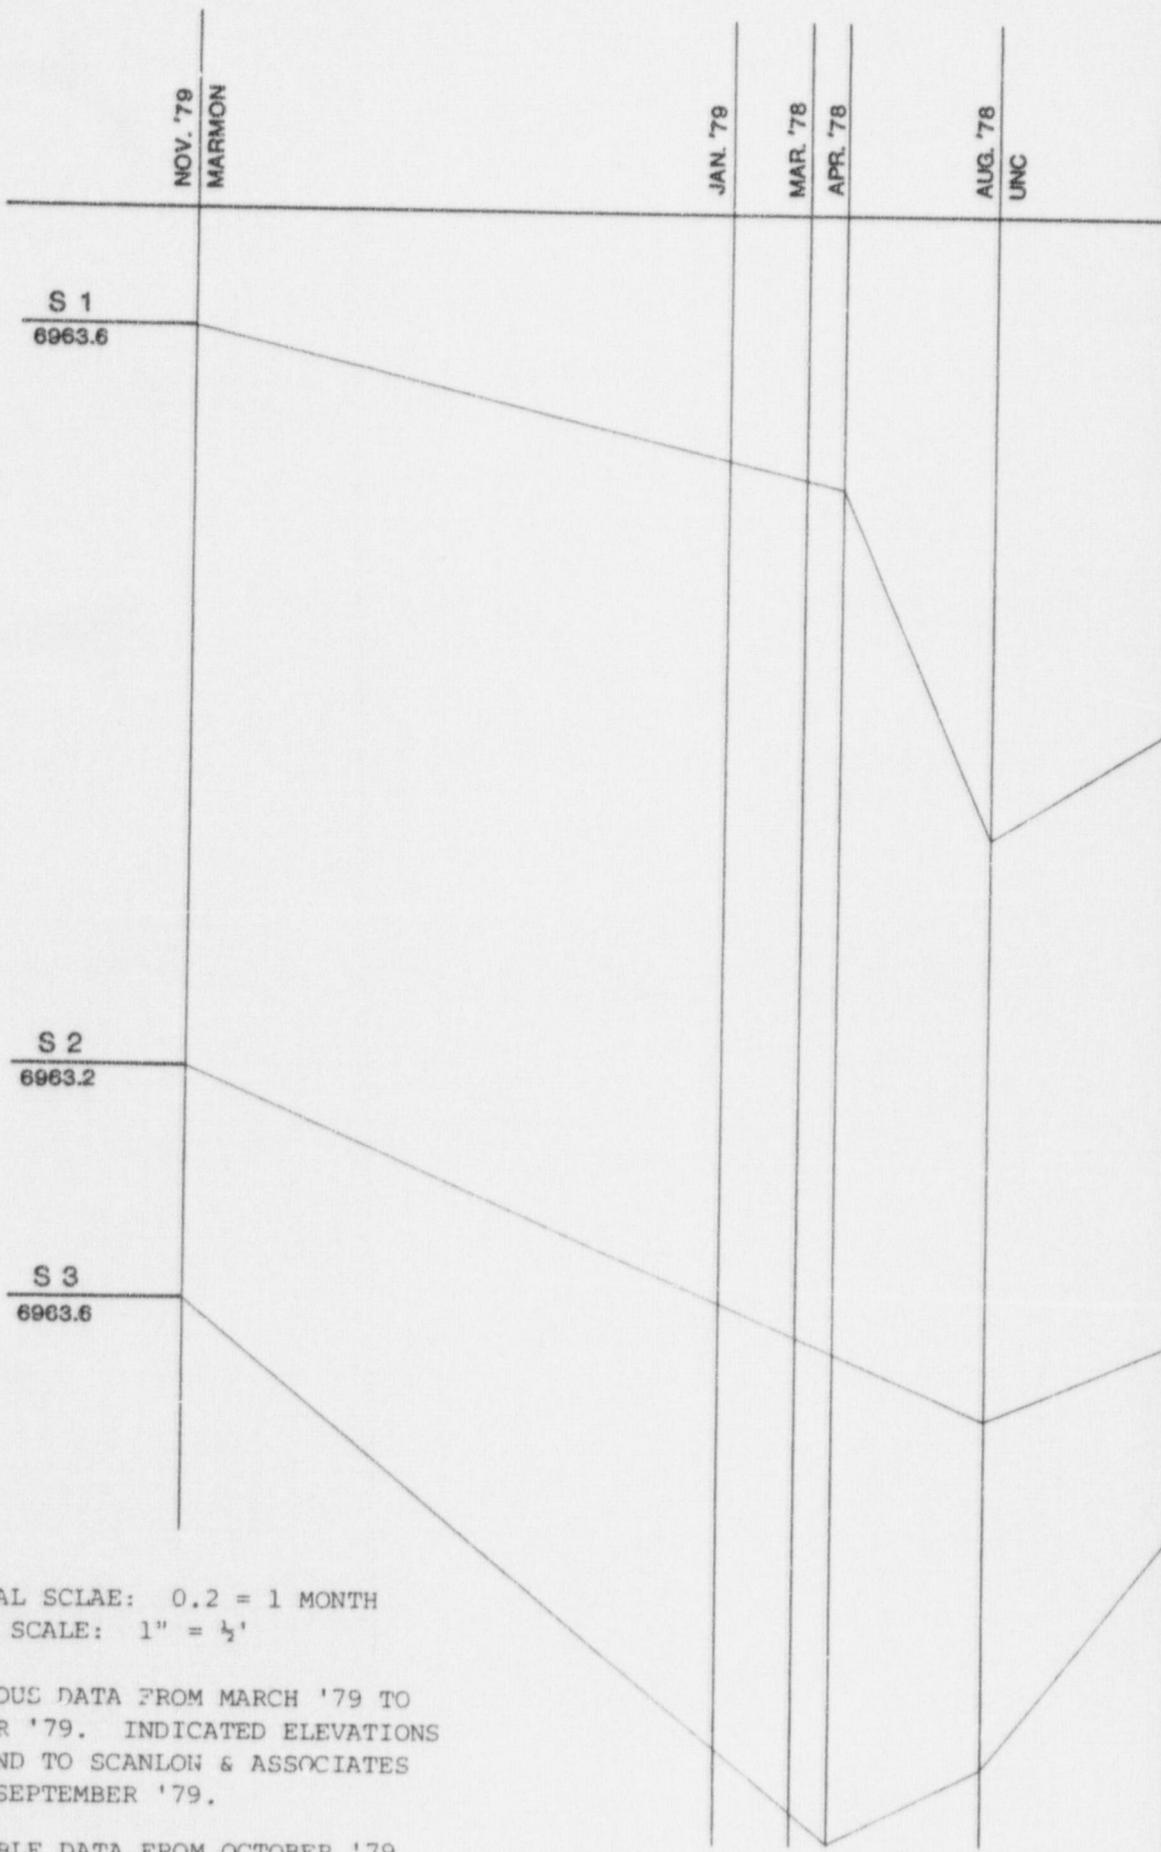
Settlement data presented on Plates 6A through 6E appear to validate laboratory test data. The effects of arroyo crossings (elimination of near-surface settlement-sensitive soils), and the effects of higher surcharge (adjacency of the breach repair and raised central cell) are clearly demonstrated.

- HORIZONTAL SCALE: 0.2 = 1 MONTH  
VERTICAL SCALE: 1" = 1/2'
- INCONGRUOUS DATA FROM MARCH '79 TO SEPTEMBER '79. INDICATED ELEVATIONS CORRESPOND TO SCANLON & ASSOCIATES SURVEY, SEPTEMBER '79.
- UNAVAILABLE DATA FROM OCTOBER '79 TO DECEMBER '79, MONUMENTS S1, S2, AND S3.
