TO: Jere Millard  
THRU: Jerry Stewart  
FROM: Sam Simpson *[Signature]*  
DATE: September 10, 1982  
SUBJECT: Request for Sample Analysis, Mariano Lake Site

- 
1. Gulf's project at Mariano Lake is currently being terminated, decommissioning, decontamination, and final clean-up activities are underway. Sample's taken on 8/25/82 by Ted Brough, Bob Barbero and Brian O'Connor in joint effort.
  2. Require Radium 226 analysis of two composite soil samples to assist in determination of background radiation levels at the project site.
  3. The smaller sample is sludge material removed from the west lagoon, require analysis of Ra-226 in this material. This information needed to support decision making on appropriate clean-up approach.
  4. Analysis of these soil samples for Ra-226 is essential before termination of Gulf's Radioactive Material License can be effected.

Photos taken by Sam Thompson EID Radiation Protection Bureau

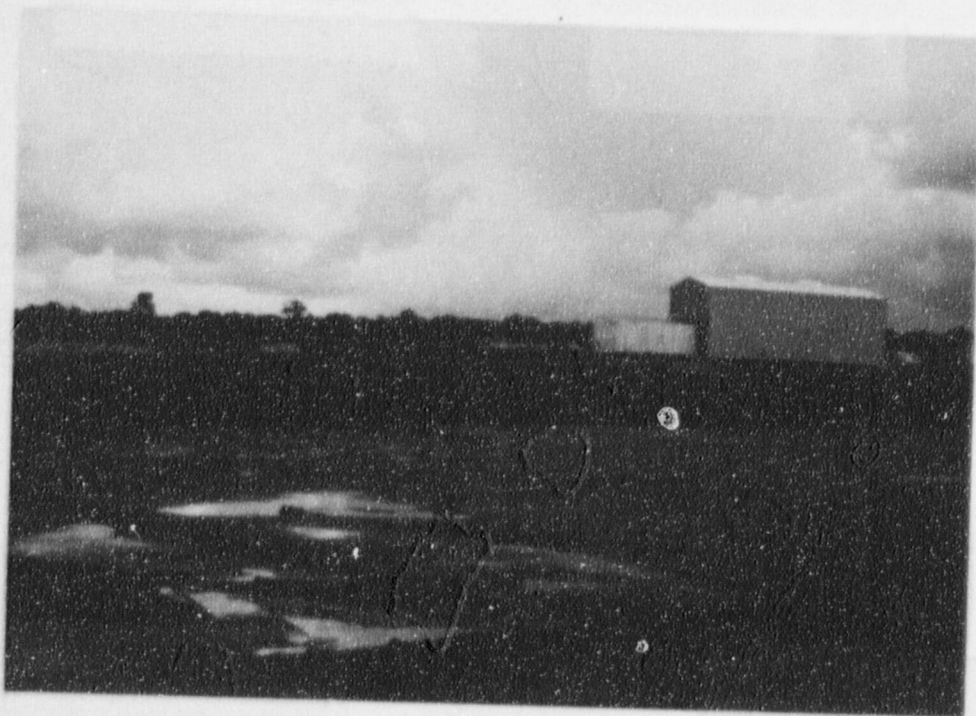
DATE 25 Aug 82 TIME \_\_\_\_\_LOCATION Marathon Lake  
Gulf Project

West pond drained -  
liner & sediment in  
place - 1X & Barium  
Chloride Treatment facilities  
in foreground.

Photo taken after heavy rainfall.  
note collection of water on north  
side of lagoon, rain run-off

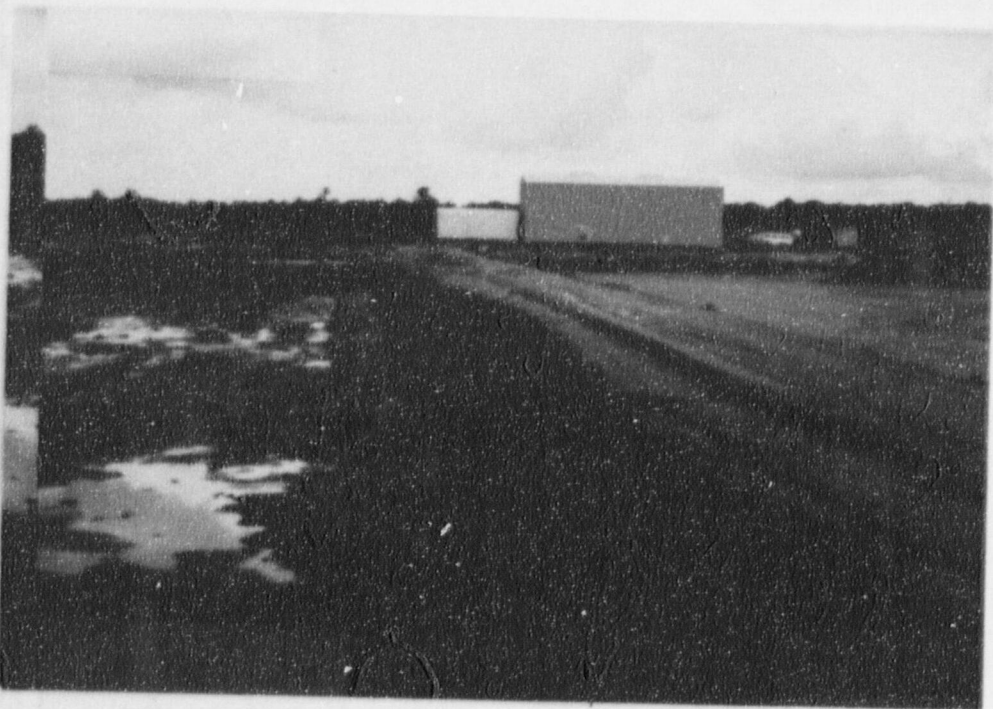
DATE 25 Aug 82 TIME \_\_\_\_\_LOCATION Marathon Lake Gulf  
1X Facility

East section of West  
lagoon & right side  
of photo is west sector  
of center lagoon.

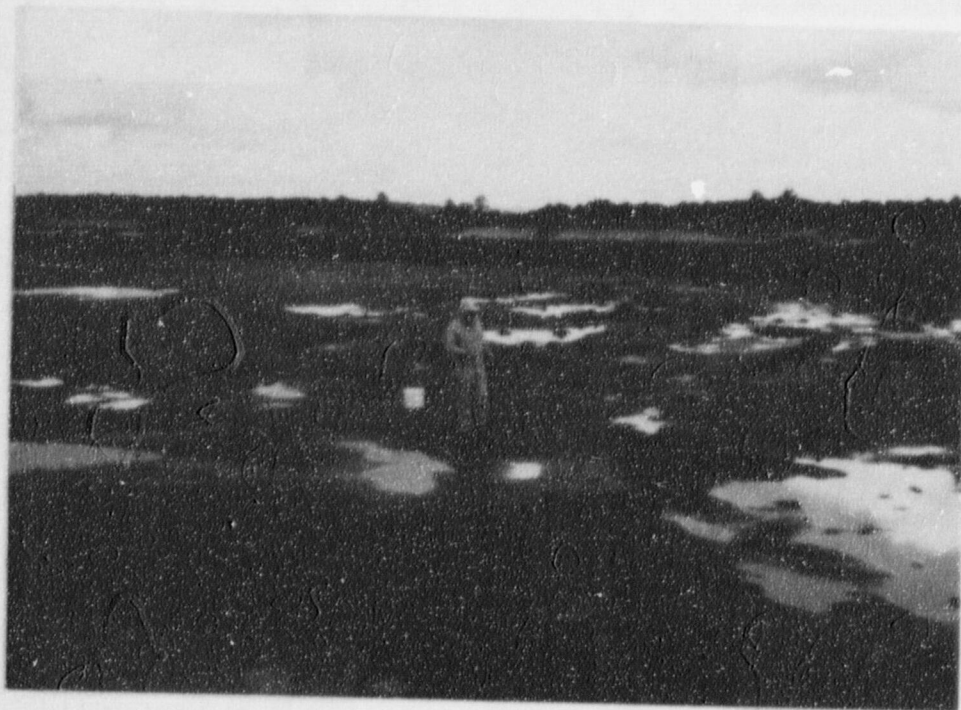
DATE 28 Aug 82 TIME \_\_\_\_\_LOCATION Guy Mariano  
Lake 1X Lagoon

Photo of West lagoon,  
previously drained -  
water puddles caused  
by recent heavy rain  
storm.

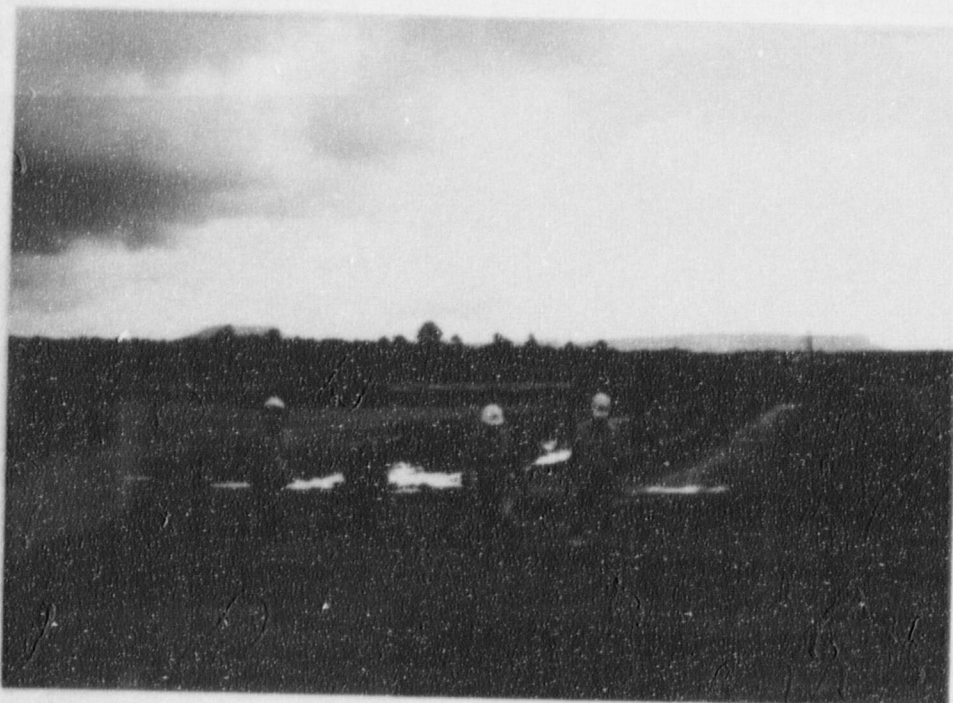
DATE 28 Aug 82 TIME \_\_\_\_\_LOCATION Guy Mariano  
Lake Lagoon

Center lagoon,  
sediment previously  
removed & processed at  
Kerr McGee Inc. w. th  
ore

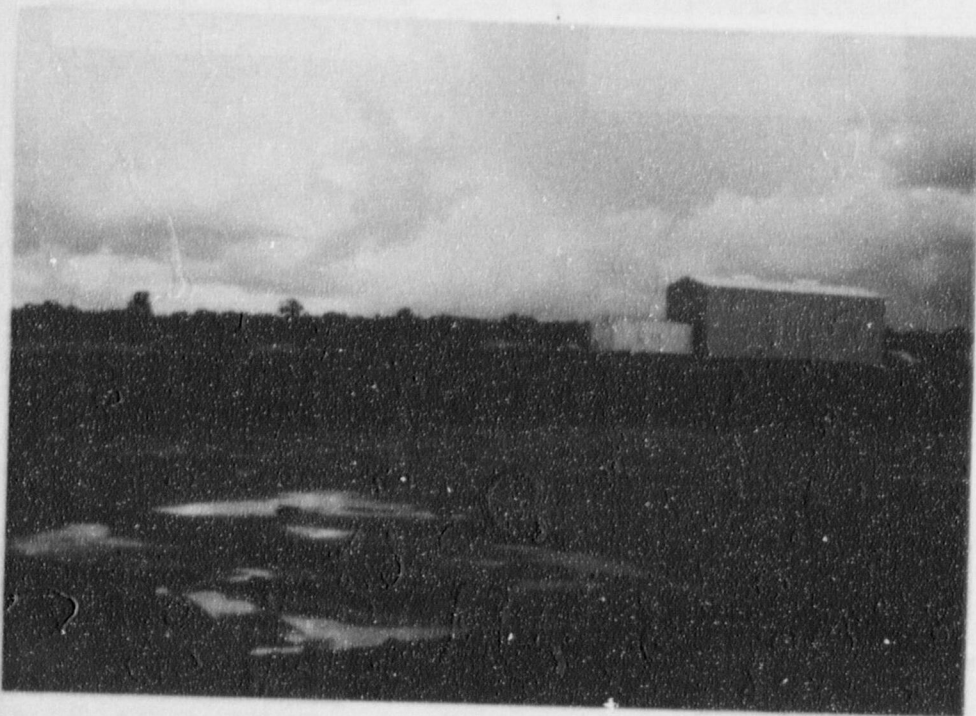
DATE 25 Aug 82 TIME \_\_\_\_\_LOCATION Manzano Lake  
Guef Project

West pond drained -  
liner & sediment in  
place - 1X & Barium  
Chloride Treatment facilities  
in foreground.

Photo taken after heavy rainfall.  
note collection of water on north  
side of lagoon, rain run-off

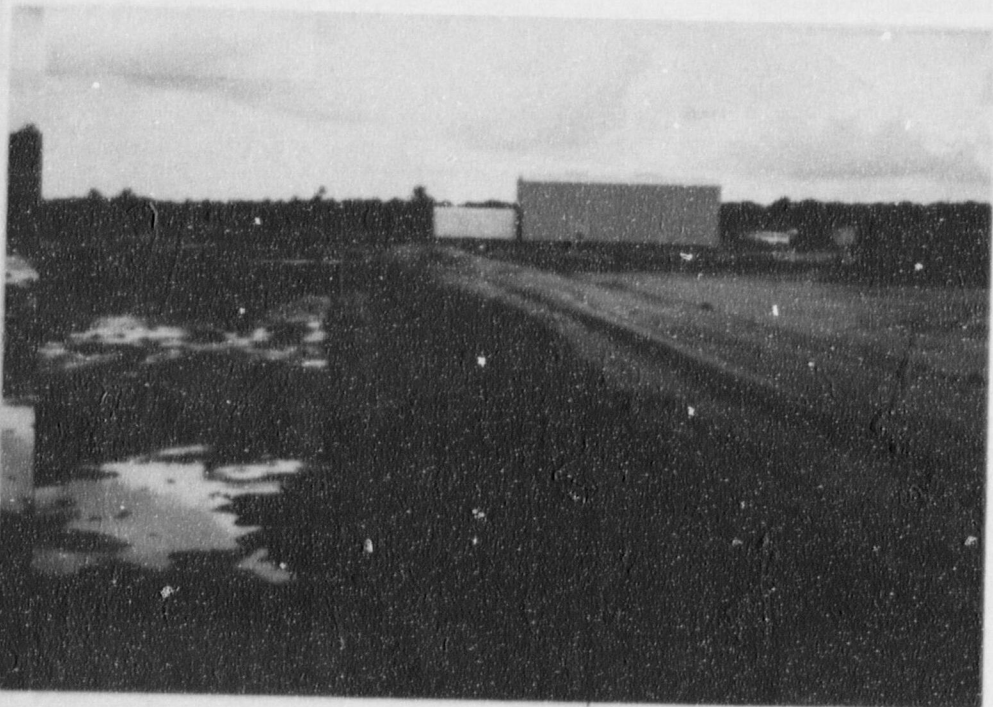
DATE 25 Aug 82 TIME \_\_\_\_\_LOCATION Manzano Lake Gulf  
1X Facility

East section of West  
lagoon & right side  
of photo is west section  
of center lagoon.

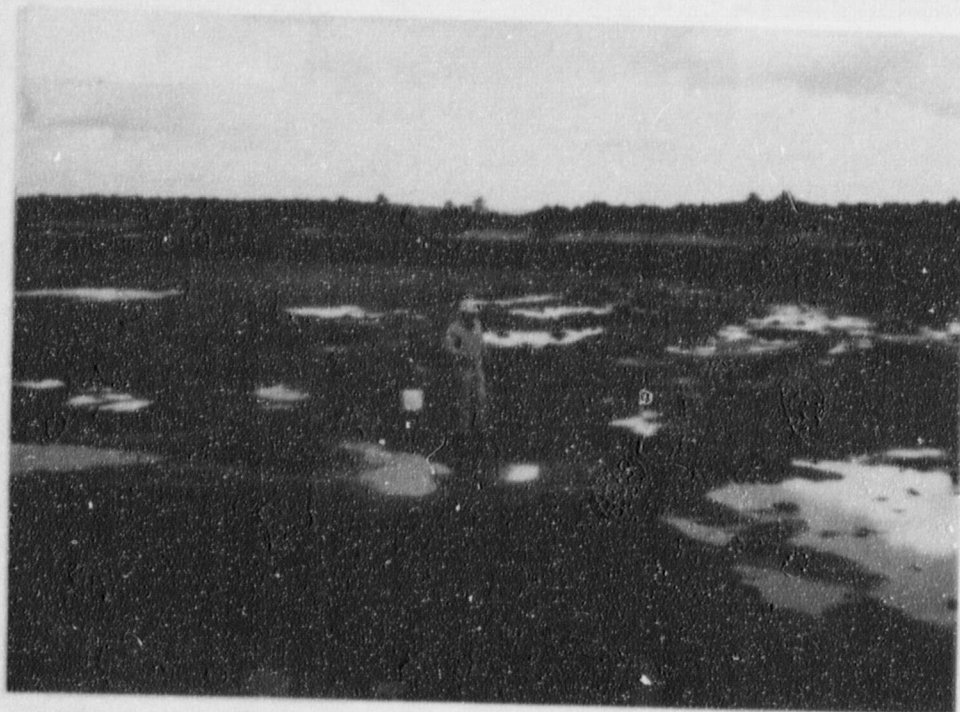
DATE 2 Aug 82 TIME \_\_\_\_\_LOCATION July Mesa  
Lake 1x Lagoon

Photo of West lagoon,  
previously drained -  
water puddles caused  
by recent heavy rain  
storm.

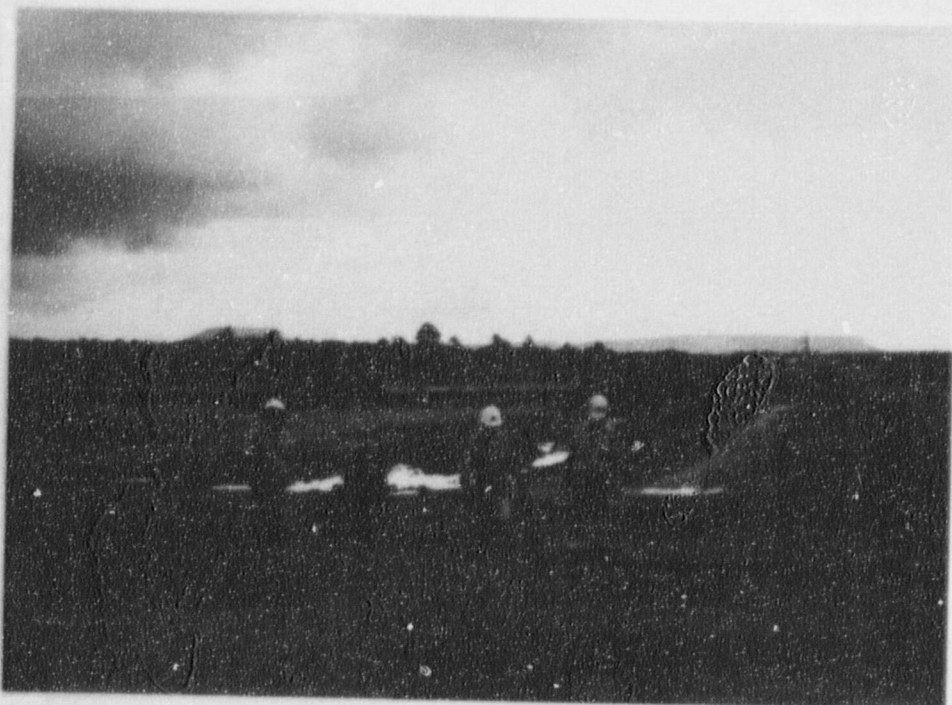
DATE 25 Aug 82 TIME \_\_\_\_\_LOCATION July Mesa  
Lake Lagoon

Center lagoon,  
sediment previously  
removed & processed at  
Kerr Mc Lee w. th  
ore

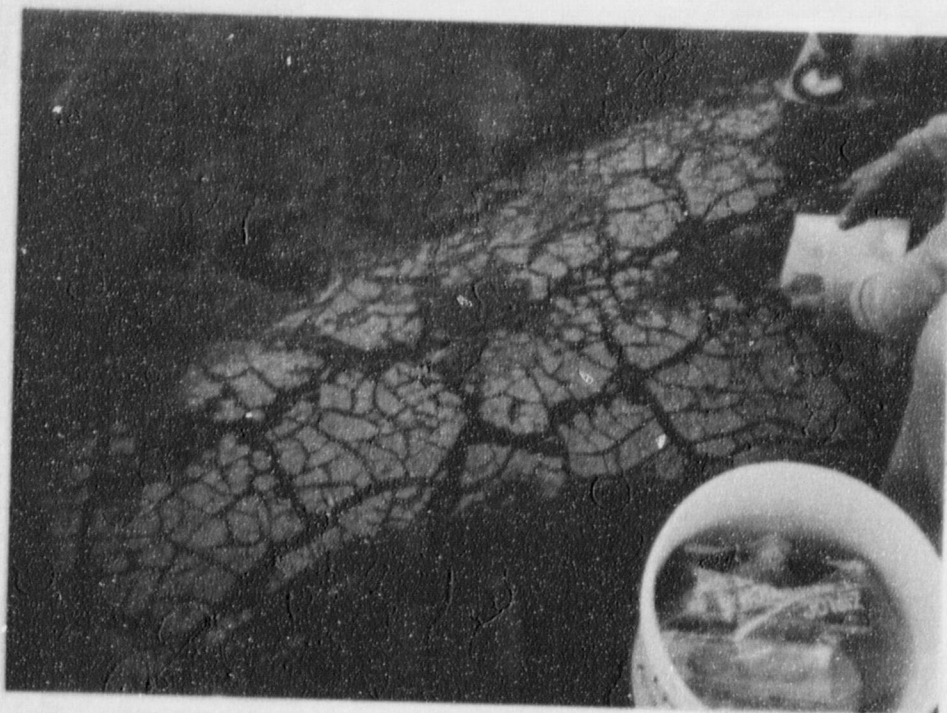
DATE Aug 21, 82 TIME \_\_\_\_\_LOCATION Gulf Marinas  
Lake Project

Mr. Ted Brough taking  
sediment sample  
from West Lagoon  
Depth 7 sediment  
Approx 3/8"

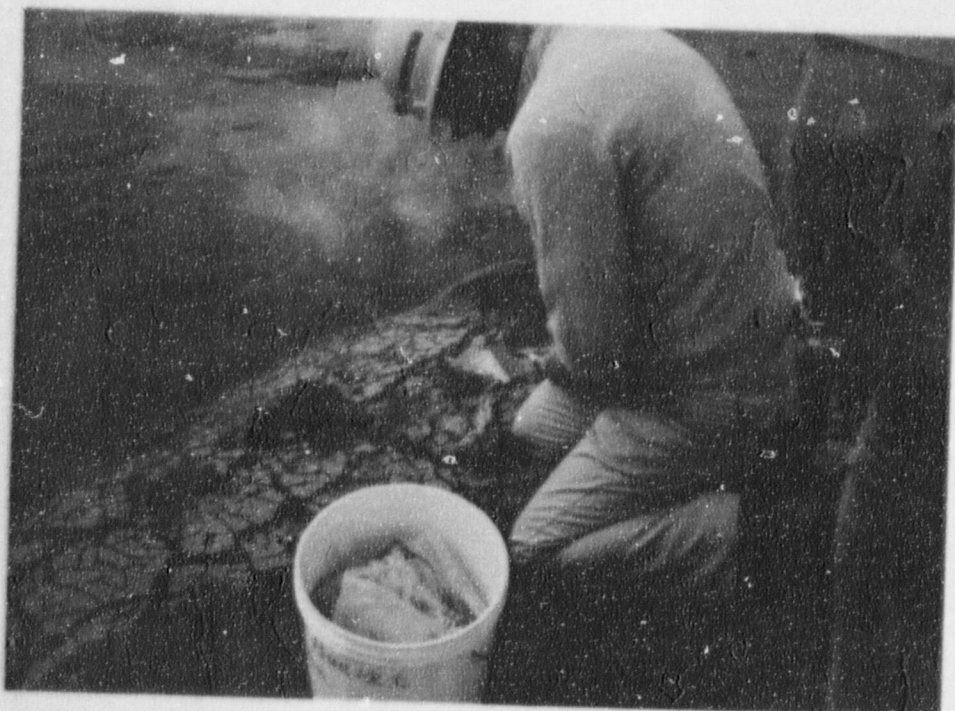
DATE Aug 21, 82 TIME \_\_\_\_\_LOCATION Gulf Marinas  
Lake 18 Project

Mr. Ted Brough taking  
Samples of sediment  
from West Lagoon

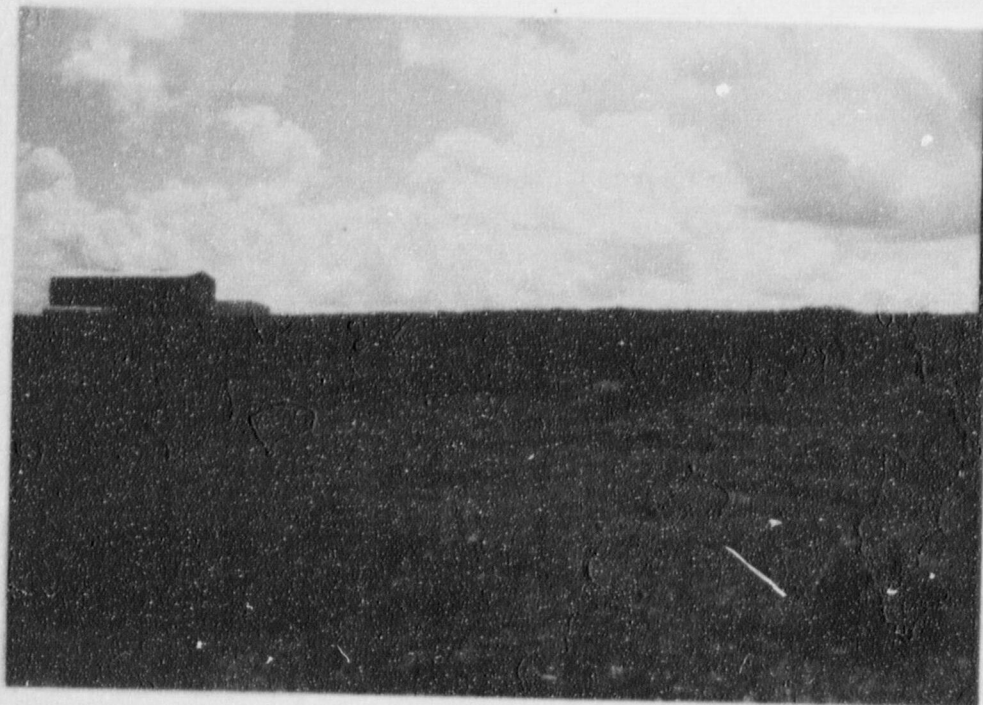
DATE Aug 21, 1982 TIME           LOCATION Guy Mariano  
Lake 1x ProjectDESCRIPTION South Sideof lagoons facing North,  
ridge is <sup>(topsoil)</sup> earth removed  
when lagoons were  
~~excavated~~ excavated.

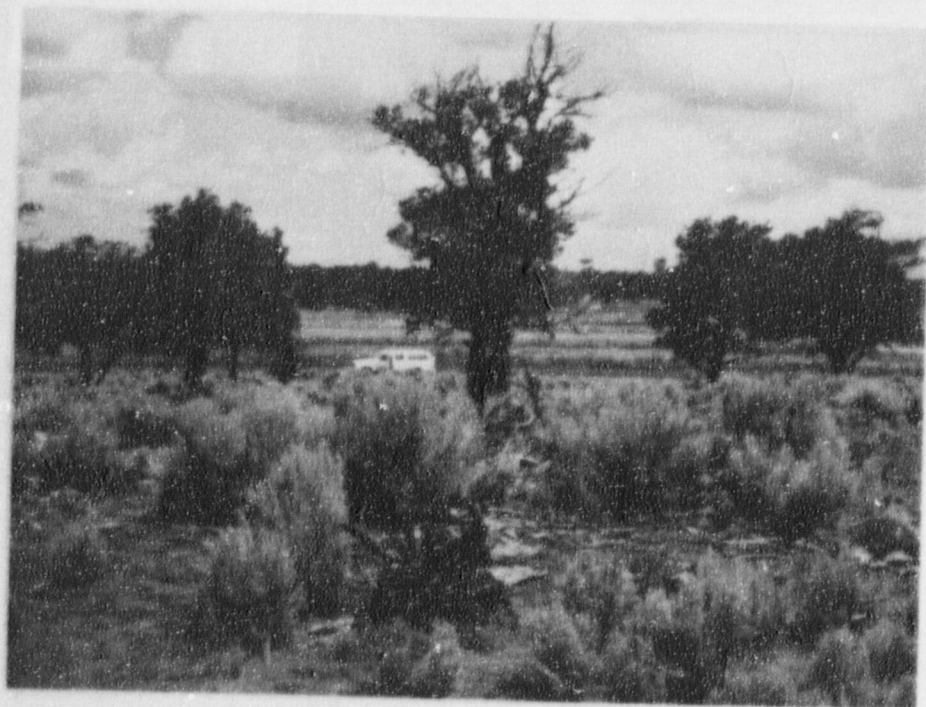
DATE Aug 21, 1982 TIME           LOCATION Guy Mariano  
Lake 1x ProjectDESCRIPTION Approximate300' from truck, packed  
~~and~~ parallel  
to south fence line  
of lagoon complex

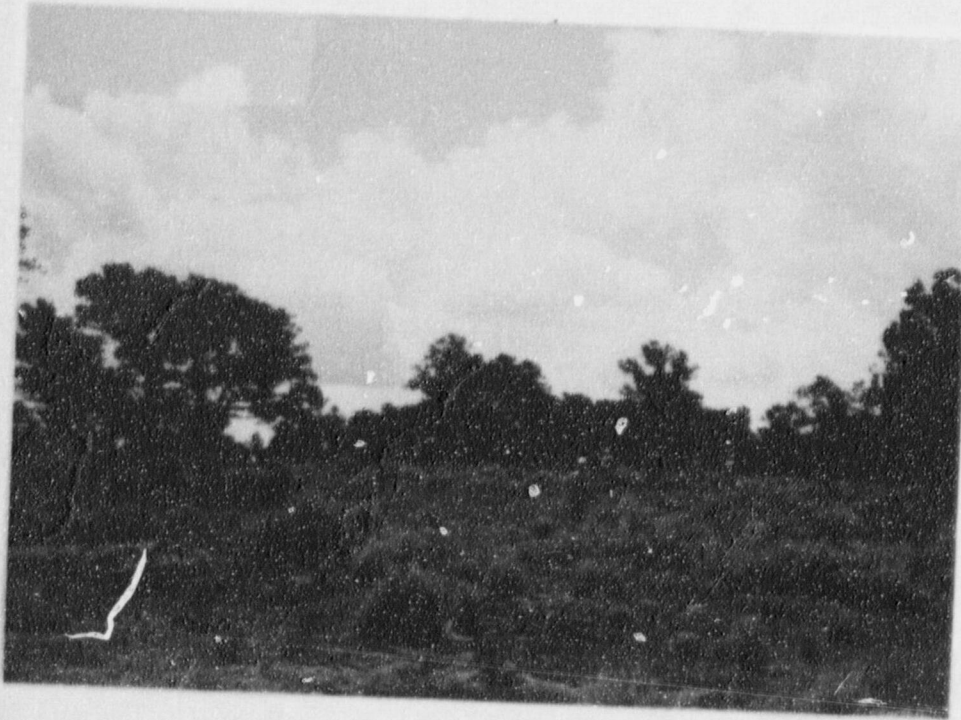
DATE Aug 25, 82 TIME \_\_\_\_\_LOCATION Gulf Marano  
Lake 1X Facility

5 mi. area of 1X  
Complot - Soil samples  
taken at 5 locations -  
300-500' from fence line  
Compacted & sent to  
Everline for analysis  
for Ra-226. Awaiting  
results.

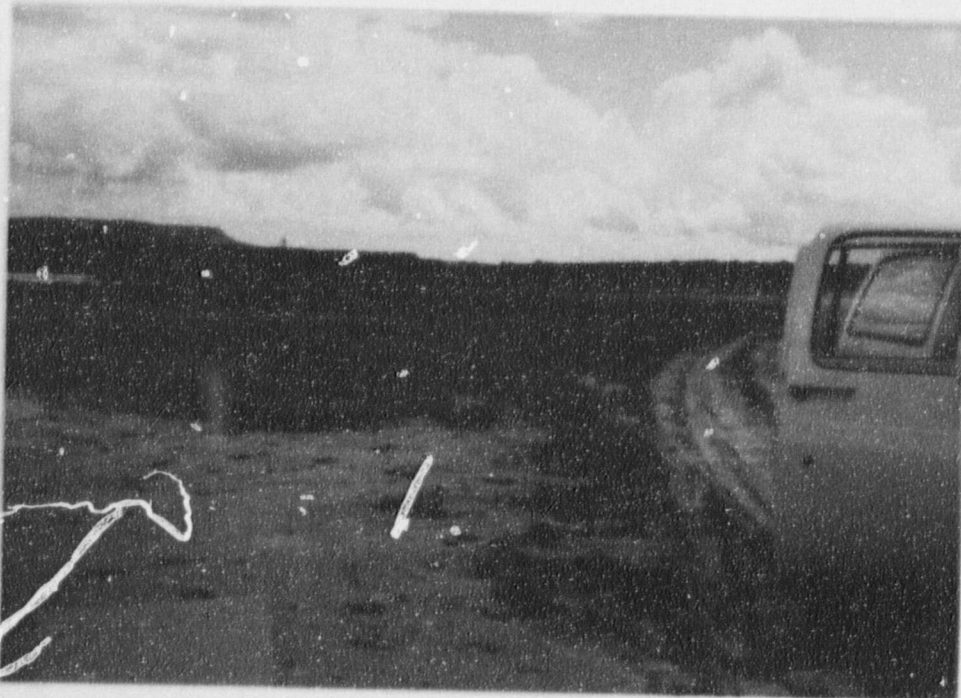
DATE Aug 25, 82 TIME \_\_\_\_\_LOCATION West of Lagoon  
Gulf Marano Lake 1X  
Facility

500' - Gamma  
reading 15 cps/hr.

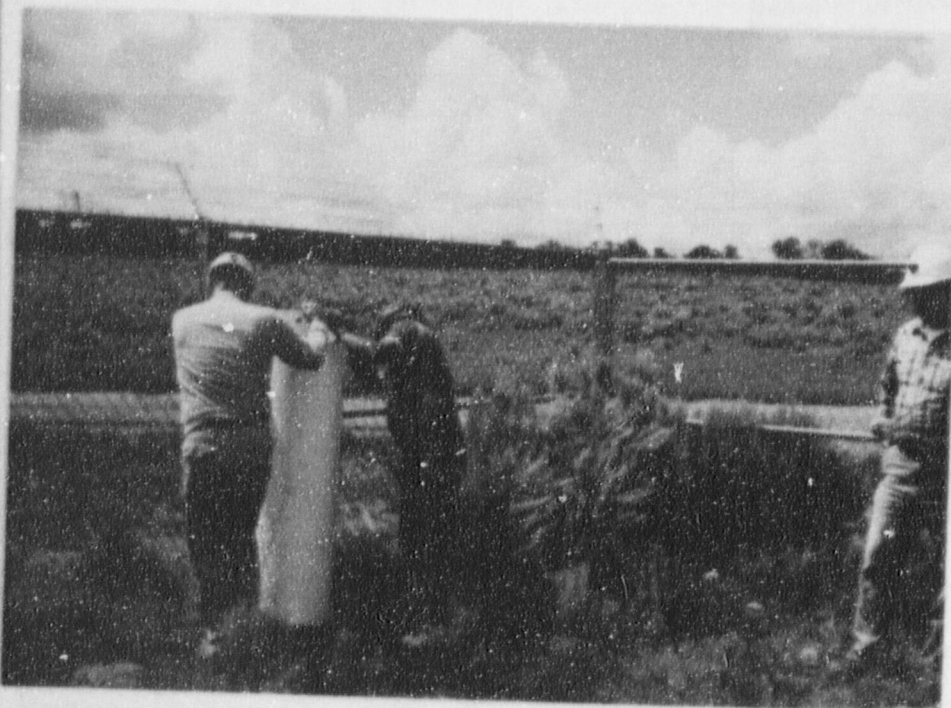
DATE Aug 25, 1971 TIME \_\_\_\_\_

DESCRIPTION S.W. Corner

of fenced lagoon area

Rodor 222 Sample being  
installed.

48 hr bag sample

.49 pCi/l

Average Radon background  
levels are ~~not~~ determined  
at:  $.55 \pm .07$  pCi/l

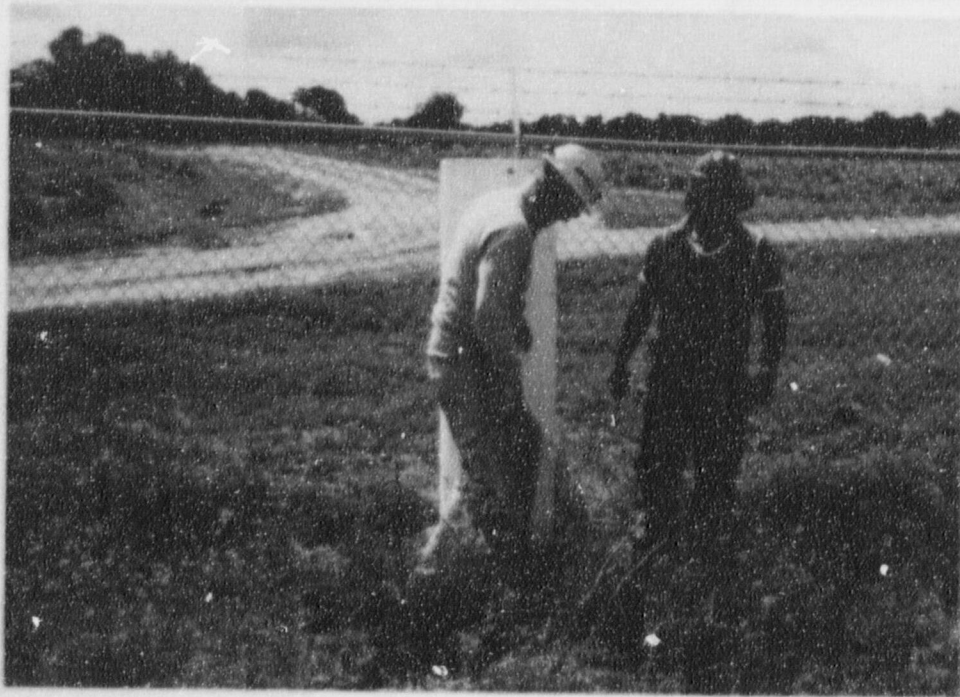
DATE Aug 25, 82 TIME \_\_\_\_\_LOCATION Guy MarianoLake 1X Project

Lucas (EIN) installingRadon-222 Sample collectionsystem S.E. corner -48 hr bag sample.190 pCi/lAverage Radon background  
levels are  $.55 \pm .07$  pCi/l

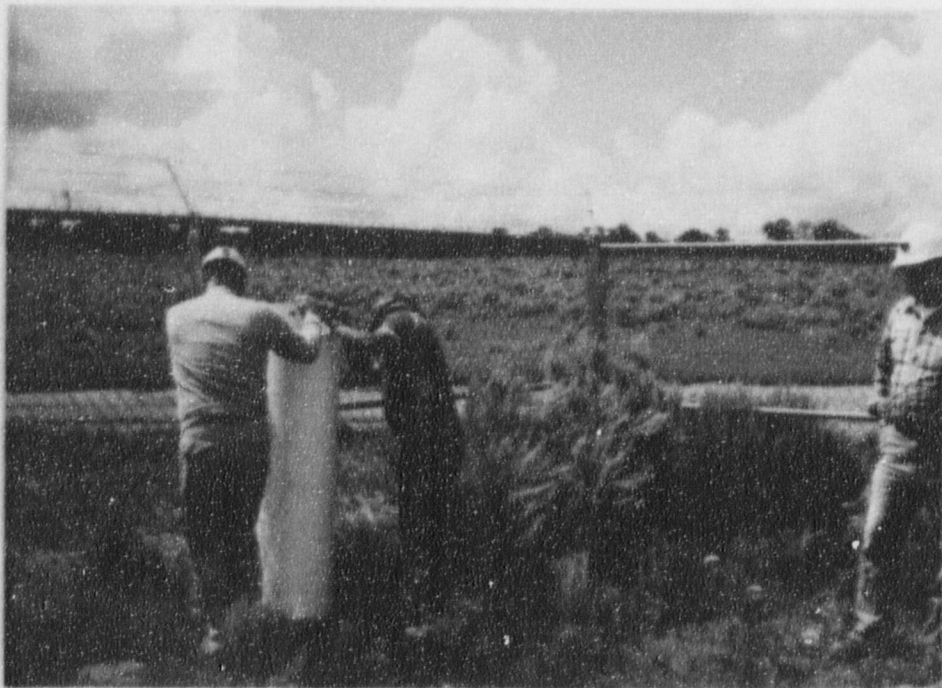
DATE Aug 25, 82 TIME \_\_\_\_\_LOCATION Guy MarianoLake 1X Project.DESCRIPTION S.W. Cornerof fenced lagoon areaRadon-222 Sample being  
installed.48 hr bag sample.49 pCi/lAverage Radon backgroundlevels are ~~not~~ determinedat:  $.55 \pm .07$  pCi/l.

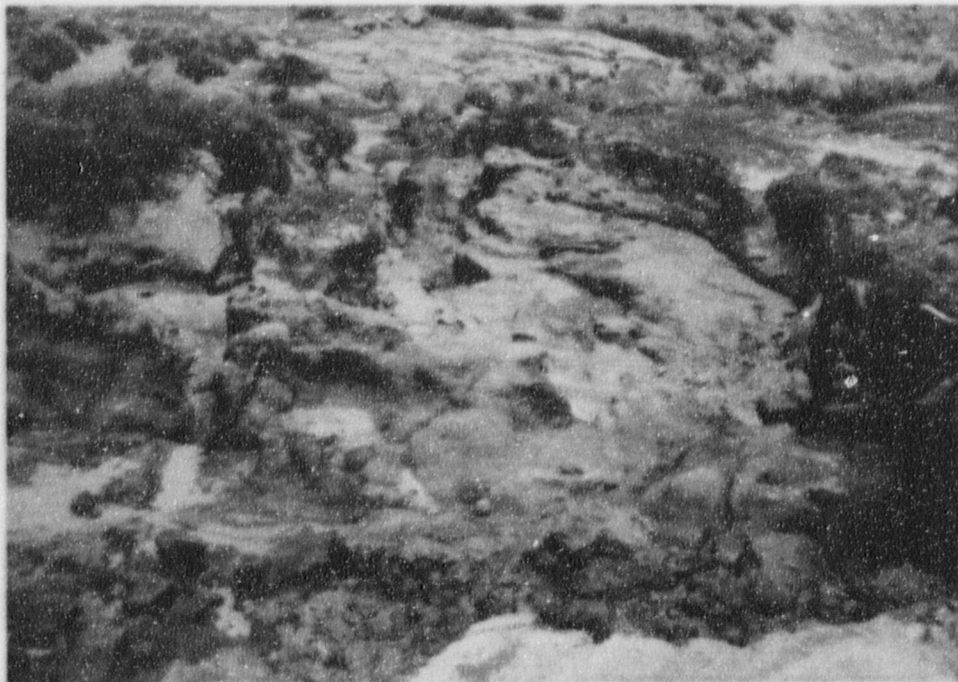
DATE Aug 25, 82 TIME \_\_\_\_\_LOCATION Mariano LakeProject 1X Facility

Approximately 350'  
North side of lagoon  
sewer-line. Example  
of headcutting arrays  
Cut through in one  
storm event.

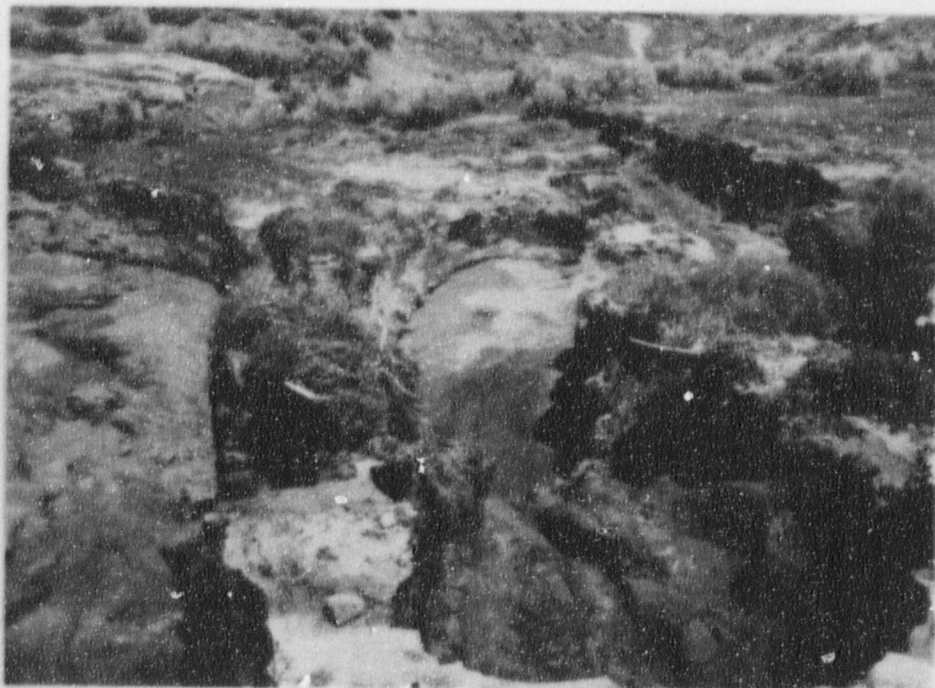
DATE Aug 25, 82 TIME \_\_\_\_\_LOCATION Mariano LakeProject 1X Facility

Approx 300' north  
of lagoon sewer  
line, view of  
arrays eroded  
in one storm event  
within 5 ft.

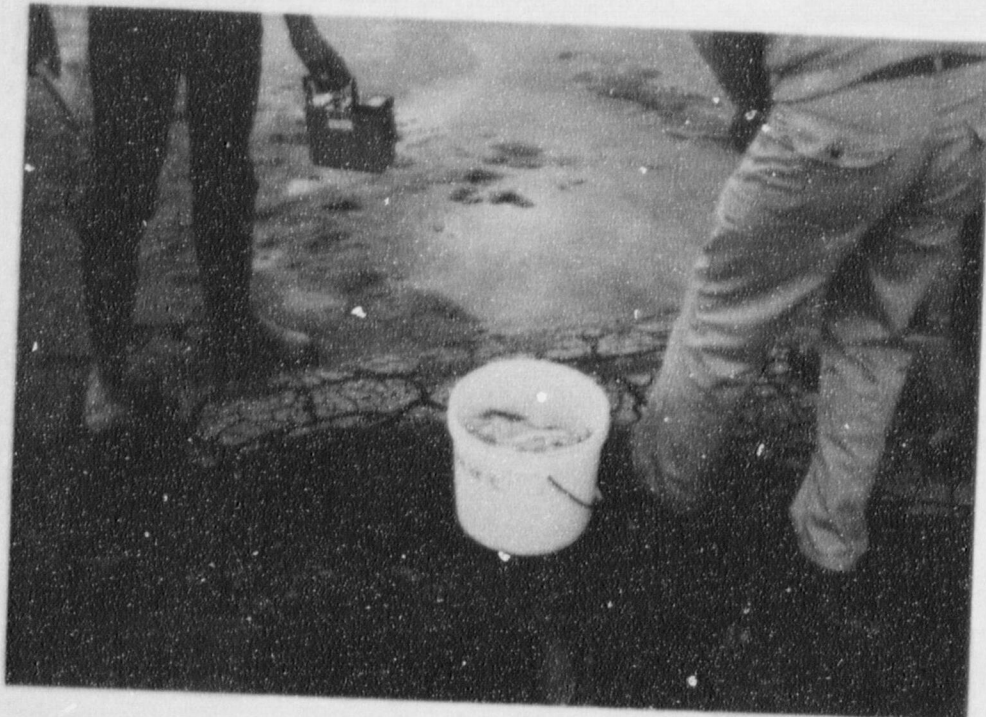
DATE Aug 20/72 TIME \_\_\_\_\_LOCATION Marion's Lake  
1x Project Guy

Gamma reading  
taken at sediment  
area 66 yd/hr,  
West Lagoon.

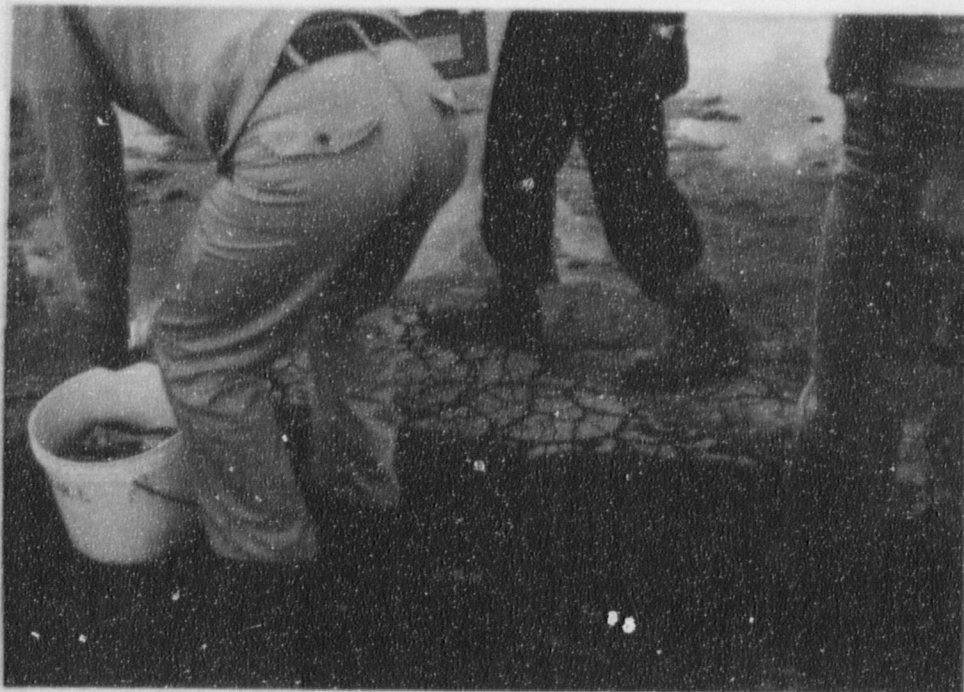
DATE Aug 20 TIME \_\_\_\_\_LOCATION Guy/Marion's  
Lake right

Extra photo of  
taking samples of  
sediment in West  
Lagoon

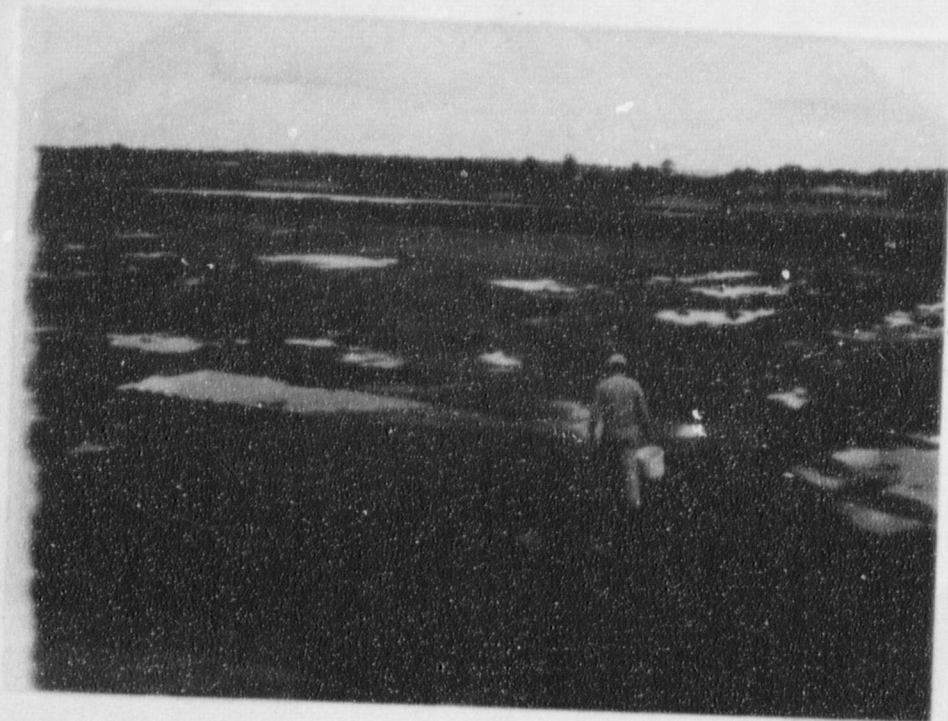
LOCATION Chief Marano  
Rake 18 Facility

Extra photo  
of West Lagoon
