**ZS-2021-0001
Attachment 2**

Zion Nuclear Power Station, Units 1 and 2

**Response to Request for Additional Information Related to the
Final Status Survey Final Reports**

Zion Nuclear Power Station, Units 1 and 2 – Request for Additional Information Related to Final Status Survey Reports, dated November 4, 2020

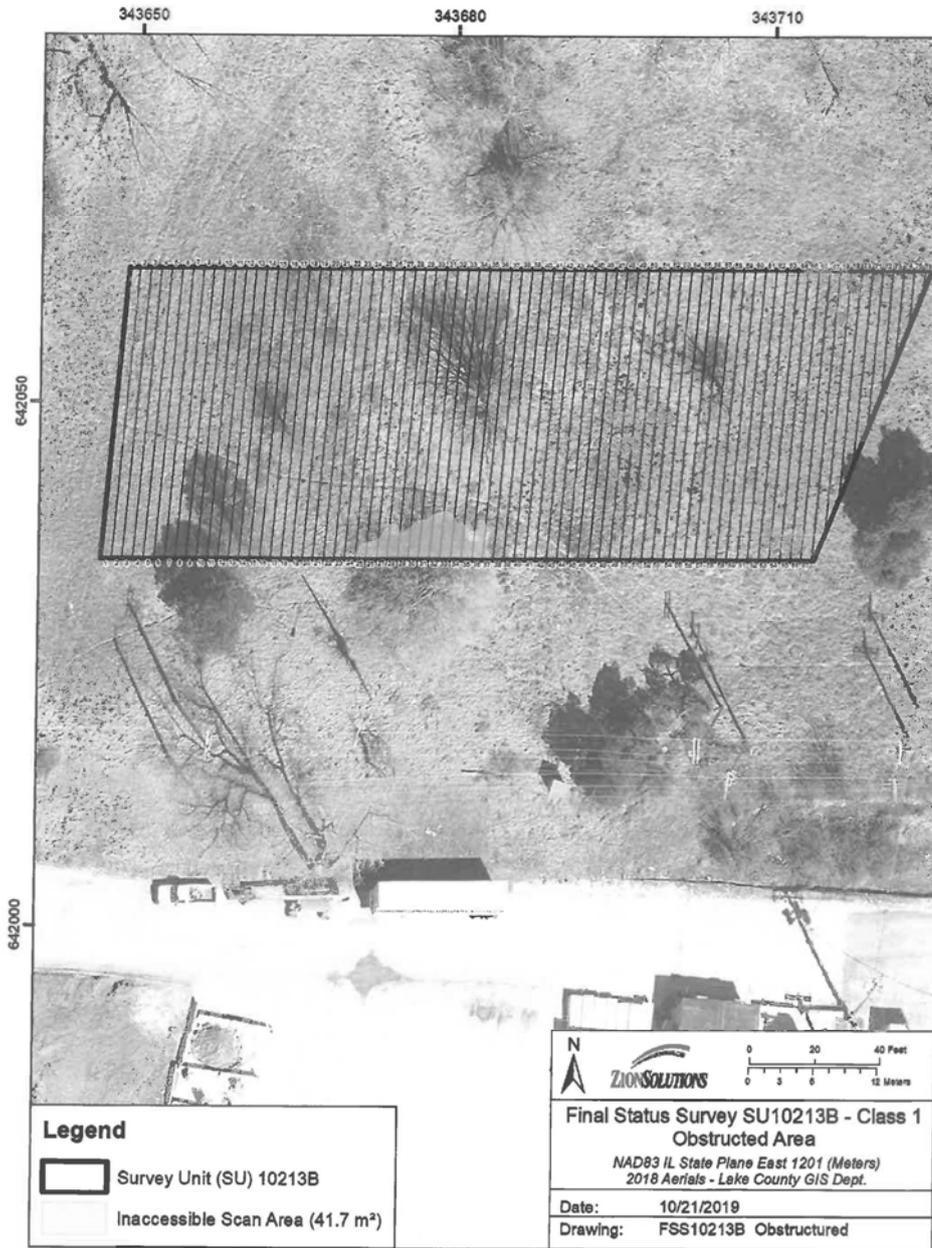
- Survey Unit 10213B – The surface in question was a 42 m² area obstructed by the branches of several large trees along the south boundary in the approximate center of the survey unit. The area of the survey unit that was subjected to scans equates to 99.92% areal coverage of the open land surface in this survey unit. The surface in question is located along the south boundary of scan rows 25 through 37. With an average observed background of 1,601 cpm, the highest scan reading observed in scan rows 25 through 37 was 2,456 cpm with an alarm setpoint of 2,253 cpm. In addition, systematic sample L1-10213B-FSGS-003-SS was acquired at the north point of the obstructed surface. The analysis of sample L1-10213B-FSGS-003-SS did not indicate the positive presence of plant-derived residual radioactivity at concentrations greater than MDC. Based on the scans and soil sample results, it can be concluded that the potential presence of residual radioactivity at concentrations exceeding background in the obstructed area was negligible. As such, no investigation was required (e.g., additional biased soil samples). It can also be reasonably concluded that the summation of the mean dose fraction for each ROC from the systematic sample population is representative of the dose exhibited by this survey unit to a 95% confidence level. Please

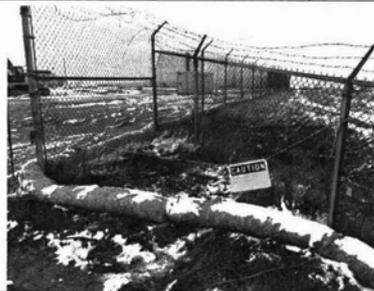
| <u>Time:</u> | <u>Observation or Comment:</u> | <u>Technician</u> |
|---|---|---|
| NOTE: | Easternmost 2-4 meters of Rows 43-45 not surveyed due to caution rope/sign denoting "razor wire and open hole." | JRM |

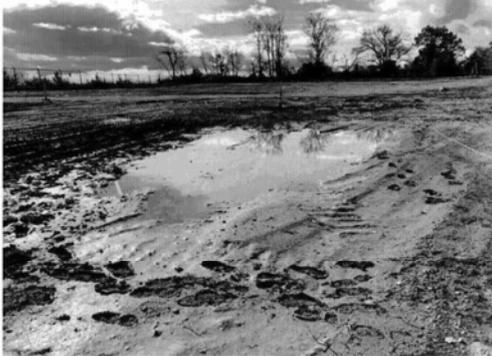
| Attachment 14 FSS Field Log Page <u>2</u> of <u>33</u> | | ZS-LT-300-001-001 Revision 6 Information Use |
|---|---|---|
| NOTE: | Rows 29-34 not surveyed due to standing water: | AB/WC/JRM |

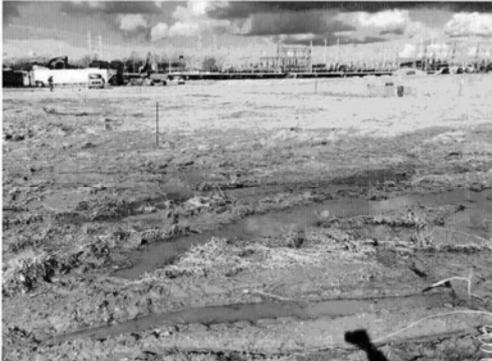
| Attachment 14 FSS Field Log Page <u>2</u> of <u>33</u> | | ZS-LT-300-001-001 Revision 6 Information Use |
|---|---|---|
| NOTE: | Northernmost 3-4 meters of rows 36-44 not surveyed due to standing water: | AB/WC/JRM |

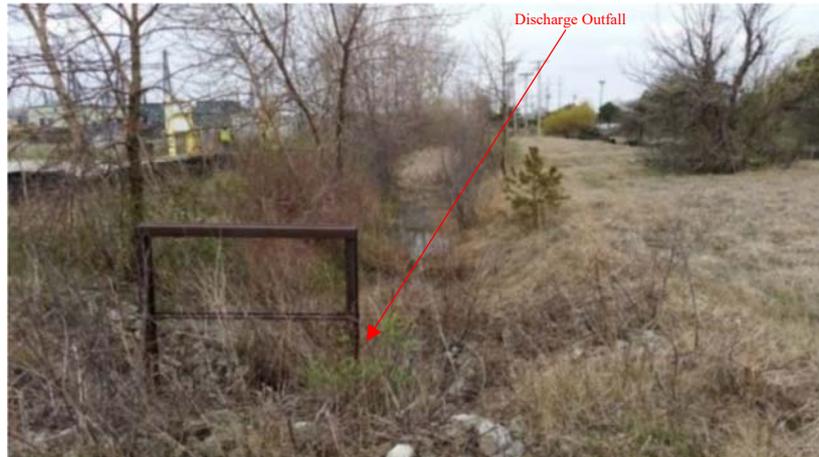
Drainage Ditch in 10212D in May of 2016

flooding of a large portion of the north half of the site. This event was precluded by several days of heavy rains coupled with the fact that the discharge outfall was clogged. In response to the flooding event, the water was removed by sump pump. It should be noted that the pump output water was analyzed for radioactivity by Radiation Protection personnel.

Before the second FSS attempt, the water pumping out of the survey unit 10212D discharge ditch had become a routine occurrence. The decision to redo the FSS was made because, at the time, the survey unit was dry enough to make another attempt. Following the second FSS attempt, another flooding event occurred; however, water pumping had rendered most of the survey unit dry when remediation commenced.

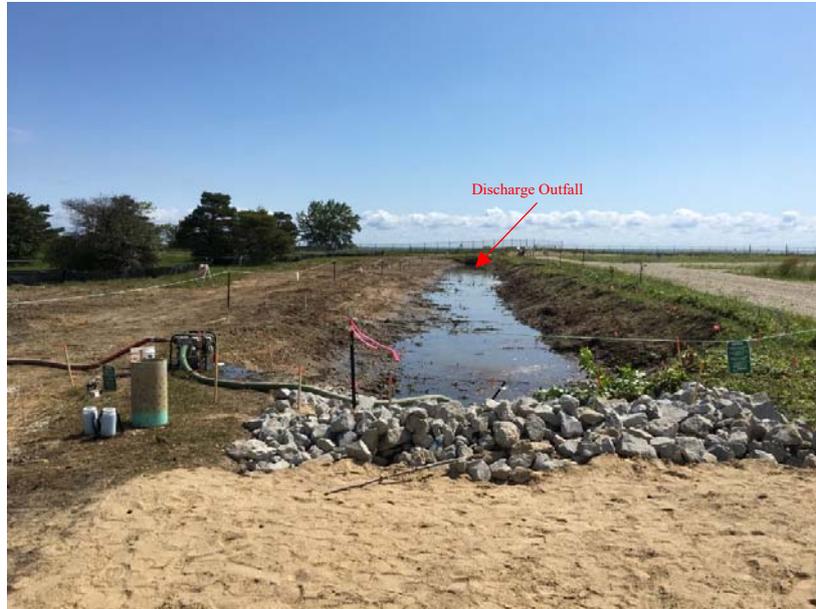
Drainage Ditch in 10212D in August of 2019

Following the soil remediation in August of 2019, the drainage ditch appeared as shown in the picture below. Please note that there is a clear comparison between the two images of the drainage ditch taken in 2016 and 2019. In the second photo, it is clear that the ditch is significantly wider than the image from 2016 and devoid of vegetation. In addition, the discharge outfall has been unclogged. What is seen in the 2019 photo was the end-state grade for this survey unit as the soils removed from the ditch that was disposed of as potentially contaminated soil was not replaced with clean fill.

The last set of post-remediation soil samples were acquired from the ditch in the condition illustrated by the photo above. Soil samples were taken underwater every 10 feet in the center of the drainage ditch and every 10 feet at the water line on the north and south banks. As illustrated in the response to NRC RAI Question #5a, the OpSOF observed for each of these sample results was less than one.

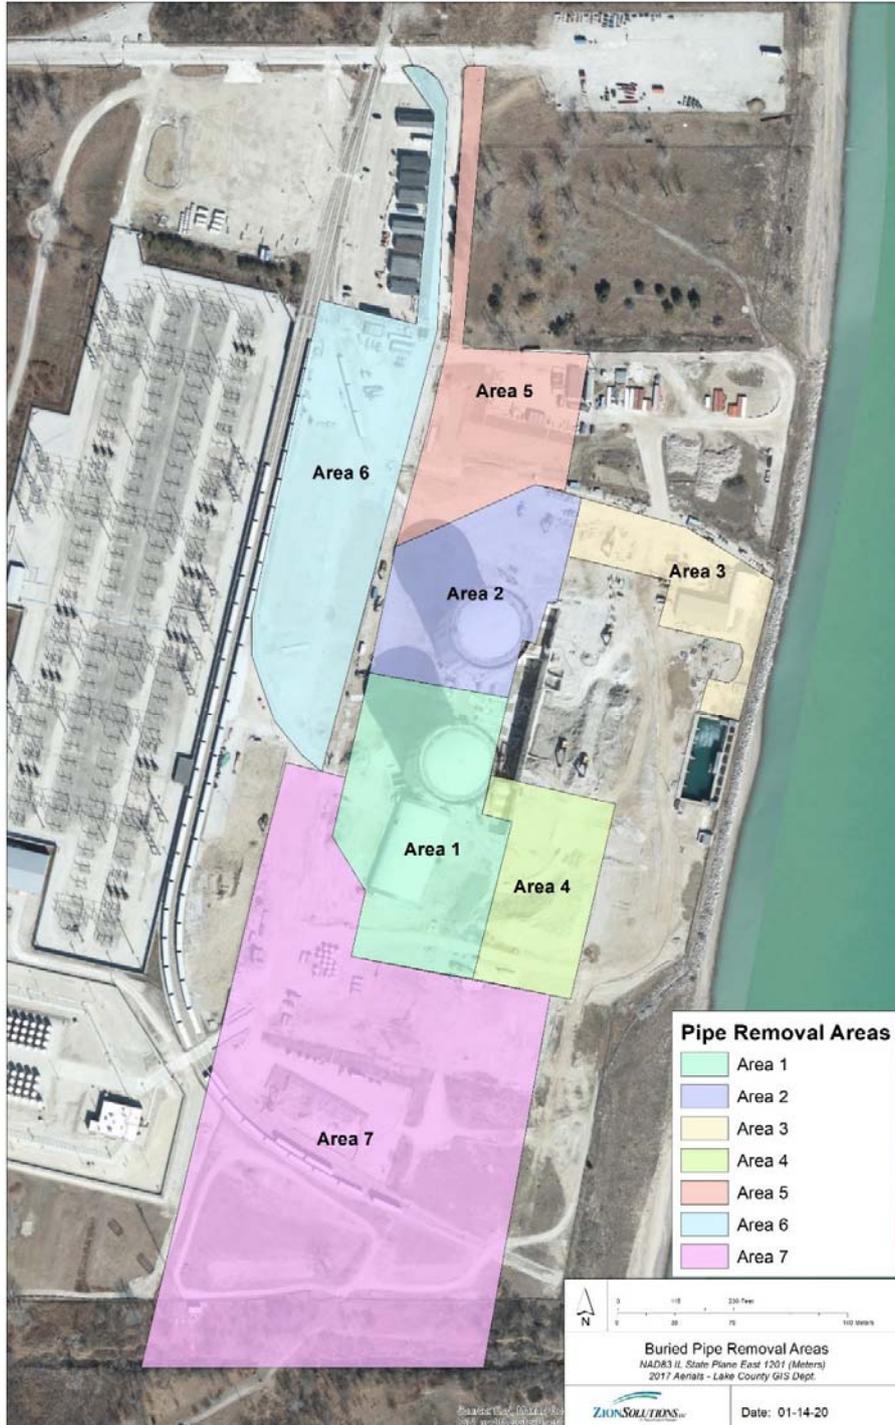
A graphic depicting the approximate locations of the buried pipe that was removed, broken into seven areas, is provided below. On the enclosure to this response, ZionSolutions has provided the spreadsheet documenting the soil sample analysis results for all soil samples acquired to assess the acceptability of excavation overburden prior to backfill into the excavation from which it was obtained.

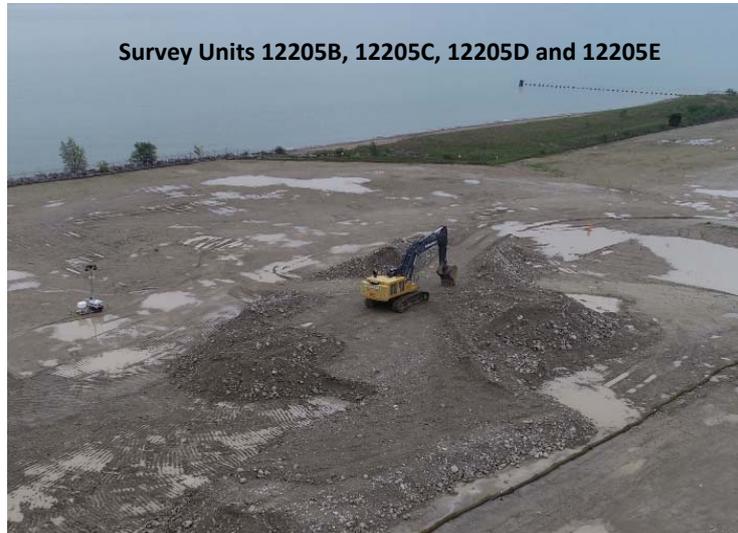
- Jan 2019 FSS was successfully performed in open lands survey units 12112, 12113, 12203C, 12203D, 12205A, 12205B, 12205C, 12205D, and 12205E. Isolation and control measures as specified in procedure ZS-LT-300-001-003 were established around each.

- Commenced transfer of CCDD from areas around Containment to the base layer for storage stockpile located in survey units 12205A, 12205B, 12205C, 12205D, and 12205E.

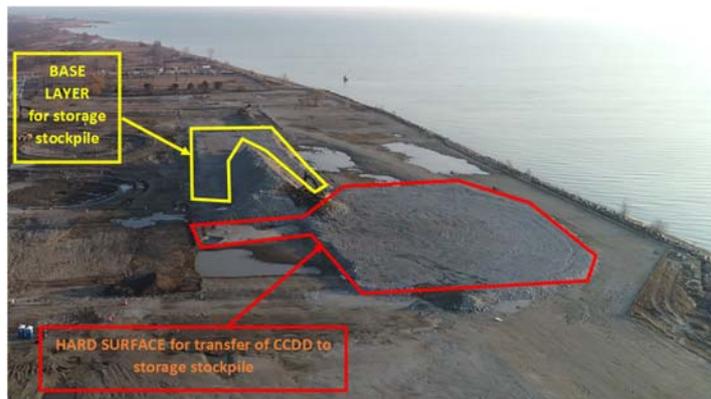
Feb 2019

FSS was successfully performed of open lands survey units 12203A and 12203B. Isolation and control measures as specified in procedure ZS-LT-300-001-003 were established around each.

Commenced dumping of CCDD from areas around Containment to the hard surface placed in survey units 12203B, 12203C, 12203D, 12112, and 12113. CCDD was then pushed from the hard surface in survey units 12205A, 12203B, 12203C, 12203D, 12112, and 12113 onto the large storage pile in survey units 12205B, 12205C, 12205D, and 12205E (note; this activity occurred with I&C measures in place – frisking, boundary control, technician monitoring).

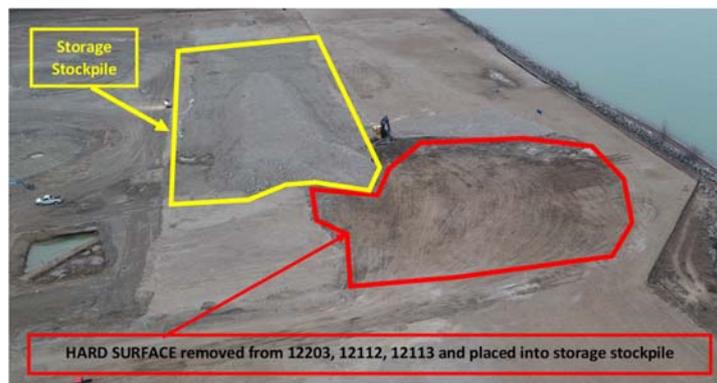
March 2019

Completed transfer of CCDD onto the large storage pile in survey units 12205A, 12205B, 12205C, 12205D, and 12205E.

CCDD hard surface removed from survey units 12203A, 12203B, 12203C, 12203D, 12112 and 12113 and placed into storage stockpile in survey units 12205A, 12205B, 12205C, 12205D, and 12205E.

Following the removal of all CCDD from survey units 12203A, 12203B, 12203C, 12203D, 12112, and 12113, a walkdown and inspection was performed. It was determined that the hard-frozen soil surface prevented mixing of CCDD with the soil during the transfer process, exposing the soil grade that was previously successfully subjected to FSS. The assessment of any potential radiological cross-contamination was to be made by surveillance as per procedure.

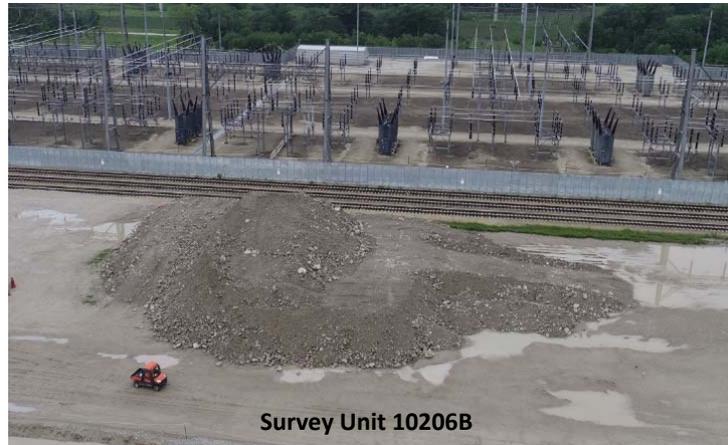
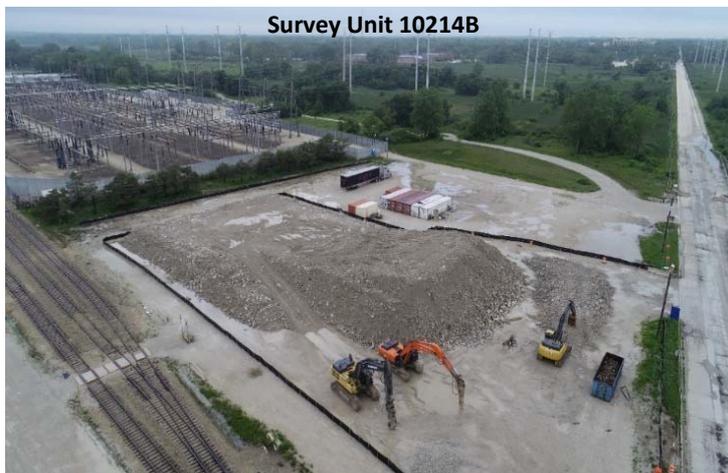
June 2019

To support shipment, the CCDD was transferred from survey units 12205A, 12205B, 12205C, 12205D, and 12205E to survey units 10214B and 10206B. All concrete debris was loaded into rail cars at these two locations and disposed of as potentially radioactive materials.

During the movement of CCDD to survey units 10214B and 10206B, walkdowns and inspections performed in survey units 12205A, 12205B, 12205C, 12205D, and 12205E noted significant intermixing and deep settling of the CCDD in the survey unit footprints.

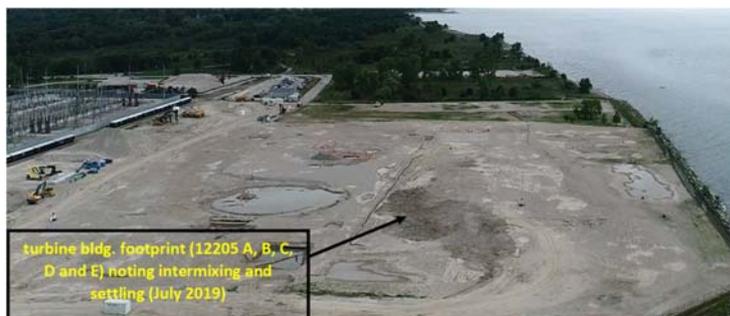
On July 30, 2019, a surveillance was performed in survey unit 12112. The surface impacted by the CCDD within the survey unit was scanned and 2 biased soil samples were acquired. Surveillance scans and soil sample analyses yielded radiological conditions consistent with FSS results for survey unit 12112 (all scans were less than investigation levels, and all soil samples were less than surface soil OpDCGLs)

A walkdown and inspection was performed following the removal of all CCDD from survey units 12205A, 12205B, 12205C, 12205D, and 12205E. Based on observations of the physical condition of these survey units, a decision was made to re-perform the FSS in survey units 12205A, 12205B, 12205C, 12205D, and 12205E. Due to intermixing and deep settling of the CCDD into the surface soil layer, removal of the CCDD had created a shallow excavated depression in the survey unit. Clean fill was imported from off-site and used to restore the grade. Condition report ES-ZION-CR-2019-0101 was initiated to capture the schedule change and any other potential impacts.

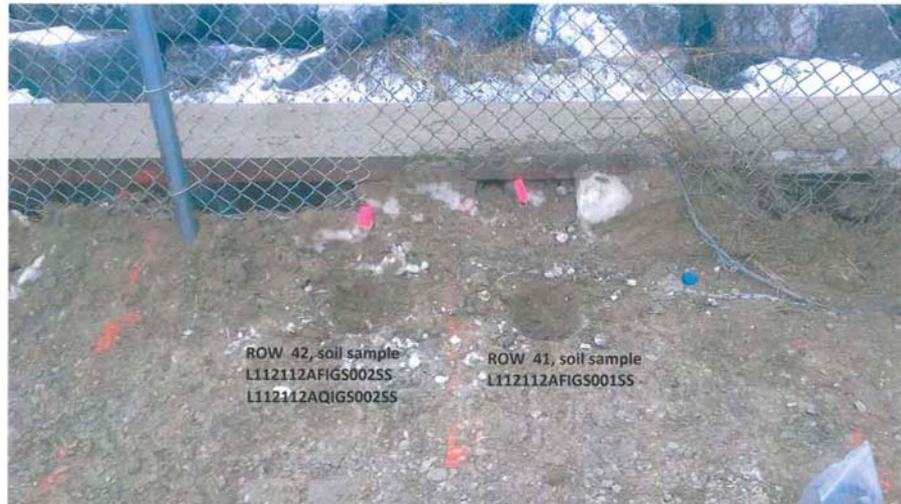
Photo of Elevated Scan Location During FSS of Survey Unit 12112 from January 2019

The gamma spectroscopy results of the investigation samples taken during FSS are presented in the following table.

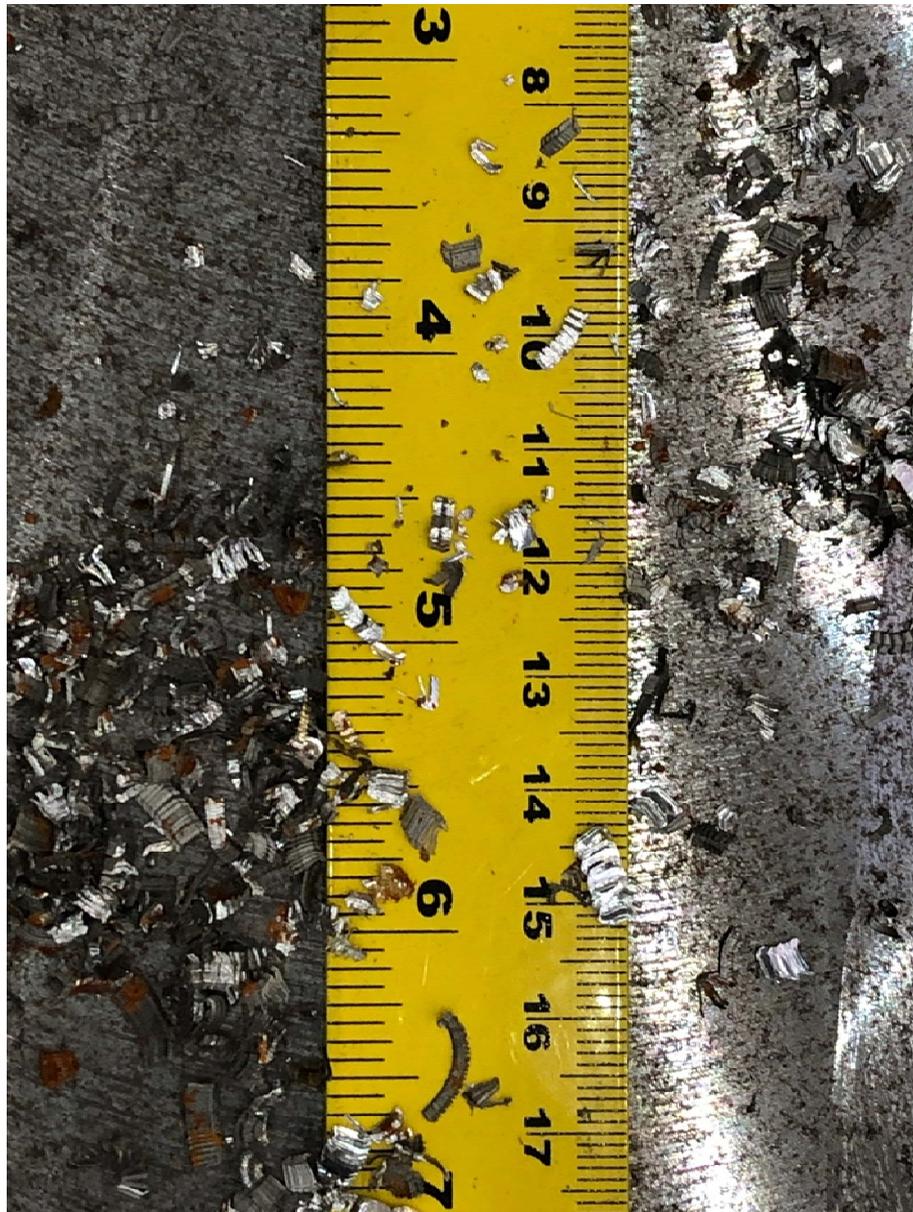
RESPONSE: The majority of all DRPs identified on-site outside of structures from 2014 onward have been composed of primarily Co-60, based upon on-site gamma spectroscopy analyses. The DRPs are metallic in nature, mildly magnetic, typically visible to the naked eye, irregular in shape, and with typical dimensions of around 1 mm in diameter and less than 1 mm thick. Below is a photo of typical tailings generated from reactor internals segmentation activities, which utilized a diamond wire saw, taken during equipment mockups. The DRPs identified on-site are similar in appearance and size to these tailings.

The identification of Co-60 as the sole gamma emitter in the majority of the DRPs identified is consistent with the neutron activated reactor internals components.

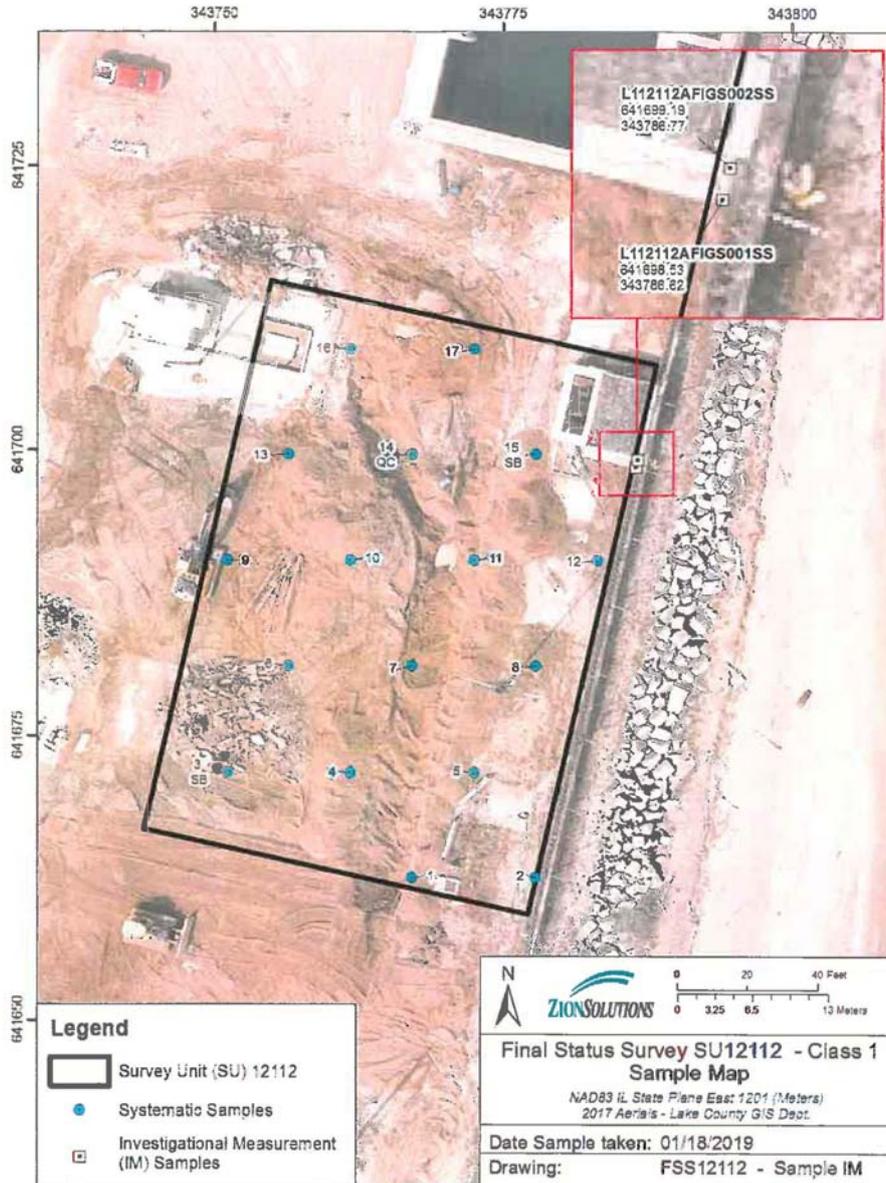
Sample Map for FSS of Survey Unit 12112 from January 2019

RESPONSE: Below is a picture identifying the location of L1-12112A-FQGS-014-SS in relation to the scan alarms in rows 41 and 42 of Survey Unit 12112. The scan alarms occurred at location of soil samples L1-12112A-FIGS-001-SS in row 41 and L1-12112A-FIGS-002-SS in row 42. The location of L1-12112A-FQGS-014-SS is annotated in map by marker 14-QC.

The scan alarms in rows 41 and 42 identified by ZS were in similar location in which ORISE identified elevated measurements. The cause of the elevated measurements in these locations were due to NORM and not DRPs as discussed in further detail in the RAI #10a response. A DRP of source strength similar in nature as to that identified in soil sample L1-12112A-FQGS-014-SS would not have been identified during scans as it would be below the MDA of the detector as discussed in further detail in the RAI #11a response.

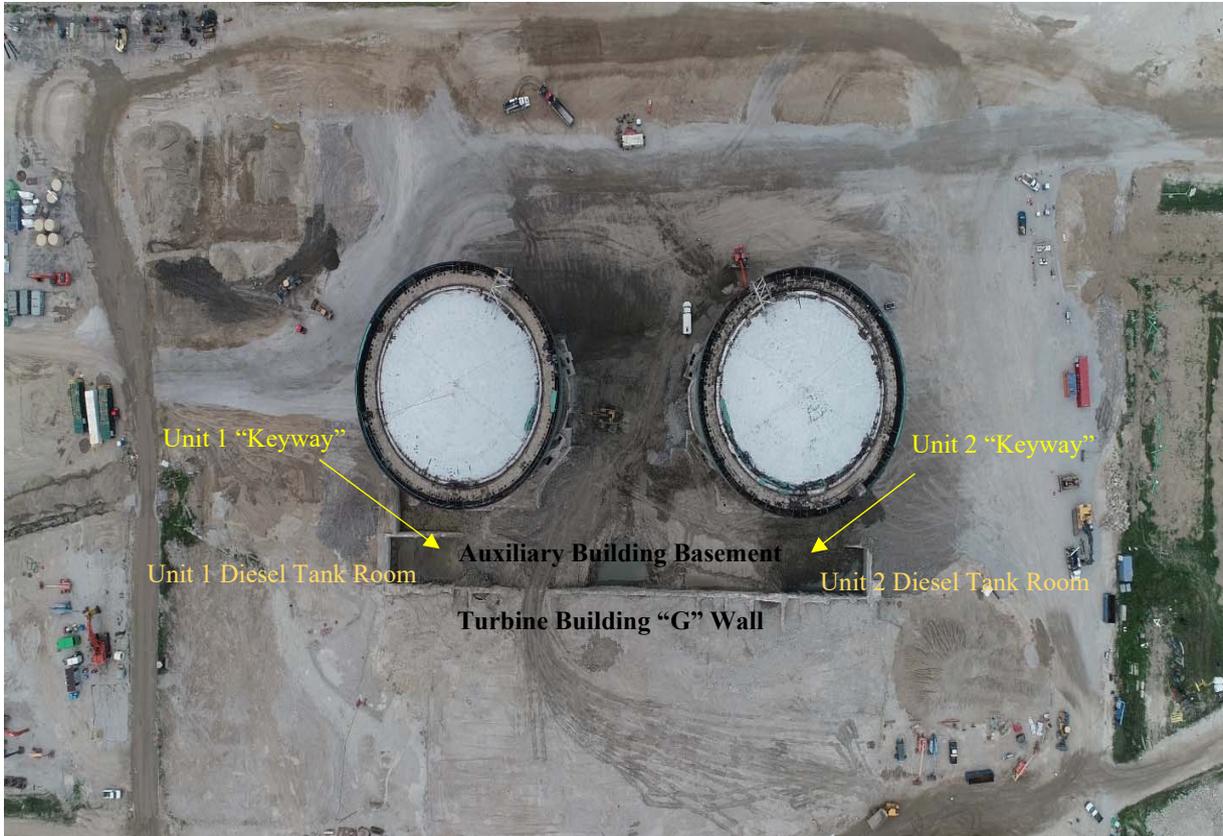
Unit 1 and Unit 2 Keyways

In 2017, the concrete ceiling and the of the Unit 1 and Unit 2 Diesel Fuel Oil Tank rooms was removed to support the removal of radioactive commodities from the Auxiliary Building. The clean fill introduced into the “keyways” prior to building demolition was completely removed and disposed of as waste, exposing the east entrances into the Steam Tunnel and the Unit 1 and 2 East and West Valve Rooms. The Unit 1 and Unit 2 East Valve rooms are located directly in the “keyways”. The interiors of the Unit 1 and 2 East and West Valve Rooms were successfully subjected to FSS in April of 2018. Prior to demolition of the Containment domes, this entire area was backfilled with clean fill from off-site. The figure below shows the keyways and the underlying structures following the removal of the indigenous soil.

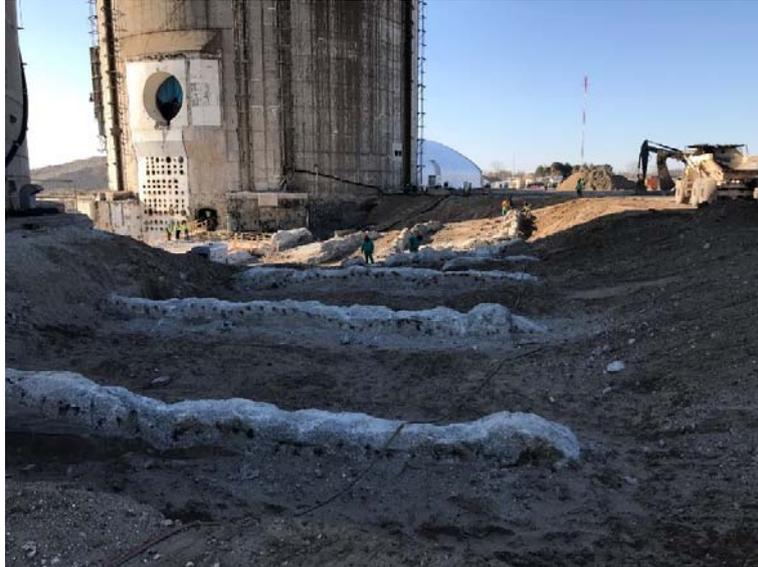
The Excavation Created for Demolition of the Fuel Handling Building

RESPONSE: In March of 2018, the walls and floor of the FHB were demolished and removed. A large excavation was created to accomplish this, and when complete, the only part of the FHB that remained was the bottom of the SFP.

The soil directly beneath the SFP slab was inaccessible. Attempts to sample the soil beneath the slab with angled boring techniques (GeoProbe) were met with refusal due to a previously unidentified mud-mat. Additionally, during FSS of the SFP/Transfer Canal, hotspots were not observed that would indicate a crack or travel path for subsurface contamination.

As illustrated in the photos, the excavation created to remove the FHB completely exposed the subsurface soils around the north, west, and south side of the SFP floor concrete slab. The subsurface soils surrounding the SFP slab were scanned and sampled as part of the FSS of this excavation prior to backfill. The results of scanning and soil samples taken directly adjacent to the SFP floor slab are found in the release records for survey units 12106 and 12107, Addendum 1 which documents the FSS of the open excavation. The following table reproduces the scan results reported in the release records.
