REPORT NO. 6

DECONTAMINATION AND DECOMMISSIONING OF THE KERR-McGEE  
CIMARRON PLUTONIUM FUEL PLANT

DECONTAMINATION AND DECOMMISSIONING OF THE CIMARRON  
CORPORATION'S CIMARRON MIXED OXIDE FUEL PLANT.

CIMARRON CORPORATION  
P. O. BOX 315  
CRESCENT, OKLAHOMA 73028

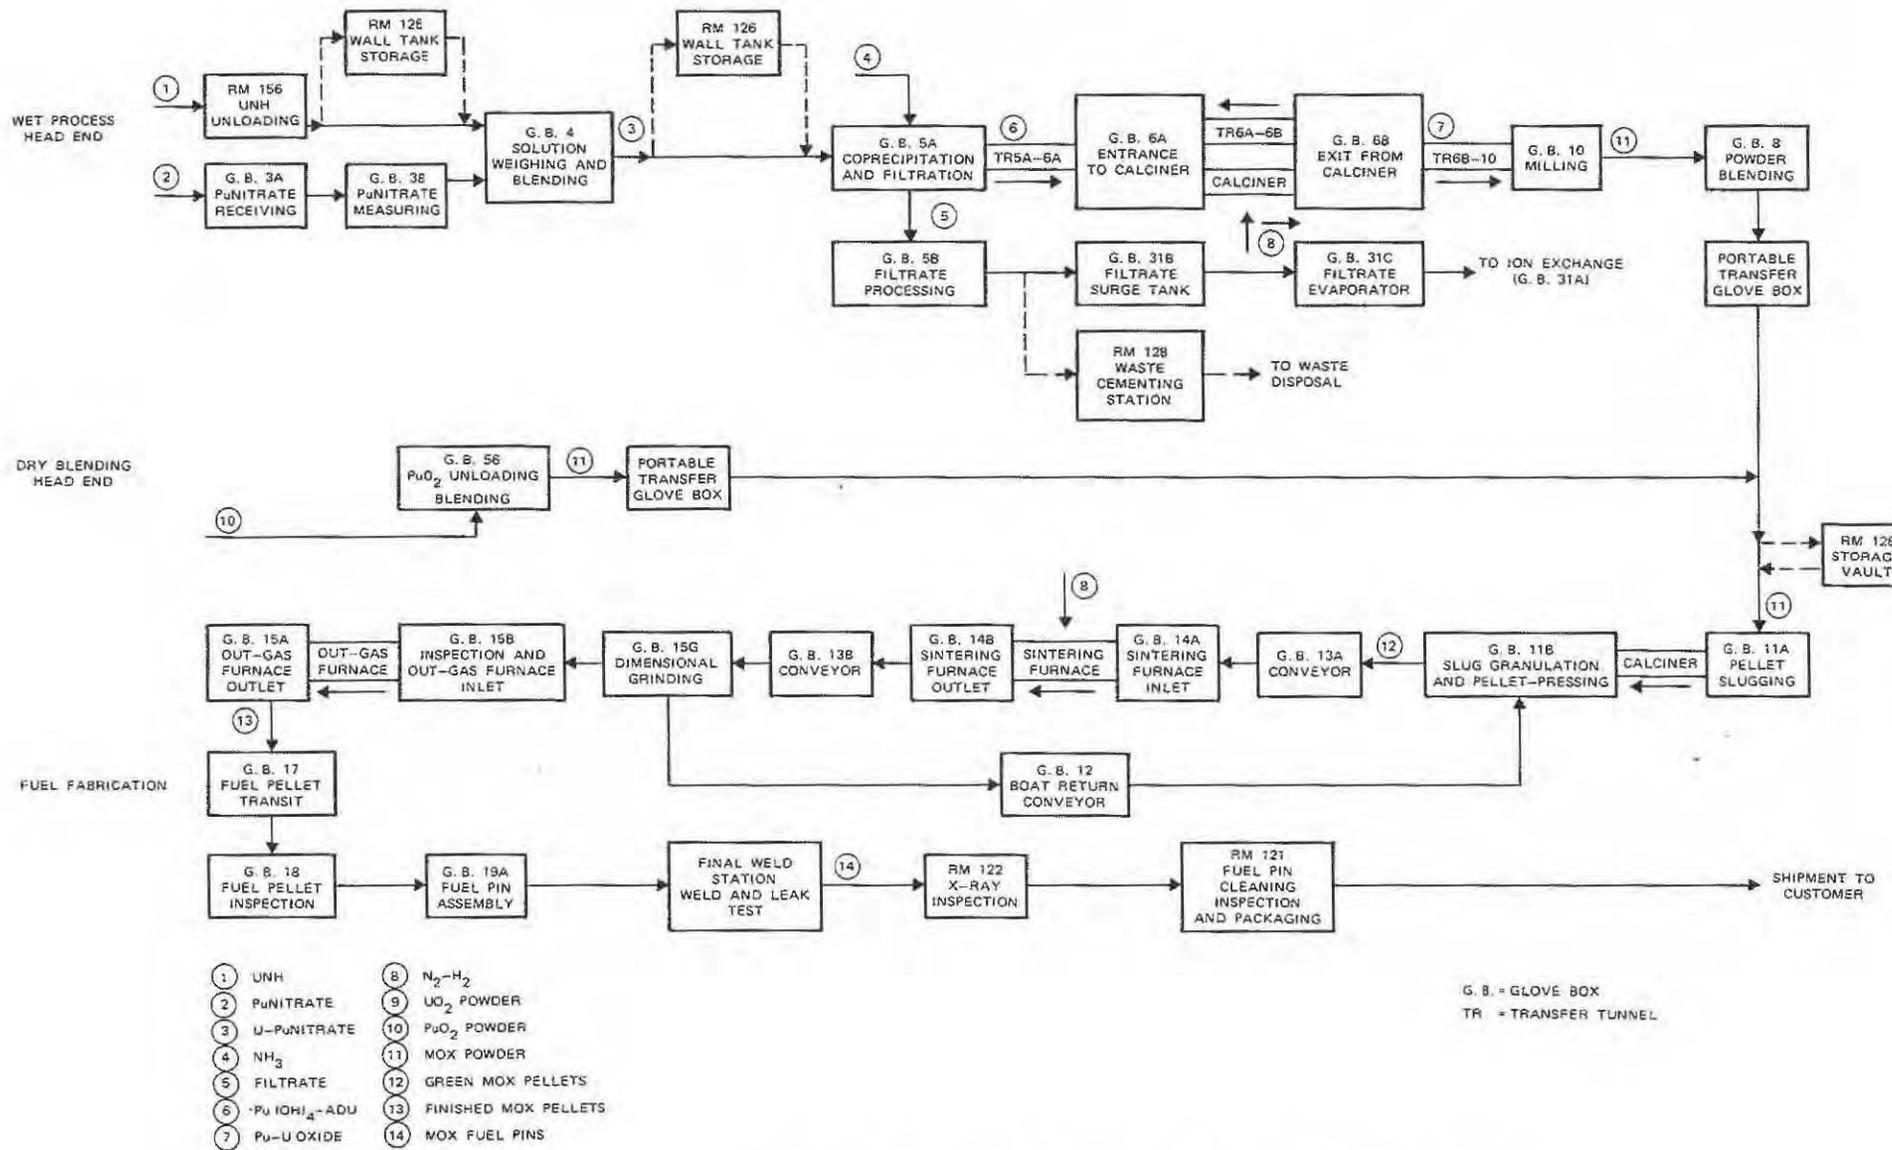
FIGURE 3

Glove Box Flow Diagram, Mainline Mixed Oxide Fabrication Process

Block outline, figure 3 illustrates the production system sequentially so that the logic of the operations can be visually understood, however there are some subtle features that are better understood by description: For example, it was discovered that weighed and blended solution performed much better through the coprecipitation and filtration process when the solution was allowed to age in the wall storage tanks a day or more. It was also discovered that uniform powder was required to control pellet density and size. Powder from several batches mixed with powder reprocessed from clean scrap operations usually had different pressing characteristics due to variations in particle size and other attributes, as a result it was necessary to add the operations of pressing this powder into biscuits or slugs and then granulate these green powder slugs into a more uniform powder particle size for production press feed stock. It was also developed that processing the slugging press pellets through a warm calciner  $100^{\circ}\text{C} \pm 10^{\circ}$  with dry nitrogen purge gas was beneficial in driving off any moisture that may have accumulated in the green powder slugs. Virgin powder batches did not always require these added operations.

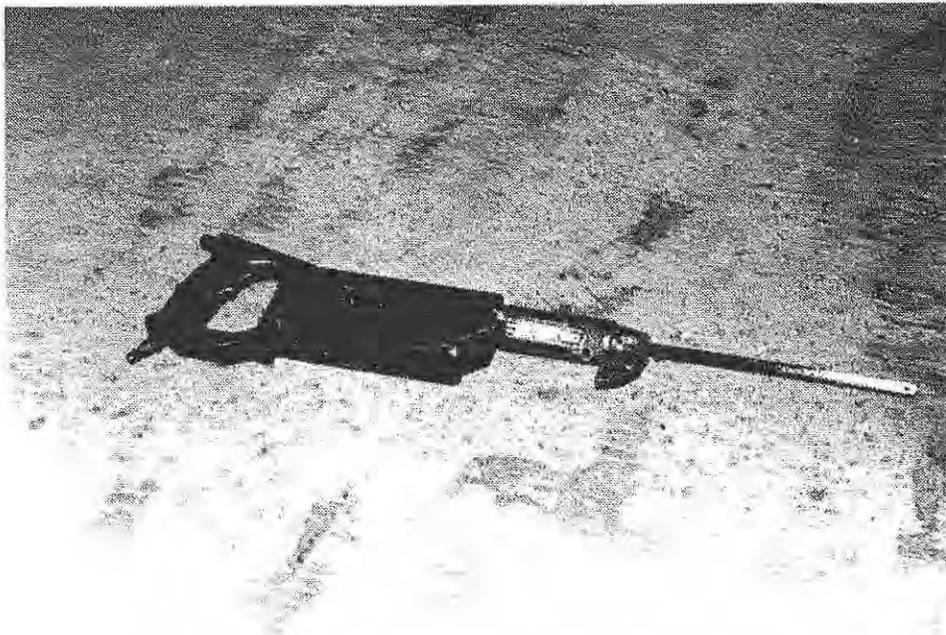
Tigair reciprocating hacksaw

This hand held power tool utilizes conventional hacksaw blades, and is used to cut framing, piping, sheet metal, and almost anything that allows access only from one side. This versatile air operated tool proved to be a real work horse with a multitude of applications.

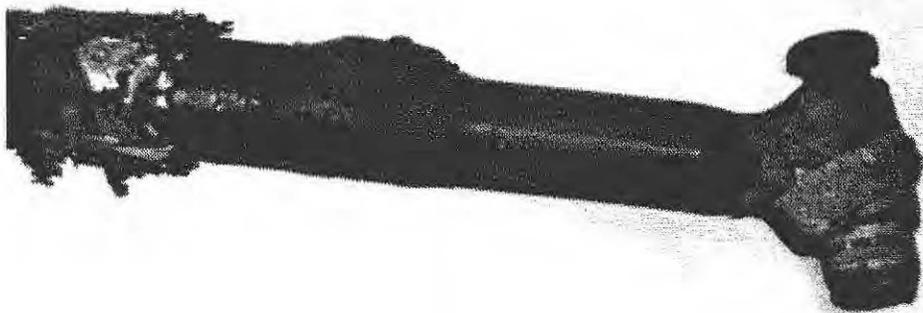
## Plasma Arc Cutting Torch

The plasma arc torch was originally developed for cutting non-ferrous metals using inert gases (Argon-Helium, etc.). In order to expand the applications of the process, modifications to the equipment were made and parameters for various gases were developed. The developed equipment can produce plasma flame temperatures estimated to be 10,000°C to 14,000°C. This broadens the list of metals that can be cut and accelerates the cutting speed. The quality of the cut of some materials may not be suitable for some production applications, but the long list of materials that can be cut and the fast cutting speeds (example: cutting speed for 3/8" stainless 20" per min.) makes this a good tool for decommissioning.

The plasma arc torch, when used inside a well ventilated glovebox can reduce sections of gloveboxes, tooling and machines to small pieces suitable for small piece assay (14" high cylindrical shaped packages at good production rates.

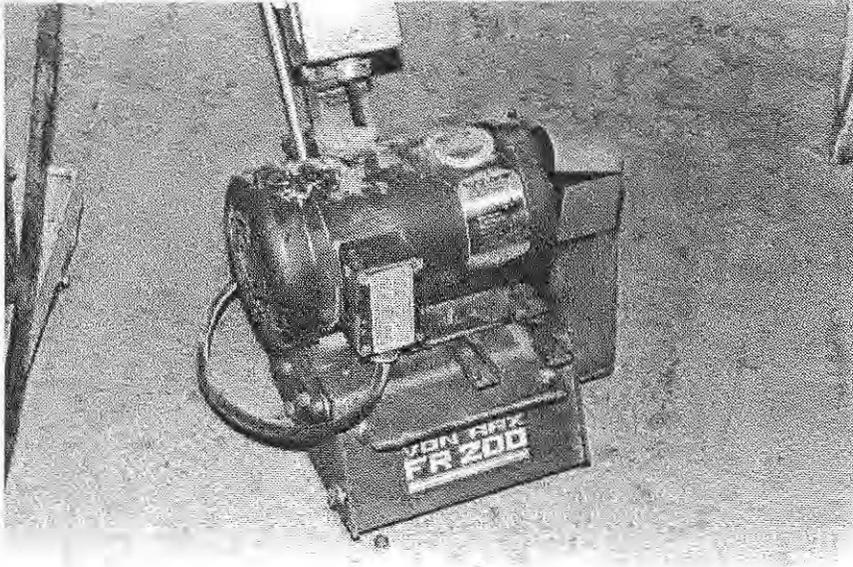
This machine has a working width of 8", weighs about 100 lbs., uses a 3 H.P. motor and scarifies 400 sq.ft. per hr.

Electric version of  
Floor Scabblers

Decontamination of the production and laboratory floor presented an unusual problem because the floor coating was an epoxy material which was applied by pouring a quantity on the floor and allowing it to flow out level. Due to the irregularities in the floor, the coating varied in thickness, (as much as 1/2"), the resilience of the material virtually eliminated the effectiveness of vacu-blasting which merely impacted the surface. Several removal methods were tried such as grinding, which loaded up the grinding wheel to the point where it would quit cutting. Removal by heat was not a practical approach because experimental work revealed that the material would off-gas when heated and the off-gas was combustable. Scabbling with impacting pistons was reasonably successful, but very slow. The method which gave us the best results was a machine which used a rotating drum with milling cutter type flails which contained tungsten carbide blades. The scarifier action of this machine would appear to mow the floor covering away, along with a skin layer of concrete. An auxiliary vacuum system with a H.E.P.A. filter box and exhaust tube to the building ventilation discharge system completes the arrangement.

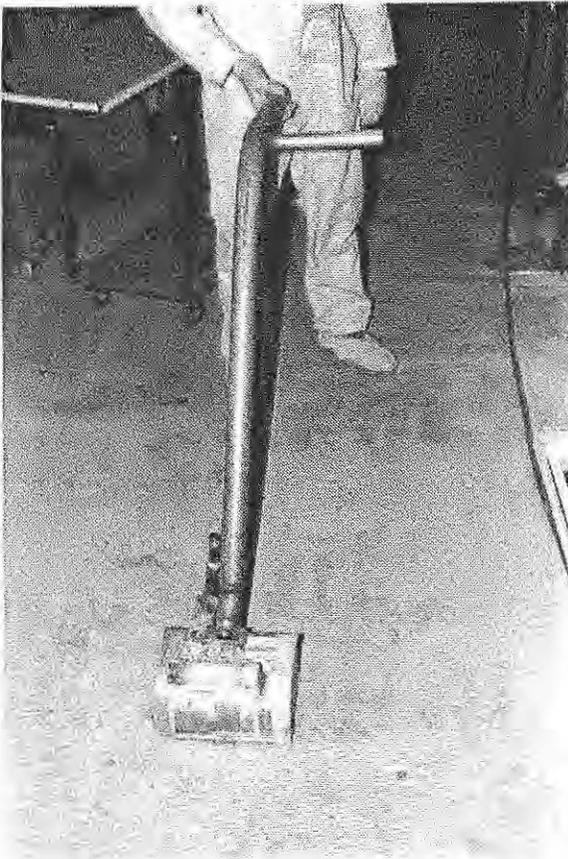
Pneumatic version and conversion  
of hand held machine to a walk  
behind floor machine.

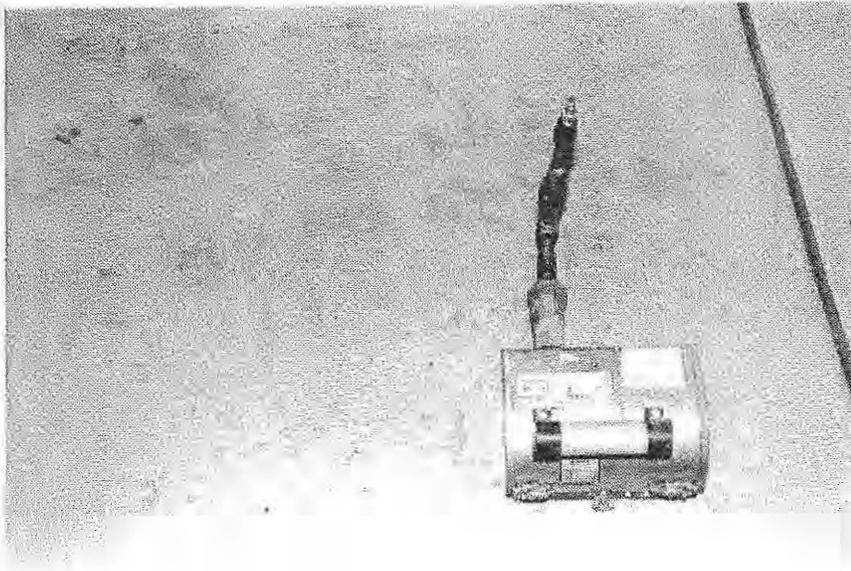
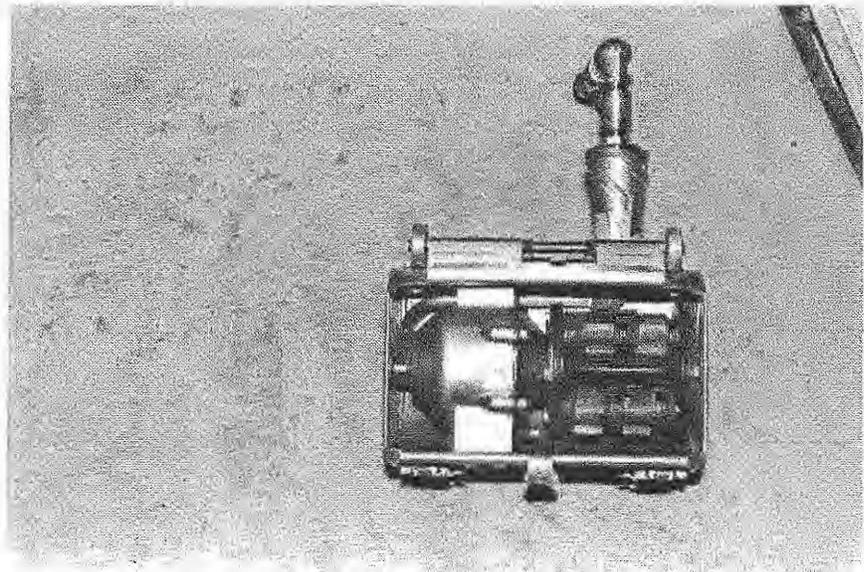
Top view hand  
held machine

Bottom view hand held  
machine showing air  
motor and drum with  
special milling cutters

Photos also show floor surface produced by this equipment.

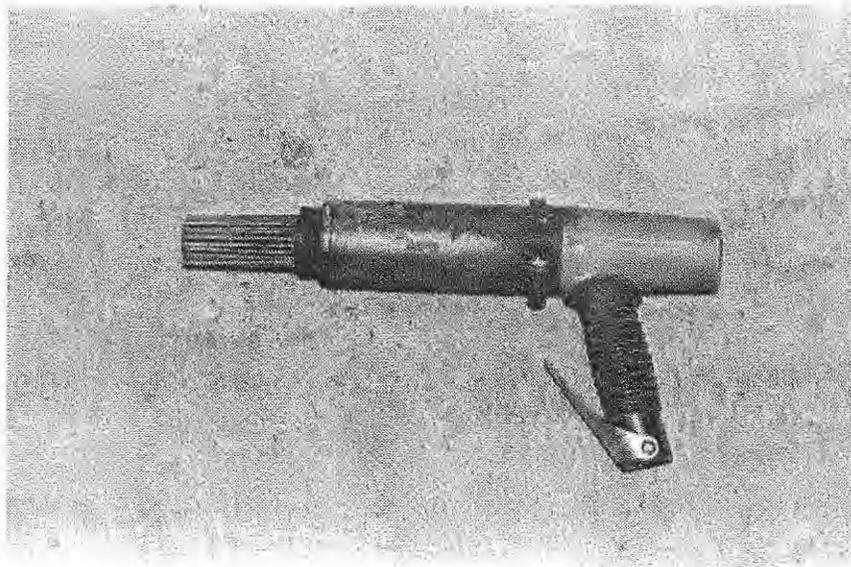
Needle scaler used in corners and other areas which were inaccessible for drum type machine.

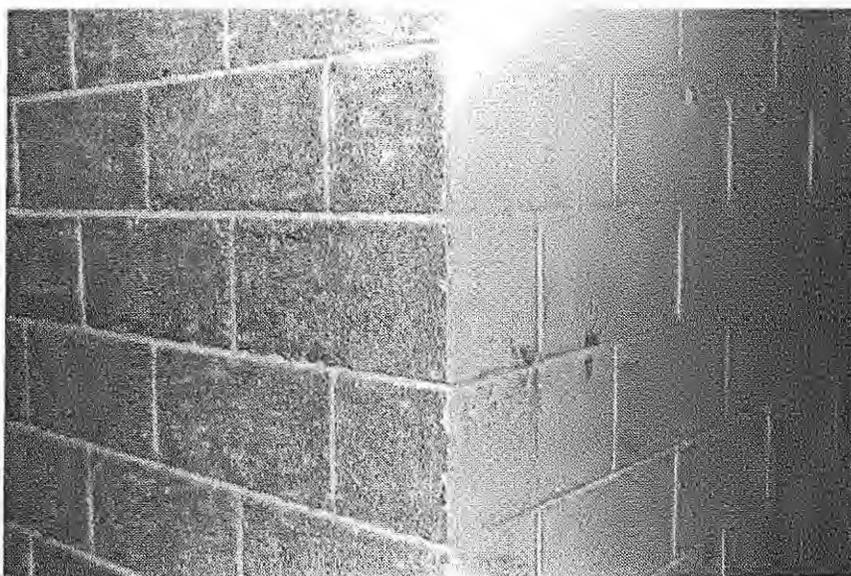
.Photo shows shot blasted wall surfaces before and after.

The vacu-blast machine is a sand or shot blasting machine that has a nozzle arrangement for vacuuming up the spent shot and debris from the blasting operation as it occurs. The machine separates the debris from the shot, cleans the shot and returns it to the feed hopper. The dust and paint flakes are collected in a cyclone dust collector and filter system. The final filter for the discharge air is a H.E.P.A. filter. This machine will prepare about 14 sq. ft. per hour of wall or ceiling. Cimarron has 4 units in service

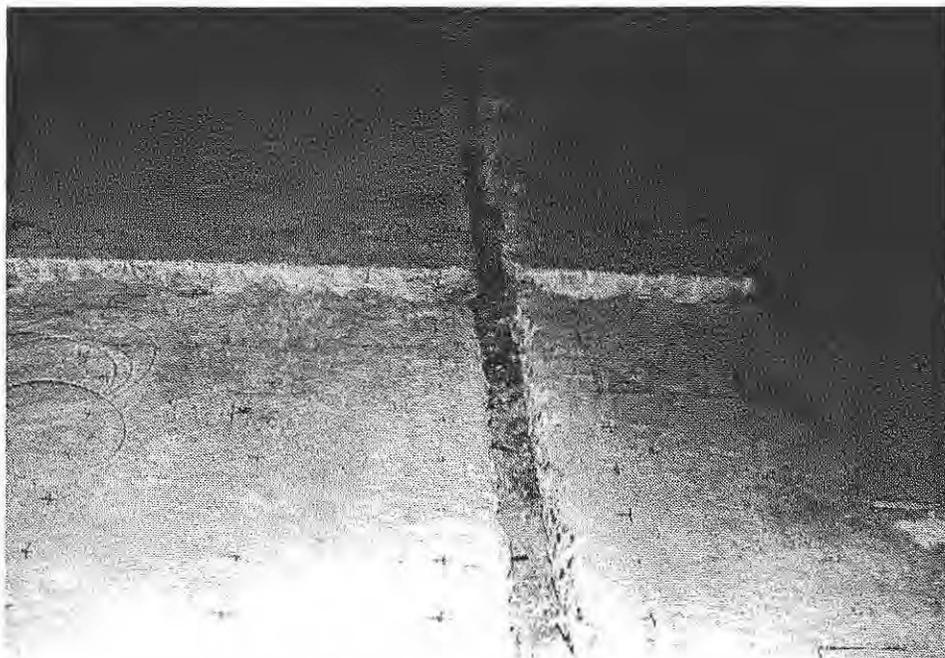
The results of removing contamination from the walls, floor, and cubicles are illustrated in the following photographs.

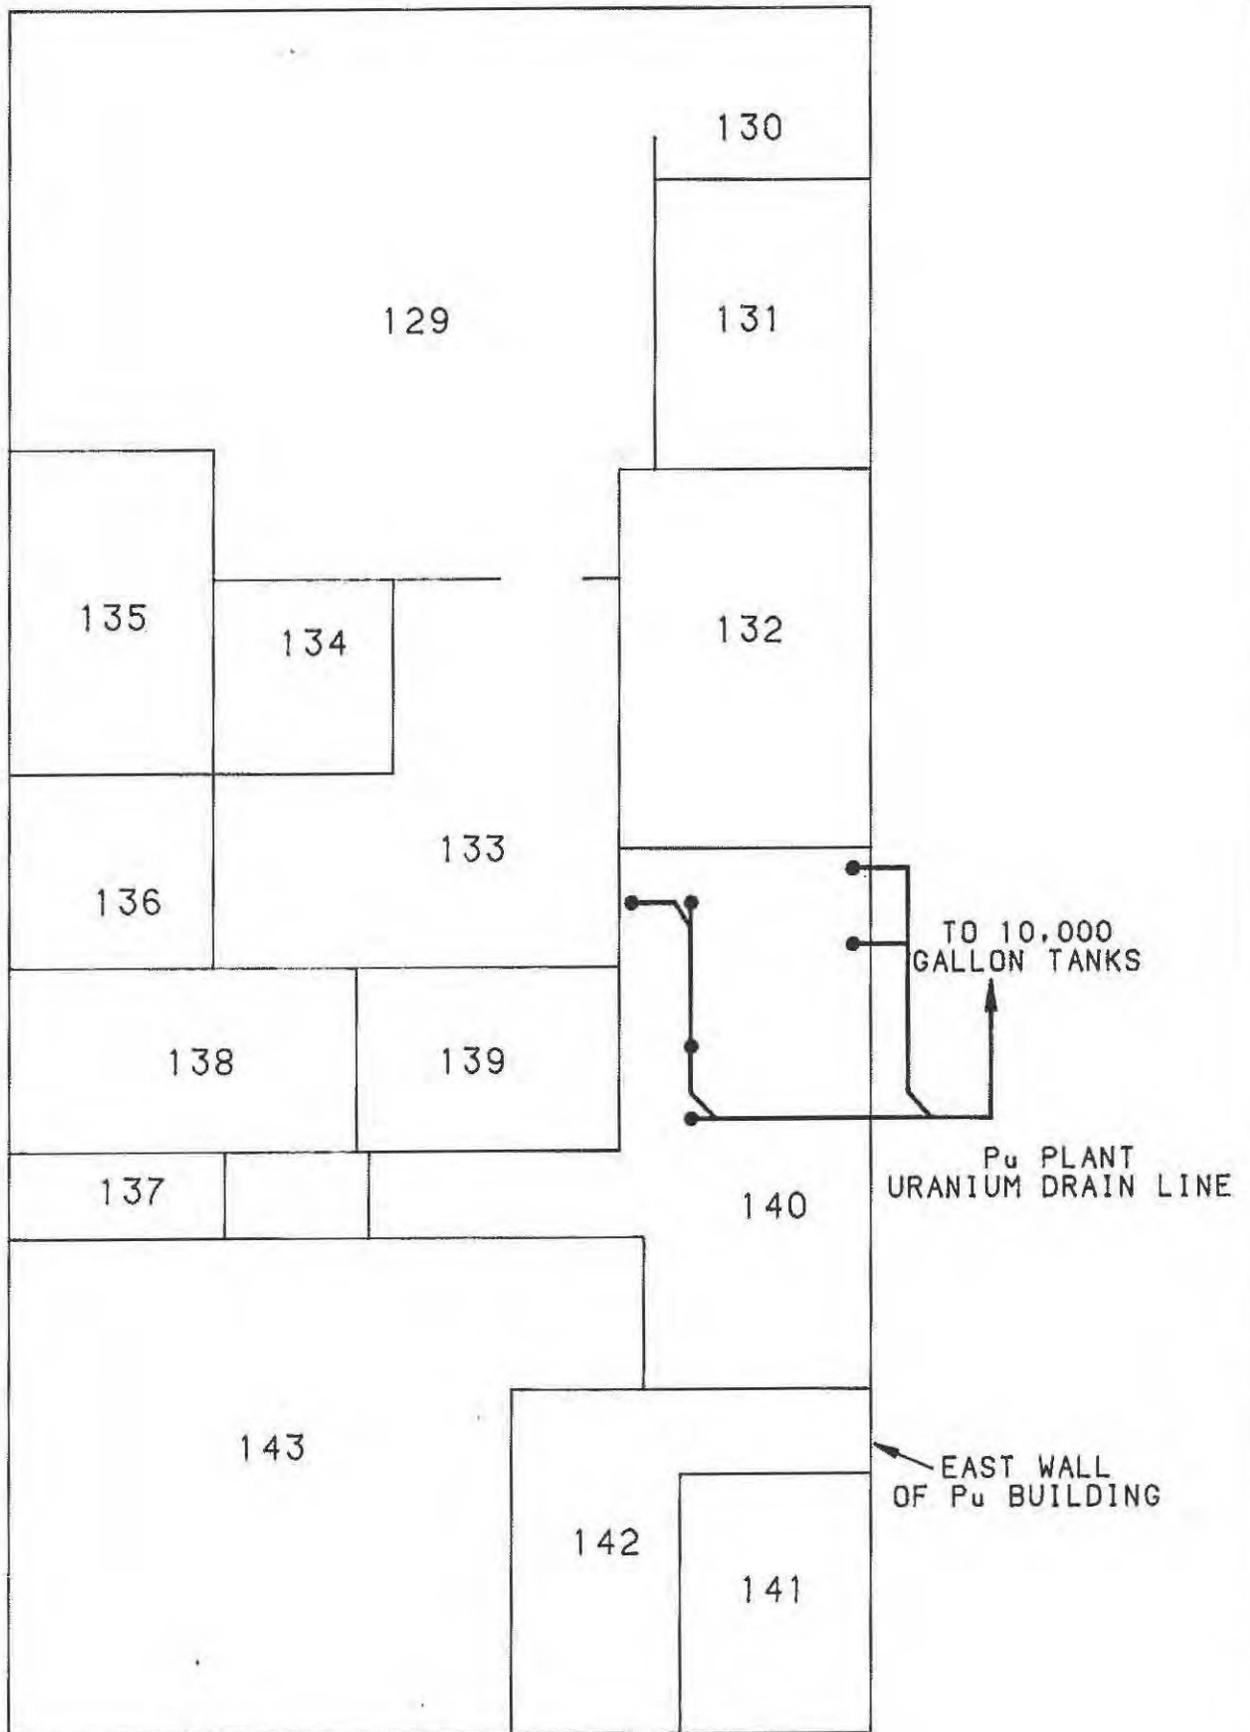
*Pu LABORATORY AREA*  
*FIGURE #1*

Since the uranium drainage system was contaminated to approximately 500 dpm/100 cm<sup>2</sup> smearable and was concentrated in one room we decided that it would be easier to remove this small system (Figure #1). This was accomplished by using a concrete saw to cut around the up risers, breaking out the concrete, and digging up the pipe. We performed a release survey on all concrete that was removed. All dirt was drummed as it was removed. All joints were inspected for leakage and surveyed for detectable contamination. After the pipe was removed each hole was surveyed with an Eberline PRM-5 with PG-2 gamma probe and soil samples were taken. Since no contamination problems were detected the dirt was then returned to the hole.

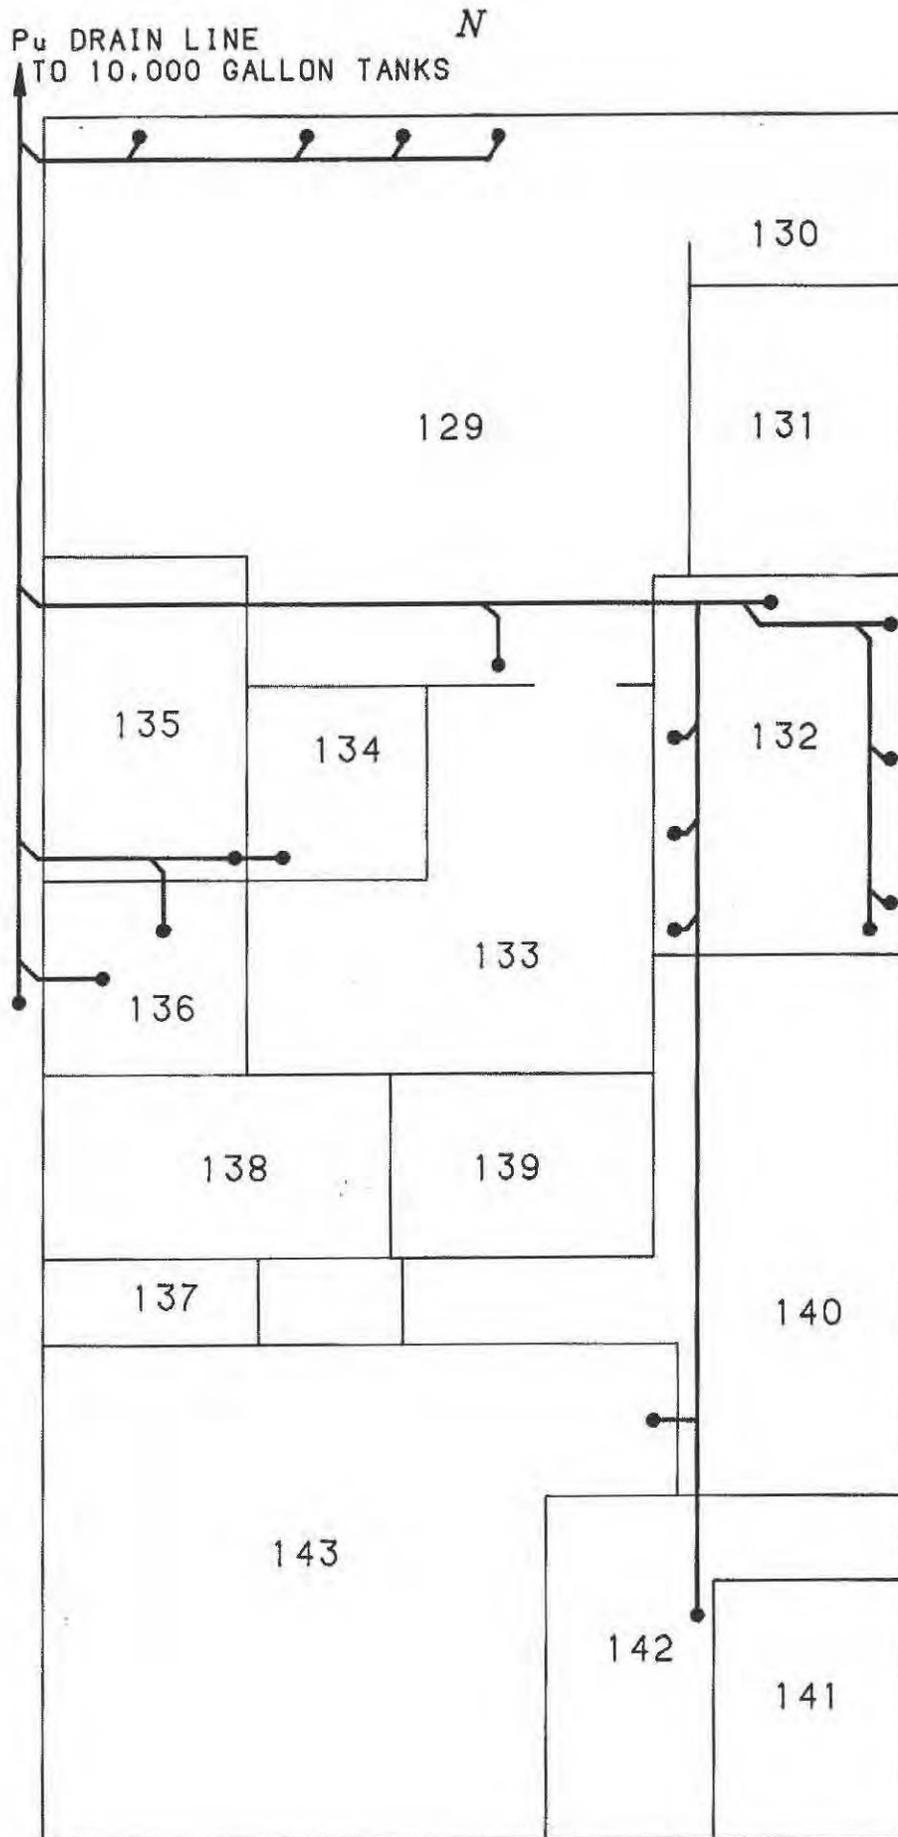
*P<sub>u</sub> LABORATORY AREA  
FIGURE #2*

Our initial plan was to clean and survey the Pu drain system (figure #2 and #2A). To accomplish this, we saw the need to acquire some special detectors and to prove that this system was leak proof. We initially removed a portion of this system outside of the building between the building and the 10,000 gallon tanks and installed a sight glass riser on the pipe at the lower level outside of the building (Figure #3). We proceeded to fill the entire system under the building with water to the floor level and marked the water level in the sight glass riser.

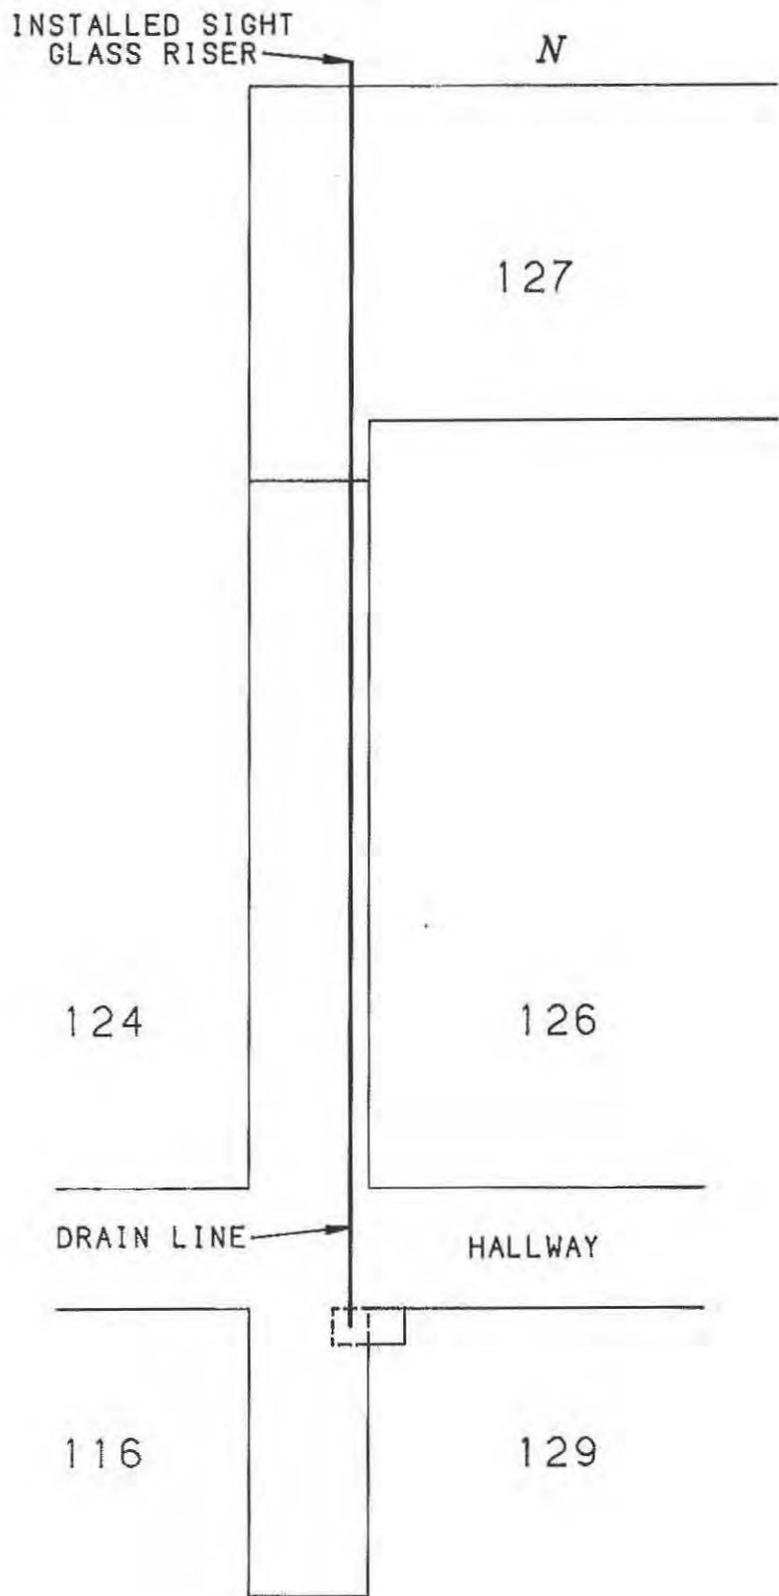
*FIGURE #3*

*Pu DRAIN LINE*

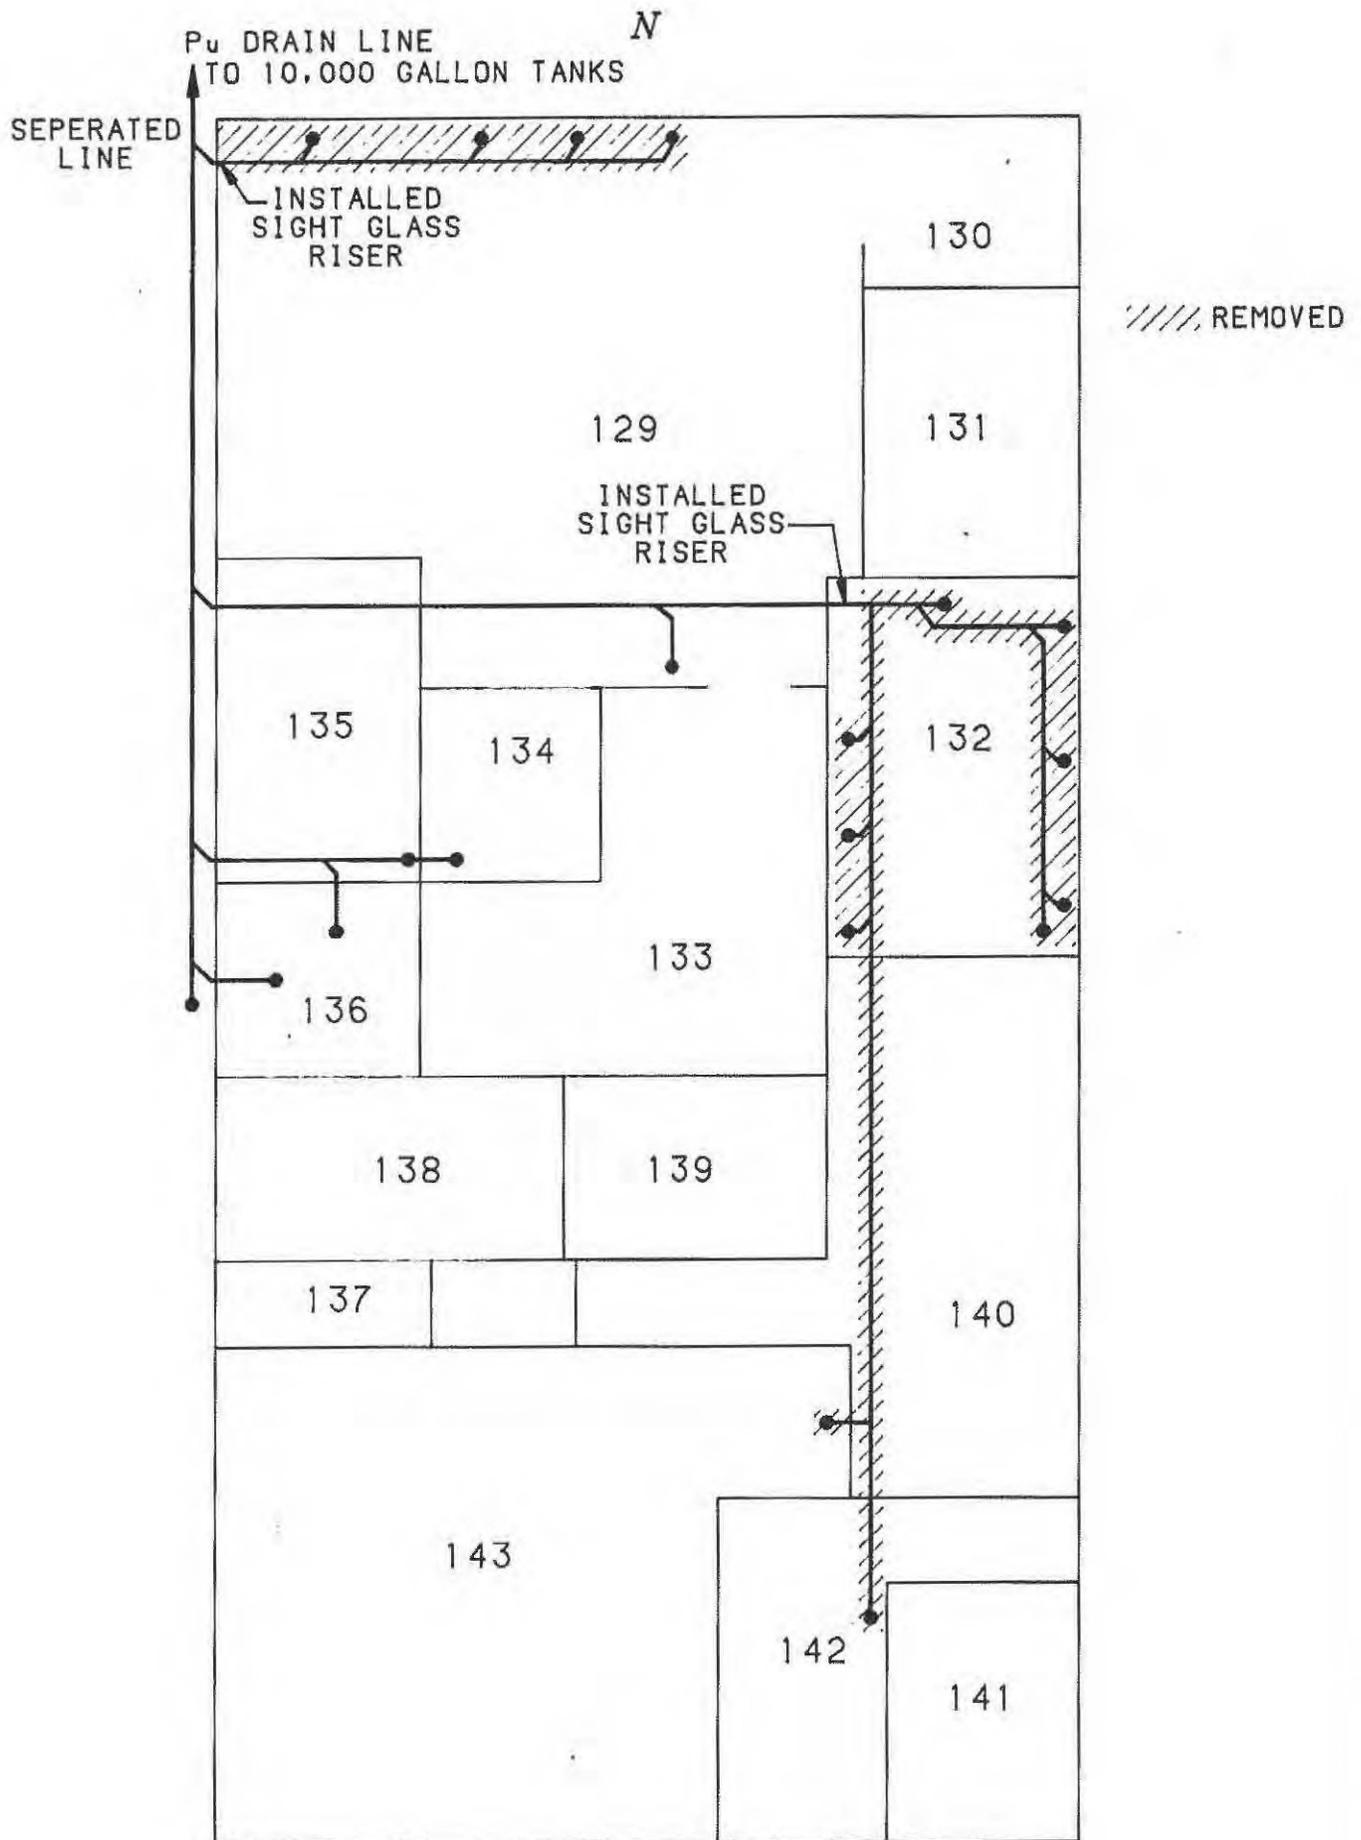
*Pu LABORATORY AREA*  
*FIGURE # 4*

The results of our initial leak test indicated a leak rate of approximately 0.5 gallons of water per minute in this remaining system. In an attempt to locate this leak we decided to remove the line from under rooms 141, 142, 143, 140, and 132 since we already had access under the floor in room 140. We also decided to cut a hole in the northwest corner of room 129 and to separate the drain line there for our next leak test (figure #4).

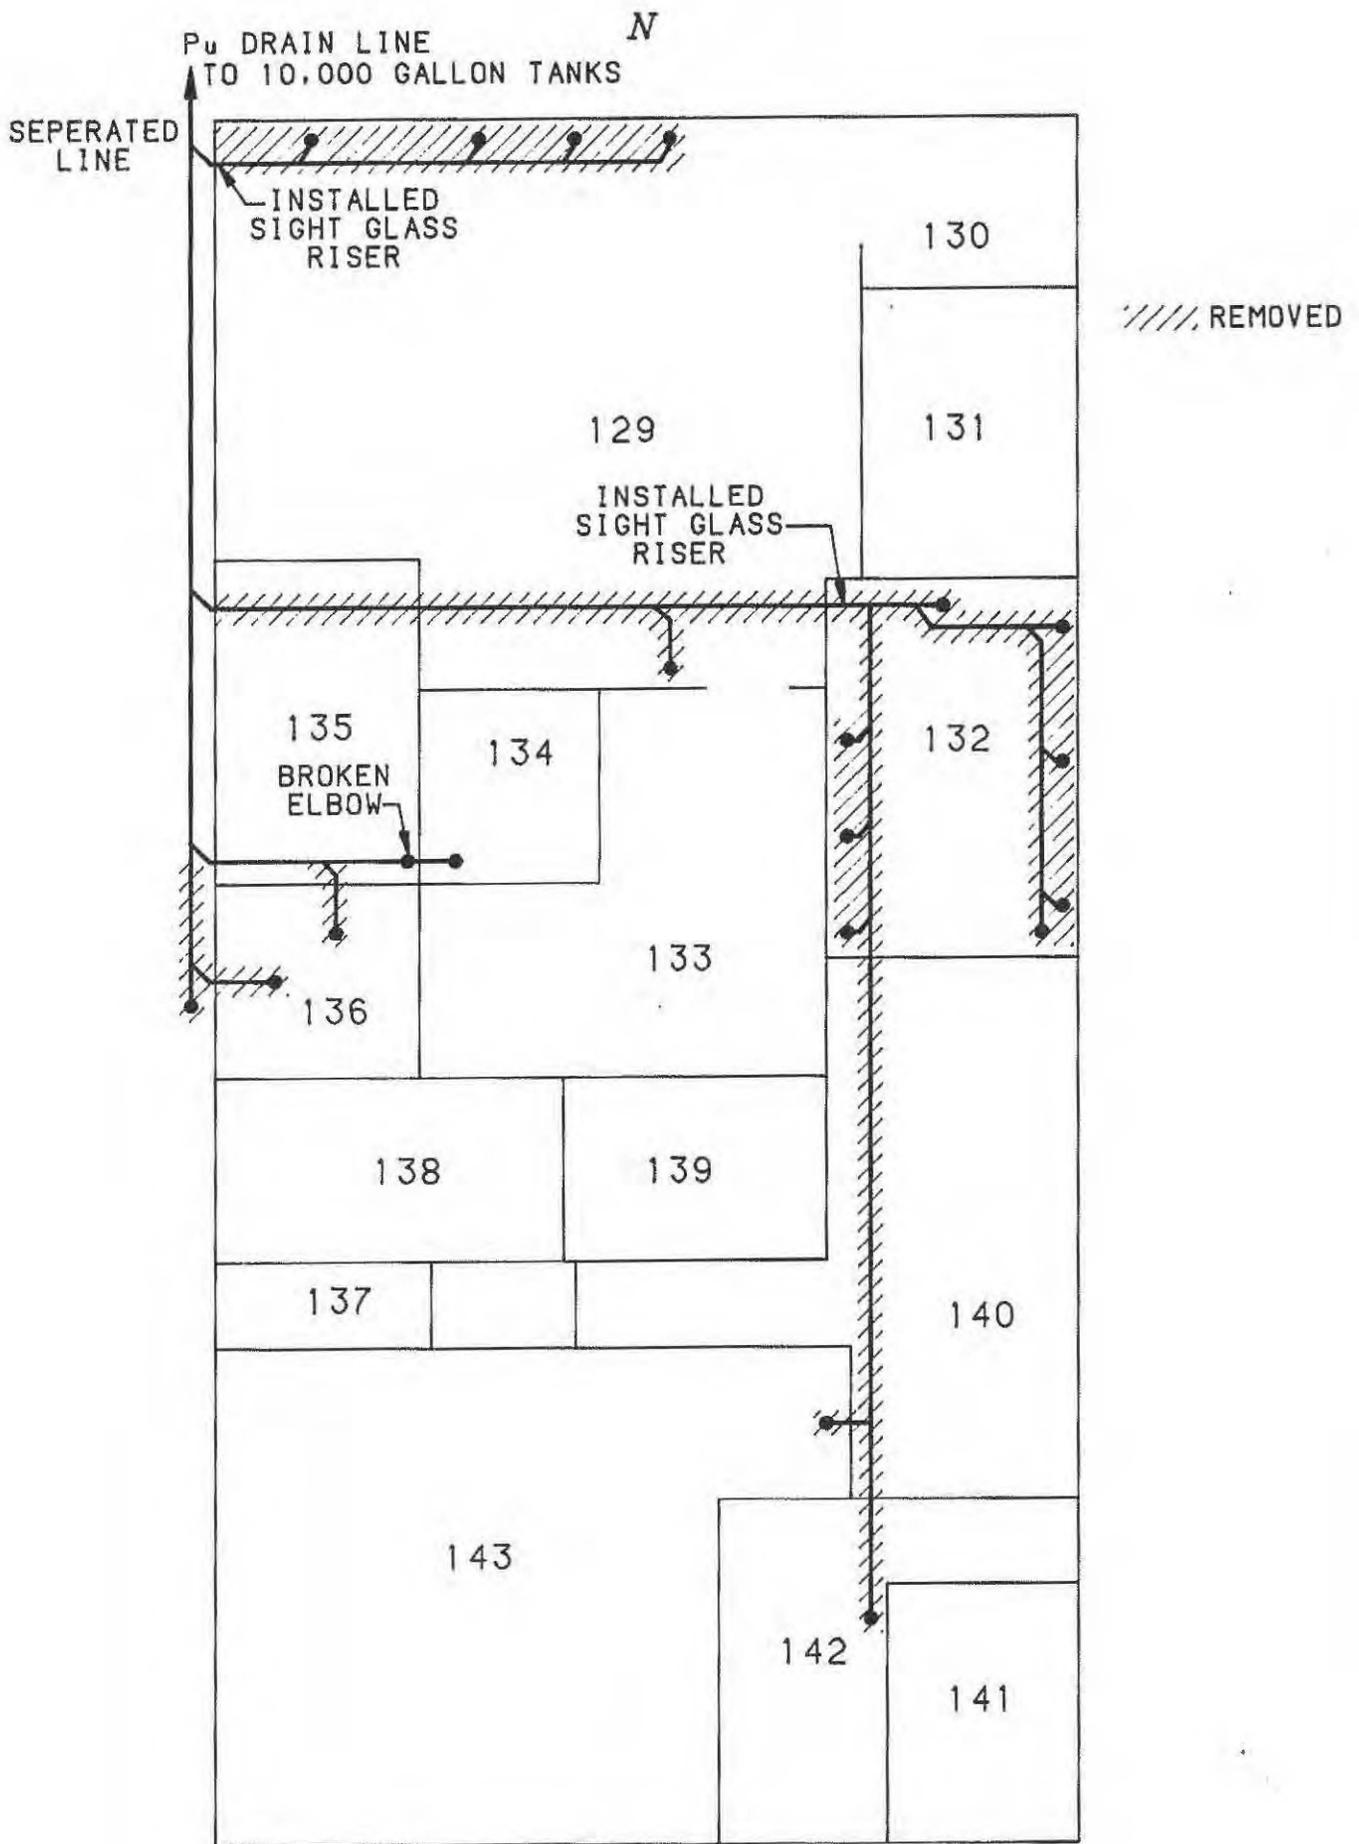
*Pu LABORATORY AREA*  
*FIGURE #5*

Our second leak test consisted of the remaining drain system in the laboratory area only. We installed two standpipes, one in the northwest corner of room 129, and the other in room 132 northwest corner (Figure #4). After filling this portion of the drain system with water, we still indicated a leak rate of approximately 0.5 gallons per minute. Because of the results of this leak test we continued to remove Pu drain line until we found a wet area in room 135. This wet dirt was drummed separately and labeled as possibly contaminated dirt (Figure #5.) As we continued to remove dirt at this location we found an elbow at approximately 6 feet below floor level with the back of the elbow broken out. Since there was only approximately 35 feet of this drain system left in the laboratory area, we decided to complete removal of this system from the laboratory area (Figure #6). Our third leak test consisted of the drain line from the northwest corner of room 129 to the north wall of the Pu building (Figure #7). After this portion of the system was filled with water and left 24 hours it indicated no leakage from this part of the system. This is a straight run of approximately 82 feet of two inch durcon pipe that runs through the exhaust ventilation tunnel and under the production hall thru room 127 (Figure #7). Initial smearable results indicated approximately 1000 dpm/100 cm<sup>2</sup> smearable in this pipe. We used a rotating steel brush with a water flush to clean this pipe to less than 20 dpm/100 cm<sup>2</sup> smearable.

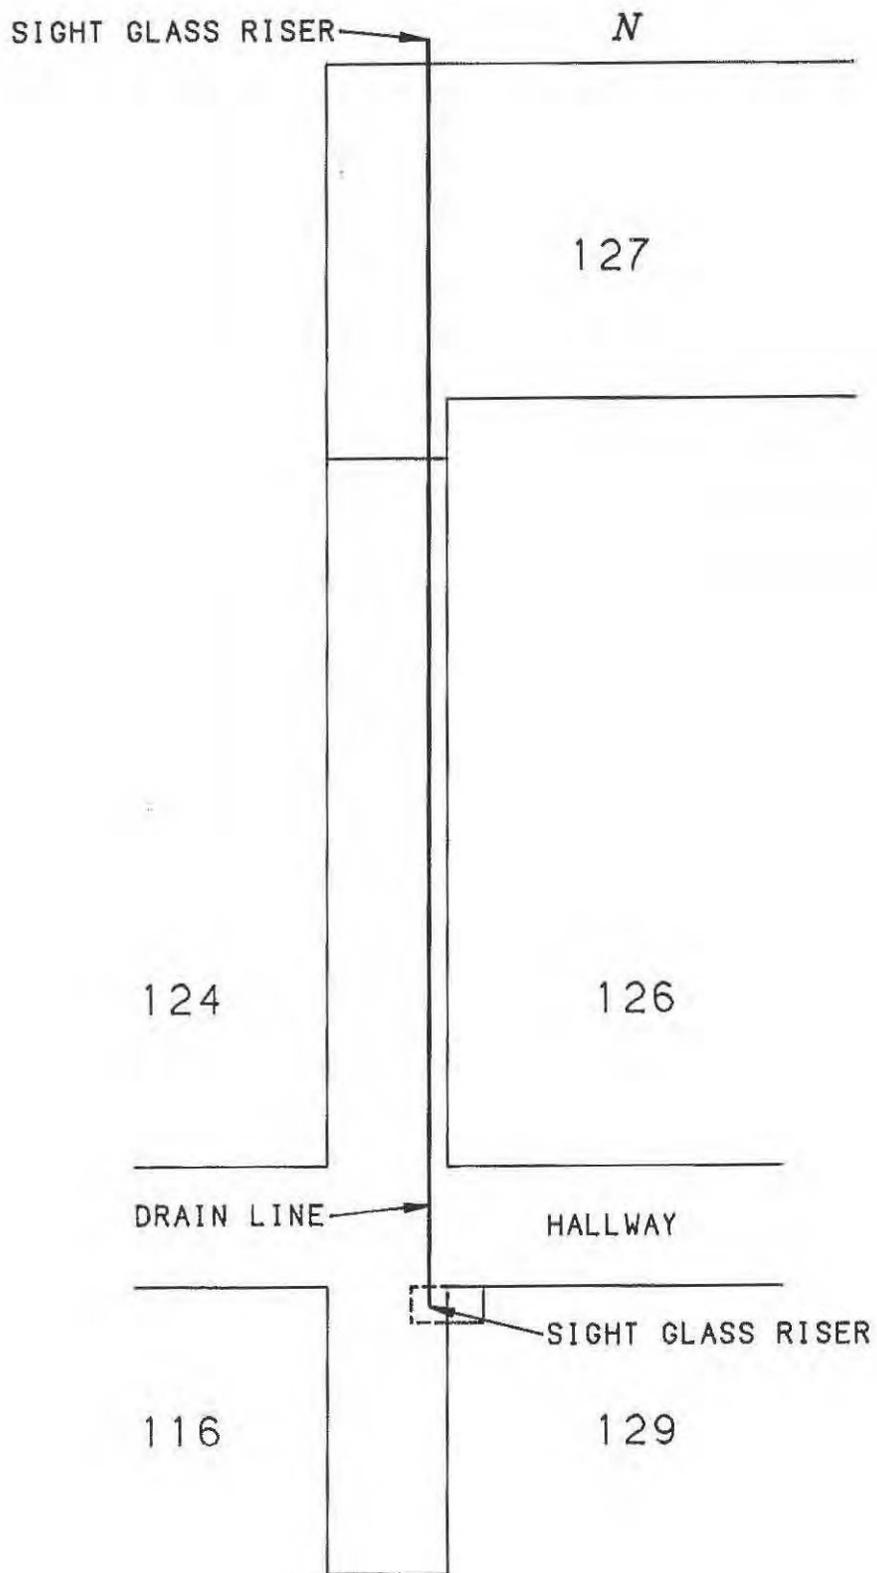
*FIGURE #7*

*Pu DRAIN LINE*
