From: Cary, Richard H. <Richard.Cary@pseg.com>
Sent: Wednesday, July 28, 2021 11:13 AM
To: incidental.take@noaa.gov; EndangeredSpecies Resource
Cc: Neilan, Brian
Subject: [External_Sender] Salem Generating Station - Incidental Take Report: Atlantic Sturgeon 7/27/2021
Attachments: Sturgeon Incidental Take Report for 07-27-2021.pdf

Appendix C, Part 2A (Sturgeon)

STURGEON DATA COLLECTION FORM

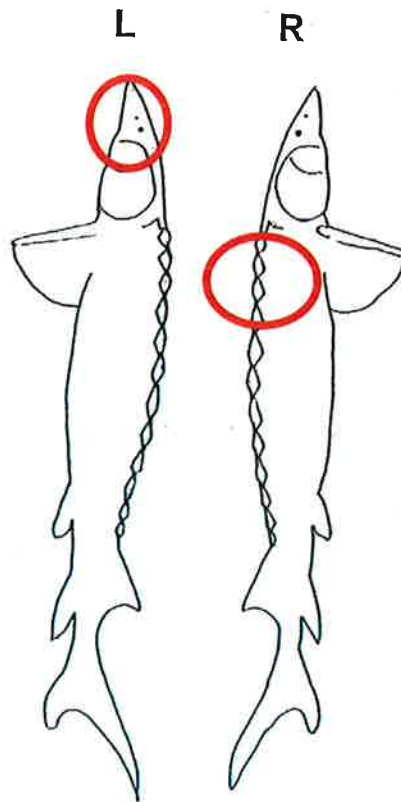
Evidence of bruising on the ventral aspect of the rostrum.

Location of large puncture wound on the right dorsal surface of the torso, posterior to the pectoral fin

Describe any wounds / abnormalities (note tar or oil, gear or debris entanglement, propeller damage, etc.). **Please note if no wounds / abnormalities are found. Specimen was deceased at the time of collection, with some damage in the form of a large laceration or puncture wound on the right dorsal surface of the torso. There was also evidence of bruising on the ventral aspect of the rostrum (refer to illustration). The puncture wound did not appear to be fresh, and the entire carcass was darkened and in a dried out condition.**

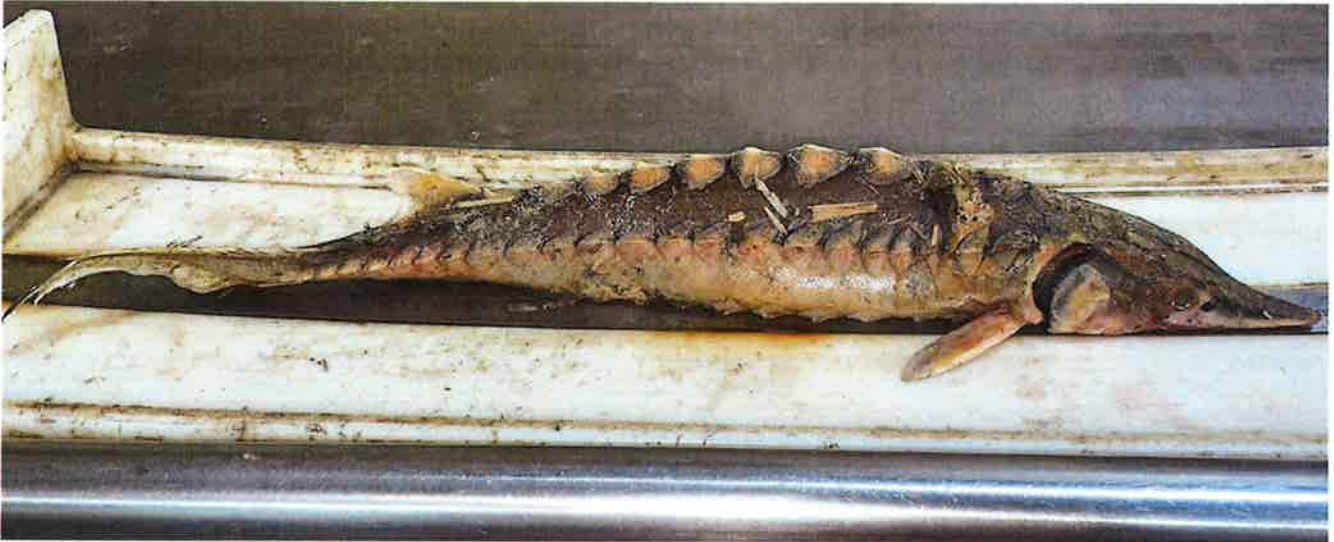
A right dorsolateral view, showing the size and condition of a deceased Atlantic sturgeon (*Acipenser oxyrinchus*), retrieved at approximately 1455 on 07/27/2021 from the Salem Circulating Water Intake trash collection basket by Salem Yard Crew personnel during routine trash rack cleaning at Salem Nuclear Generating Station (07/27/2021).

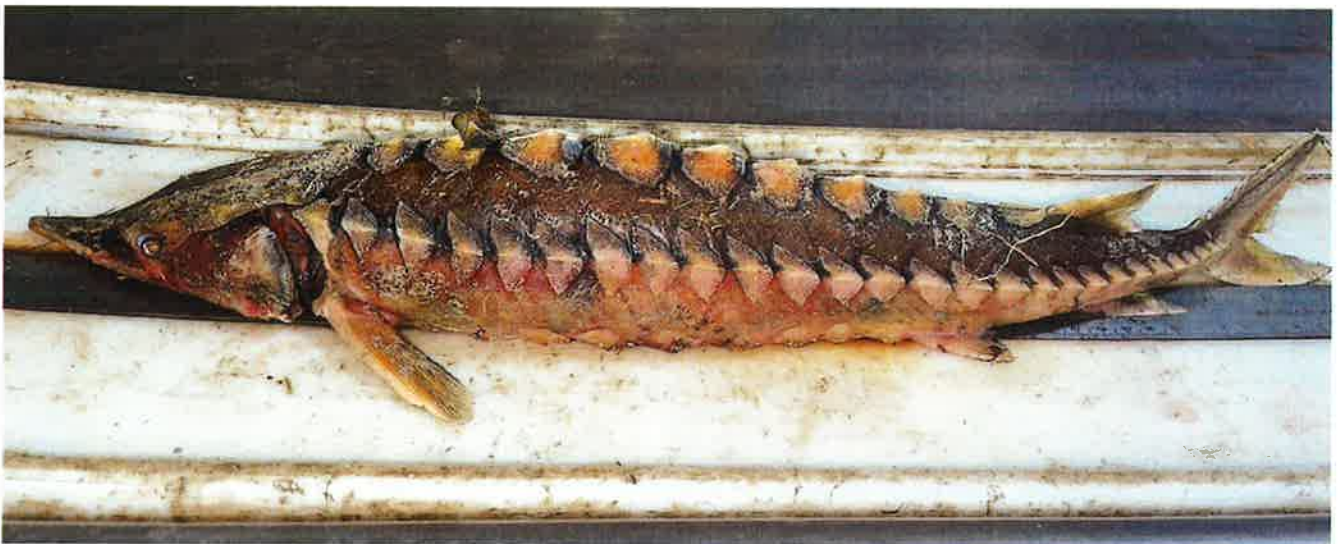
A left dorsolateral view, showing the condition of the specimen at the time of the collection. Except for a laceration or puncture wound on the right dorsal surface of the torso and some bruising on portions of the head and rostrum, no additional damage was observed (07/27/2021).

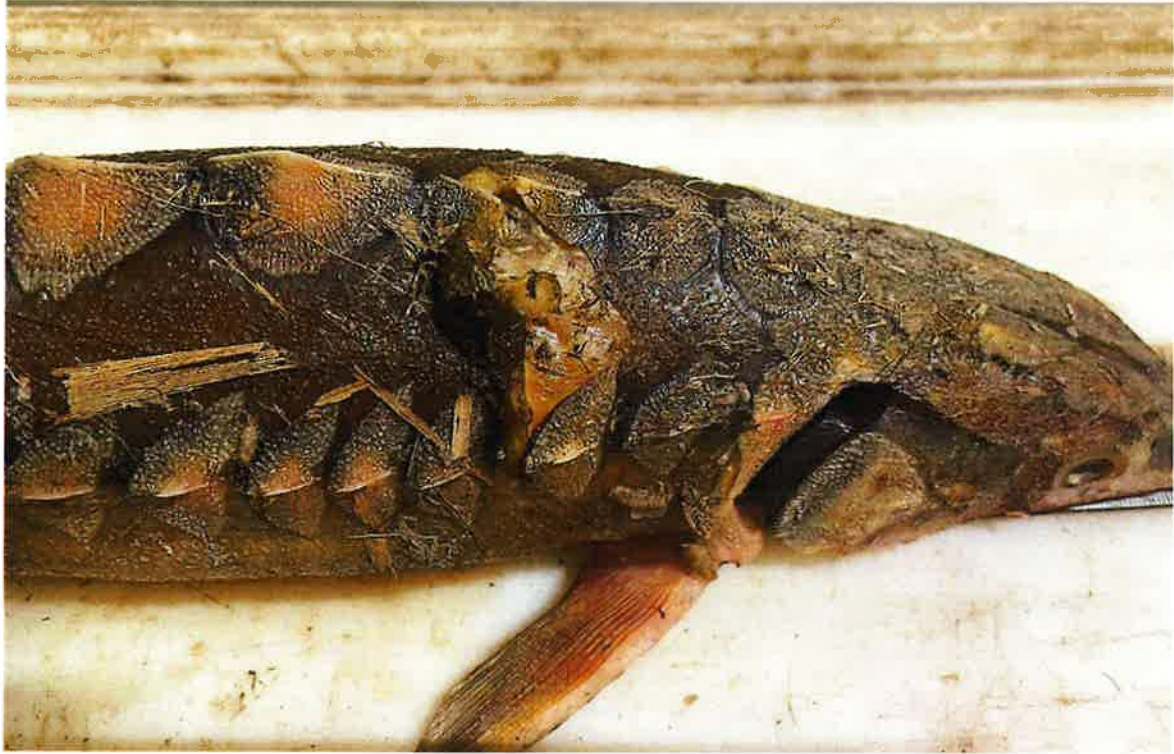
Dorsal view of the right side of the torso, showing the location of a large laceration or puncture wound. At the time of observation, the entire specimen was in a dried-out condition. The wound did not appear to be fresh, indicating it was not likely the cause of death (07/27/2021).

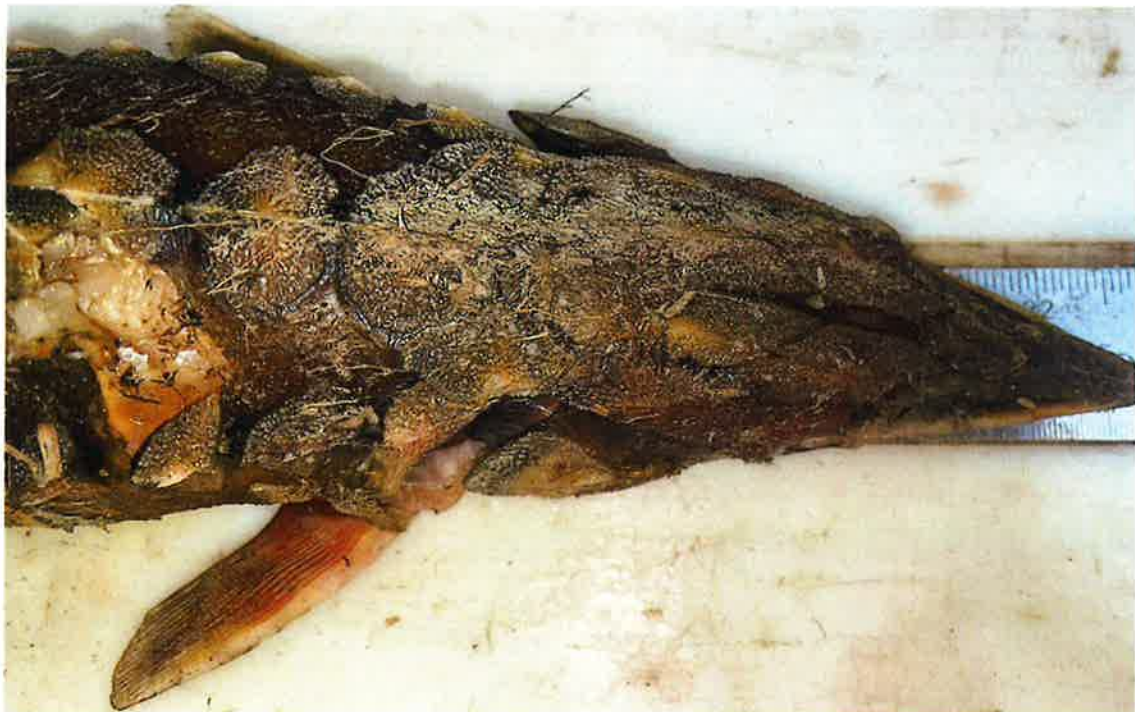
A dorsal view of the head, showing the characteristic elongated rostrum. Some evidence of bruising was observed on portions of the head, particularly on the ventral aspect of the rostrum. (07/27/2021).

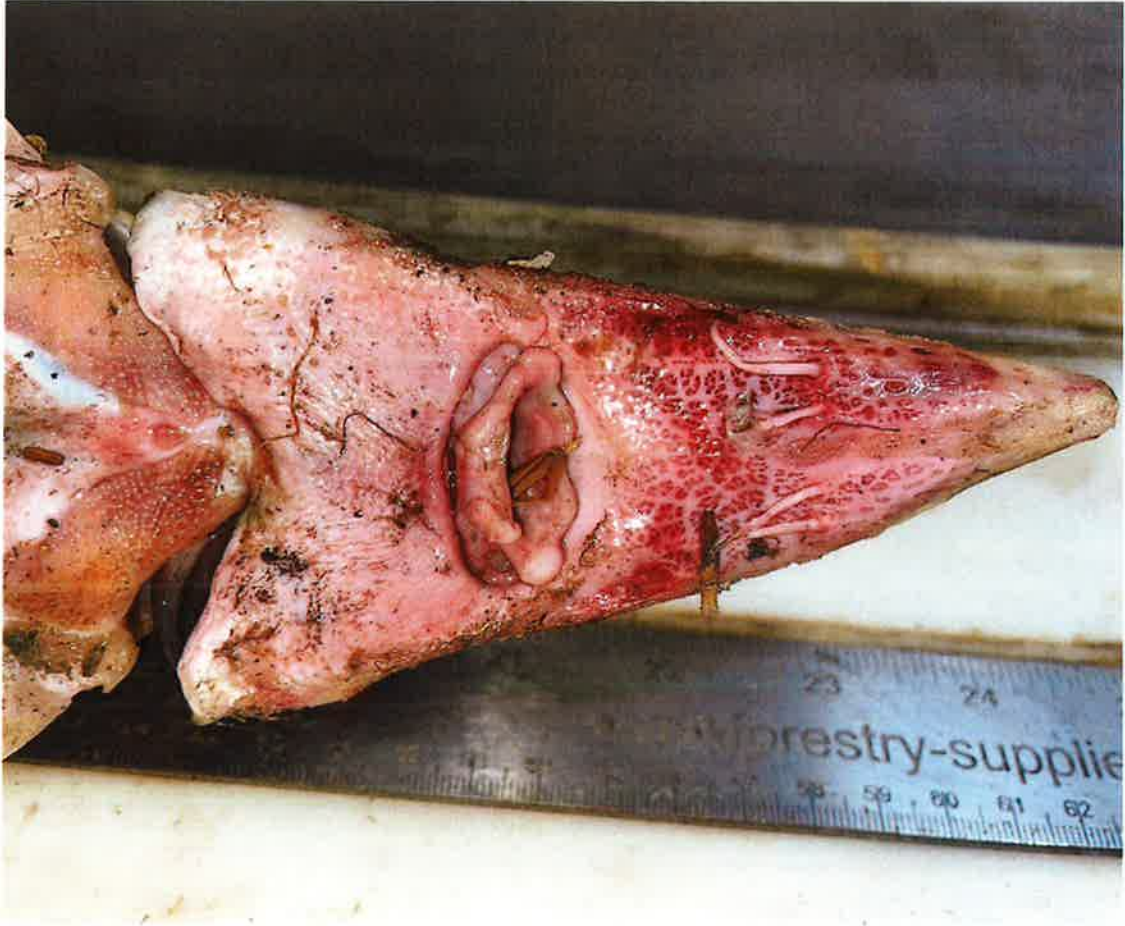
A ventral view of the head, showing the characteristic elongated rostrum. Bruising of the surface tissue was evident at the time of collection and processing (07/27/2021).
