**Test Report**Document No.: **TR-3023626** Rev. No. **000** Page 1 of 66 (66 Total Pages)Project No.: **02008.01.0000.00** Project Name: **INC OP-Raw Material Shipping Container**Title: **Test Report for the Industrial Nuclear Company Outer Package, Raw Material Shipping Container (OP-RMSC)****Summary:**

This procedure documents the required free and puncture drop tests for qualifying the Industrial Nuclear Company (INC) OP-RMSC package to the requirements of Title 10, Code of Federal Regulations, Part 71 (10 CFR 71), *Packaging and Transportation of Radioactive Material*, as a radioactive material package. The results of these tests will be utilized as supporting documentation for INC's application to the US Nuclear Regulatory Commission to obtain a transportation license under Docket No. 71-9387.

Title: Test Report for the INC OP-RMSC Package

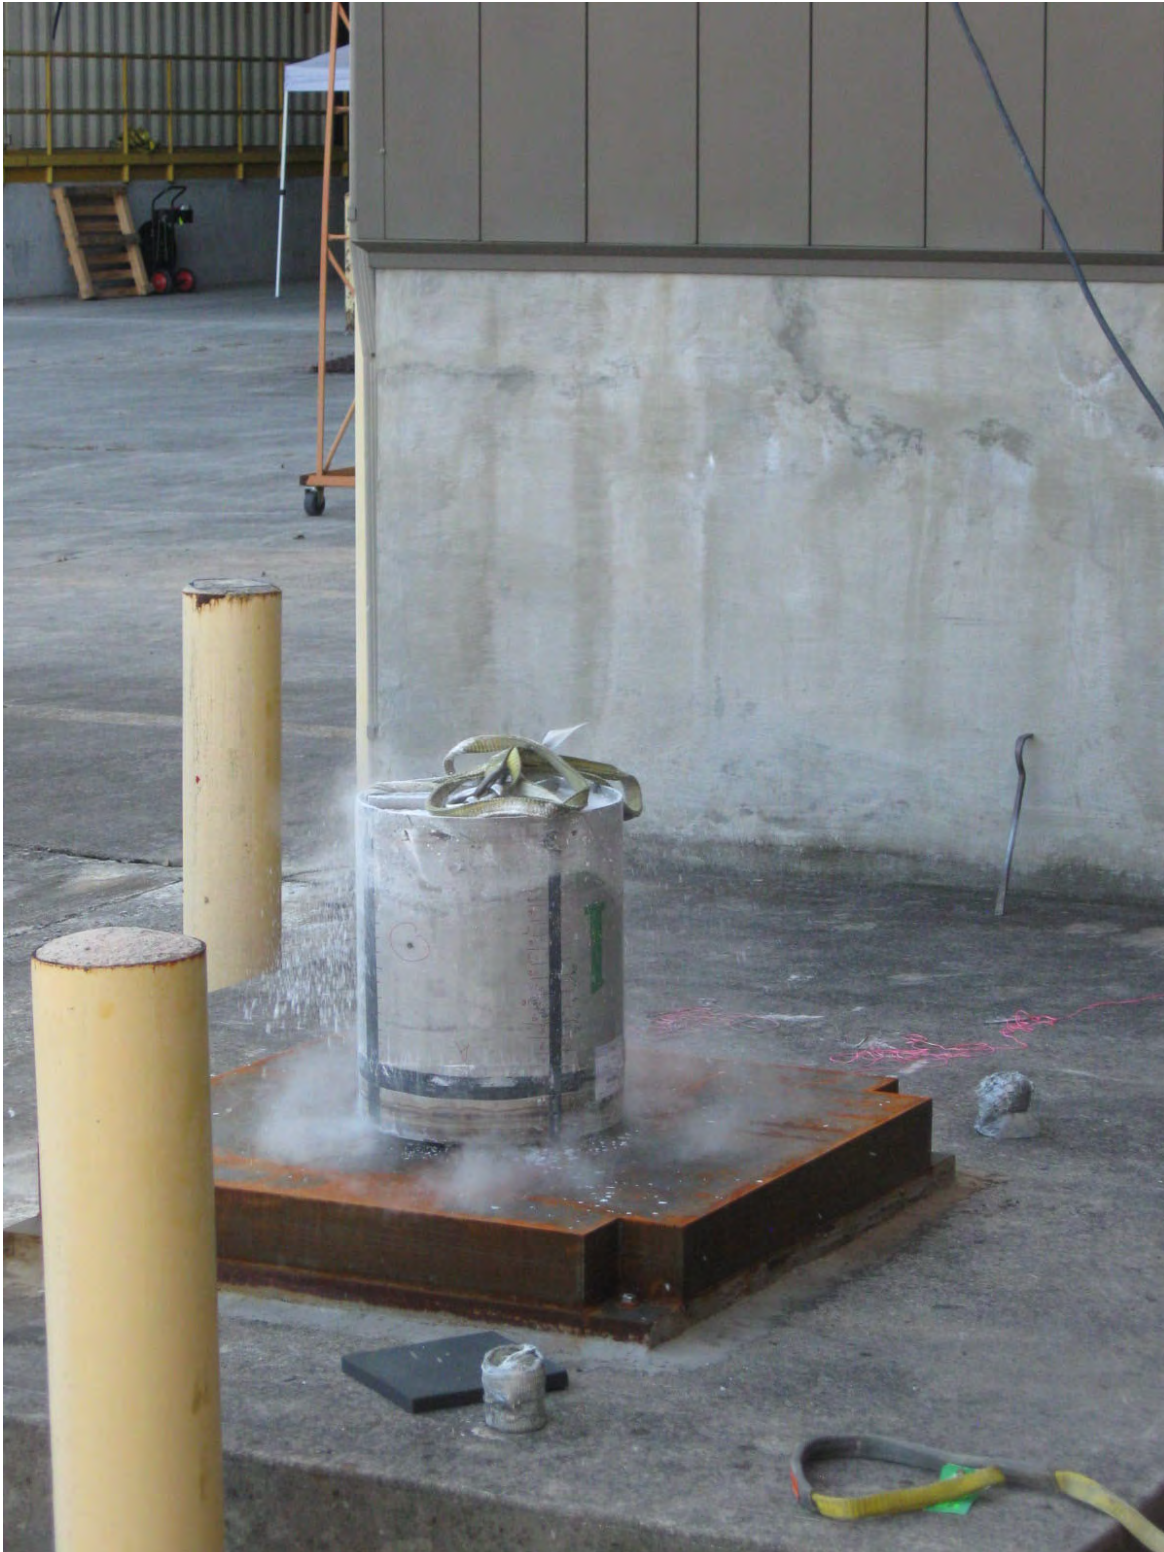
FIGURE B.1.1-2 – Test Unit at Impact, NCT 4-Foot Top Down Drop

The package rebounded (bounced) upon impact off the drop pad, and remained upright. No external damage was noted. Figures B.1.1-X photo-documents Test Number 1 for CTU-1.

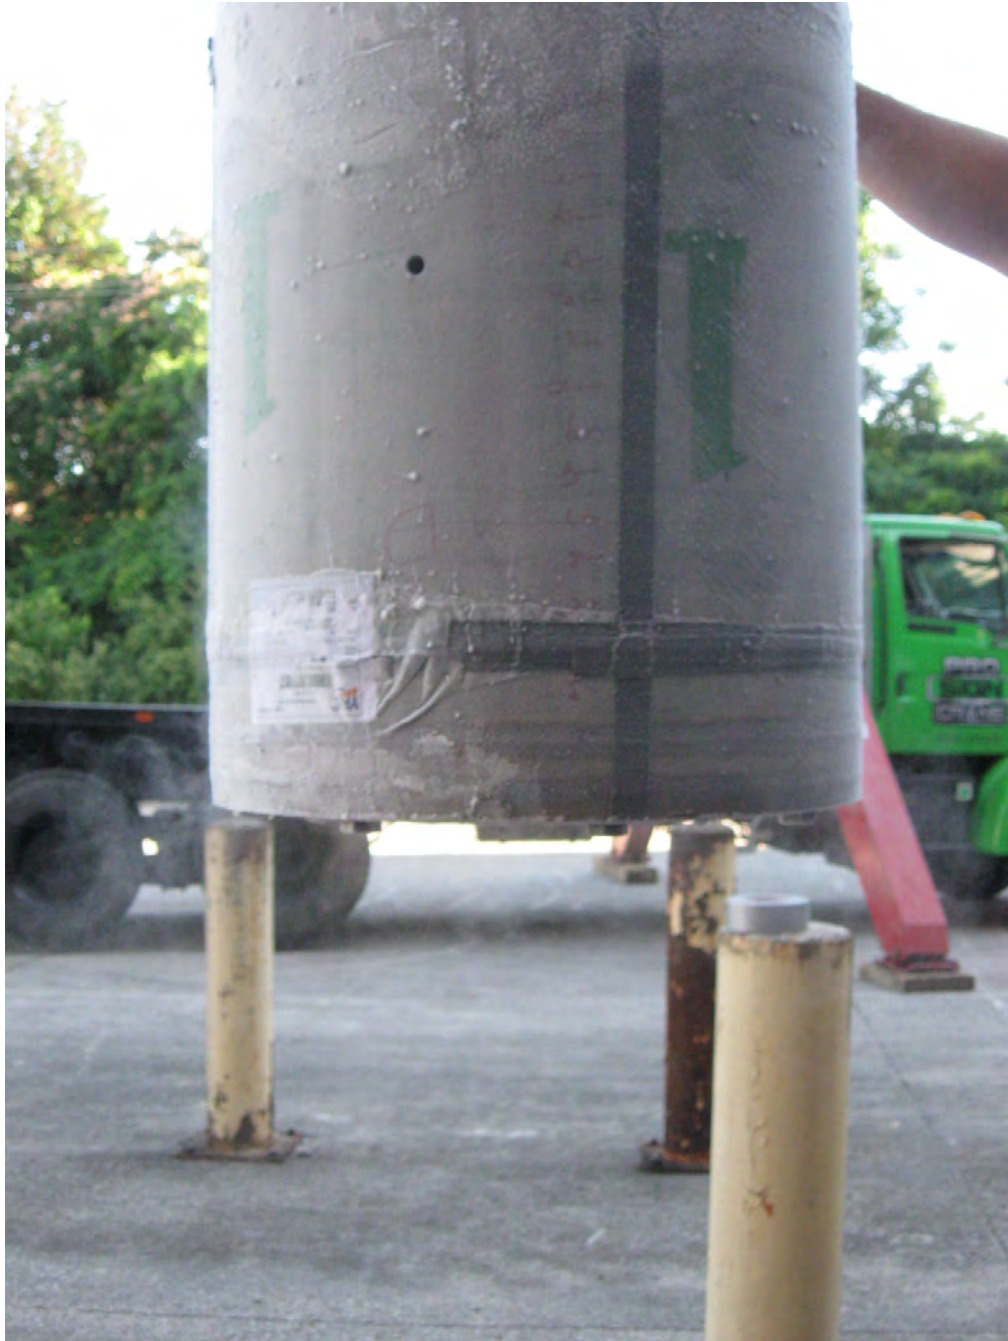
FIGURE B.1.1-3– Close-up View of Top/Side Following NCT 4-Foot Top Down Drop

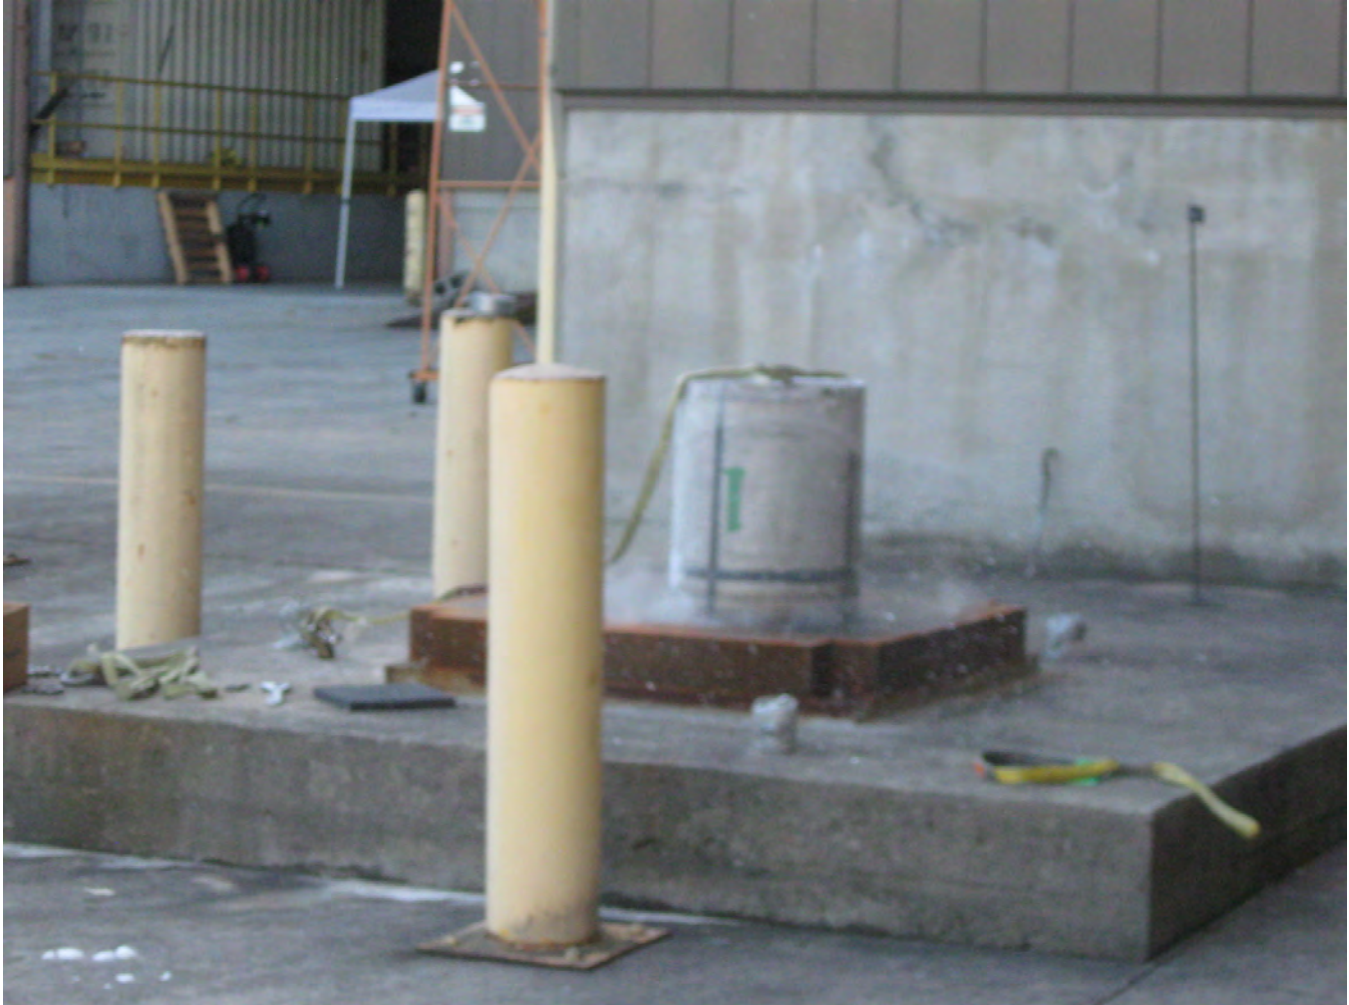
FIGURE B.1.2-2 – Test Unit at Impact, HAC 30-Foot Top Down Drop

The package impacted the drop pad and did not rebound (bounce). The package remained upright on drop pad. No external damage was noted. All of the bolts securing the inner lid failed, allowing the inner lid to separate from the body and contact the closure lid. The RMSC payload remained within the OP-RMSC. Figures B.1.2-X photo-documents Test Number 2 for CTU-1.

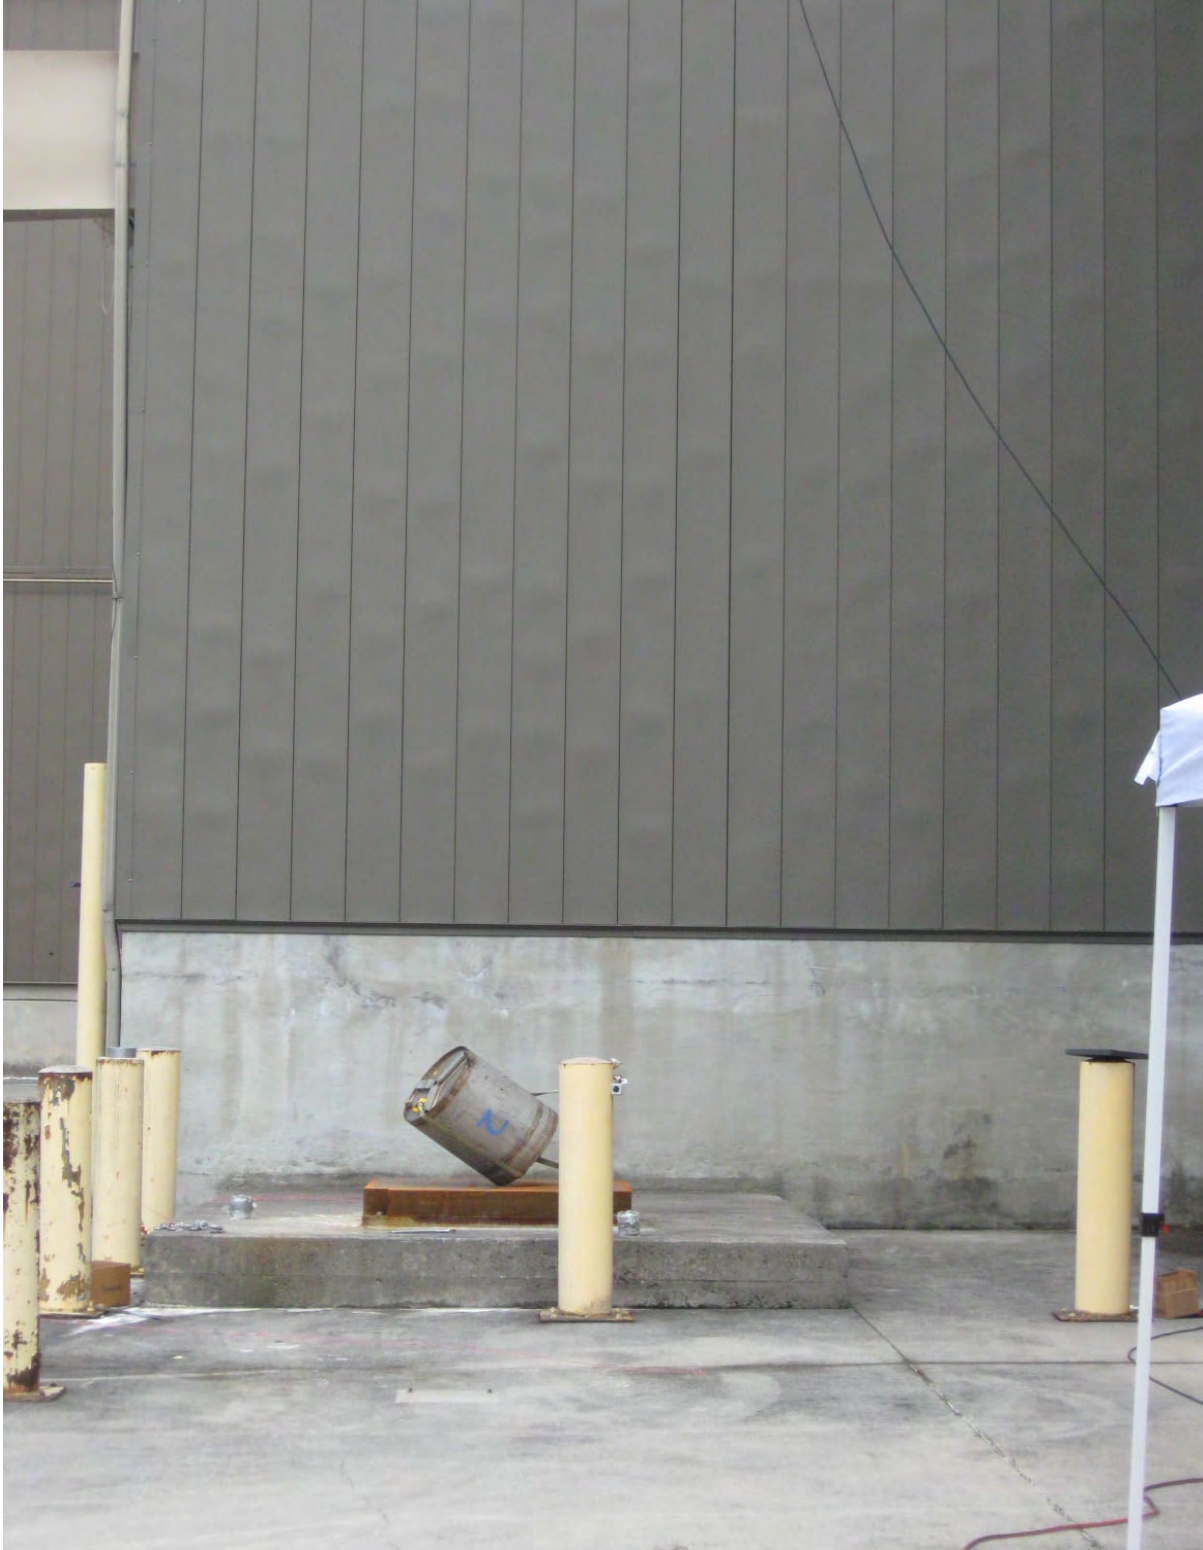
FIGURE B.1.3-2 – Test Unit Immediately After HAC 30-Foot Side Drop

The package rebounded (bounced) upon impact off the drop pad, and fell to its side. Impact created a ~4 inch wide flat along the side of the outer shell. One closure lid bolt on the impact side failed. No other external damage was noted. Figures B.1.3-X photo-documents Test Number 2 for CTU-2.

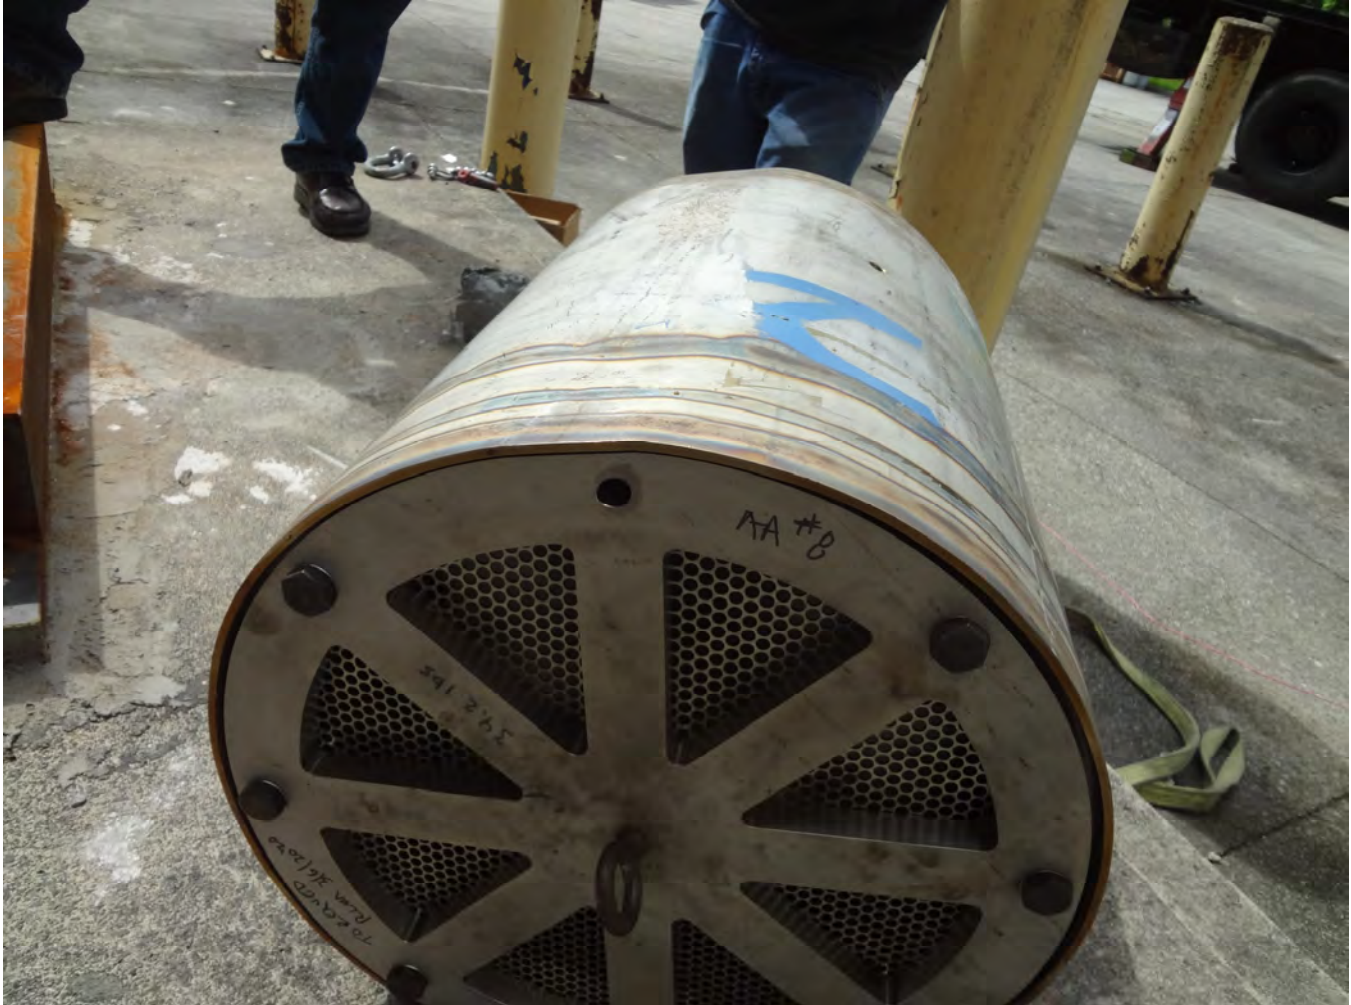
FIGURE B.1.3-3 – Close-up View of Deformed Side Flat (~4 inch Width), Failed Closure Lid Bolt, HAC 30-Foot Side Drop

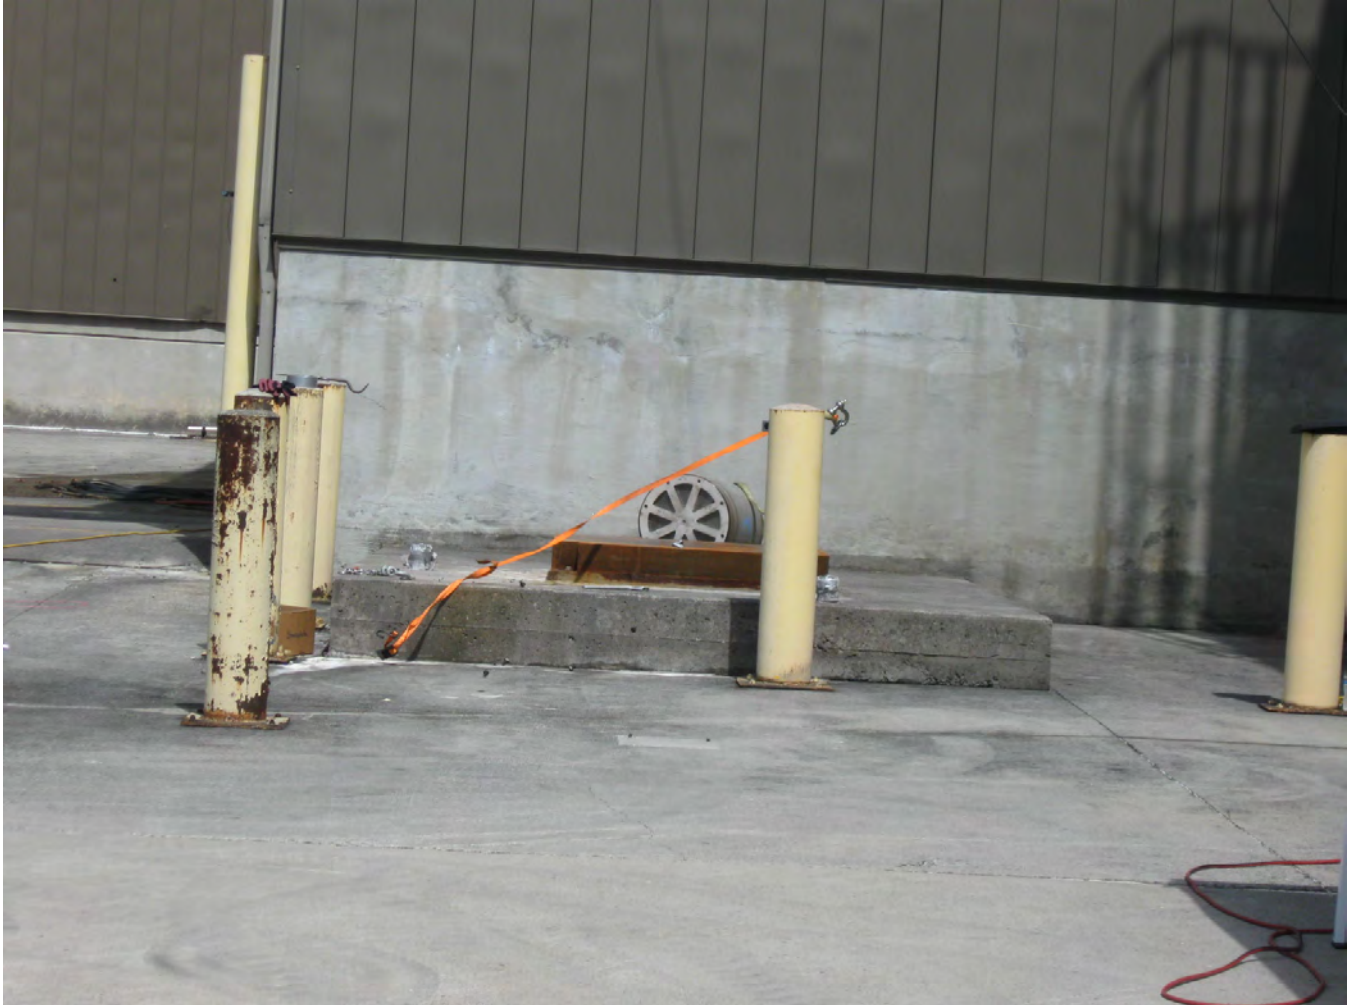
FIGURE B.1.4-2 – Test Unit After HAC 30-Foot CG-Over-Top Corner Drop

The package rebounded (bounced) upon impact off the drop pad, and fell to its side. The impact produced a ~1/2 inch buckle/fold on the outer shell. Five (5) of the remaining seven (7) closure lid bolts failed. However, the closure lid did not separate from the body. No other damage was visible or noted. Figures B.1.4-X photo-documents Test Number 2 for CTU-2.

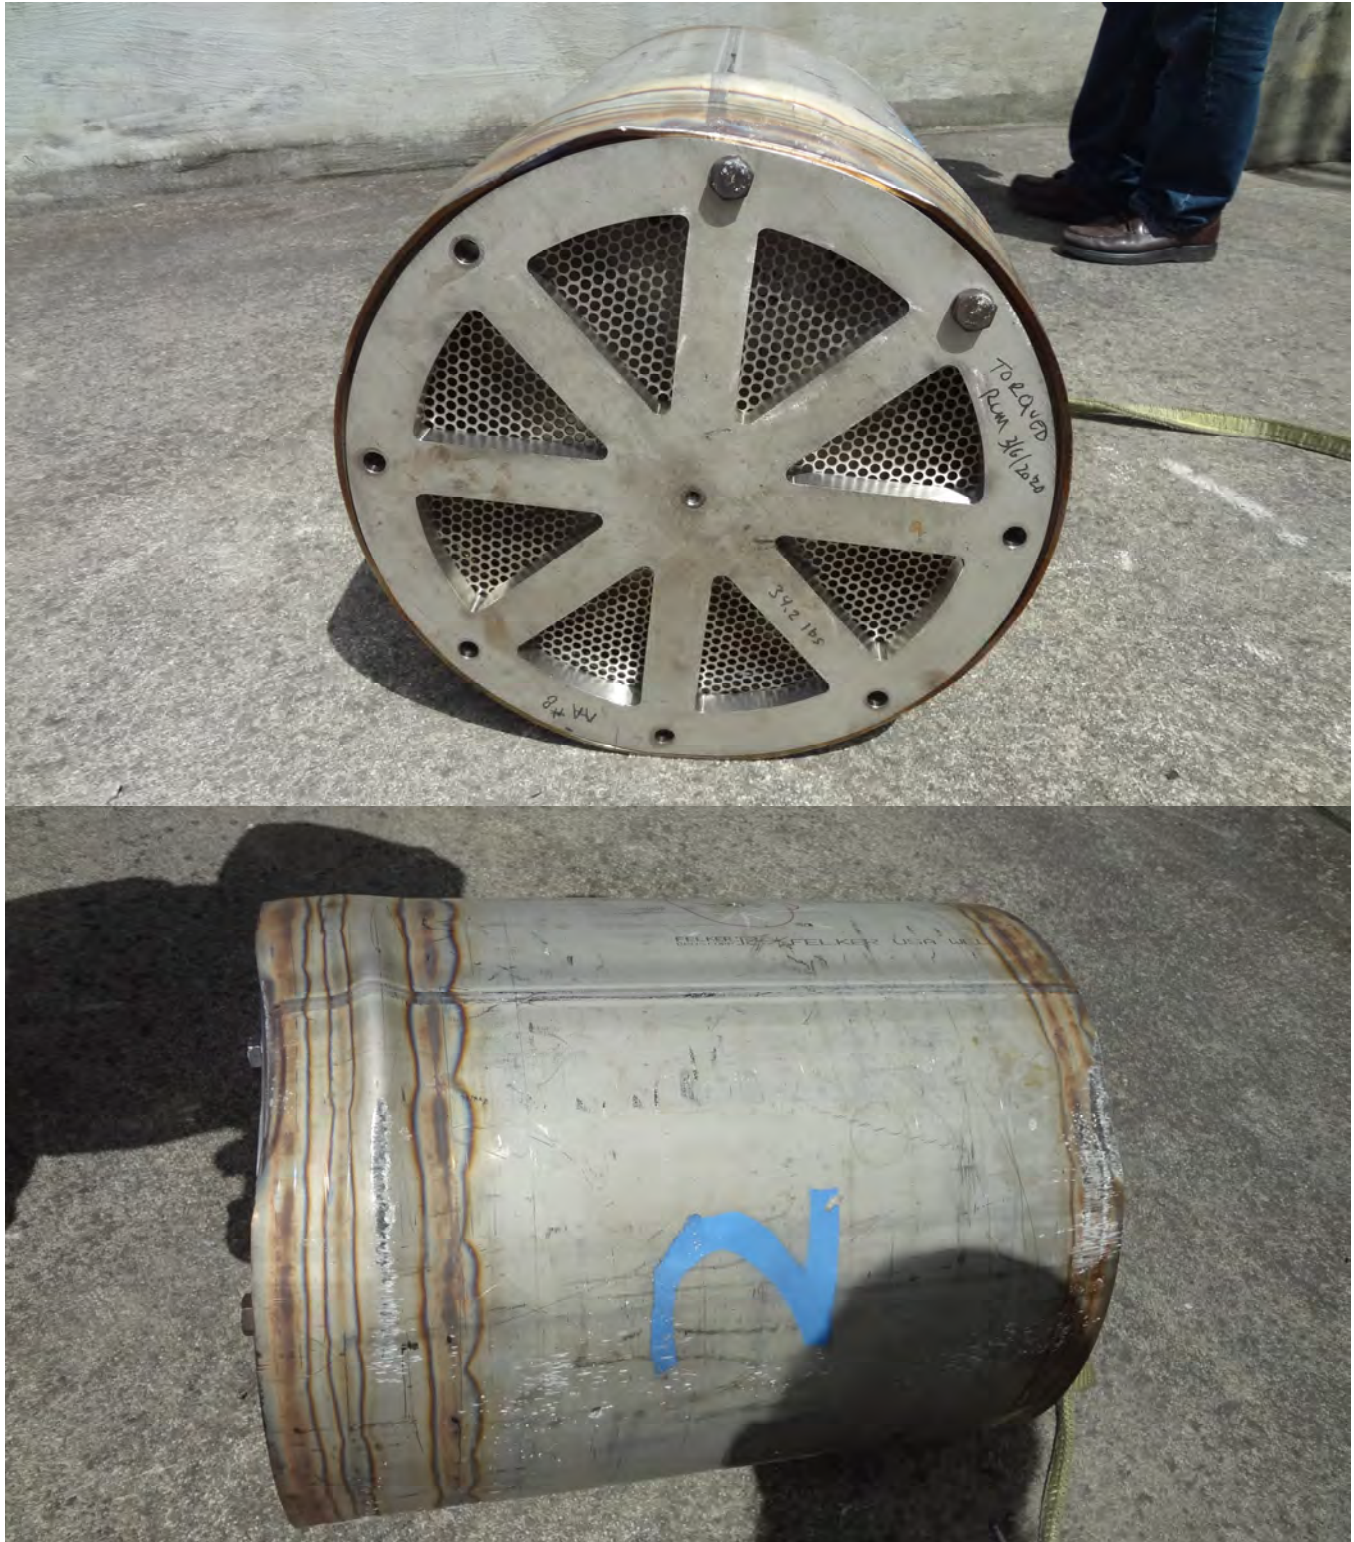
FIGURE B.1.4-3 –View of Failed Closure Lid Bolts, Deformed Shell/Lid Interface, HAC 30-Foot CG-Over-Top Corner Drop

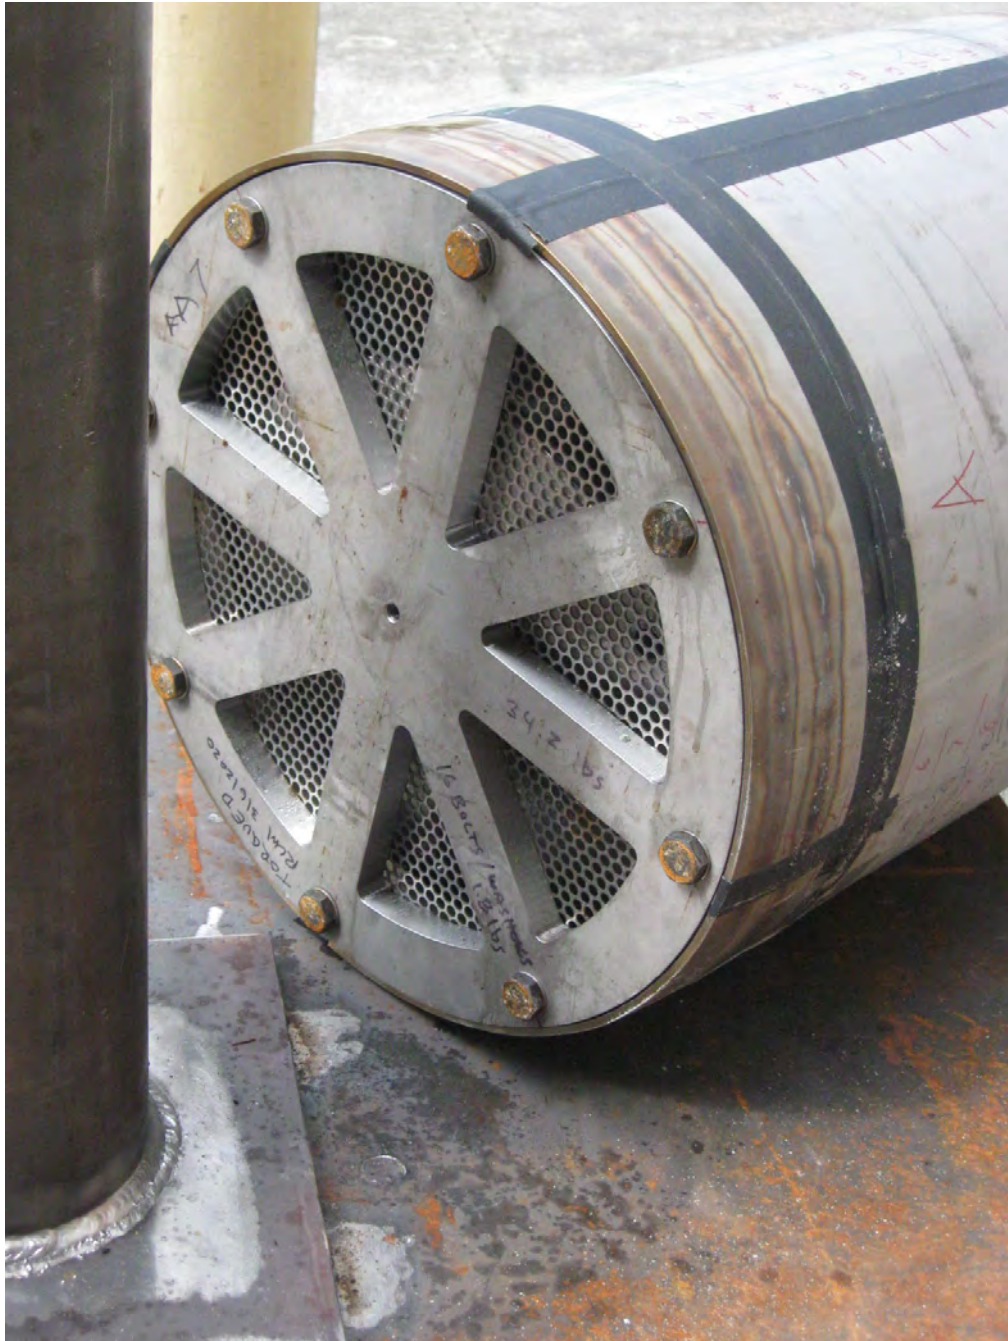
FIGURE B.1.5-2 – Close-up View of Closure Lid After Puncture Drop

The package rebounded (bounced) upon impact off the drop pad, and fell to its side. No damage was observed from the impact. Figures B.1.5-X photo-documents Test Number 5 for CTU-1.

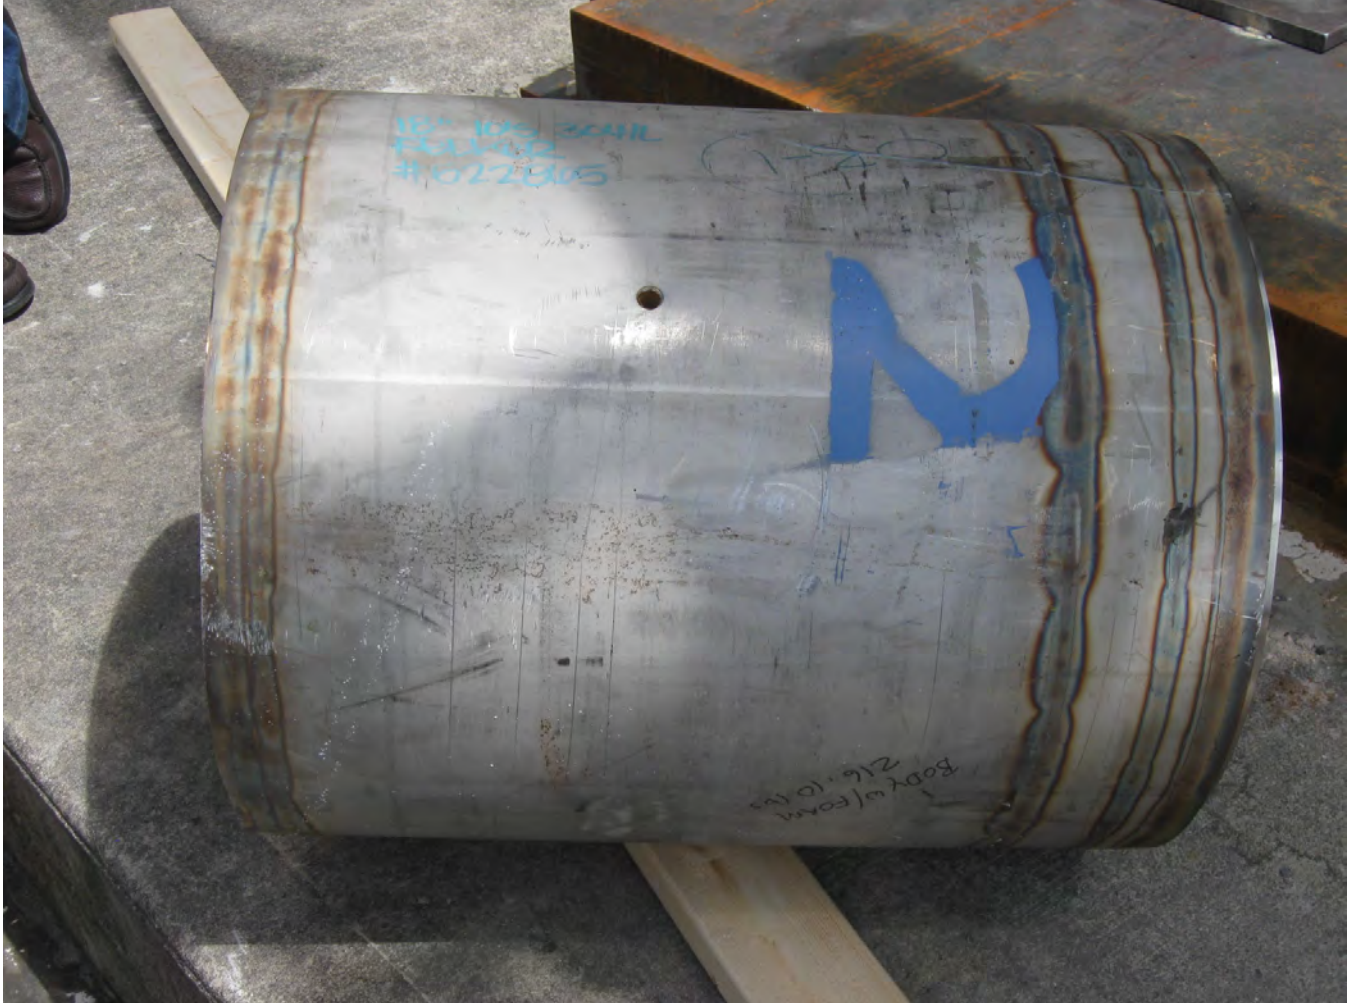
FIGURE B.1.6-2 – Close-up View of Side After Puncture Drop

The package rebounded (bounced) off the puncture bar immediately following impact. The impact struck the previous damage from the 30-foot free drop, resulting in a small deformed area of the outer shell. No other external damage was noted. Figures B.1.6-X photo-documents Test Number 6 for CTU-2.

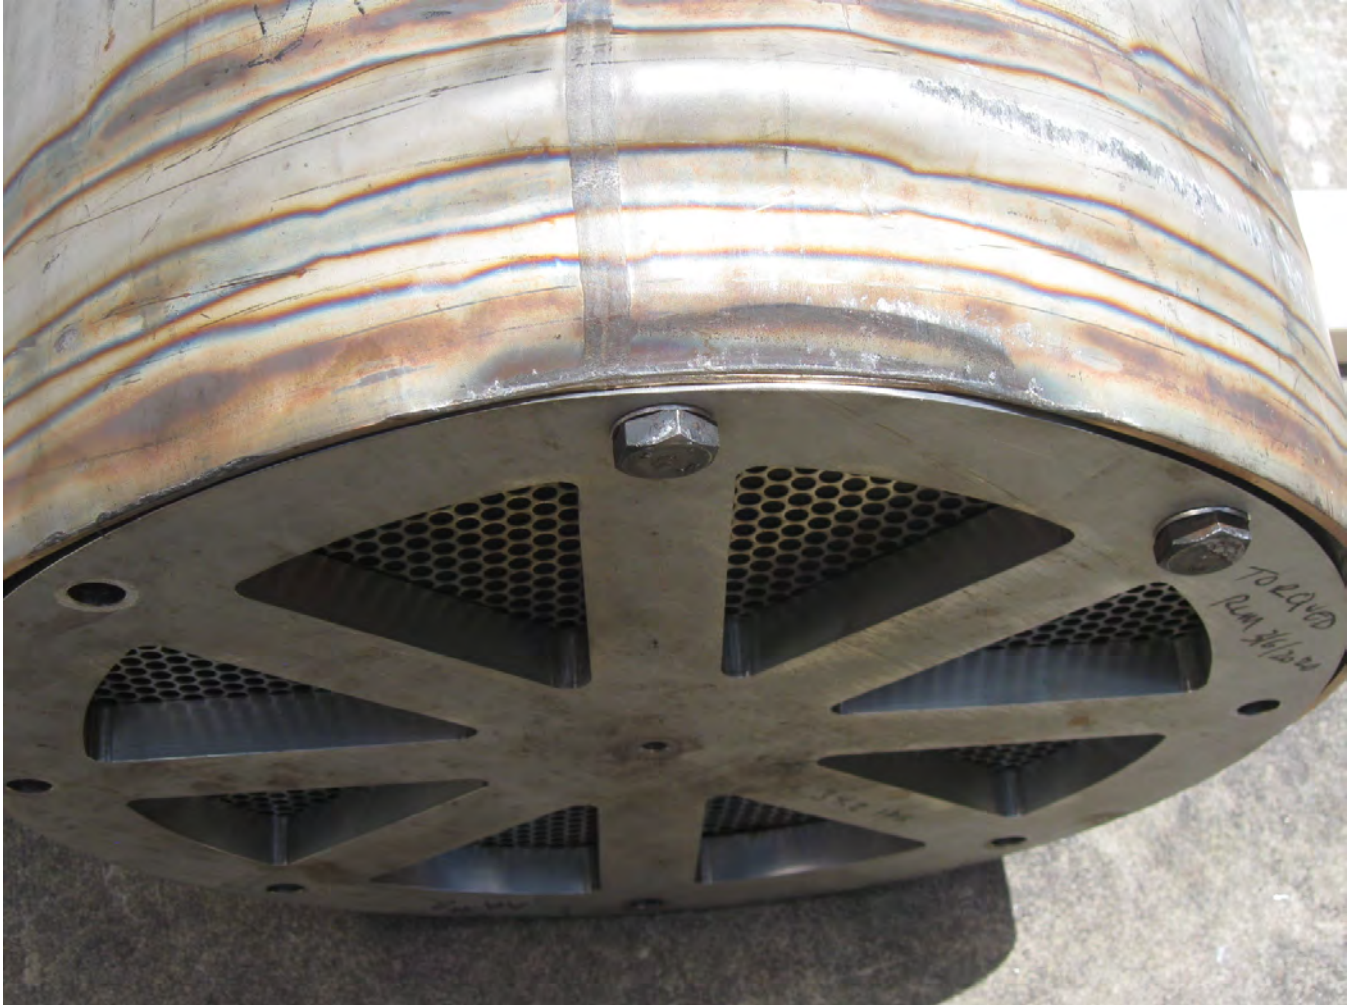
FIGURE B.1.7-2 – Close-up View of Top Corner After Puncture Drop

The package rebounded (bounced) off the puncture bar immediately following impact. The impact struck the previous damage from the 30-foot free drop with no measureable deformation. No other external damage was noted. Figures B.1.7-X photo-documents Test Number 7 for CTU-2.

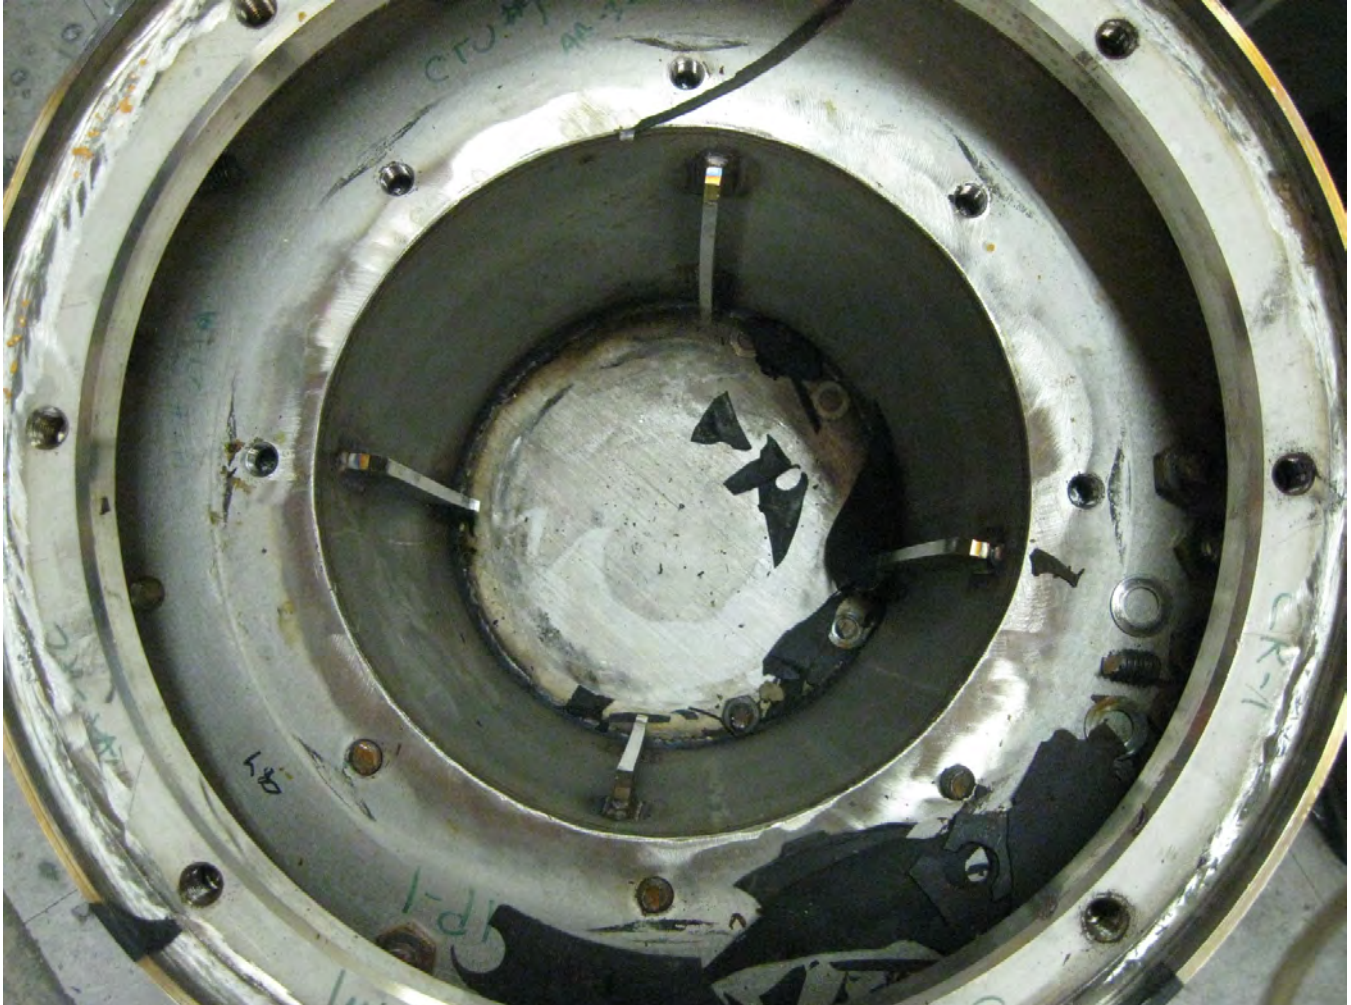
FIGURE B.2-3 – CTU-1 Post-Test Disassembly: View of OP-RMSC Payload Cavity

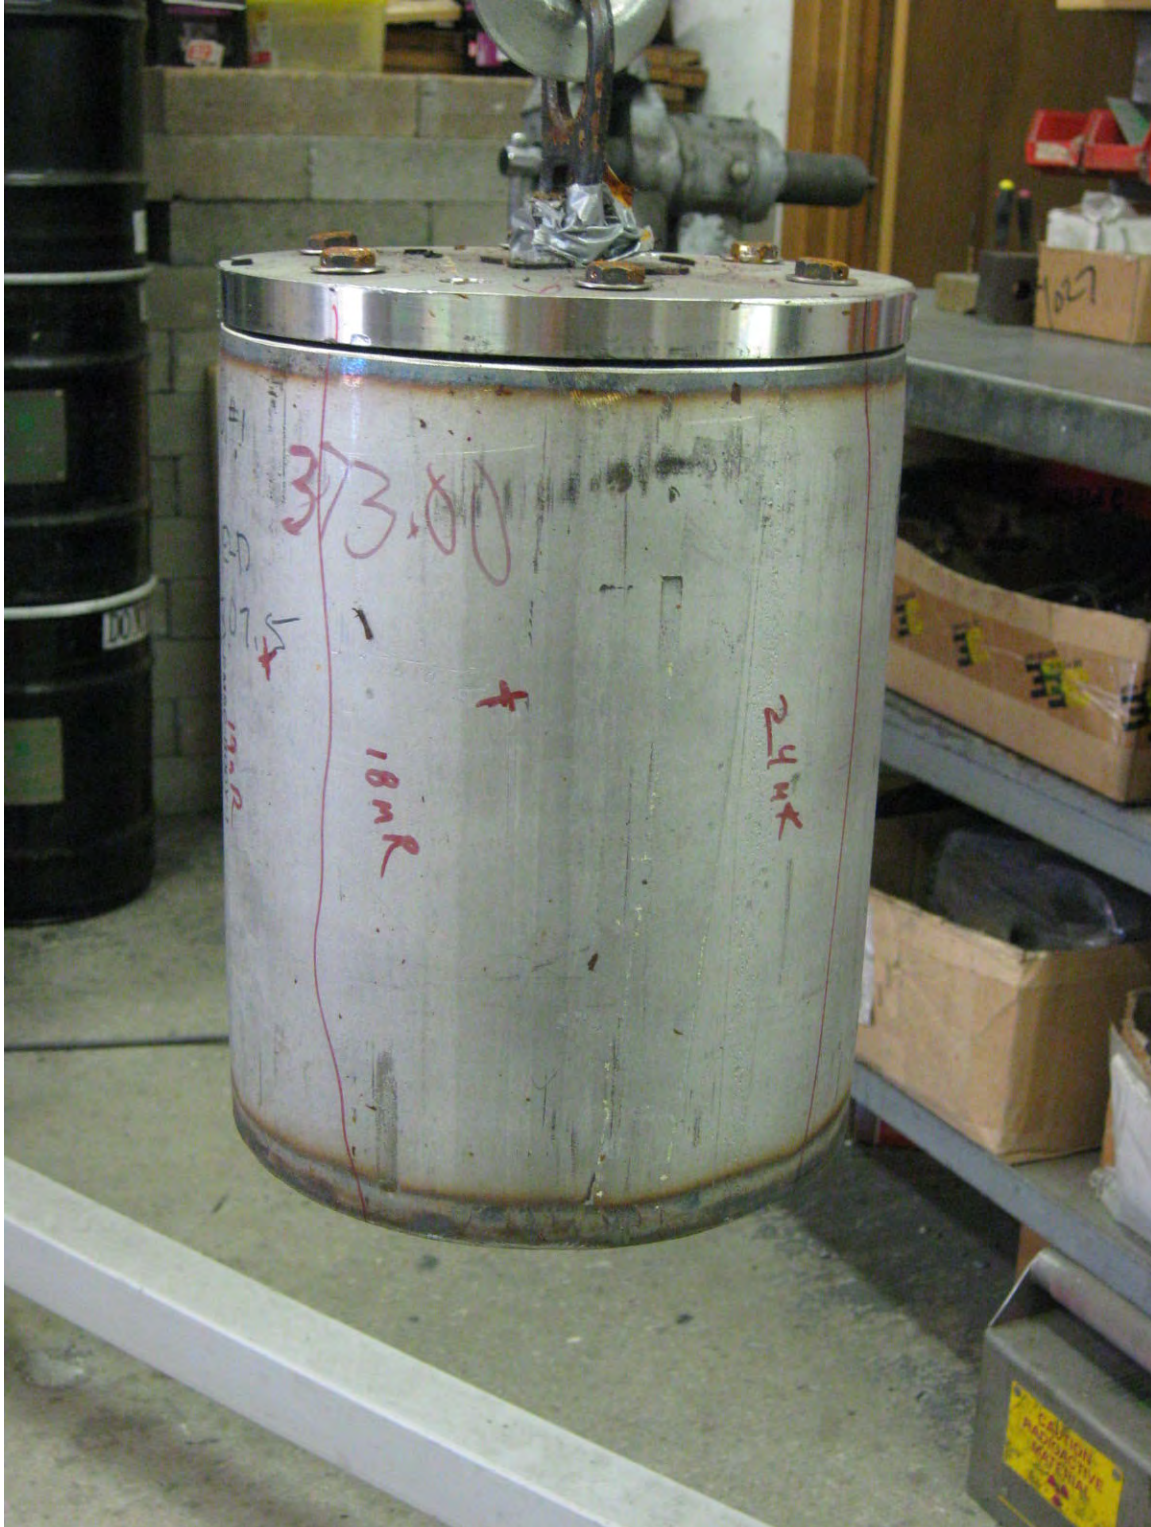
FIGURE B.2-4 – CTU-1 Post-Test Disassembly: Overall View of RMSC Payload

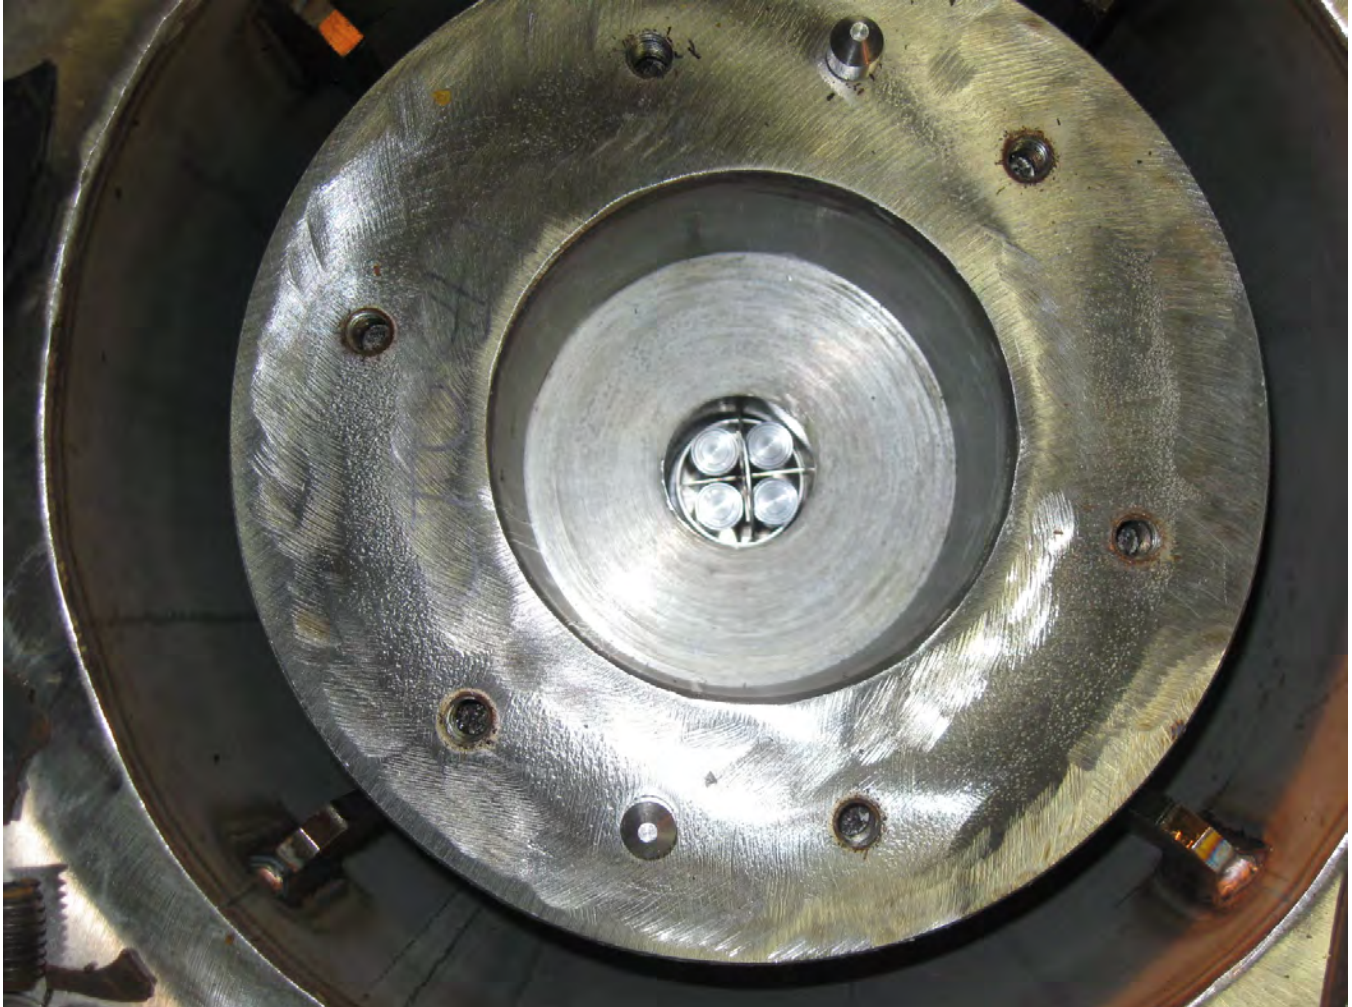
FIGURE B.2-5 – CTU-1 Post-Test Disassembly: View of Dummy Sources in RMSC Payload

Both OP-RMSC CTUs were disassembled to access and remove the RMSC payloads. For CTU-1, the center of the inner lid was deformed from the 30-foot top down free drop by the alloy hoist ring on the RMSC payload lid. Similarly, the same deformation of the inner lid of CTU-2 was observed from the 30-foot CG-over-top corner free drop. The alloy hoist ring bolt was also sheared from the RMSC payload lid due to the impact. For the 30-foot side free drop, the inner shell of CTU-2 was deformed by the RMSC payload, which shifted the RMSC payload off center in the cavity. After removal from the OP-RMSC body, no exterior damage was observed for either RMSC payload. Additionally, there was no damage to the four (4) dummy special form capsules or the capsule holder after the removal of the RMSC lid.

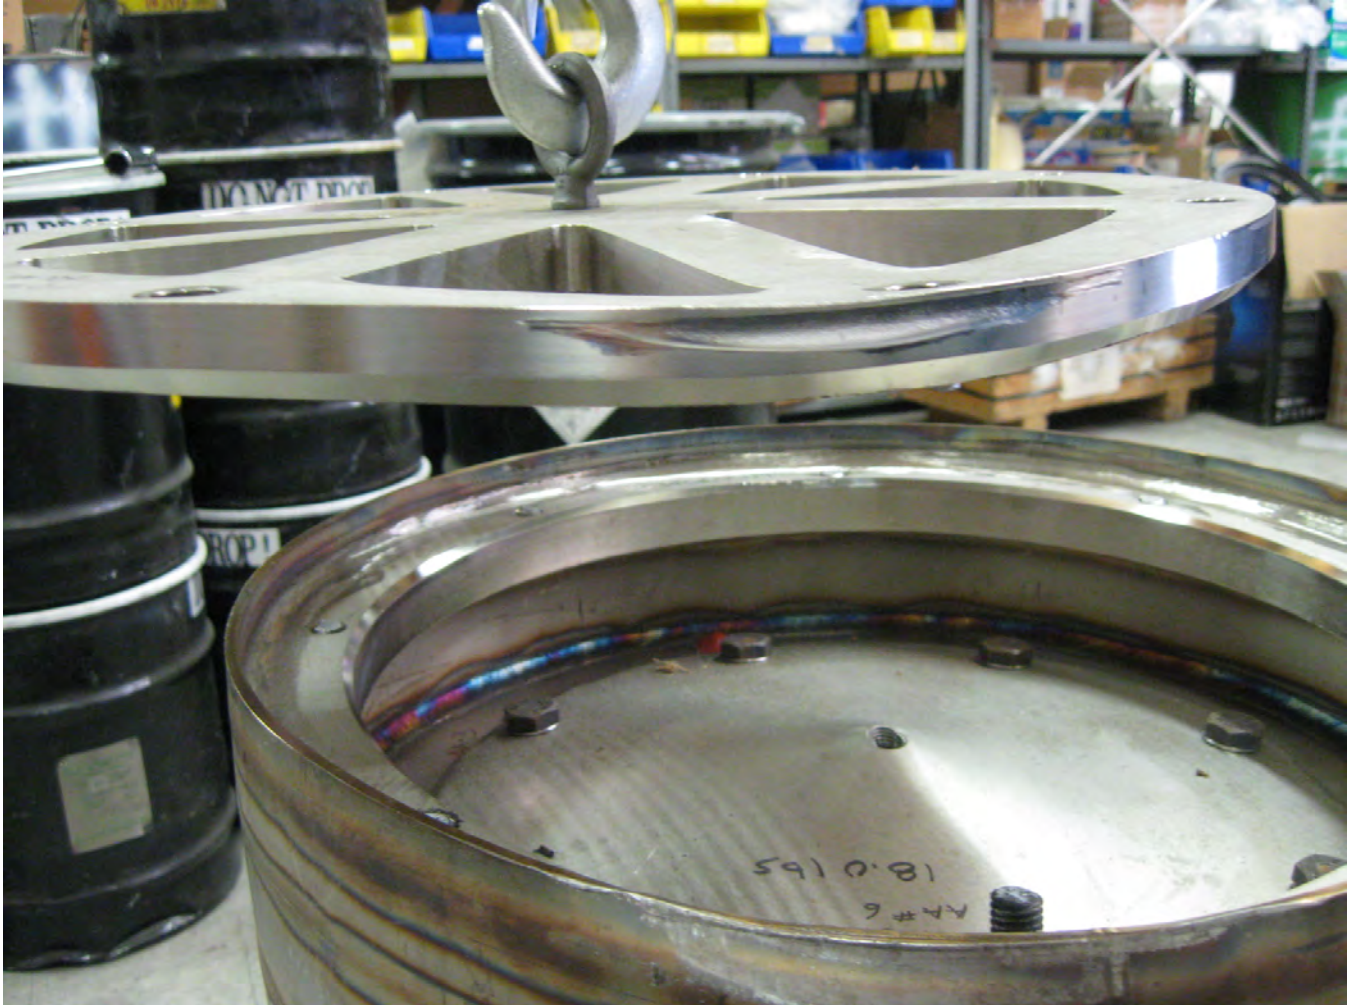
FIGURE B.2-6 – CTU-2 Post-Test Disassembly: View of OP-RMSC Closure Lid w/ CG-Over-Top Corner Impact Damage
