**Test Report**Document No.: **TR-3023626** Rev. No. **000** Page 1 of 66 (66 Total Pages)Project No.: **02008.01.0000.00** Project Name: **INC OP-Raw Material Shipping Container**Title: **Test Report for the Industrial Nuclear Company Outer Package, Raw Material Shipping Container (OP-RMSC)****Summary:**

This procedure documents the required free and puncture drop tests for qualifying the Industrial Nuclear Company (INC) OP-RMSC package to the requirements of Title 10, Code of Federal Regulations, Part 71 (10 CFR 71), *Packaging and Transportation of Radioactive Material*, as a radioactive material package. The results of these tests will be utilized as supporting documentation for INC's application to the US Nuclear Regulatory Commission to obtain a transportation license under Docket No. 71-9387.

Title: Test Report for the INC OP-RMSC Package

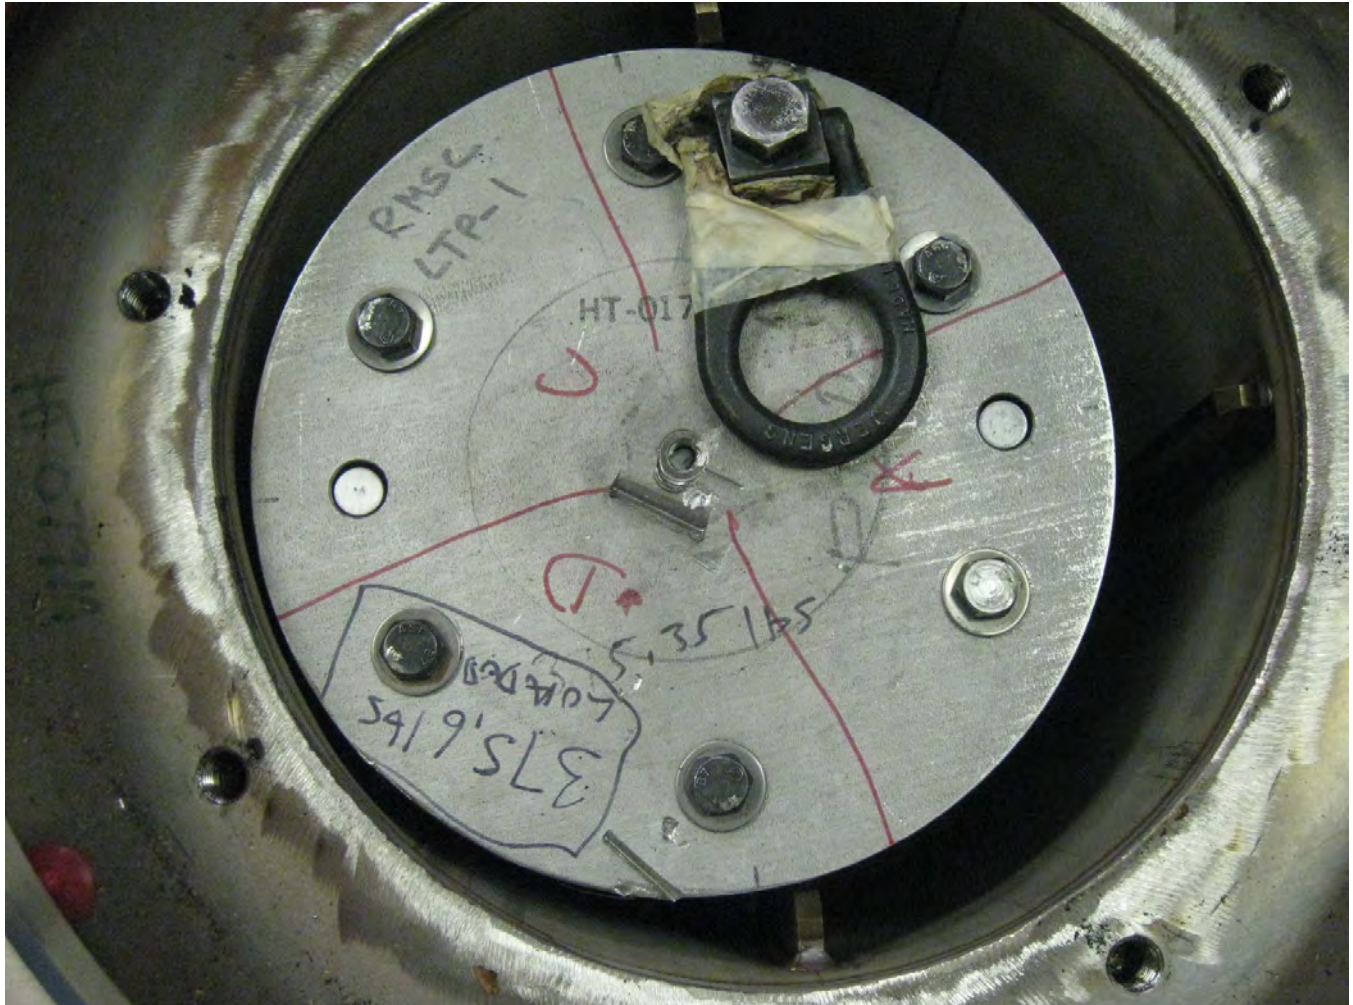
FIGURE B.2-7 – CTU-2 Post-Test Disassembly: View of RMSC Payload w/ Sheared Hoist Ring Hex Bolt and CG-Over-Top Corner Impact Damage to Lid

Both OP-RMSC CTUs were disassembled to access and remove the RMSC payloads. For CTU-1, the center of the inner lid was deformed from the 30-foot top down free drop by the alloy hoist ring on the RMSC payload lid. Similarly, the same deformation of the inner lid of CTU-2 was observed from the 30-foot CG-over-top corner free drop. The alloy hoist ring bolt was also sheared from the RMSC payload lid due to the impact. For the 30-foot side free drop, the inner shell of CTU-2 was deformed by the RMSC payload, which shifted the RMSC payload off center in the cavity. After removal from the OP-RMSC body, no exterior damage was observed for either RMSC payload. Additionally, there was no damage to the four (4) dummy special form capsules or the capsule holder after the removal of the RMSC lid.

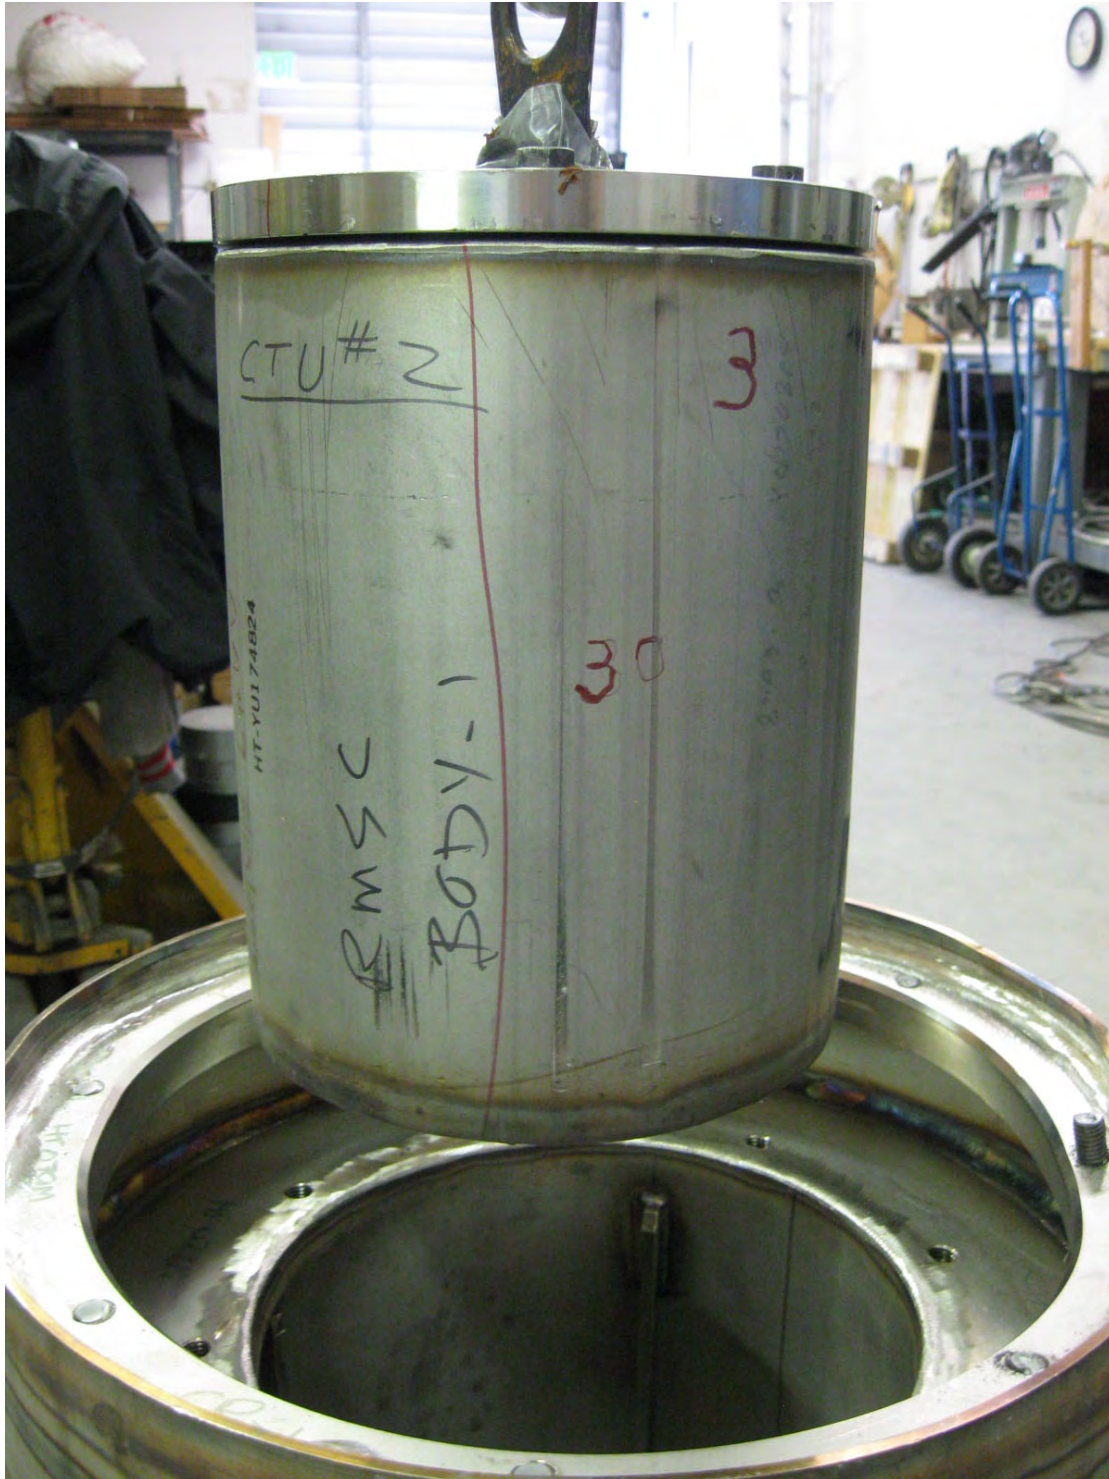
FIGURE B.2-8 – CTU-2 Post-Test Disassembly: Overall View of RMSC Payload
