DEPARTMENT OF HEALTH & HUMAN SERVICES

National Institutes of Health
Rocky Mountain Laboratories, NIAID
903 South 4th Street
Hamilton, Montana 59840
Phone: (406) 375-7467
FAX: (406) 363-9336

RE: NRC Information Notice 2021-1: Buried Waste Vault

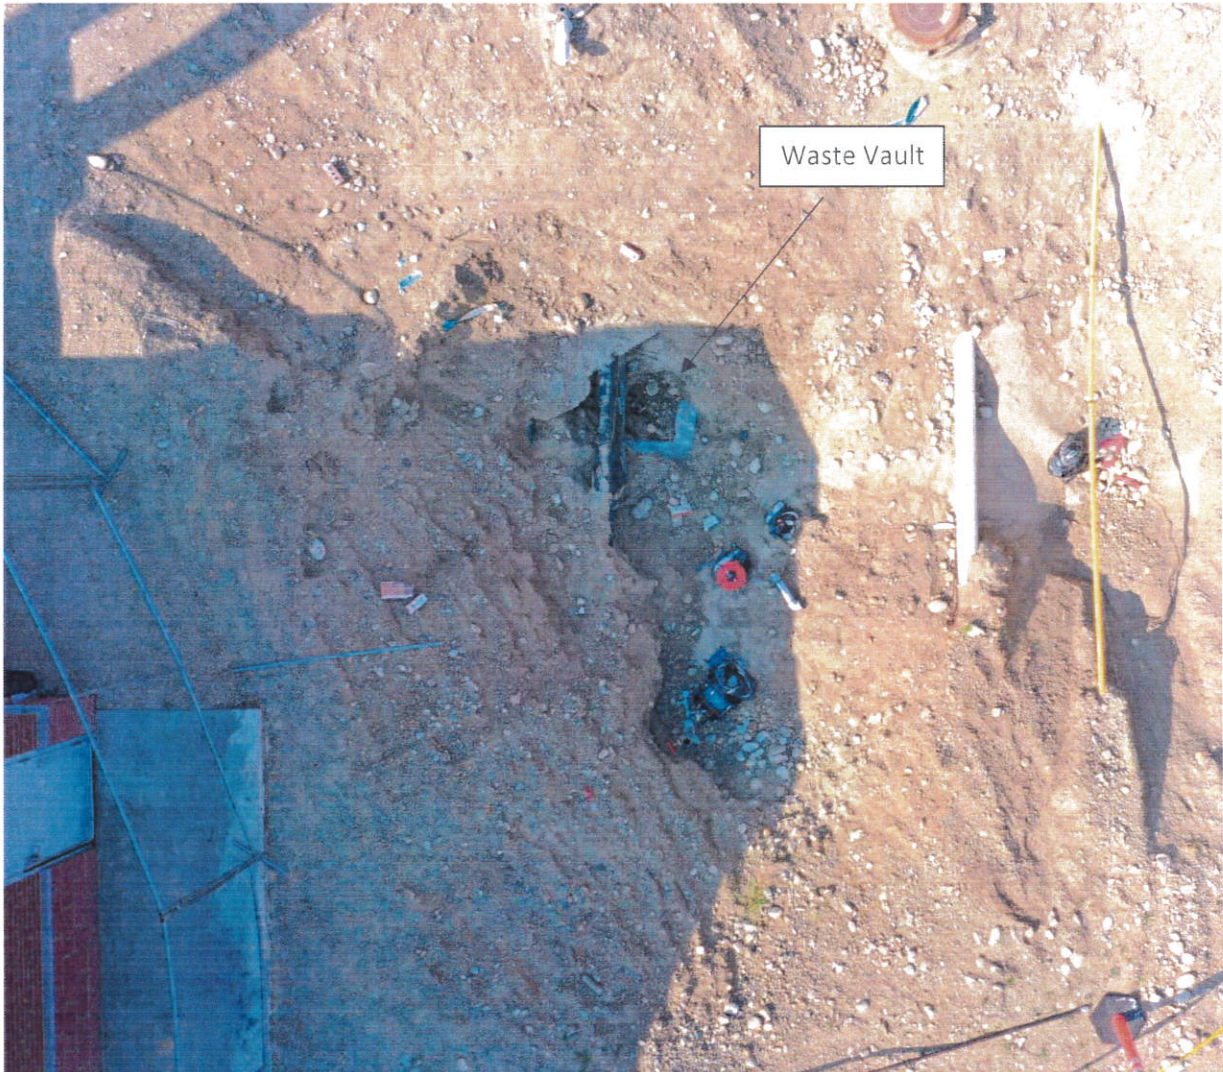
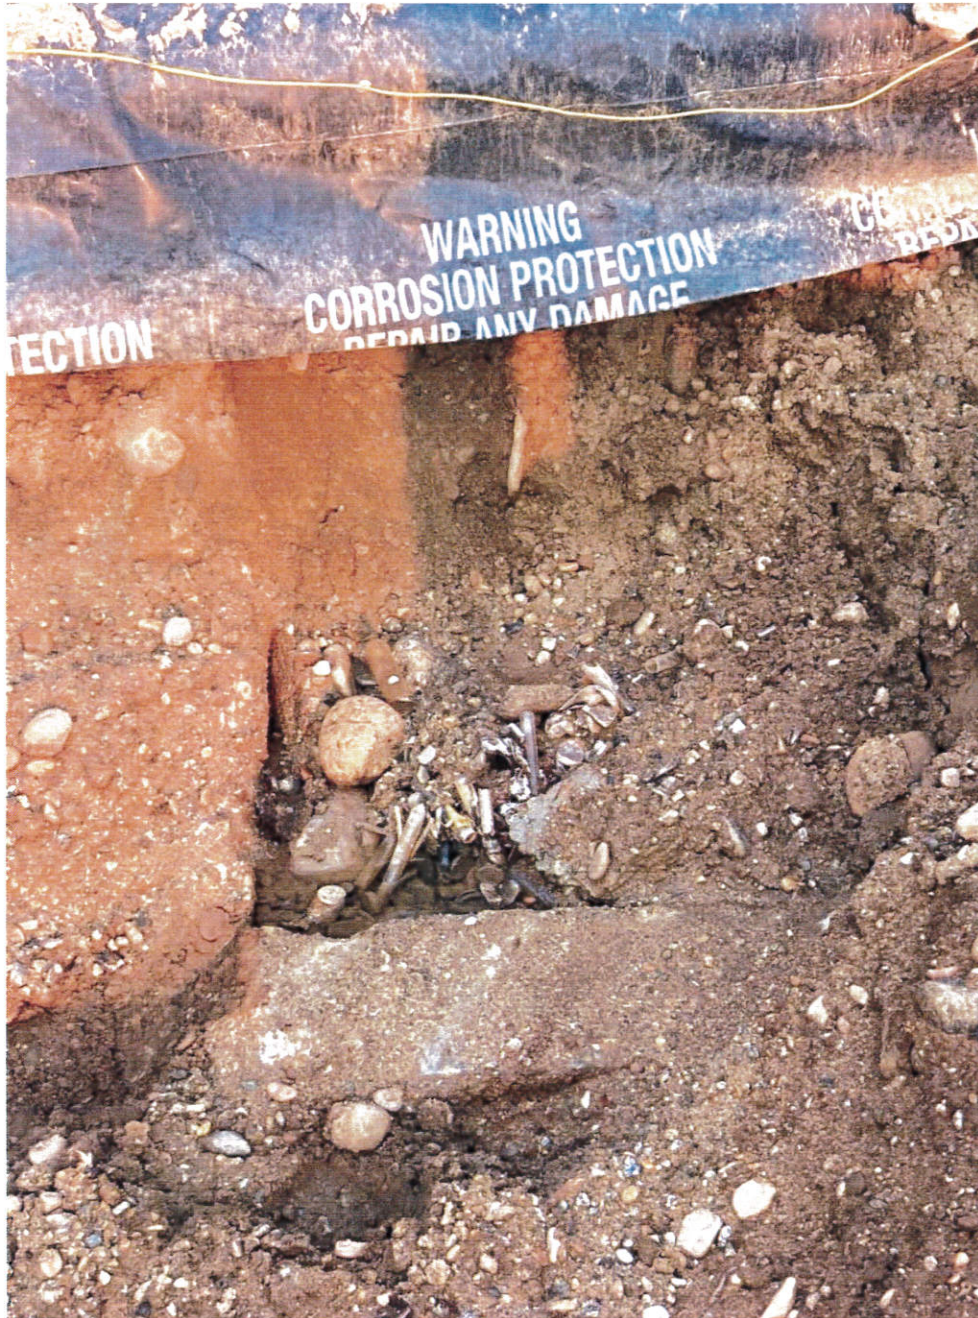
In summary, a buried waste vault was discovered on the RML campus on August 8, 2021 while excavating for new construction. Only the southeast corner of the vault was initially exposed (Figs. 1-2). In the exposed area of the vault was found vials, glassware, plasticware, absorbent pads, gloves, planchets, and other common lab waste articles (Fig. 3). Some of the vials had "Radioactive Material" stickers on them and have subsequently been identified as I-131 vials used by Squibb and Sons from 1952-1968. No readings above background were found by Geiger-Mueller detector, scintillating NaI, or liquid scintillation counting (LSC). Although RML had six other historic low-level radioactive waste (LLRW) vault/pits that were used as acceptable methods of LLRW disposal from 1956-1978, there is no record of the existence of this vault. The six historic pits were decommissioned in 1996 as part of a Voluntary Cleanup Program (VCP). Characterization of the VCP vault/pits at the time determined that isotopes were not present above the NRC standards defining radioactive waste (10 CFR 20.2005) and were therefore excavated and disposed of as non-radioactive waste in accordance with all applicable regulations.

FIGURE 1: AERIAL VIEW OF VAULT SITE

FIGURE 2: CLOSE-UP OF WASTE VAULT

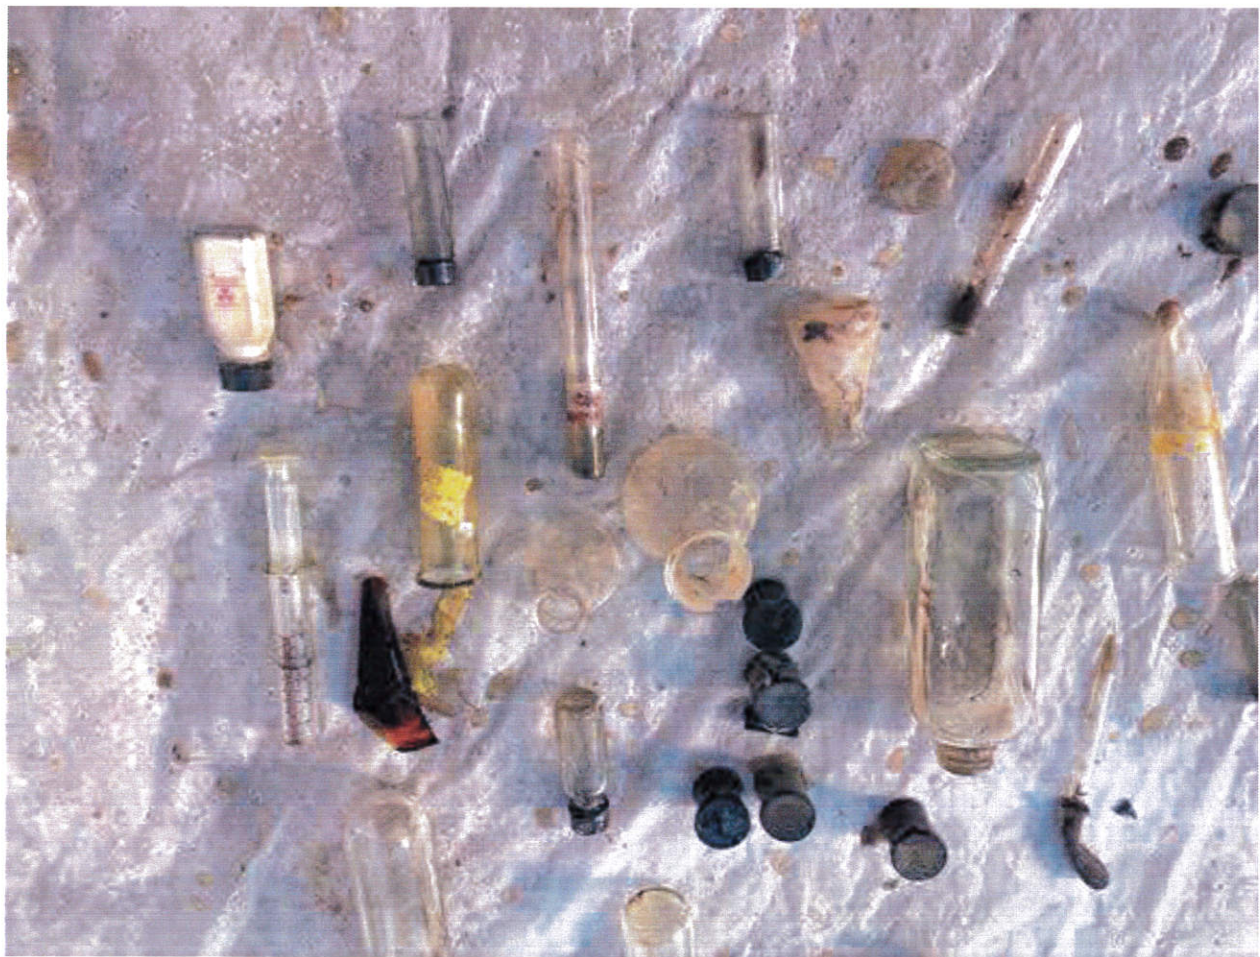
FIGURE 3: EXAMPLES OF WASTE FOUND IN VAULT

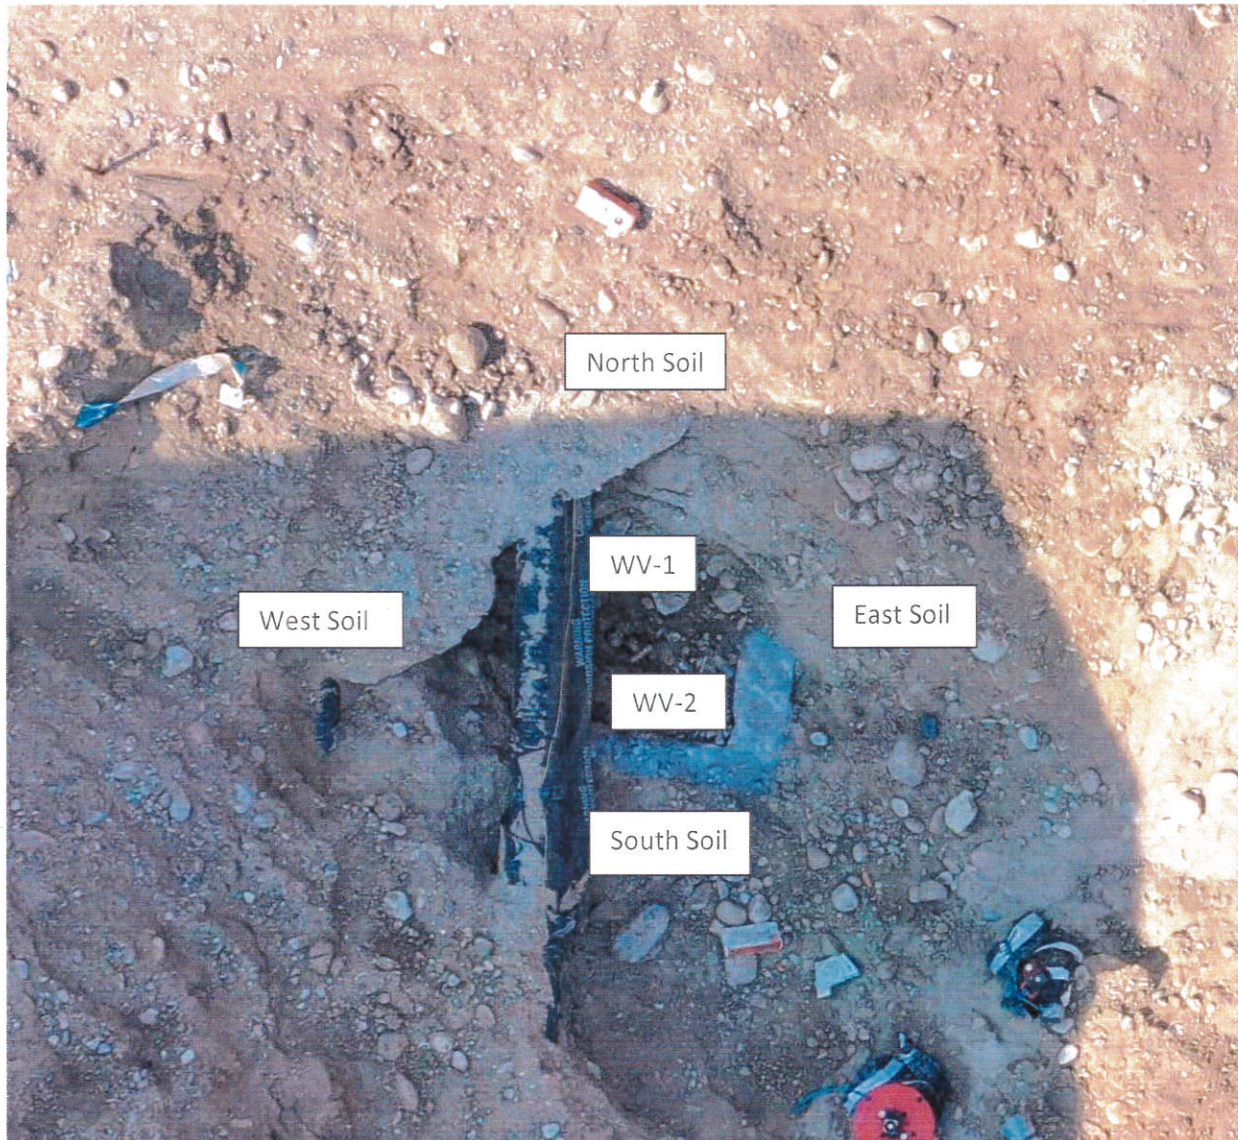
FIGURE 4: SITE CHARACTERIZATION SAMPLE LOCATIONS

The buried vault is relatively small, internal dimensions are 3 ft. x 3 ft. x 12 in. deep. As described above, no radiological activity was detected by field instrumentation. Soil, water and swab samples taken from the pit and analyzed by LSC indicated there was no radiological activity at levels detectable by RML equipment. RML contracted with Tetra Tech Environmental Consulting and Engineering to conduct sampling of the vault and surrounding soil (Fig. 4) for laboratory analysis of radionuclides, TCLP metals, petroleum hydrocarbons, and other environmental constituents of concern (COCs). Reported test results from material and liquid within vault were below the NRC standards (10 CFR 20.2005) defining radioactive waste (Table 1). Additionally, test results from surrounding soil indicate
