2.5 GEOLOGY, SEISMOLOGY, AND GEOTECHNICAL ENGINEERING

SUSQUEHANNA STEAM ELECTRIC STATION
 UNITS 1 & 2
 FINAL SAFETY ANALYSIS REPORT

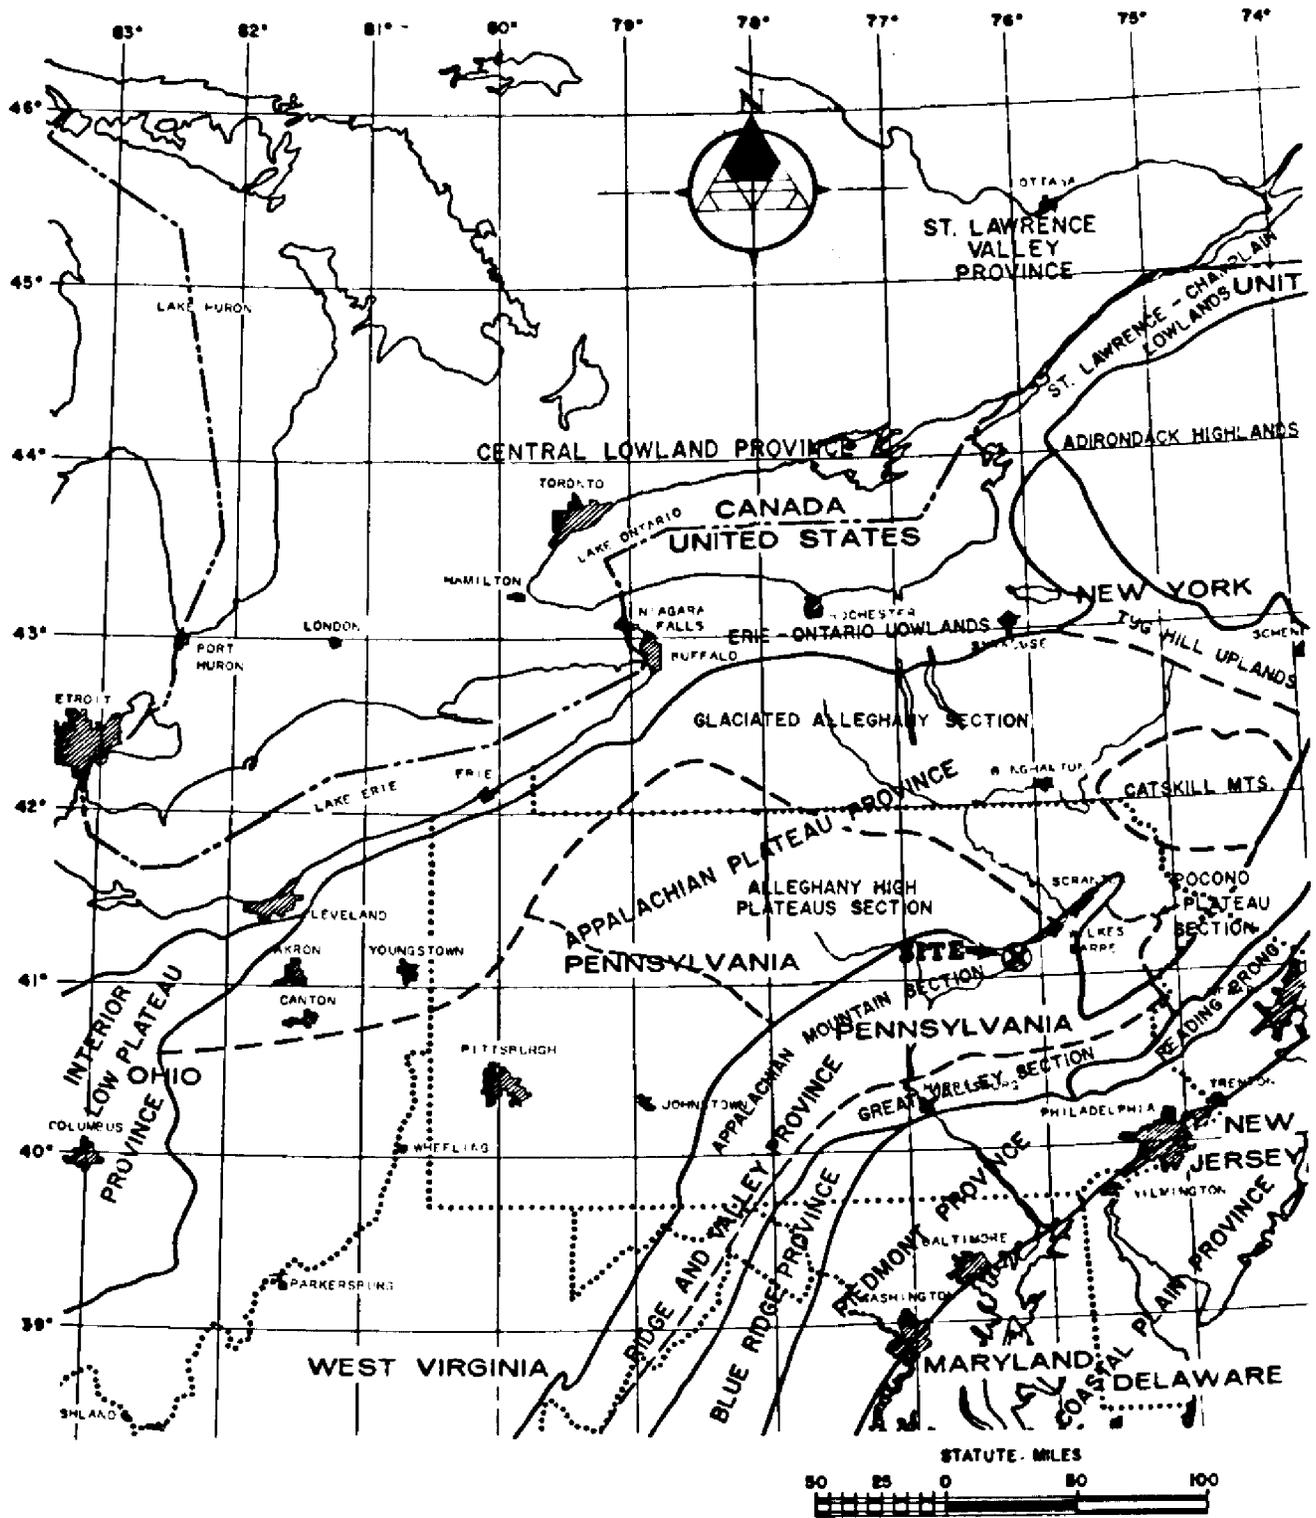
The site is located (Figure 2.5-1) in the Valley and Ridge Physiographic Province which is bordered on the southeast by the Reading Prong and on the northwest by the Appalachian Plateau Physiographic Province (Figure 2.5-2).

PHYSIOGRAPHIC DIVISIONS TAKEN FROM PHYSIOGRAPHY OF EASTERN UNITED STATES BY N.M. FENNEMAN, 1938.

Beyond the front lies the Appalachian Plateaus (Figure 2.5-2), a gently rolling highland formed on broad folds of low structural relief that plunge gently to the southwest. The strata consist predominantly of an upper Paleozoic cyclic sequence of sandstone, shale, limestone and coal.

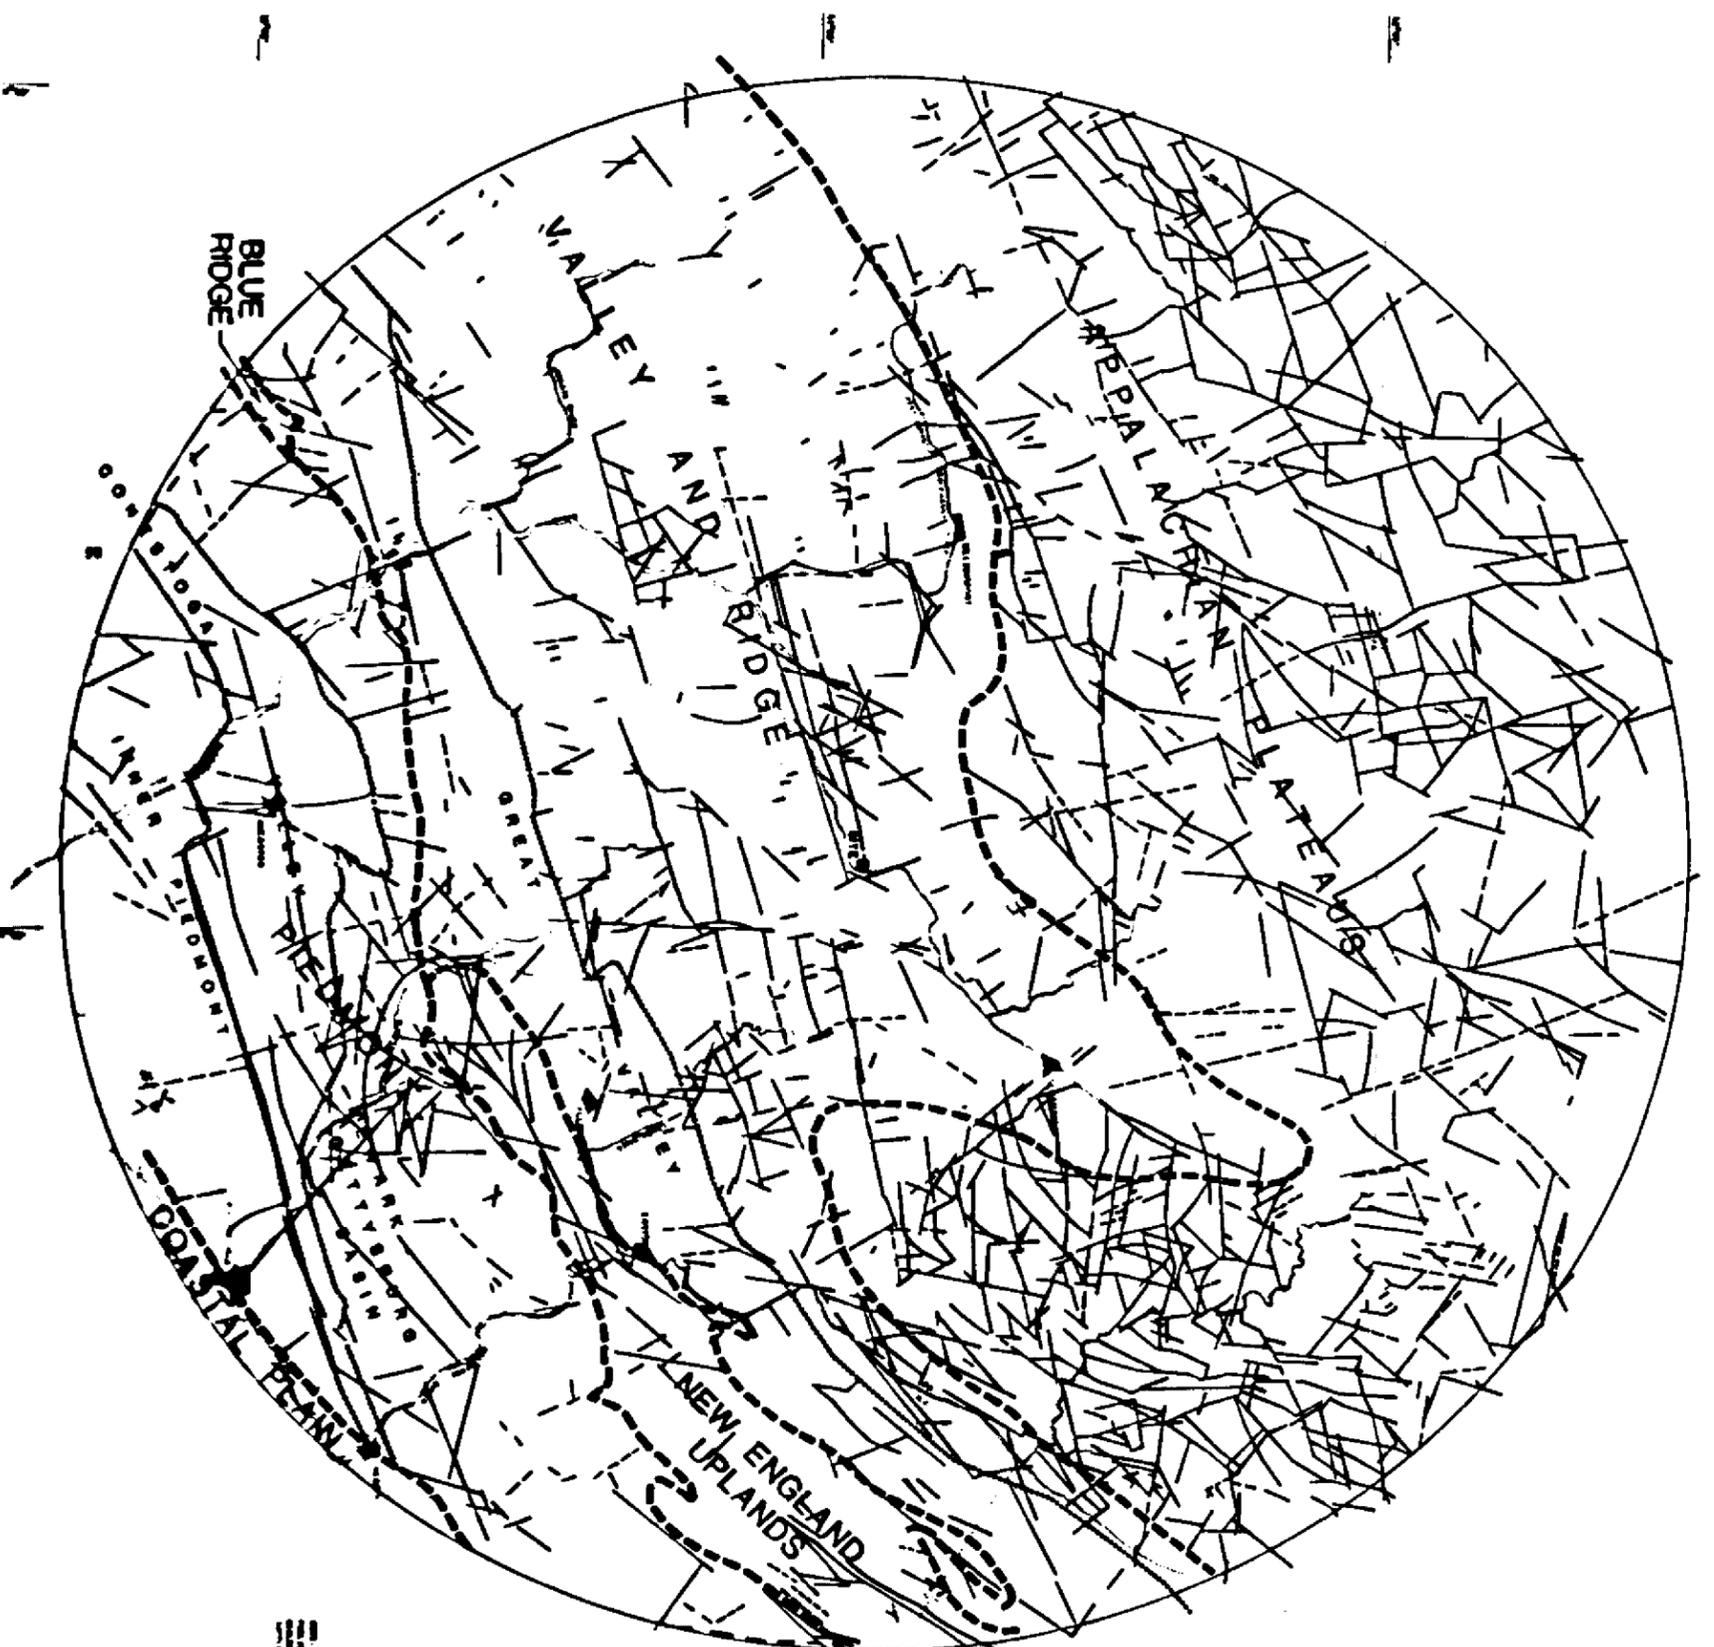
This figure shows the regional landforms and lineaments of the Susquehanna River Basin. The map is based on geological data from the United States Geological Survey (USGS) and the Pennsylvania Geological Survey (PGS). The lineaments shown on the map are based on the work of the Pennsylvania Geological Survey (PGS) and the United States Geological Survey (USGS).

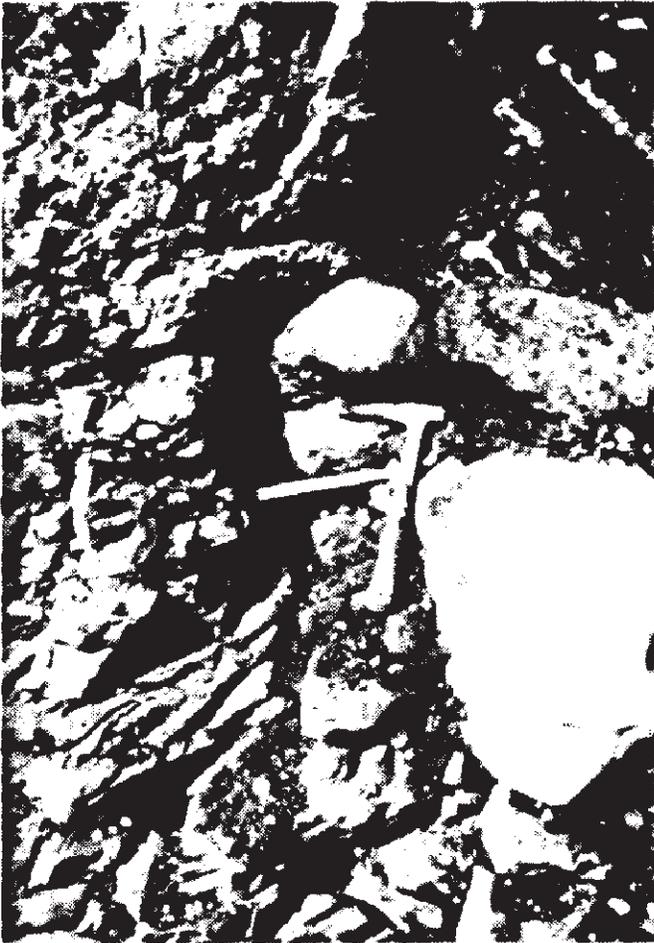
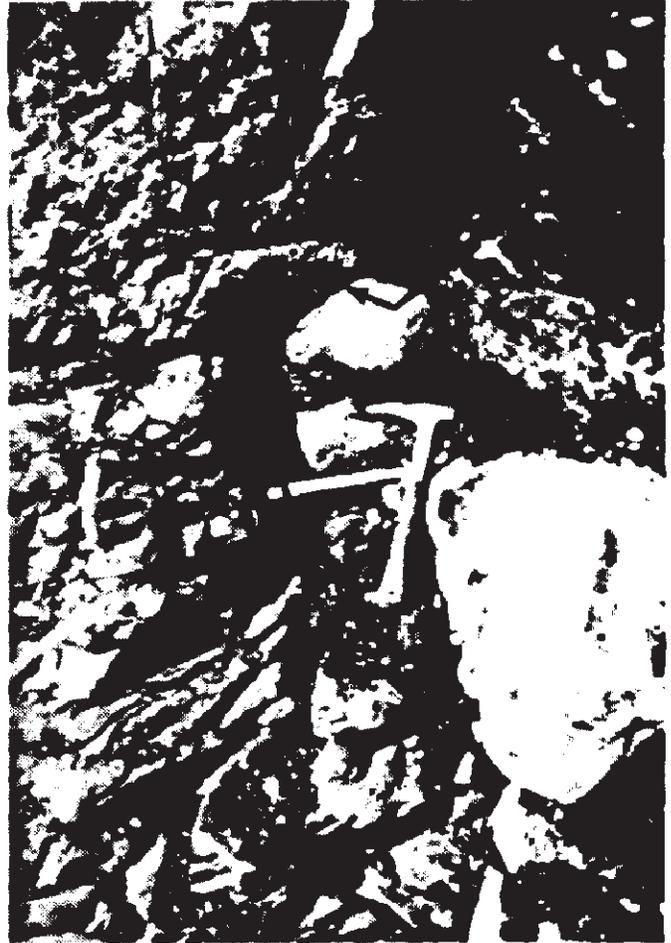
Looking west at an excavated slope which shows the intersection of the weathered shear plane, bedding plane A, with the eroded rock surface. The intersection of these two surfaces is slightly above and to the left of the top of the hammer, as indicated in the photograph on the right. Scale is 8 inches long.

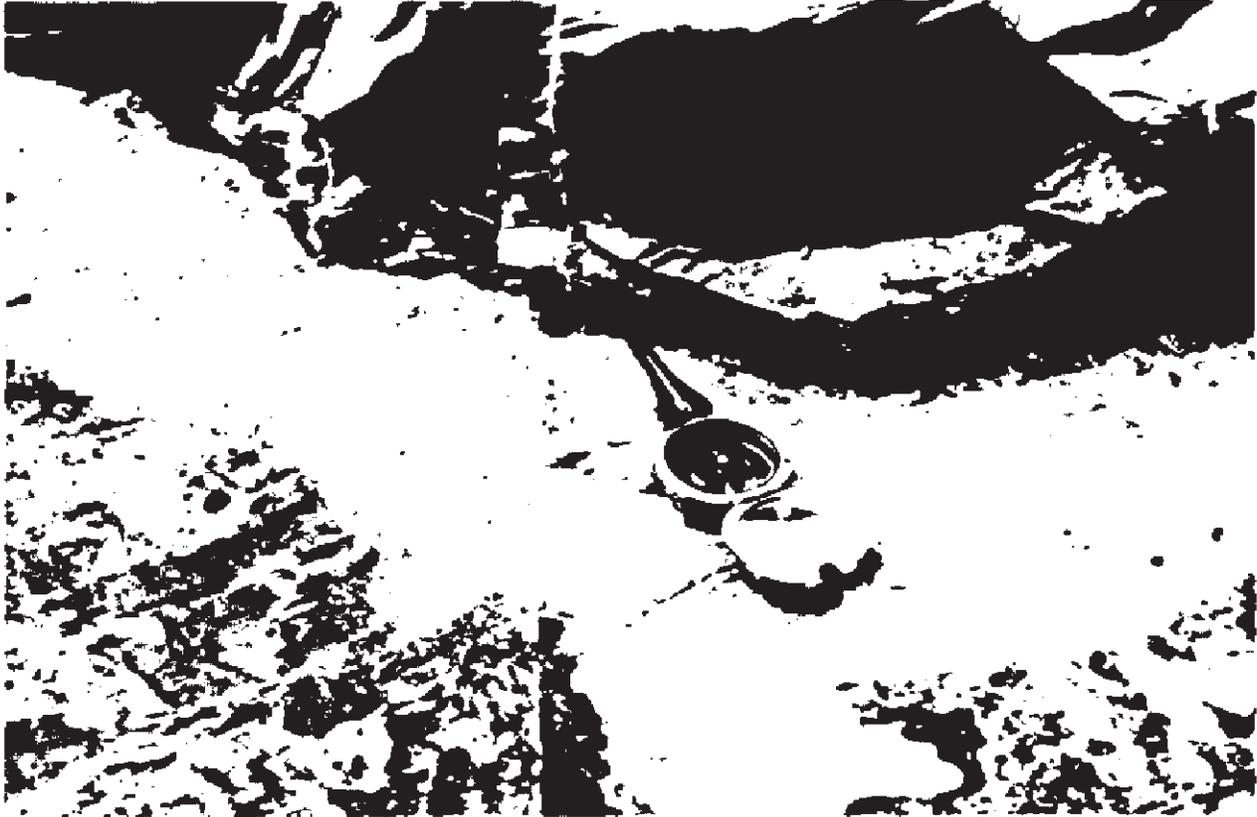
A closer view of the same exposure described in the preceding photograph. Compass is oriented parallel to slickenside lamination which trends S3°E. If movement represented by the slickenside had occurred subsequent to formation of the calcite veinlet, the vein would have been offset. Photo taken May 22, 1974.

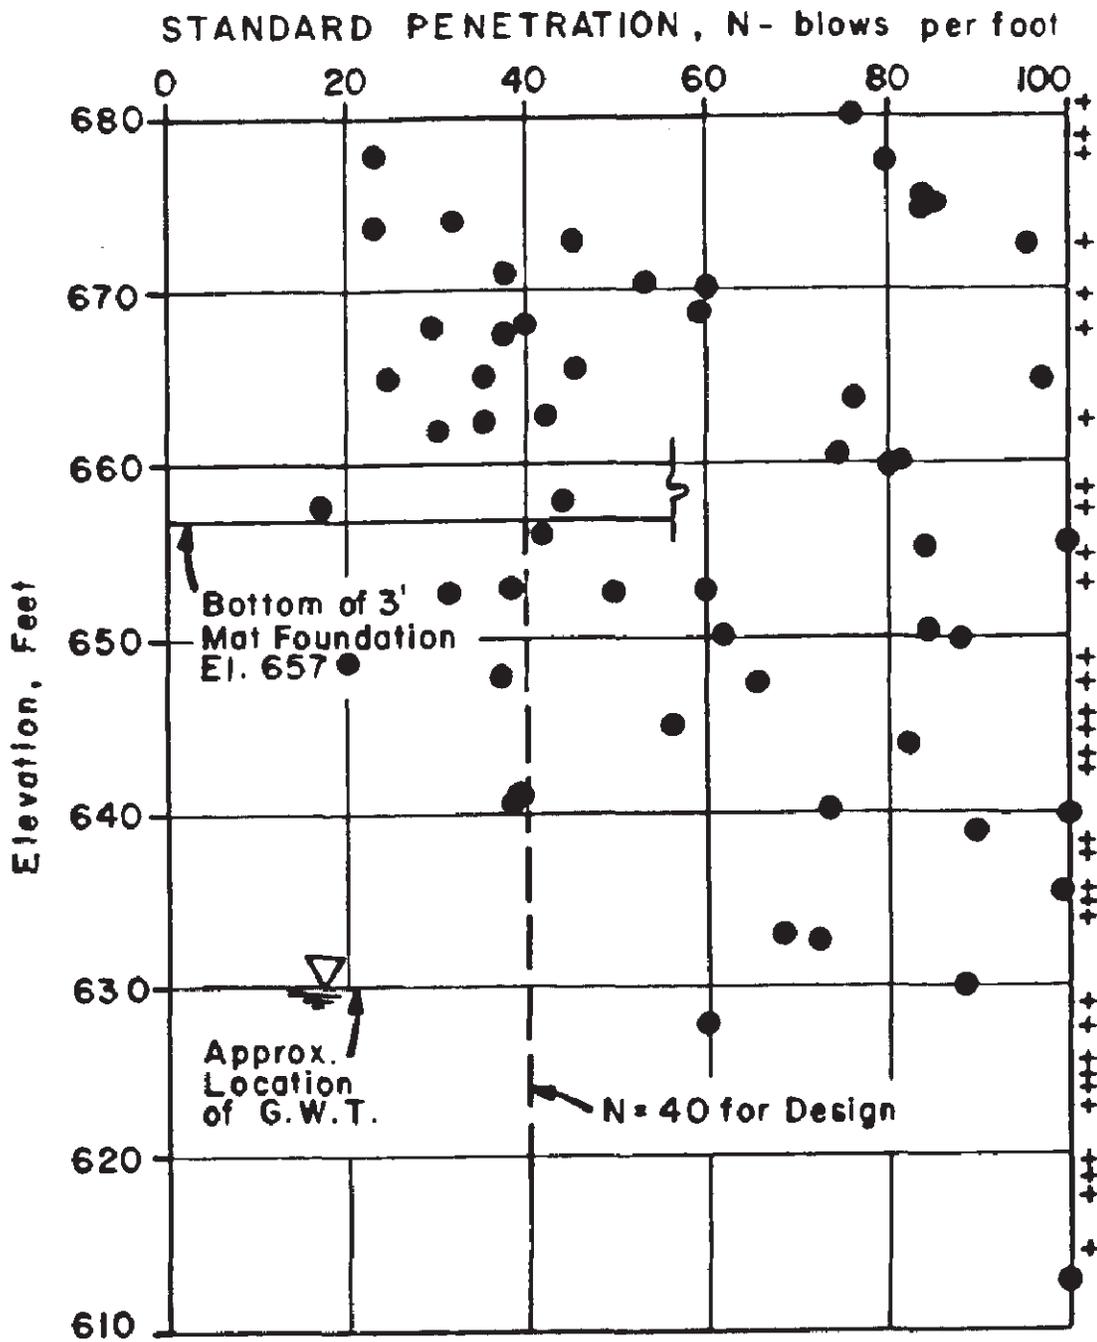
<p>SUSQUEHANNA STEAM ELECTRIC STATION UNITS 1 & 2 FINAL SAFETY ANALYSIS REPORT</p>
<p>"N" VALUE VERSUS ELEVATION AT ESSW PUMPHOUSE SITE</p>
<p>FIGURE 2.5-33, Rev 47</p>

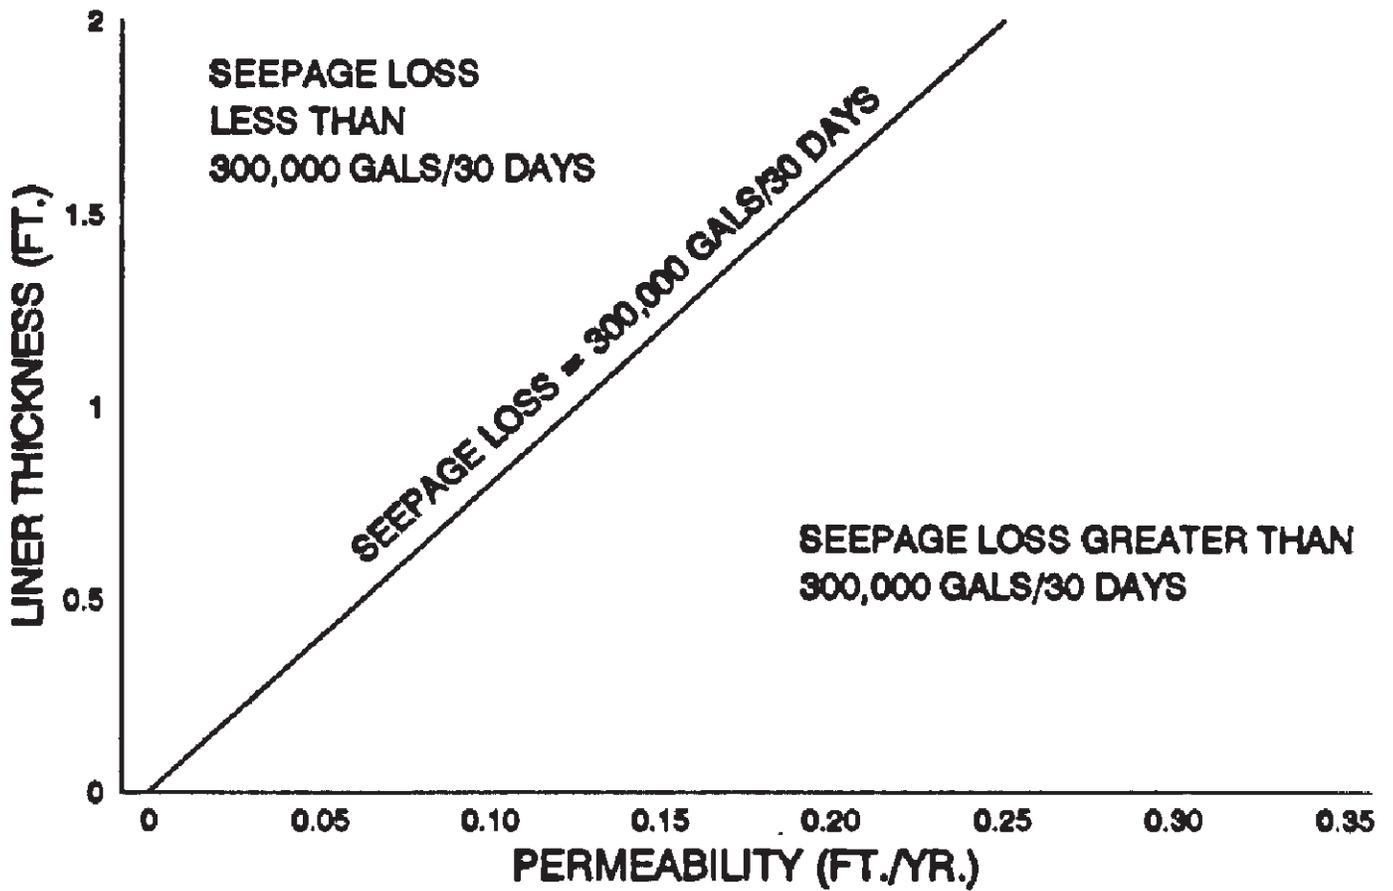
<p>SUSQUEHANNA STEAM ELECTRIC STATION UNITS 1 & 2 FINAL SAFETY ANALYSIS REPORT</p>
<p>SPRAY POND, RELATIONSHIP BETWEEN LINER THICKNESS, LINER PERMEABILITY AND SEEPAGE LOSS</p>
<p>FIGURE 2.5-57, Rev 47</p>
