Fermi 3 EGLE/USACE Joint Permit Application

October 28, 2021

WETLAND PROJECT INFORMATION AND IMPACTS

Detroit Edison Fermi Site, Monroe County Wetland Investigation Report

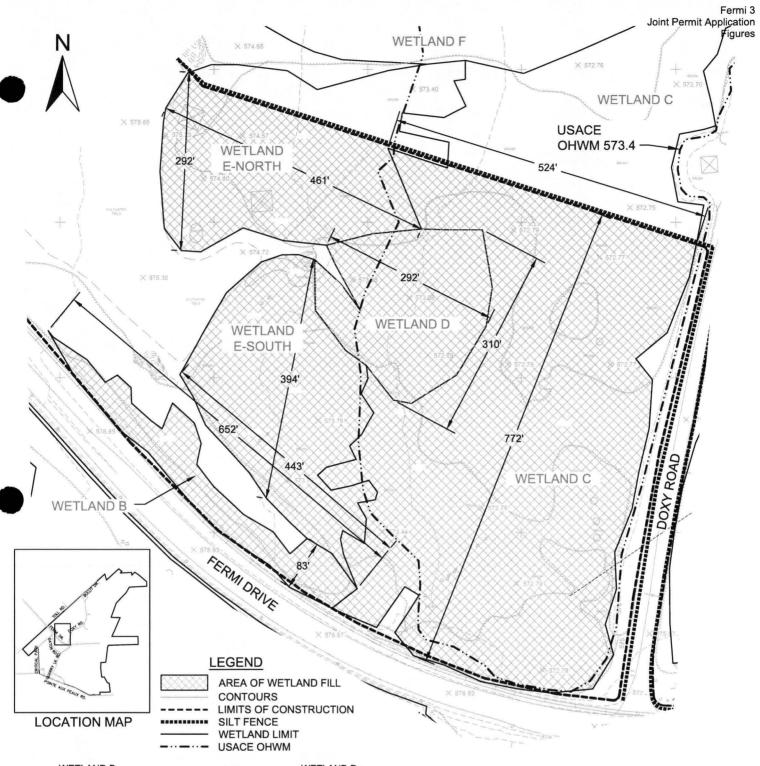
FIGURE 12-4B CONSTRUCTION AREA 3 PLAN VIEW B

WETLAND B
AREA = 0.76 acres
USACE OHWM DREDGE = 4,276 CY
USACE OHWM EXCAVATION = 1,855 CY
WETLAND EXCAVATION = 6,131 CY
WETLAND FILL = 5,805 CY

WETLAND C
AREA = 6.93 acres
USACE OHWM DREDGE = 55,772 CY
USACE OHWM EXCAVATION = NA
WETLAND EXCAVATION = 55,772 CY
WETLAND FILL = 71,226 CY

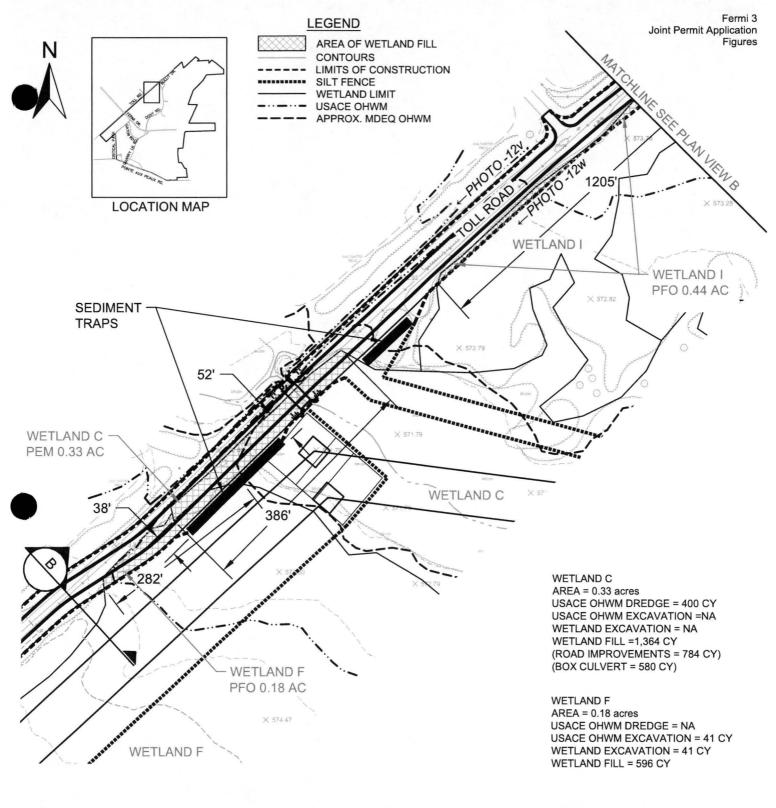
FIGURE 12-8A NEW OPERATIONS ACCESS ROAD PLAN VIEW A

- SPOILS FROM EXCAVATION WILL BE PLACED IN CONSTRUCTION AREA 1.
- 2. MECHANIZED LAND CLEARING WILL OCCUR WITHIN THE CONSTRUCTION FOOTPRINT.
- WETLAND C IMPACTS ARE FROM THE ROAD IMPROVEMENTS AND BOX CULVERT. (FIGURE 14-2E)

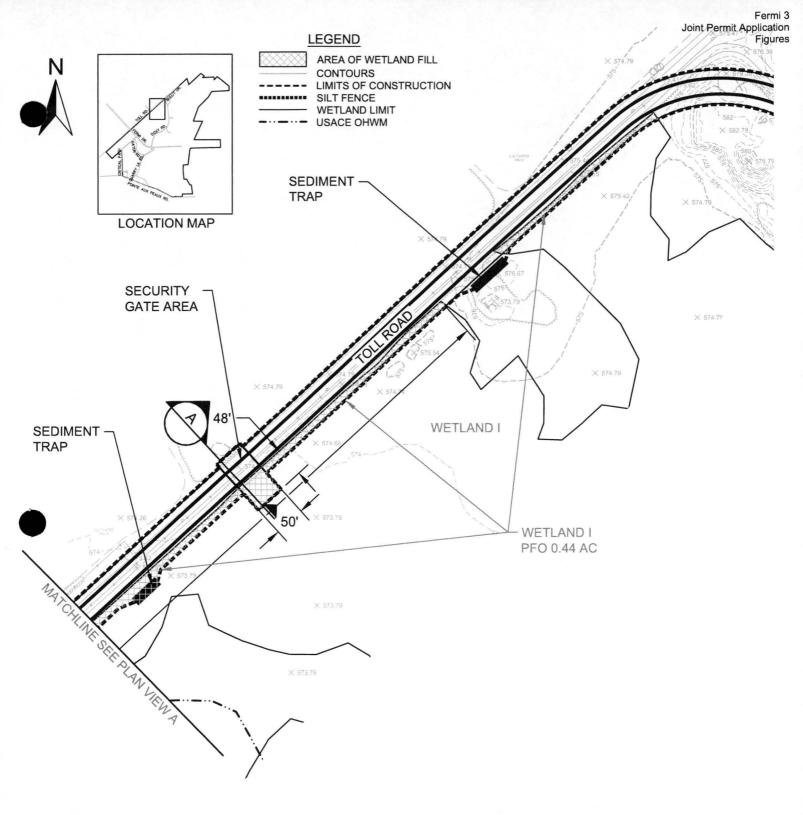
FIGURE 12-8B NEW OPERATIONS ACCESS ROAD PLAN VIEW B

- SPOILS FROM EXCAVATION WILL BE PLACED IN CONSTRUCTION AREA 1.
- 2. MECHANIZED LAND CLEARING WILL OCCUR WITHIN THE CONSTRUCTION FOOTPRINT.

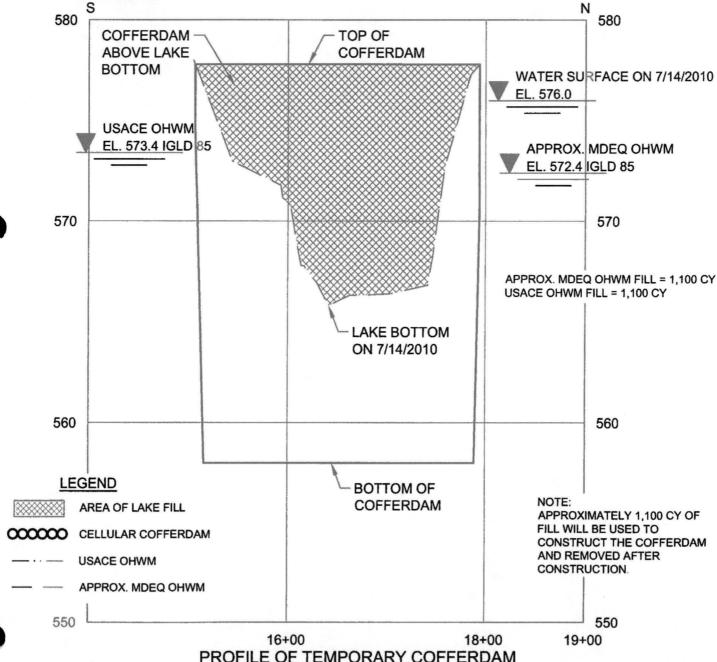
SCALE: 1"=100' HORZ.; 1"=5' VERT. (IGLD 85 DATUM) FIGURE 10-2F LAKE ERIE CONSTRUCTION AREA PROPOSED COFFERDAM

PROFILE OF TEMPORARY COFFERDAM
