Subject: [External_Sender] SALEM GENERATING STATION-INCIDENTAL TAKE OF ATLANTIC STURGEON
Sent Date: 3/23/2022 12:39:43 PM
Received Date: 3/23/2022 12:40:07 PM
From: Strait, Kenneth A.

Appendix C, Part 2A (Sturgeon)

STURGEON DATA COLLECTION FORM

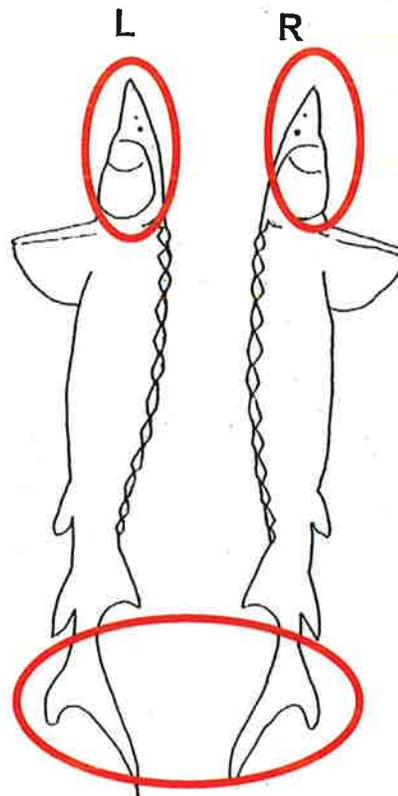
Draw wounds, abnormalities, tag locations on diagram and briefly describe below

Bones and surface
scutes above the
operculum missing

Bones at the top of the
skull showing severe
fractures. The eye on the
right side of the head
missing.

A laceration observed on
the ventral portion of the
caudal peduncle and
evidence of decomposition
along the edge of caudal
fin.

Describe any wounds / abnormalities (note tar or oil, gear or debris entanglement, propeller damage, etc.). **Please note if no wounds / abnormalities are found. Specimen was deceased and in a moderate state of decomposition at the time of collection and observation. The head shows evidence of severe skull fractures, with missing bone and scutes above the left operculum, and a missing eye on the right side. Additional damage includes a laceration to the ventral portion of the caudal peduncle, in the area of the anal fin. Decomposition observed along the edges of the caudal fin (refer to illustration).**

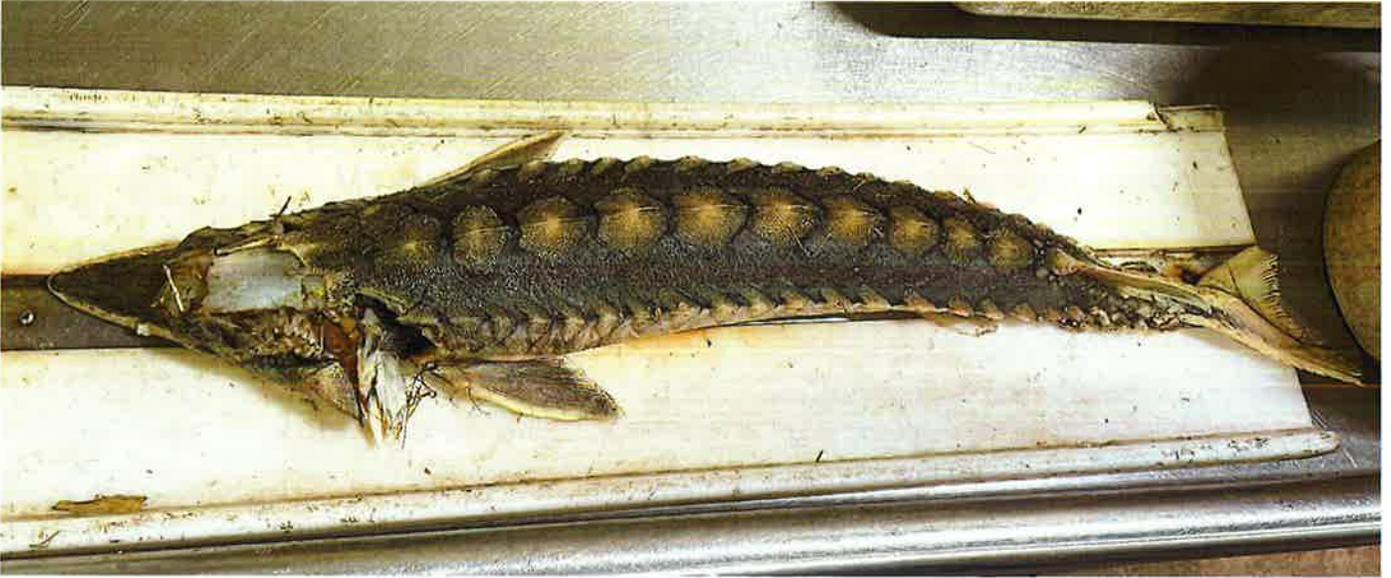
A dorsal view, showing the size and condition of a deceased and moderately decomposed Atlantic sturgeon (*Acipenser oxyrinchus*), retrieved at approximately 13:57 on 03/22/2022 from the Salem Circulating Water Intake trash collection basket by Salem Yard Crew personnel during routine trash rack cleaning at Salem Nuclear Generating Station (03/22/2022).

Comments: A deceased and moderately decomposed Atlantic sturgeon was collected from the Salem Circulating Water Intake Structure during routine trash rack cleaning on 03/22/2022, at approximately 13:57. After positive identification was made by Environmental Consulting Services personnel, the specimen was photographed and inspected for tags. No evidence of external tags was found, and no existing PIT tag was indicated. A pelvic fin clip was also collected for future DNA analysis. Upon completion of processing, the specimen was placed on ice and prepared for transport back to the ECSI main office, where it will be stored under refrigeration, awaiting direction on further disposition. The fin clip sample has been stored in refrigeration and will be held for aggregated shipment to a designated laboratory.

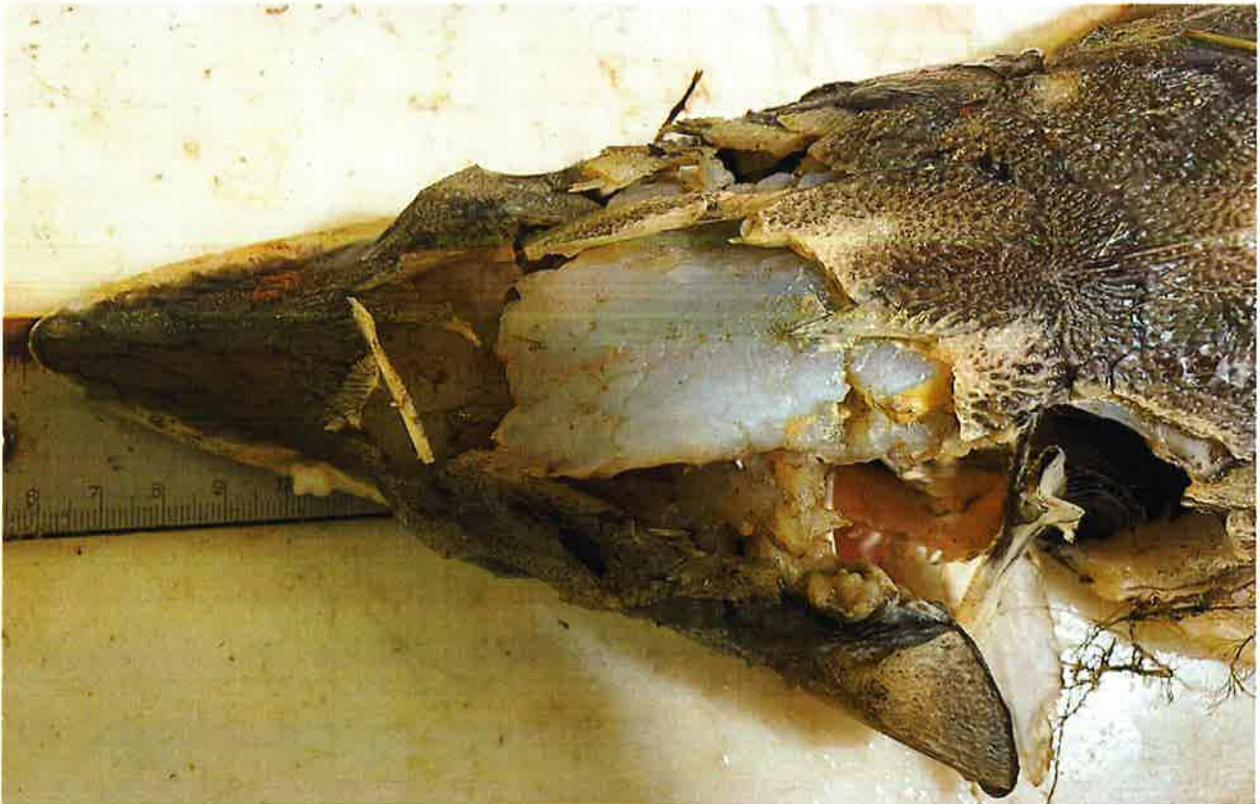
A dorsal view, showing severe fractures of the bones at the top of the skull. Damage to the head also included missing bone and scutes in the vicinity of the operculum on the left side, and a missing eye on the right side of the head (03/22/2022).

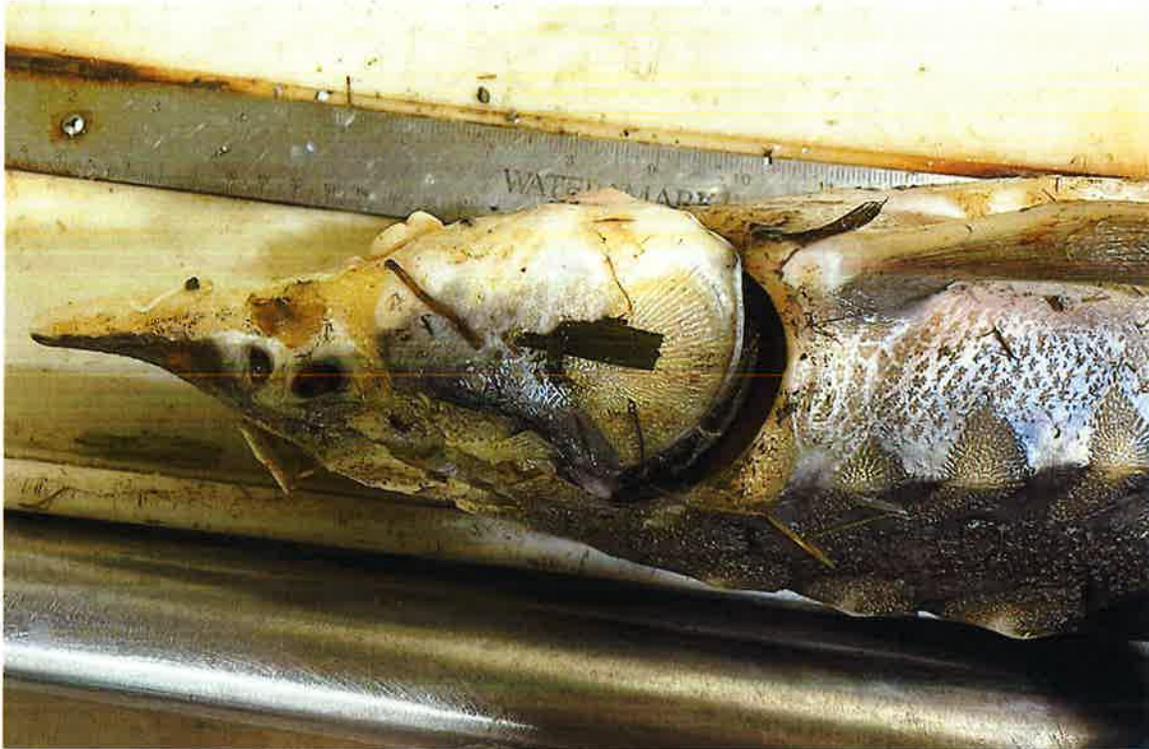
A right dorsolateral view, showing a missing eye and evidence of bone fractures of the skull (03/22/2022).

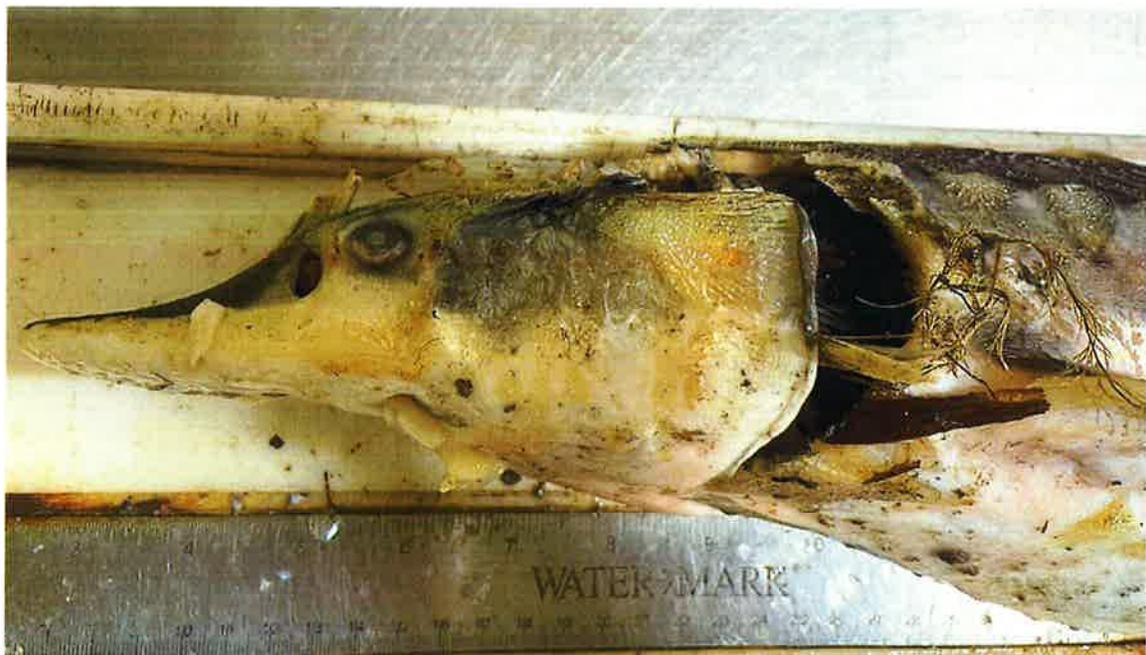
A left dorsolateral view, showing some evidence of bone fractures at the top of the skull and missing bone above the operculum (03/22/2022).

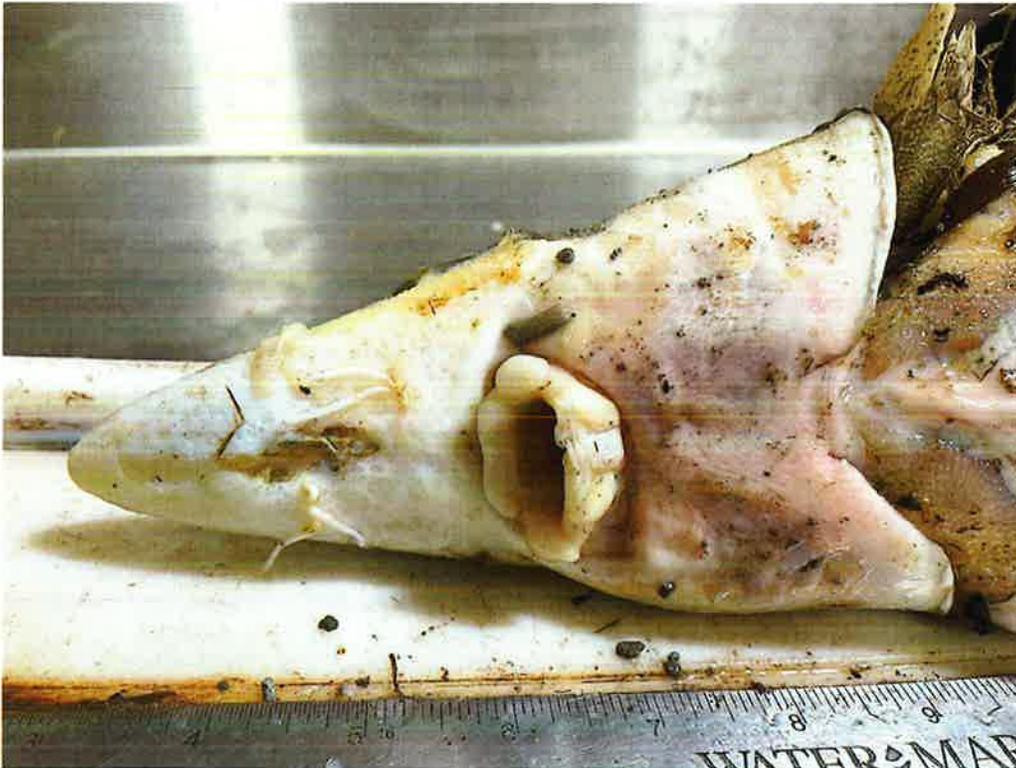
A ventral view of the specimen, showing the characteristic long rostrum and small mouth (03/22/2022).

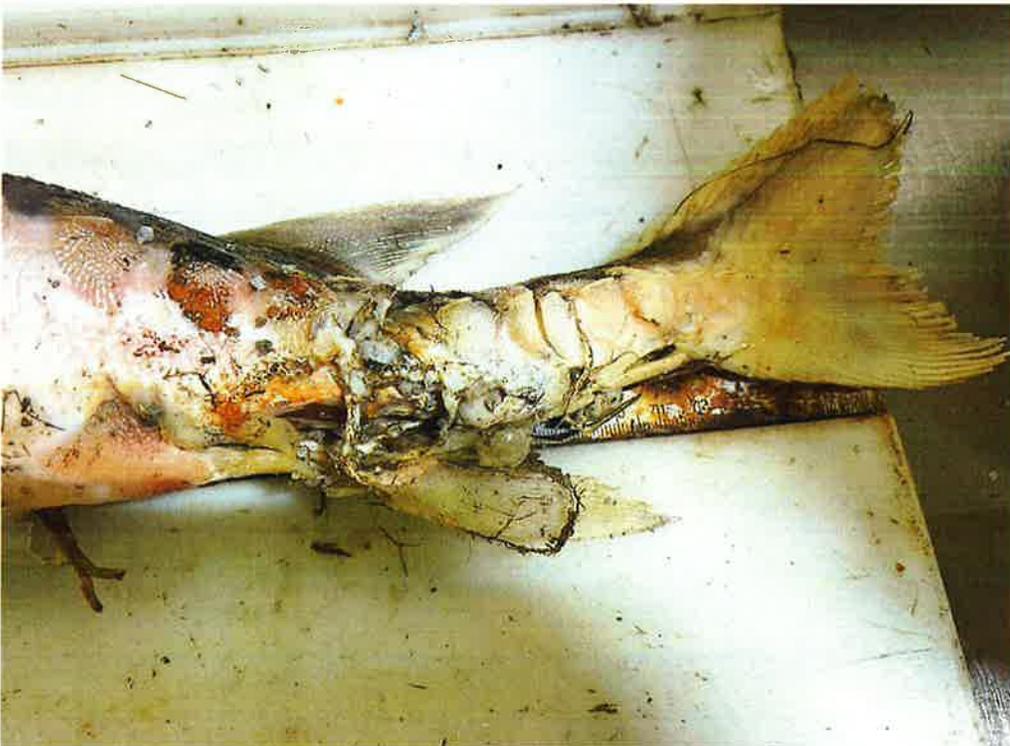
A left, dorsolateral view of the tail, showing a laceration to the ventral portion of the caudal peduncle, in the vicinity of the anal fin, and evidence of decomposition of the tissue on the outer edges of the caudal fin (03/22/2022).
