APPENDIX B – Part 1 (Sea Turtle)

**Incident Report Sea Turtle Take – PSEG Salem Generating Station**

**Salem SGS Incidental Take Report - Sea Turtle  
Attachment 1**

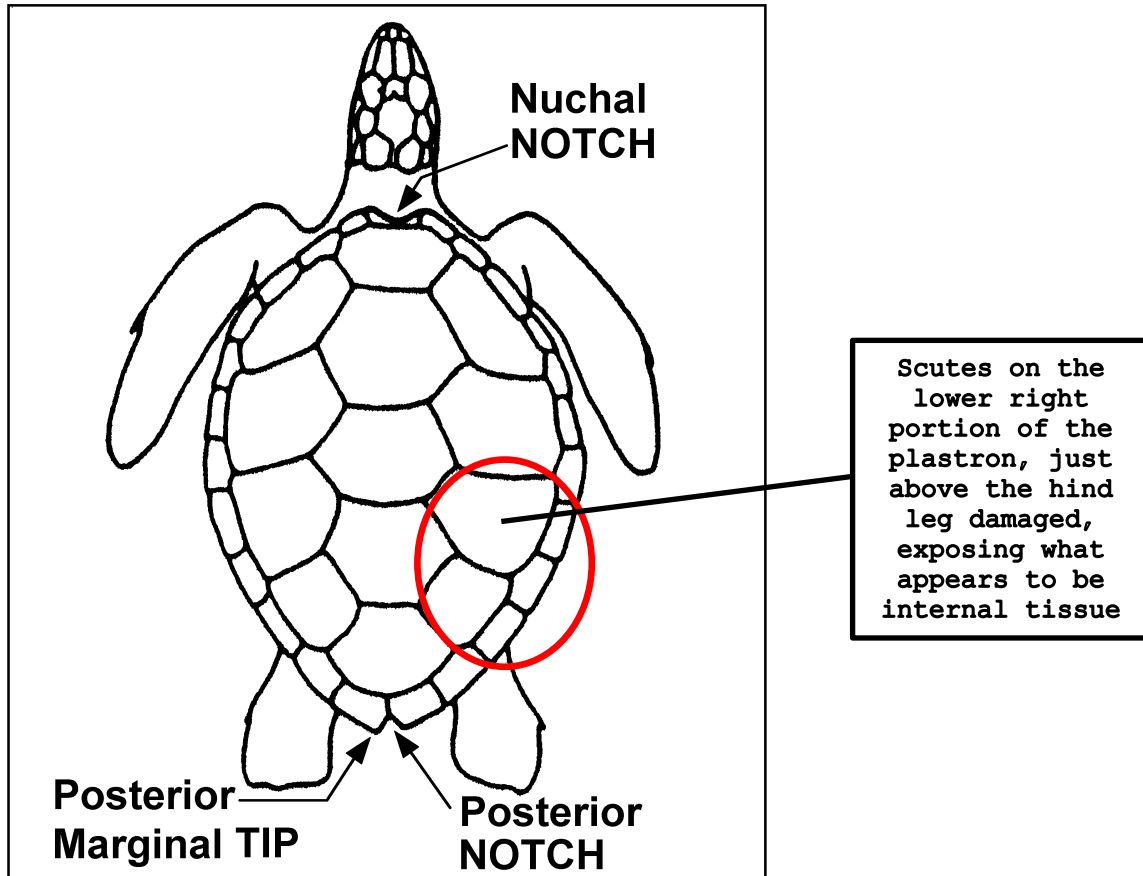
Draw wounds, abnormalities, tag locations on diagram and briefly describe below.

**At the time of processing, the specimen was deceased, with damage observed to the scutes in the lower right portion of the plastron, exposing flesh and underlying tissue (refer to illustration). Specimen was also exhibiting the early stages of decomposition, indicated by the loss of the surface layer of several scutes on the carapace, and by exhibiting a foul odor. Based on this evidence, it is likely the specimen perished at some point prior to its observation and collection at the facility. External tags were not observed, and an internal PIT tag was not indicated.**

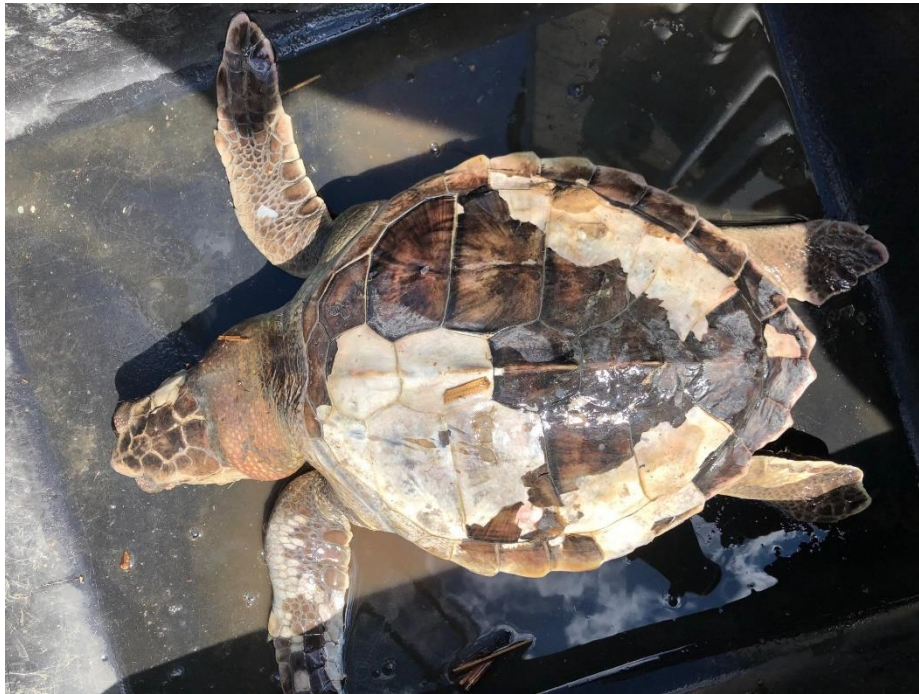
Dorsal view of a deceased Kemp's ridley sea turtle, as it appeared after retrieval from Salem CWIS intake on 08-31-2022 by Salem Yard crew personnel. Specimen revealed signs of the onset of decomposition, indicated by the missing Surface layer on several scutes on the carapace as well as a foul odor (08/31/2022).

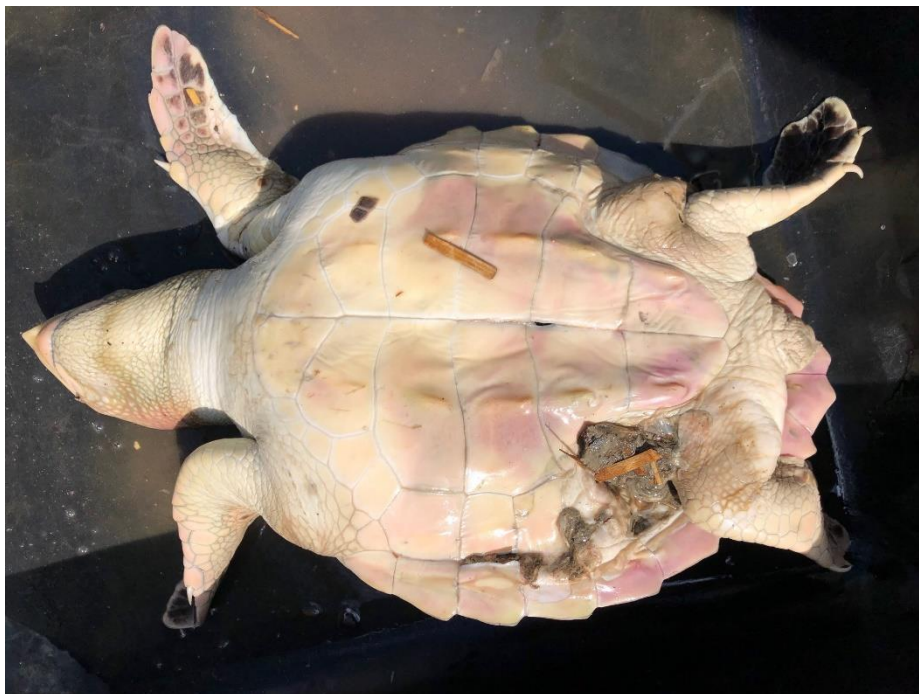
A ventral view of the specimen, showing the condition of the plastron. Damage to scutes was observed in the lower right portion of the body, with flesh and tissue exposed just above the hind leg (08/31/2022).

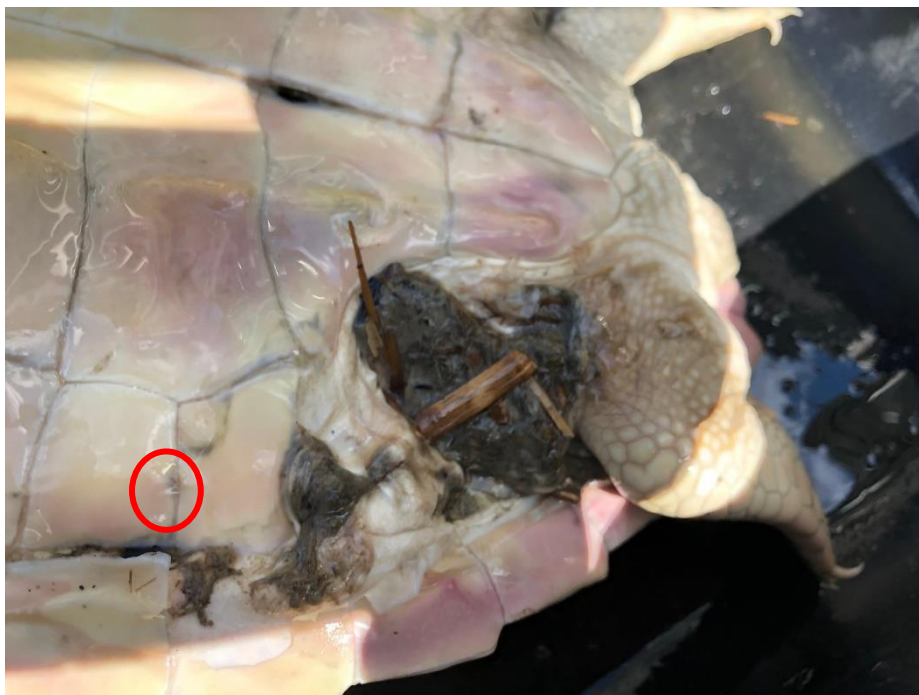
A posterior view, providing a close up of damaged scutes and exposed flesh observed in the lower right portion of the plastron. The overall round body appearance and the existence of distinct pores near the margins of each of the four inframarginal scutes, as indicated by the red circle in the photo, verify the identity of the specimen as a Kemp's ridley (08/31/2022).
