SEABROOK STATION UPDATED FINAL SAFETY ANALYSIS REPORT	Site Topography and Plot Plan	
	Rev. 12	Figure 2.4-1

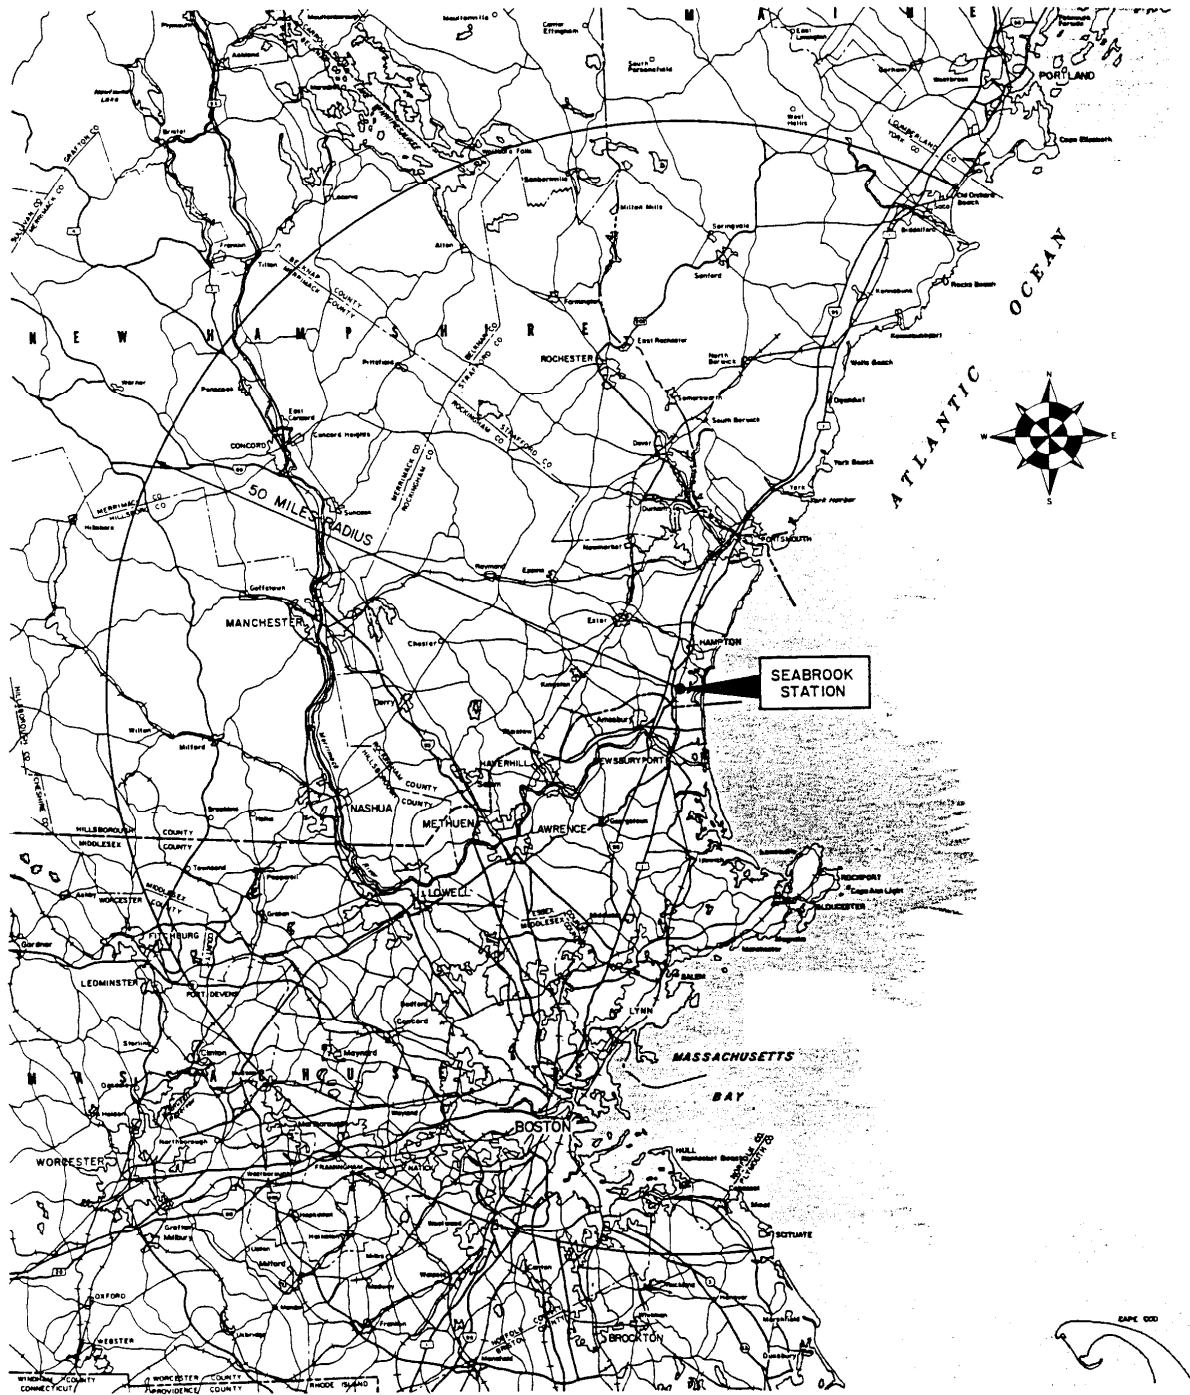
Figure 2.4-2

Topographic Map Depicting Major Hydrologic Features of
Region

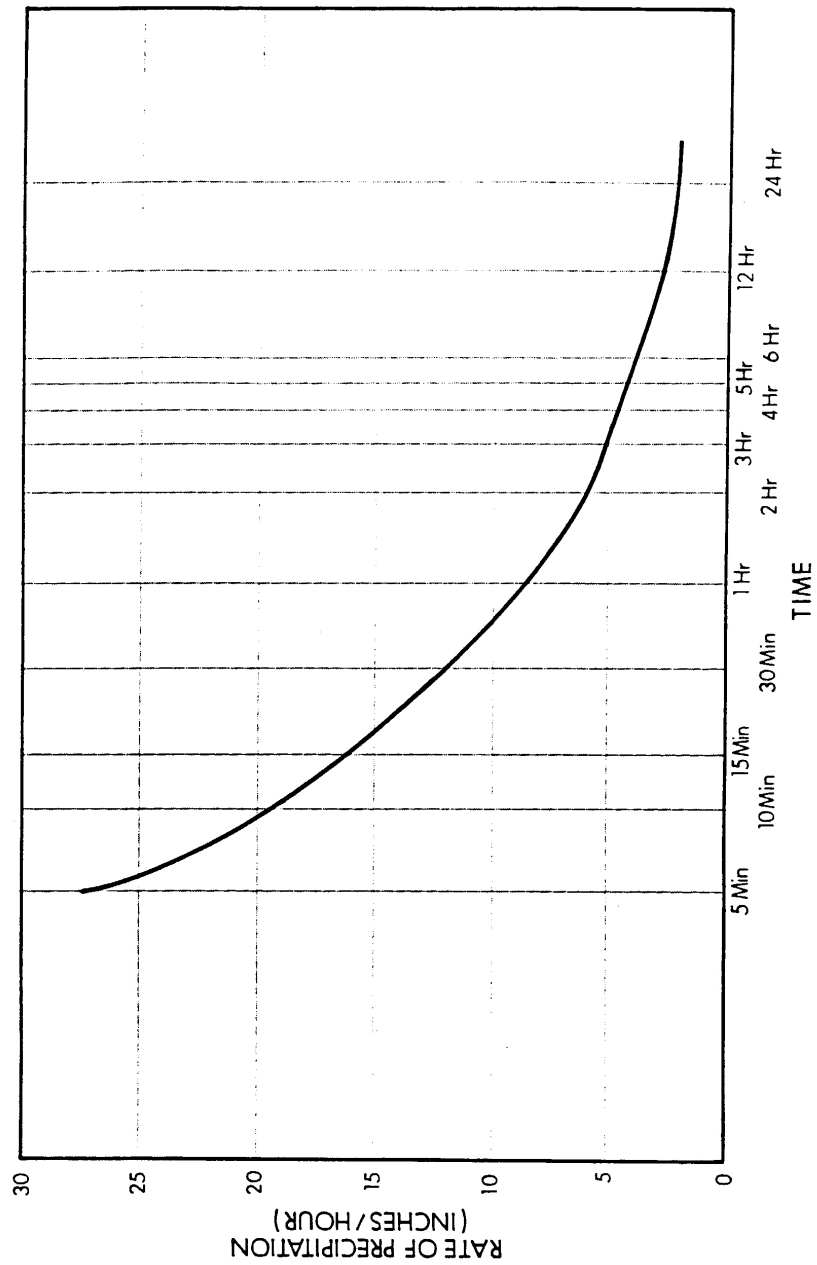
SEABROOK STATION UPDATED FINAL SAFETY ANALYSIS REPORT	Time Incremental Distribution of Local PMP	
		Figure 2.4-3

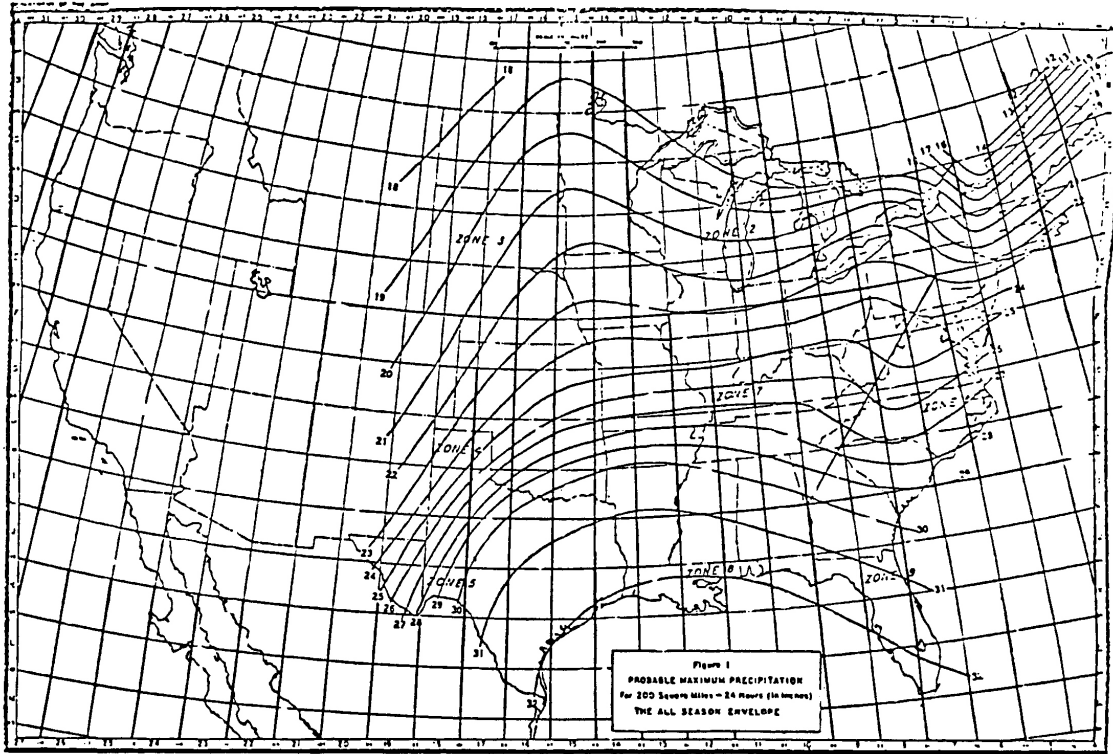
Figure 2.4-4

Probable Maximum Precipitation for 200 Square Miles – 24
Hours (in Inches) – The All Season Envelope

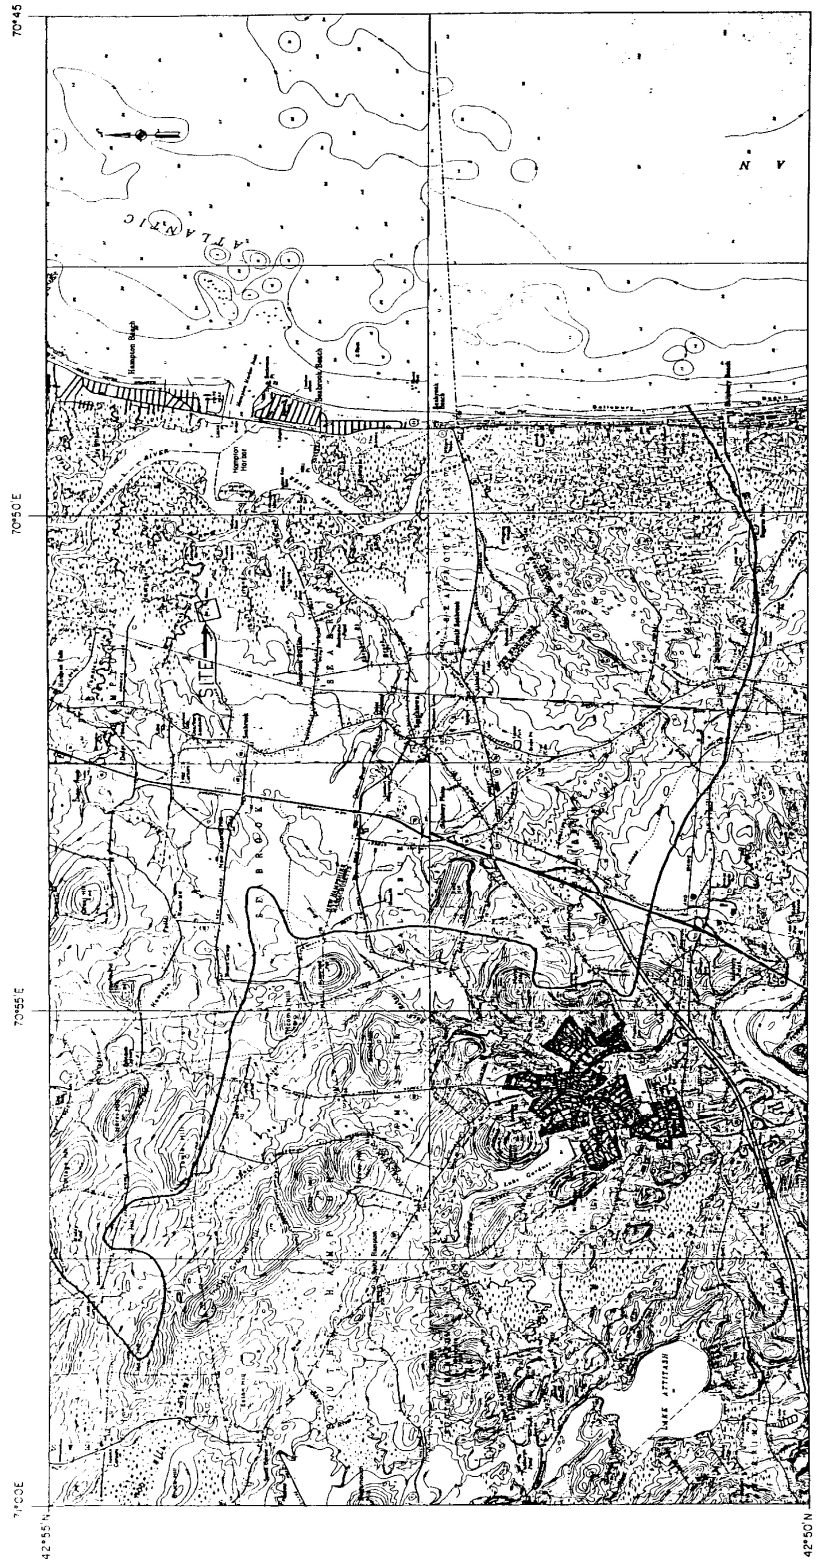
Figure 2.4-7 Sh. 2 of 2

Hampton Harbor Drainage Basin – Detailed Topography
[2 Sheets]

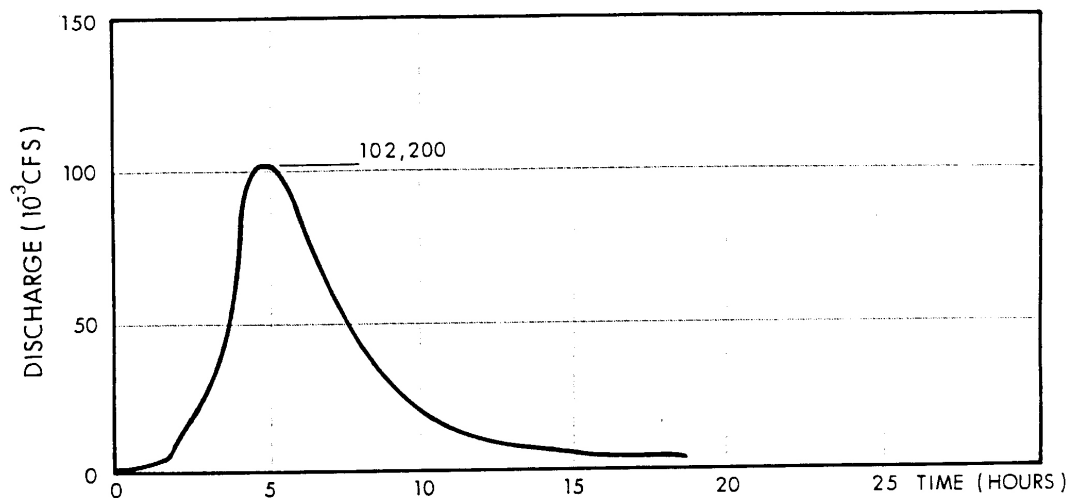
(A) NATURAL DRAINAGE AREA (35.2 SQ. MILES)

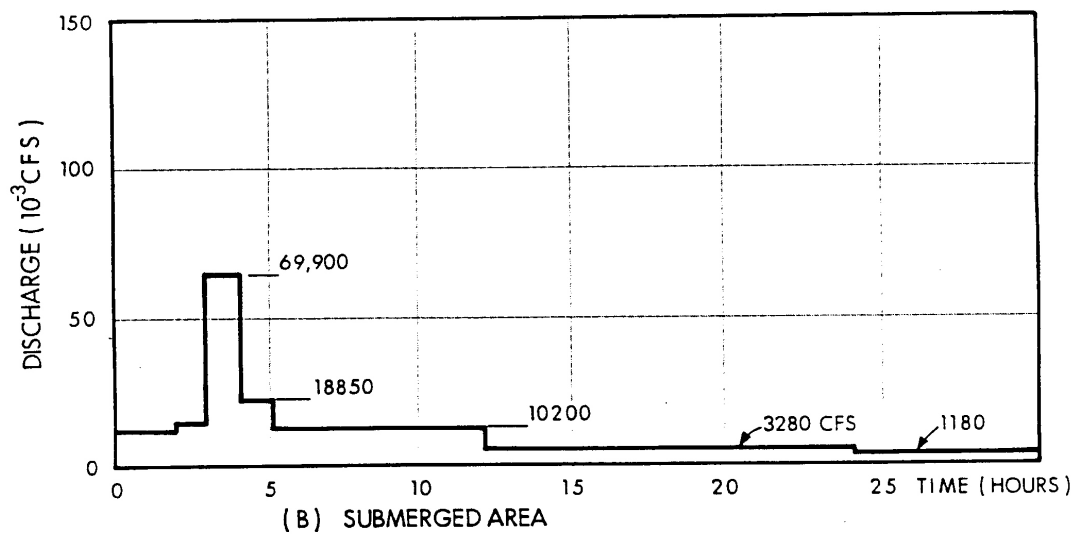
(B) SUBMERGED AREA

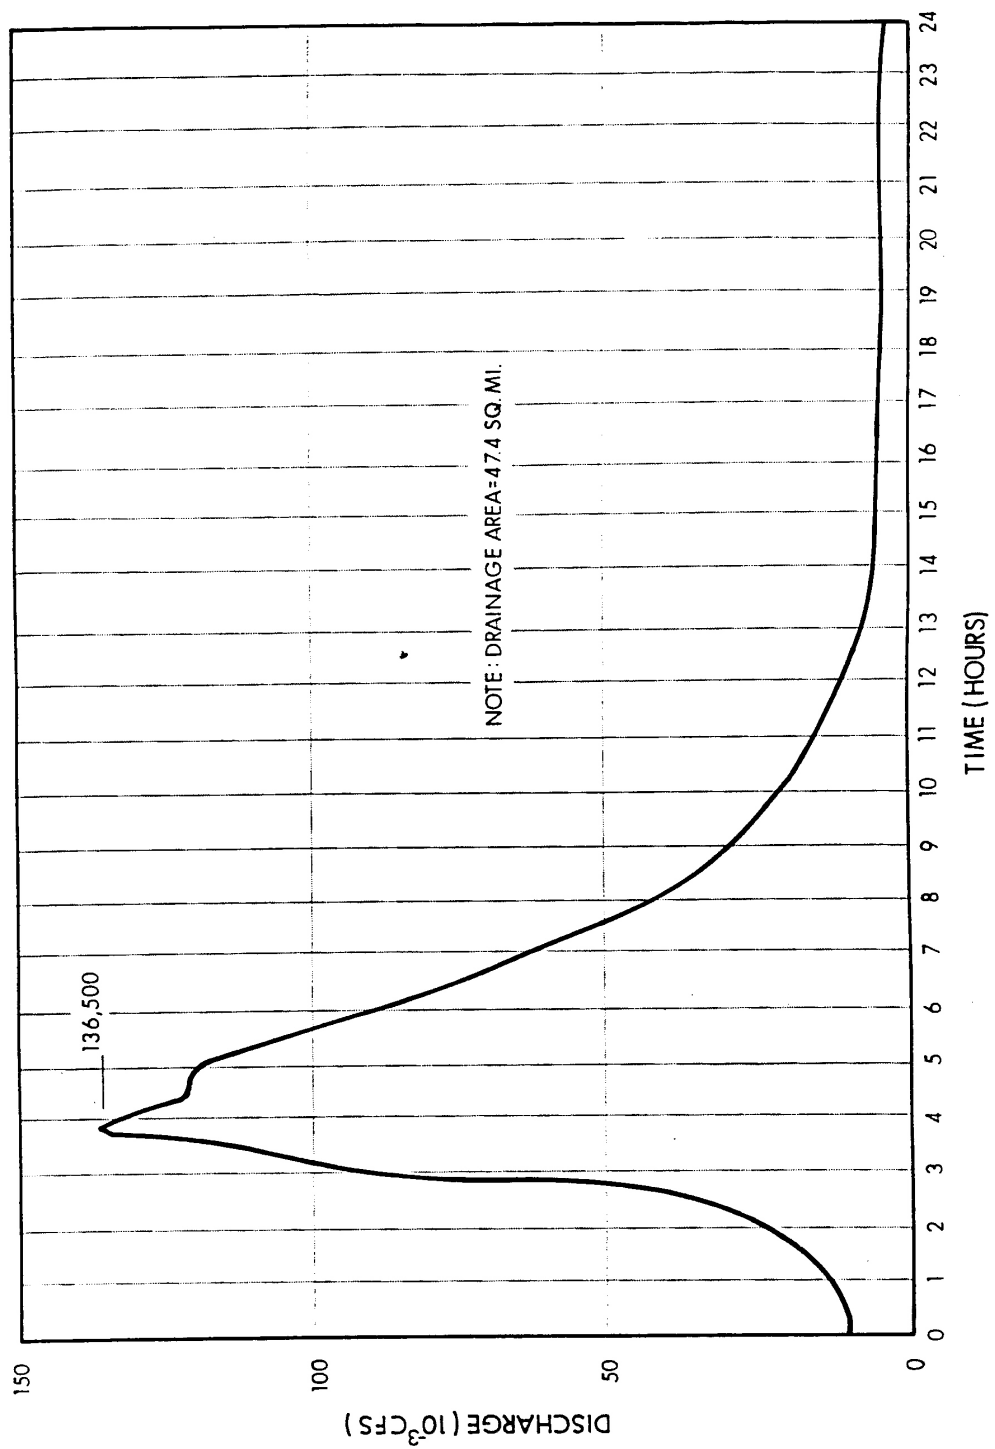
SEABROOK STATION UPDATED FINAL SAFETY ANALYSIS REPORT	PMF Discharge Hydrograph	
		Figure 2.4-9

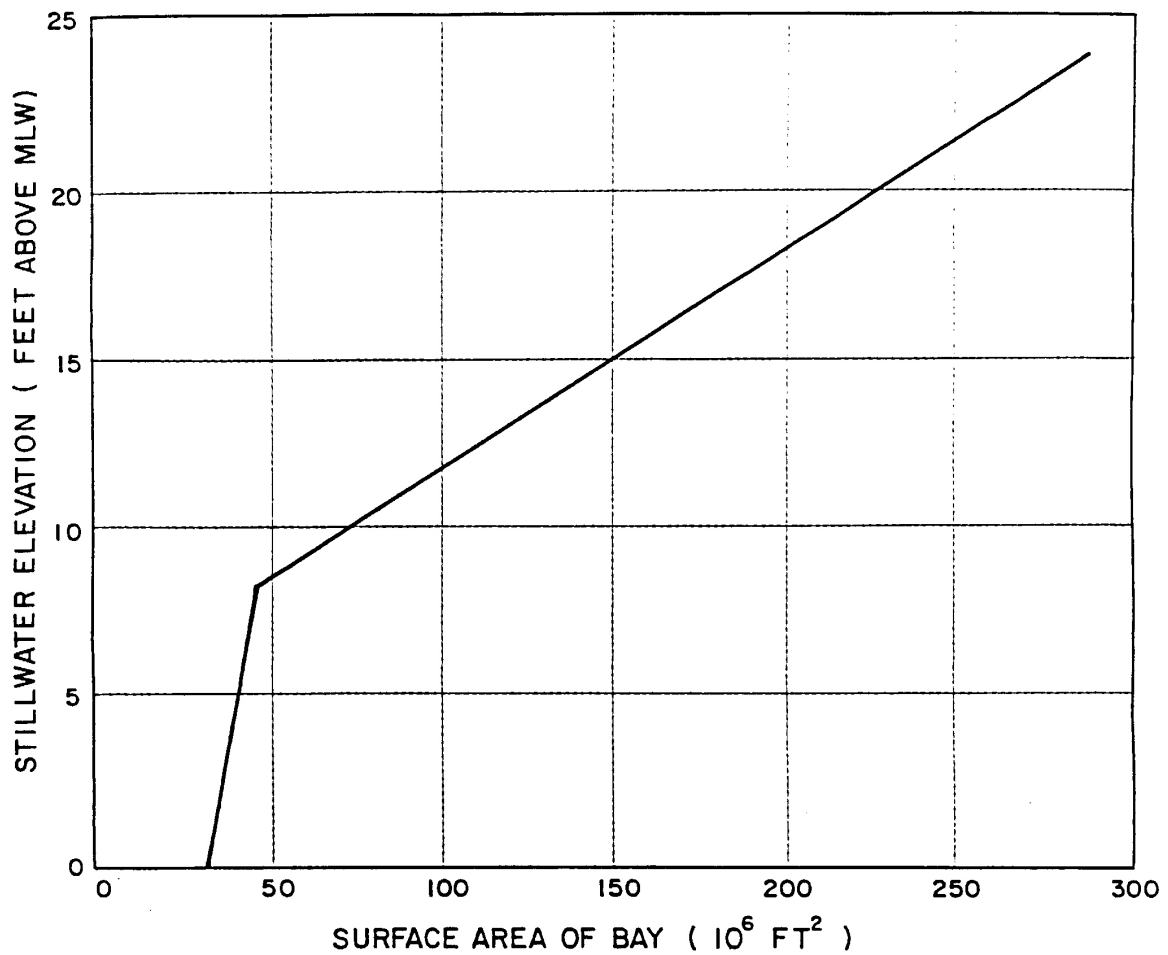
SEABROOK STATION UPDATED FINAL SAFETY ANALYSIS REPORT	Hampton Harbor Surface Area vs. Elevation	
		Figure 2.4-10

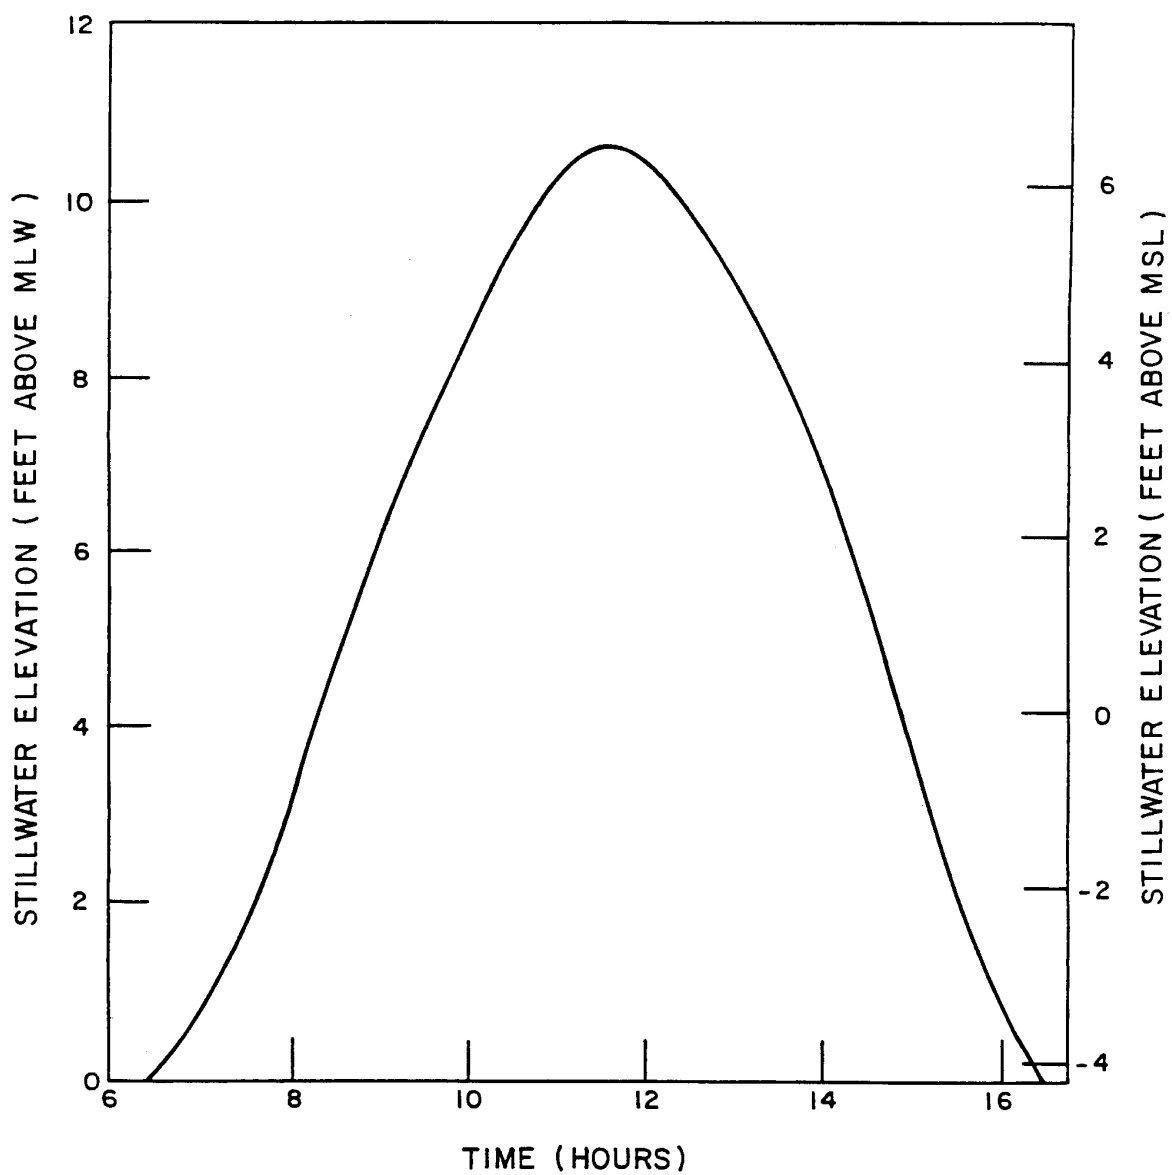
SEABROOK STATION UPDATED FINAL SAFETY ANALYSIS REPORT	Astronomical Tidal Cycle – Hampton Harbor – November 22, 1972	
		Figure 2.4-11

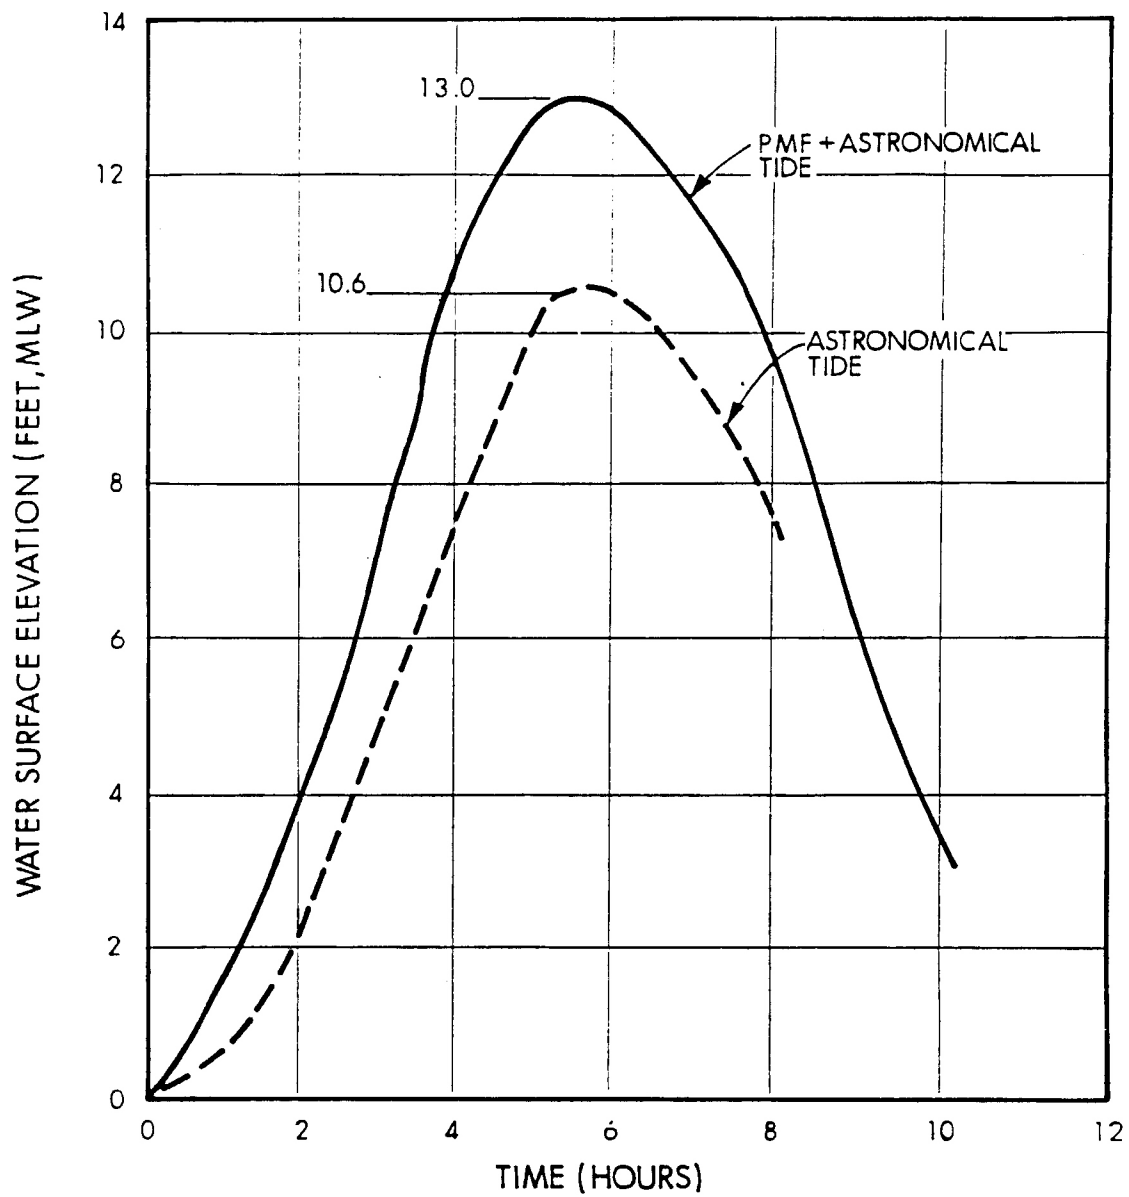
Figure 2.4-12

Hampton Harbor PMF Hydrograph

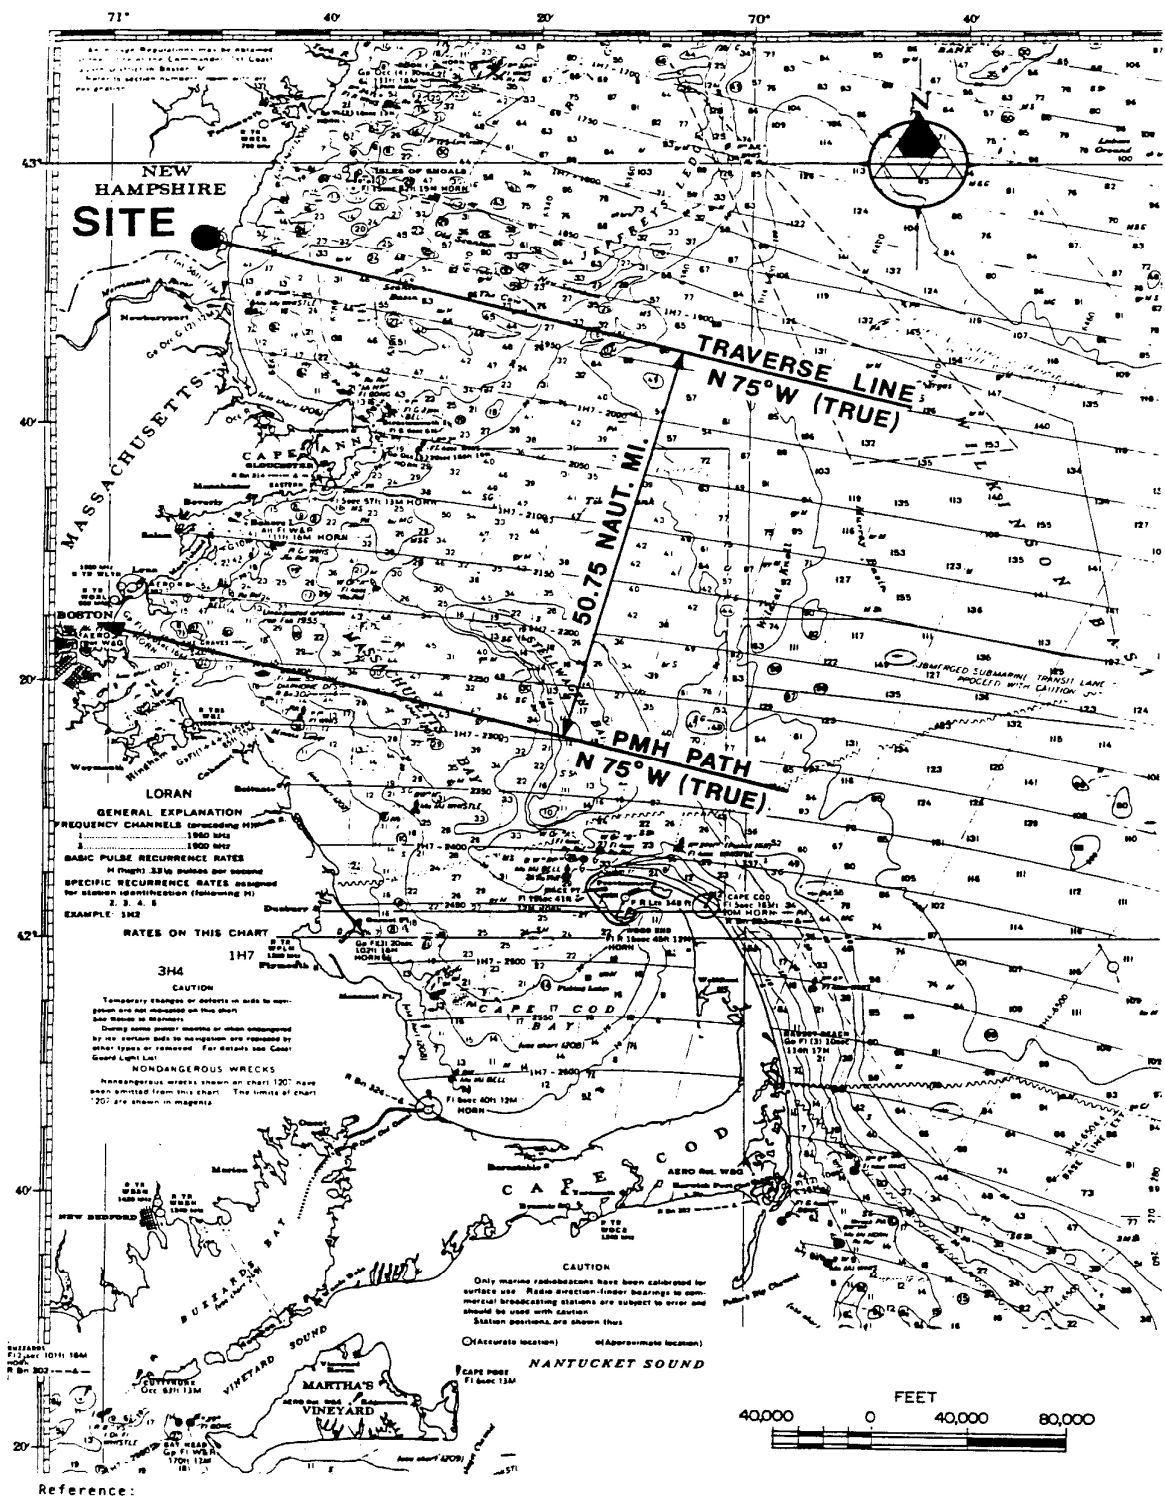
Figure 2.4-13

PMH Path

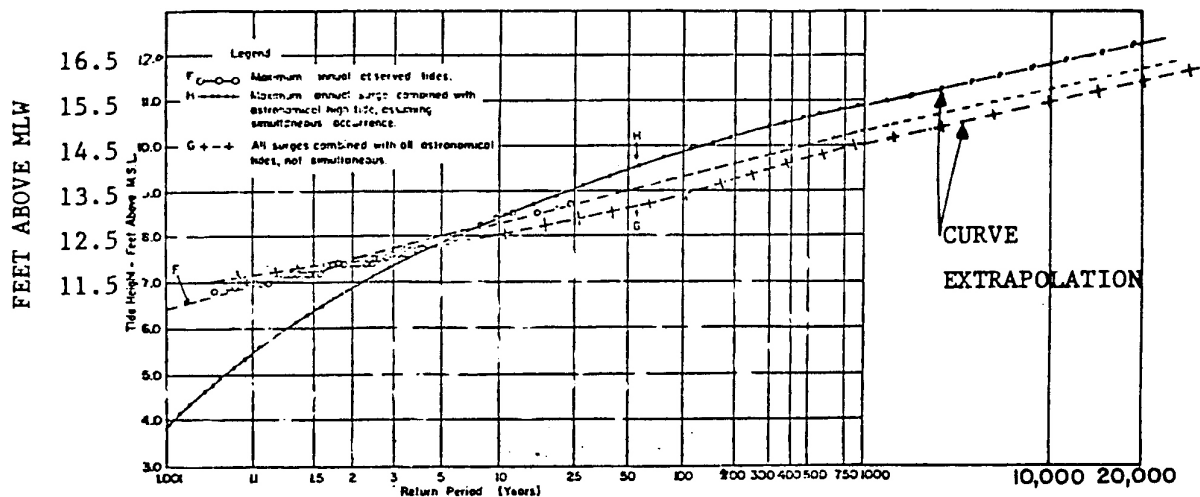
Estimated probability of extreme high tide height at Portland, Maine. (Based on data for 1914-1959.)

Estimated Probability of Extreme High Tide at Portland, Maine and Boston, Mass.

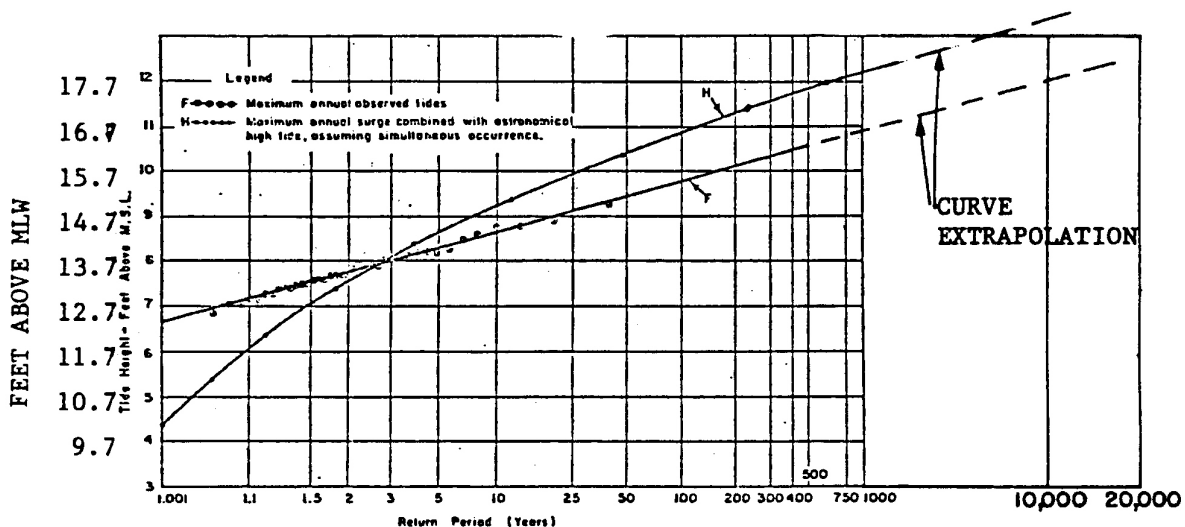
Estimated probability of extreme high tide height at Boston, Mass. (Based on data for 1922-1960)

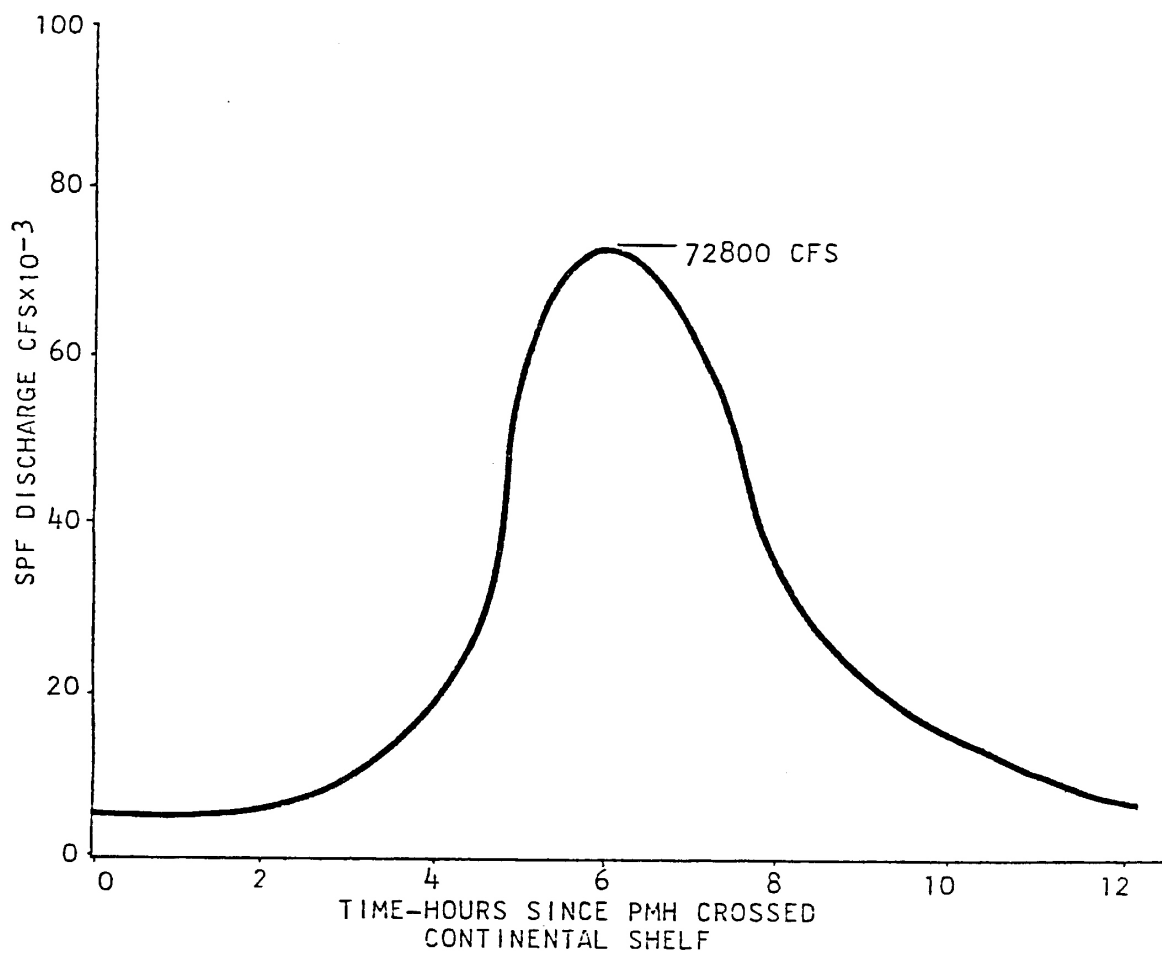
SEABROOK STATION UPDATED FINAL SAFETY ANALYSIS REPORT	SPF Discharge Hydrograph	
		Figure 2.4-17

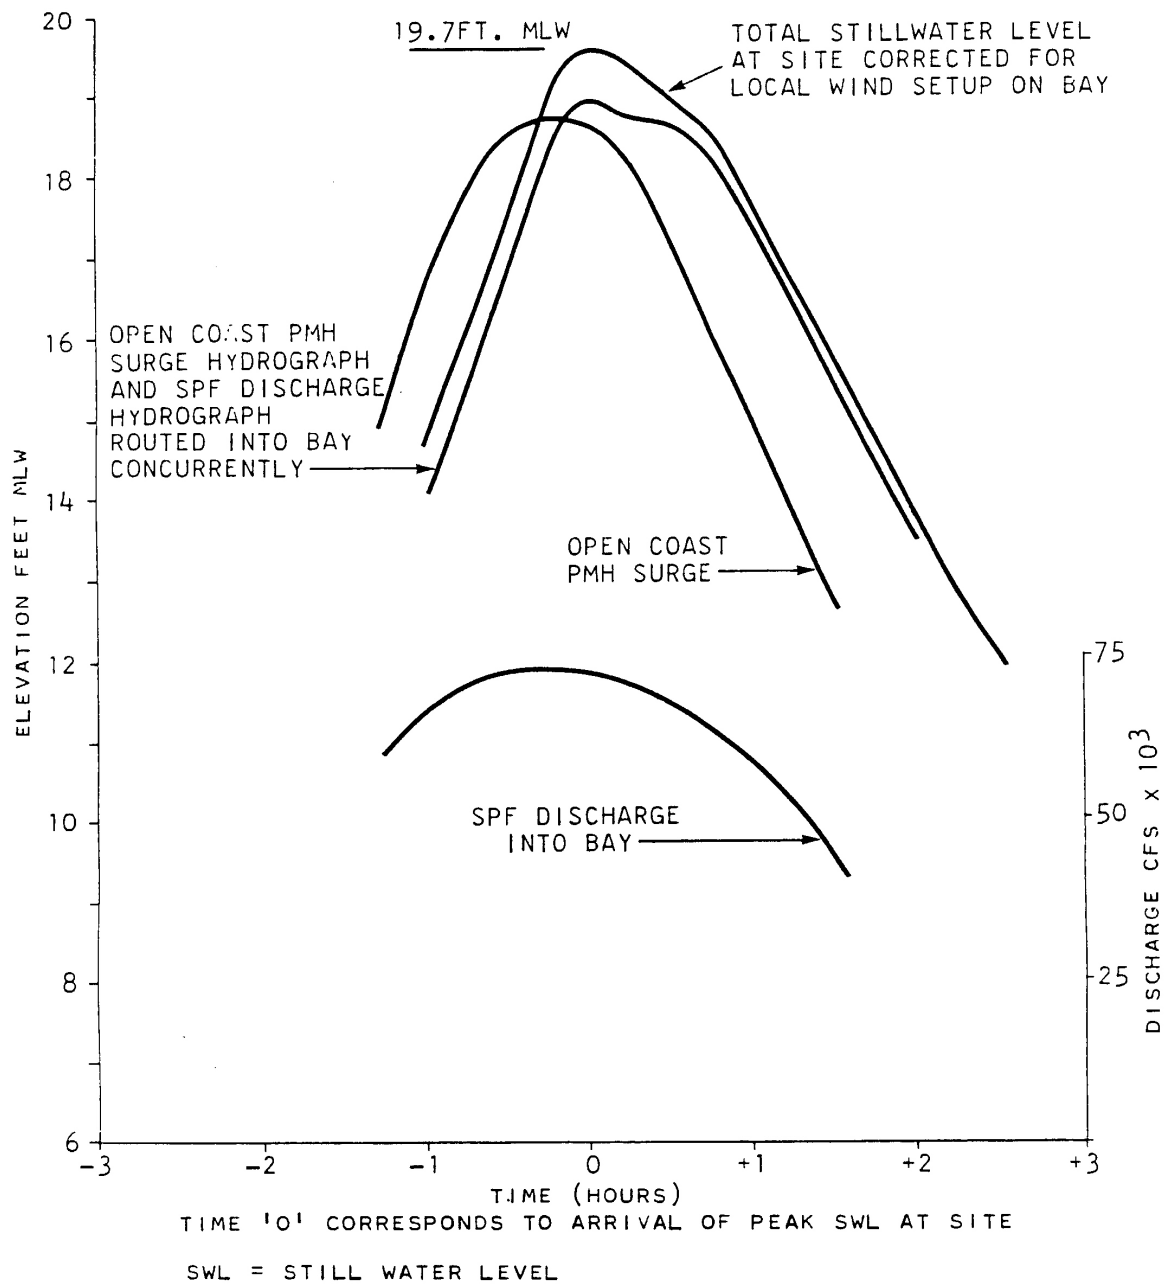
SEABROOK STATION UPDATED FINAL SAFETY ANALYSIS REPORT	Resultant PMH and SPF Stillwater Levels	
		Figure 2.4-18

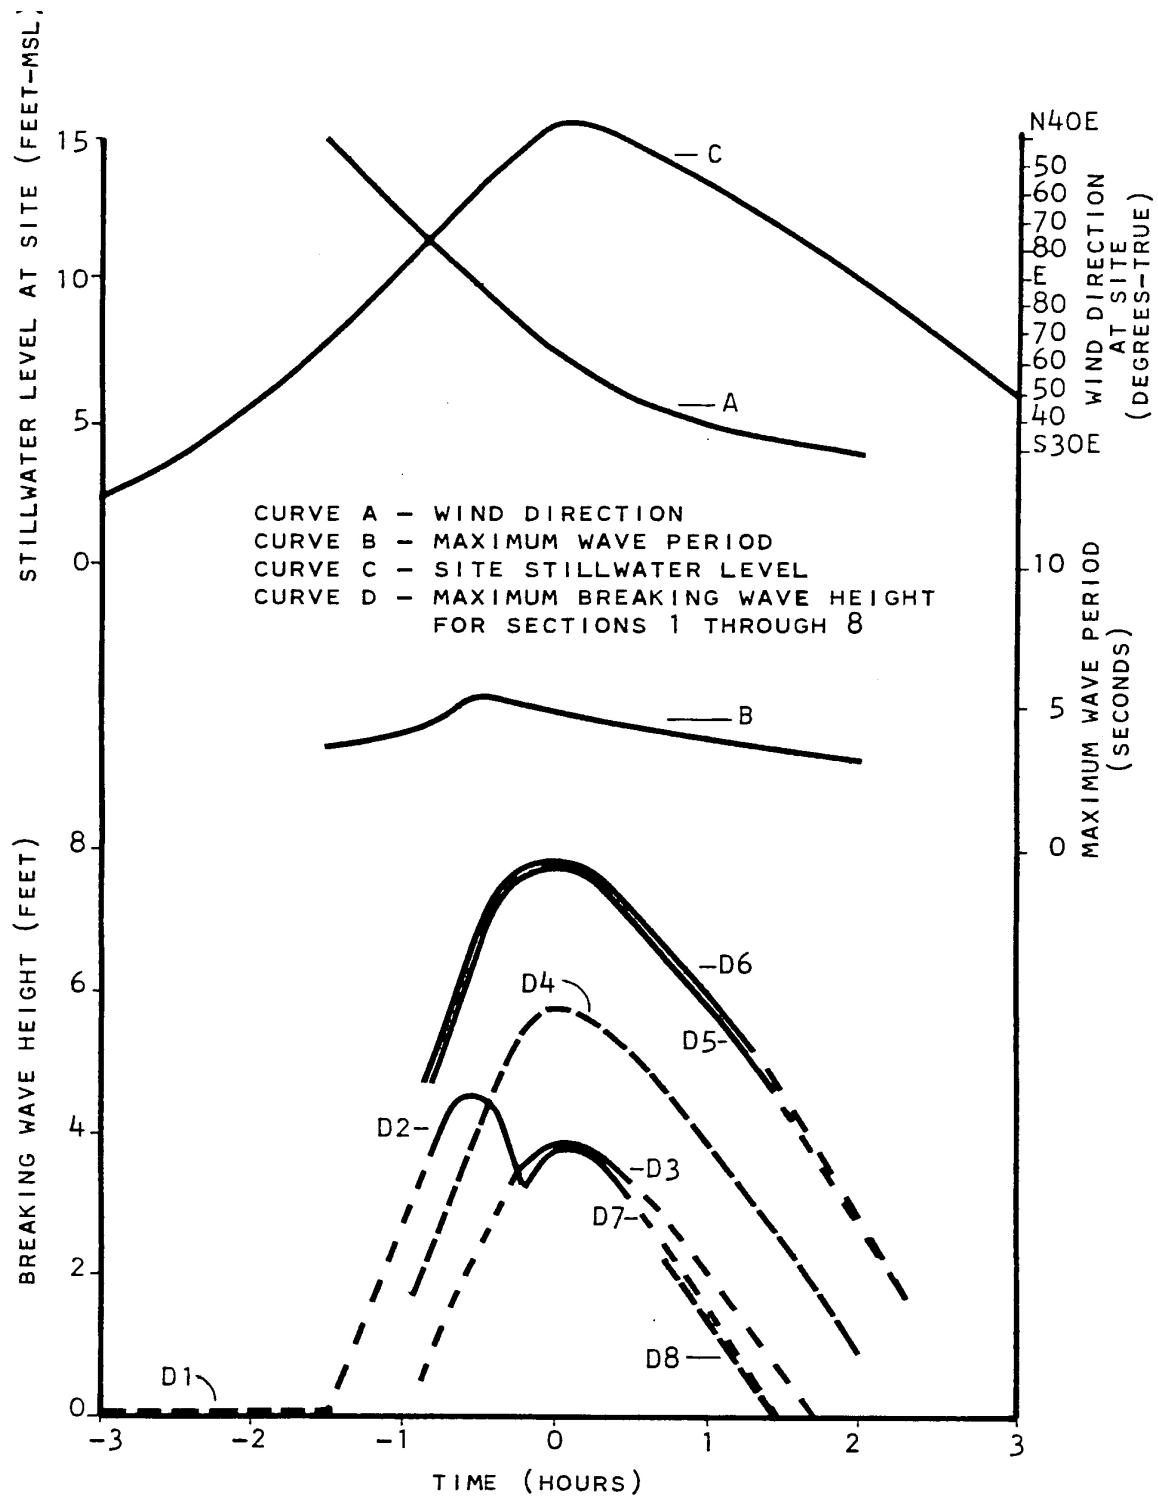
Figure 2.4-19

Design Wave Heights, Periods and Waterlevels

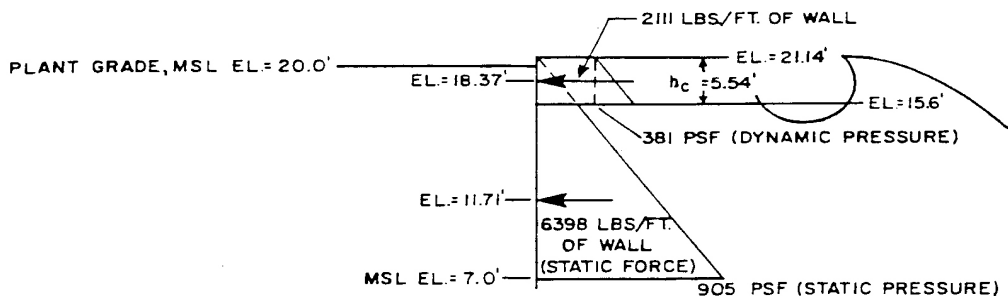
BROKEN WAVE CONDITION ON VERTICAL SEAWALL

WAVE PARAMETERS

$H_b = 7.91'$ (BREAKING WAVE HEIGHT)

$T =$ (INDEPENDENT OF WAVE PERIOD)

$d_s = 8.6'$ (WATER DEPTH IN FRONT OF STRUCTURE)

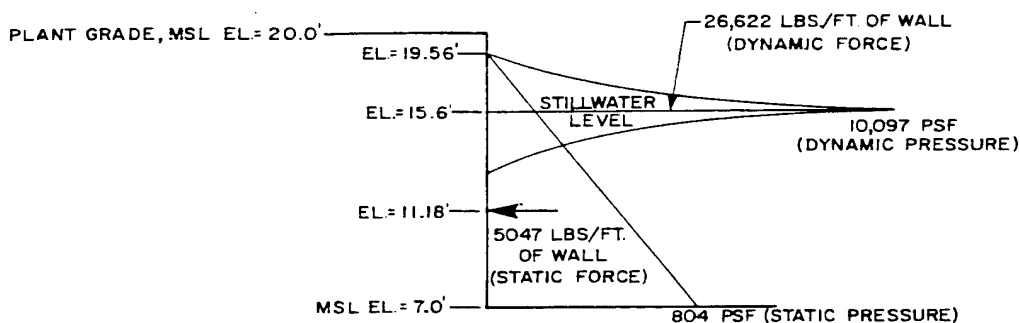
BREAKING WAVE CONDITION ON VERTICAL SEAWALL

WAVE PARAMETERS

$H_b = 7.91'$ (BREAKING WAVE HEIGHT)

$T = 4.8$ SECONDS (WAVE PERIOD)

$d_s = 8.6'$ (WATER DEPTH IN FRONT OF STRUCTURE)

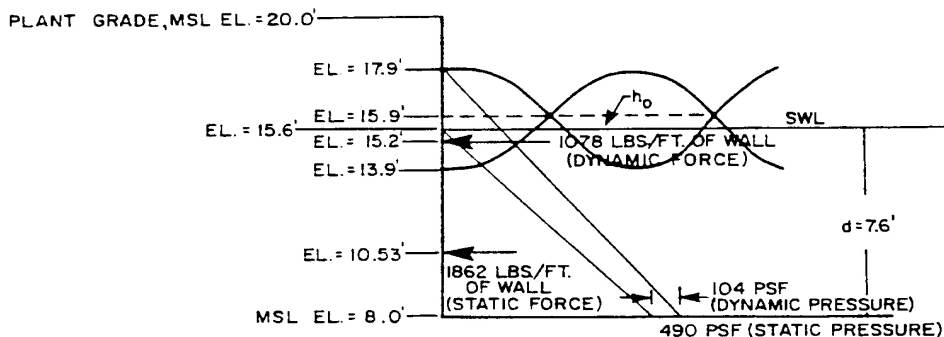
NON-BREAKING WAVE CONDITION ON RETAINING WALL

WAVE PARAMETERS

$H = 2.0'$ (WAVE HEIGHT)

$T = 4.8$ SECONDS (WAVE PERIOD)

$d_s = 7.6'$ (WATER DEPTH IN FRONT OF STRUCTURE)

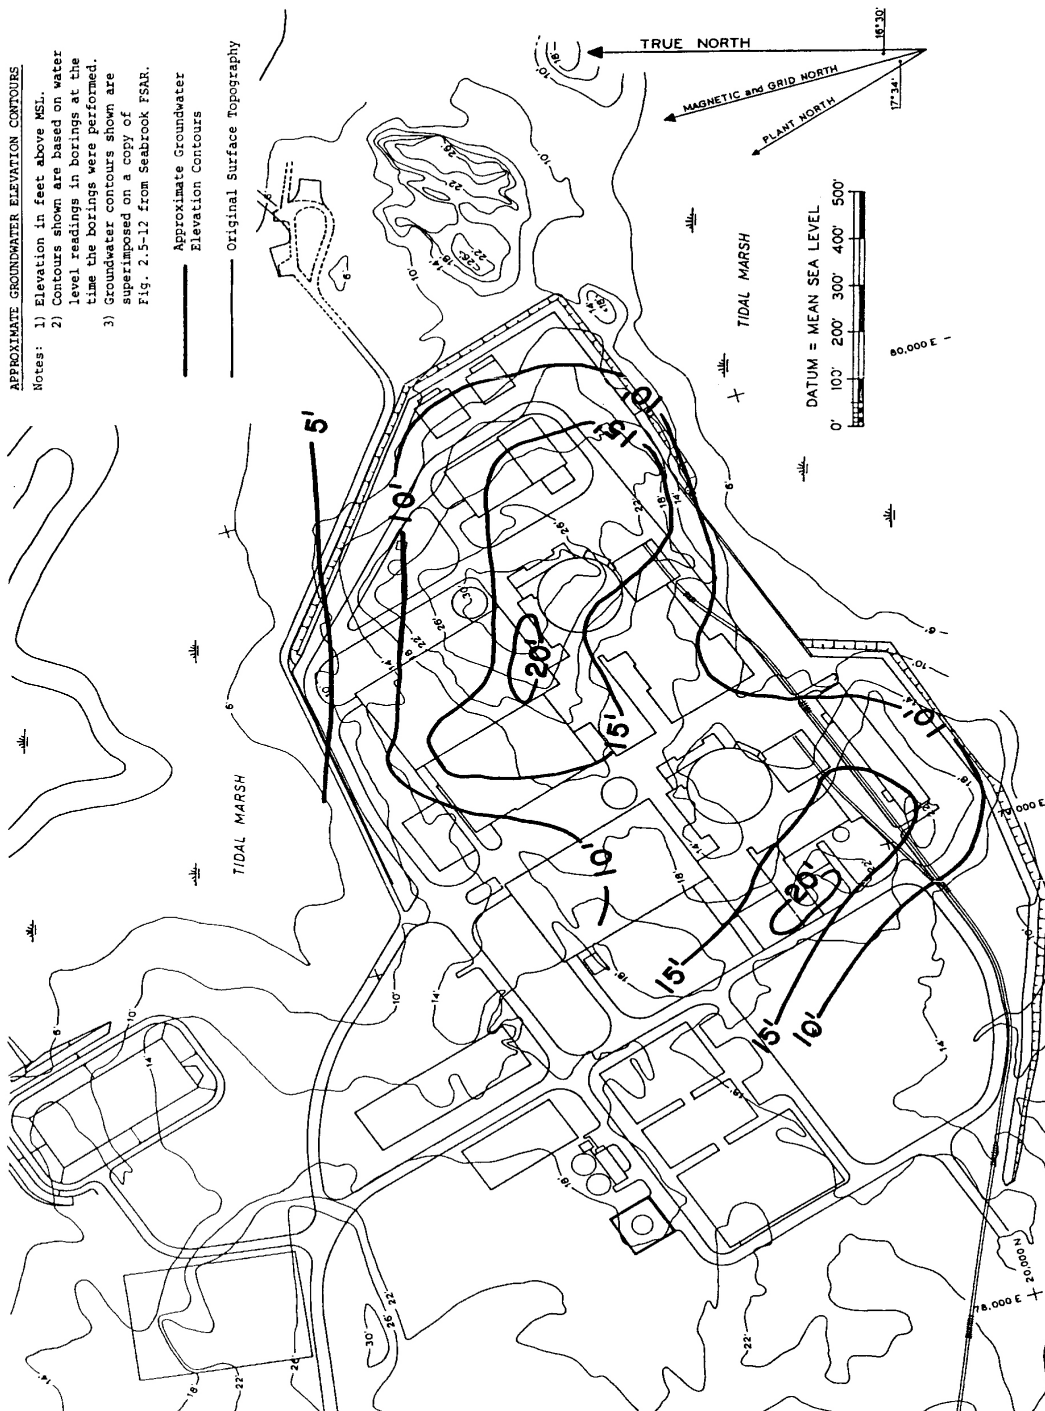
SEABROOK STATION UPDATED FINAL SAFETY ANALYSIS REPORT	Groundwater Contours in Plant Site Area Prior to Construction	
	Figure	2.4-29

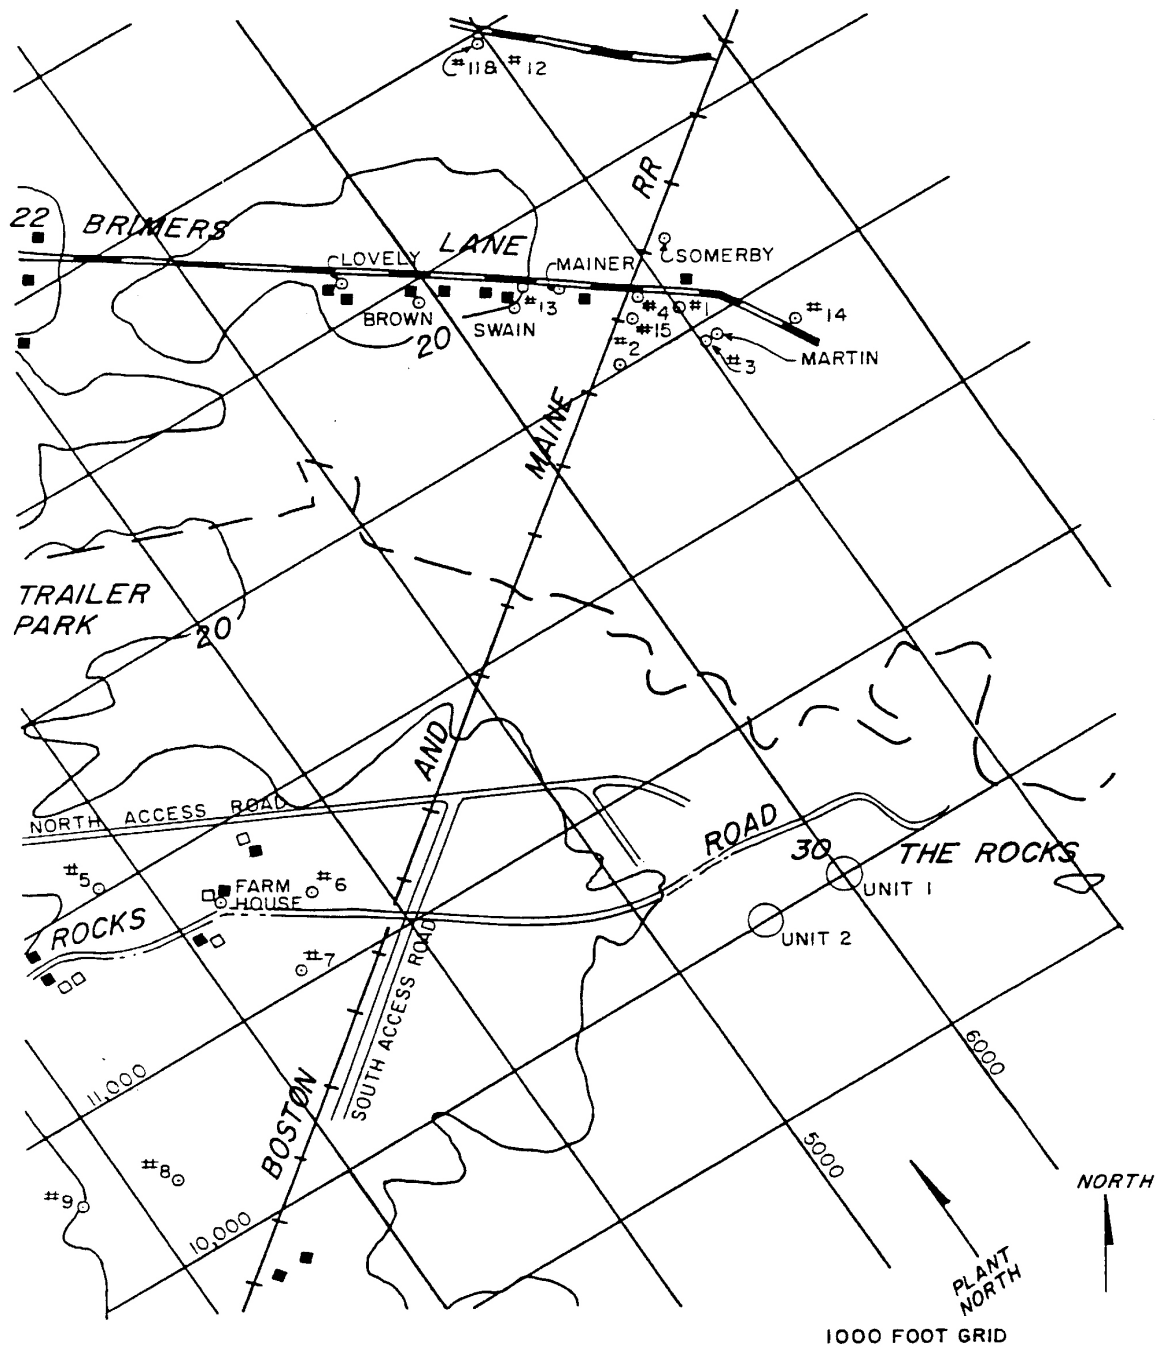
Figure 2.4-30

Site Vicinity Wells
